**Humboldt Secondary Complex *JR*
Saint Paul Public Schools**

Lead-Based Paint Inspection

Inspection Dates: 2/8/97, 2/11/97, 2/18/97, 2/19/97, 2/23/97

MEC Project # 62/0197F

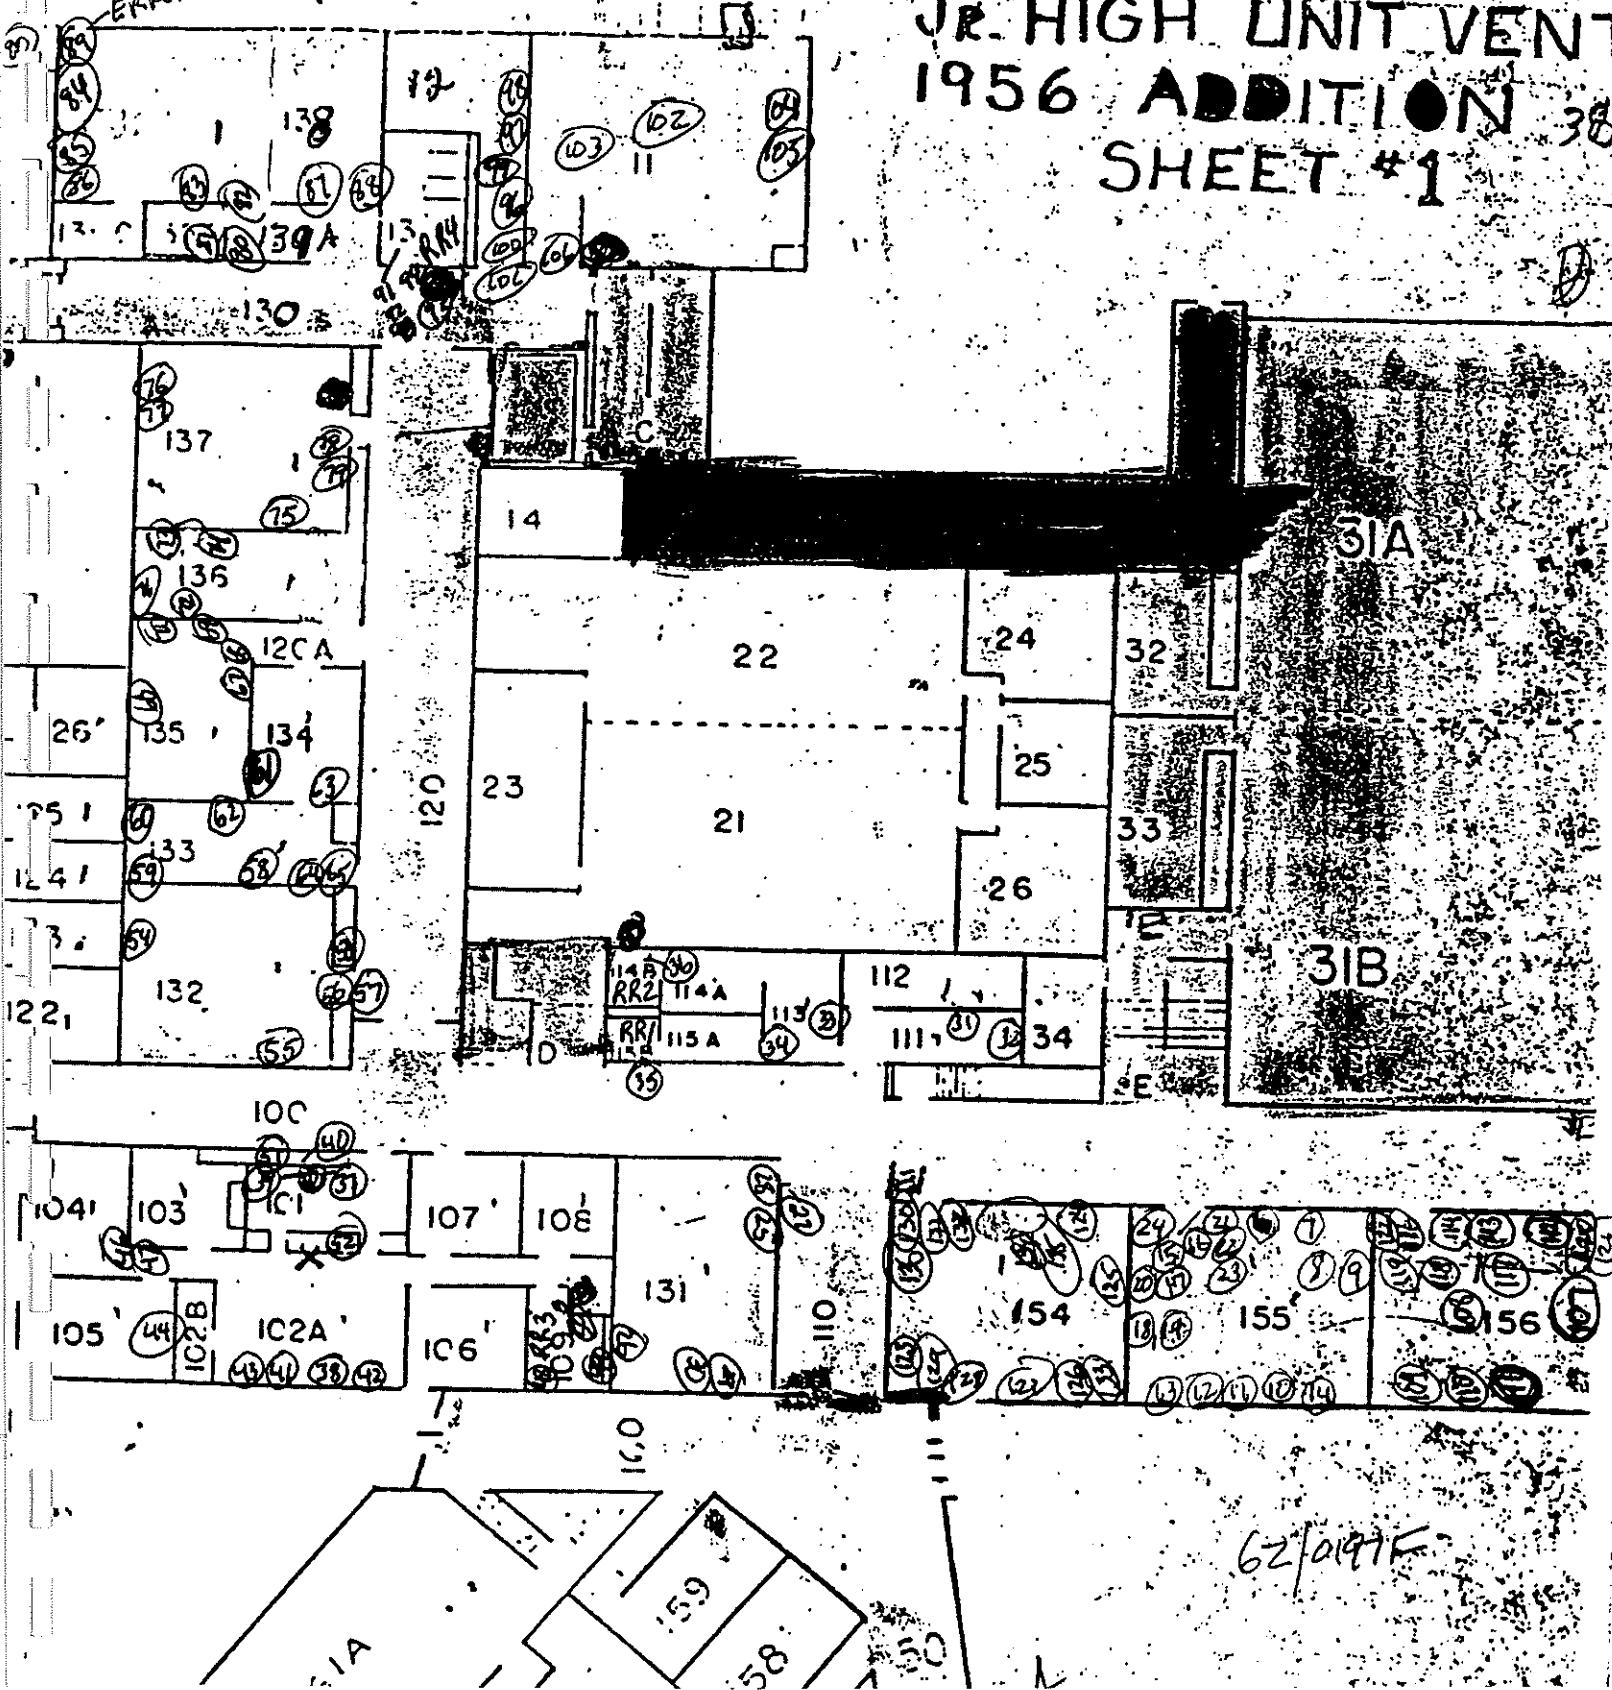
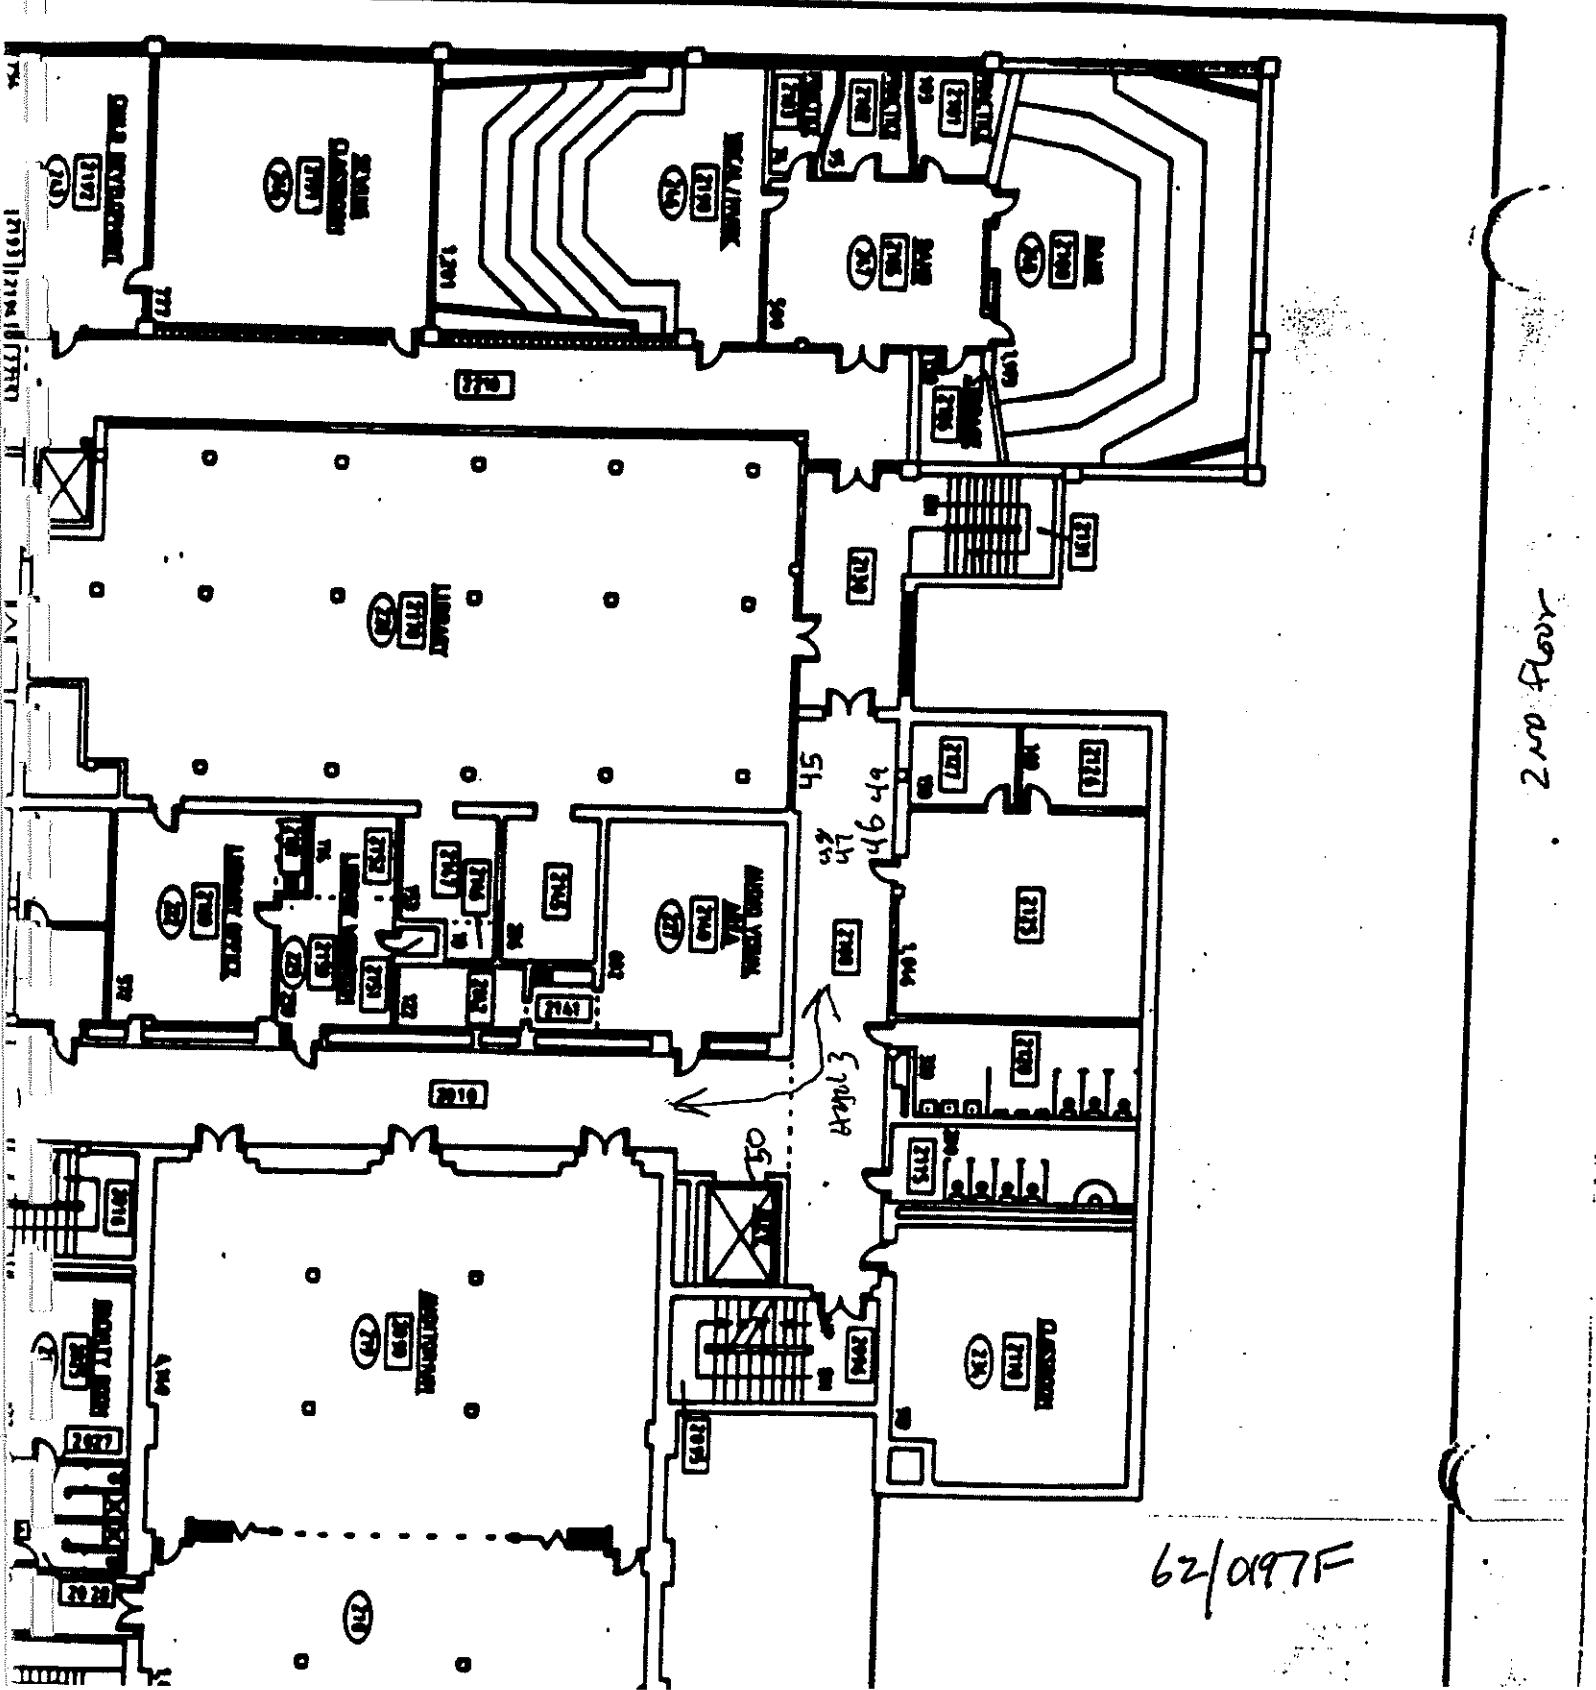
JR. HIGH UNIT VENT
1956 ADDITION SHEET #1

2/19/97
SITE 2

All room and area designations used in this report are depicted on sampling maps found in Appendix A.
