740 York
Saint Paul Public Schools

Lead-Based Paint Inspection

MEC Project # 62/0197BH

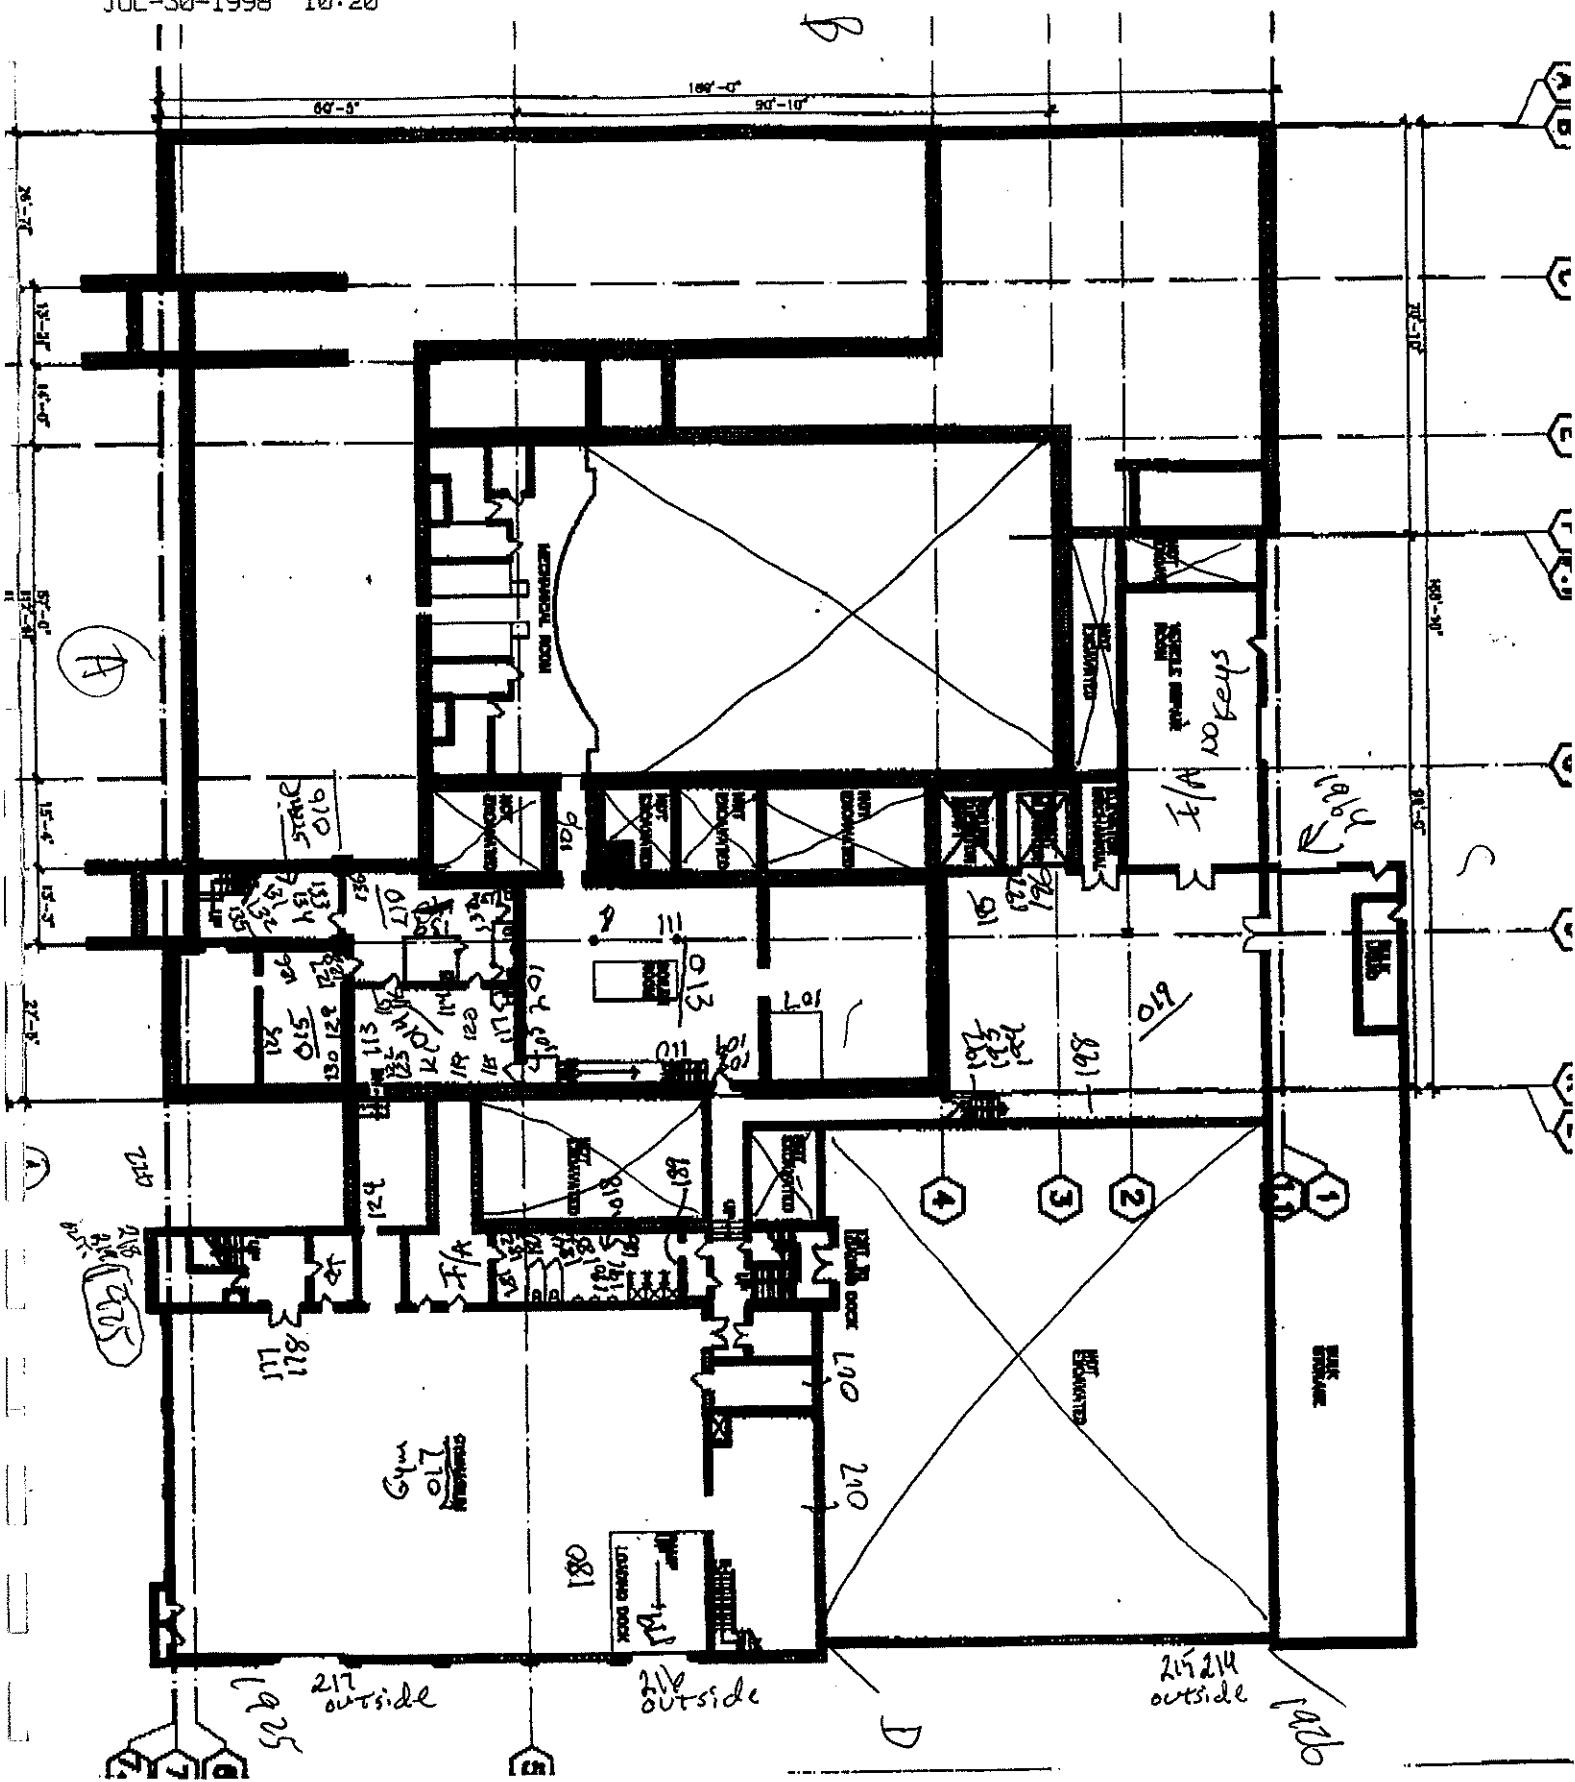
BASEMENT PLAN

EAST SIDE COMMUNITY FACILITY
140 YORK AVENUE
ST. PAUL, MINNESOTA
55102

All room and area designations used in this report are depicted on sampling maps found in Appendix A.

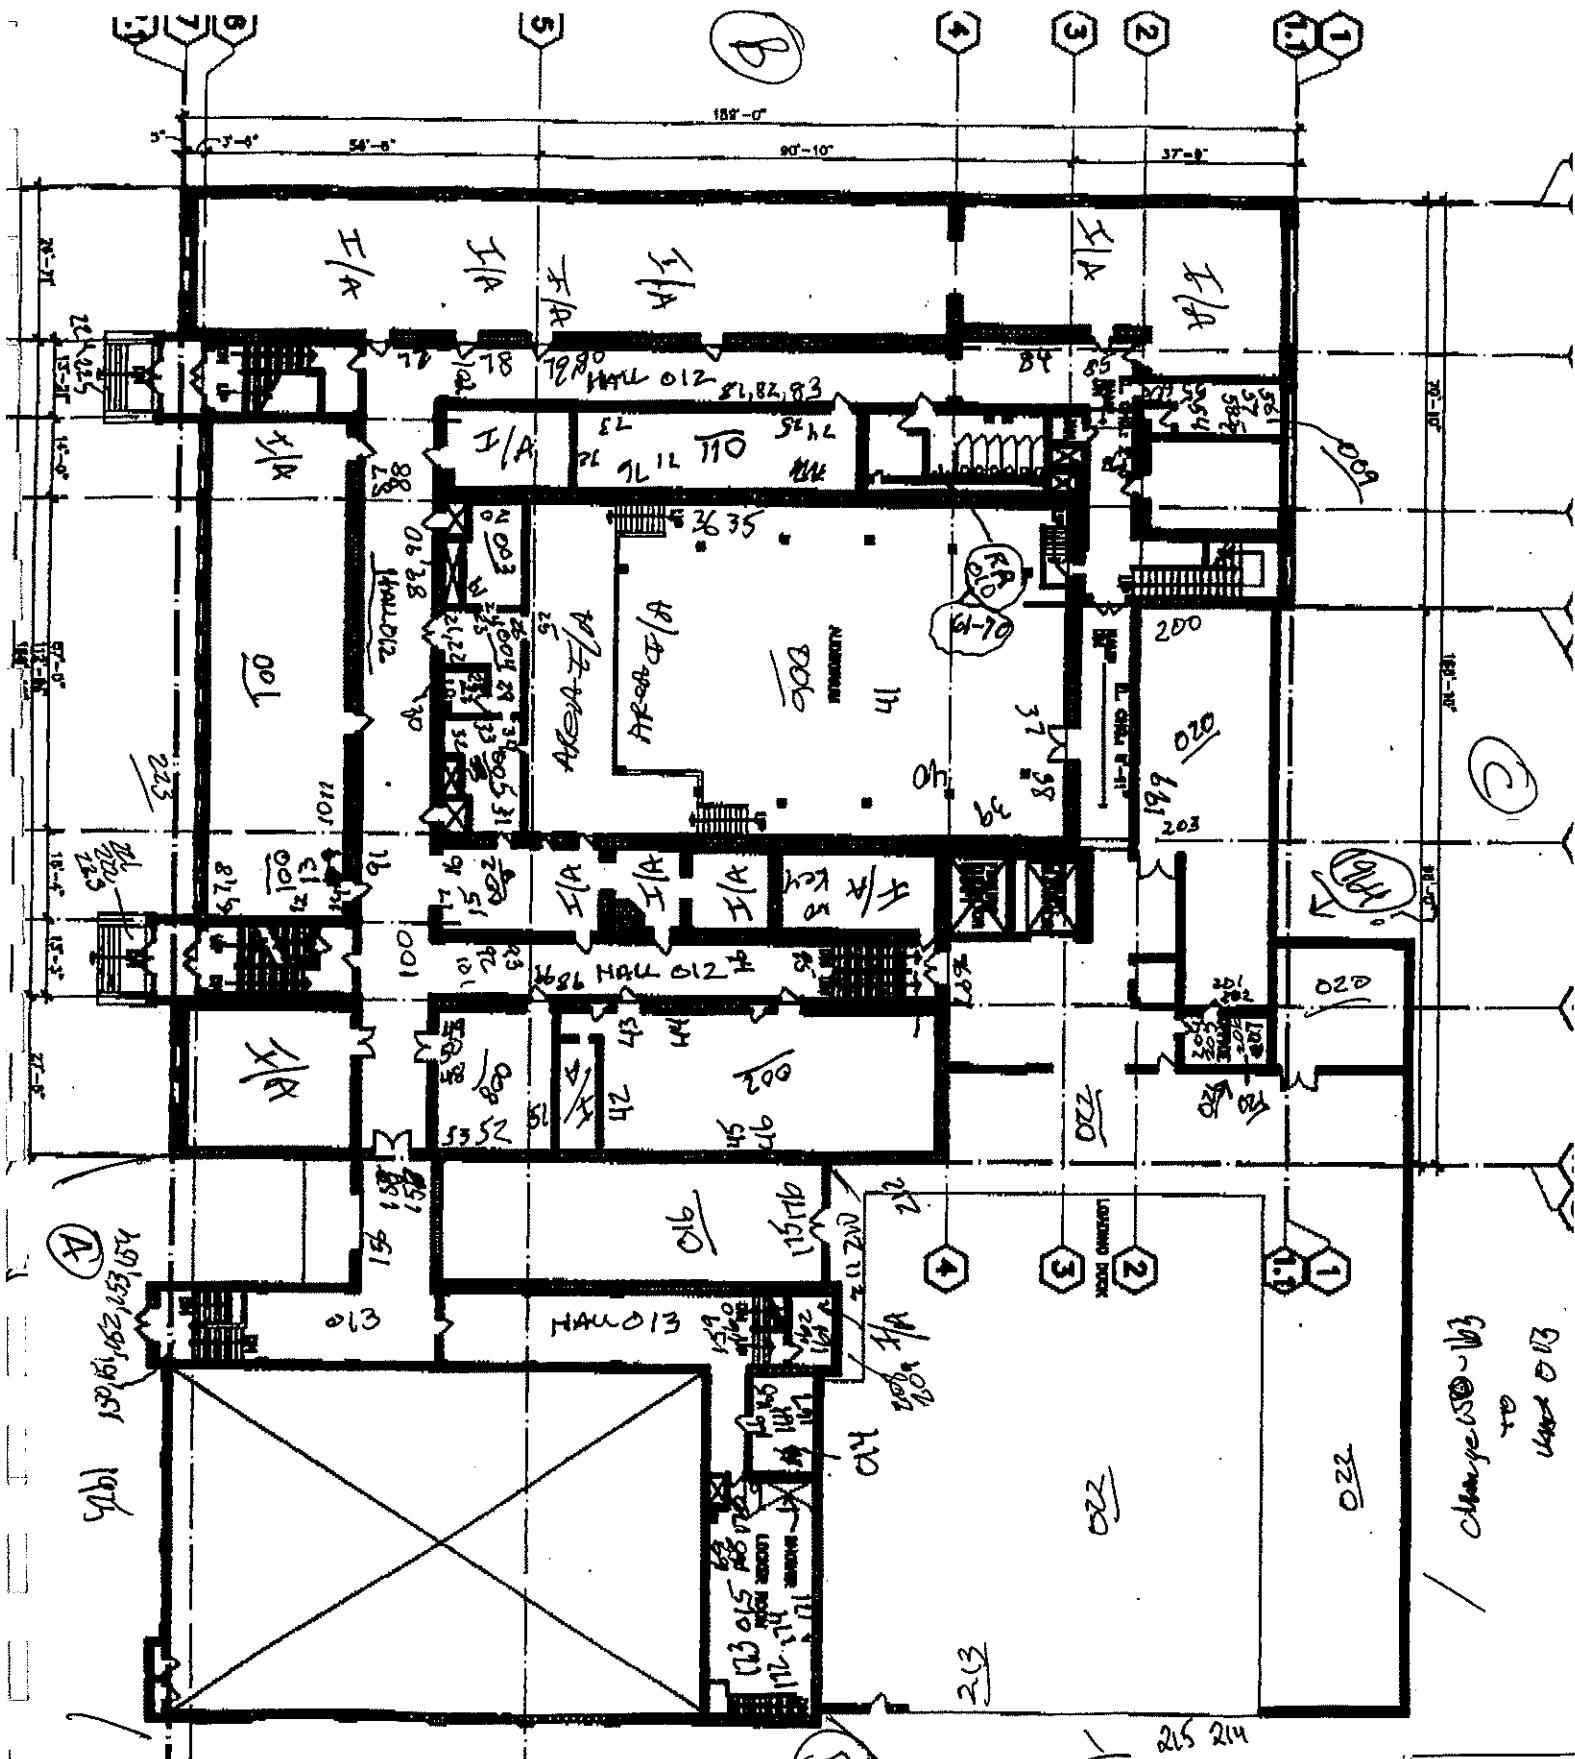
GROUND FLOOR PLAN

EAST SIDE COMMUNITY FACILITY
700 YORK AVENUE
ST. PAUL, MINNESOTA
55102

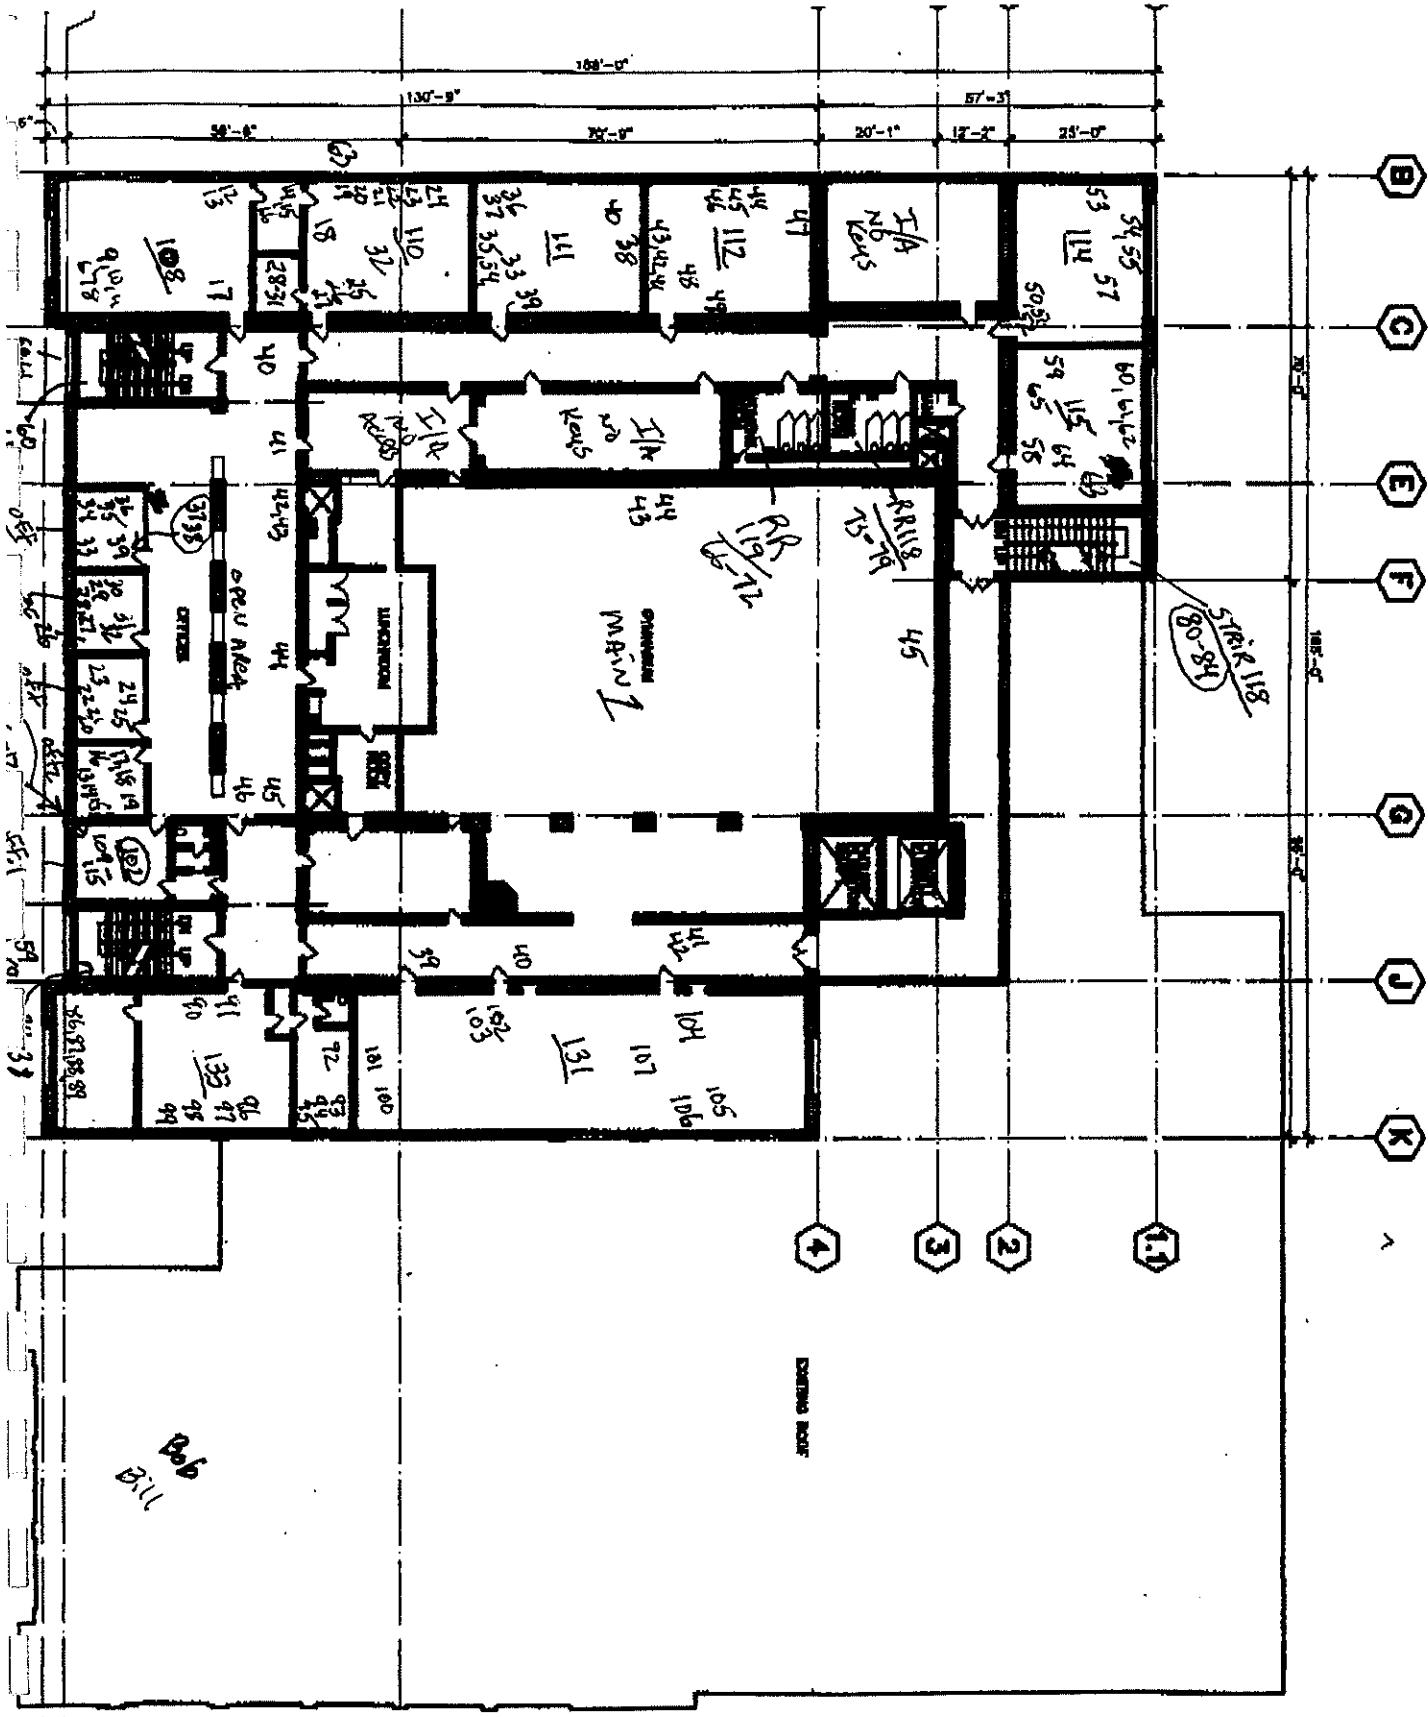
FIRST FLOOR PLAN

EAST SIDE COMMUNITY FACILITY
240 TOWER AVENUE
ST. PAUL, MINN.
55105
