**Maxfield Magnet School of Academic Excellence
Saint Paul Public Schools**

Lead-Based Paint Inspection

MEC Project # 62/0197L

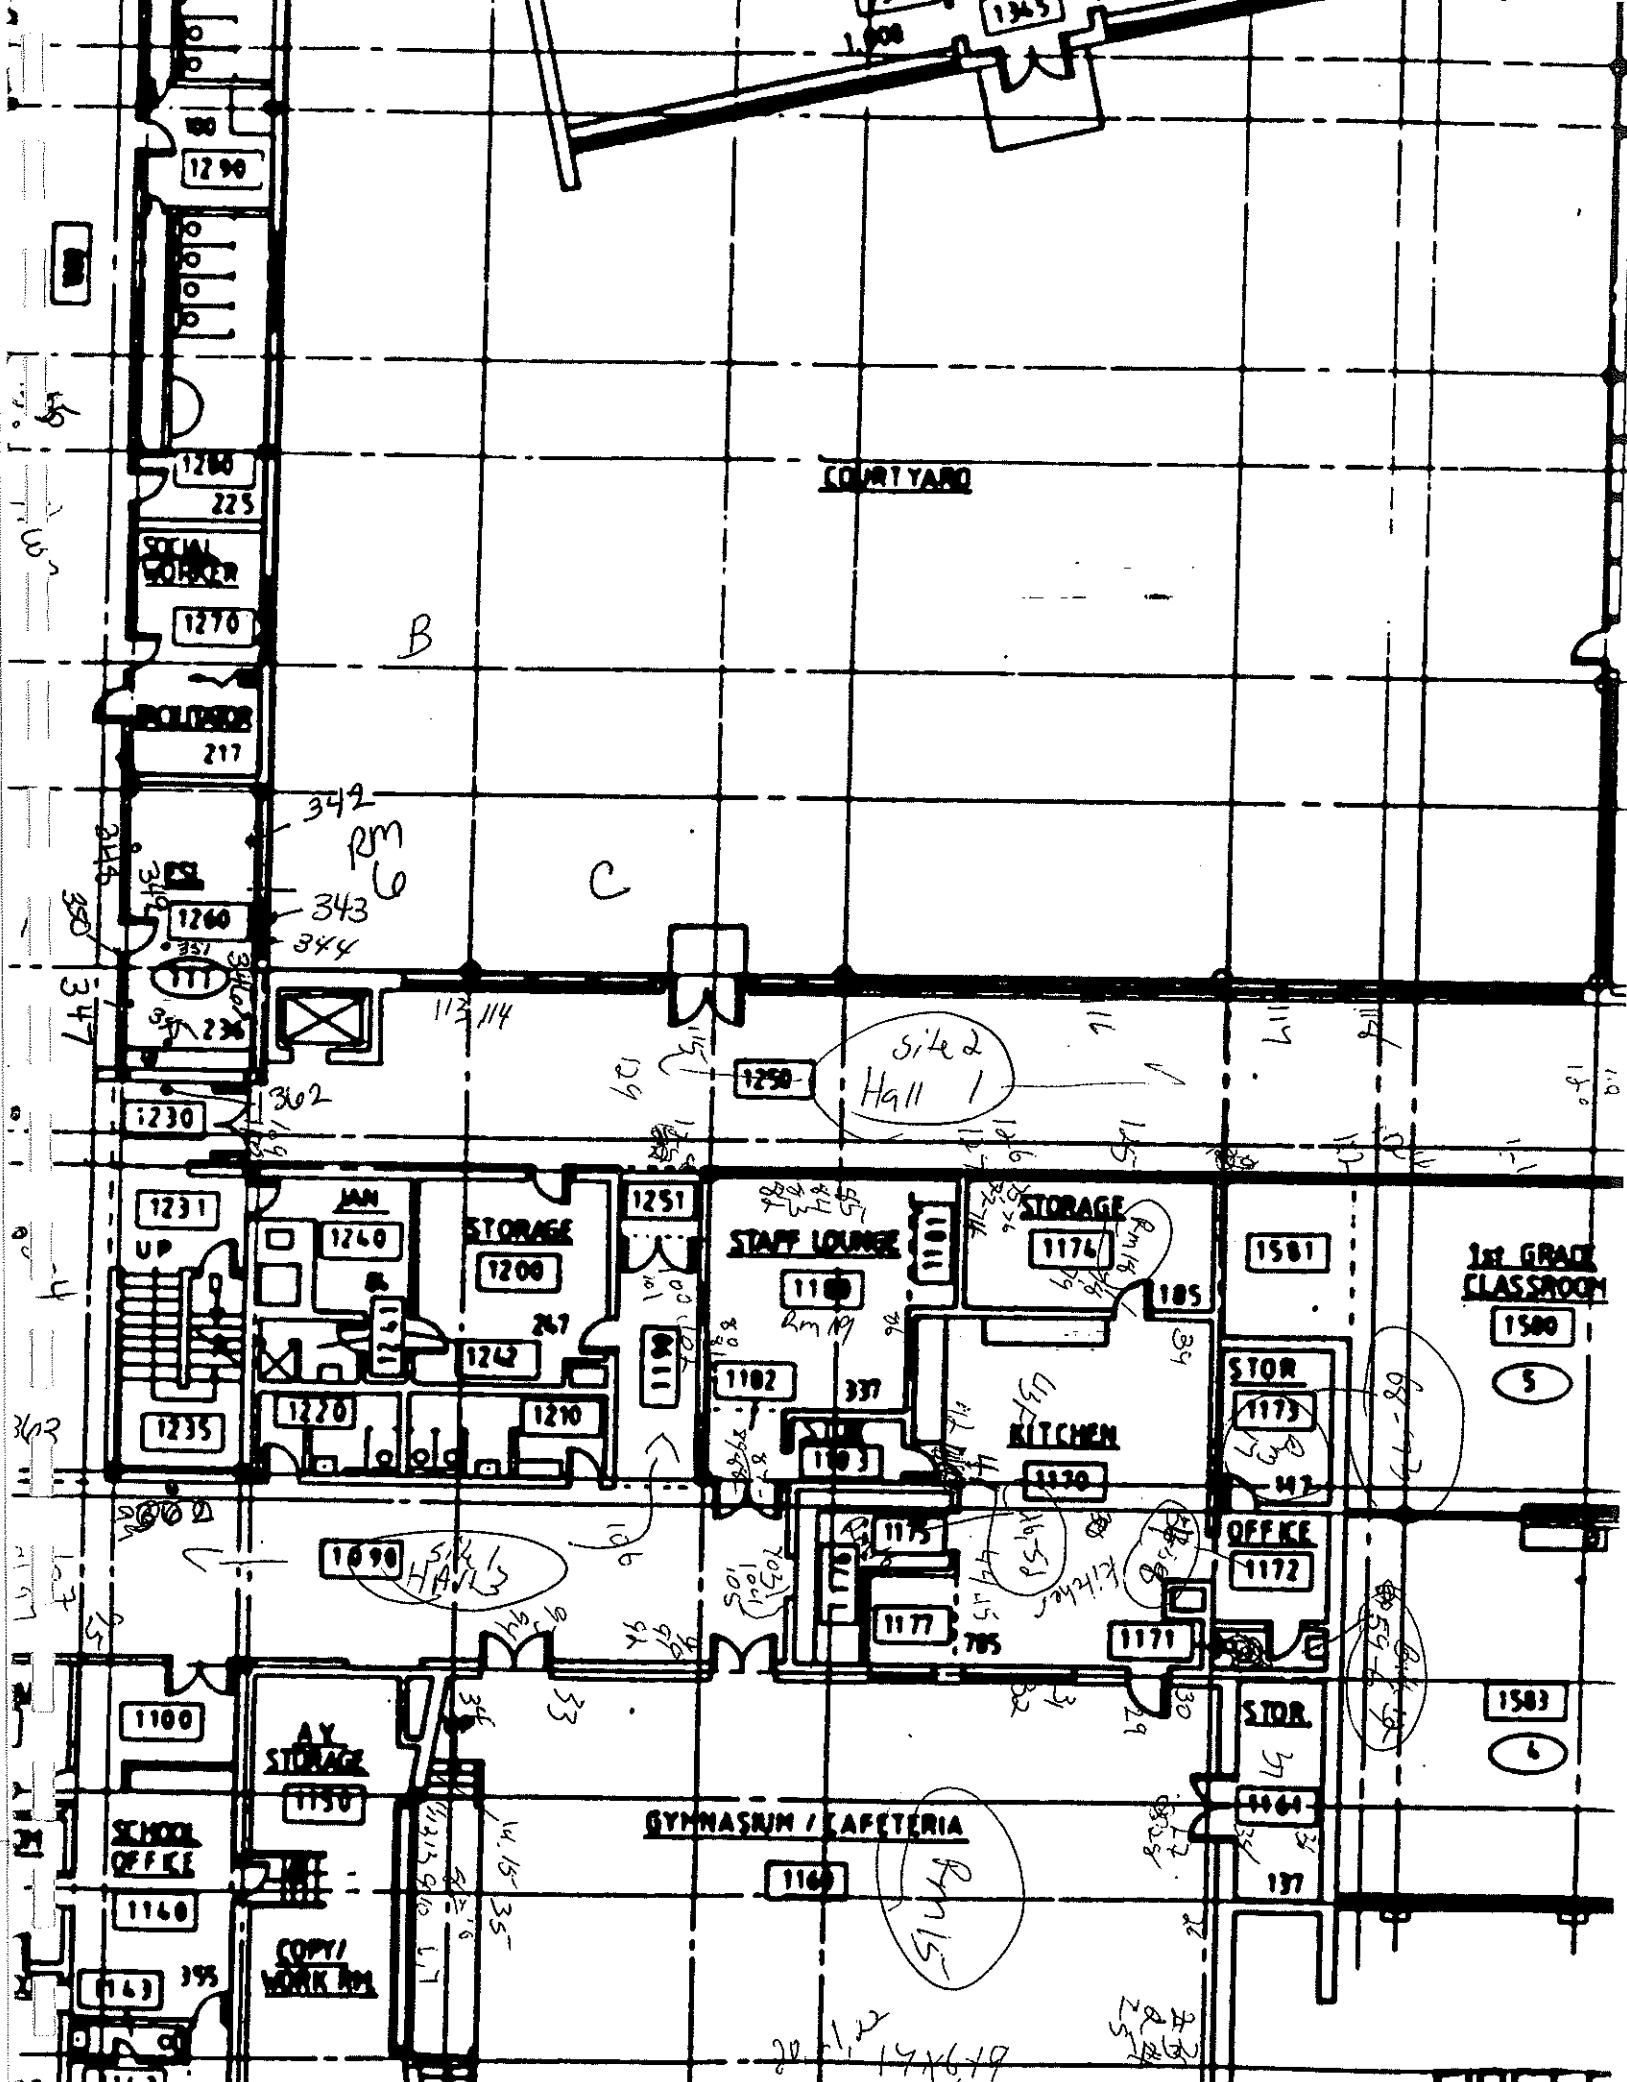
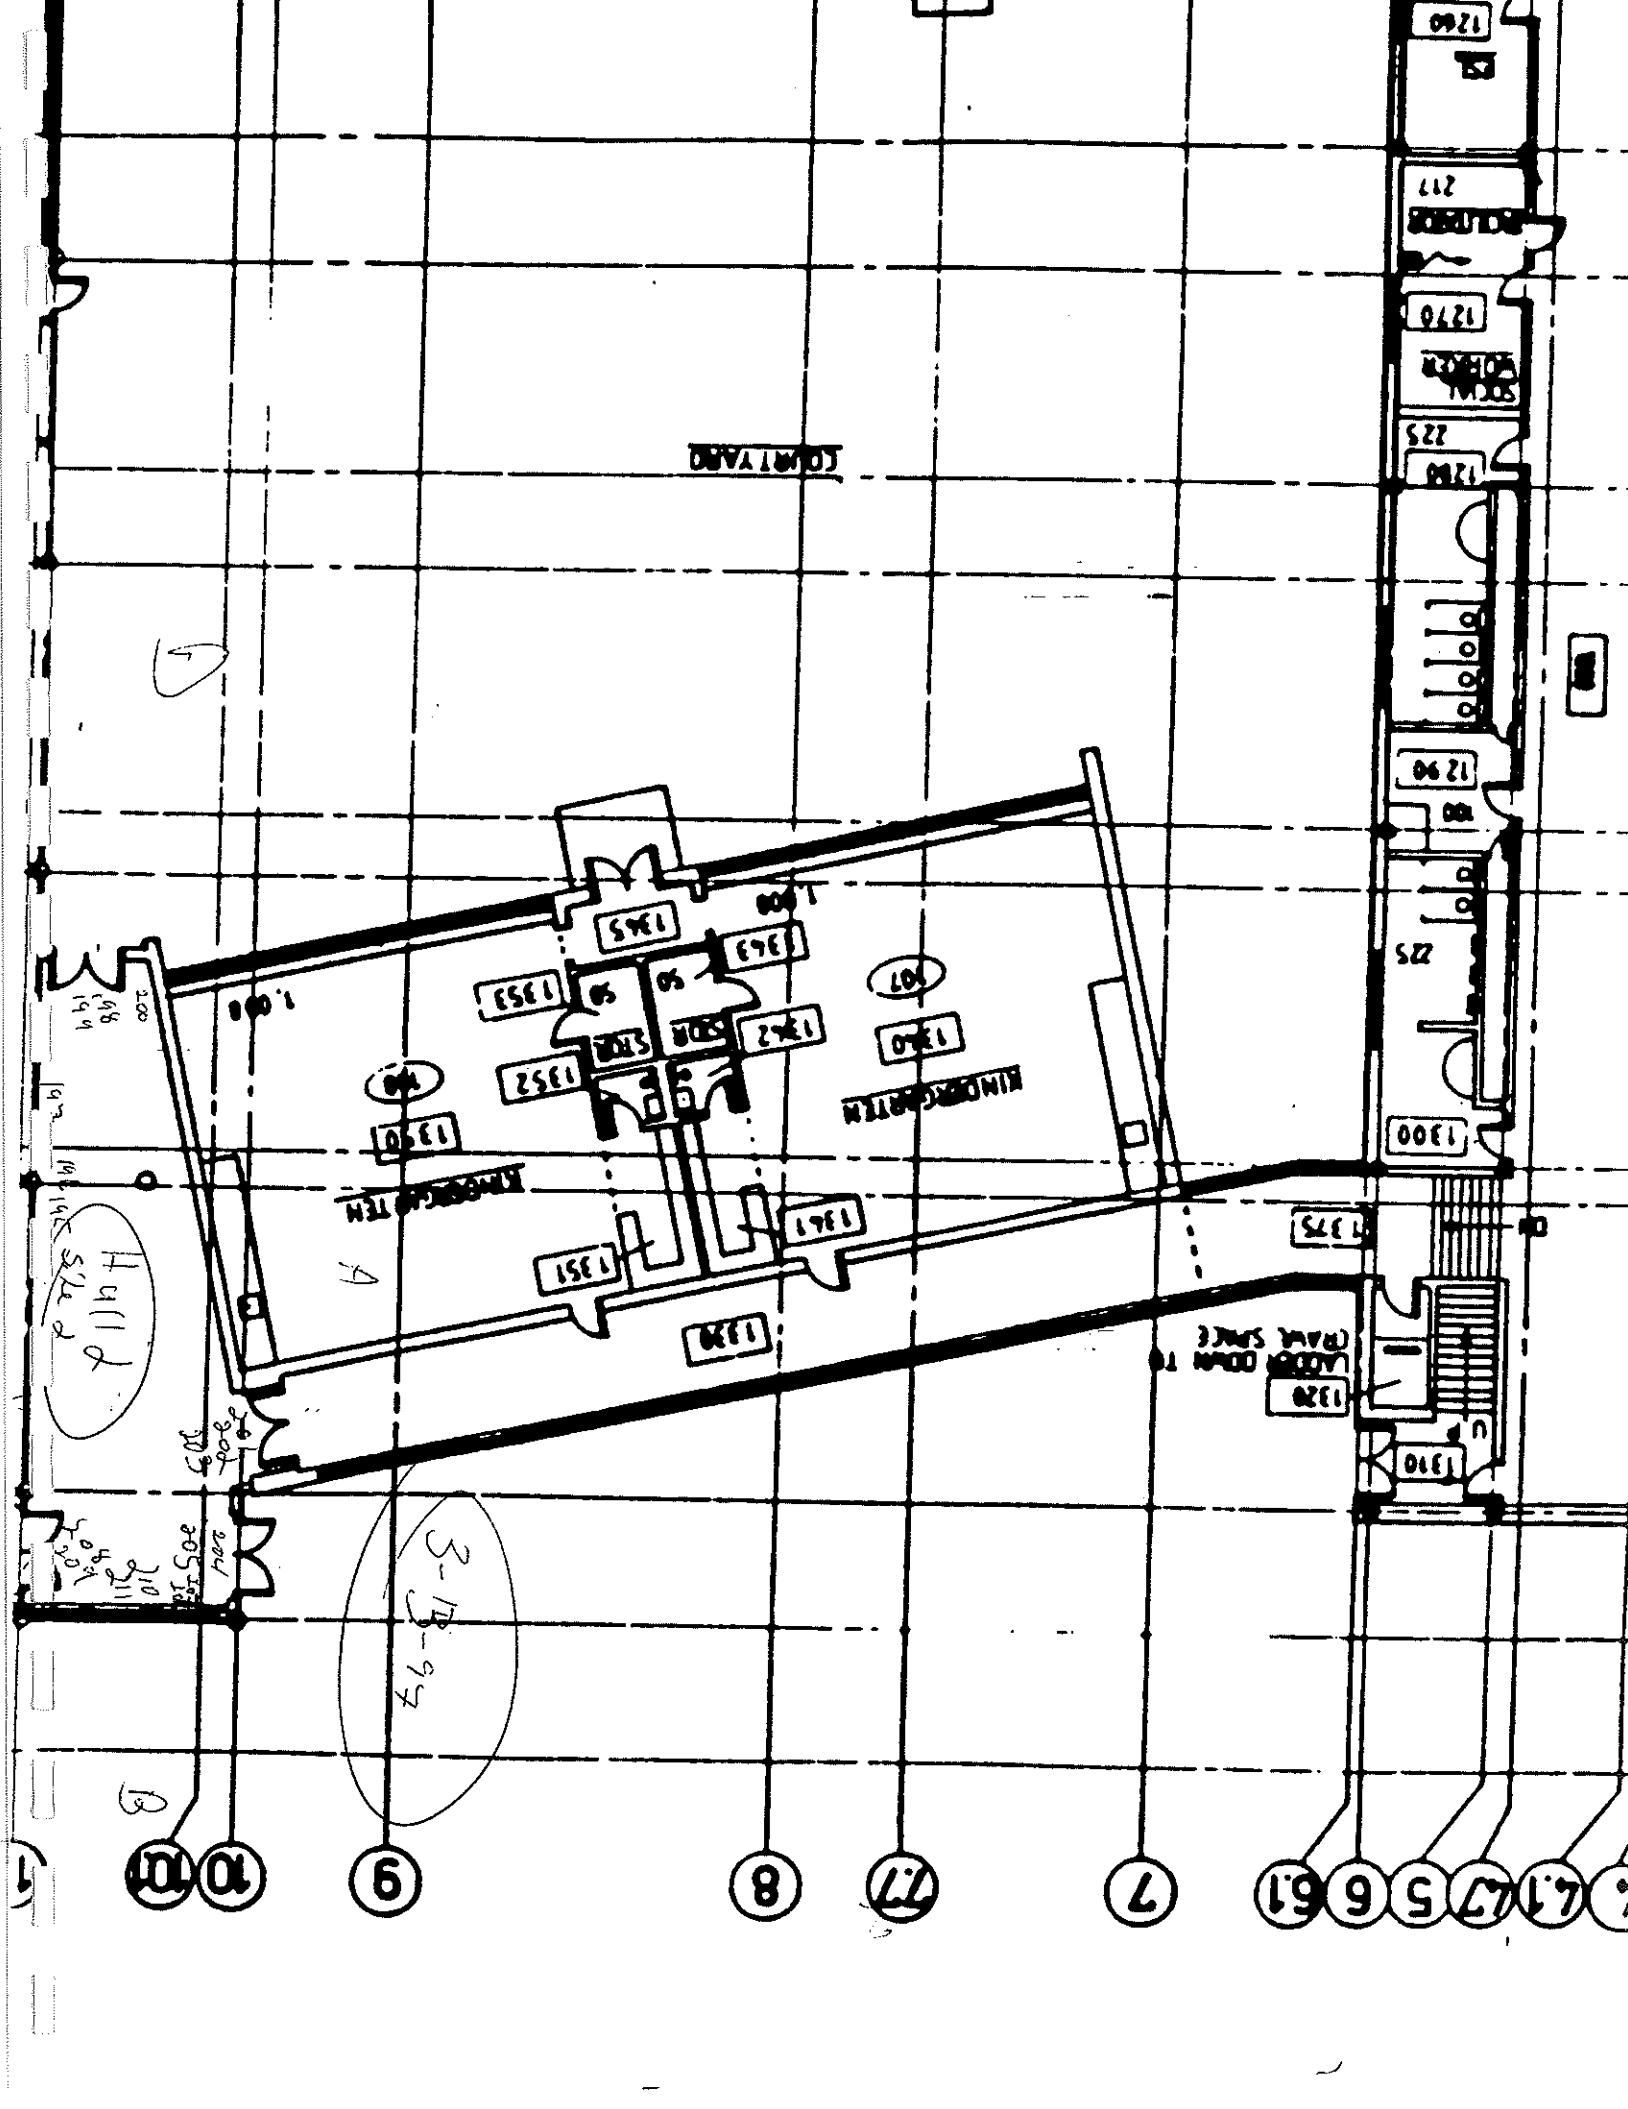
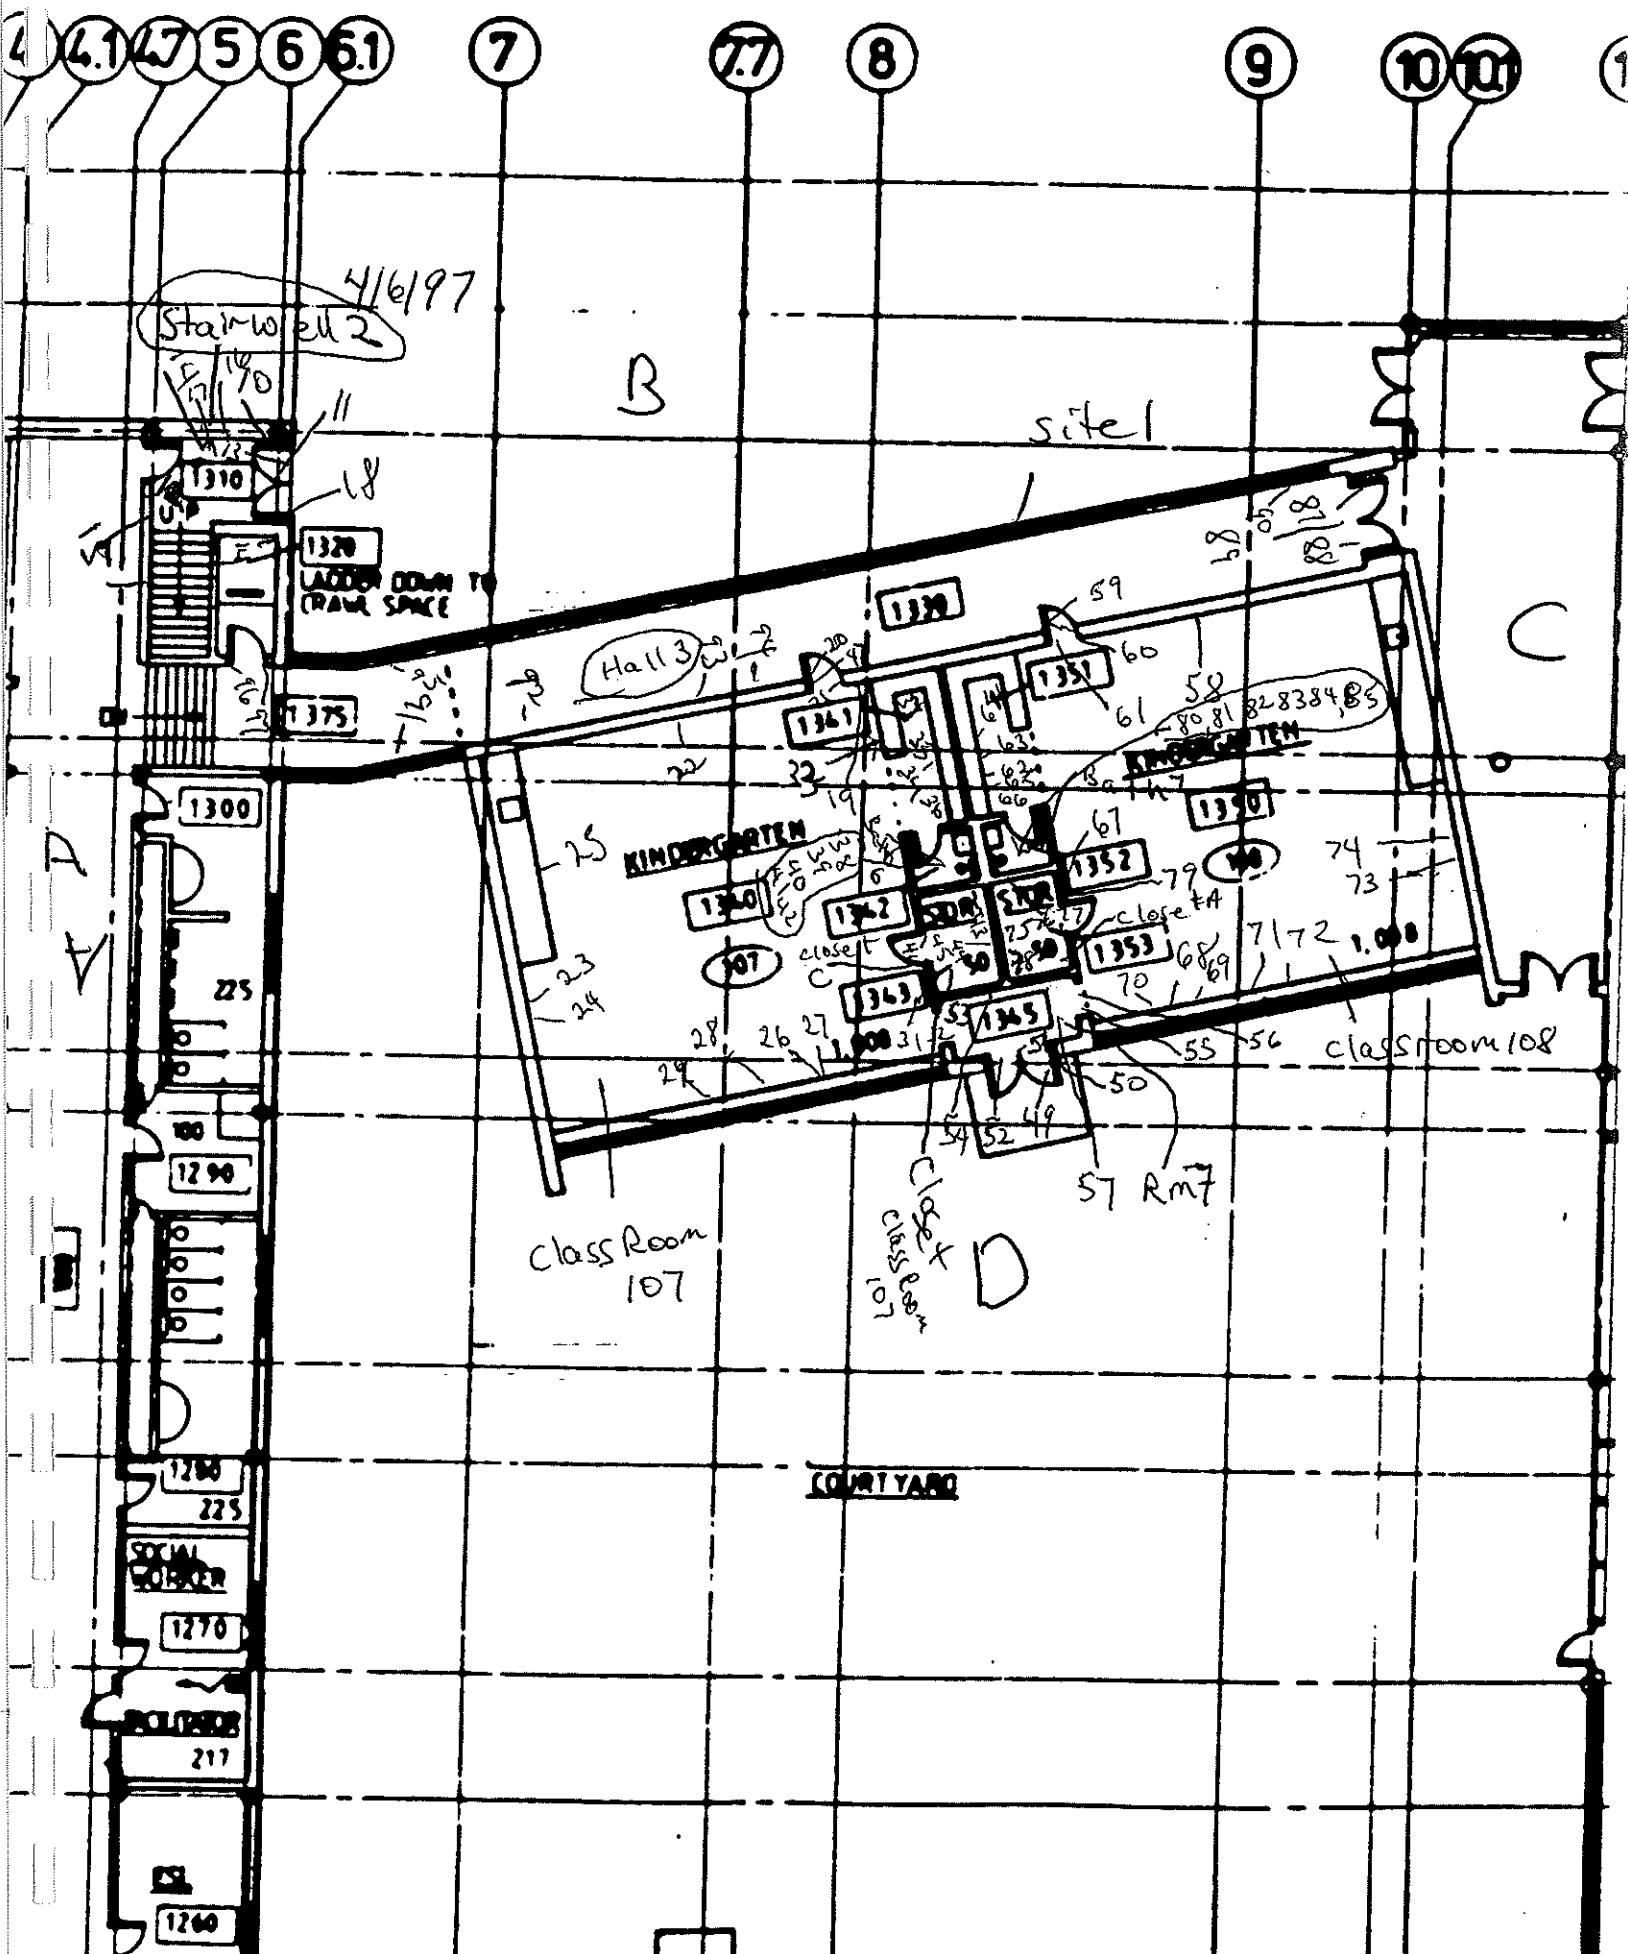
XRF TESTING DATA WITH LOCATION MAPS

All room and area designations used in this report are depicted on sampling maps found in Appendix A.
