**Nokomis Montessori Magnet  
Saint Paul Public Schools**

**Lead-Based Paint Inspection**

**Inspection Dates: 7/30/97, 5/13/98**

**MEC Project # 62/0197AU**

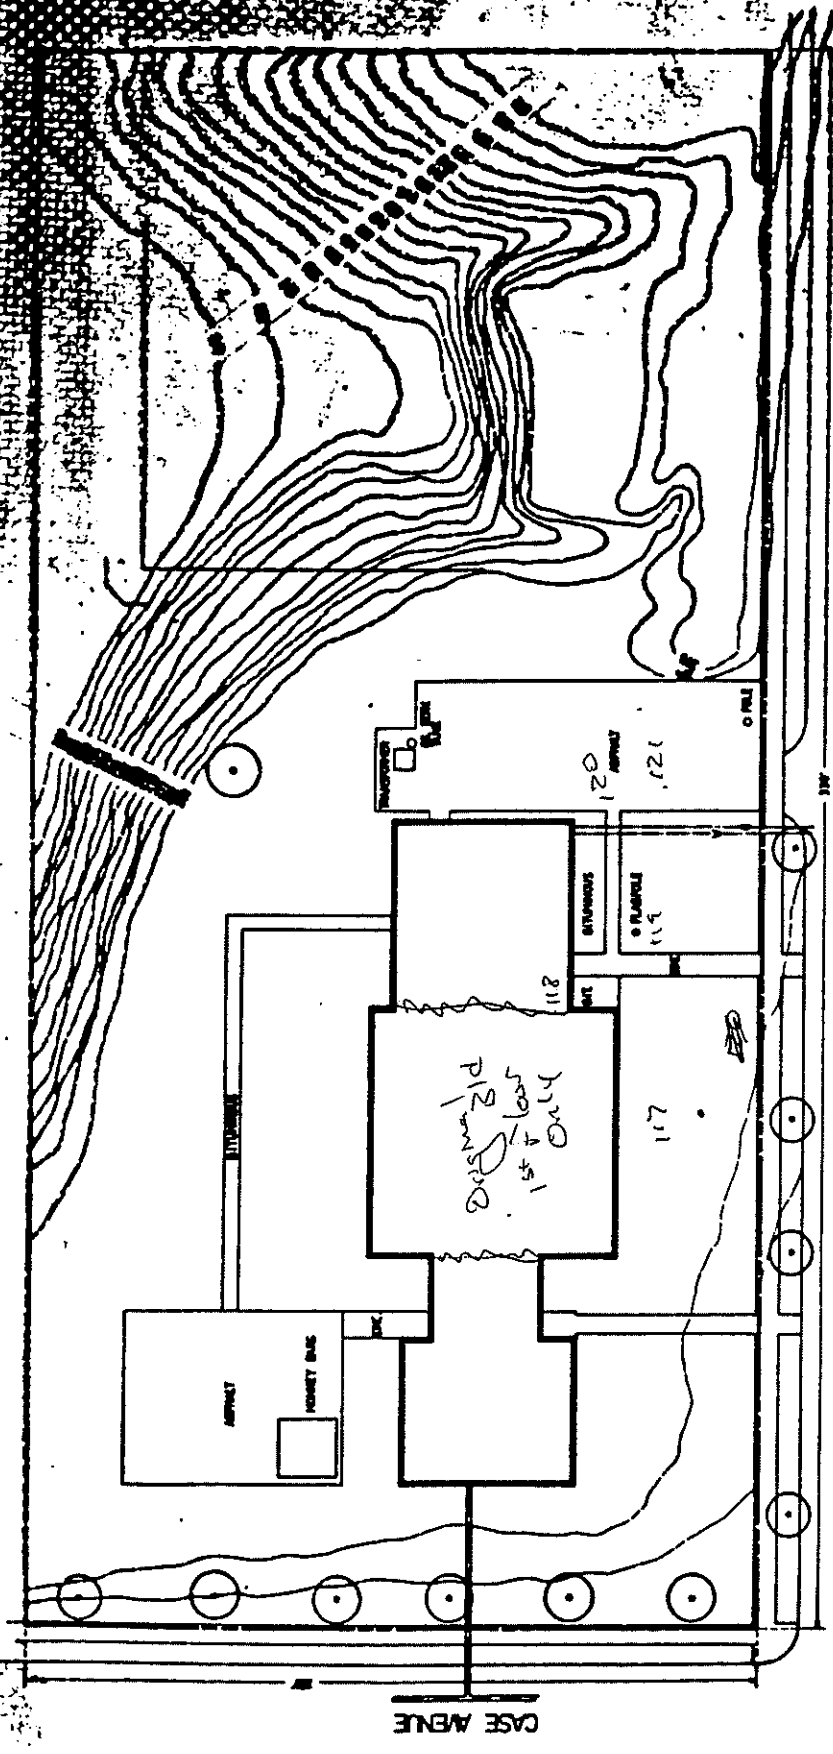
## XRF TESTING DATA WITH LOCATION MAPS

RUTH STREET

CASE AVENUE

All room and area designations used in this report are depicted on sampling maps found in Appendix A.
