**Sheridan Elementary School  
Saint Paul Public Schools**

**Lead-Based Paint Inspection**

**Inspection Dates: 10/16/97, 10/17/97**

**MEC Project # 62/0197BC**

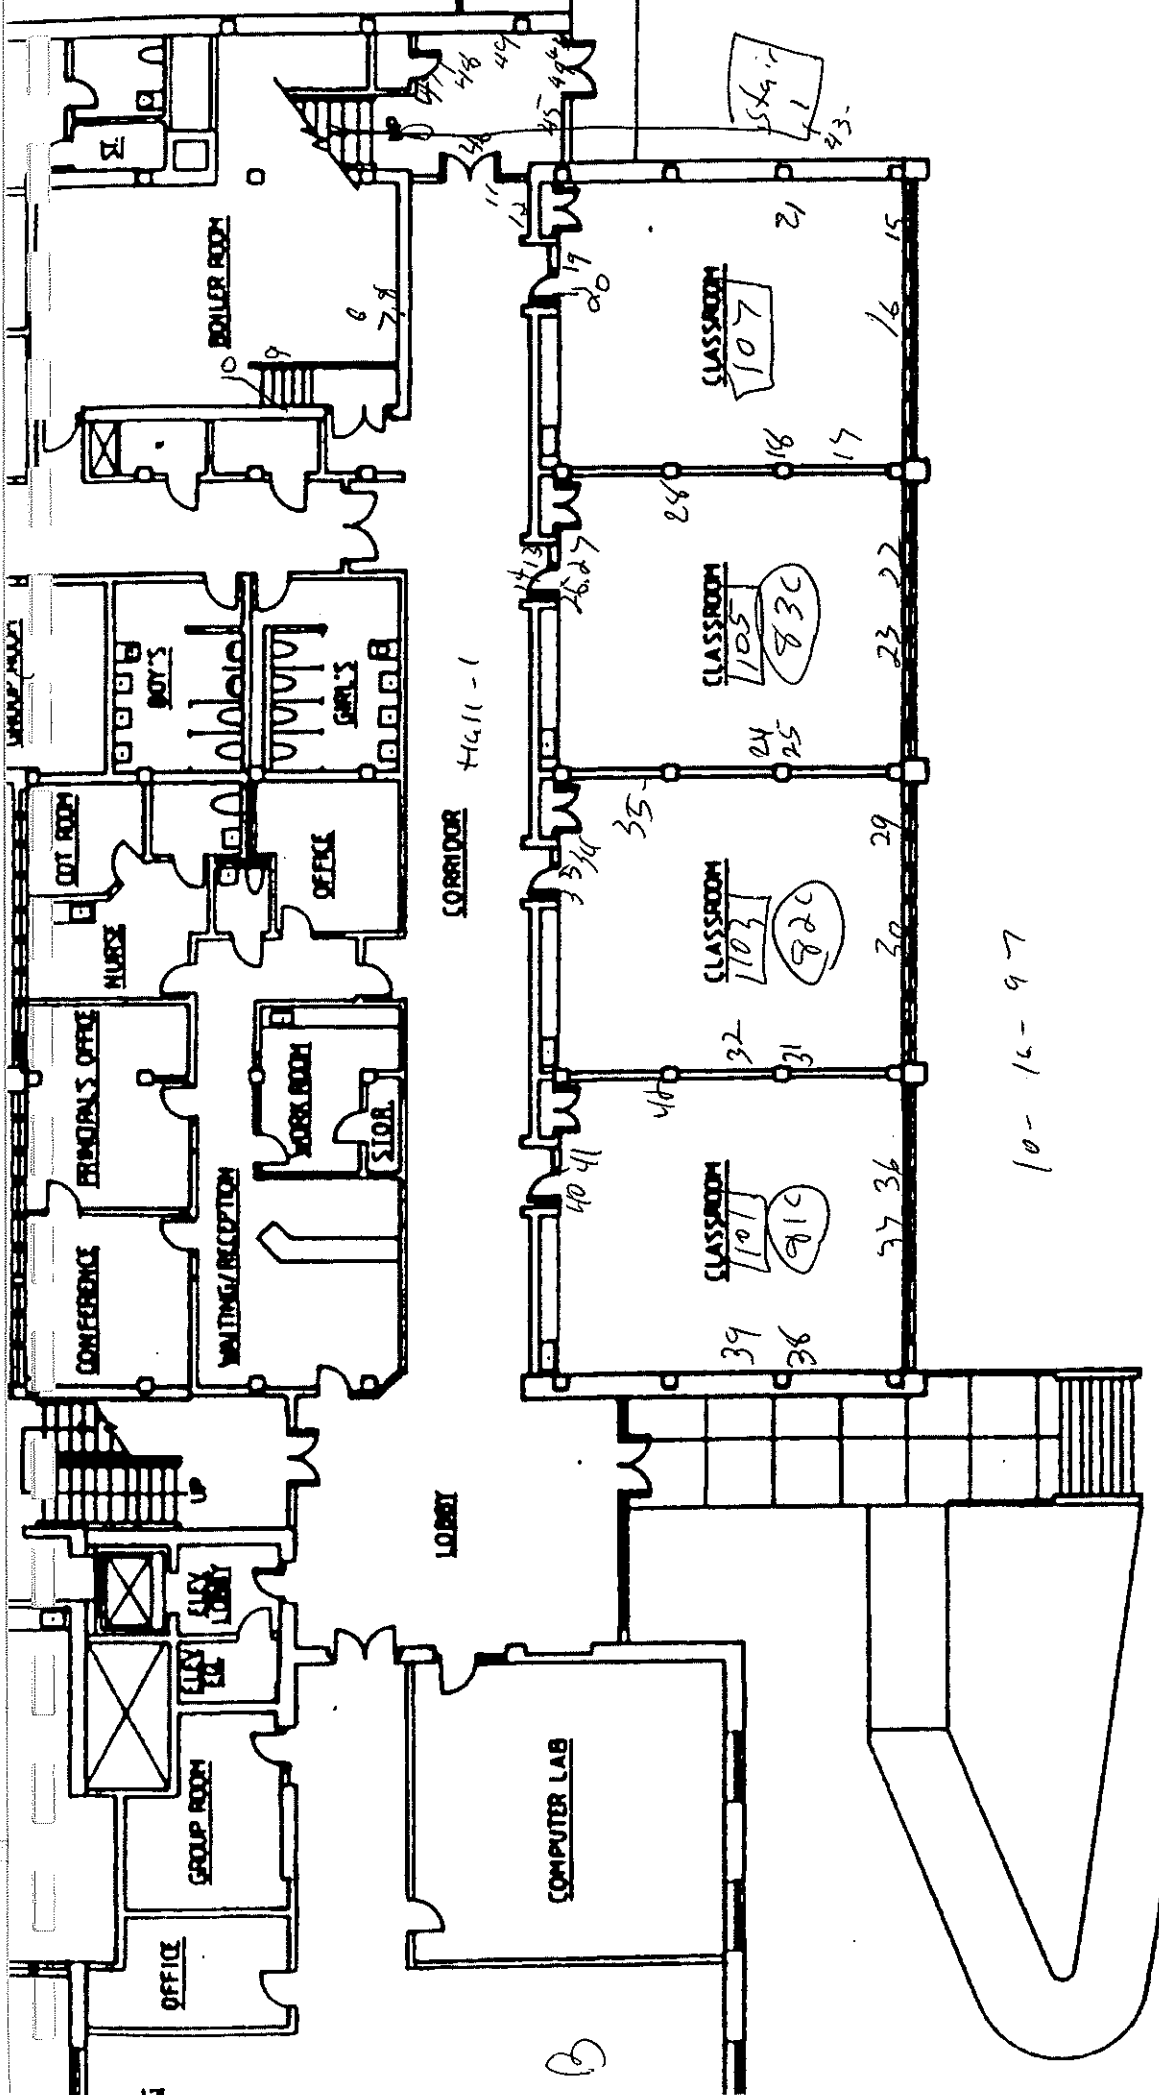
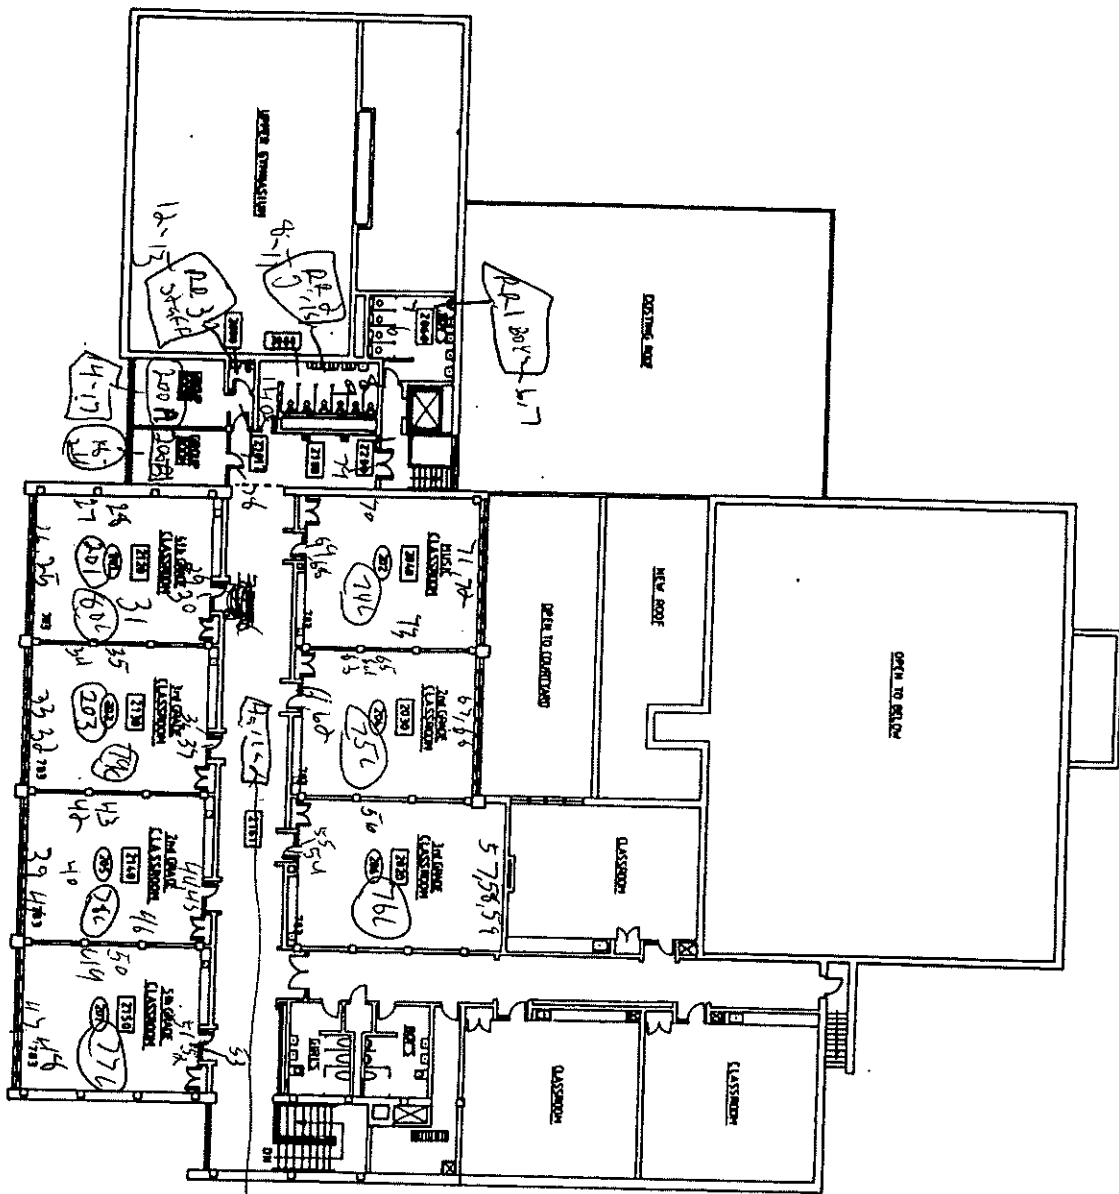
**XRF TESTING DATA  
WITH  
LOCATION MAPS**

SHERIDAN ELEMENTARY  
525 WHITE BEAR AVE.  
ST. PAUL, MINNESOTA

All room and area designations used in this report are depicted on sampling maps found in Appendix A.
