**Randolph Heights Elementary  
Saint Paul Public Schools**

**Lead-Based Paint Inspection**

**Inspection Dates: 4/8/97, 4/9/97, 4/15/97, 4/17/97, 4/19/97**

**MEC Project # 62/0197W**

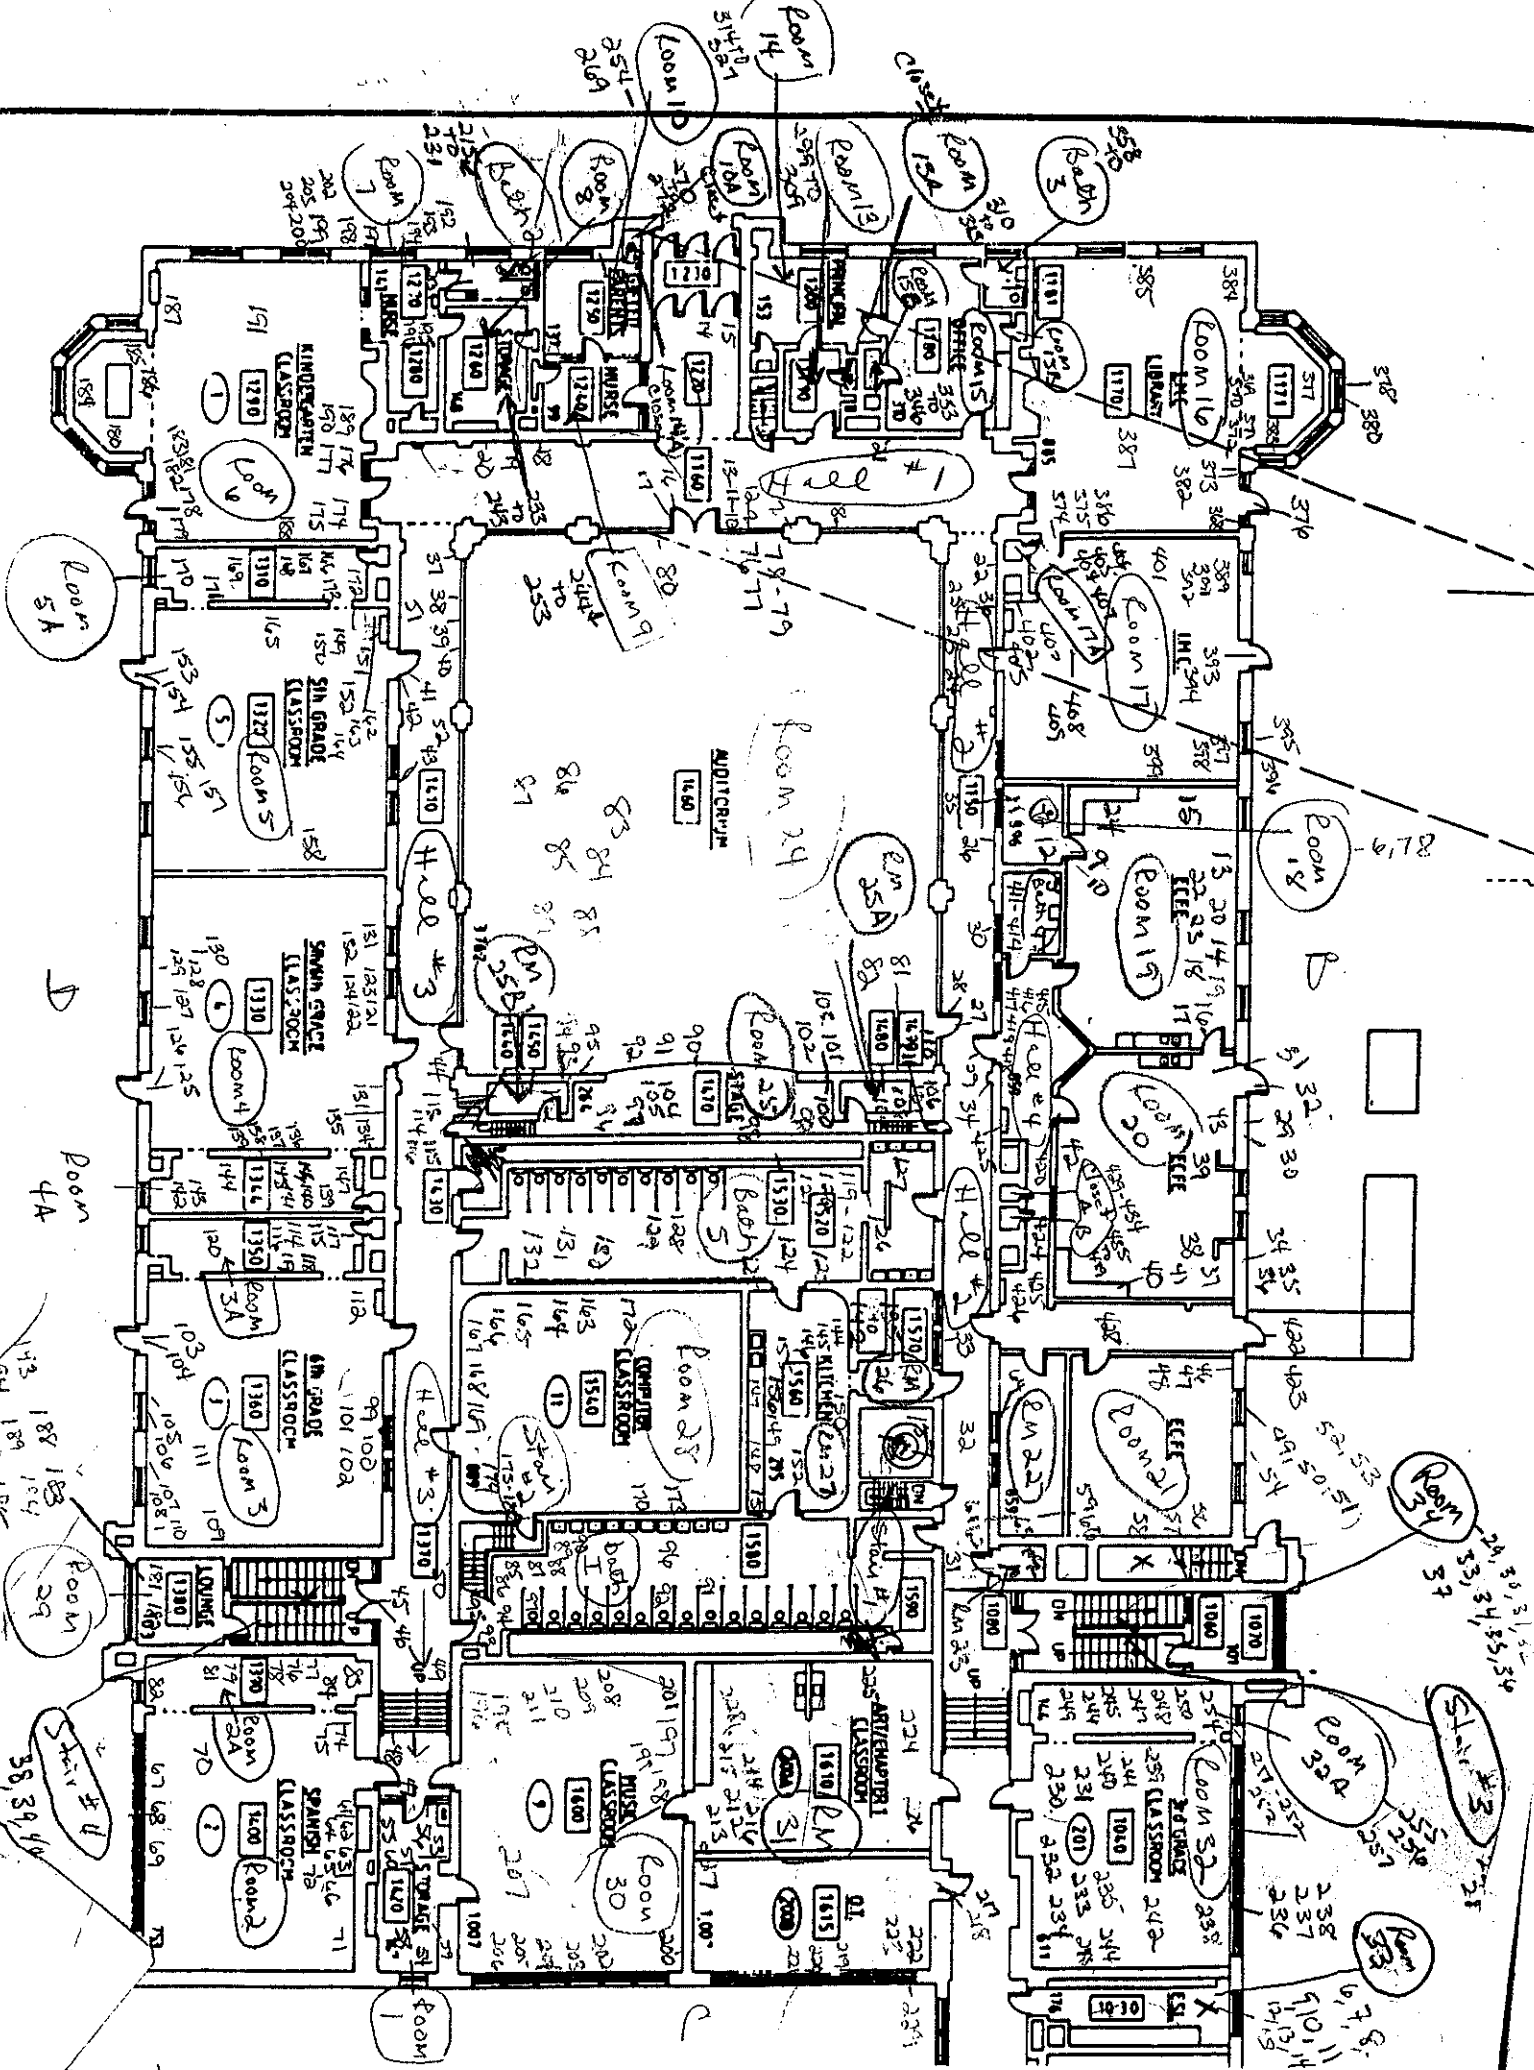
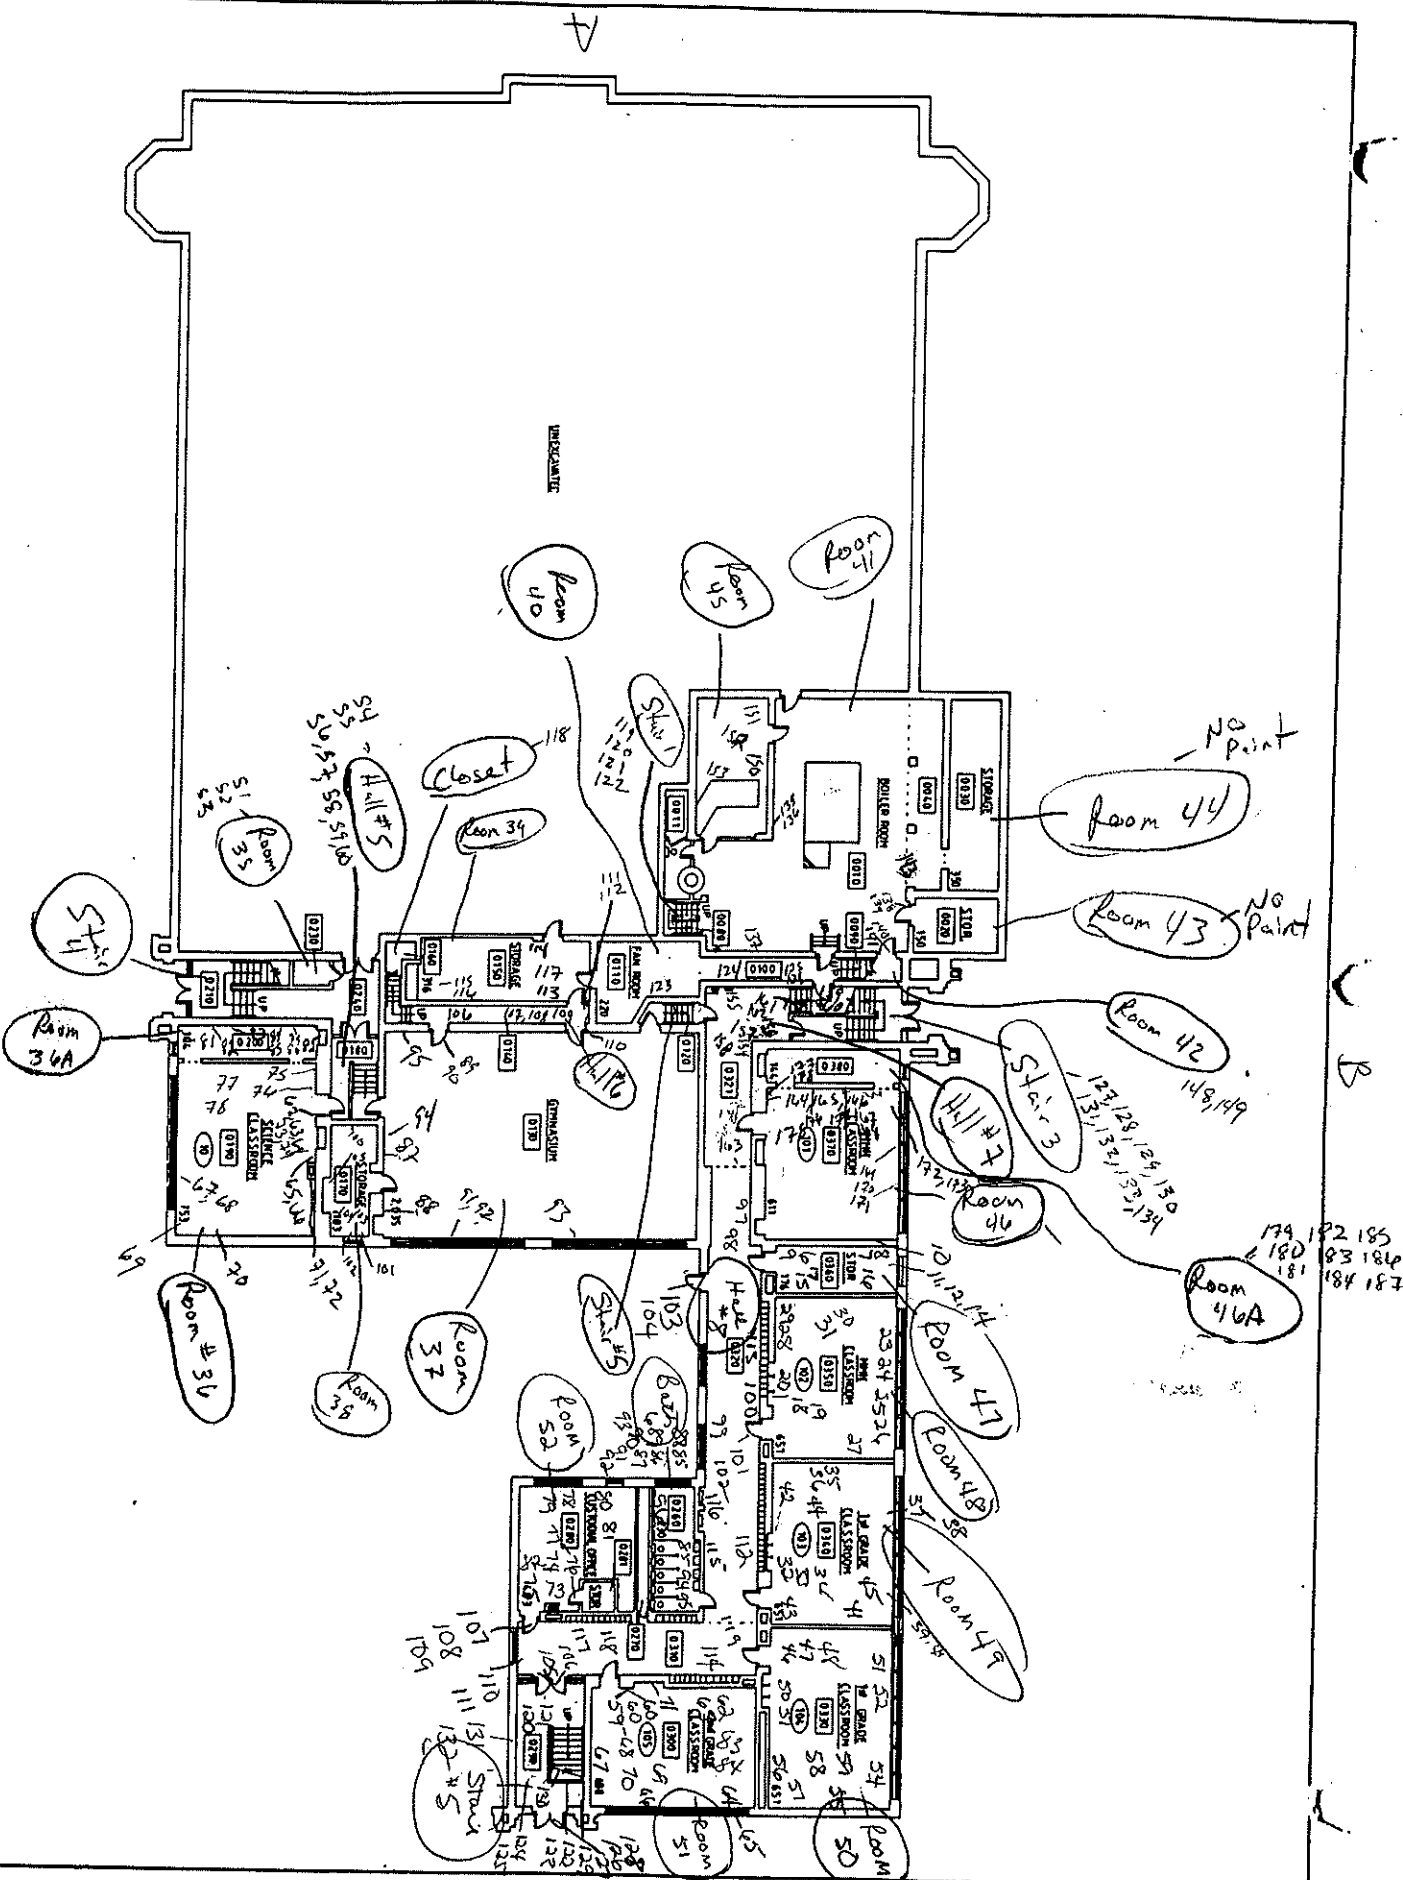
### FIRST FLOOR PLAN

RANDOLPH HEIGHTS ELEMENTARY  
348 HAMLINE AVE. S  
ST. PAUL, MINNESOTA

CONSTRUCTED: 1916, 21, 23

All room and area designations used in this report are depicted on sampling maps found in Appendix A.
