**Wheelock Early Education  
Saint Paul Public Schools**

**Lead-Based Paint Inspection**

**Inspection Dates: 6/9/98**

**MEC Project # 62/0197BF**

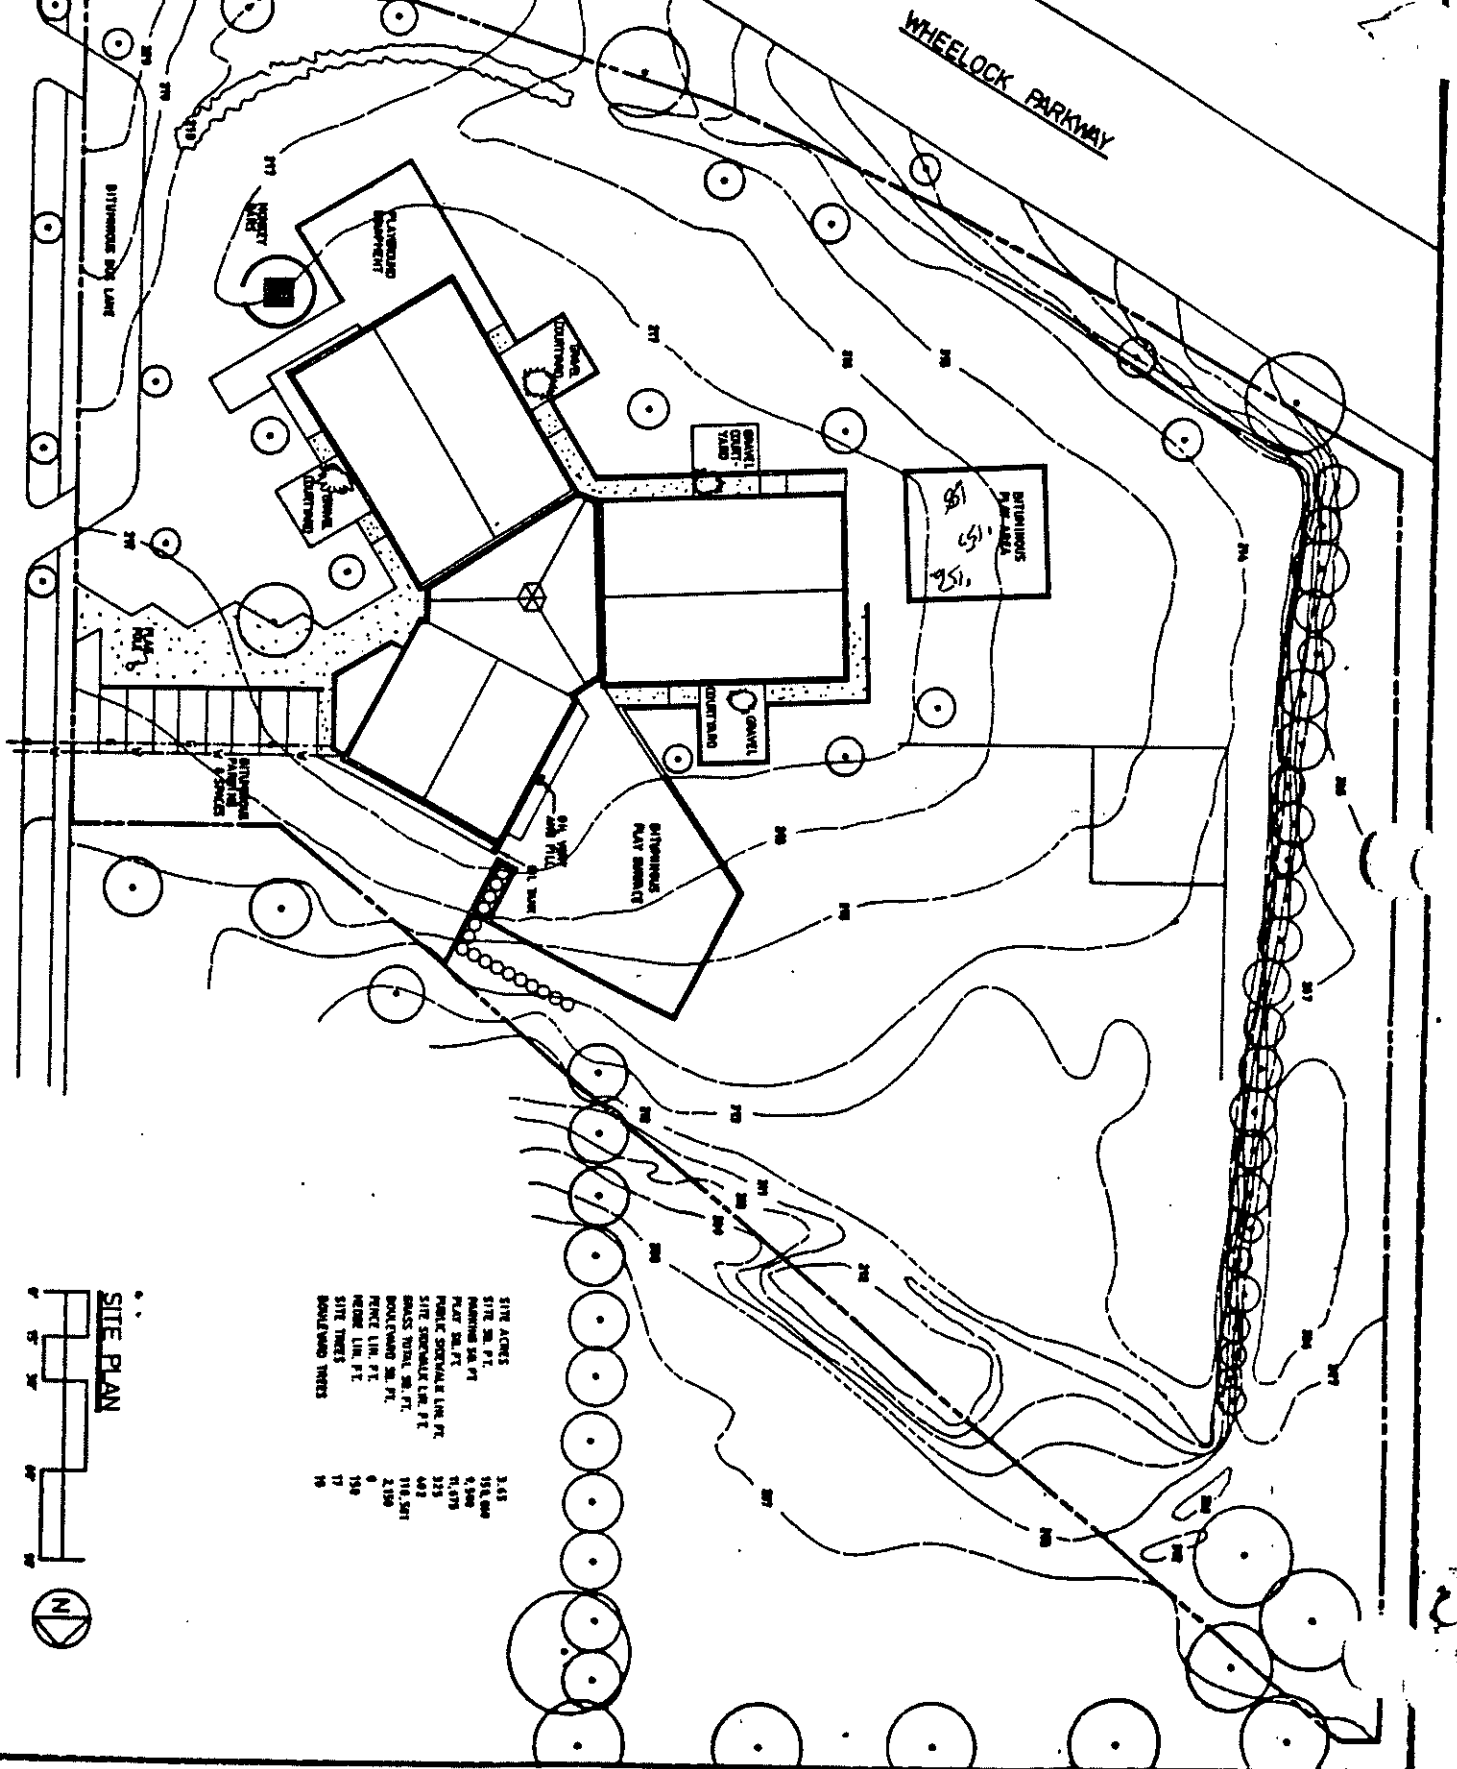
### **XRF TESTING DATA WITH LOCATION MAPS**

All room and area designations used in this report are depicted on sampling maps found in Appendix A.

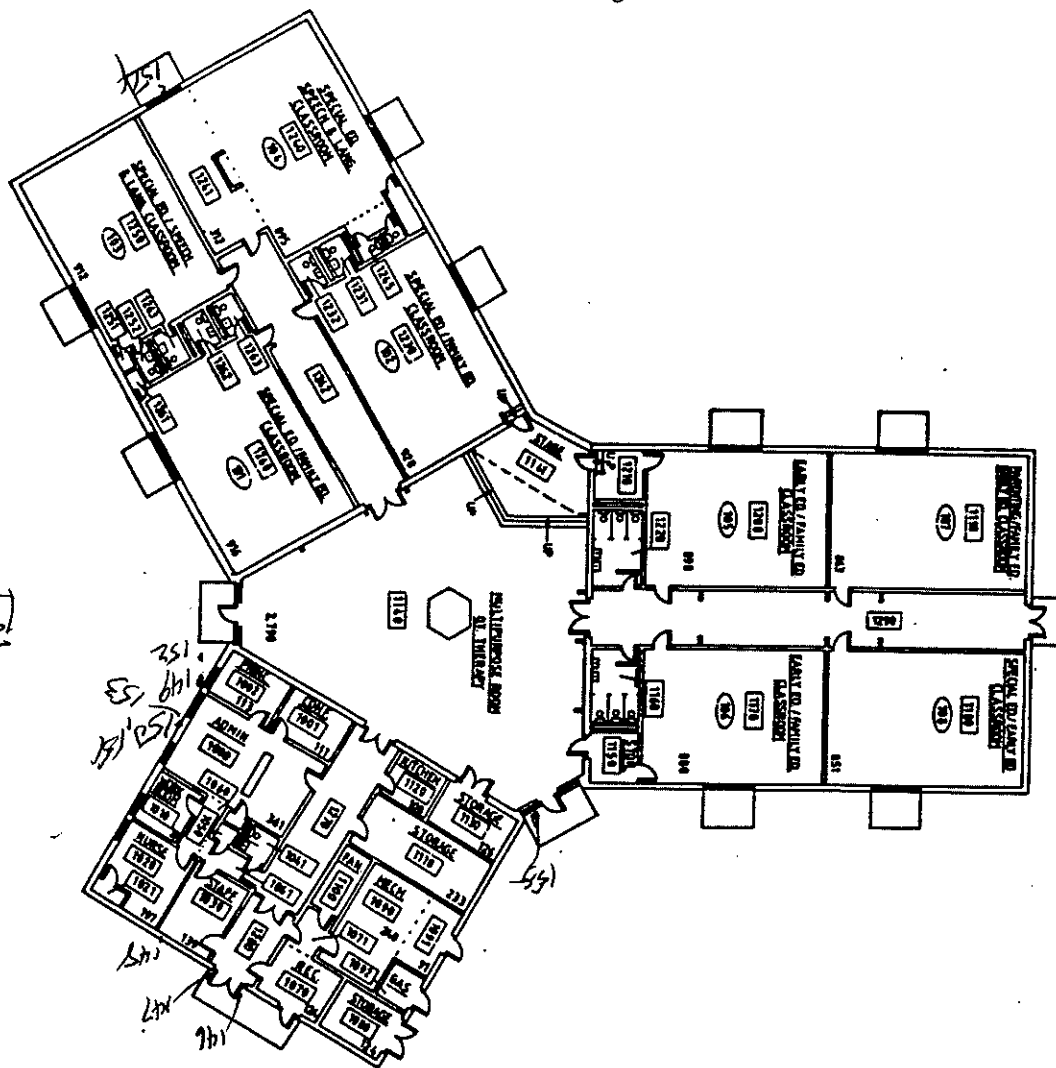
SHEET  
2  
3

WHELOCK ELEMENTARY  
1521 EDGERTON ST  
ST. PAUL, MINNESOTA 55101

CONSTRUCTED 1962
