Half Hollow Hills CSD  
Six Month AHERA Surveillance  
Half Hollow Hills High School West & 2 Garages  
May 2023

Project #23546

## Six Month AHERA Surveillance

Half Hollow Hills High School West & 2 Garages  
375 Wolf Hill Road  
Dix Hills, NY 11746

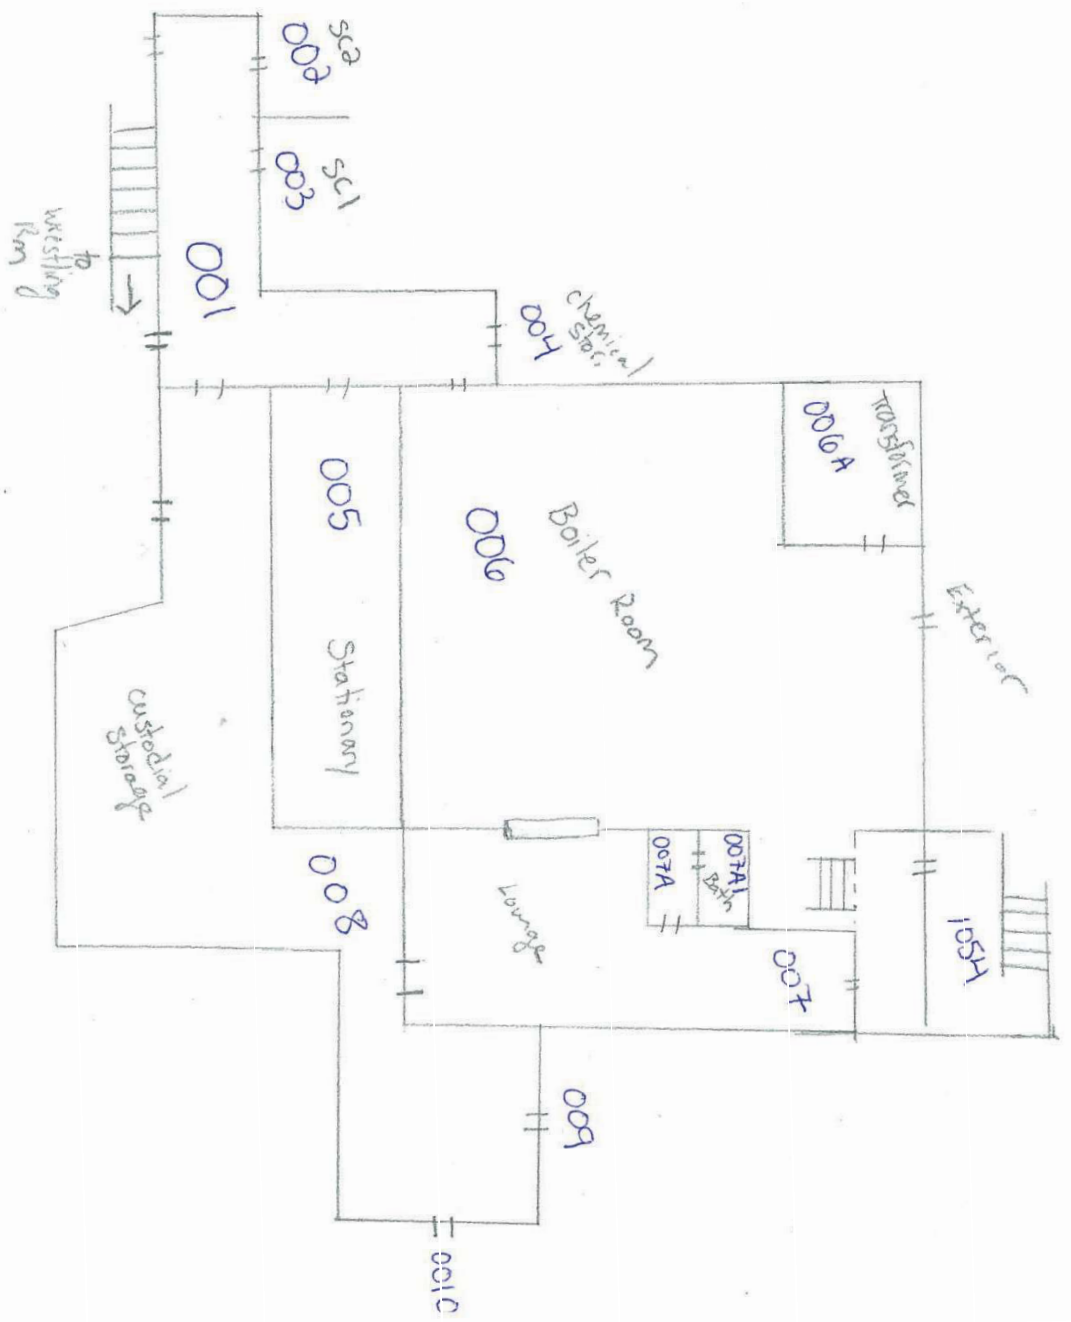
<b>ENVIROSCIENCE CONSULTANTS</b> 2150 SMITHTOWN AVENUE RONKONKOMA, NY 11779 (631) 580-3191 FAX 580-3195 www.envirohealth.org		<b>ENVIRONMENTAL CONSULTANTS</b> KEY PLAN NO SCALE		<b>PROJECT</b> SIX MONTH AHIRA SURVEILLANCE HALF HOLLOW HILLS HIGH SCHOOL WEST BASEMENT FLOOR PLAN

An Inventory of Asbestos Containing Materials by location, including the AHERA Functional Space identification number is in Appendix B. This inventory includes the material, quantity, amount damaged, the hazard level, the AHERA Reassessment category, and recommended response actions. A remarks column includes sampling and abatement action and other pertinent information.
