Half Hollow Hills CSD
Six Month AHERA Surveillance
Vanderbilt Elementary School & 1 Garage
May 2023

Project #23546

Six Month AHERA Surveillance

Vanderbilt Elementary School & 1 Garage
350 Deer Park Avenue
Dix Hills, NY 11746

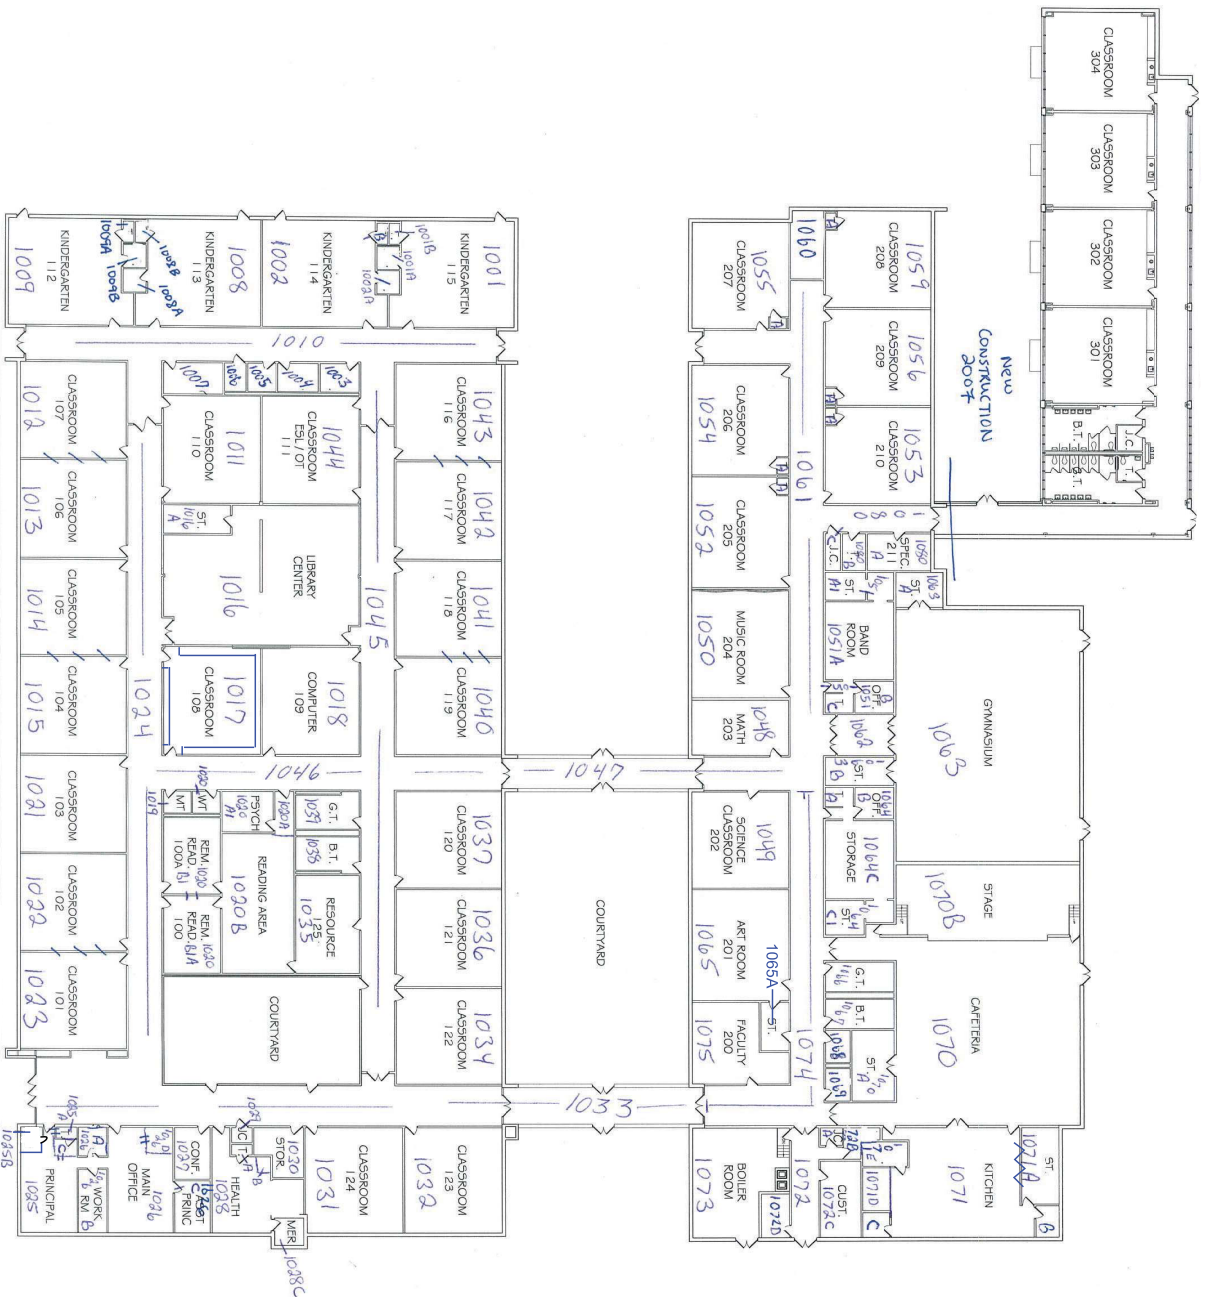
Appendix C

DRAWINGS

Appendix C - Drawings - Functional Space Number Floor Plans
