# FACILITY CONDITION ASSESSMENT

**Alexandria City Public Schools**  
2000 North Beauregard Street  
Alexandria, Virginia 22311  
John Finnigan

Jefferson-Houston K-8  
1501 Cameron Street  
Alexandria, Virginia 22302

*November 29, 2021*

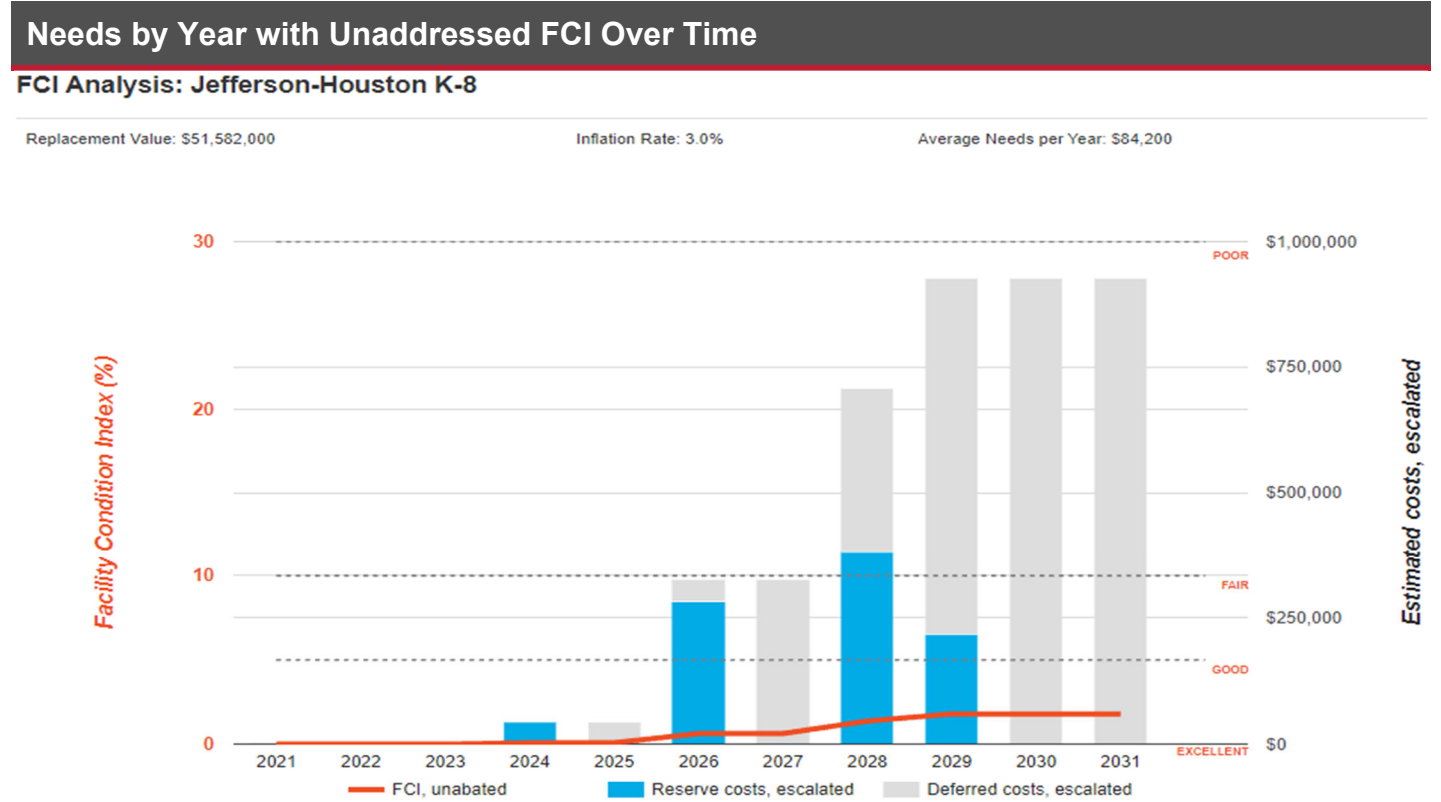
The vertical bars below represent the year-by-year needs identified for the site. The orange line in the graph below forecasts what would happen to the FCI (left Y axis) over time, assuming zero capital expenditures over the next ten years. The dollar amounts allocated for each year (blue bars) are associated with the values along the right Y axis.

<i>Replacement Value</i> \$ 51,581,700	<i>Total SF</i> 171,939	<i>Cost/SF</i> \$ 300
Est Reserve Cost		FCI
Current	\$ 0	0.0 %
3-Year	\$ 44,000	0.1 %
5-Year	\$ 325,200	0.6 %
10-Year	\$ 926,200	1.8 %
