Facilities Condition Assessment Report

I. FCA Executive Summary

North Kitsap School District

Breidablik Elementary School Main
25142 Waghorn Rd NW
Poulsbo, WA

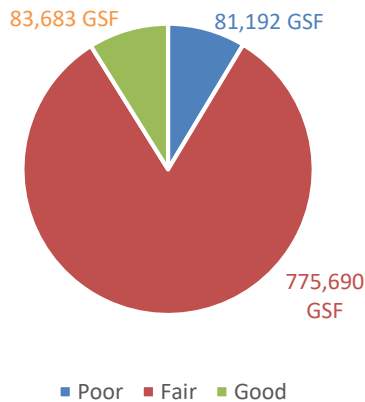
BCA Condition Scores
Asset Portfolio GSF

FACILITY	BUILDING NAME	YEAR BUILT	BCA Scores
Breidablik Elementary School	Main	1989	55.09% Poor
David Woffle Elementary	Main	1989	67.12% Fair
David Woffle Elementary	Playshed	1989	84.89% Fair
Facilities/Maintenance	Main	1959	71.63% Fair
Hilder Pearson Elementary	Lower	1951	71.29% Fair
Hilder Pearson Elementary	Upper	1968	72.40% Fair
Kingston High School	North Building	2007	84.55% Fair
Kingston High School	South Building	2007	84.13% Fair
Kingston Middle School	One-story Building	1988	65.74% Fair
Kingston Middle School	Two-story Building	1993	70.62% Fair
North Kitsap Community	North Kitsap Community Center	1975	79.33% Fair
North Kitsap High School	100 Building	1969	83.48% Fair
North Kitsap High School	Gym	1962	79.64% Fair
North Kitsap High School	Main	1956	89.08% Good
North Kitsap High School	Music	1956	74.10% Fair
North Kitsap High School	Old Vocational	1956	43.83% Poor
North Kitsap High School	Technology	1988	79.89% Fair

North Kitsap Stadium	Stadium	1974	81.98% Fair
PAL (formerly Spectrum)	Spectrum School	1955	73.24% Fair
Poulsbo Elementary School	Main	1974	73.11% Fair
Poulsbo Middle School	Bldg 1 - Classrooms	1975	75.24% Fair
Poulsbo Middle School	Building 2 - Gym/Cafeteria	1975	73.96% Fair
Richard Gordon Elementary	Main	1994	70.20% Fair
Student Support Center	Admin	1956	61.66% Poor
Suquamish Elementary School	Main	1961	80.42% Fair
Transportation Center	Main (Bus Barn)	1958	83.93% Fair
Vinland Elementary School	Main	1994	70.15% Fair

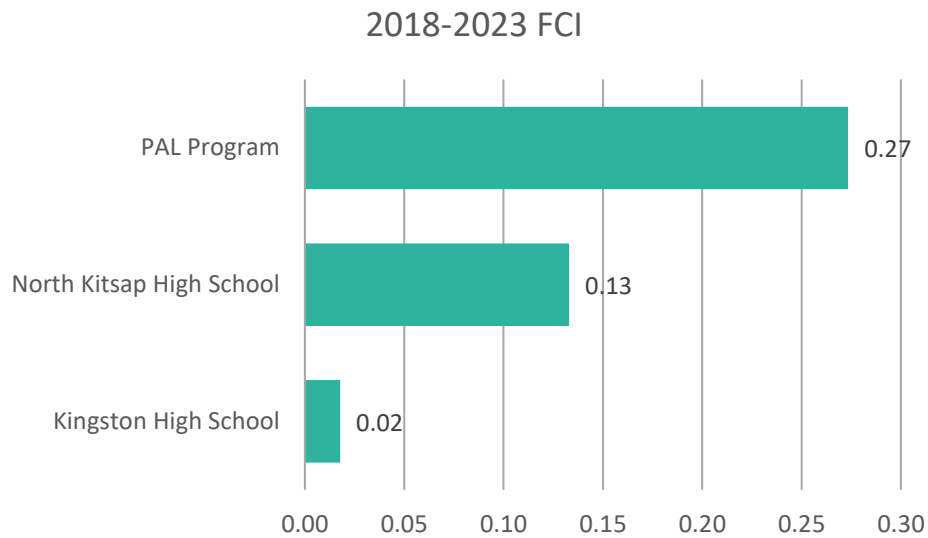
High School Sites FCI Scores

The 3 High School level facilities were rated overall with an average 5-year FCI score of 0.14 and range from 0.02 to 0.27.

Facility	Building	2018 FCI	2018-2023 FCI	2018-2027 FCI	2018-2037 FCI
Kingston High School	North Building	0.00	0.02	0.02	0.39
Kingston High School	South Building	0.00	0.02	0.02	0.40
North Kitsap High School	100 Building	0.02	0.04	0.06	0.44
North Kitsap High School	Gym	0.06	0.08	0.23	0.52
North Kitsap High School	Main	0.00	0.02	0.02	0.17
North Kitsap High School	Music	0.09	0.23	0.24	0.37
North Kitsap High School	Old Vocational	0.72	0.72	0.72	0.72
North Kitsap High School	Technology	0.13	0.33	0.33	0.49
PAL Program	Main	0.27	0.27	0.27	0.58
Average		0.15	0.19	0.21	0.45

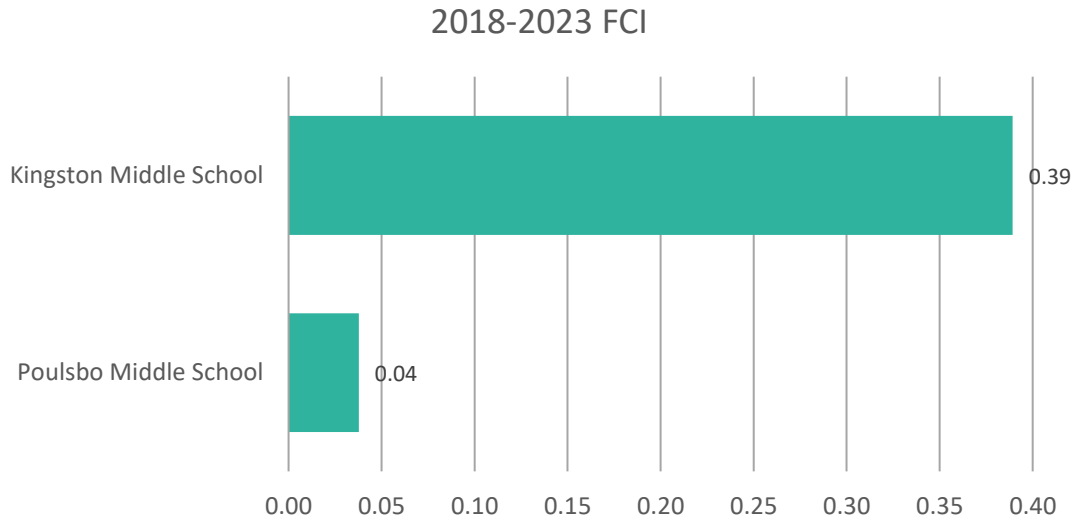
Middle School Sites FCI Scores

The 2 Middle School level facilities were rated overall with an average 5-year FCI score of 0.21 and range from 0.04 to 0.39.

Facility	Building	2018 FCI	2018-2023 FCI	2018-2027 FCI	2018-2037 FCI
Kingston Middle School	One-story Building	0.37	0.40	0.40	0.53
Kingston Middle School	Two-story Building	0.09	0.35	0.41	0.53
Poulsbo Middle School	Building 1 - Classrooms	0.01	0.02	0.05	0.46
Poulsbo Middle School	Building 2 - Gym/Cafeteria	0.03	0.07	0.13	0.46
Average		0.13	0.21	0.25	0.49

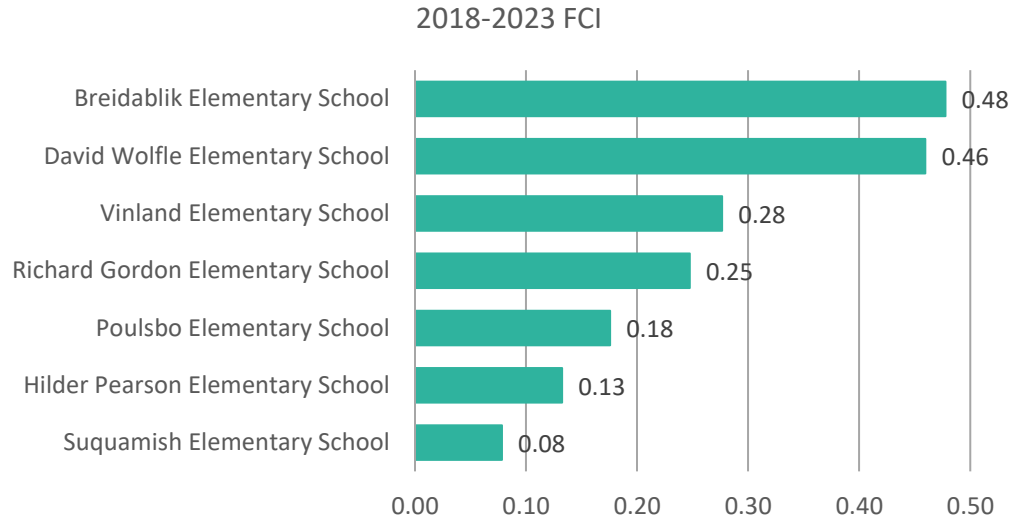
Elementary School / ELC - Site FCI Scores

The 7 Elementary School level facilities were rated overall with an average FCI score of 0.26 and range from 0.08 to 0.48.

Facility	Building	2018 FCI	2018-2023 FCI	2018-2027 FCI	2018-2037 FCI
Breidablik Elementary School	Main	0.28	0.48	0.48	0.61
David Wolfle Elementary School	Main	0.13	0.48	0.48	0.65
David Wolfle Elementary School	Playshed	0.04	0.12	0.12	0.25
Hilder Pearson Elementary School	Lower	0.08	0.13	0.28	0.57
Hilder Pearson Elementary School	Upper	0.07	0.13	0.27	0.56
Poulsbo Elementary School	Main	0.09	0.18	0.22	0.53
Richard Gordon Elementary School	Main	0.11	0.25	0.48	0.62
Suquamish Elementary School	Main	0.04	0.08	0.11	0.49
Vinland Elementary School	Main	0.12	0.28	0.51	0.65
Average		0.11	0.24	0.33	0.55

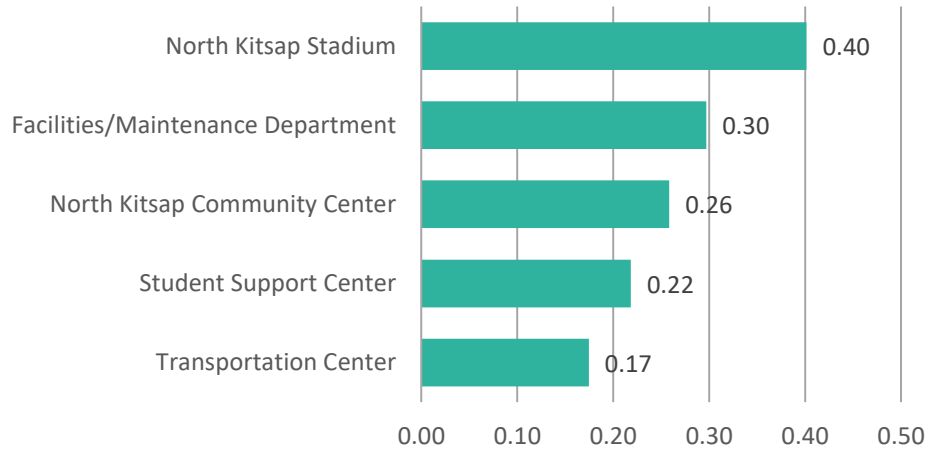
The 5 District Support facilities were rated overall with an average FCI score of 0.27 and range from 0.17 to 0.40.

Facility	Building	2018 FCI	2018-2023 FCI	2018-2027 FCI	2018-2037 FCI
Facilities/Maintenance Department	Main	0.03	0.30	0.34	0.67
North Kitsap Community Center	Main	0.14	0.26	0.34	0.57
North Kitsap Stadium	Stadium	0.34	0.40	0.44	0.49
Student Support Center	Admin	0.08	0.22	0.36	0.67
Transportation Center	Main	0.00	0.17	0.55	0.73
Average		0.12	0.27	0.41	0.63

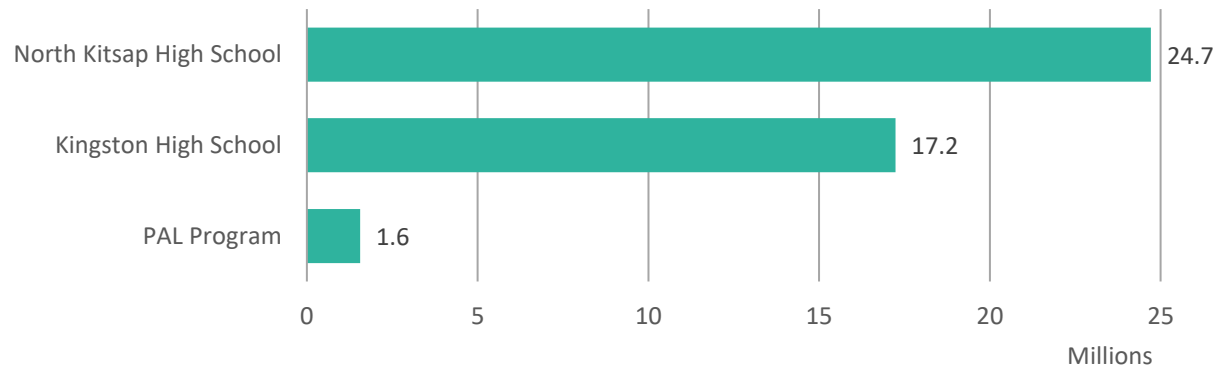
The following tables provide a comprehensive overview of costs projected to occur over the next 20 years at the 3 High School Sites.

Facility	Cost
Kingston High School	\$17,235,073
North Kitsap High School	\$24,712,402
PAL Program	\$1,557,996
Total	\$43,505,471

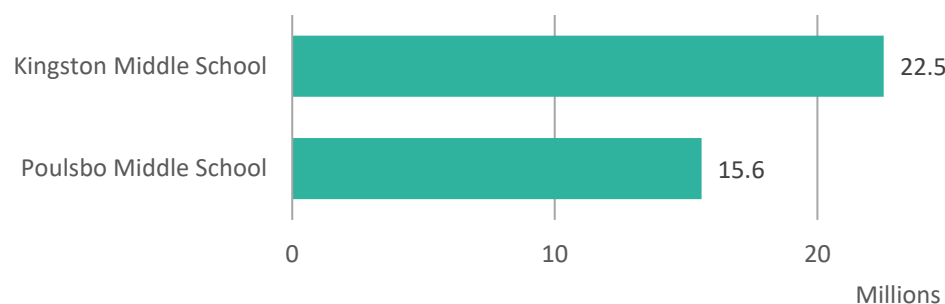
Middle Schools - Cost Projections by Site (2018-2037)

The following tables provide a comprehensive overview of costs projected to occur over the period of 2018-2037.

Facility	Cost
Kingston Middle School	\$22,525,775
Poulsbo Middle School	\$15,585,139
Total	\$38,110,914

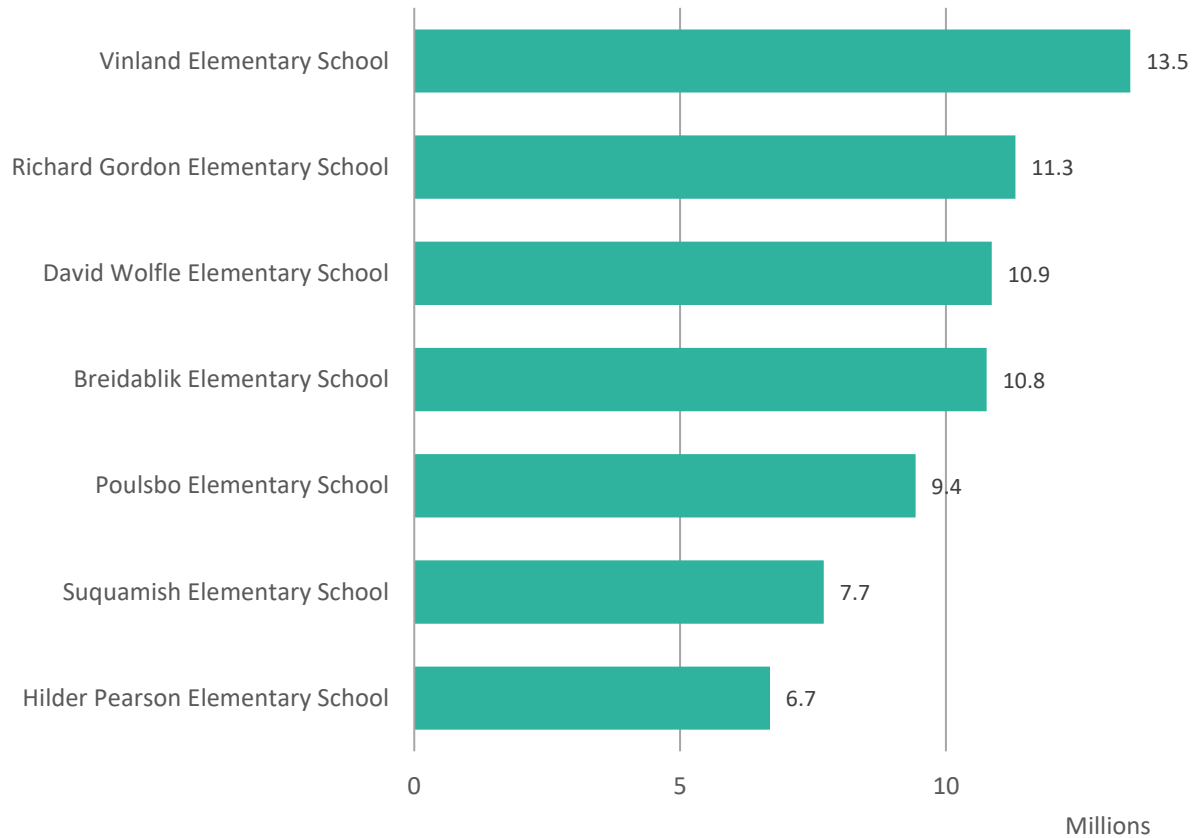
Elementary - Cost Projections by Site (2018-2037)

The following tables provide a comprehensive overview of costs projected to occur over the next 20 years at the 7 Elementary and Early Learning Center Sites.

Site	Cost
Breidablik Elementary School	\$10,765,623
David Wolfle Elementary School	\$10,863,984
Hilder Pearson Elementary School	\$6,689,153
Poulsbo Elementary School	\$9,428,041
Richard Gordon Elementary School	\$11,305,829
Suquamish Elementary School	\$7,703,451
Vinland Elementary School	\$13,467,547
Total	\$70,223,629

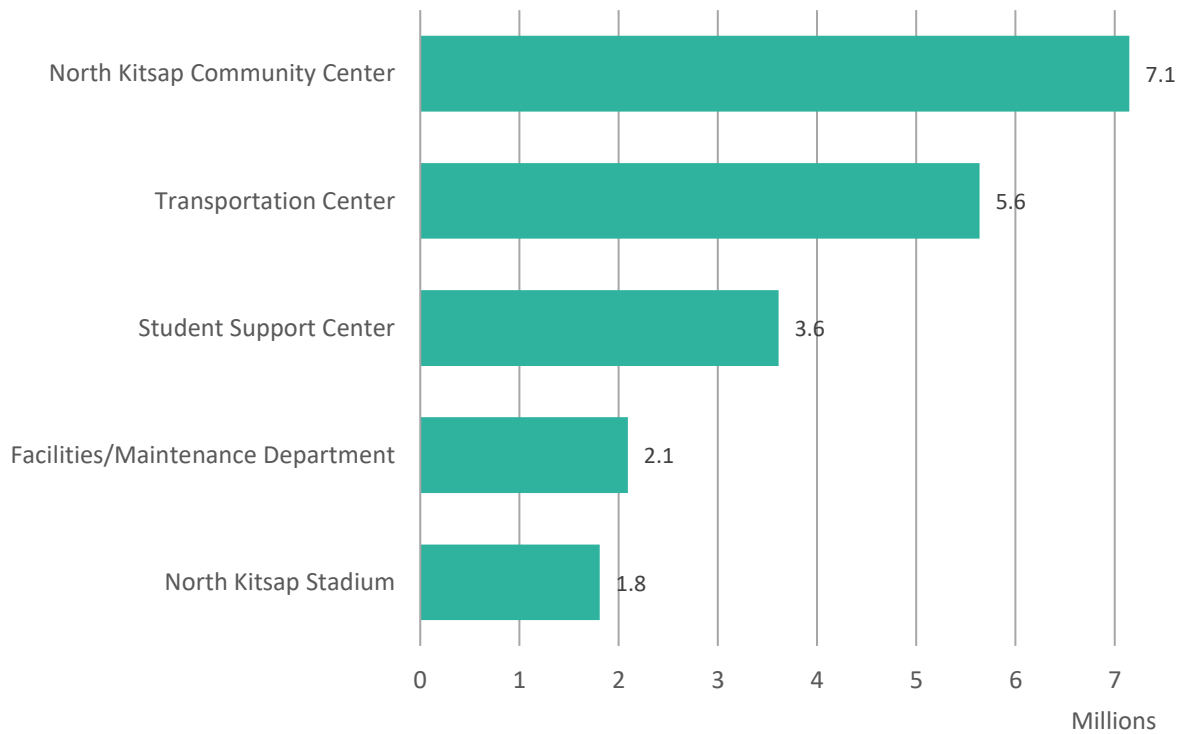
District Support- Cost Projections by Site (2018-2037)

The following tables provide a comprehensive overview of costs projected to occur over the next 20 years at the five District Support Sites.

Facility	Cost
Facilities/Maintenance Department	\$2,092,614
North Kitsap Community Center	\$7,148,504
North Kitsap Stadium	\$1,810,274
Student Support Center	\$3,612,782
Transportation Center	\$5,638,234
Grand Total	\$20,302,408

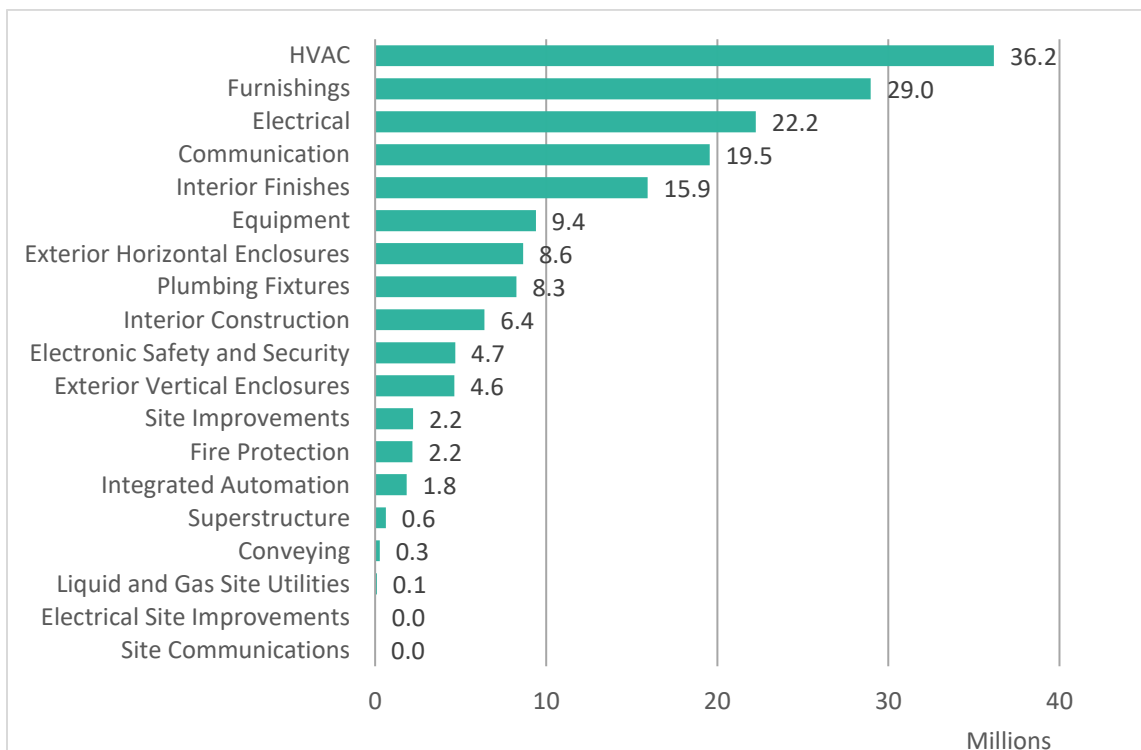
Cost Projections by Level 2 Systems (2018-2037)

Level 2 Subsystems	Total
Communication	\$19,549,625
Conveying	\$267,594
Electrical	\$22,248,762
Electrical Site Improvements	\$33,500
Electronic Safety and Security	\$4,680,497
Equipment	\$9,393,400
Exterior Horizontal Enclosures	\$8,645,835
Exterior Vertical Enclosures	\$4,629,680
Fire Protection	\$2,183,921
Furnishings	\$28,971,461
HVAC	\$36,162,378
Integrated Automation	\$1,849,534
Interior Construction	\$6,391,164
Interior Finishes	\$15,934,835
Liquid and Gas Site Utilities	\$96,500
Plumbing Fixtures	\$8,252,771
Site Communications	\$5,000
Site Improvements	\$2,212,740
Superstructure	\$626,183
Total	\$172,135,381

The District's HVAC systems represent the highest cost projections with \$36 million. These "active" building systems have greatly suffered due to previous maintenance practices. The lack of regular air filter changes and water treatment of hydronic systems has shortened the normal expected life of these systems. Recommissioning HVAC systems is strongly recommended to mitigate the accelerated decline of these critical systems. Furnishings (\$29 million) and Electrical (\$22 million) systems then follow in terms of systems needs.

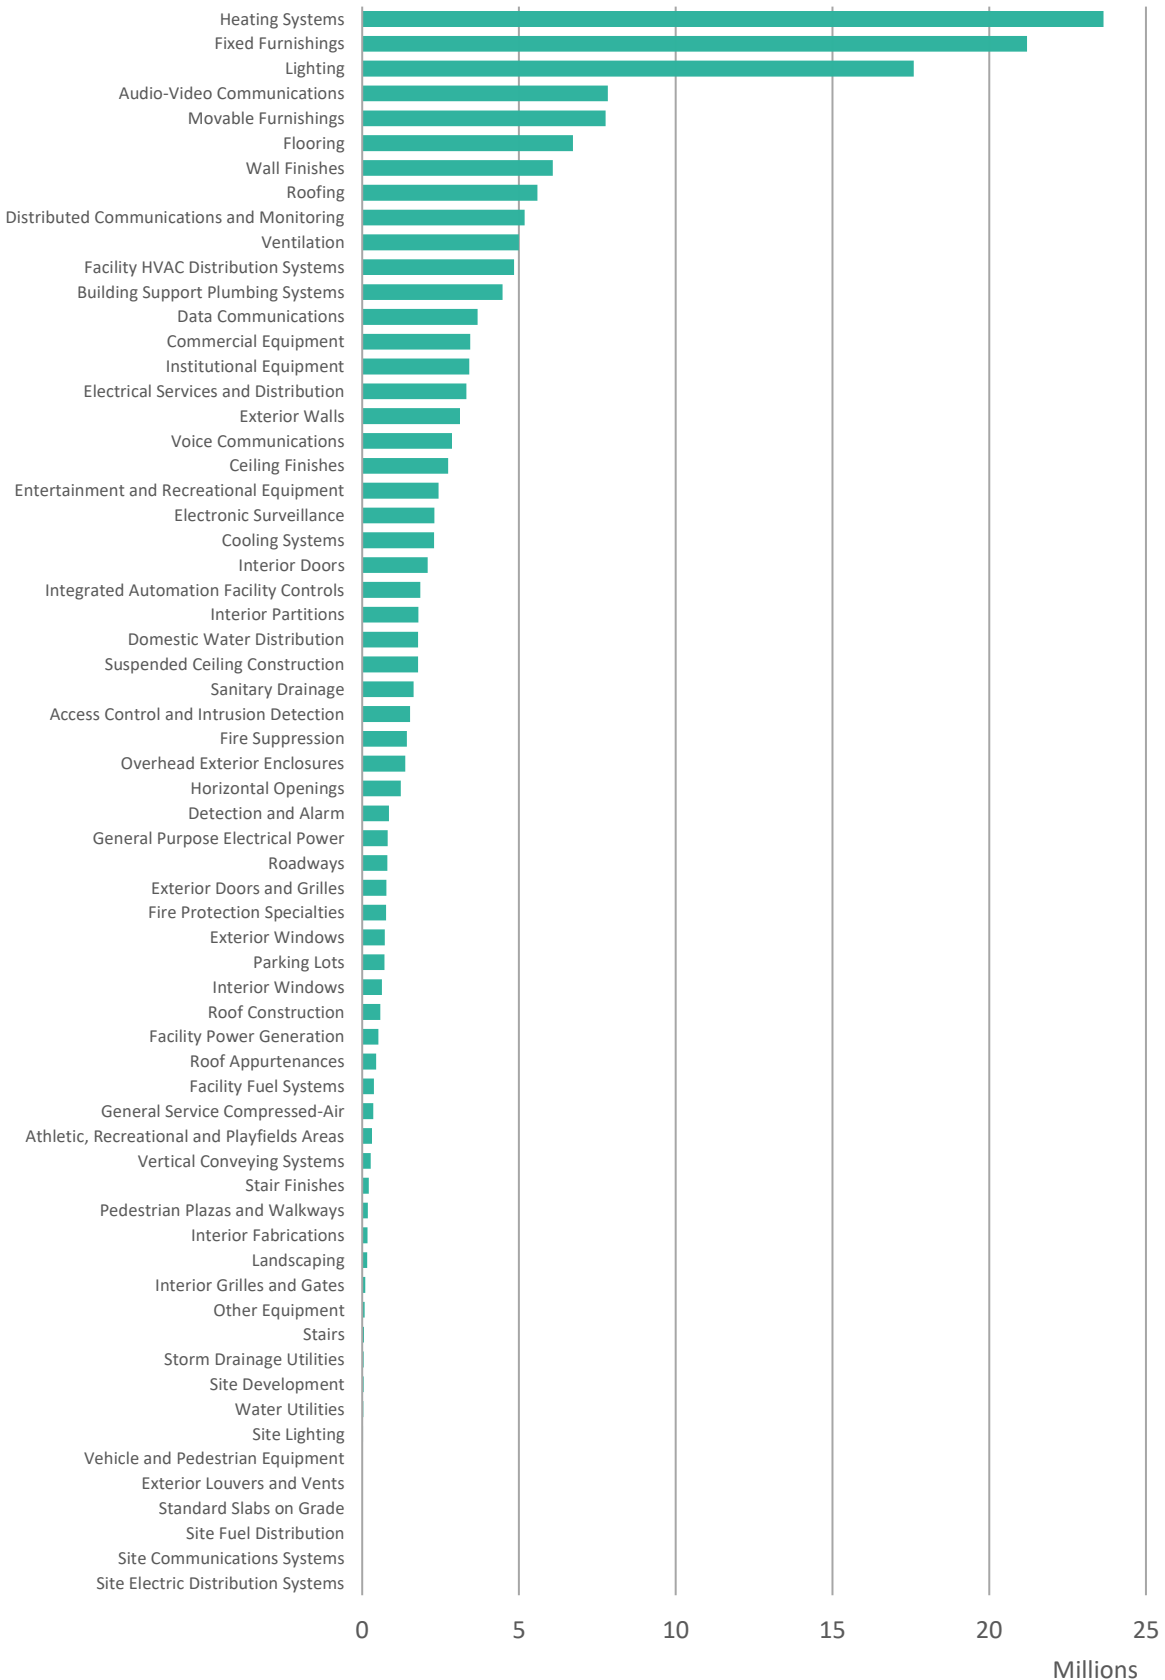
Cost Projections by Level 3 Subsystems (2018-2037)

Level 3 Subsystems	Total
Access Control and Intrusion Detection	\$1,523,308
Athletic, Recreational and Playfields Areas	\$314,960
Audio-Video Communications	\$7,830,696
Building Support Plumbing Systems	\$4,481,699
Ceiling Finishes	\$2,745,863
Commercial Equipment	\$3,449,606
Cooling Systems	\$2,293,243
Data Communications	\$3,680,355
Detection and Alarm	\$850,786
Distributed Communications and Monitoring	\$5,177,727
Domestic Water Distribution	\$1,779,205
Electrical Services and Distribution	\$3,323,474
Electronic Surveillance	\$2,306,404
Entertainment and Recreational Equipment	\$2,433,585
Exterior Doors and Grilles	\$768,686
Exterior Louvers and Vents	\$17,386
Exterior Walls	\$3,119,208
Exterior Windows	\$724,401
Facility Fuel Systems	\$374,501
Facility HVAC Distribution Systems	\$4,849,262
Facility Power Generation	\$519,328
Fire Protection Specialties	\$762,337
Fire Suppression	\$1,421,584
Fixed Furnishings	\$21,208,491

Wall Finishes	\$6,081,139
Water Utilities	\$35,000
Total	\$172,142,421

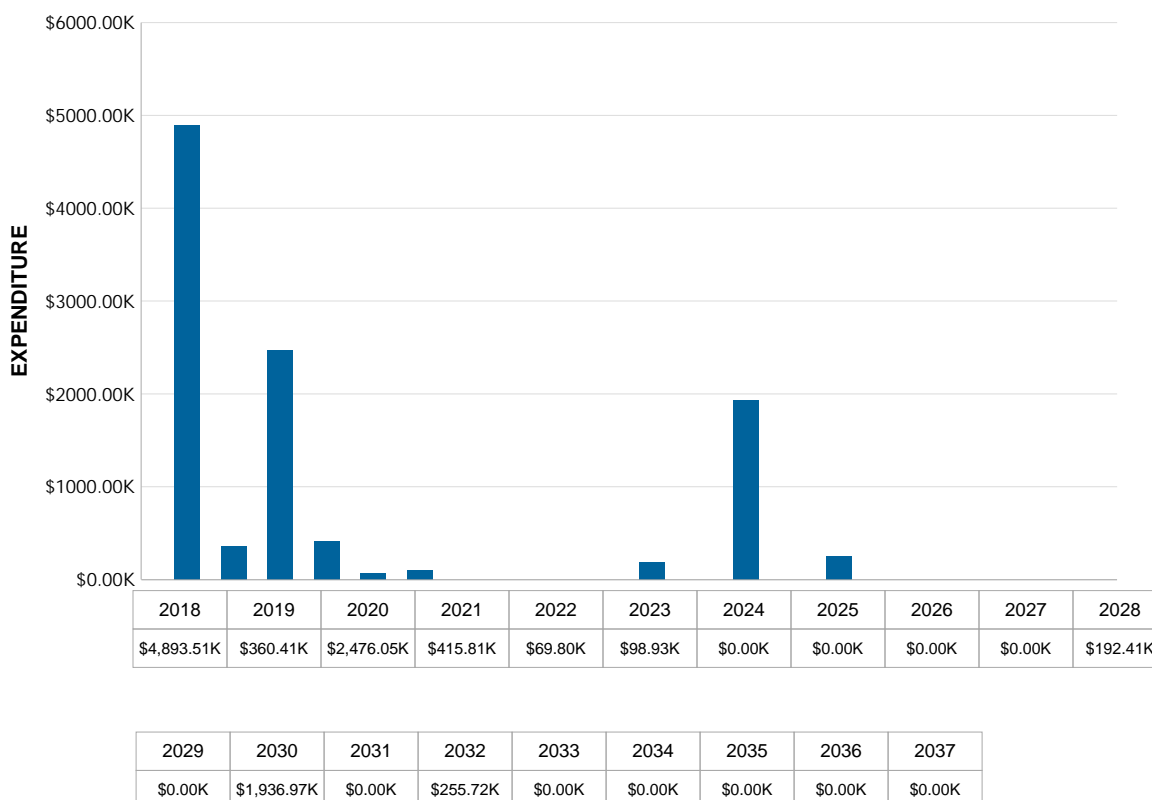
Expenditure Forecast Over Study Period

The building expenditure summary section provides an executive overview of the findings from the assessment. The chart below provides a summary of yearly anticipated expenditures over the study period for the Breidablik Elementary School Main building. In addition, we have scheduled key findings highlighting key items of greater than \$5,000 and their anticipated failure year. Further details of these expenditures are included within each respective report section and within the expenditure forecast, in Appendix A of this report. The results illustrate a total anticipated expenditure over the study period of approximately \$10,699,623.

- B Shell: Replace Roofing at an estimated cost of \$245,831 in year 2018
- B Shell: Replace Exterior Windows at an estimated cost of \$85,076 in year 2018

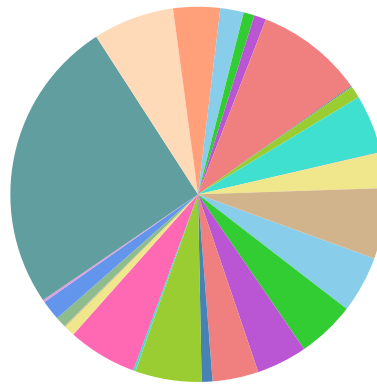
Distribution of Immediate Needs by Building System

Building System	Estimated Cost	Percentage of Total Cost
Building Support Plumbing Systems	\$239,401	4.89 %
Ceiling Finishes	\$243,853	4.98 %
Commercial Equipment	\$213,680	4.37 %
Data Communications	\$193,895	3.96 %
Detection and Alarm	\$45,506	0.93 %
Distributed Communications and Monitoring	\$279,961	5.72 %
Domestic Water Distribution	\$9,600	0.20 %
Entertainment and Recreational Equipment	\$291,832	5.96 %
Exterior Doors and Grilles	\$46,001	0.94 %
Exterior Louvers and Vents	\$4,452	0.09 %
Exterior Walls	\$45,142	0.92 %
Exterior Windows	\$85,076	1.74 %
Facility HVAC Distribution Systems	\$10,333	0.21 %
Fixed Furnishings	\$1,243,005	25.40 %

Flooring	\$342,284	6.99 %
Institutional Equipment	\$197,357	4.03 %
Integrated Automation Facility Controls	\$98,926	2.02 %
Interior Doors	\$45,996	0.94 %
Interior Fabrications	\$50,452	1.03 %
Moveable Furnishings	\$455,554	9.31 %
Other Equipment	\$3,957	0.08 %
Roof Appurtenances	\$51,936	1.06 %
Roof Coverings	\$245,831	5.02 %
Ventilation	\$1,350	0.03 %
Voice Communications	\$150,368	3.07 %
Wall Finishes	\$297,767	6.08 %
Total	\$4,893,514	100 %

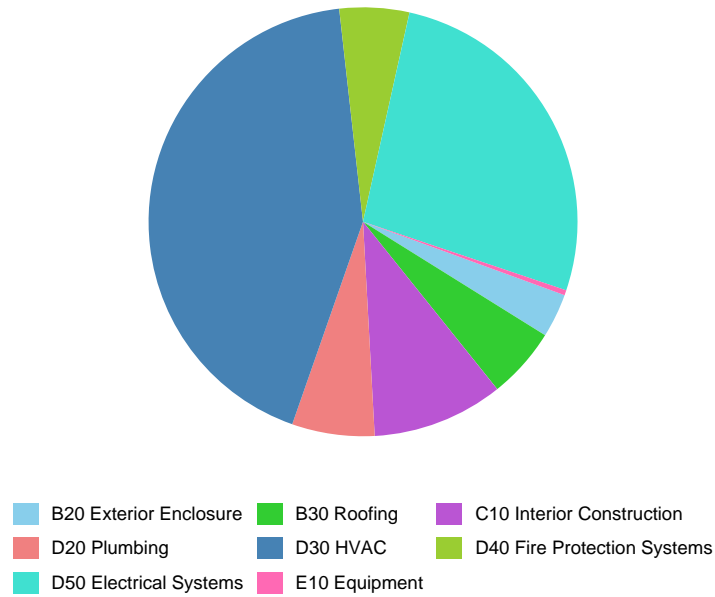
Distribution of Capital Needs by Building System

Building System	Estimated Cost	Percentage of Total Cost
B20 Exterior Enclosure	\$192,411	3.31 %
B30 Roofing	\$312,062	5.37 %
C10 Interior Construction	\$574,265	9.89 %
D20 Plumbing	\$361,309	6.22 %
D30 HVAC	\$2,488,804	42.87 %
D40 Fire Protection Systems	\$305,187	5.26 %
D50 Electrical Systems	\$1,550,170	26.70 %
E10 Equipment	\$21,900	0.38 %
Total	\$5,806,109	100 %

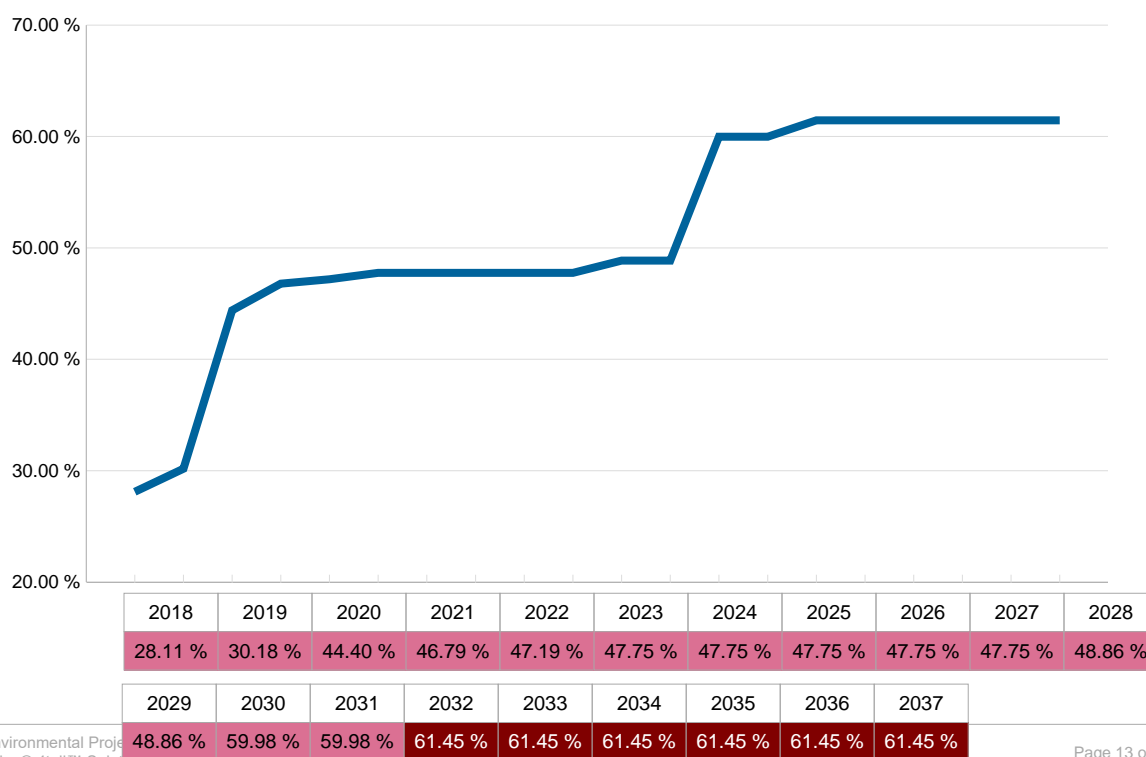
Cumulative Effects of FCI Over the Study Period

The Chart below indicates the cumulative effects of the FCI ratio over the study period assuming the required funds and expenditures are NOT provided to address the identified works and deferred maintenance each year.

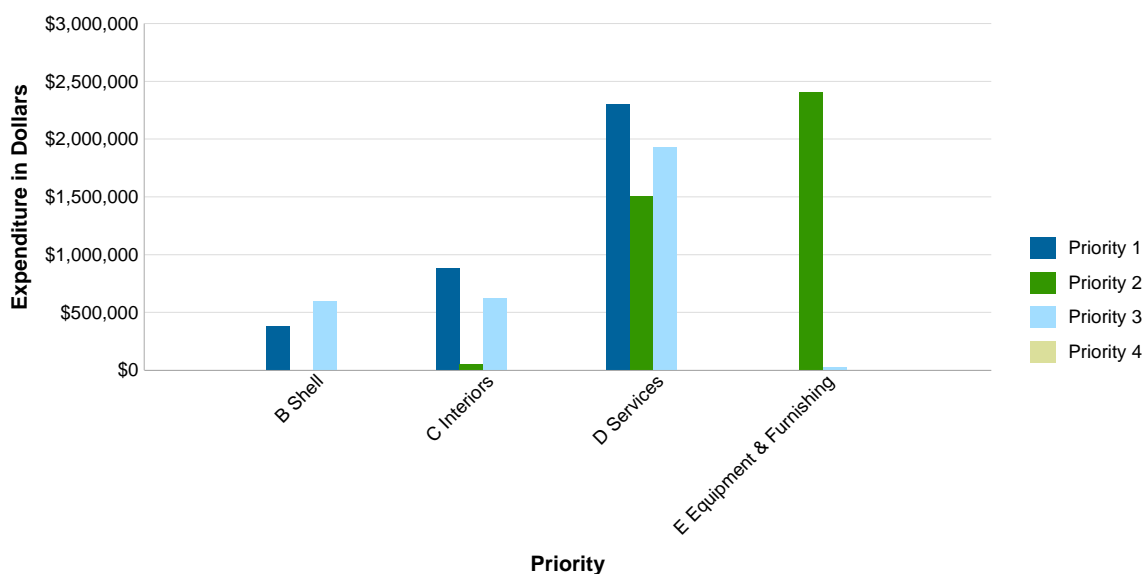
Planning Horizon Needs by System and Priority

The chart below illustrates the breakdown of expenditure according the priority coding providing an opportunity to strategically plan and effectively direct funding to the highest priority.

Building System	Priority 1	Priority 2	Priority 3	Priority 4	Total
B Shell	\$382,844	\$0	\$600,067	\$0	\$982,911
C Interiors	\$883,904	\$50,452	\$620,261	\$0	\$1,554,617
D Services	\$2,300,524	\$1,505,786	\$1,928,499	\$0	\$5,734,809
E Equipment & Furnishing	\$0	\$2,405,386	\$21,900	\$0	\$2,427,286
Total	\$3,567,272	\$3,961,624	\$3,170,727	\$0	\$10,699,623

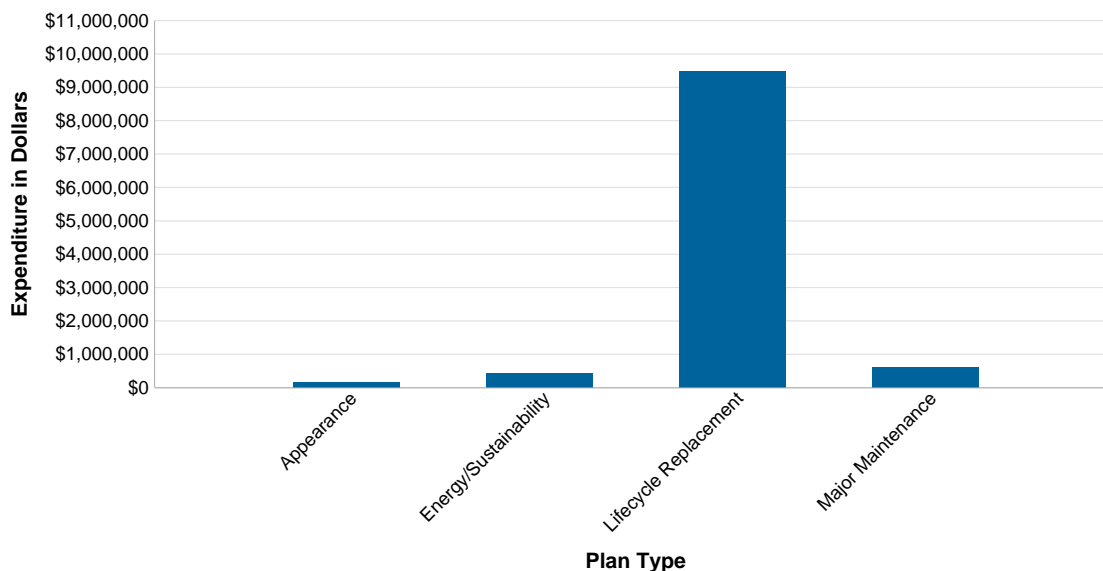
Planning Horizon Needs by Category

The chart below illustrates the breakdown of expenditure according to the Plan Type or deficiency categories providing an opportunity to strategically plan and effectively direct funding.

Building System	Total Cost
Appearance	\$154,770
Energy/Sustainability	\$424,482
Lifecycle Replacement	\$9,491,455
Major Maintenance	\$628,916
Total	\$10,699,623

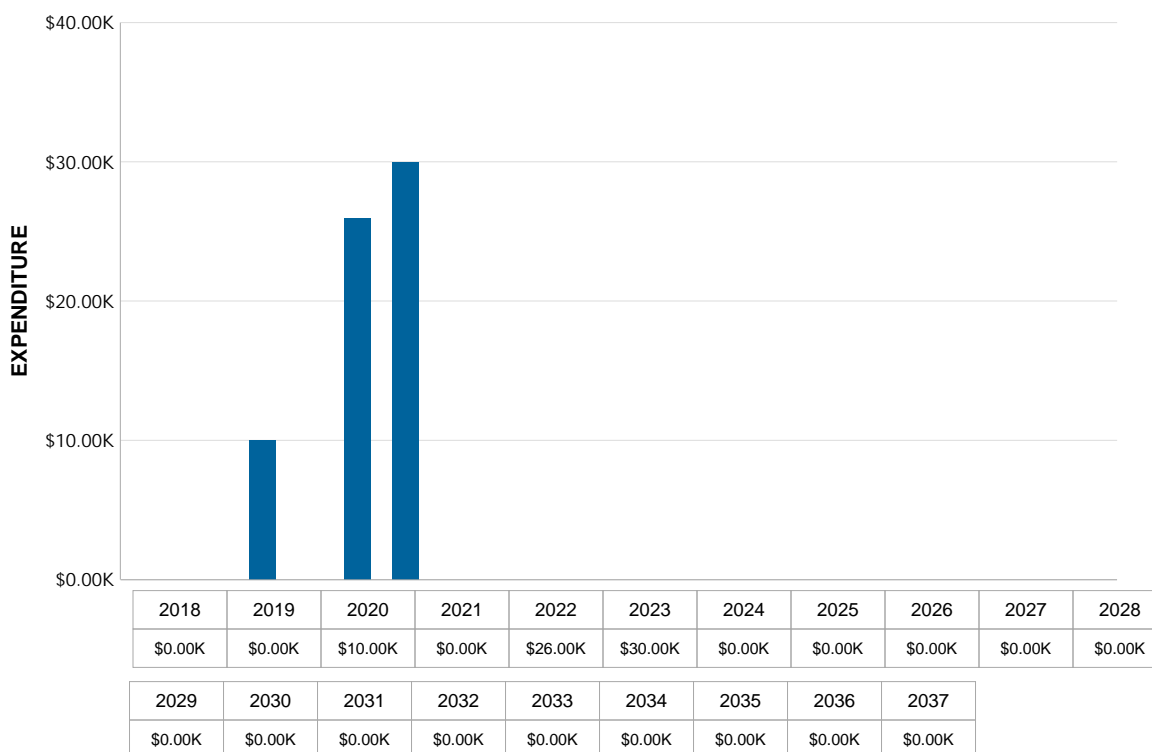
Expenditure Forecast Over Study Period

The building expenditure summary section provides an executive overview of the findings from the assessment. The chart below provides a summary of yearly anticipated expenditures over the study period for the Breidablik Elementary School Site building. In addition, we have scheduled key findings highlighting key items of greater than \$5,000 and their anticipated failure year. Further details of these expenditures are included within each respective report section and within the expenditure forecast, in Appendix A of this report. The results illustrate a total anticipated expenditure over the study period of approximately \$66,000.

- G Building Sitework: Allowance for general Landscaping Maintenance at an estimated cost of \$10,000 in year 2020
- G Building Sitework: Allowance for repair and replacement of site development systems at an estimated cost of \$15,000 in year 2022
- G Building Sitework: Cut and patch asphalt to repair sink hole. Selective turf repairs at an estimated cost of \$11,000 in year 2022
- G Building Sitework: Allowance for selective removal and replacement with seal coat. at an estimated cost of \$10,000 in year 2023
- G Building Sitework: Allowance for selective removal and replacement with seal coat. at an estimated cost of \$10,000 in year 2023
- G Building Sitework: Remove roots and grind down pavement hazards at an estimated cost of \$10,000 in year 2023

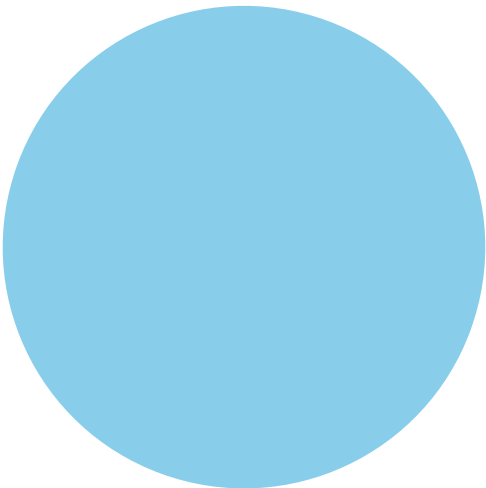
Distribution of Capital Needs by Building System

Building System	Estimated Cost	Percentage of Total Cost
G20 Site Improvements	\$66,000	100.00 %
Total	\$66,000	100 %

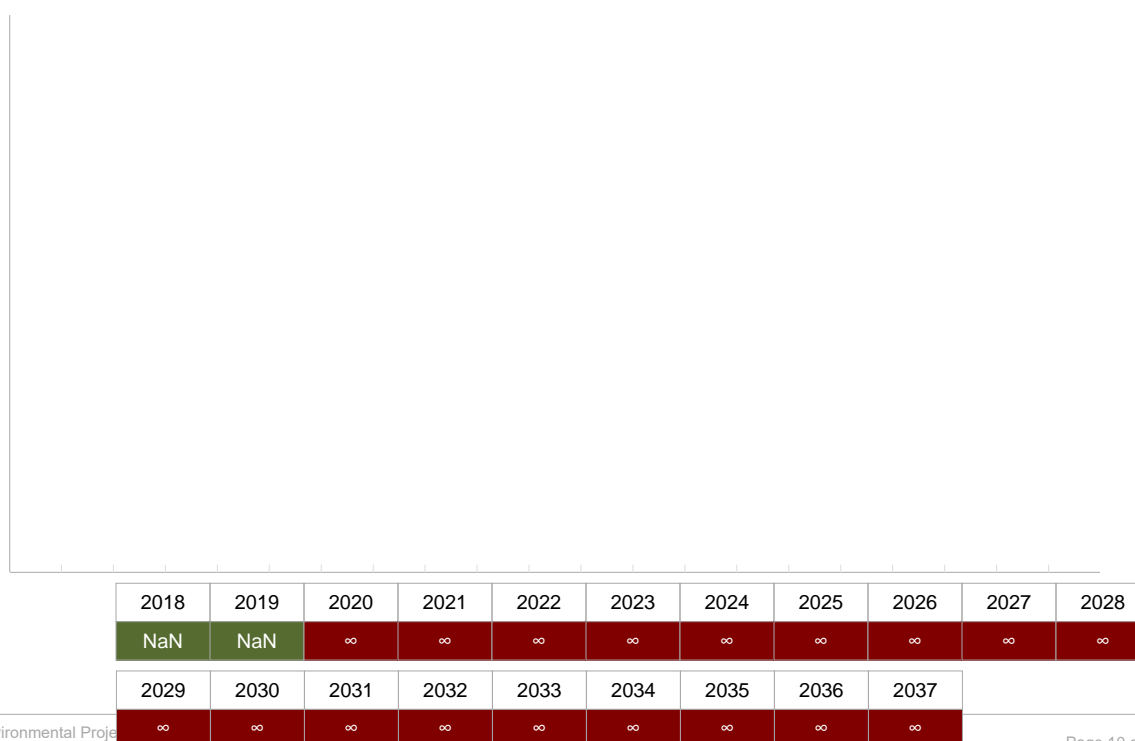
Cumulative Effects of FCI Over the Study Period

The Chart below indicates the cumulative effects of the FCI ratio over the study period assuming the required funds and expenditures are NOT provided to address the identified works and deferred maintenance each year.

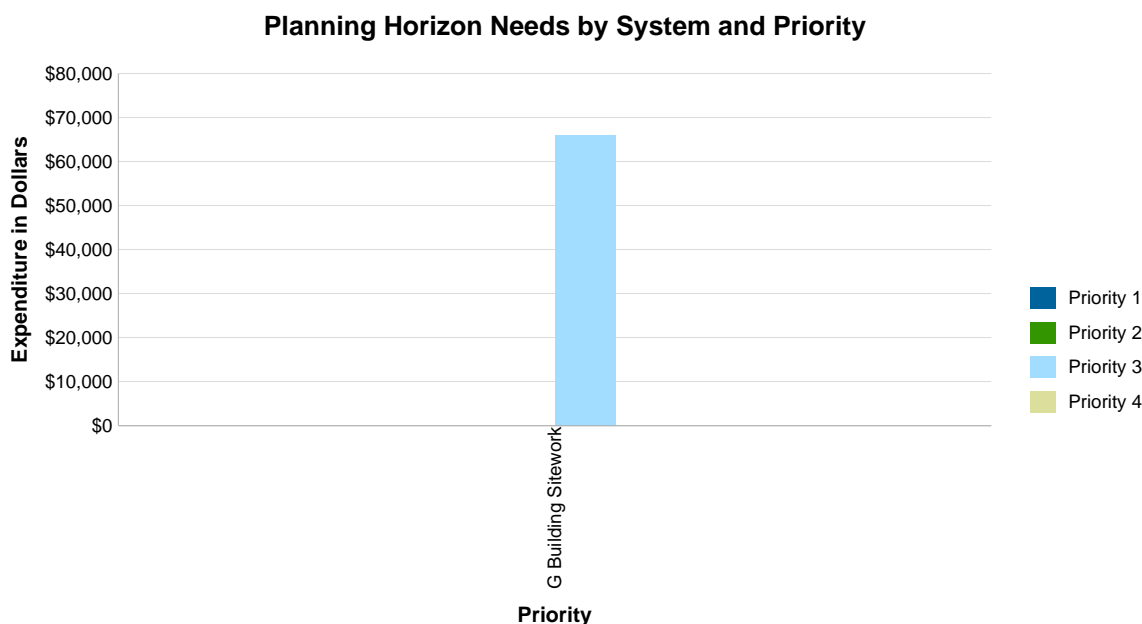
The chart below illustrates the breakdown of expenditure according the priority coding providing an opportunity to strategically plan and effectively direct funding to the highest priority.

Building System	Priority 1	Priority 2	Priority 3	Priority 4	Total
G Building Sitework	\$0	\$0	\$66,000	\$0	\$66,000
Total	\$0	\$0	\$66,000	\$0	\$66,000

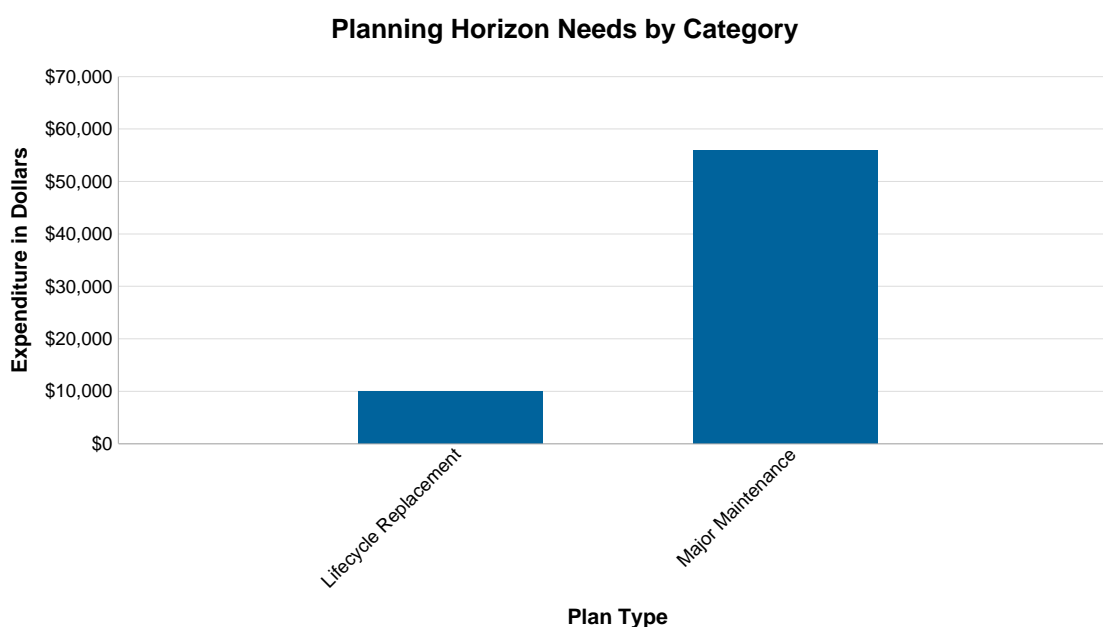
The chart below illustrates the breakdown of expenditure according to the Plan Type or deficiency categories providing an opportunity to strategically plan and effectively direct funding.

Building System	Total Cost
Lifecycle Replacement	\$10,000
Major Maintenance	\$56,000
Total	\$66,000

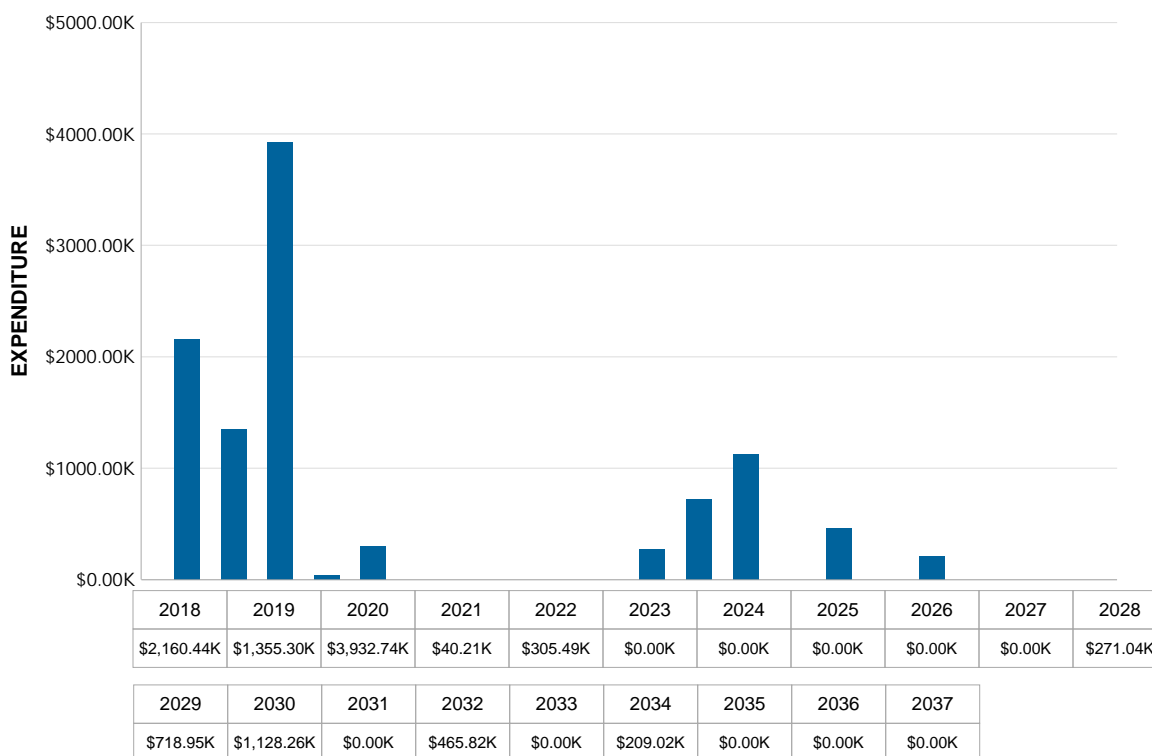
Expenditure Forecast Over Study Period

The building expenditure summary section provides an executive overview of the findings from the assessment. The chart below provides a summary of yearly anticipated expenditures over the study period for the David Wolfle Elementary School Main building. In addition, we have scheduled key findings highlighting key items of greater than \$5,000 and their anticipated failure year. Further details of these expenditures are included within each respective report section and within the expenditure forecast, in Appendix A of this report. The results illustrate a total anticipated expenditure over the study period of approximately \$10,587,285.

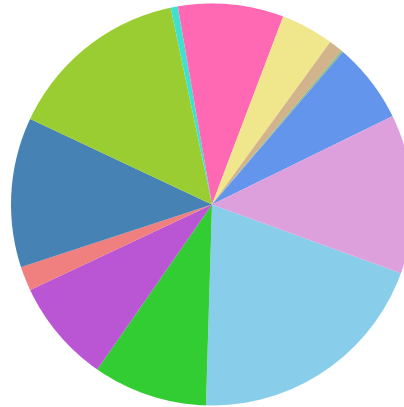
Distribution of Immediate Needs by Building System

Building System	Estimated Cost	Percentage of Total Cost
Audio-Video Communications	\$430,448	19.92 %
Commercial Equipment	\$198,456	9.19 %
Data Communications	\$180,081	8.34 %
Detection and Alarm	\$42,264	1.96 %
Distributed Communications and Monitoring	\$260,015	12.04 %
Flooring	\$317,898	14.71 %
General Purpose Electrical Power	\$12,336	0.57 %
Institutional Equipment	\$183,297	8.48 %
Integrated Automation Facility Controls	\$91,878	4.25 %
Lighting	\$23,888	1.11 %
Other Equipment	\$3,675	0.17 %
Voice Communications	\$139,655	6.46 %
Wall Finishes	\$276,553	12.80 %
Total	\$2,160,444	100 %

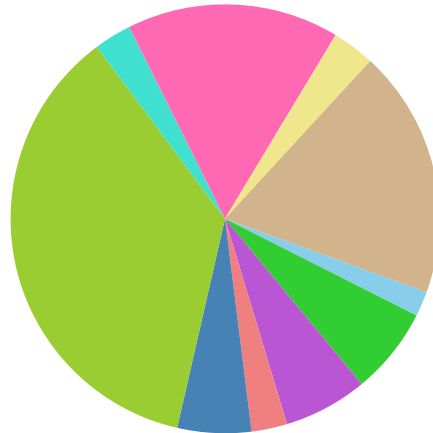
Distribution of Capital Needs by Building System

Building System	Estimated Cost	Percentage of Total Cost
B20 Exterior Enclosure	\$158,949	1.89 %
B30 Roofing	\$553,565	6.57 %
C10 Interior Construction	\$533,352	6.33 %
C20 Interior Finishes	\$226,479	2.69 %
D20 Plumbing	\$468,731	5.56 %
D30 HVAC	\$3,051,825	36.22 %
D40 Fire Protection Systems	\$237,505	2.82 %
D50 Electrical Systems	\$1,347,850	15.99 %
E10 Equipment	\$271,040	3.22 %
E20 Furnishings	\$1,577,545	18.72 %
Total	\$8,426,841	100 %

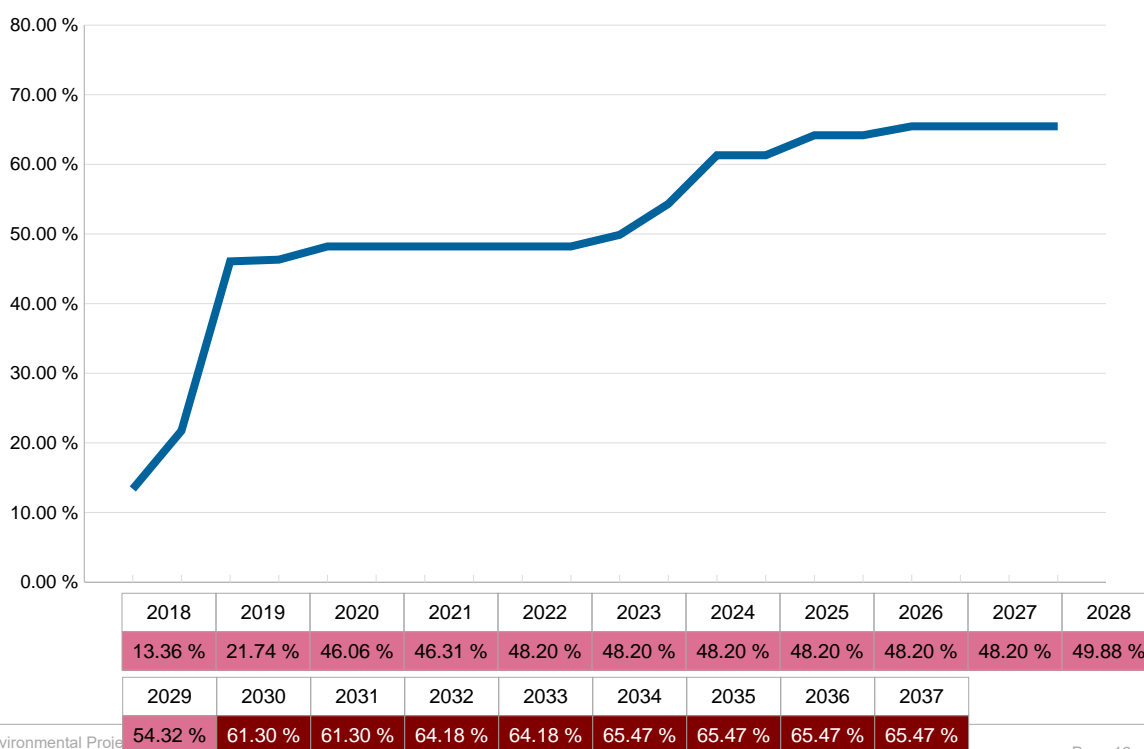
Cumulative Effects of FCI Over the Study Period

The Chart below indicates the cumulative effects of the FCI ratio over the study period assuming the required funds and expenditures are NOT provided to address the identified works and deferred maintenance each year.

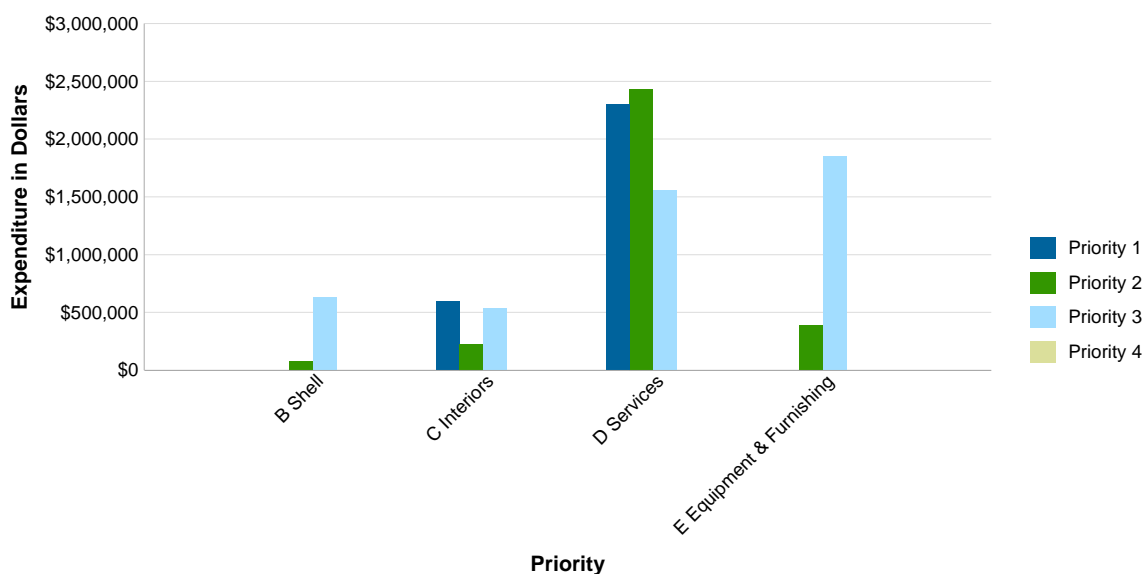
Planning Horizon Needs by System and Priority

Building System	Priority 1	Priority 2	Priority 3	Priority 4	Total
B Shell	\$0	\$79,015	\$633,499	\$0	\$712,514
C Interiors	\$594,451	\$226,479	\$533,352	\$0	\$1,354,282
D Services	\$2,298,788	\$2,432,108	\$1,555,580	\$0	\$6,286,475
E Equipment & Furnishing	\$0	\$385,428	\$1,848,585	\$0	\$2,234,014
Total	\$2,893,238	\$3,123,031	\$4,571,016	\$0	\$10,587,285

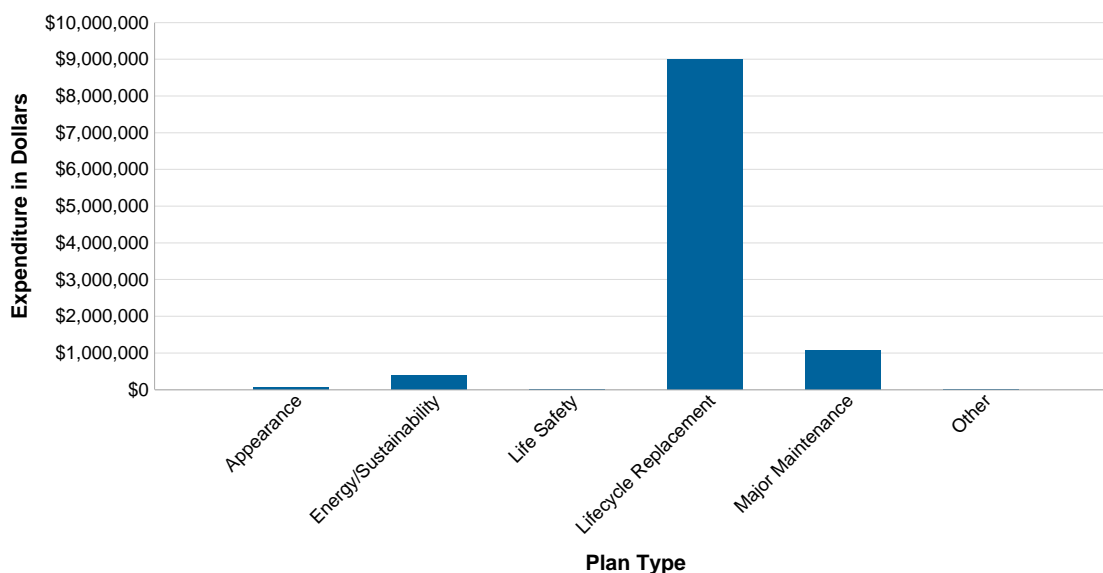
Planning Horizon Needs by Category

Building System	Total Cost
Appearance	\$79,934
Energy/Sustainability	\$395,998
Life Safety	\$23,888
Lifecycle Replacement	\$9,007,719
Major Maintenance	\$1,067,409
Other	\$12,336
Total	\$10,587,285
