Facilities Condition Assessment Report

I. FCA Executive Summary

North Kitsap School District

Breidablik Elementary School Main
25142 Waghorn Rd NW
Poulsbo, WA

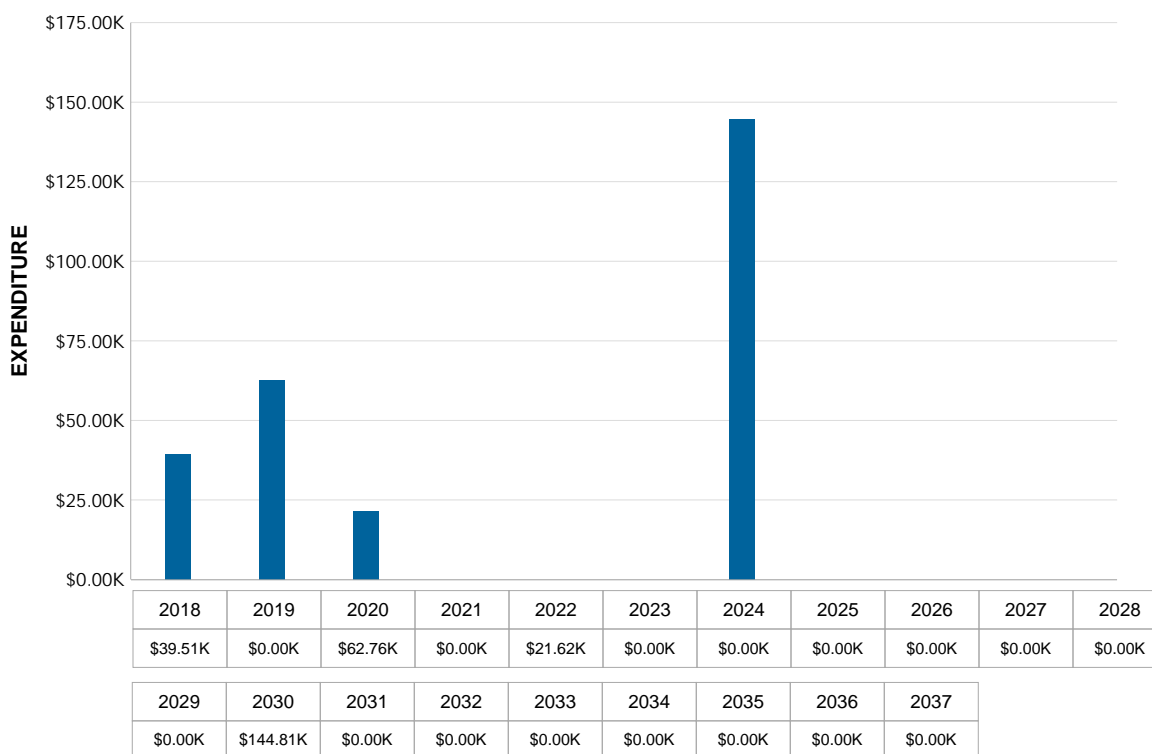
Expenditure Forecast Over Study Period

The building expenditure summary section provides an executive overview of the findings from the assessment. The chart below provides a summary of yearly anticipated expenditures over the study period for the David Wolfle Elementary School Playshed building. In addition, we have scheduled key findings highlighting key items of greater than \$5,000 and their anticipated failure year. Further details of these expenditures are included within each respective report section and within the expenditure forecast, in Appendix A of this report. The results illustrate a total anticipated expenditure over the study period of approximately \$268,700.

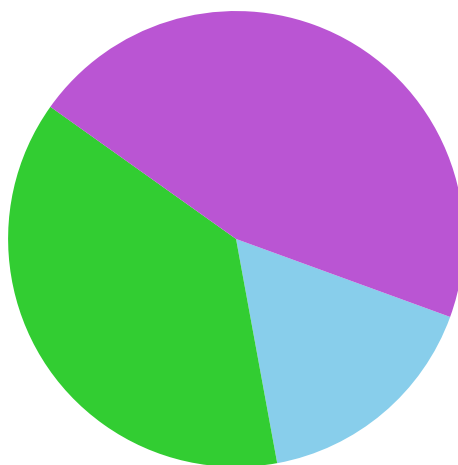
Distribution of Immediate Needs by Building System

Building System	Estimated Cost	Percentage of Total Cost
Exterior Walls	\$6,540	16.55 %
Roof Coverings	\$14,910	37.74 %
Wall Finishes	\$18,060	45.71 %
Total	\$39,510	100 %

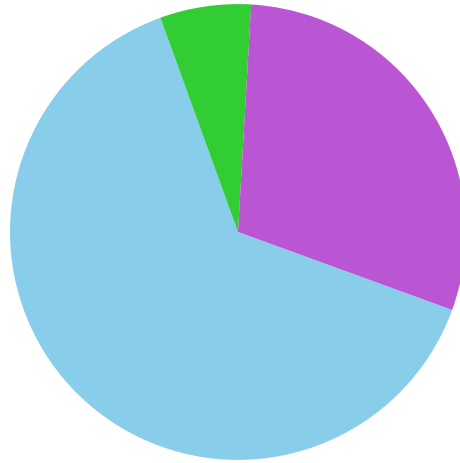
Distribution of Capital Needs by Building System

Building System	Estimated Cost	Percentage of Total Cost
B30 Roofing	\$146,480	63.91 %
C20 Interior Finishes	\$14,790	6.45 %
D50 Electrical Systems	\$67,920	29.63 %
Total	\$229,190	100 %

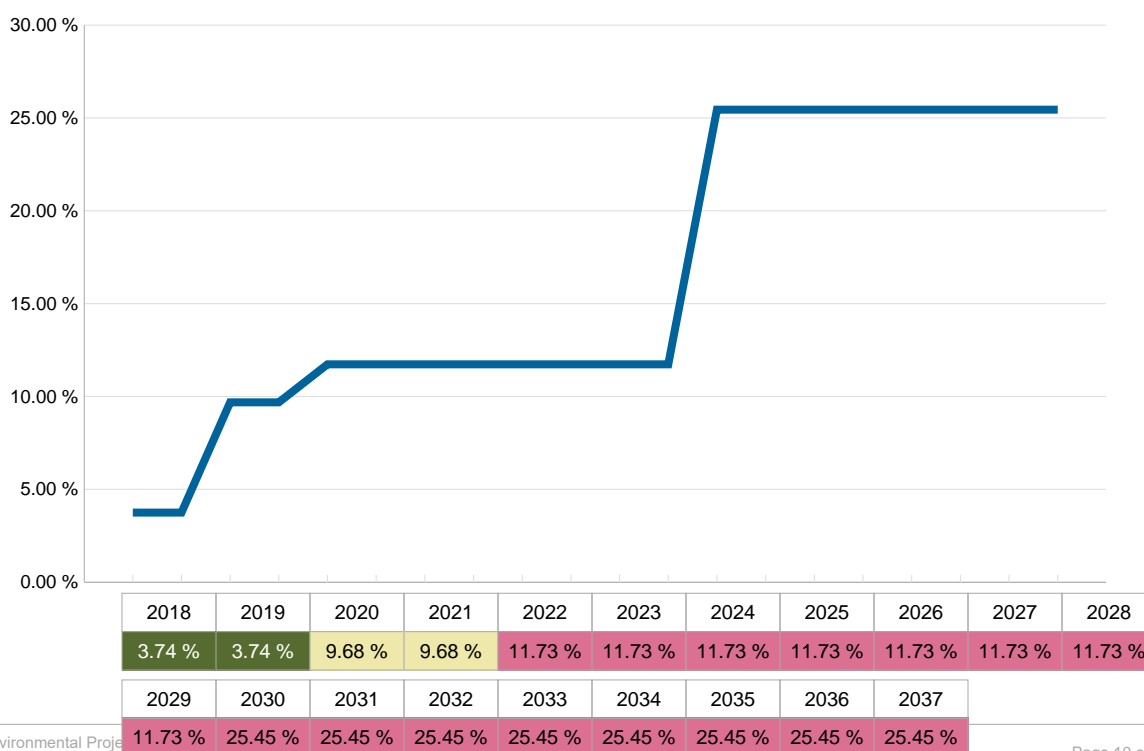
Cumulative Effects of FCI Over the Study Period

The Chart below indicates the cumulative effects of the FCI ratio over the study period assuming the required funds and expenditures are NOT provided to address the identified works and deferred maintenance each year.

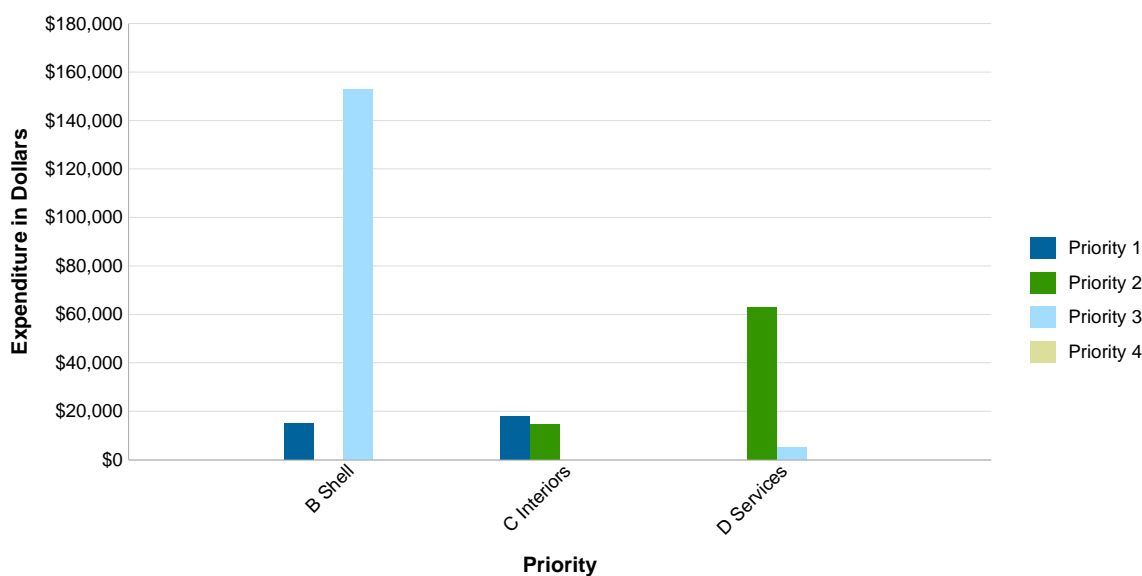
Planning Horizon Needs by System and Priority

Building System	Priority 1	Priority 2	Priority 3	Priority 4	Total
B Shell	\$14,910	\$0	\$153,020	\$0	\$167,930
C Interiors	\$18,060	\$14,790	\$0	\$0	\$32,850
D Services	\$0	\$62,760	\$5,160	\$0	\$67,920
Total	\$32,970	\$77,550	\$158,180	\$0	\$268,700

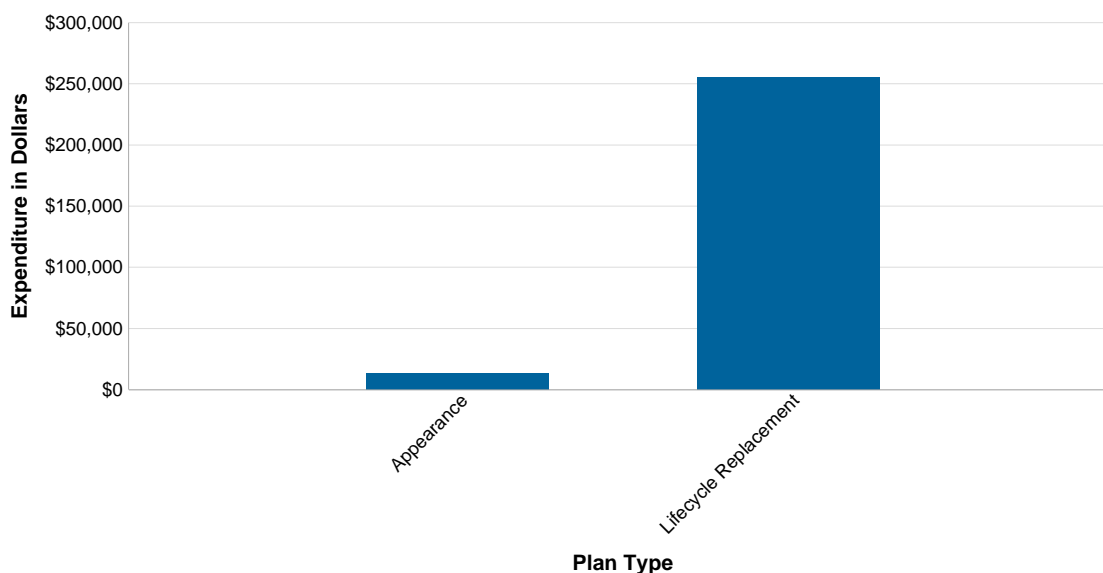
Planning Horizon Needs by Category

Building System	Total Cost
Appearance	\$13,365
Lifecycle Replacement	\$255,335
Total	\$268,700

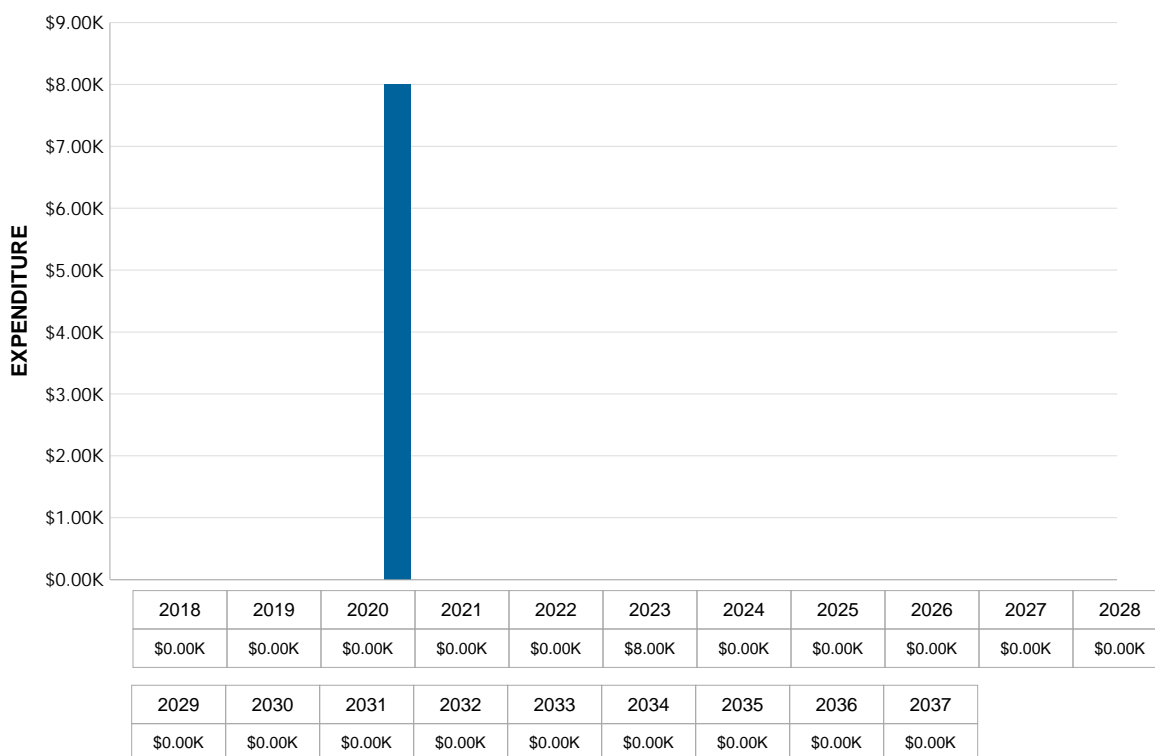
Expenditure Forecast Over Study Period

The building expenditure summary section provides an executive overview of the findings from the assessment. The chart below provides a summary of yearly anticipated expenditures over the study period for the David Wolfle Elementary School Site building. In addition, we have scheduled key findings highlighting key items of greater than \$5,000 and their anticipated failure year. Further details of these expenditures are included within each respective report section and within the expenditure forecast, in Appendix A of this report. The results illustrate a total anticipated expenditure over the study period of approximately \$8,000.

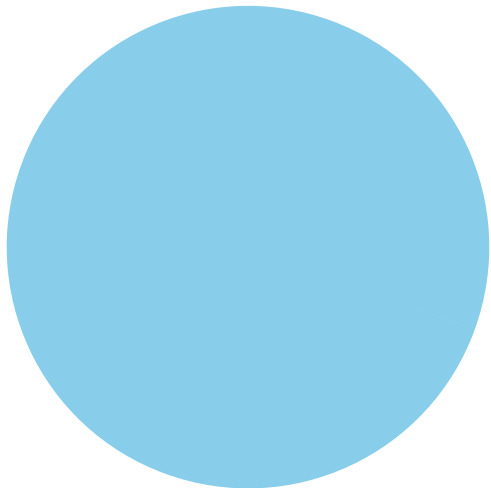
Distribution of Capital Needs by Building System

Building System	Estimated Cost	Percentage of Total Cost
G20 Site Improvements	\$8,000	100.00 %
Total	\$8,000	100 %

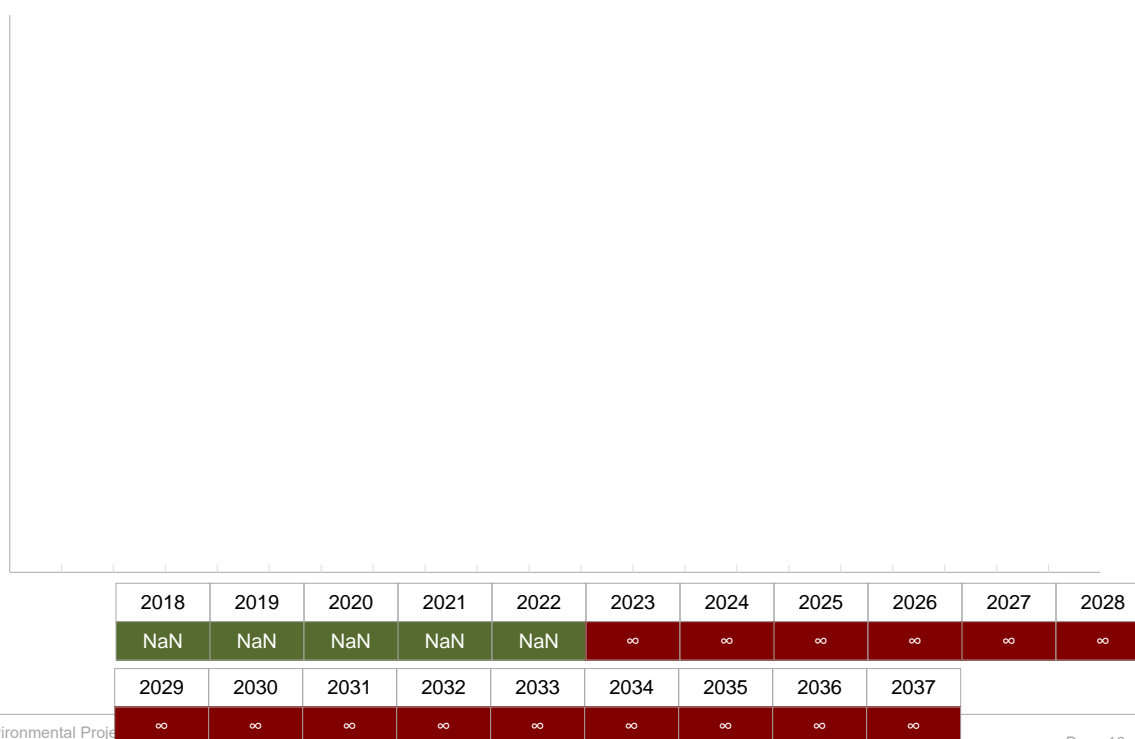
Cumulative Effects of FCI Over the Study Period

The Chart below indicates the cumulative effects of the FCI ratio over the study period assuming the required funds and expenditures are NOT provided to address the identified works and deferred maintenance each year.

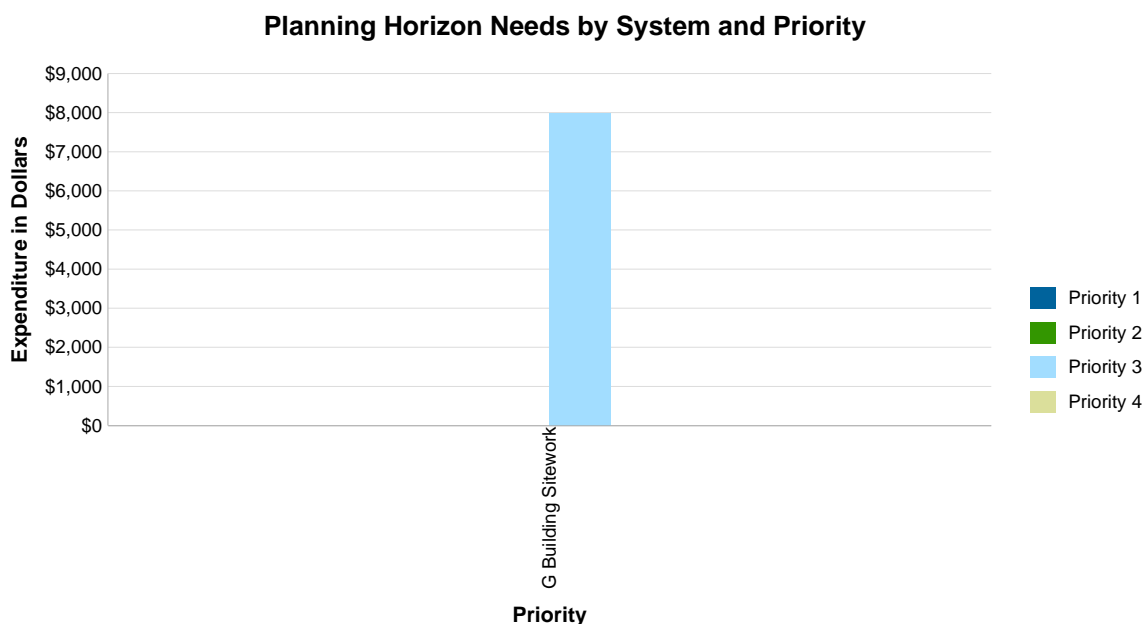
The chart below illustrates the breakdown of expenditure according the priority coding providing an opportunity to strategically plan and effectively direct funding to the highest priority.

Building System	Priority 1	Priority 2	Priority 3	Priority 4	Total
G Building Sitework	\$0	\$0	\$8,000	\$0	\$8,000
Total	\$0	\$0	\$8,000	\$0	\$8,000

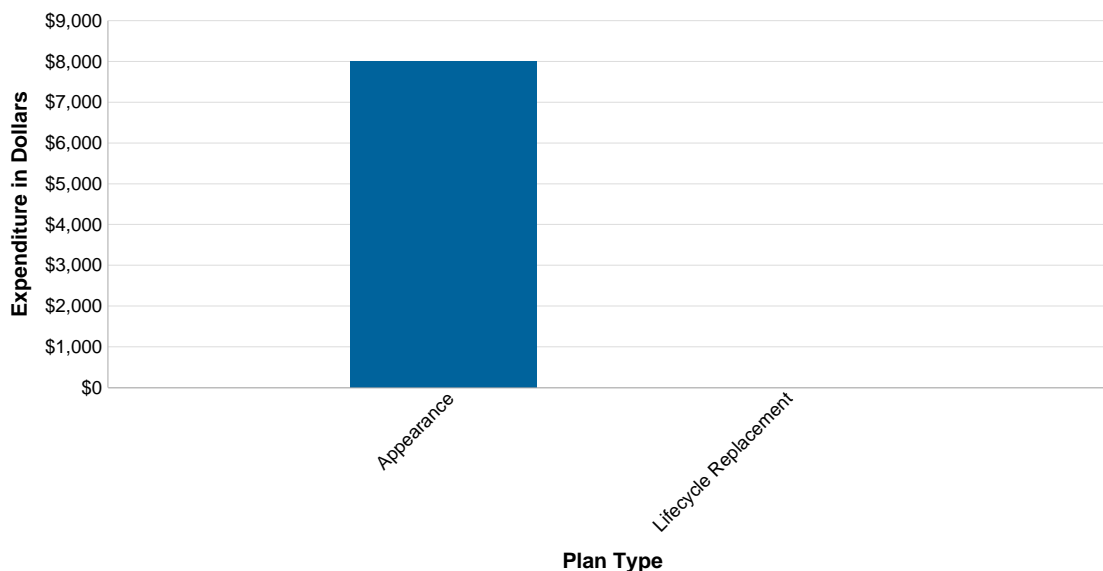
Planning Horizon Needs by Category

Building System	Total Cost
Appearance	\$8,000
Lifecycle Replacement	\$0
Total	\$8,000

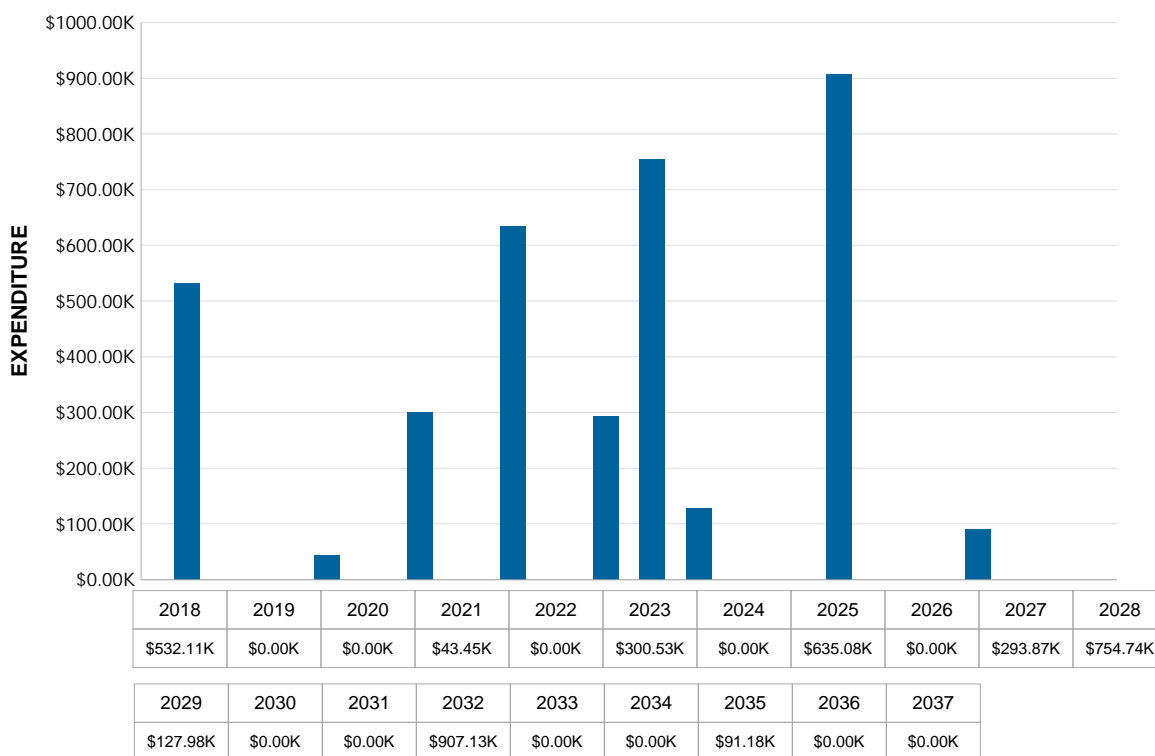
Expenditure Forecast Over Study Period

The building expenditure summary section provides an executive overview of the findings from the assessment. The chart below provides a summary of yearly anticipated expenditures over the study period for the Hilder Pearson Elementary School Lower building. In addition, we have scheduled key findings highlighting key items of greater than \$5,000 and their anticipated failure year. Further details of these expenditures are included within each respective report section and within the expenditure forecast, in Appendix A of this report. The results illustrate a total anticipated expenditure over the study period of approximately \$3,686,067.

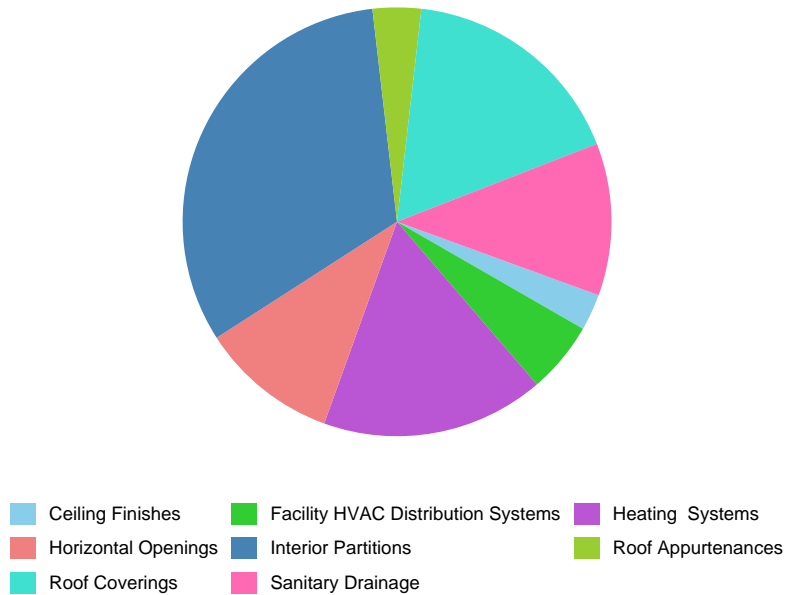
Distribution of Immediate Needs by Building System

Building System	Estimated Cost	Percentage of Total Cost
Ceiling Finishes	\$14,660	2.76 %
Facility HVAC Distribution Systems	\$28,666	5.39 %
Heating Systems	\$89,500	16.82 %
Horizontal Openings	\$55,297	10.39 %
Interior Partitions	\$171,624	32.25 %
Roof Appurtenances	\$19,419	3.65 %
Roof Coverings	\$91,915	17.27 %
Sanitary Drainage	\$61,030	11.47 %
Total	\$532,111	100 %

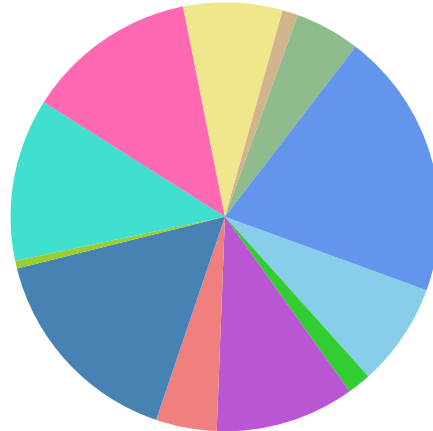
Distribution of Capital Needs by Building System

Building System	Estimated Cost	Percentage of Total Cost
B20 Exterior Enclosure	\$246,155	7.80 %
B30 Roofing	\$56,222	1.78 %
C20 Interior Finishes	\$330,488	10.48 %
D20 Plumbing	\$144,612	4.59 %
D30 HVAC	\$501,742	15.91 %
D40 Fire Protection Systems	\$18,494	0.59 %
D50 Electrical Systems	\$386,894	12.27 %
D60 Communication Systems	\$406,683	12.89 %
D70 Security Systems	\$235,429	7.46 %
D80 Automation Systems	\$36,988	1.17 %
E10 Equipment	\$155,165	4.92 %
E20 Furnishings	\$635,084	20.14 %
Total	\$3,153,956	100 %

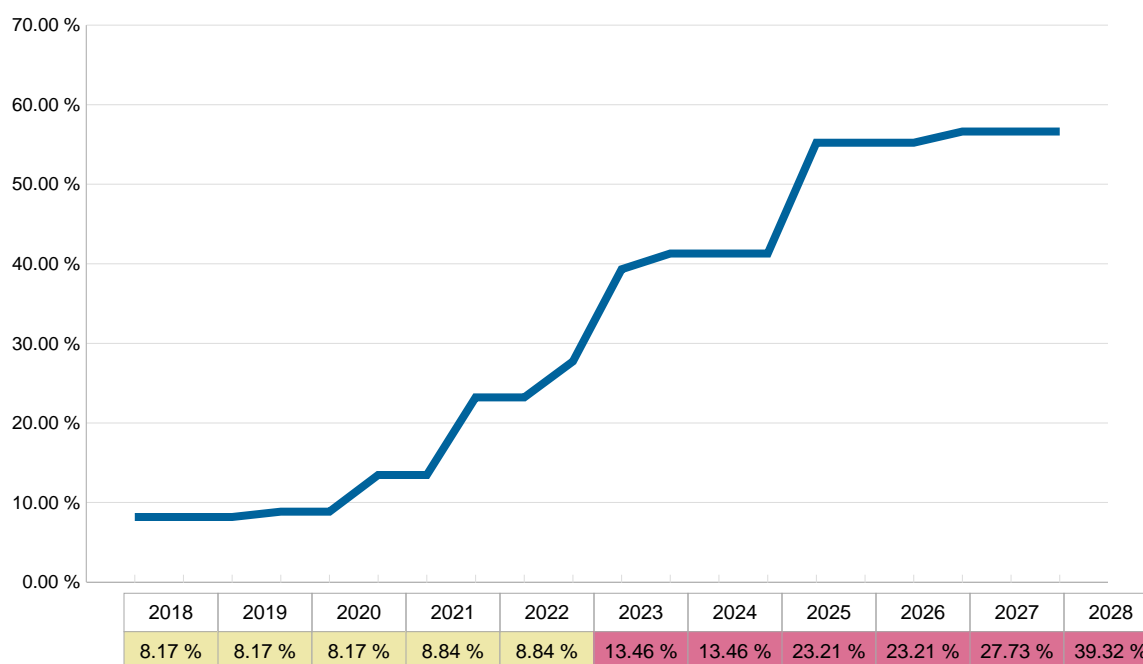
Cumulative Effects of FCI Over the Study Period

The Chart below indicates the cumulative effects of the FCI ratio over the study period assuming the required funds and expenditures are NOT provided to address the identified works and deferred maintenance each year.

2029	2030	2031	2032	2033	2034	2035	2036	2037
41.29 %	41.29 %	41.29 %	55.22 %	55.22 %	55.22 %	56.62 %	56.62 %	56.62 %

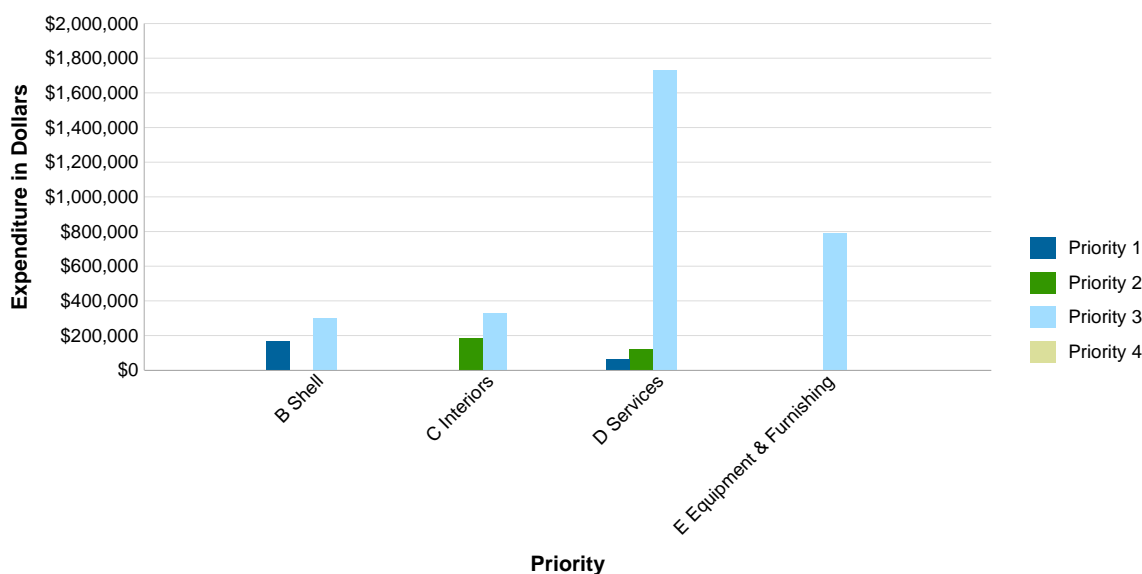
Planning Horizon Needs by System and Priority

The chart below illustrates the breakdown of expenditure according the priority coding providing an opportunity to strategically plan and effectively direct funding to the highest priority.

Building System	Priority 1	Priority 2	Priority 3	Priority 4	Total
B Shell	\$166,631	\$0	\$302,377	\$0	\$469,008
C Interiors	\$0	\$186,284	\$330,488	\$0	\$516,772
D Services	\$61,030	\$118,166	\$1,730,843	\$0	\$1,910,038
E Equipment & Furnishing	\$0	\$0	\$790,249	\$0	\$790,249
Total	\$227,661	\$304,450	\$3,153,956	\$0	\$3,686,067

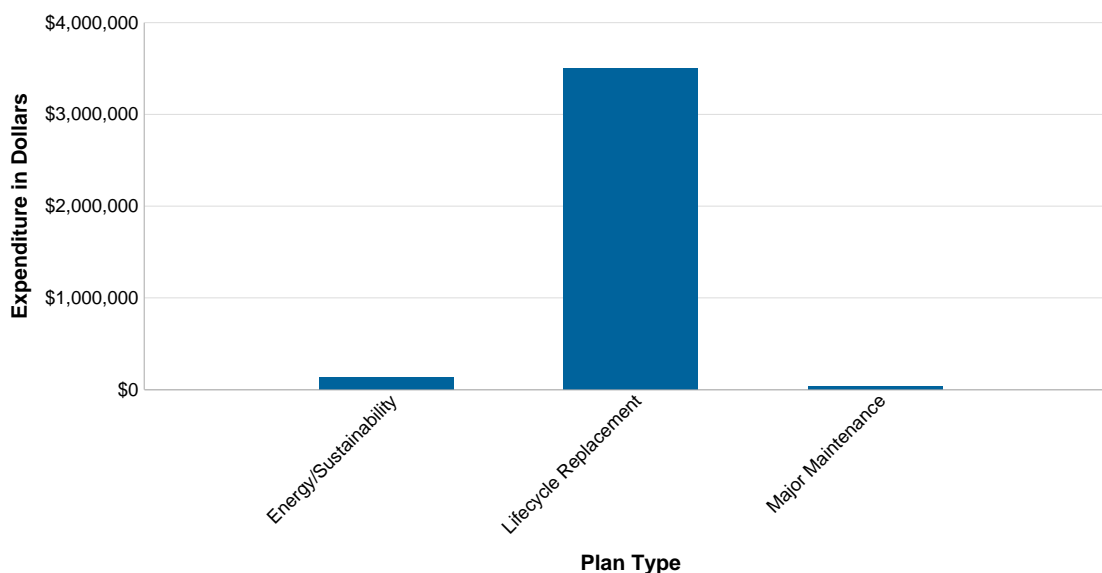
Planning Horizon Needs by Category

The chart below illustrates the breakdown of expenditure according to the Plan Type or deficiency categories providing an opportunity to strategically plan and effectively direct funding.

Building System	Total Cost
Energy/Sustainability	\$134,669
Lifecycle Replacement	\$3,509,791
Major Maintenance	\$41,607
Total	\$3,686,067

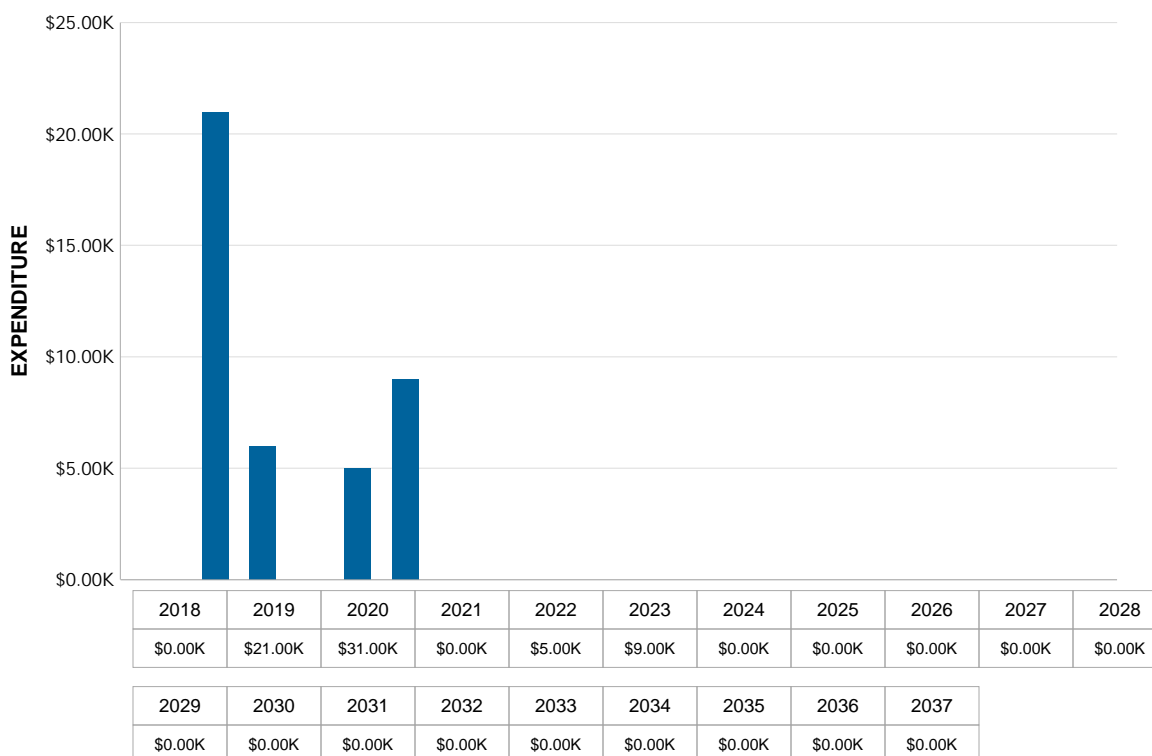
Expenditure Forecast Over Study Period

The building expenditure summary section provides an executive overview of the findings from the assessment. The chart below provides a summary of yearly anticipated expenditures over the study period for the Hilder Pearson Elementary School Site building. In addition, we have scheduled key findings highlighting key items of greater than \$5,000 and their anticipated failure year. Further details of these expenditures are included within each respective report section and within the expenditure forecast, in Appendix A of this report. The results illustrate a total anticipated expenditure over the study period of approximately \$66,000.

- G Building Sitework: Allowance for site fire protection study at an estimated cost of \$15,000 in year 2019
- G Building Sitework: Allowance for fence repairs at an estimated cost of \$6,000 in year 2019
- G Building Sitework: ADA study at an estimated cost of \$15,000 in year 2020
- G Building Sitework: Allowance for ADA study at an estimated cost of \$10,000 in year 2020
- G Building Sitework: Selective cut and patch of uneven walkways/trip hazards at an estimated cost of \$6,000 in year 2020
- G Building Sitework: Turf repairs at an estimated cost of \$5,000 in year 2022
- G Building Sitework: Allowance for selective removal and replacement with seal coat. at an estimated cost of \$9,000 in year 2023

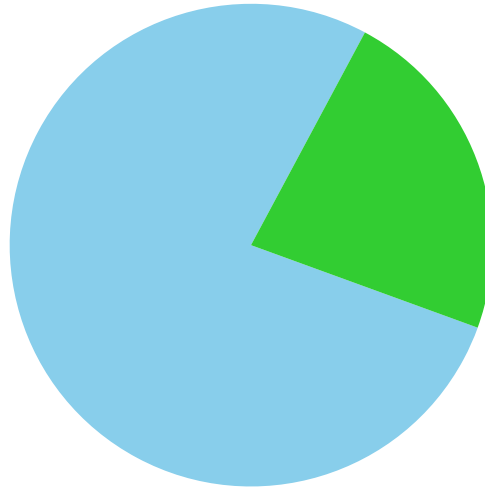
Distribution of Capital Needs by Building System

■ G20 Site Improvements ■ G30 Site Civil/Mechanical Utilities

Building System	Estimated Cost	Percentage of Total Cost
G20 Site Improvements	\$51,000	77.27 %
G30 Site Civil/Mechanical Utilities	\$15,000	22.73 %
Total	\$66,000	100 %

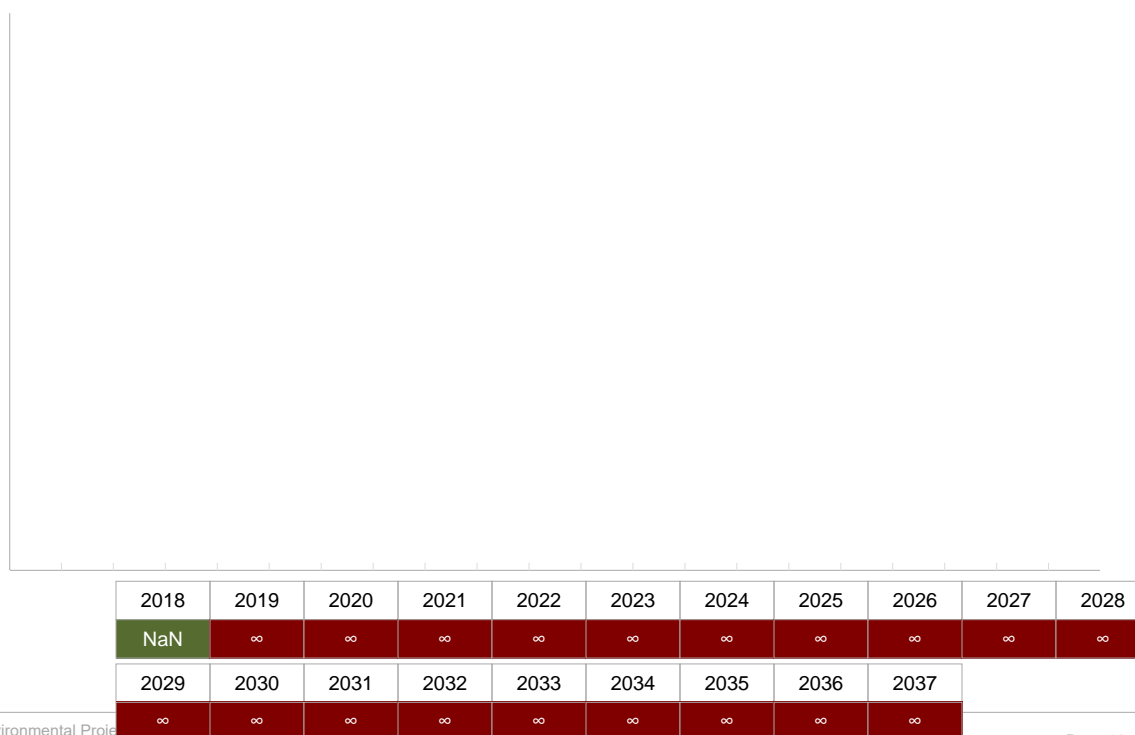
Cumulative Effects of FCI Over the Study Period

The Chart below indicates the cumulative effects of the FCI ratio over the study period assuming the required funds and expenditures are NOT provided to address the identified works and deferred maintenance each year.

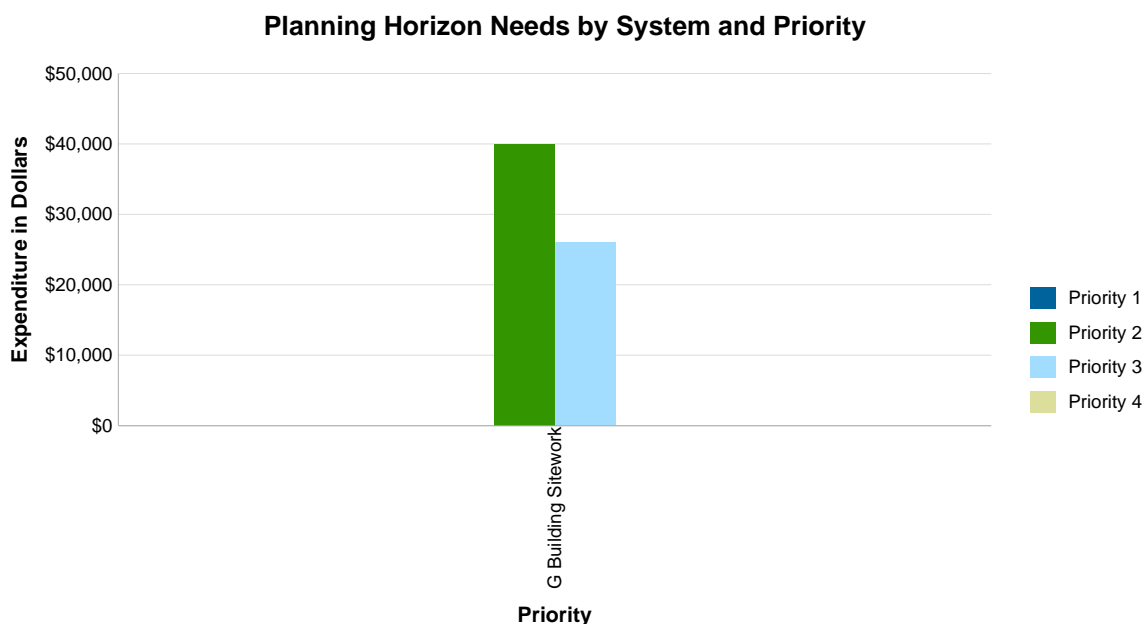
The chart below illustrates the breakdown of expenditure according the priority coding providing an opportunity to strategically plan and effectively direct funding to the highest priority.

Building System	Priority 1	Priority 2	Priority 3	Priority 4	Total
G Building Sitework	\$0	\$40,000	\$26,000	\$0	\$66,000
Total	\$0	\$40,000	\$26,000	\$0	\$66,000

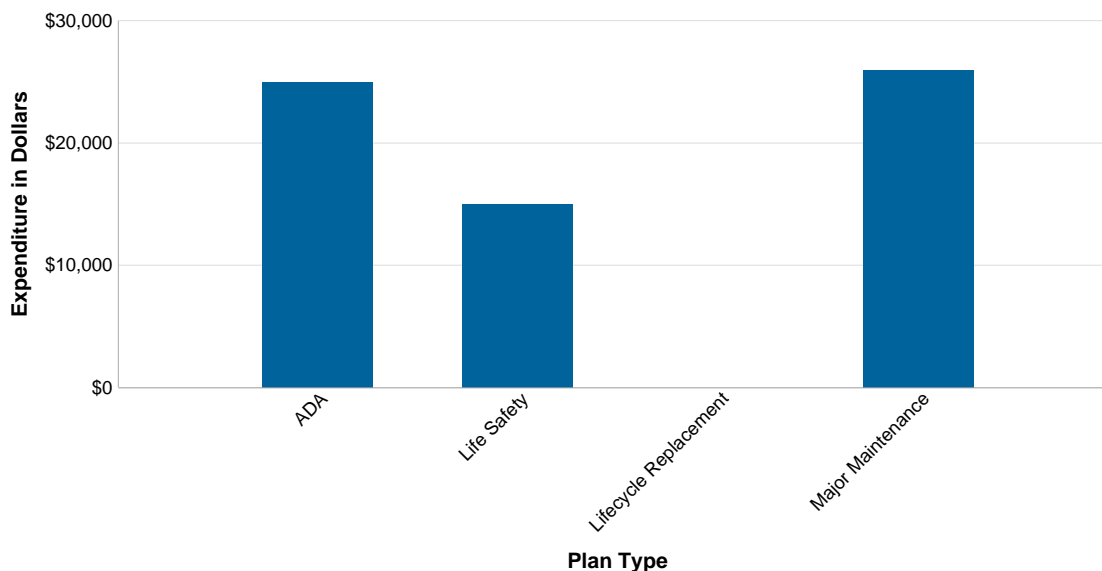
Planning Horizon Needs by Category

The chart below illustrates the breakdown of expenditure according to the Plan Type or deficiency categories providing an opportunity to strategically plan and effectively direct funding.

Building System	Total Cost
ADA	\$25,000
Life Safety	\$15,000
Lifecycle Replacement	\$0
Major Maintenance	\$26,000
Total	\$66,000

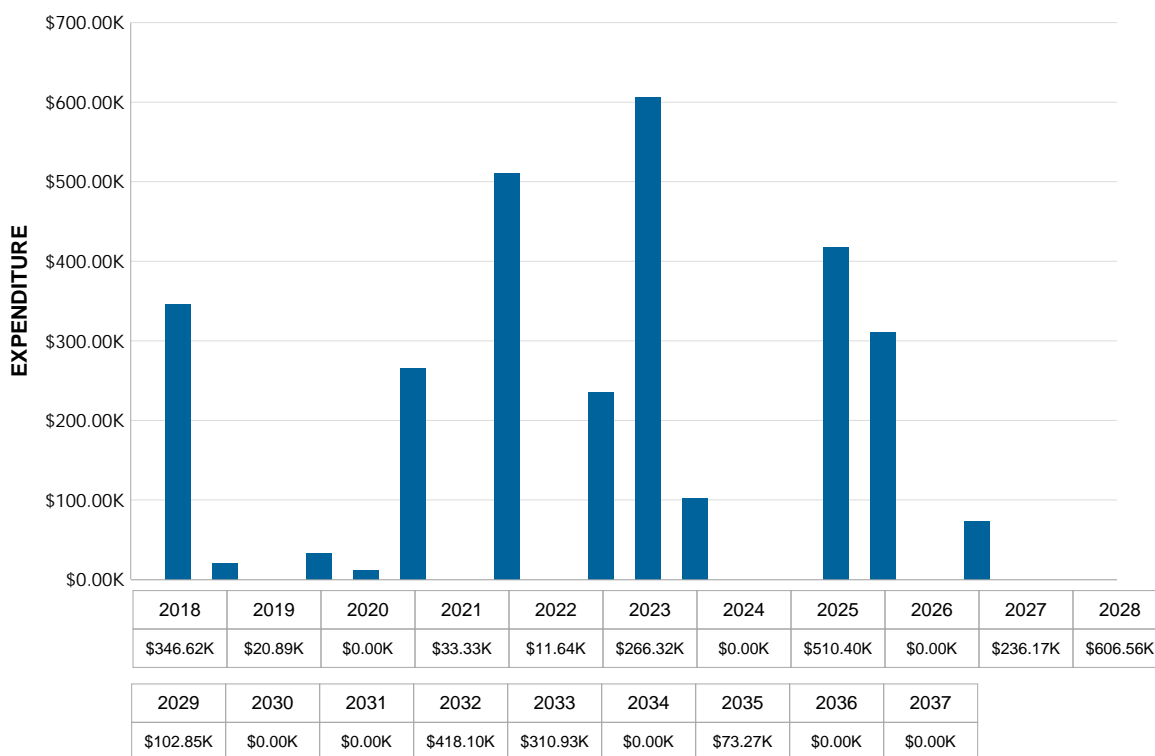
Expenditure Forecast Over Study Period

The building expenditure summary section provides an executive overview of the findings from the assessment. The chart below provides a summary of yearly anticipated expenditures over the study period for the Hilder Pearson Elementary School Upper building. In addition, we have scheduled key findings highlighting key items of greater than \$5,000 and their anticipated failure year. Further details of these expenditures are included within each respective report section and within the expenditure forecast, in Appendix A of this report. The results illustrate a total anticipated expenditure over the study period of approximately \$2,937,086.

- B Shell: Replace Roofing at an estimated cost of \$91,915 in year 2018
- B Shell: Replace Horizontal Openings at an estimated cost of \$55,297 in year 2018

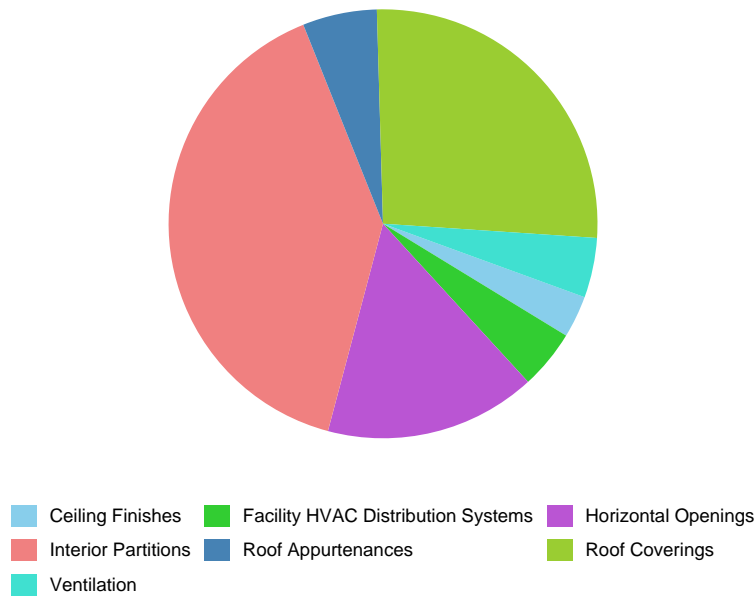
Distribution of Immediate Needs by Building System

Building System	Estimated Cost	Percentage of Total Cost
Ceiling Finishes	\$10,995	3.17 %
Facility HVAC Distribution Systems	\$15,458	4.46 %
Horizontal Openings	\$55,297	15.95 %
Interior Partitions	\$137,929	39.79 %
Roof Appurtenances	\$19,419	5.60 %
Roof Coverings	\$91,915	26.52 %
Ventilation	\$15,606	4.50 %
Total	\$346,618	100 %

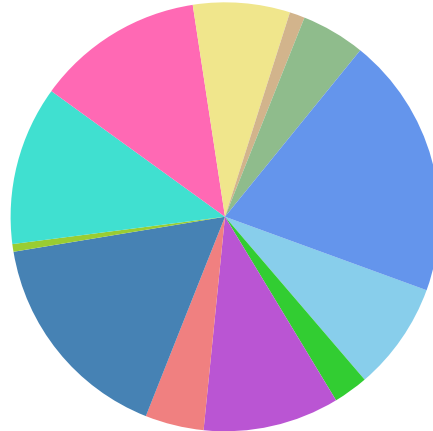
Distribution of Capital Needs by Building System

Building System	Estimated Cost	Percentage of Total Cost
B20 Exterior Enclosure	\$211,588	8.17 %
B30 Roofing	\$67,862	2.62 %
C20 Interior Finishes	\$265,602	10.25 %
D20 Plumbing	\$114,631	4.43 %
D30 HVAC	\$424,124	16.37 %
D40 Fire Protection Systems	\$14,863	0.57 %
D50 Electrical Systems	\$310,934	12.00 %
D60 Communication Systems	\$326,837	12.62 %
D70 Security Systems	\$189,206	7.30 %
D80 Automation Systems	\$29,726	1.15 %
E10 Equipment	\$124,701	4.81 %
E20 Furnishings	\$510,395	19.70 %
Total	\$2,590,468	100 %

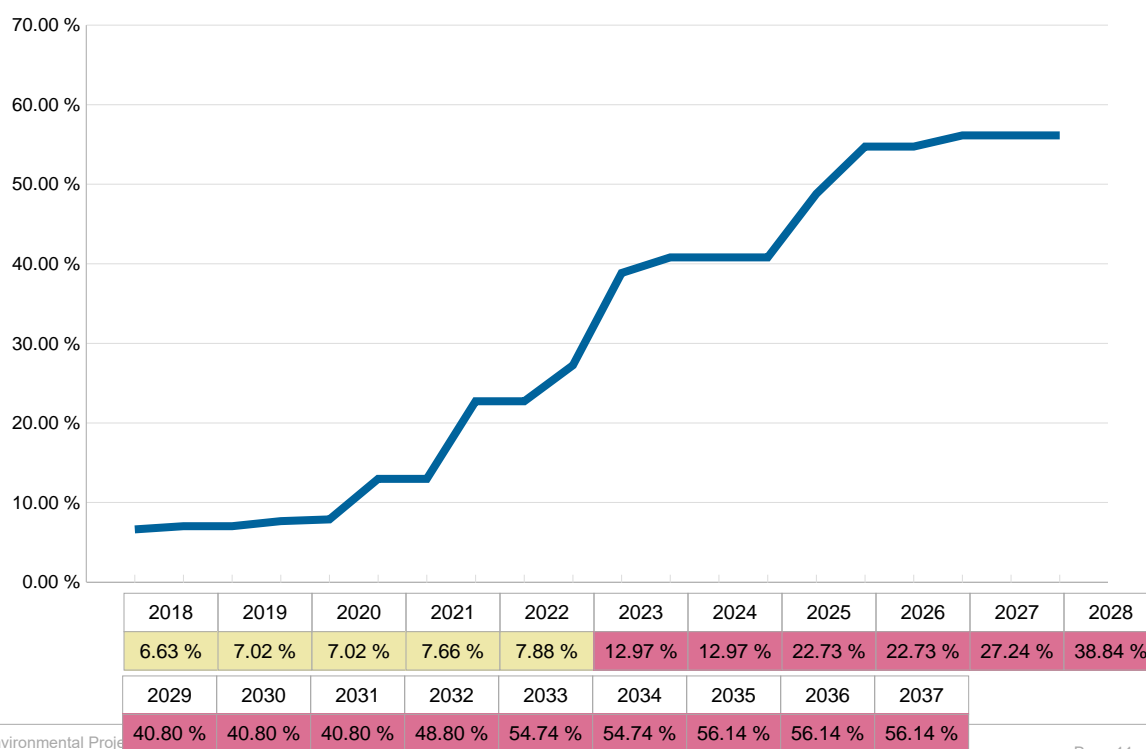
Cumulative Effects of FCI Over the Study Period

The Chart below indicates the cumulative effects of the FCI ratio over the study period assuming the required funds and expenditures are NOT provided to address the identified works and deferred maintenance each year.

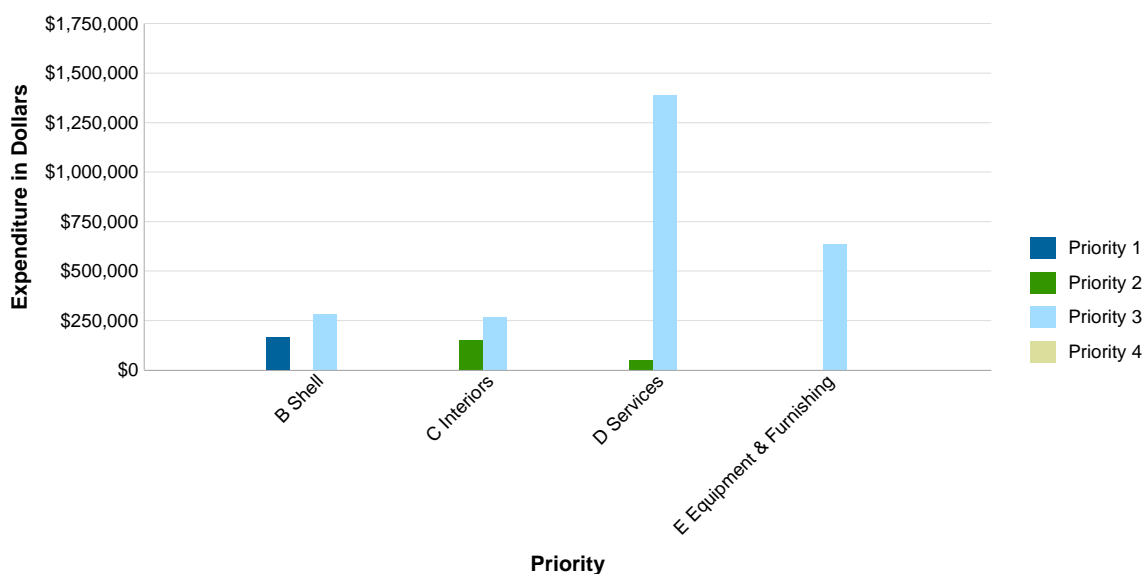
Planning Horizon Needs by System and Priority

The chart below illustrates the breakdown of expenditure according the priority coding providing an opportunity to strategically plan and effectively direct funding to the highest priority.

Building System	Priority 1	Priority 2	Priority 3	Priority 4	Total
B Shell	\$166,631	\$0	\$279,450	\$0	\$446,081
C Interiors	\$0	\$148,924	\$265,602	\$0	\$414,525
D Services	\$0	\$51,954	\$1,389,430	\$0	\$1,441,384
E Equipment & Furnishing	\$0	\$0	\$635,096	\$0	\$635,096
Total	\$166,631	\$200,878	\$2,569,578	\$0	\$2,937,086

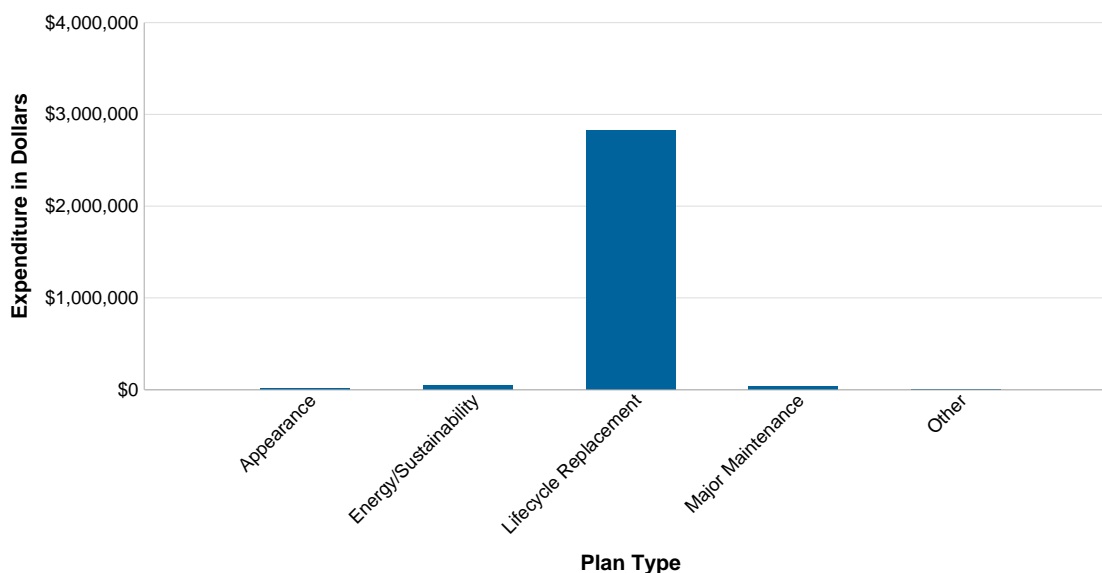
Planning Horizon Needs by Category

The chart below illustrates the breakdown of expenditure according to the Plan Type or deficiency categories providing an opportunity to strategically plan and effectively direct funding.

Building System	Total Cost
Appearance	\$11,640
Energy/Sustainability	\$53,781
Lifecycle Replacement	\$2,829,167
Major Maintenance	\$41,168
Other	\$1,330
Total	\$2,937,086

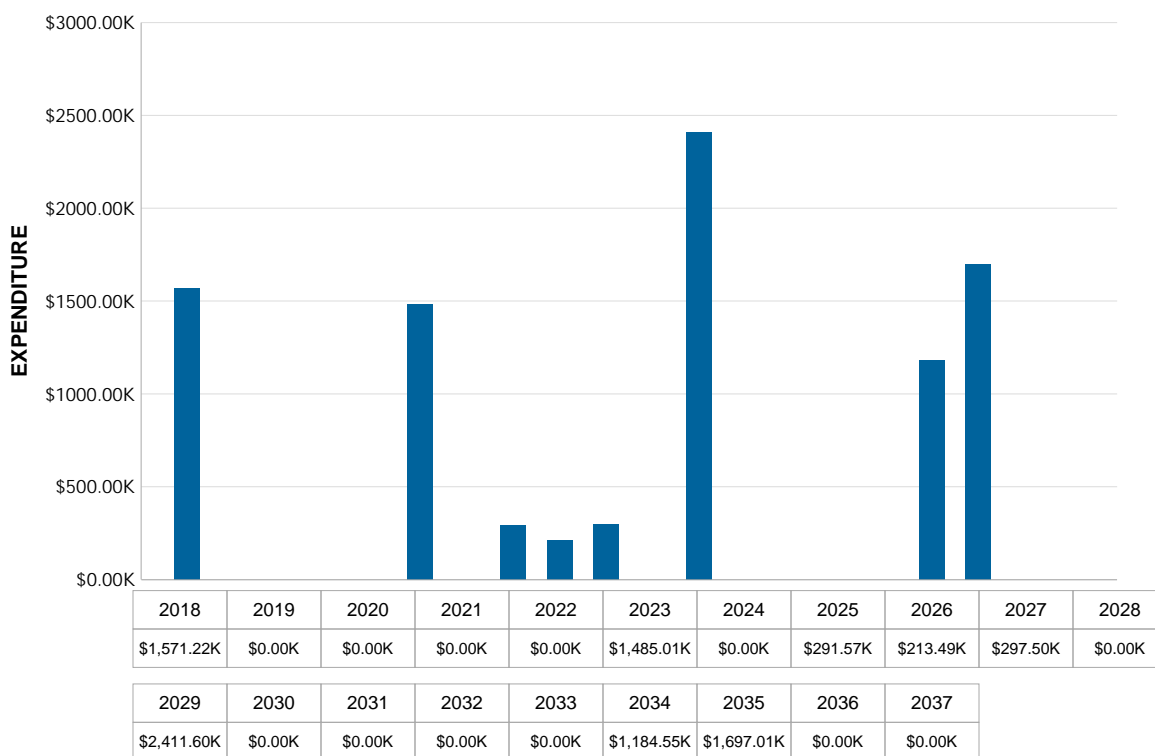
Expenditure Forecast Over Study Period

The building expenditure summary section provides an executive overview of the findings from the assessment. The chart below provides a summary of yearly anticipated expenditures over the study period for the Poulsbo Elementary School Main building. In addition, we have scheduled key findings highlighting key items of greater than \$5,000 and their anticipated failure year. Further details of these expenditures are included within each respective report section and within the expenditure forecast, in Appendix A of this report. The results illustrate a total anticipated expenditure over the study period of approximately \$9,151,941.

- B Shell: Re-roof or major repair at an estimated cost of \$1,309,577 in year 2018
- B Shell: Paint cementitious siding at an estimated cost of \$47,441 in year 2018

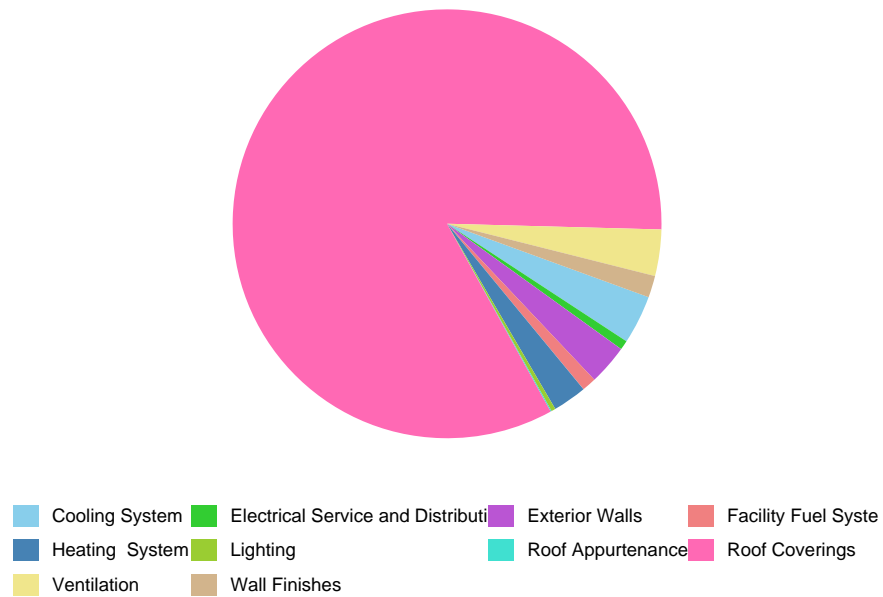
Distribution of Immediate Needs by Building System

Building System	Estimated Cost	Percentage of Total Cost
Cooling Systems	\$57,750	3.68 %
Electrical Service and Distribution	\$11,000	0.70 %
Exterior Walls	\$47,441	3.02 %
Facility Fuel Systems	\$16,900	1.08 %
Heating Systems	\$40,155	2.56 %
Lighting	\$5,000	0.32 %
Roof Appurtenances	\$1,250	0.08 %
Roof Coverings	\$1,311,077	83.44 %
Ventilation	\$54,950	3.50 %
Wall Finishes	\$25,697	1.64 %
Total	\$1,571,220	100 %

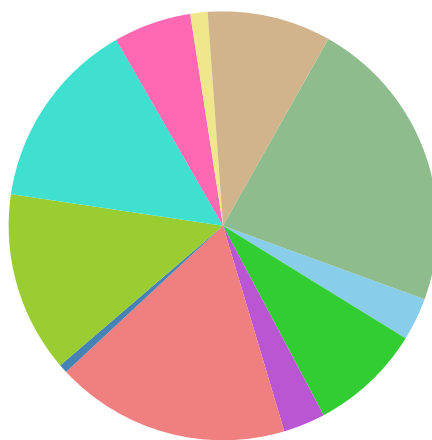
Distribution of Capital Needs by Building System

Building System	Estimated Cost	Percentage of Total Cost
B30 Roofing	\$245,607	3.24 %
C20 Interior Finishes	\$639,469	8.44 %
D20 Plumbing	\$239,183	3.16 %
D30 HVAC	\$1,340,710	17.69 %
D40 Fire Protection Systems	\$49,418	0.65 %
D50 Electrical Systems	\$1,033,825	13.64 %
D60 Communication Systems	\$1,086,702	14.34 %
D70 Security Systems	\$443,774	5.85 %
D80 Automation Systems	\$98,836	1.30 %
E10 Equipment	\$706,183	9.32 %
E20 Furnishings	\$1,697,014	22.39 %
Total	\$7,580,721	100 %
