Facilities Condition Assessment Report

I. FCA Executive Summary

North Kitsap School District

Breidablik Elementary School Main
25142 Waghorn Rd NW
Poulsbo, WA

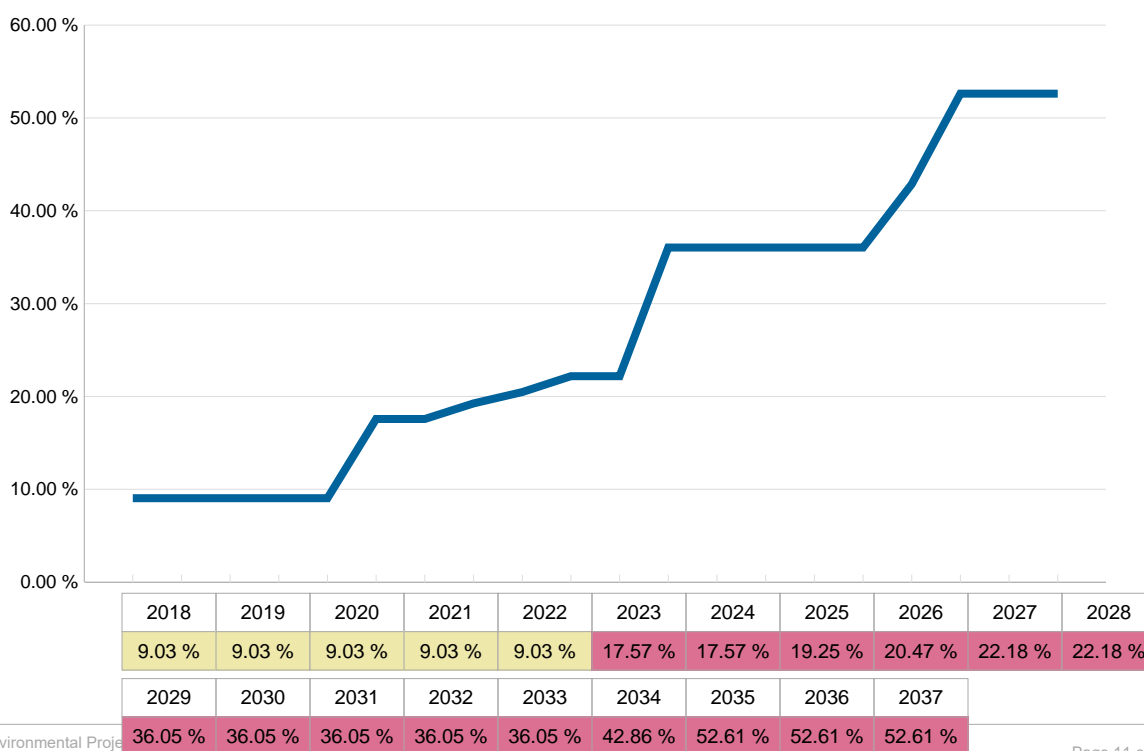
Cumulative Effects of FCI Over the Study Period

The Chart below indicates the cumulative effects of the FCI ratio over the study period assuming the required funds and expenditures are NOT provided to address the identified works and deferred maintenance each year.

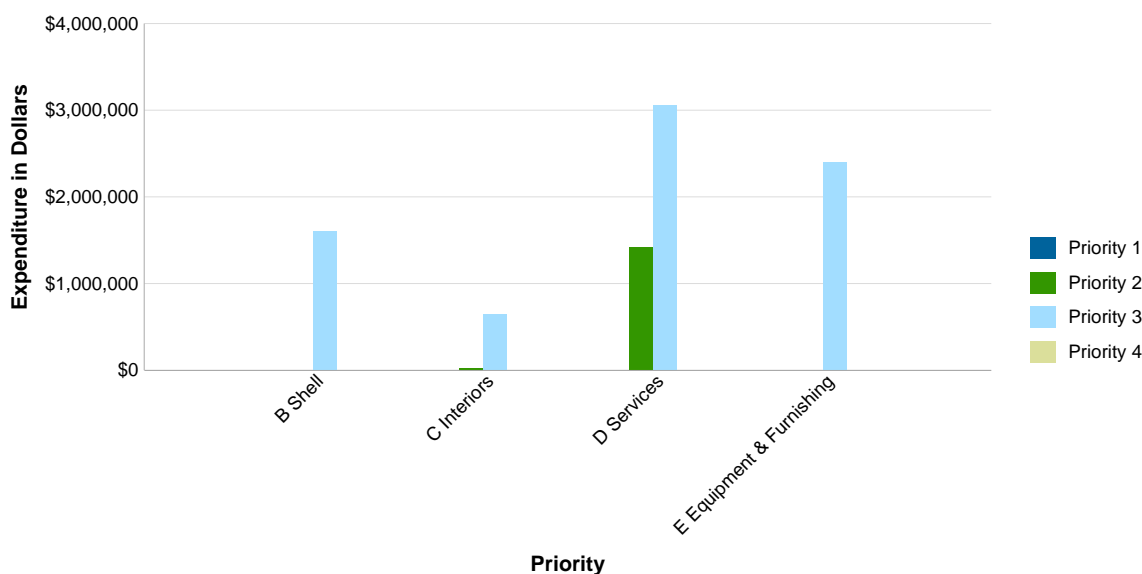
Planning Horizon Needs by System and Priority

The chart below illustrates the breakdown of expenditure according the priority coding providing an opportunity to strategically plan and effectively direct funding to the highest priority.

Building System	Priority 1	Priority 2	Priority 3	Priority 4	Total
B Shell	\$0	\$0	\$1,605,376	\$0	\$1,605,376
C Interiors	\$0	\$25,697	\$639,469	\$0	\$665,166
D Services	\$0	\$1,416,758	\$3,061,444	\$0	\$4,478,202
E Equipment & Furnishing	\$0	\$0	\$2,403,197	\$0	\$2,403,197
Total	\$0	\$1,442,455	\$7,709,486	\$0	\$9,151,941

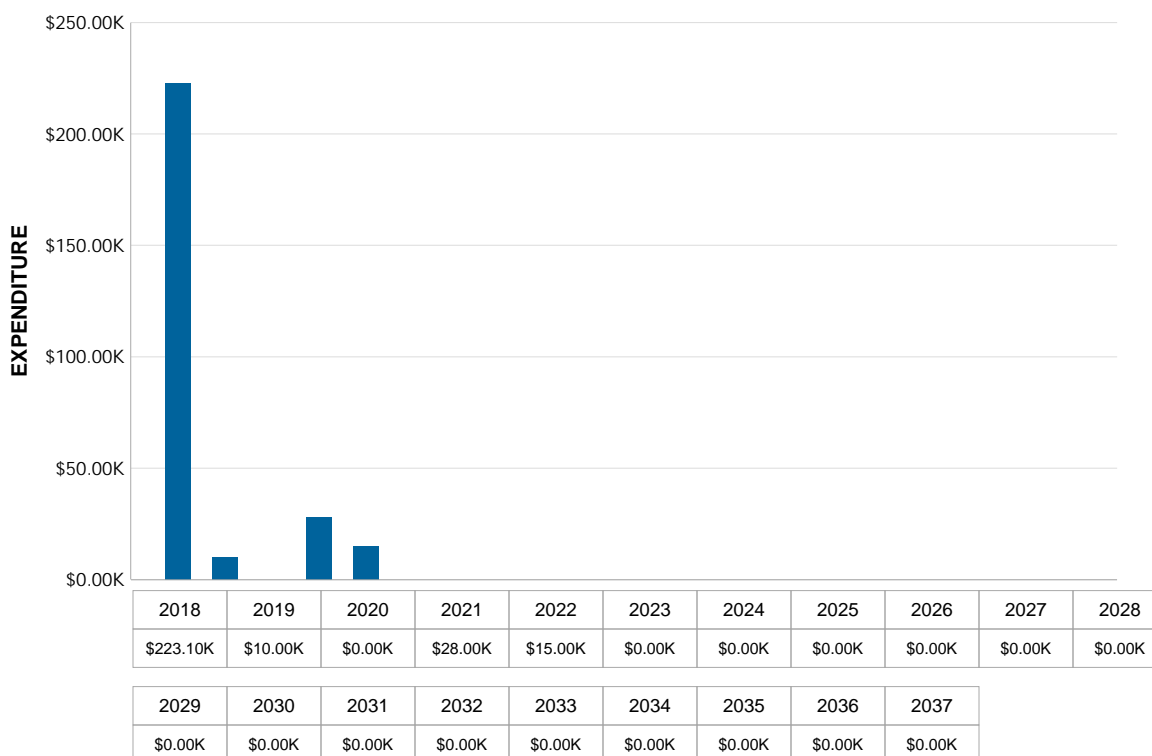
Expenditure Forecast Over Study Period

The building expenditure summary section provides an executive overview of the findings from the assessment. The chart below provides a summary of yearly anticipated expenditures over the study period for the Poulsbo Elementary School Site building. In addition, we have scheduled key findings highlighting key items of greater than \$5,000 and their anticipated failure year. Further details of these expenditures are included within each respective report section and within the expenditure forecast, in Appendix A of this report. The results illustrate a total anticipated expenditure over the study period of approximately \$276,100.

- G Building Sitework: Remove and replace existing asphalt with selective grading and drainage at an estimated cost of \$171,600 in year 2018
- G Building Sitework: Grade/pave with grind and overlay at an estimated cost of \$44,000 in year 2018

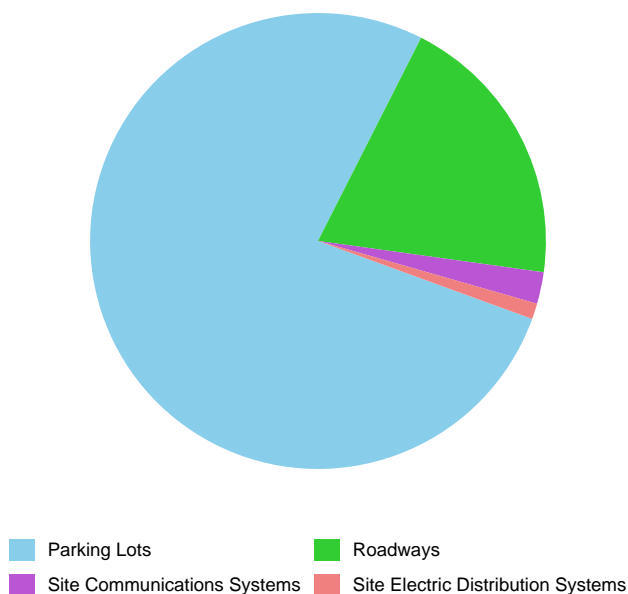
Distribution of Immediate Needs by Building System

Building System	Estimated Cost	Percentage of Total Cost
Parking Lots	\$171,600	76.92 %
Roadways	\$44,000	19.72 %
Site Communications Systems	\$5,000	2.24 %
Site Electric Distribution Systems	\$2,500	1.12 %
Total	\$223,100	100 %

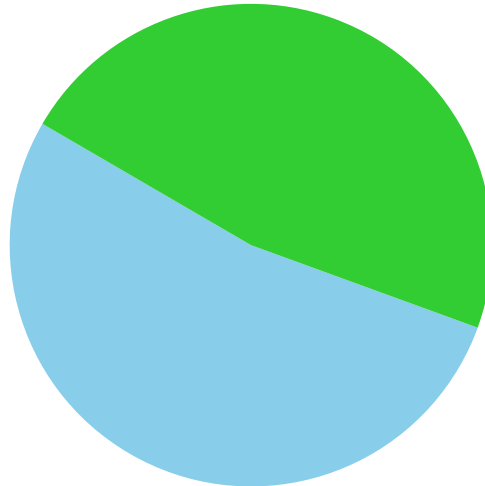
Distribution of Capital Needs by Building System

■ G20 Site Improvements ■ G30 Site Civil/Mechanical Utilities

Building System	Estimated Cost	Percentage of Total Cost
G20 Site Improvements	\$28,000	52.83 %
G30 Site Civil/Mechanical Utilities	\$25,000	47.17 %
Total	\$53,000	100 %

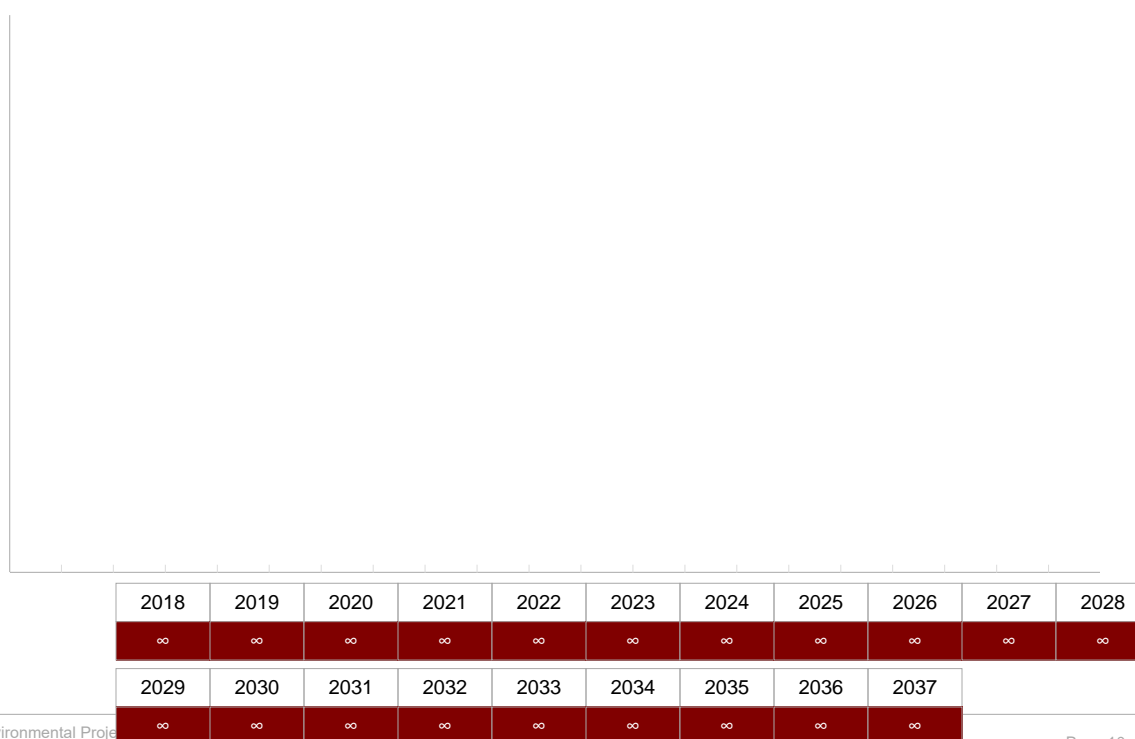
Cumulative Effects of FCI Over the Study Period

The Chart below indicates the cumulative effects of the FCI ratio over the study period assuming the required funds and expenditures are NOT provided to address the identified works and deferred maintenance each year.

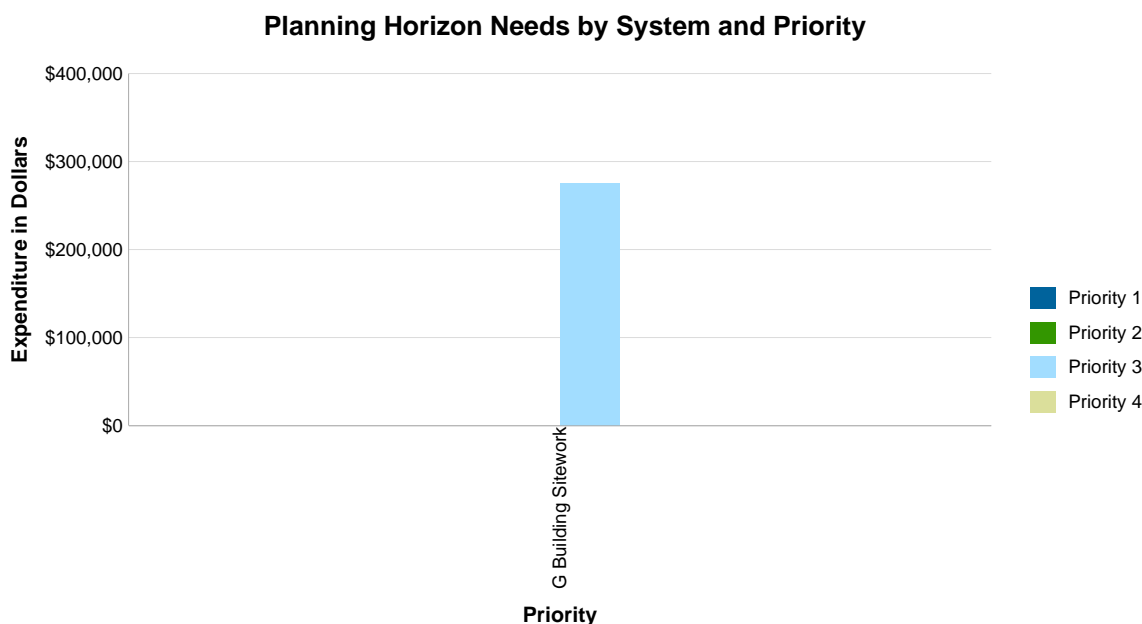
The chart below illustrates the breakdown of expenditure according the priority coding providing an opportunity to strategically plan and effectively direct funding to the highest priority.

Building System	Priority 1	Priority 2	Priority 3	Priority 4	Total
G Building Sitework	\$0	\$0	\$276,100	\$0	\$276,100
Total	\$0	\$0	\$276,100	\$0	\$276,100

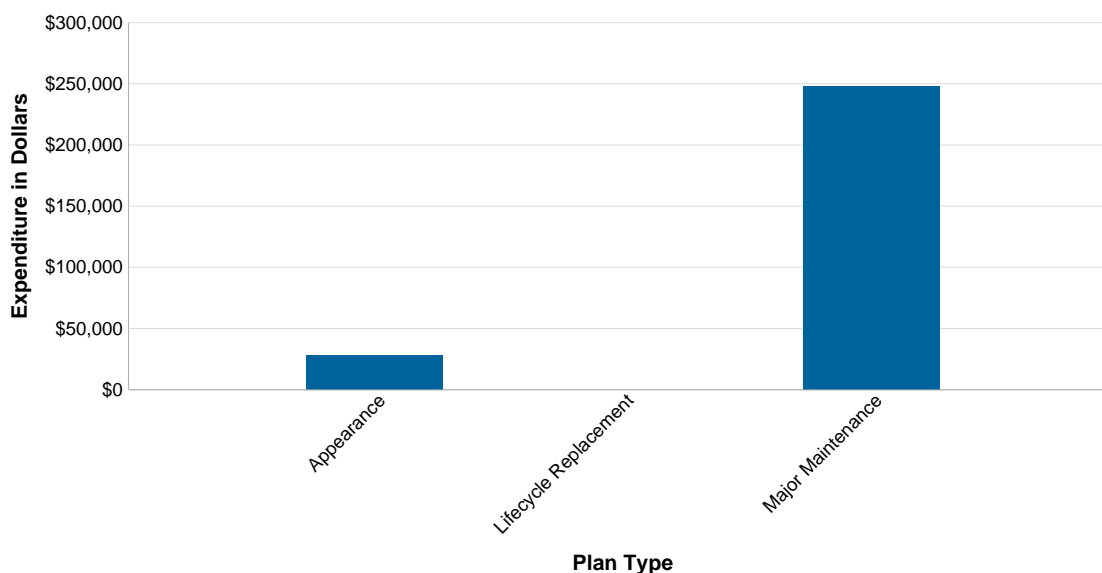
Planning Horizon Needs by Category

The chart below illustrates the breakdown of expenditure according to the Plan Type or deficiency categories providing an opportunity to strategically plan and effectively direct funding.

Building System	Total Cost
Appearance	\$28,000
Lifecycle Replacement	\$0
Major Maintenance	\$248,100
Total	\$276,100

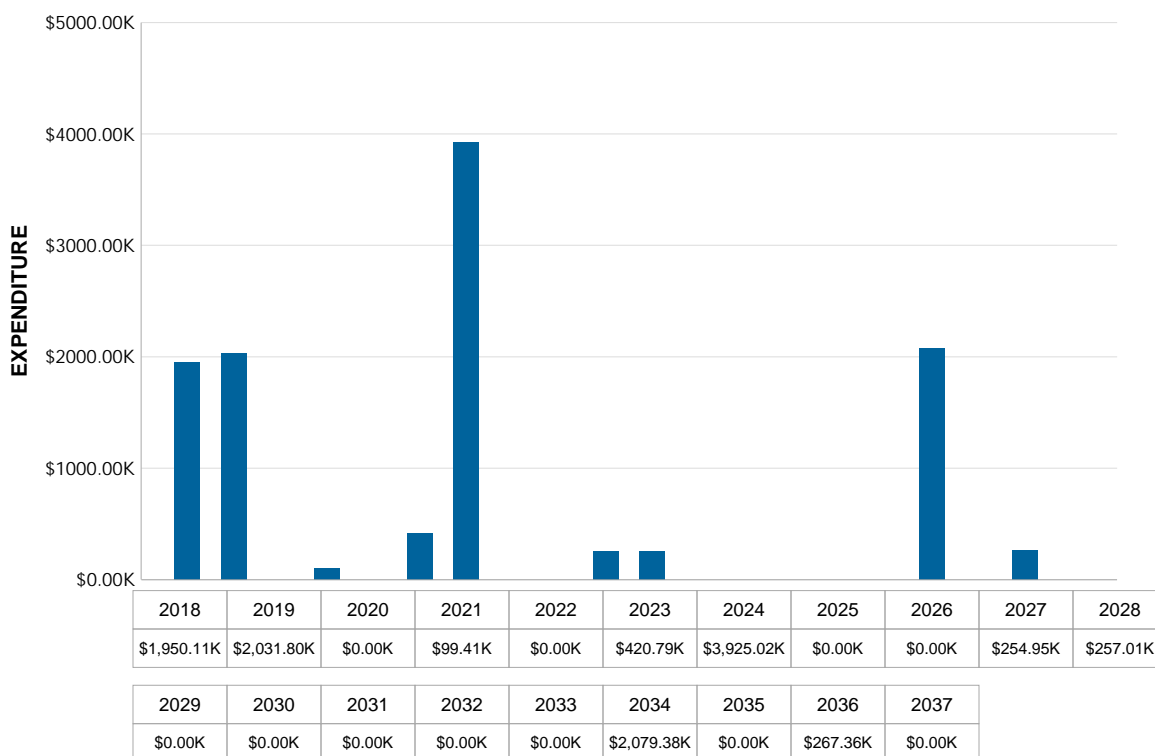
Expenditure Forecast Over Study Period

The building expenditure summary section provides an executive overview of the findings from the assessment. The chart below provides a summary of yearly anticipated expenditures over the study period for the Richard Gordon Elementary School Main building. In addition, we have scheduled key findings highlighting key items of greater than \$5,000 and their anticipated failure year. Further details of these expenditures are included within each respective report section and within the expenditure forecast, in Appendix A of this report. The results illustrate a total anticipated expenditure over the study period of approximately \$11,285,829.

- B Shell: Repaint siding, caulk at transitions at an estimated cost of \$49,644 in year 2018
- B Shell: Paint exterior doors and grilles, weatherstrip, replace hardware at an estimated cost of \$26,891 in year 2019

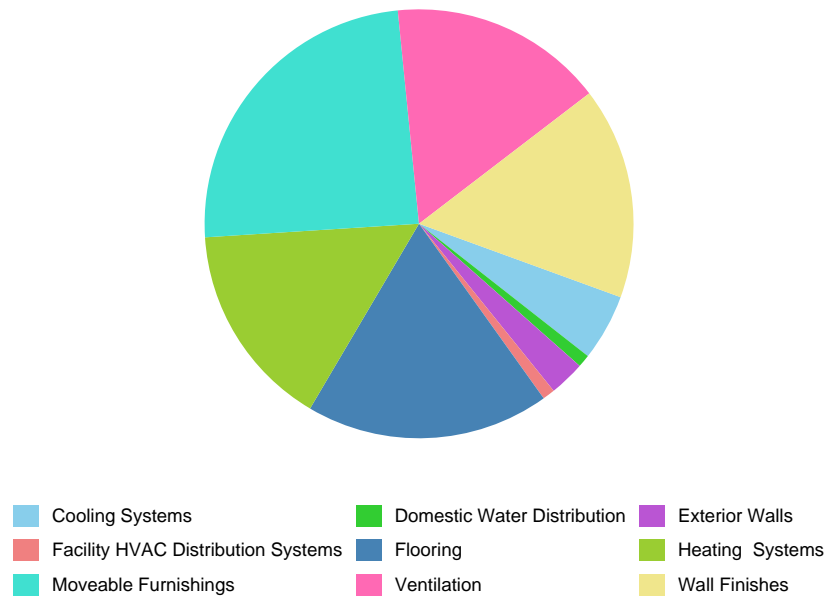
Distribution of Immediate Needs by Building System

Building System	Estimated Cost	Percentage of Total Cost
Cooling Systems	\$98,000	5.03 %
Domestic Water Distribution	\$18,500	0.95 %
Exterior Walls	\$52,144	2.67 %
Facility HVAC Distribution Systems	\$18,100	0.93 %
Flooring	\$357,854	18.35 %
Heating Systems	\$302,477	15.51 %
Moveable Furnishings	\$476,277	24.42 %
Ventilation	\$315,449	16.18 %
Wall Finishes	\$311,312	15.96 %
Total	\$1,950,113	100 %

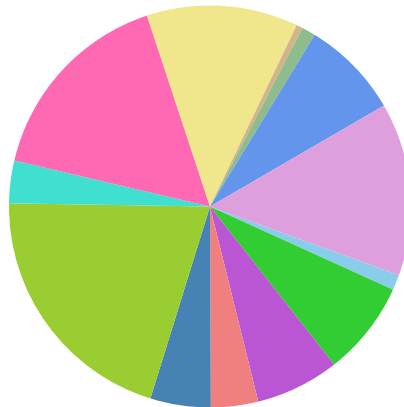
Distribution of Capital Needs by Building System

Building System	Estimated Cost	Percentage of Total Cost
B20 Exterior Enclosure	\$115,837	1.24 %
B30 Roofing	\$710,142	7.61 %
C10 Interior Construction	\$629,193	6.74 %
C20 Interior Finishes	\$354,234	3.79 %
D20 Plumbing	\$453,523	4.86 %
D30 HVAC	\$1,909,761	20.46 %
D40 Fire Protection Systems	\$319,069	3.42 %
D50 Electrical Systems	\$1,517,259	16.25 %
D60 Communication Systems	\$1,137,169	12.18 %
D70 Security Systems	\$47,576	0.51 %
D80 Automation Systems	\$103,426	1.11 %
E10 Equipment	\$738,979	7.92 %
E20 Furnishings	\$1,299,548	13.92 %
Total	\$9,335,716	100 %

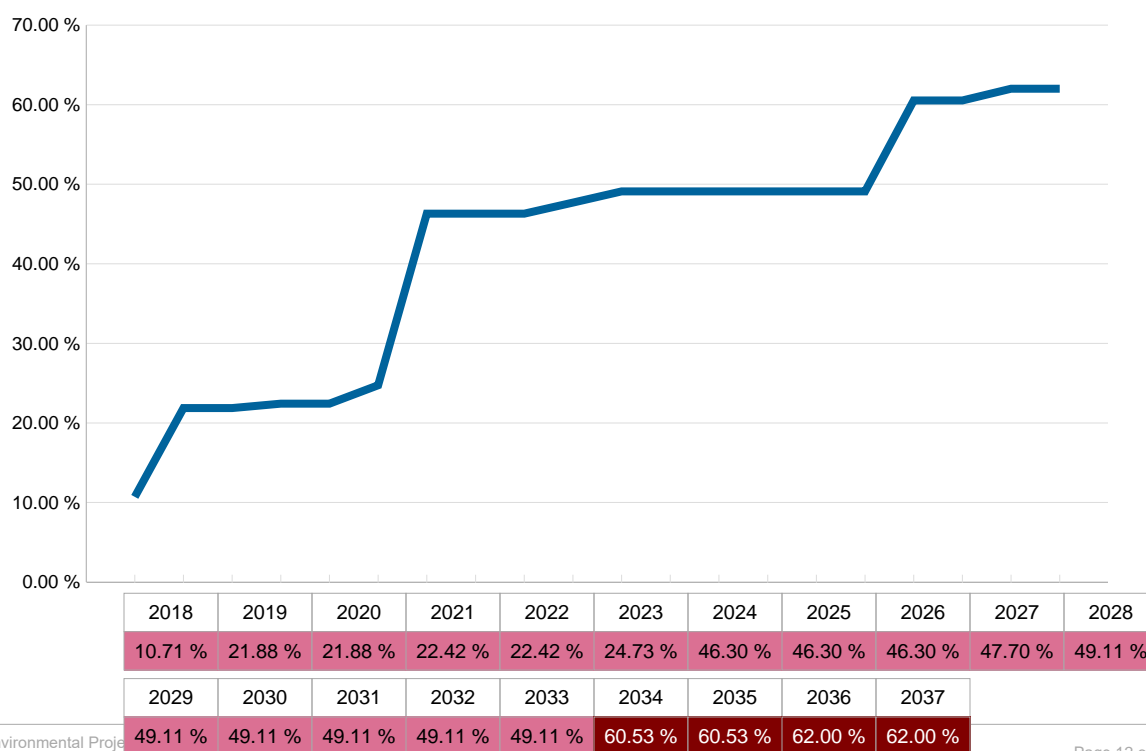
Cumulative Effects of FCI Over the Study Period

The Chart below indicates the cumulative effects of the FCI ratio over the study period assuming the required funds and expenditures are NOT provided to address the identified works and deferred maintenance each year.

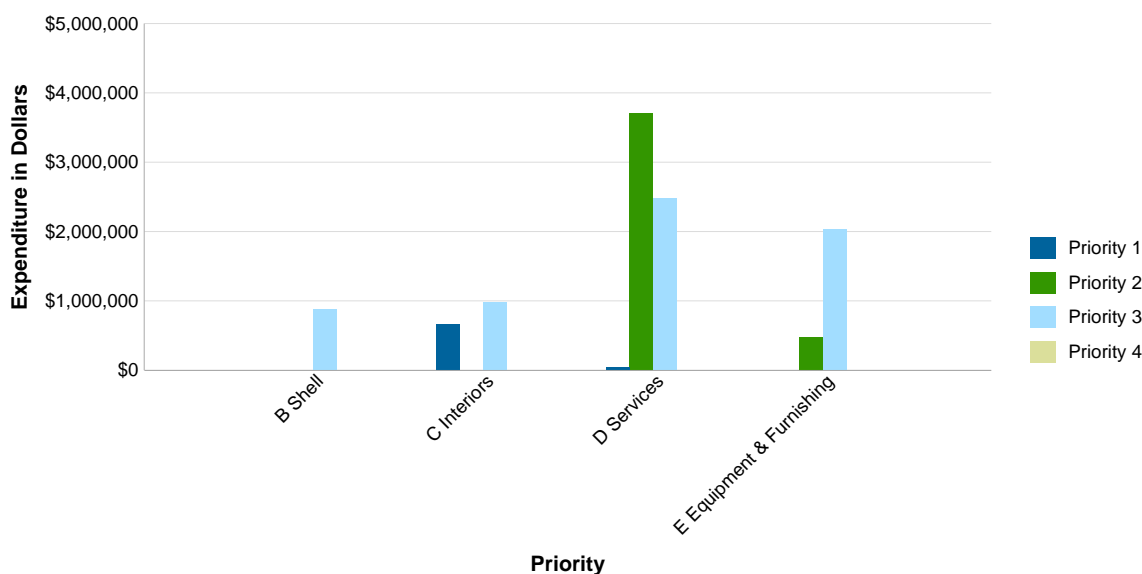
Planning Horizon Needs by System and Priority

The chart below illustrates the breakdown of expenditure according the priority coding providing an opportunity to strategically plan and effectively direct funding to the highest priority.

Building System	Priority 1	Priority 2	Priority 3	Priority 4	Total
B Shell	\$0	\$0	\$878,123	\$0	\$878,123
C Interiors	\$669,166	\$0	\$983,427	\$0	\$1,652,593
D Services	\$47,576	\$3,712,177	\$2,480,556	\$0	\$6,240,309
E Equipment & Furnishing	\$0	\$476,277	\$2,038,526	\$0	\$2,514,803
Total	\$716,742	\$4,188,454	\$6,380,633	\$0	\$11,285,829

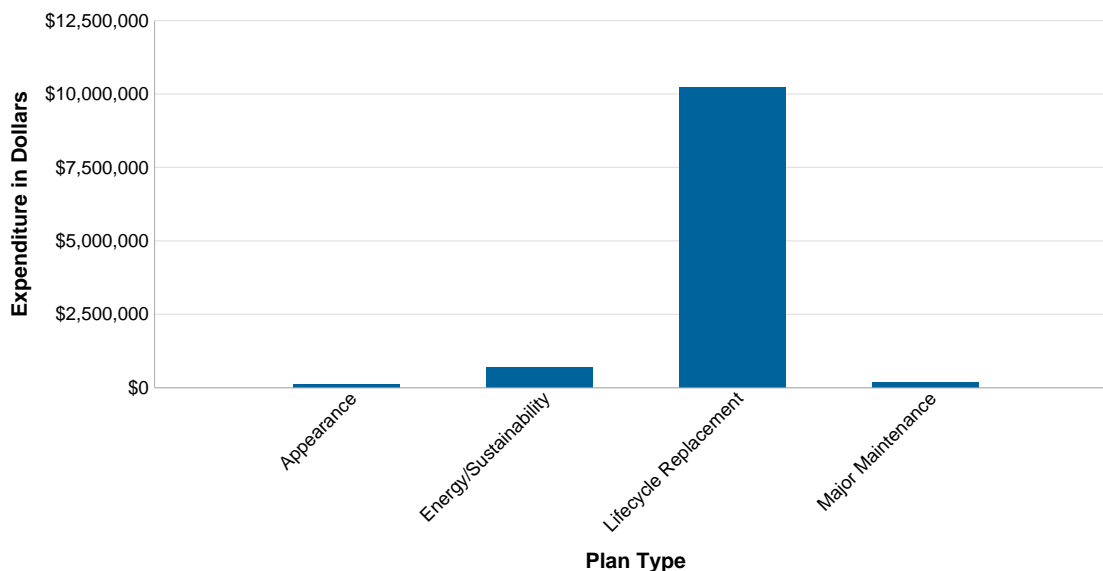
Planning Horizon Needs by Category

The chart below illustrates the breakdown of expenditure according to the Plan Type or deficiency categories providing an opportunity to strategically plan and effectively direct funding.

Building System	Total Cost
Appearance	\$126,180
Energy/Sustainability	\$715,926
Lifecycle Replacement	\$10,239,174
Major Maintenance	\$204,549
Total	\$11,285,829

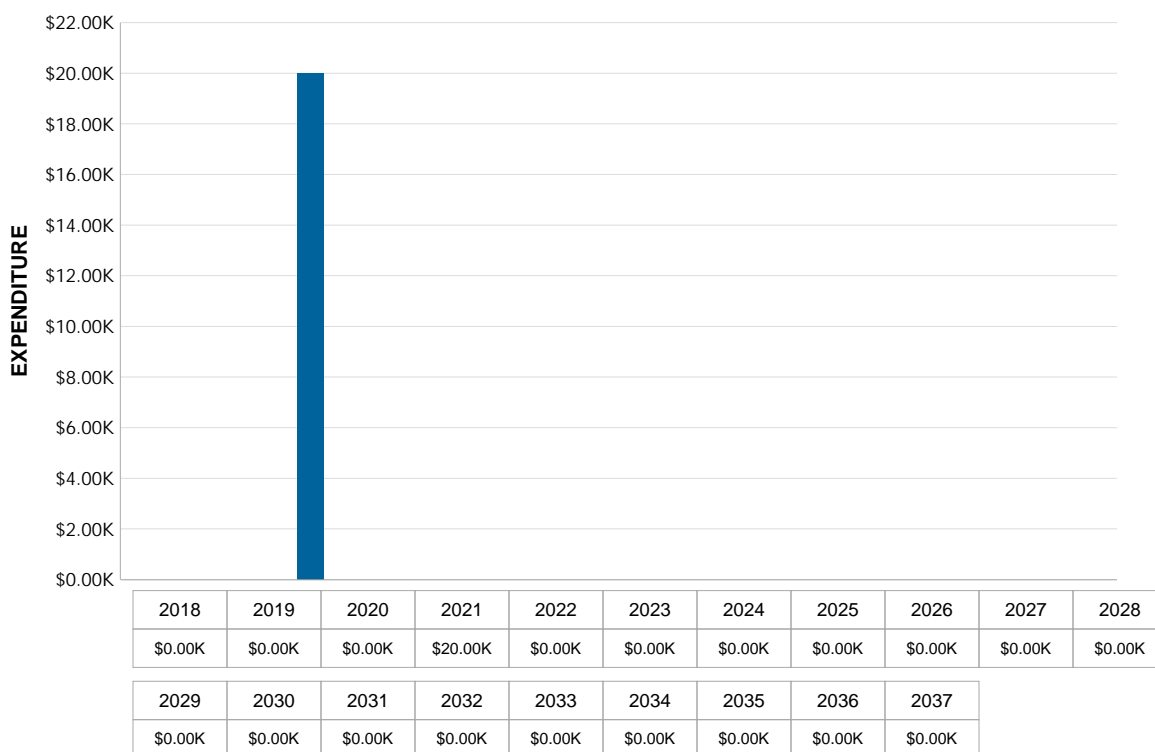
Expenditure Forecast Over Study Period

The building expenditure summary section provides an executive overview of the findings from the assessment. The chart below provides a summary of yearly anticipated expenditures over the study period for the Richard Gordon Elementary School Site building. In addition, we have scheduled key findings highlighting key items of greater than \$5,000 and their anticipated failure year. Further details of these expenditures are included within each respective report section and within the expenditure forecast, in Appendix A of this report. The results illustrate a total anticipated expenditure over the study period of approximately \$20,000.

- G Building Sitework: Maintenance/mulching and selective planting. Aerate/topdress/overseed turf. at an estimated cost of \$7,500 in year 2021
- G Building Sitework: Selective demolition and patch. Seal coat. at an estimated cost of \$7,500 in year 2021
- G Building Sitework: Aerate/topdress/overseed. at an estimated cost of \$5,000 in year 2021

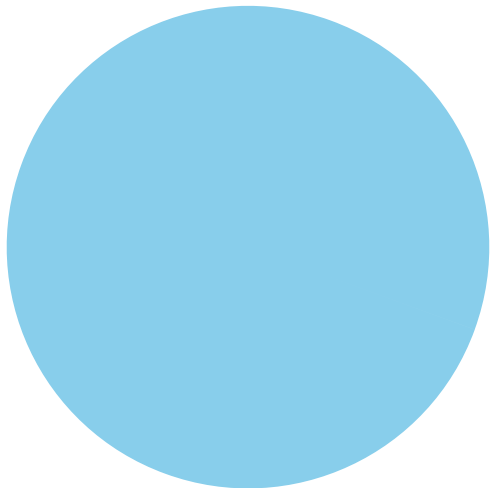
Distribution of Capital Needs by Building System

Building System	Estimated Cost	Percentage of Total Cost
G20 Site Improvements	\$20,000	100.00 %
Total	\$20,000	100 %

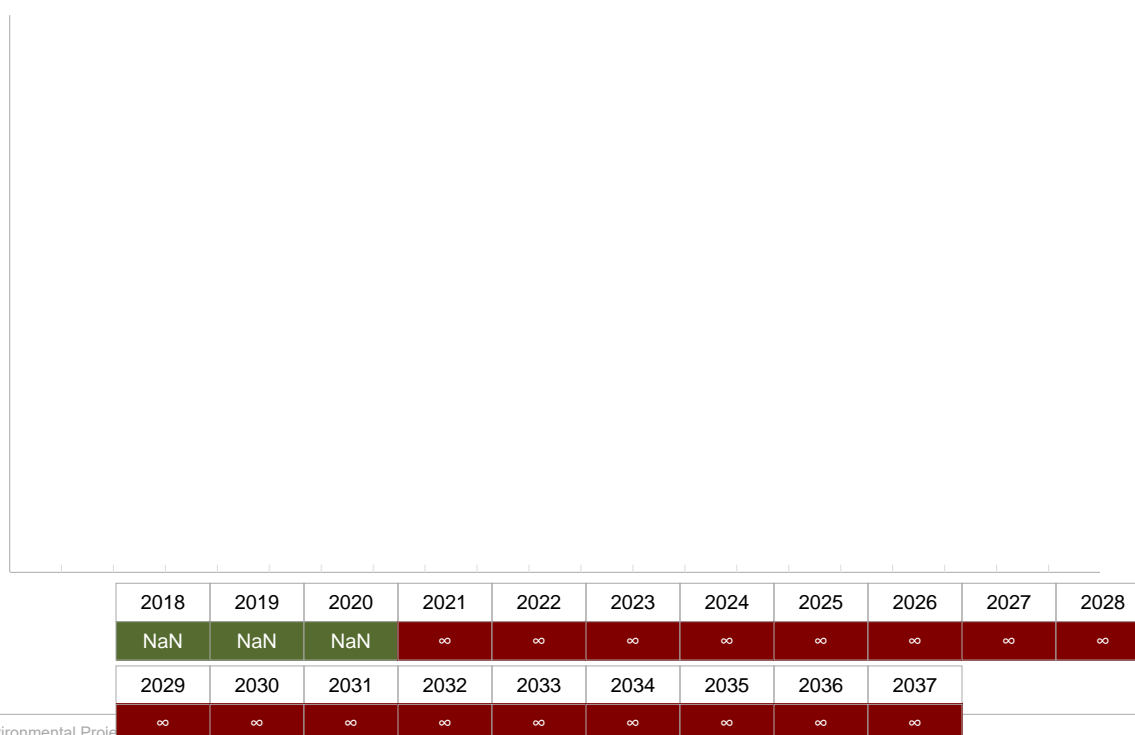
Cumulative Effects of FCI Over the Study Period

The Chart below indicates the cumulative effects of the FCI ratio over the study period assuming the required funds and expenditures are NOT provided to address the identified works and deferred maintenance each year.

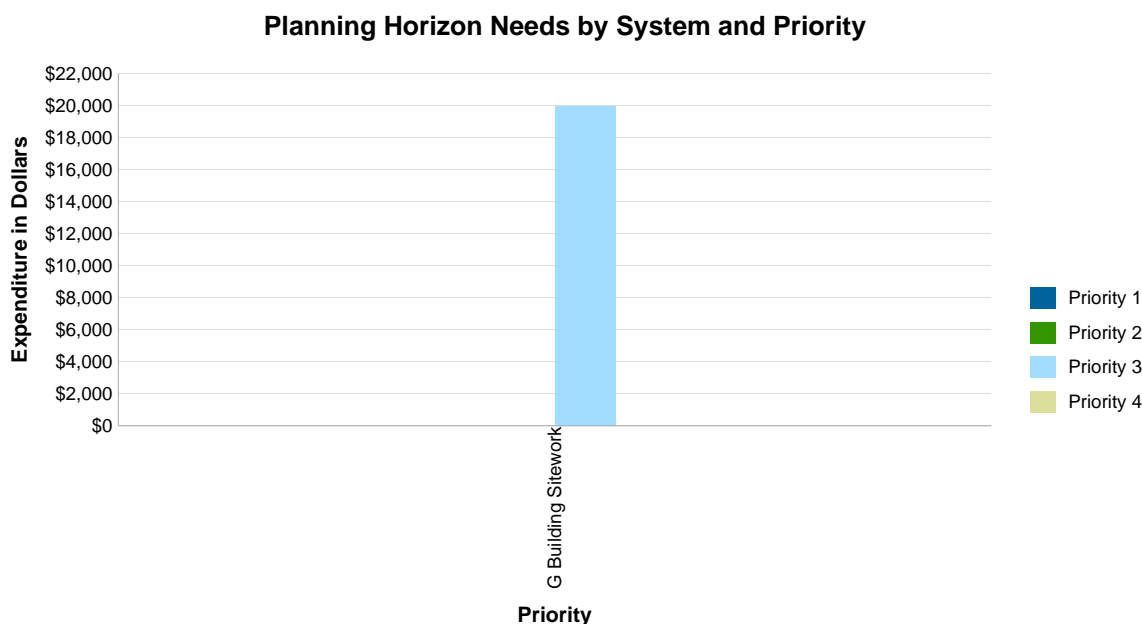
The chart below illustrates the breakdown of expenditure according the priority coding providing an opportunity to strategically plan and effectively direct funding to the highest priority.

Building System	Priority 1	Priority 2	Priority 3	Priority 4	Total
G Building Sitework	\$0	\$0	\$20,000	\$0	\$20,000
Total	\$0	\$0	\$20,000	\$0	\$20,000

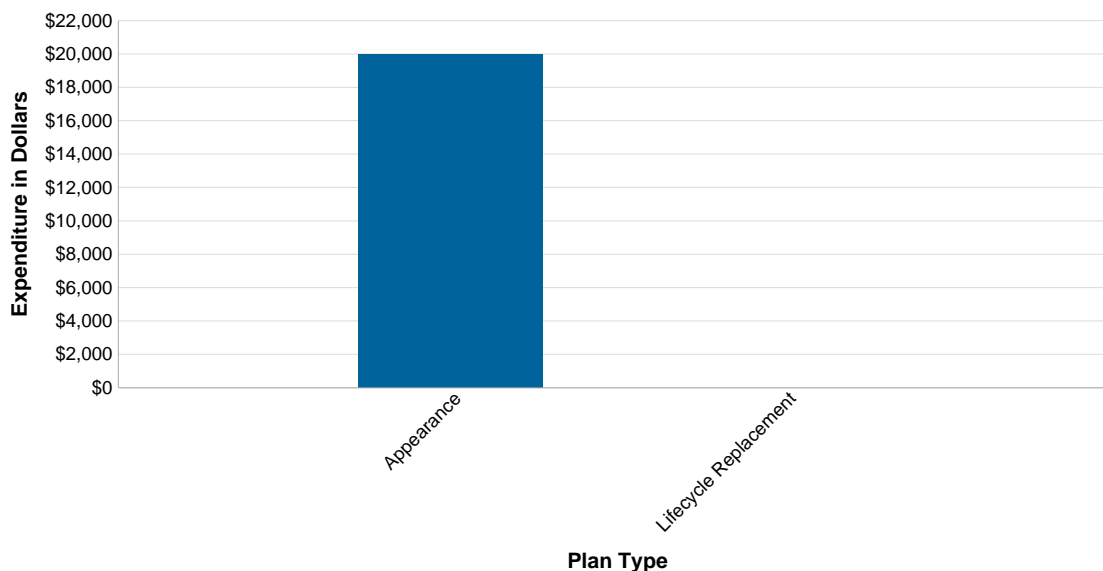
Planning Horizon Needs by Category

The chart below illustrates the breakdown of expenditure according to the Plan Type or deficiency categories providing an opportunity to strategically plan and effectively direct funding.

Building System	Total Cost
Appearance	\$20,000
Lifecycle Replacement	\$0
Total	\$20,000

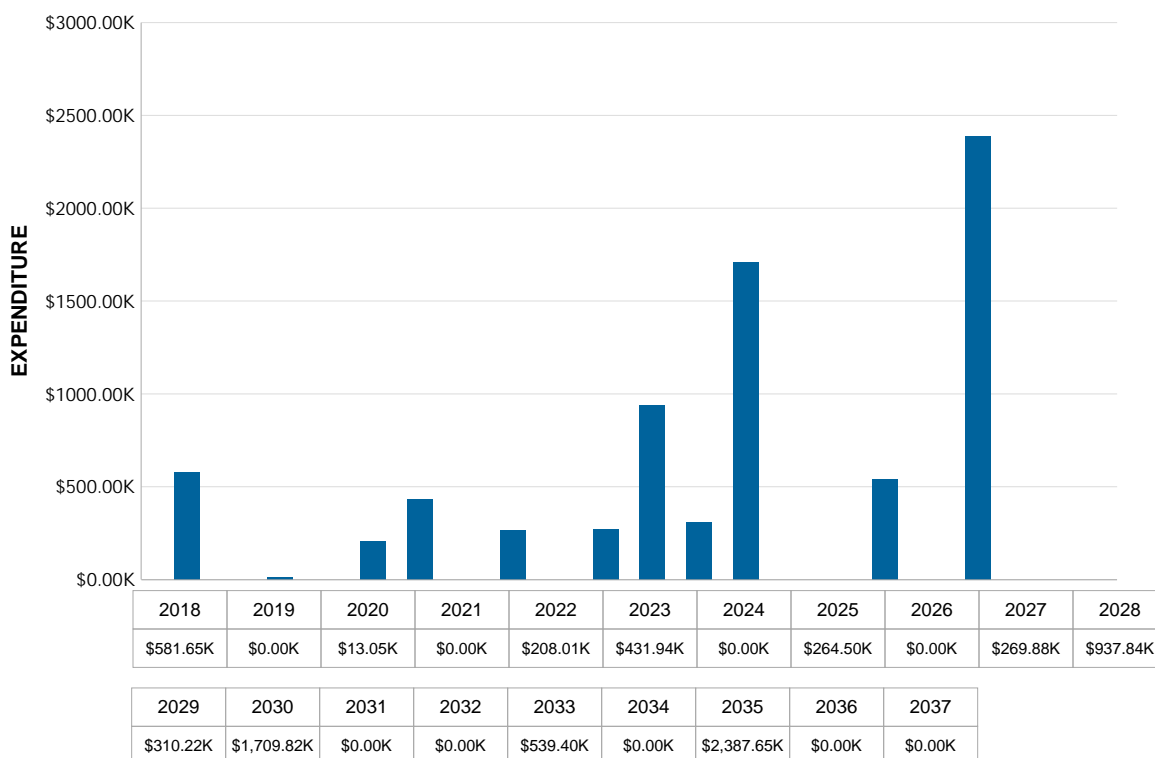
Expenditure Forecast Over Study Period

The building expenditure summary section provides an executive overview of the findings from the assessment. The chart below provides a summary of yearly anticipated expenditures over the study period for the Suquamish Elementary School Main building. In addition, we have scheduled key findings highlighting key items of greater than \$5,000 and their anticipated failure year. Further details of these expenditures are included within each respective report section and within the expenditure forecast, in Appendix A of this report. The results illustrate a total anticipated expenditure over the study period of approximately \$7,653,951.

- B Shell: Replace roof for 1/2 of building at an estimated cost of \$145,366 in year 2018
- B Shell: Replace appurtenances (gutters, vents, skylights, etc.) at all areas where roof is upgraded (50% total roof area) at an estimated cost of \$71,120 in year 2018

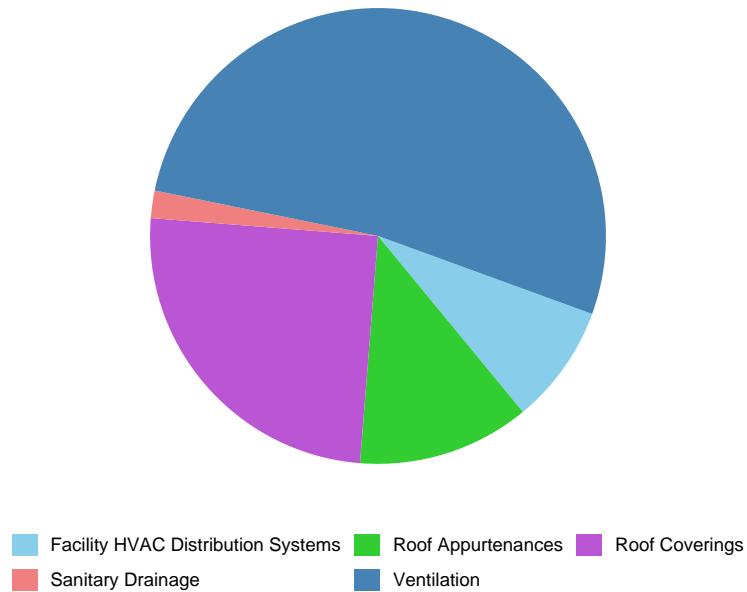
Distribution of Immediate Needs by Building System

Building System	Estimated Cost	Percentage of Total Cost
Facility HVAC Distribution Systems	\$49,313	8.48 %
Roof Appurtenances	\$71,120	12.23 %
Roof Coverings	\$145,366	24.99 %
Sanitary Drainage	\$11,334	1.95 %
Ventilation	\$304,513	52.35 %
Total	\$581,647	100 %

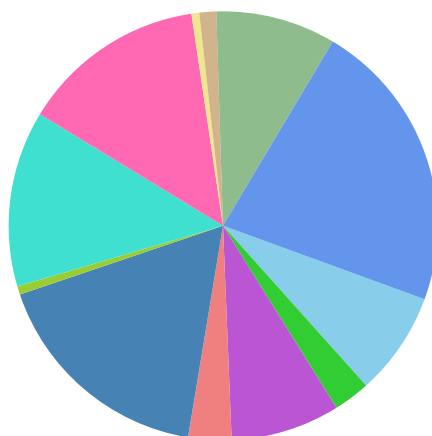
Distribution of Capital Needs by Building System

Building System	Estimated Cost	Percentage of Total Cost
B20 Exterior Enclosure	\$553,202	7.82 %
B30 Roofing	\$194,213	2.75 %
C20 Interior Finishes	\$582,566	8.24 %
D20 Plumbing	\$230,027	3.25 %
D30 HVAC	\$1,216,238	17.20 %
D40 Fire Protection Systems	\$44,830	0.63 %
D50 Electrical Systems	\$937,844	13.26 %
D60 Communication Systems	\$985,812	13.94 %
D70 Security Systems	\$41,244	0.58 %
D80 Automation Systems	\$89,660	1.27 %
E10 Equipment	\$640,621	9.06 %
E20 Furnishings	\$1,556,049	22.00 %
Total	\$7,072,304	100 %

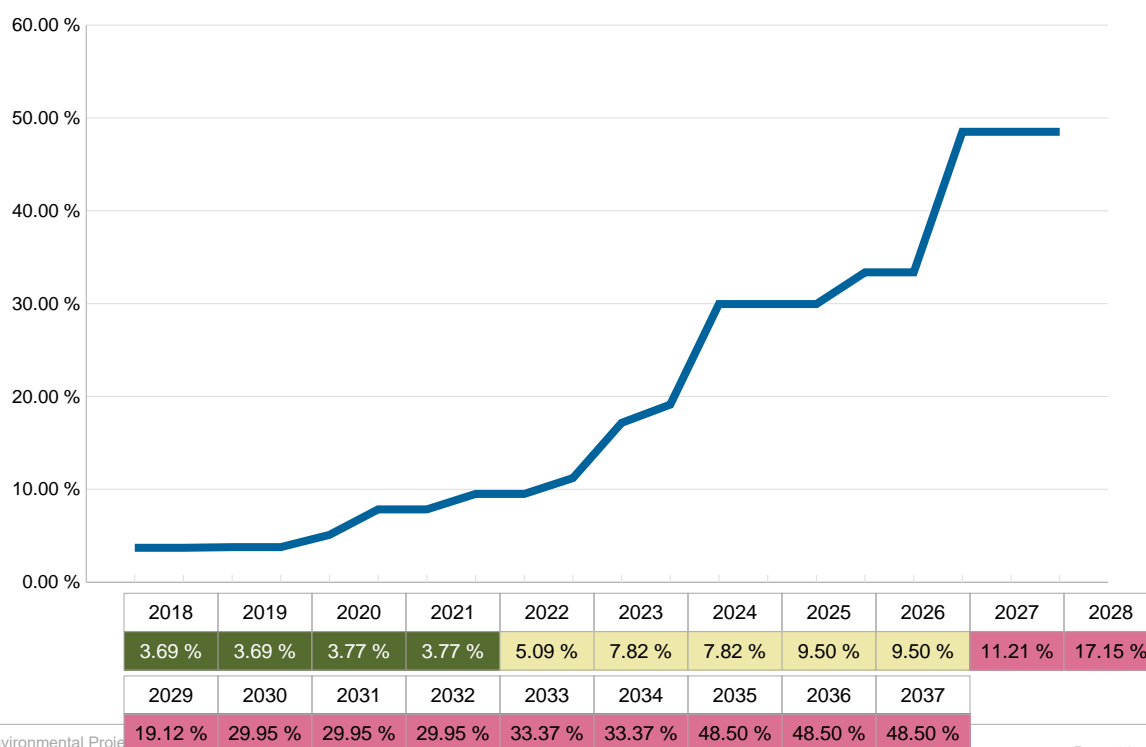
Cumulative Effects of FCI Over the Study Period

The Chart below indicates the cumulative effects of the FCI ratio over the study period assuming the required funds and expenditures are NOT provided to address the identified works and deferred maintenance each year.

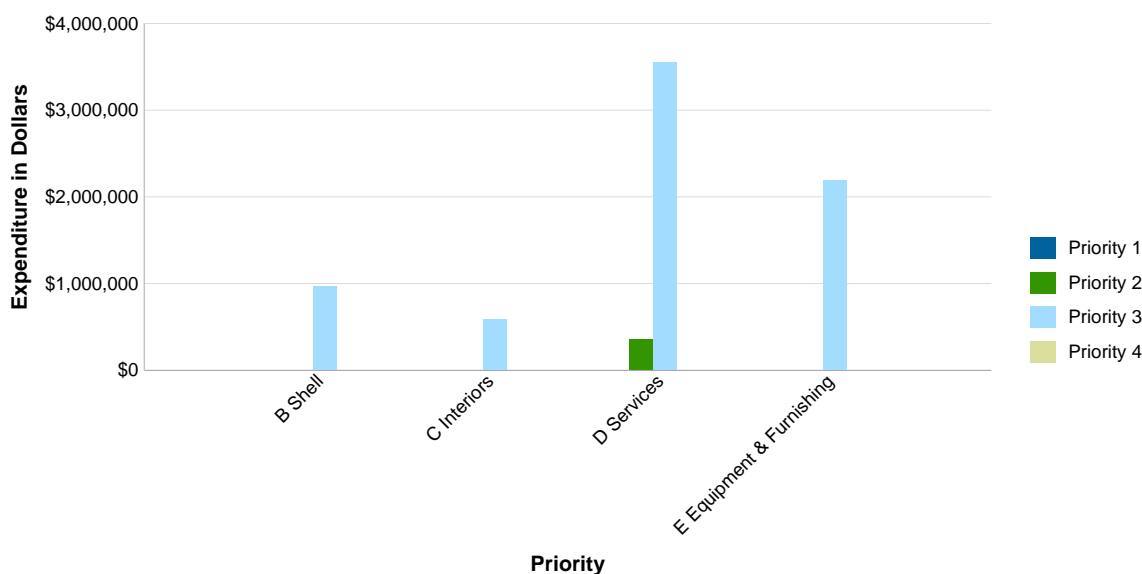
Planning Horizon Needs by System and Priority

The chart below illustrates the breakdown of expenditure according the priority coding providing an opportunity to strategically plan and effectively direct funding to the highest priority.

Building System	Priority 1	Priority 2	Priority 3	Priority 4	Total
B Shell	\$0	\$0	\$963,901	\$0	\$963,901
C Interiors	\$0	\$0	\$582,566	\$0	\$582,566
D Services	\$0	\$353,826	\$3,556,988	\$0	\$3,910,814
E Equipment & Furnishing	\$0	\$0	\$2,196,669	\$0	\$2,196,669
Total	\$0	\$353,826	\$7,300,125	\$0	\$7,653,951

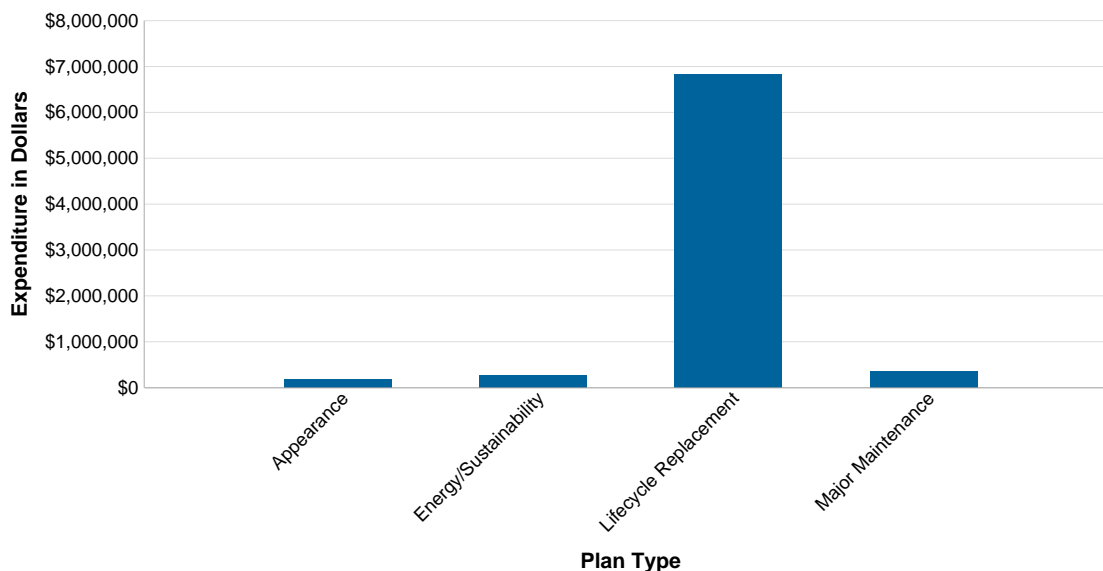
Planning Horizon Needs by Category

The chart below illustrates the breakdown of expenditure according to the Plan Type or deficiency categories providing an opportunity to strategically plan and effectively direct funding.

Building System	Total Cost
Appearance	\$185,820
Energy/Sustainability	\$273,463
Lifecycle Replacement	\$6,832,191
Major Maintenance	\$362,477
Total	\$7,653,951

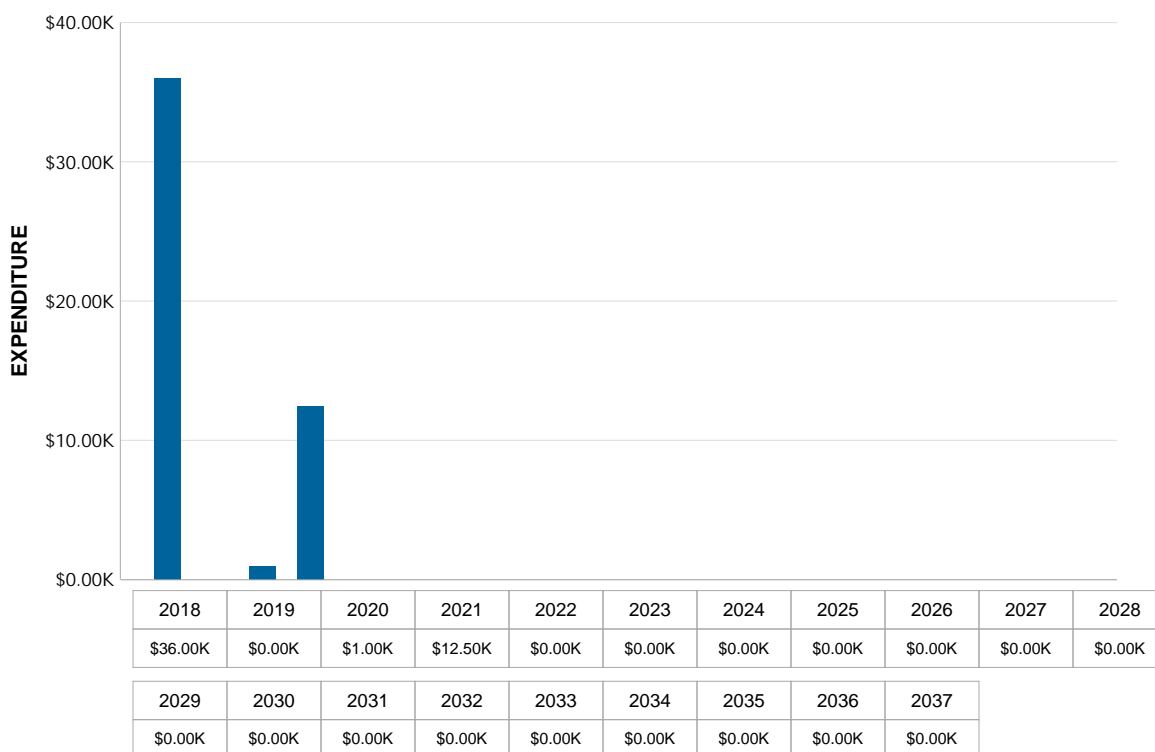
Expenditure Forecast Over Study Period

The building expenditure summary section provides an executive overview of the findings from the assessment. The chart below provides a summary of yearly anticipated expenditures over the study period for the Suquamish Elementary School Site building. In addition, we have scheduled key findings highlighting key items of greater than \$5,000 and their anticipated failure year. Further details of these expenditures are included within each respective report section and within the expenditure forecast, in Appendix A of this report. The results illustrate a total anticipated expenditure over the study period of approximately \$49,500.

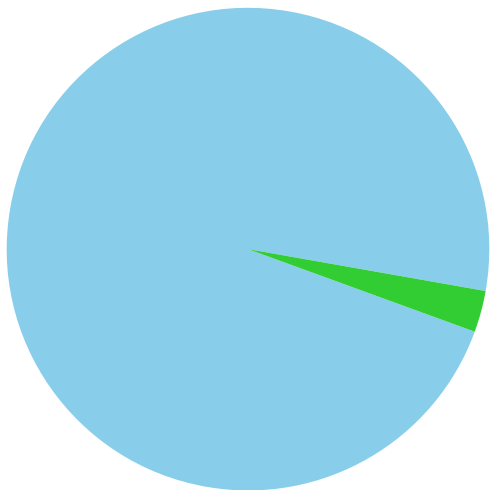
Distribution of Immediate Needs by Building System

■ Parking Lots ■ Site Lighting

Building System	Estimated Cost	Percentage of Total Cost
Parking Lots	\$35,000	97.22 %
Site Lighting	\$1,000	2.78 %
Total	\$36,000	100 %

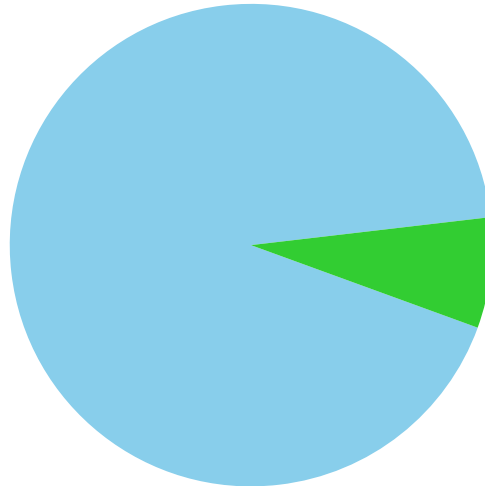
Distribution of Capital Needs by Building System

■ G20 Site Improvements ■ G30 Site Civil/Mechanical Utilities

Building System	Estimated Cost	Percentage of Total Cost
G20 Site Improvements	\$12,500	92.59 %
G30 Site Civil/Mechanical Utilities	\$1,000	7.41 %
Total	\$13,500	100 %

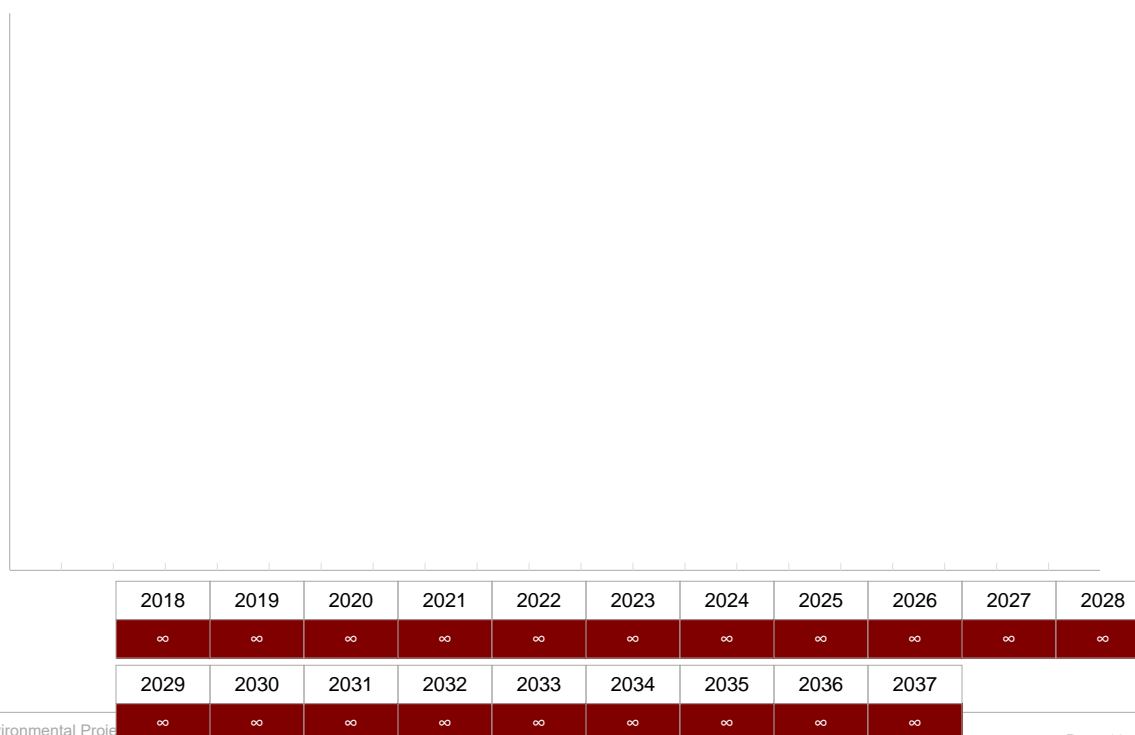
Cumulative Effects of FCI Over the Study Period

The Chart below indicates the cumulative effects of the FCI ratio over the study period assuming the required funds and expenditures are NOT provided to address the identified works and deferred maintenance each year.

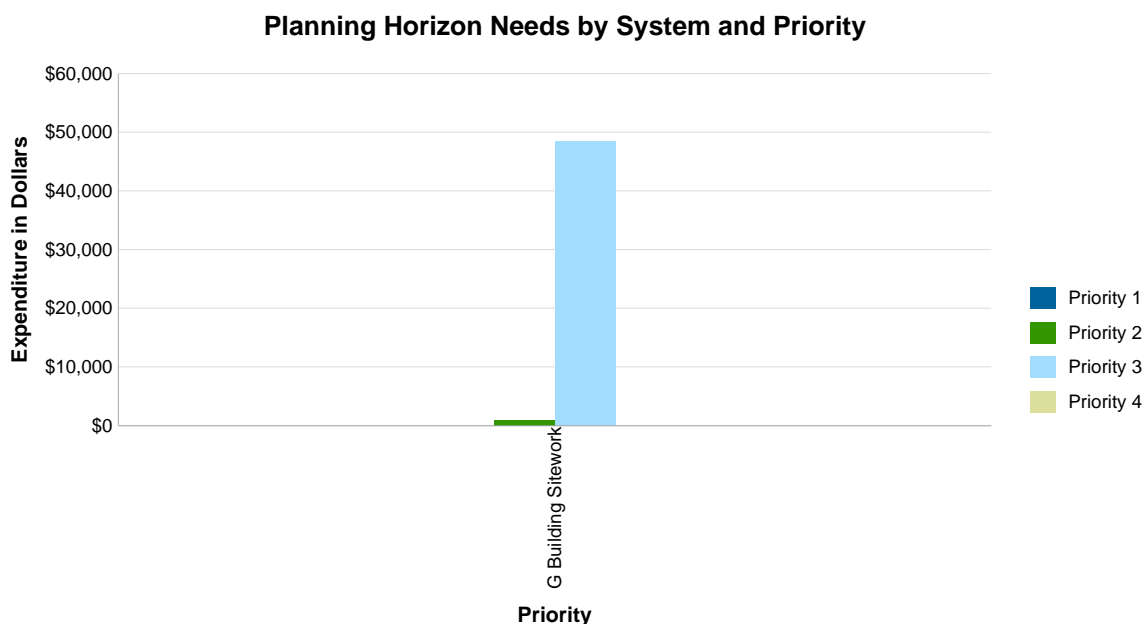
The chart below illustrates the breakdown of expenditure according the priority coding providing an opportunity to strategically plan and effectively direct funding to the highest priority.

Building System	Priority 1	Priority 2	Priority 3	Priority 4	Total
G Building Sitework	\$0	\$1,000	\$48,500	\$0	\$49,500
Total	\$0	\$1,000	\$48,500	\$0	\$49,500
