Facilities Condition Assessment Report

I. FCA Executive Summary

North Kitsap School District

Breidablik Elementary School Main
25142 Waghorn Rd NW
Poulsbo, WA

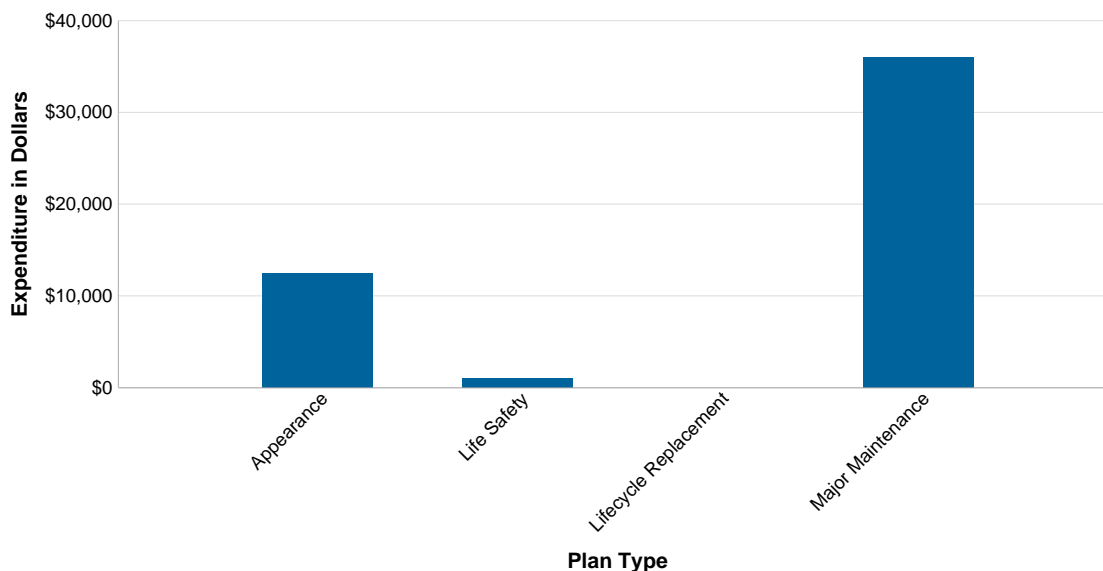
Planning Horizon Needs by Category

The chart below illustrates the breakdown of expenditure according to the Plan Type or deficiency categories providing an opportunity to strategically plan and effectively direct funding.

Building System	Total Cost
Appearance	\$12,500
Life Safety	\$1,000
Lifecycle Replacement	\$0
Major Maintenance	\$36,000
Total	\$49,500

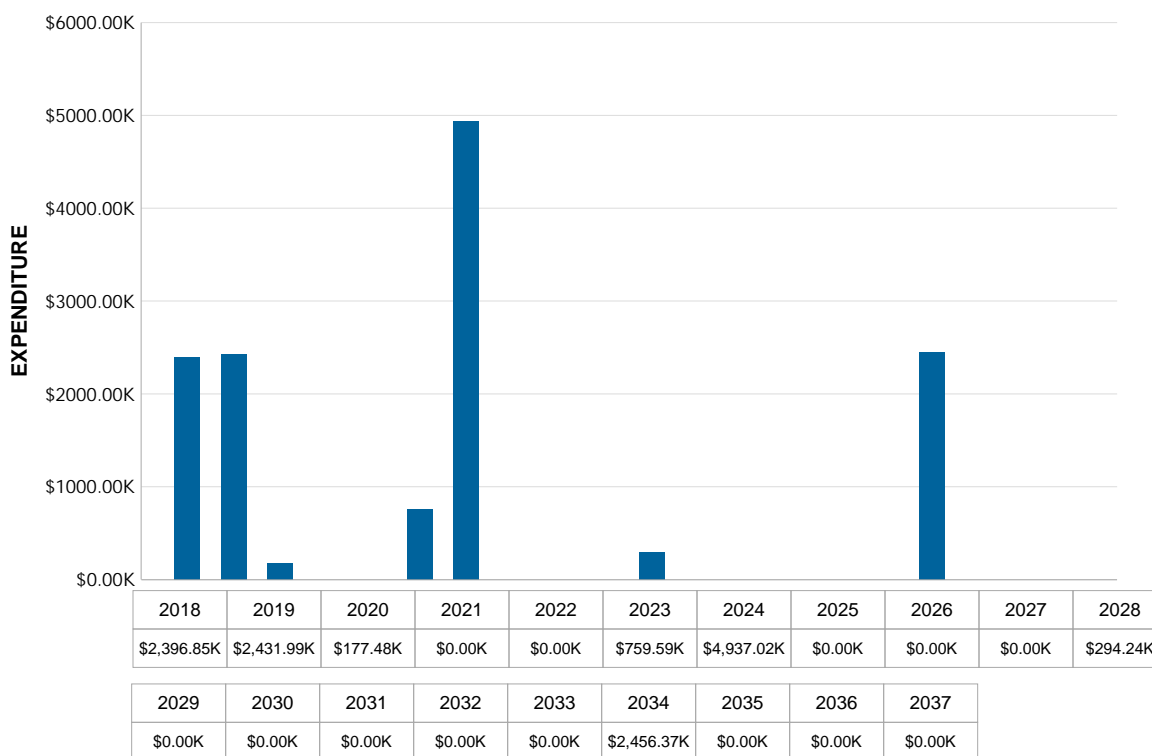
Expenditure Forecast Over Study Period

The building expenditure summary section provides an executive overview of the findings from the assessment. The chart below provides a summary of yearly anticipated expenditures over the study period for the Vinland Elementary School Main building. In addition, we have scheduled key findings highlighting key items of greater than \$5,000 and their anticipated failure year. Further details of these expenditures are included within each respective report section and within the expenditure forecast, in Appendix A of this report. The results illustrate a total anticipated expenditure over the study period of approximately \$13,453,547.

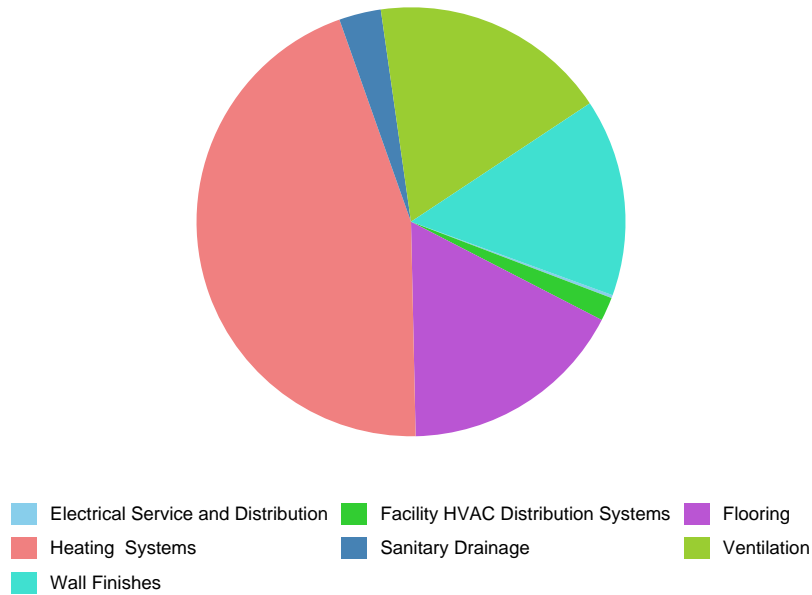
Distribution of Immediate Needs by Building System

Building System	Estimated Cost	Percentage of Total Cost
Electrical Service and Distribution	\$5,500	0.23 %
Facility HVAC Distribution Systems	\$42,750	1.78 %
Flooring	\$409,692	17.09 %
Heating Systems	\$1,076,642	44.92 %
Sanitary Drainage	\$75,761	3.16 %
Ventilation	\$430,098	17.94 %
Wall Finishes	\$356,408	14.87 %
Total	\$2,396,851	100 %

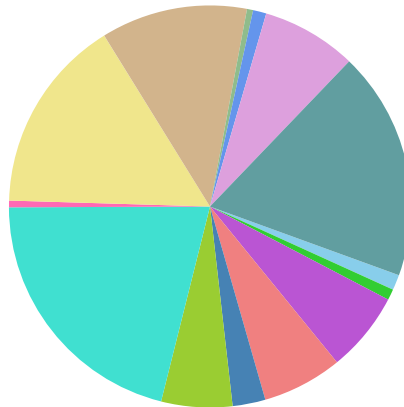
Distribution of Capital Needs by Building System

Building System	Estimated Cost	Percentage of Total Cost
B10 SuperStructure	\$136,650	1.24 %
B20 Exterior Enclosure	\$96,503	0.87 %
B30 Roofing	\$713,408	6.45 %
C10 Interior Construction	\$712,564	6.44 %
C20 Interior Finishes	\$291,876	2.64 %
D20 Plumbing	\$631,236	5.71 %
D30 HVAC	\$2,324,349	21.02 %
D40 Fire Protection Systems	\$59,204	0.54 %
D50 Electrical Systems	\$1,737,045	15.71 %
D60 Communication Systems	\$1,301,896	11.77 %
D70 Security Systems	\$54,468	0.49 %
D80 Automation Systems	\$118,408	1.07 %
E10 Equipment	\$846,025	7.65 %
E20 Furnishings	\$2,033,065	18.39 %
Total	\$11,056,697	100 %

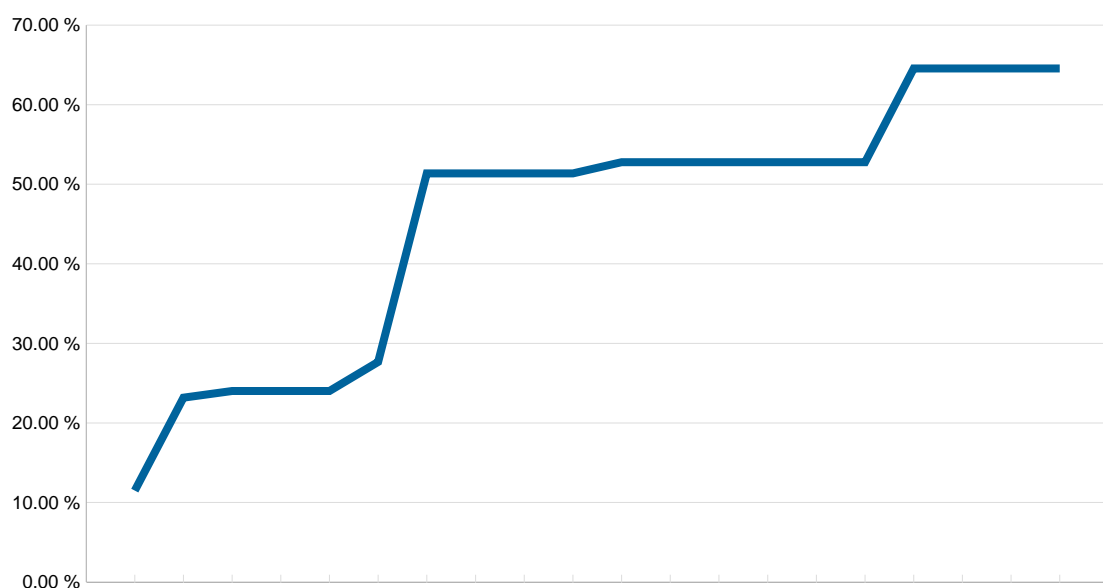
Cumulative Effects of FCI Over the Study Period

The Chart below indicates the cumulative effects of the FCI ratio over the study period assuming the required funds and expenditures are NOT provided to address the identified works and deferred maintenance each year.

2018	2019	2020	2021	2022	2023	2024	2025	2026	2027	2028
11.50 %	23.17 %	24.02 %	24.02 %	24.02 %	27.67 %	51.36 %	51.36 %	51.36 %	51.36 %	52.77 %
2029	2030	2031	2032	2033	2034	2035	2036	2037		
52.77 %	52.77 %	52.77 %	52.77 %	52.77 %	64.56 %	64.56 %	64.56 %	64.56 %

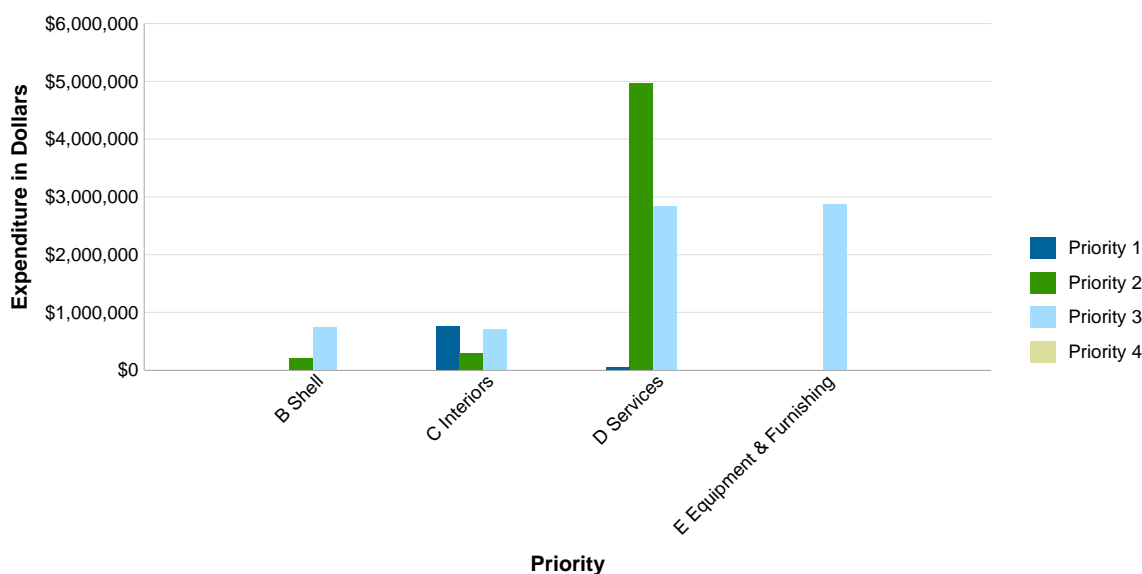
Planning Horizon Needs by System and Priority

The chart below illustrates the breakdown of expenditure according the priority coding providing an opportunity to strategically plan and effectively direct funding to the highest priority.

Building System	Priority 1	Priority 2	Priority 3	Priority 4	Total
B Shell	\$0	\$198,814	\$747,747	\$0	\$946,561
C Interiors	\$766,100	\$291,876	\$712,564	\$0	\$1,770,539
D Services	\$54,468	\$4,964,549	\$2,838,340	\$0	\$7,857,357
E Equipment & Furnishing	\$0	\$0	\$2,879,091	\$0	\$2,879,091
Total	\$820,567	\$5,455,238	\$7,177,741	\$0	\$13,453,547

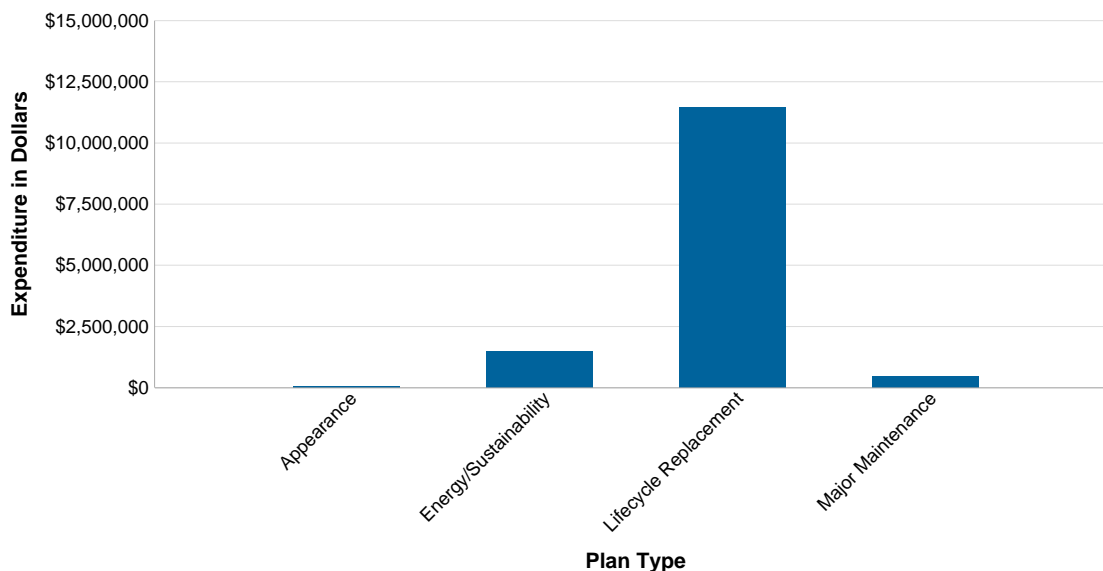
Planning Horizon Needs by Category

The chart below illustrates the breakdown of expenditure according to the Plan Type or deficiency categories providing an opportunity to strategically plan and effectively direct funding.

Building System	Total Cost
Appearance	\$52,692
Energy/Sustainability	\$1,490,769
Lifecycle Replacement	\$11,452,422
Major Maintenance	\$457,665
Total	\$13,453,547

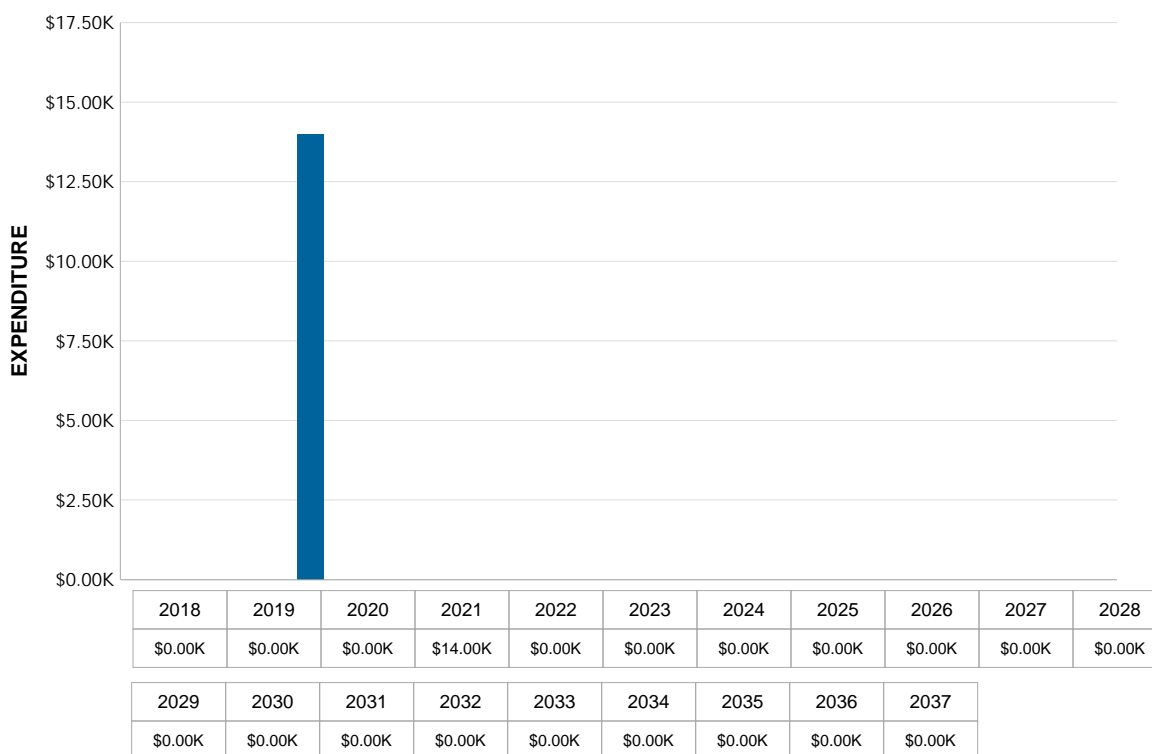
Expenditure Forecast Over Study Period

The building expenditure summary section provides an executive overview of the findings from the assessment. The chart below provides a summary of yearly anticipated expenditures over the study period for the Vinland Elementary School Site building. In addition, we have scheduled key findings highlighting key items of greater than \$5,000 and their anticipated failure year. Further details of these expenditures are included within each respective report section and within the expenditure forecast, in Appendix A of this report. The results illustrate a total anticipated expenditure over the study period of approximately \$14,000.

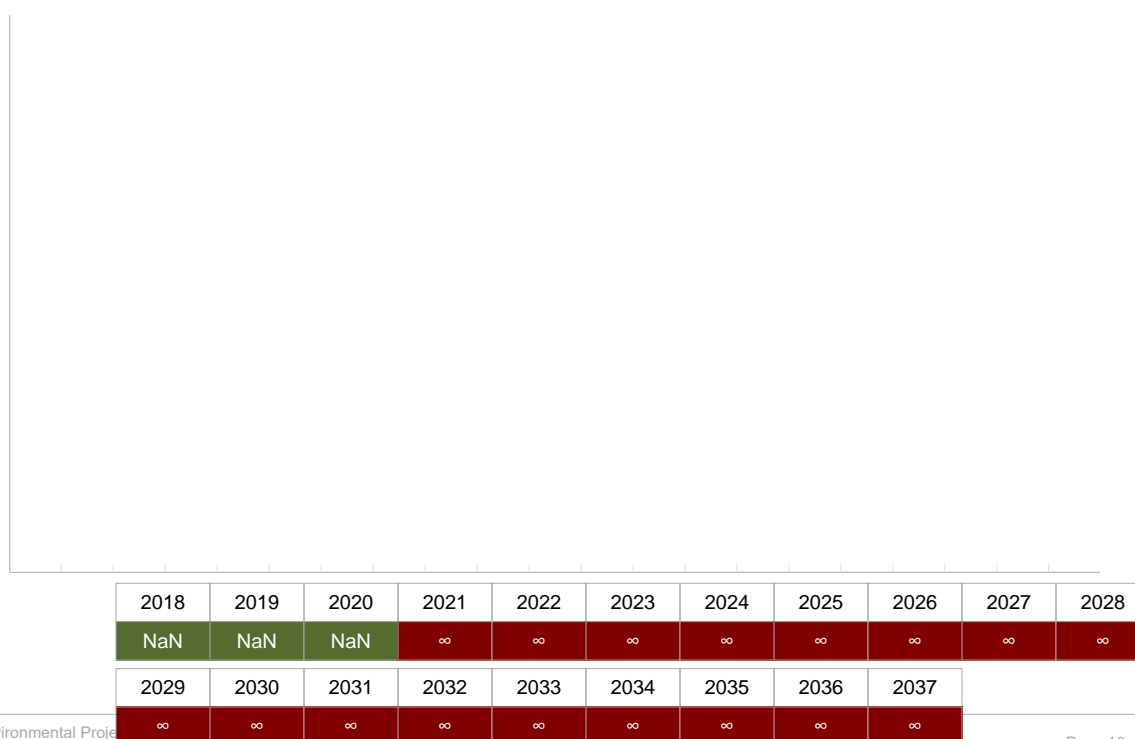
Cumulative Effects of FCI Over the Study Period

The Chart below indicates the cumulative effects of the FCI ratio over the study period assuming the required funds and expenditures are NOT provided to address the identified works and deferred maintenance each year.

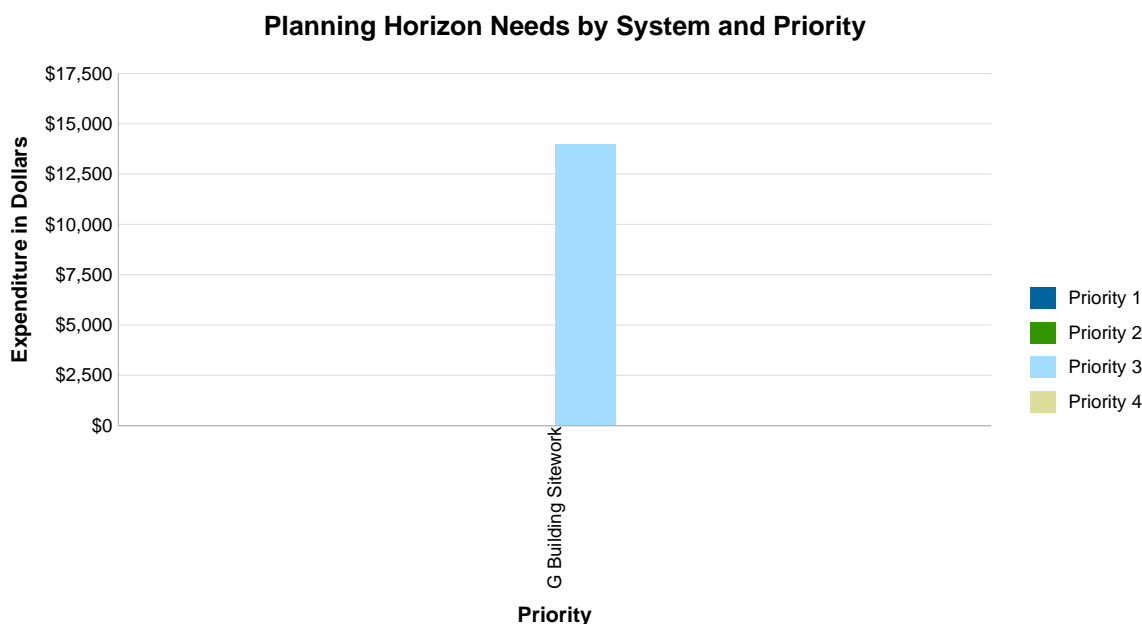
The chart below illustrates the breakdown of expenditure according the priority coding providing an opportunity to strategically plan and effectively direct funding to the highest priority.

Building System	Priority 1	Priority 2	Priority 3	Priority 4	Total
G Building Sitework	\$0	\$0	\$14,000	\$0	\$14,000
Total	\$0	\$0	\$14,000	\$0	\$14,000

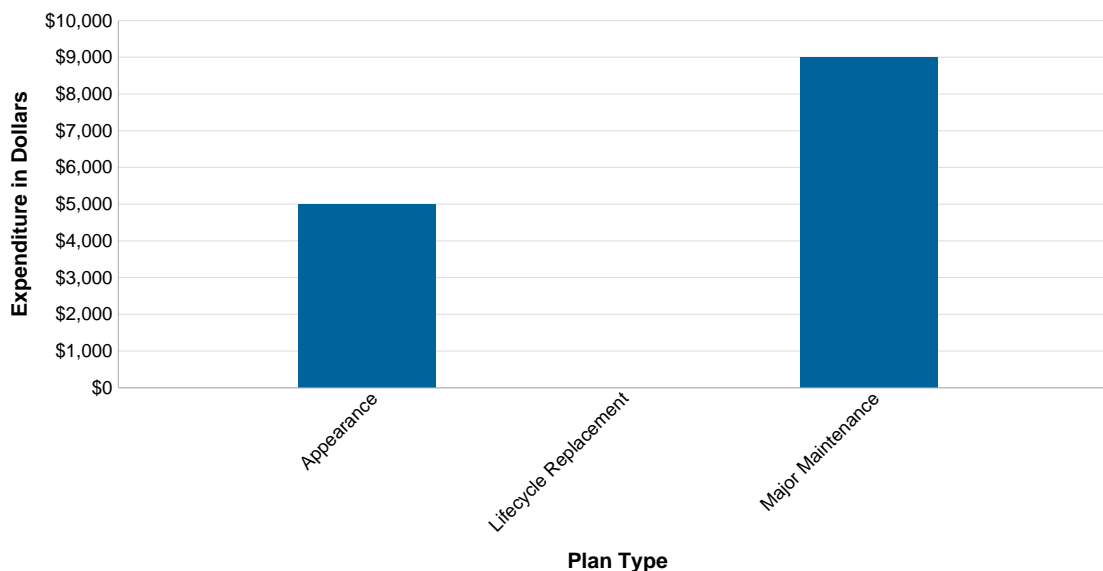
Planning Horizon Needs by Category

The chart below illustrates the breakdown of expenditure according to the Plan Type or deficiency categories providing an opportunity to strategically plan and effectively direct funding.

Building System	Total Cost
Appearance	\$5,000
Lifecycle Replacement	\$0
Major Maintenance	\$9,000
Total	\$14,000

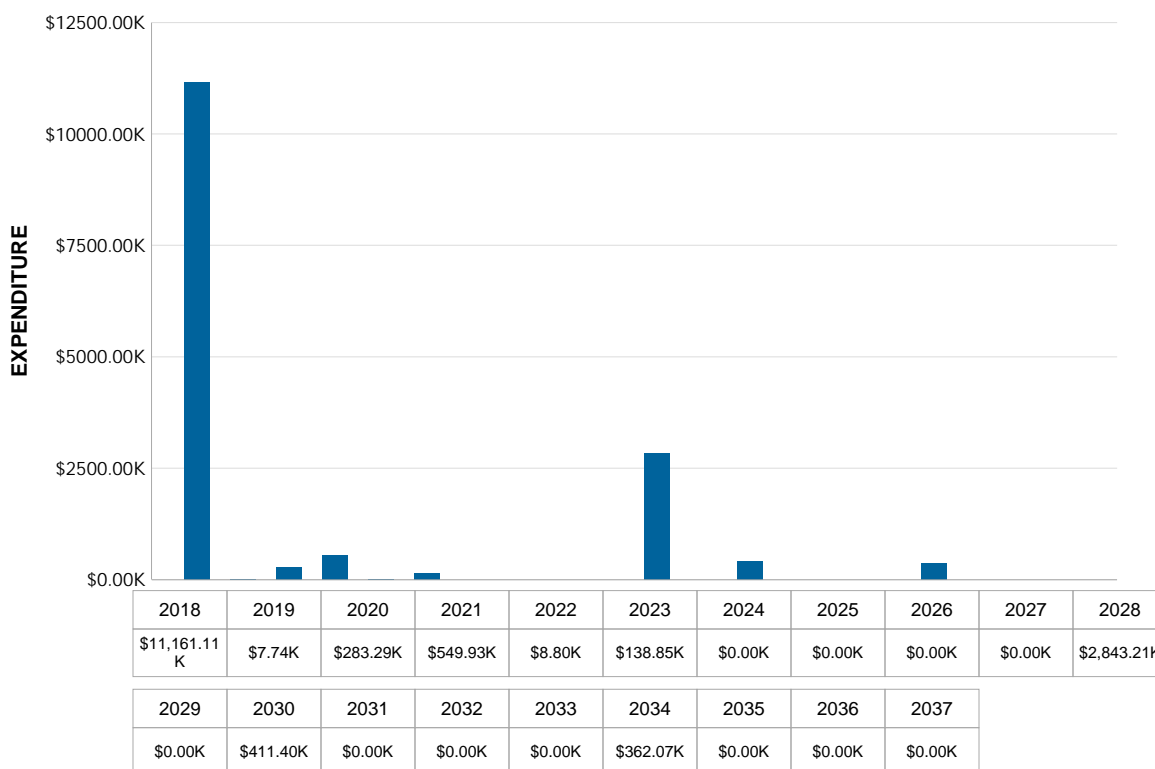
Expenditure Forecast Over Study Period

The building expenditure summary section provides an executive overview of the findings from the assessment. The chart below provides a summary of yearly anticipated expenditures over the study period for the Kingston Middle School One-story Building building. In addition, we have scheduled key findings highlighting key items of greater than \$5,000 and their anticipated failure year. Further details of these expenditures are included within each respective report section and within the expenditure forecast, in Appendix A of this report. The results illustrate a total anticipated expenditure over the study period of approximately \$15,766,393.

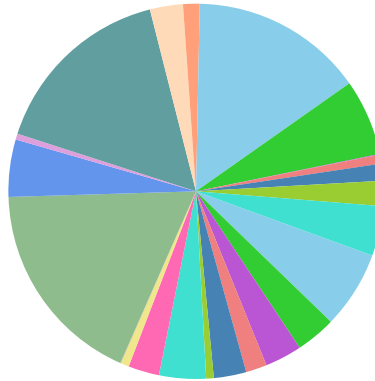
Distribution of Immediate Needs by Building System

Building System	Estimated Cost	Percentage of Total Cost
Audio-Video Communications	\$745,618	6.68 %
Building Support Plumbing Systems	\$385,143	3.45 %
Commercial Equipment	\$355,514	3.19 %
Cooling Systems	\$202,121	1.81 %
Data Communications	\$311,934	2.79 %
Detection and Alarm	\$73,209	0.66 %
Distributed Communications and Monitoring	\$450,395	4.04 %
Electronic Surveillance	\$298,406	2.67 %
Fire Protection Specialties	\$79,575	0.71 %
Fire Suppression	\$5,500	0.05 %
Fixed Furnishings	\$1,999,720	17.92 %
Flooring	\$550,659	4.93 %
General Service Compressed-Air	\$57,382	0.51 %
Heating Systems	\$1,794,501	16.08 %

Institutional Equipment	\$317,504	2.84 %
Integrated Automation Facility Controls	\$159,150	1.43 %
Lighting	\$1,664,709	14.92 %
Moveable Furnishings	\$732,886	6.57 %
Other Equipment	\$6,366	0.06 %
Roof Coverings	\$86,737	0.78 %
Ventilation	\$163,129	1.46 %
Voice Communications	\$241,908	2.17 %
Wall Finishes	\$479,042	4.29 %
Total	\$11,161,106	100 %

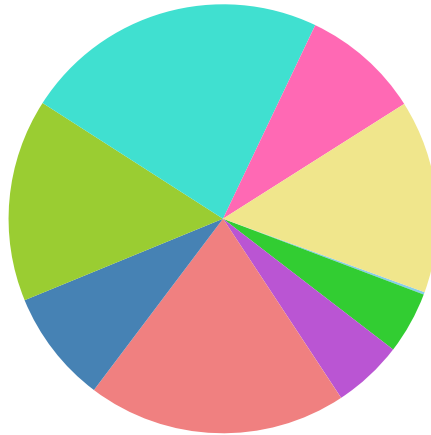
Distribution of Capital Needs by Building System

Building System	Estimated Cost	Percentage of Total Cost
A40 Slabs on Grade	\$8,800	0.19 %
B20 Exterior Enclosure	\$215,648	4.68 %
B30 Roofing	\$243,888	5.30 %
C10 Interior Construction	\$900,789	19.56 %
C20 Interior Finishes	\$392,305	8.52 %
D20 Plumbing	\$703,508	15.28 %
D30 HVAC	\$1,058,926	22.99 %
D40 Fire Protection Systems	\$411,403	8.93 %
D50 Electrical Systems	\$670,022	14.55 %
Total	\$4,605,288	100 %

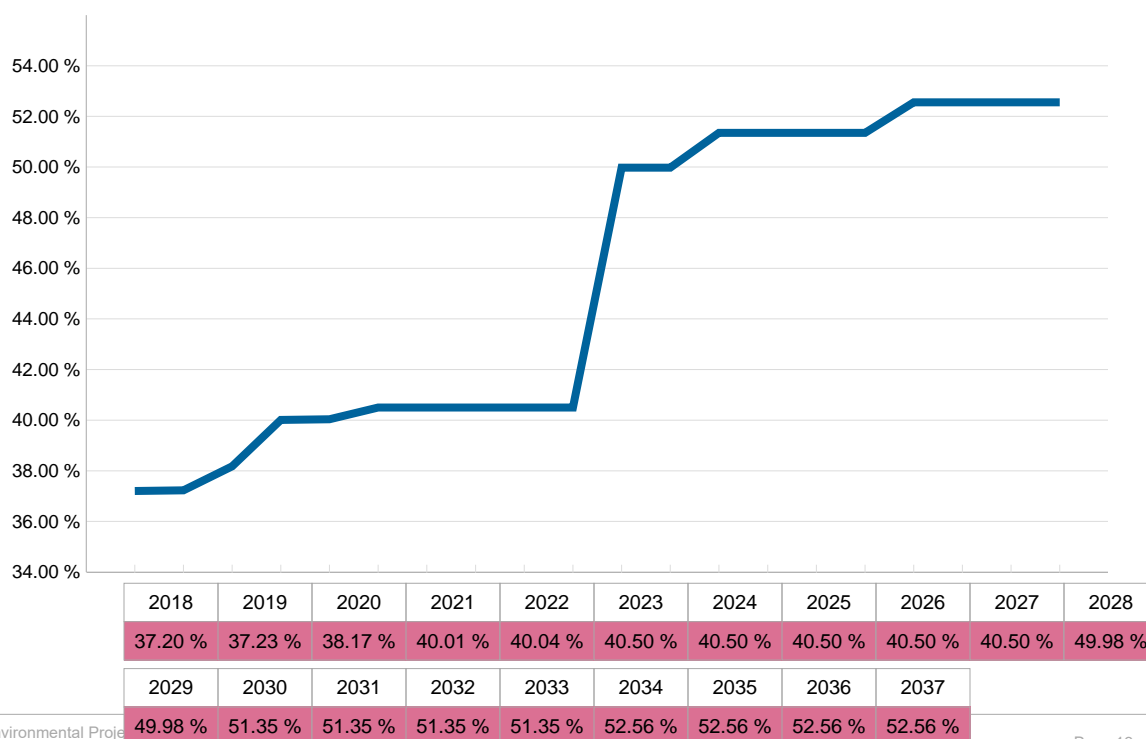
Cumulative Effects of FCI Over the Study Period

The Chart below indicates the cumulative effects of the FCI ratio over the study period assuming the required funds and expenditures are NOT provided to address the identified works and deferred maintenance each year.

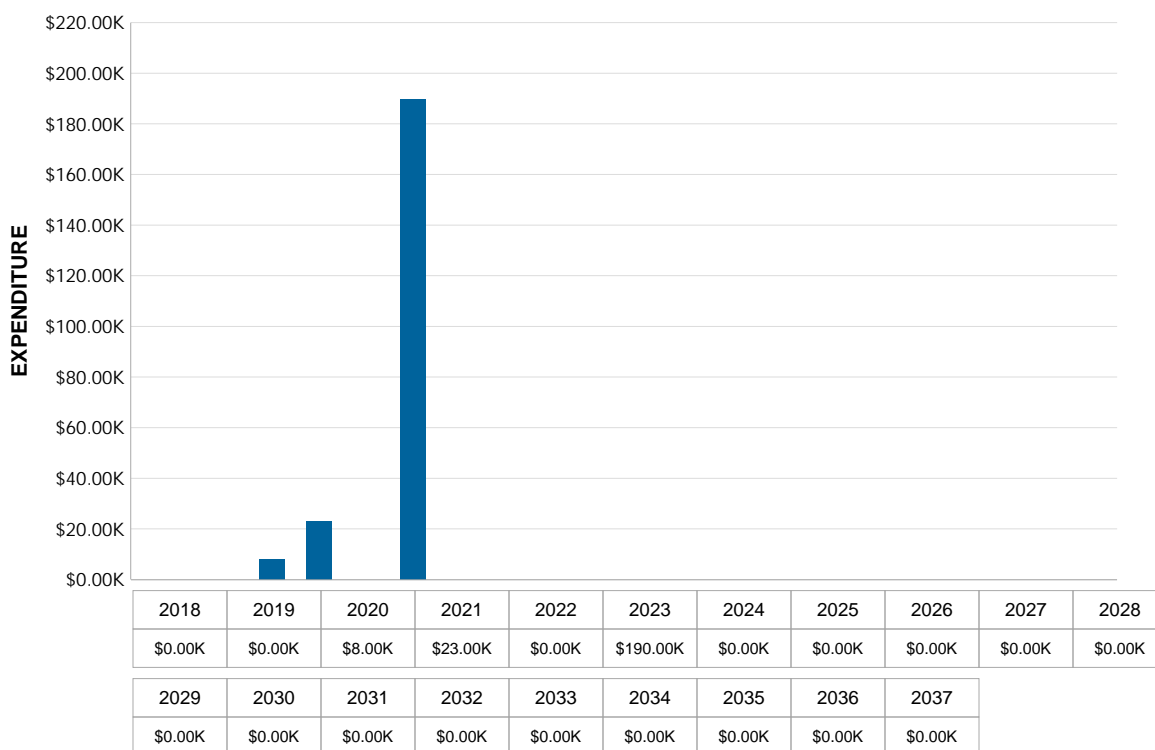
Expenditure Forecast Over Study Period

The building expenditure summary section provides an executive overview of the findings from the assessment. The chart below provides a summary of yearly anticipated expenditures over the study period for the Kingston Middle School Site building. In addition, we have scheduled key findings highlighting key items of greater than \$5,000 and their anticipated failure year. Further details of these expenditures are included within each respective report section and within the expenditure forecast, in Appendix A of this report. The results illustrate a total anticipated expenditure over the study period of approximately \$221,000.

- G Building Sitework: Selective repairs panel settlement and root damage and replace deteriorated joints at an estimated cost of \$8,000 in year 2020
- G Building Sitework: Weed/mulch and selective planting. Aerate/topdress/overseed turf areas. Repair failing irrigation. at an estimated cost of \$10,000 in year 2021
- G Building Sitework: Selective demolition and re-pave/grind and overlay. Seal coat. at an estimated cost of \$8,000 in year 2021
- G Building Sitework: Level/fill uneven areas and re-seed. at an estimated cost of \$5,000 in year 2021
- G Building Sitework: Grind & overlay major areas of parking & drop off lanes. at an estimated cost of \$140,000 in year 2023
- G Building Sitework: Remove and replace concrete. at an estimated cost of \$50,000 in year 2023

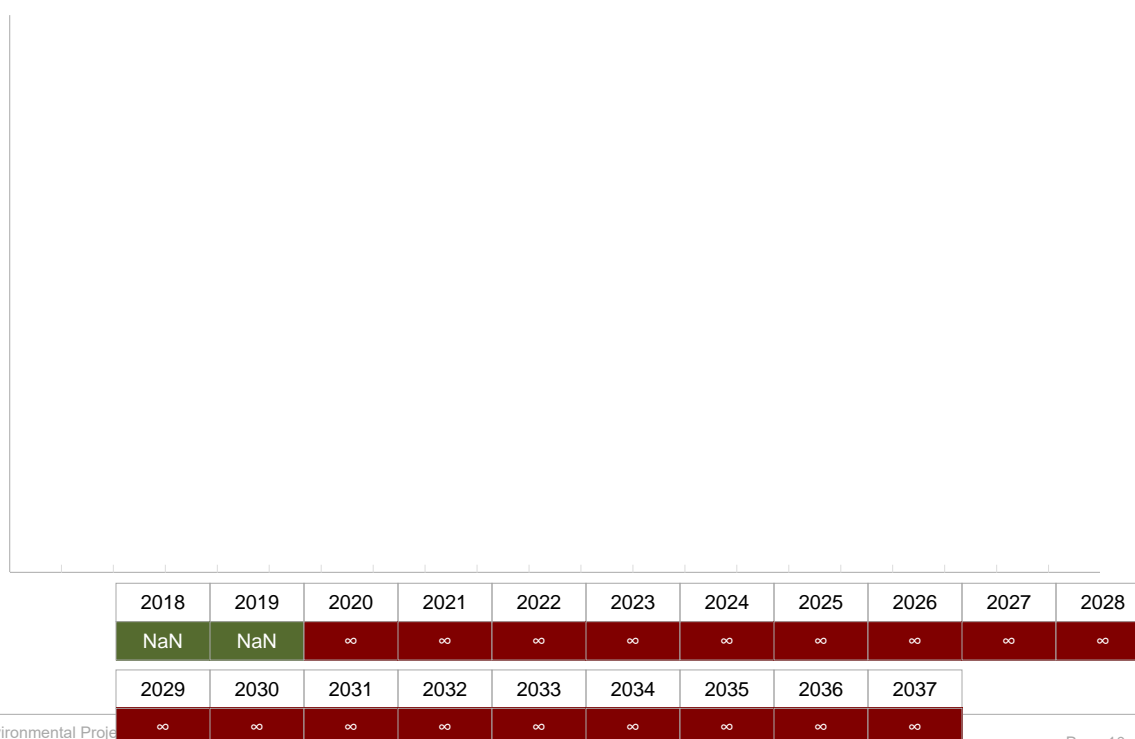
Cumulative Effects of FCI Over the Study Period

The Chart below indicates the cumulative effects of the FCI ratio over the study period assuming the required funds and expenditures are NOT provided to address the identified works and deferred maintenance each year.

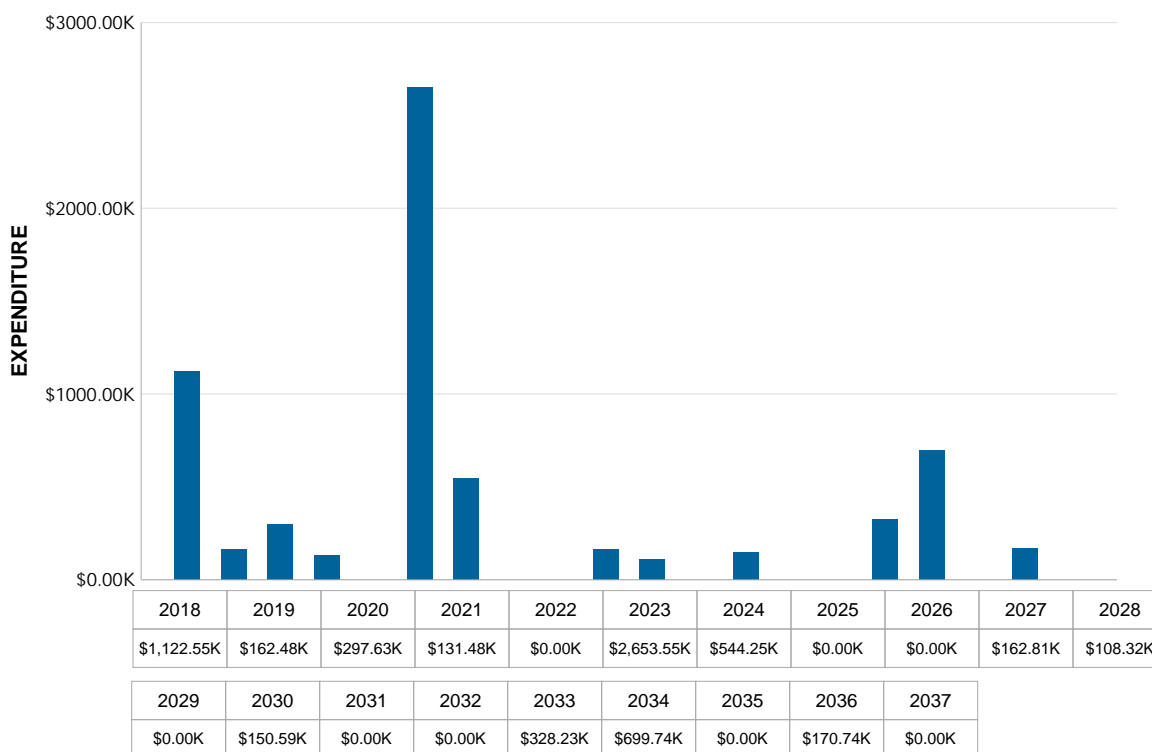
Expenditure Forecast Over Study Period

The building expenditure summary section provides an executive overview of the findings from the assessment. The chart below provides a summary of yearly anticipated expenditures over the study period for the Kingston Middle School Two-story Building building. In addition, we have scheduled key findings highlighting key items of greater than \$5,000 and their anticipated failure year. Further details of these expenditures are included within each respective report section and within the expenditure forecast, in Appendix A of this report. The results illustrate a total anticipated expenditure over the study period of approximately \$6,532,382.

- B Shell: Replace damaged gutters in approximately 5 locations. at an estimated cost of \$7,250 in year 2020
- B Shell: Replace Exterior Windows at an estimated cost of \$56,803 in year 2028

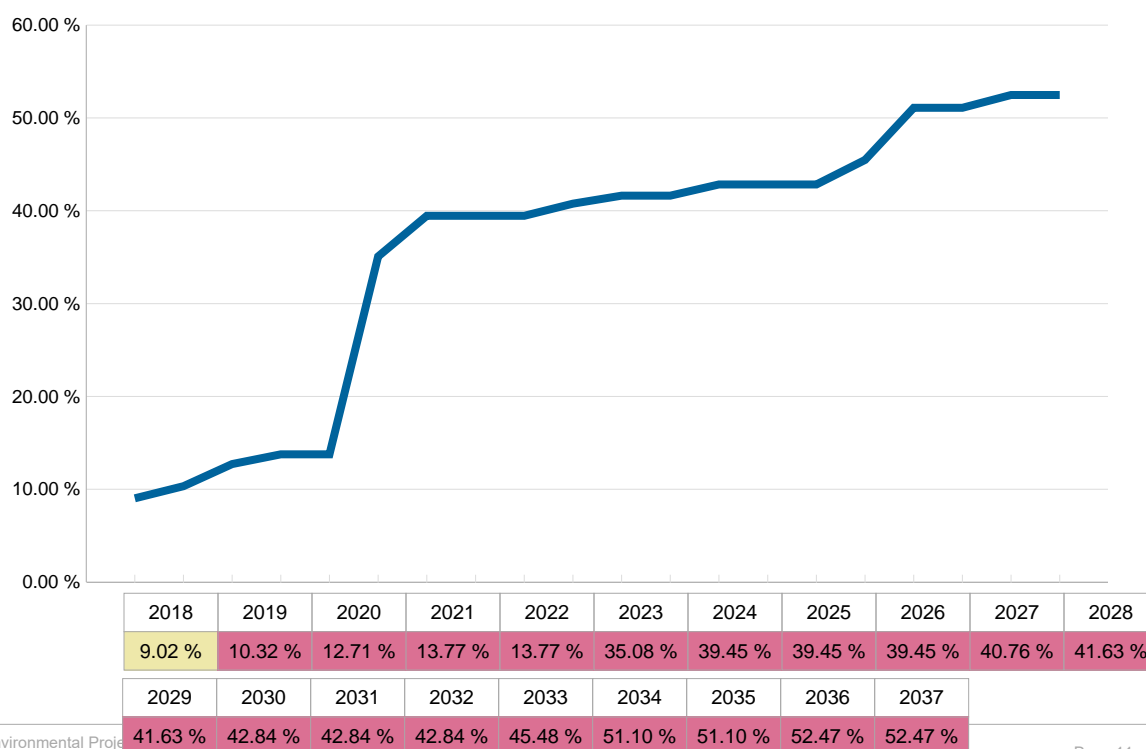
Cumulative Effects of FCI Over the Study Period

The Chart below indicates the cumulative effects of the FCI ratio over the study period assuming the required funds and expenditures are NOT provided to address the identified works and deferred maintenance each year.

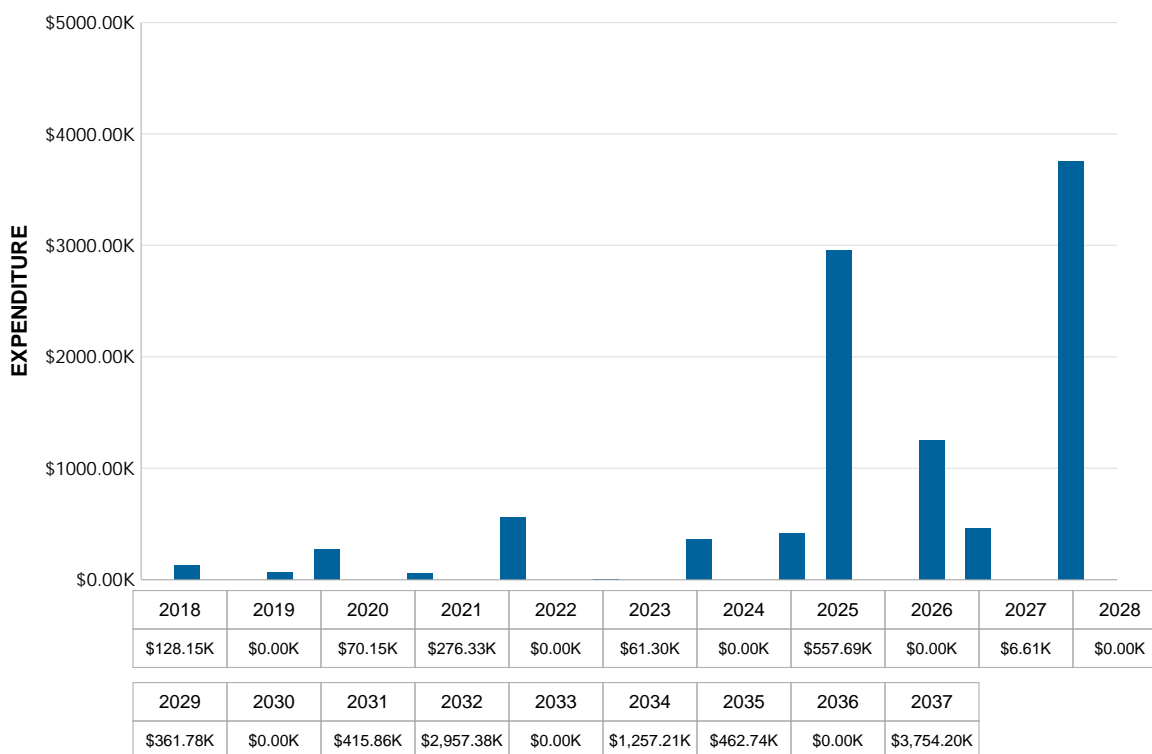
Expenditure Forecast Over Study Period

The building expenditure summary section provides an executive overview of the findings from the assessment. The chart below provides a summary of yearly anticipated expenditures over the study period for the Poulsbo Middle School Building 1 - Classrooms building. In addition, we have scheduled key findings highlighting key items of greater than \$5,000 and their anticipated failure year. Further details of these expenditures are included within each respective report section and within the expenditure forecast, in Appendix A of this report. The results illustrate a total anticipated expenditure over the study period of approximately \$10,309,389.

- A SubStructure: Level concrete and epoxy grout crack. at an estimated cost of \$7,040 in year 2021
- B Shell: Refinish stairs. at an estimated cost of \$16,827 in year 2021

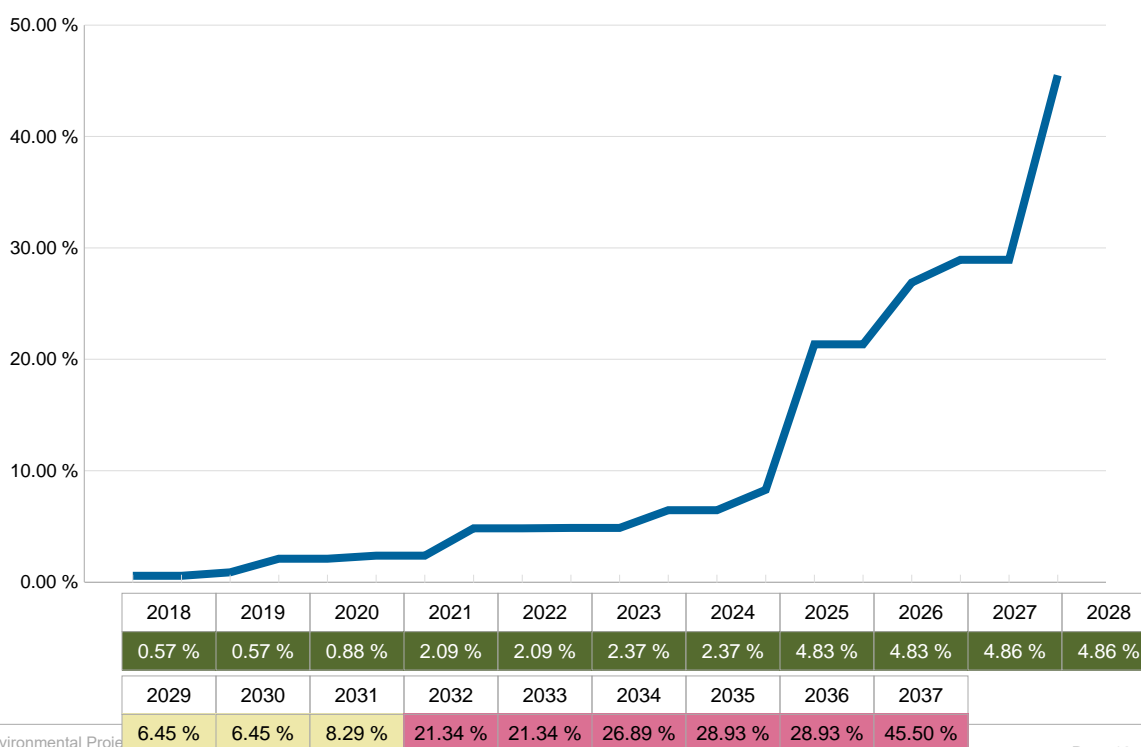
Cumulative Effects of FCI Over the Study Period

The Chart below indicates the cumulative effects of the FCI ratio over the study period assuming the required funds and expenditures are NOT provided to address the identified works and deferred maintenance each year.

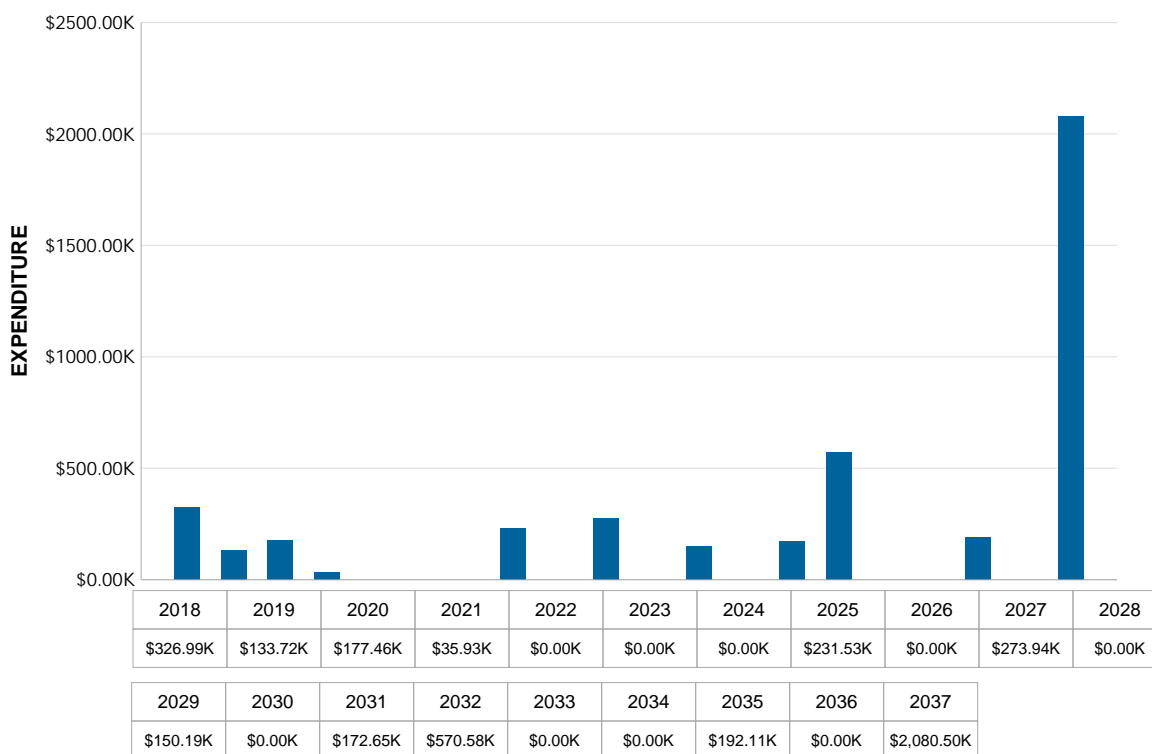
Expenditure Forecast Over Study Period

The building expenditure summary section provides an executive overview of the findings from the assessment. The chart below provides a summary of yearly anticipated expenditures over the study period for the Poulsbo Middle School Building 2 - Gym/Cafeteria building. In addition, we have scheduled key findings highlighting key items of greater than \$5,000 and their anticipated failure year. Further details of these expenditures are included within each respective report section and within the expenditure forecast, in Appendix A of this report. The results illustrate a total anticipated expenditure over the study period of approximately \$4,345,590.

- B Shell: Paint exterior walls. at an estimated cost of \$22,953 in year 2021
- B Shell: Paint exterior doors and grilles. at an estimated cost of \$12,973 in year 2021

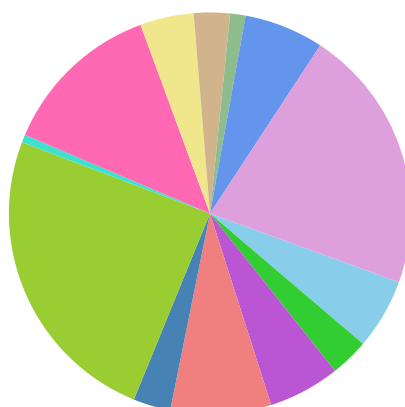
Distribution of Capital Needs by Building System

Building System	Estimated Cost	Percentage of Total Cost
B20 Exterior Enclosure	\$228,034	5.67 %
B30 Roofing	\$123,997	3.09 %
C10 Interior Construction	\$231,527	5.76 %
C20 Interior Finishes	\$325,584	8.10 %
D20 Plumbing	\$120,753	3.00 %
D30 HVAC	\$988,049	24.59 %
D40 Fire Protection Systems	\$24,949	0.62 %
D50 Electrical Systems	\$521,933	12.99 %
D60 Communication Systems	\$173,645	4.32 %
D70 Security Systems	\$116,512	2.90 %
D80 Automation Systems	\$49,898	1.24 %
E10 Equipment	\$256,975	6.39 %
E20 Furnishings	\$856,749	21.32 %
Total	\$4,018,604	100 %

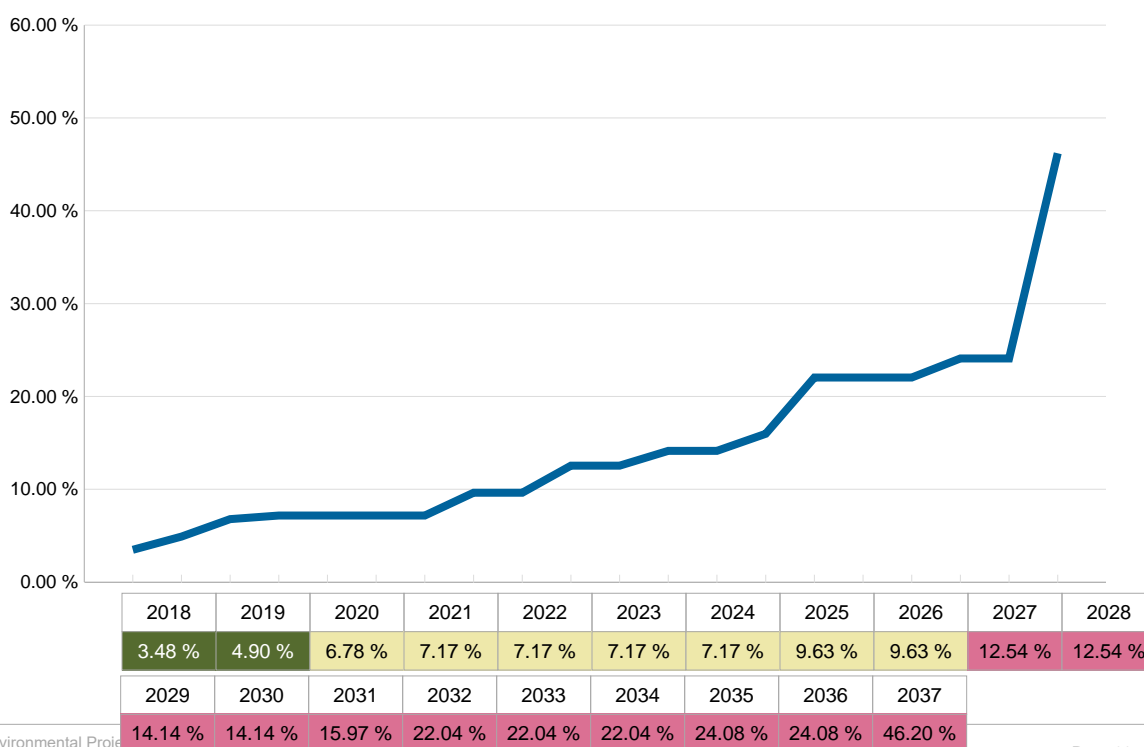
Cumulative Effects of FCI Over the Study Period

The Chart below indicates the cumulative effects of the FCI ratio over the study period assuming the required funds and expenditures are NOT provided to address the identified works and deferred maintenance each year.

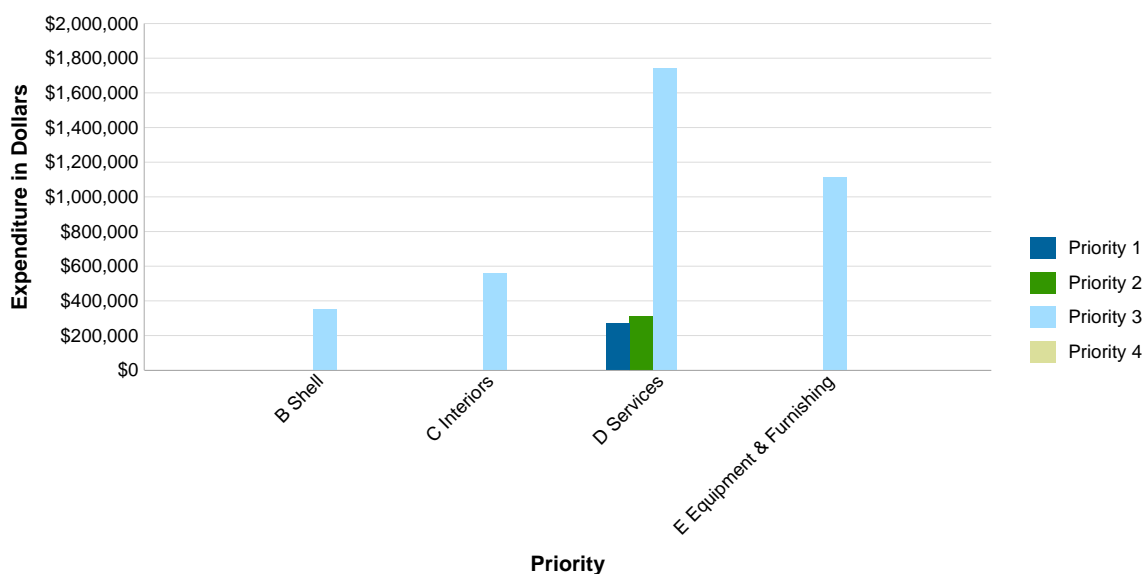
Planning Horizon Needs by System and Priority

The chart below illustrates the breakdown of expenditure according the priority coding providing an opportunity to strategically plan and effectively direct funding to the highest priority.

Building System	Priority 1	Priority 2	Priority 3	Priority 4	Total
B Shell	\$0	\$0	\$352,030	\$0	\$352,030
C Interiors	\$0	\$0	\$557,111	\$0	\$557,111
D Services	\$268,202	\$312,383	\$1,742,141	\$0	\$2,322,725
E Equipment & Furnishing	\$0	\$0	\$1,113,723	\$0	\$1,113,723
Total	\$268,202	\$312,383	\$3,765,006	\$0	\$4,345,590

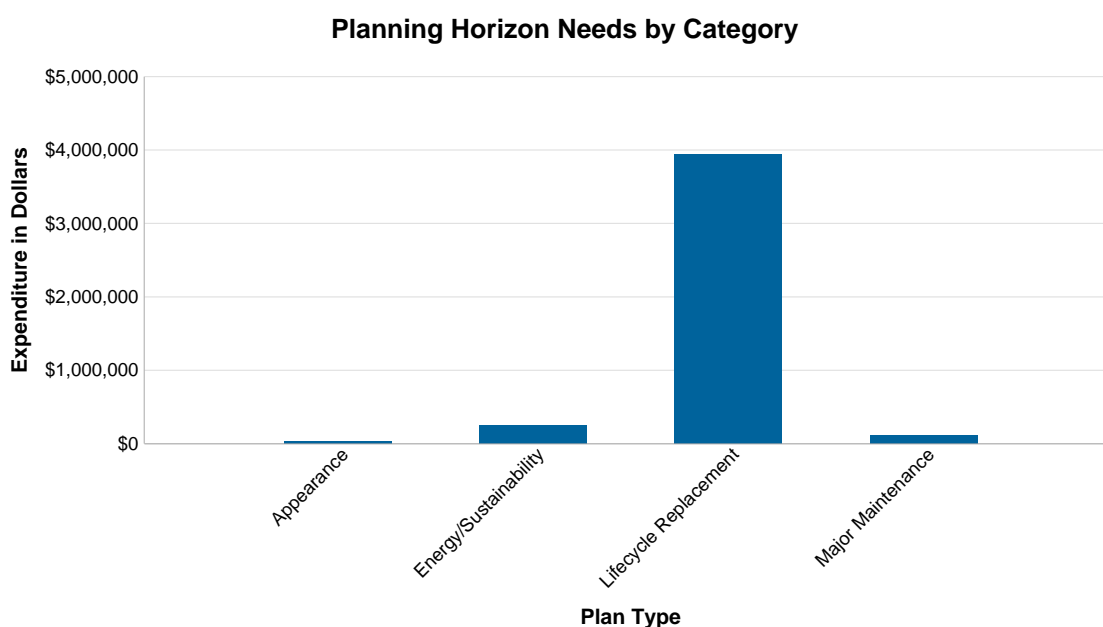
The chart below illustrates the breakdown of expenditure according to the Plan Type or deficiency categories providing an opportunity to strategically plan and effectively direct funding.

Building System	Total Cost
Appearance	\$35,927
Energy/Sustainability	\$249,967
Lifecycle Replacement	\$3,939,697
Major Maintenance	\$120,000
Total	\$4,345,590

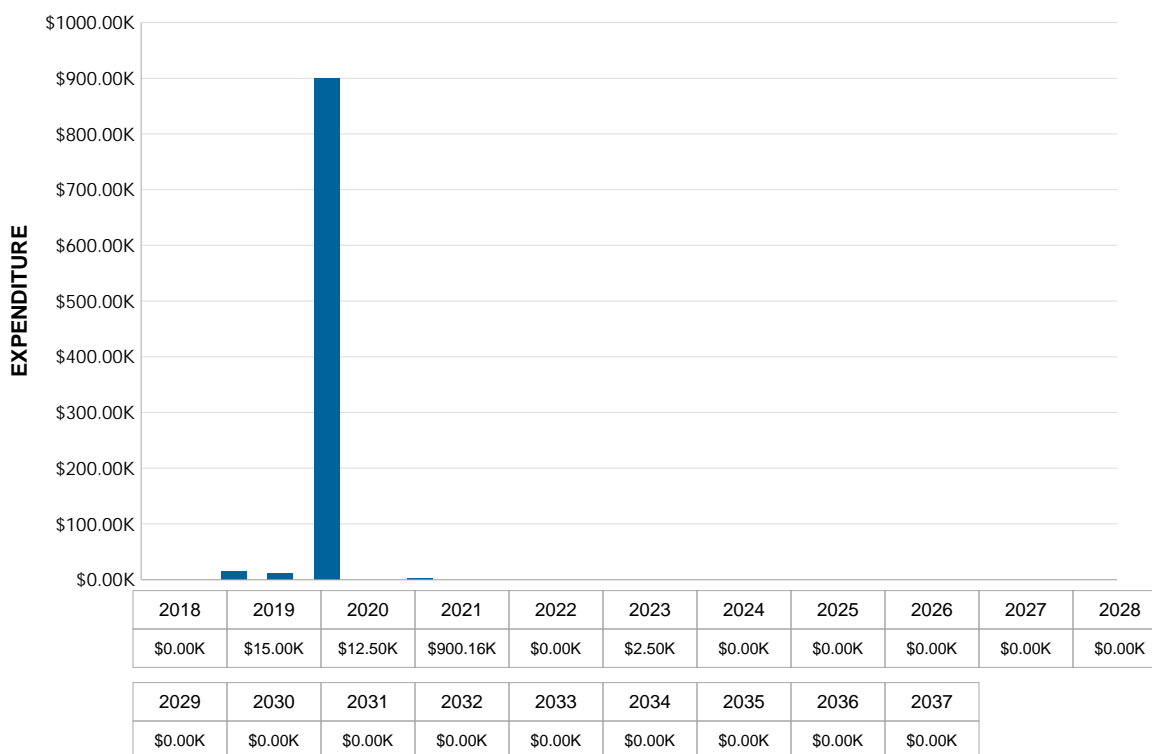
Expenditure Forecast Over Study Period

The building expenditure summary section provides an executive overview of the findings from the assessment. The chart below provides a summary of yearly anticipated expenditures over the study period for the Poulsbo Middle School Site building. In addition, we have scheduled key findings highlighting key items of greater than \$5,000 and their anticipated failure year. Further details of these expenditures are included within each respective report section and within the expenditure forecast, in Appendix A of this report. The results illustrate a total anticipated expenditure over the study period of approximately \$930,160.
