Facilities Condition Assessment Report

I. FCA Executive Summary

North Kitsap School District

Breidablik Elementary School Main
25142 Waghorn Rd NW
Poulsbo, WA

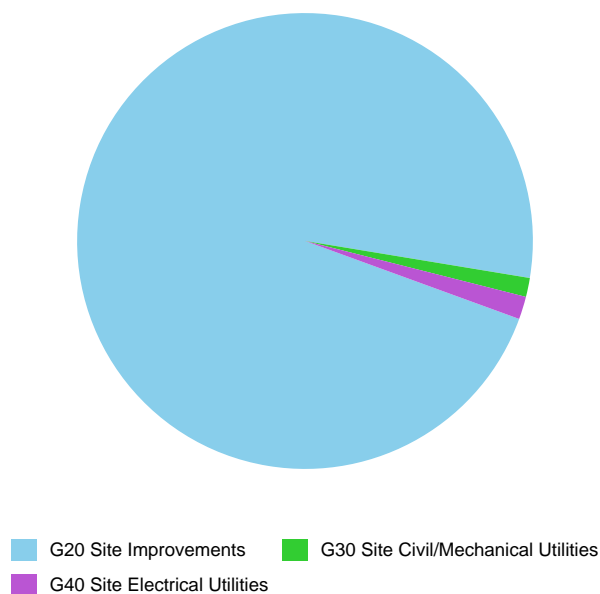
Distribution of Capital Needs by Building System

Building System	Estimated Cost	Percentage of Total Cost
G20 Site Improvements	\$902,660	97.04 %
G30 Site Civil/Mechanical Utilities	\$12,500	1.34 %
G40 Site Electrical Utilities	\$15,000	1.61 %
Total	\$930,160	100 %

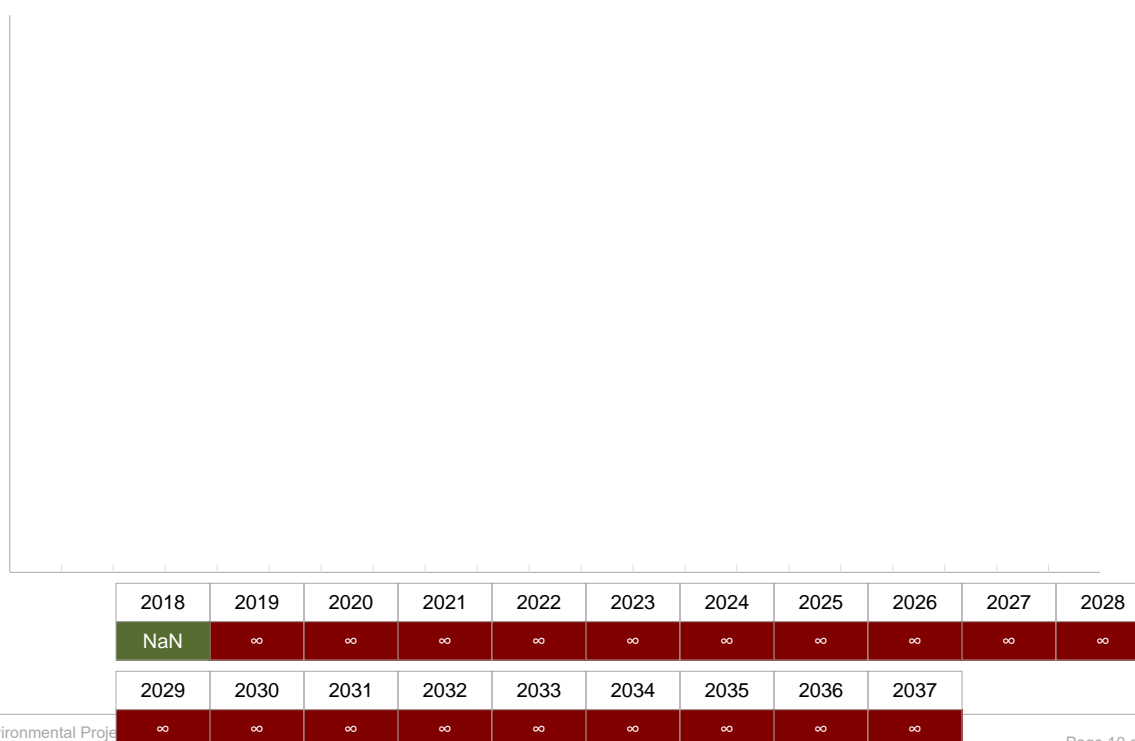
Cumulative Effects of FCI Over the Study Period

The Chart below indicates the cumulative effects of the FCI ratio over the study period assuming the required funds and expenditures are NOT provided to address the identified works and deferred maintenance each year.

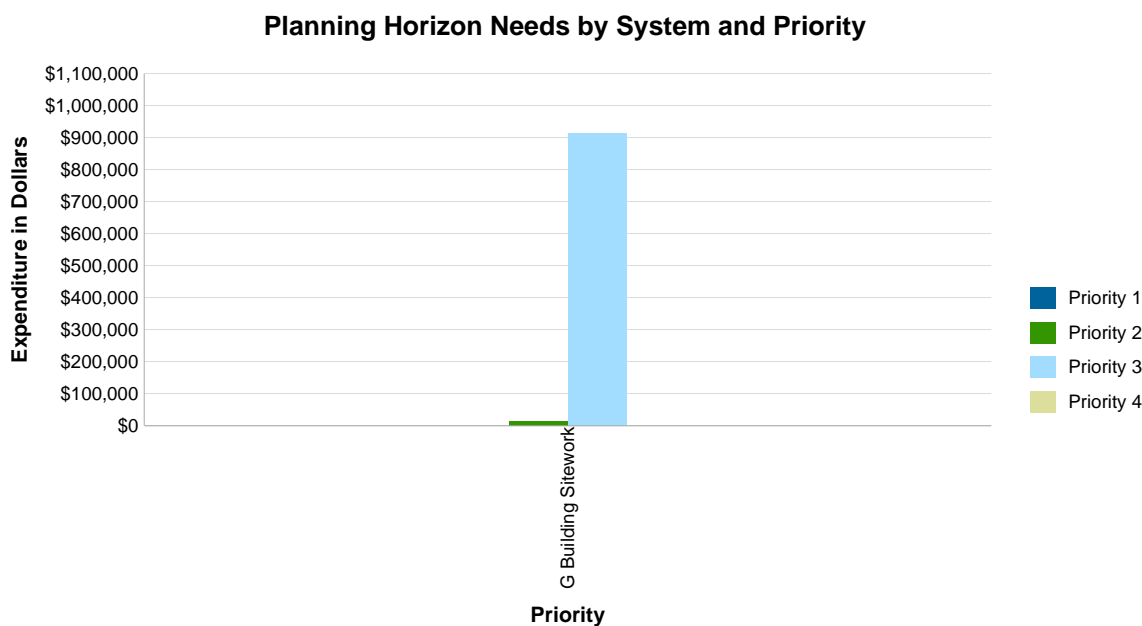
The chart below illustrates the breakdown of expenditure according the priority coding providing an opportunity to strategically plan and effectively direct funding to the highest priority.

Building System	Priority 1	Priority 2	Priority 3	Priority 4	Total
G Building Sitework	\$0	\$15,000	\$915,160	\$0	\$930,160
Total	\$0	\$15,000	\$915,160	\$0	\$930,160

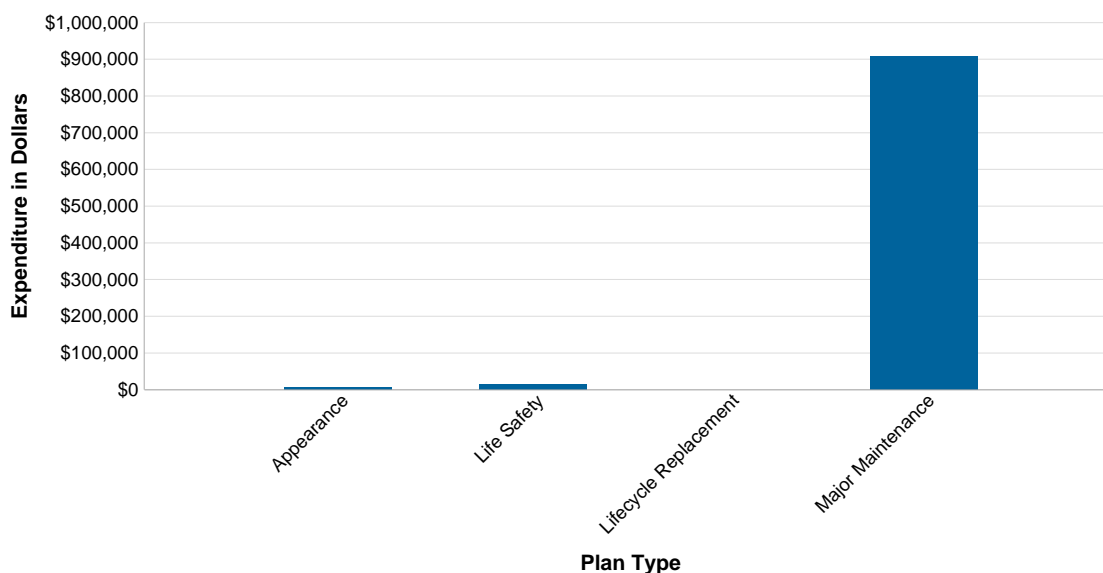
Planning Horizon Needs by Category

The chart below illustrates the breakdown of expenditure according to the Plan Type or deficiency categories providing an opportunity to strategically plan and effectively direct funding.

Building System	Total Cost
Appearance	\$7,500
Life Safety	\$15,000
Lifecycle Replacement	\$0
Major Maintenance	\$907,660
Total	\$930,160

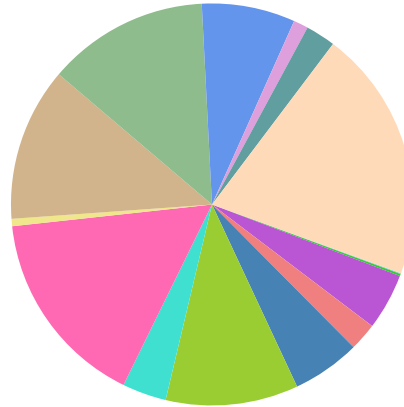
Distribution of Capital Needs by Building System

Building System	Estimated Cost	Percentage of Total Cost
A40 Slabs on Grade	\$7,040	0.07 %
B10 SuperStructure	\$16,827	0.17 %
B20 Exterior Enclosure	\$462,739	4.55 %
B30 Roofing	\$227,276	2.23 %
C10 Interior Construction	\$557,691	5.48 %
C20 Interior Finishes	\$1,085,935	10.67 %
D20 Plumbing	\$361,013	3.55 %
D30 HVAC	\$1,630,404	16.01 %
D40 Fire Protection Systems	\$60,096	0.59 %
D50 Electrical Systems	\$1,257,208	12.35 %
D60 Communication Systems	\$1,321,511	12.98 %
D70 Security Systems	\$765,022	7.51 %
D80 Automation Systems	\$120,192	1.18 %
E10 Equipment	\$244,591	2.40 %

E20 Furnishings	\$2,063,697	20.27 %
Total	\$10,181,242	100 %

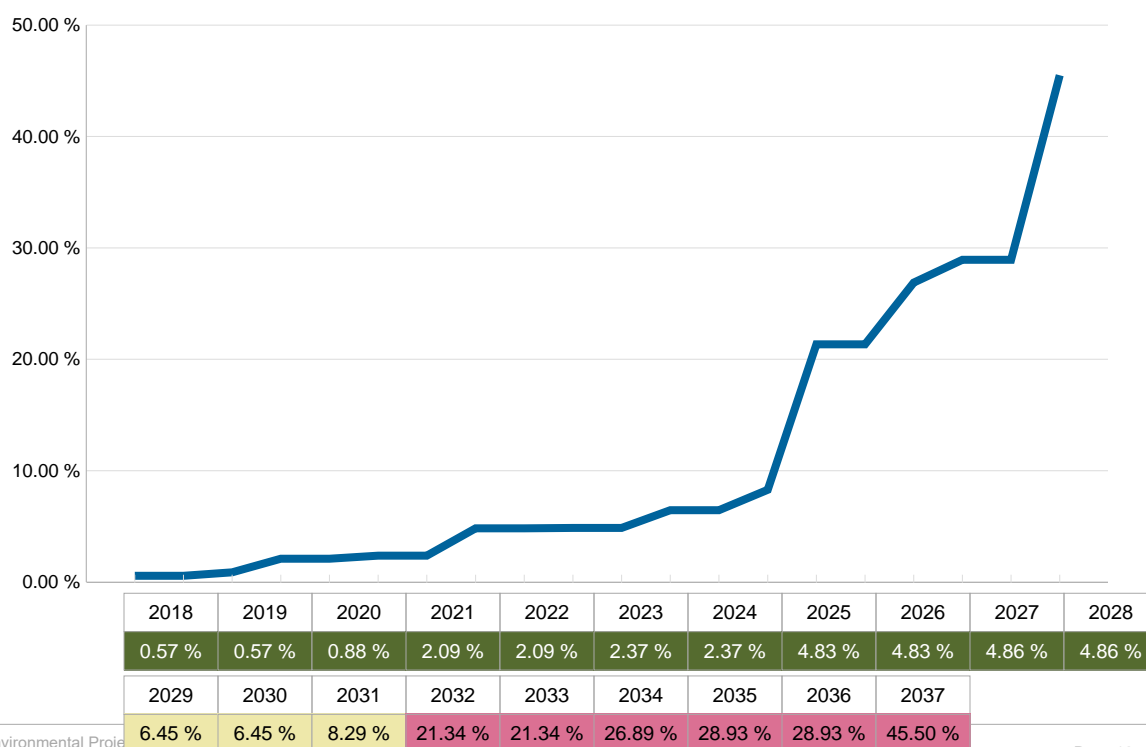
Cumulative Effects of FCI Over the Study Period

The Chart below indicates the cumulative effects of the FCI ratio over the study period assuming the required funds and expenditures are NOT provided to address the identified works and deferred maintenance each year.

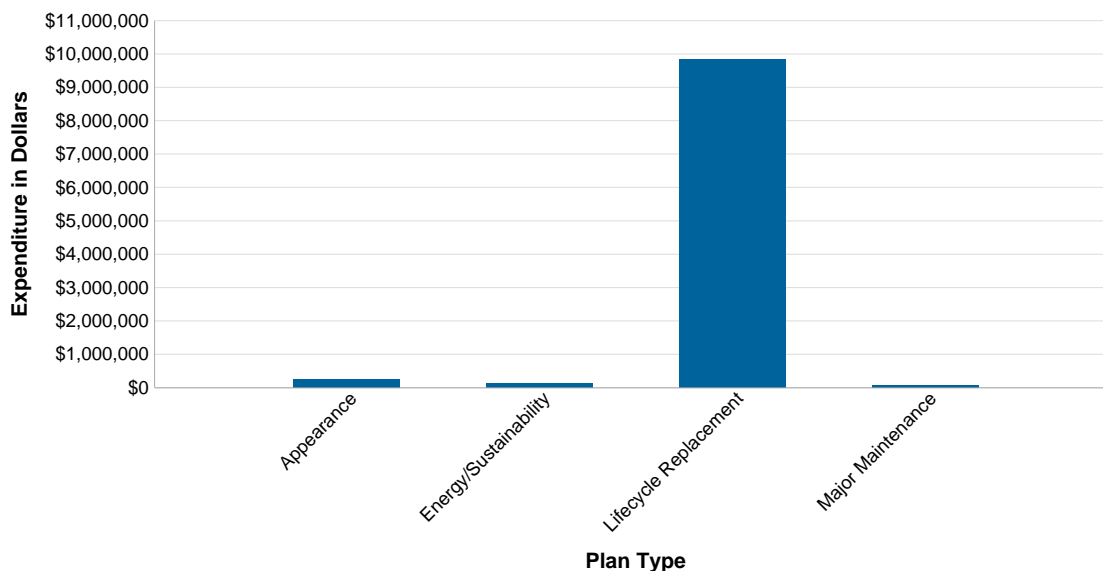
Planning Horizon Needs by Category

The chart below illustrates the breakdown of expenditure according to the Plan Type or deficiency categories providing an opportunity to strategically plan and effectively direct funding.

Building System	Total Cost
Appearance	\$264,251
Energy/Sustainability	\$135,761
Lifecycle Replacement	\$9,834,768
Major Maintenance	\$74,609
Total	\$10,309,389

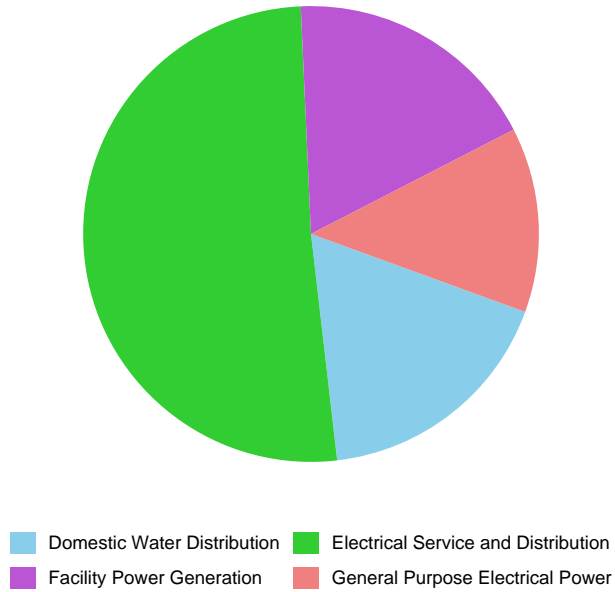
Distribution of Immediate Needs by Building System

Building System	Estimated Cost	Percentage of Total Cost
Domestic Water Distribution	\$57,584	17.61 %
Electrical Service and Distribution	\$167,158	51.12 %
Facility Power Generation	\$59,331	18.14 %
General Purpose Electrical Power	\$42,912	13.12 %
Total	\$326,986	100 %

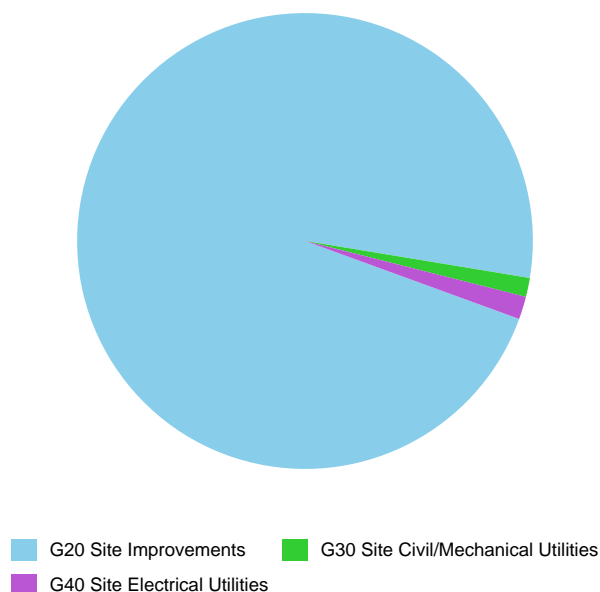
Distribution of Capital Needs by Building System

Building System	Estimated Cost	Percentage of Total Cost
G20 Site Improvements	\$902,660	97.04 %
G30 Site Civil/Mechanical Utilities	\$12,500	1.34 %
G40 Site Electrical Utilities	\$15,000	1.61 %
Total	\$930,160	100 %

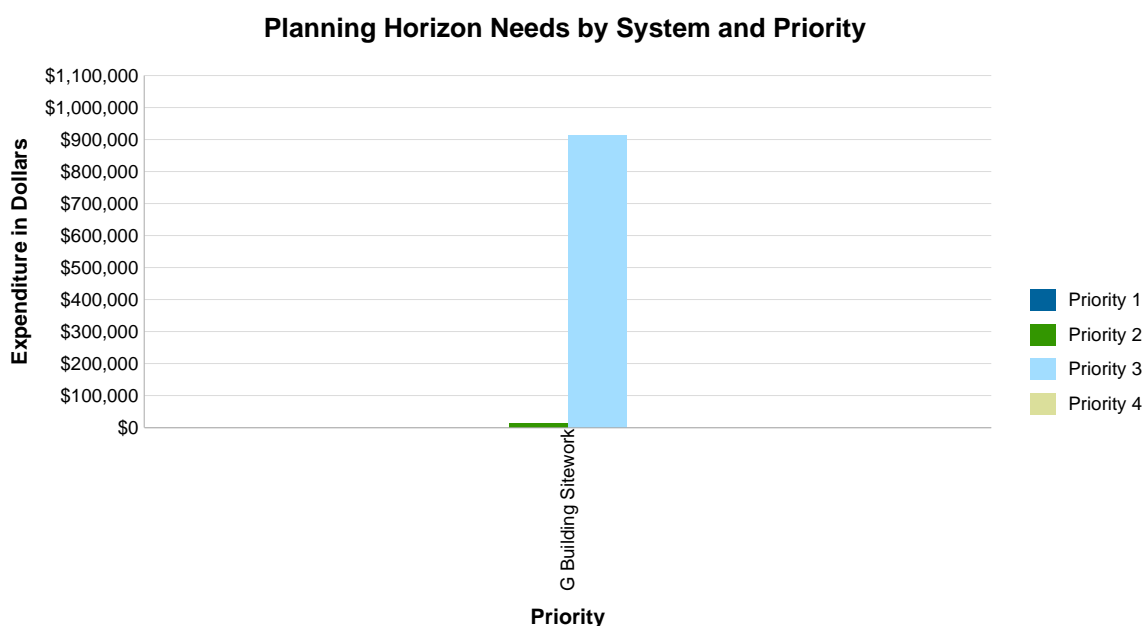
The chart below illustrates the breakdown of expenditure according the priority coding providing an opportunity to strategically plan and effectively direct funding to the highest priority.

Building System	Priority 1	Priority 2	Priority 3	Priority 4	Total
G Building Sitework	\$0	\$15,000	\$915,160	\$0	\$930,160
Total	\$0	\$15,000	\$915,160	\$0	\$930,160

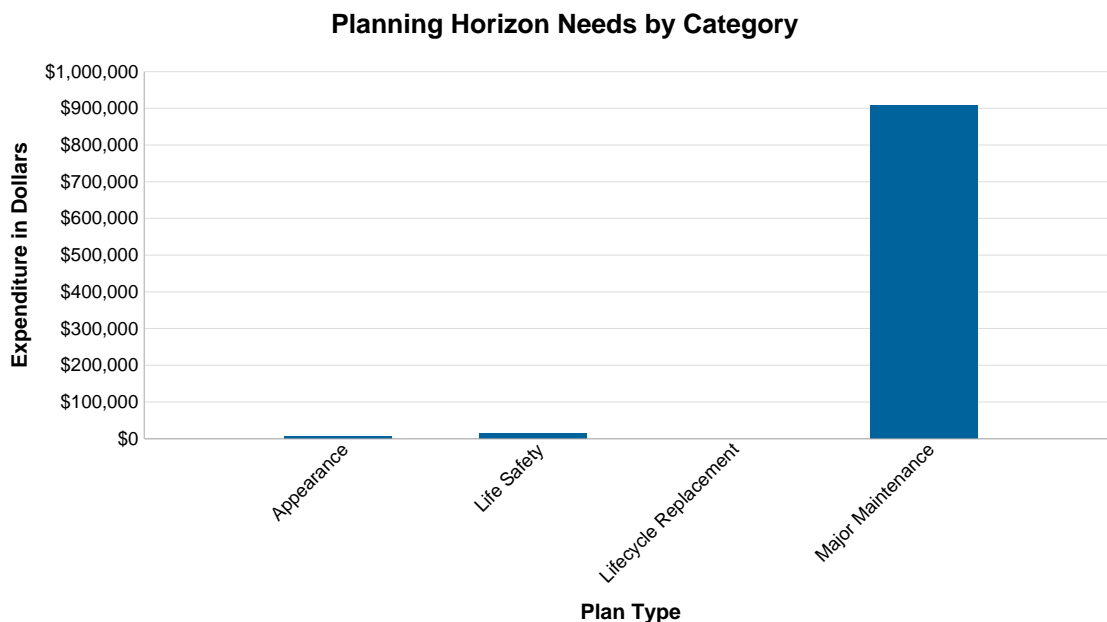
The chart below illustrates the breakdown of expenditure according to the Plan Type or deficiency categories providing an opportunity to strategically plan and effectively direct funding.

Building System	Total Cost
Appearance	\$7,500
Life Safety	\$15,000
Lifecycle Replacement	\$0
Major Maintenance	\$907,660
Total	\$930,160

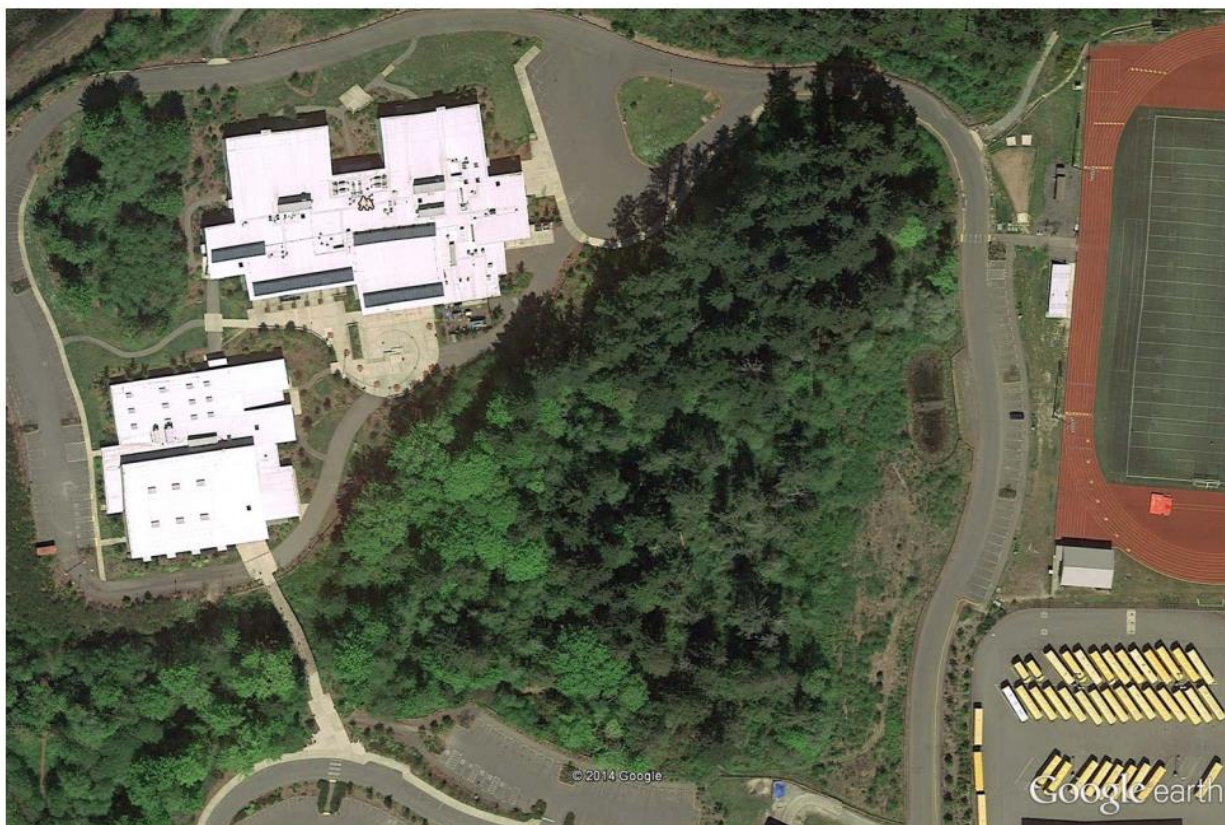
Site plan

Building	2018-2023 FCI	Original Construction	Year Mod/Add	GSF
North	0.02	2007	N/A	81,124
South	0.02	2007	N/A	31,087

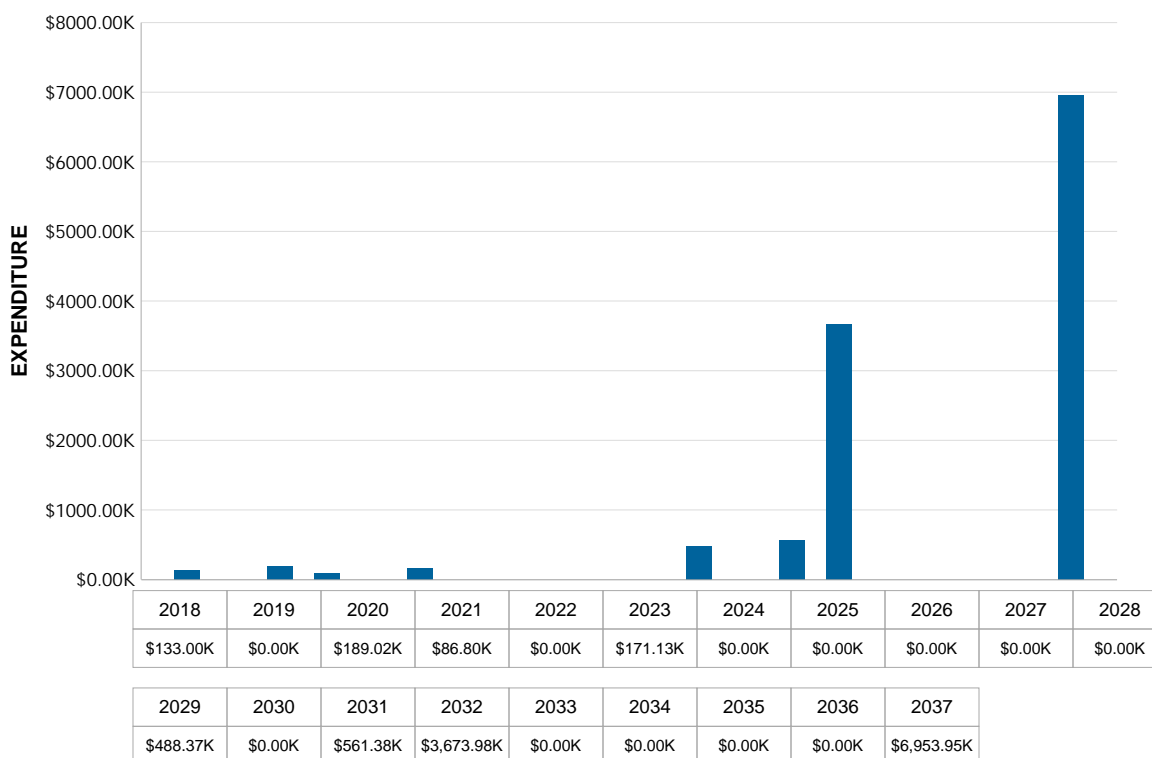
Expenditure Forecast Over Study Period

The building expenditure summary section provides an executive overview of the findings from the assessment. The chart below provides a summary of yearly anticipated expenditures over the study period for the Kingston High School North Building building. In addition, we have scheduled key findings highlighting key items of greater than \$5,000 and their anticipated failure year. Further details of these expenditures are included within each respective report section and within the expenditure forecast, in Appendix A of this report. The results illustrate a total anticipated expenditure over the study period of approximately \$12,257,621.

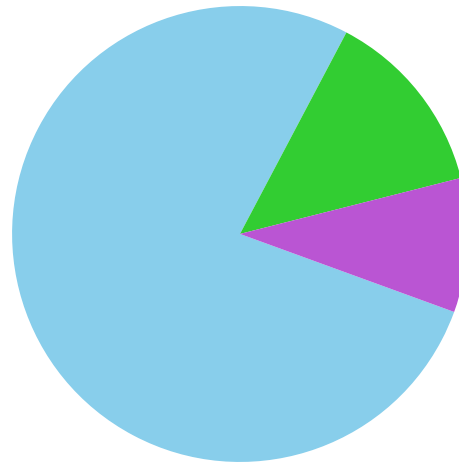
Distribution of Immediate Needs by Building System

■ Heating Systems
 ■ Roof Appurtenances
■ Roof Coverings

Building System	Estimated Cost	Percentage of Total Cost
Heating Systems	\$102,643	77.18 %
Roof Appurtenances	\$17,700	13.31 %
Roof Coverings	\$12,653	9.51 %
Total	\$132,996	100 %

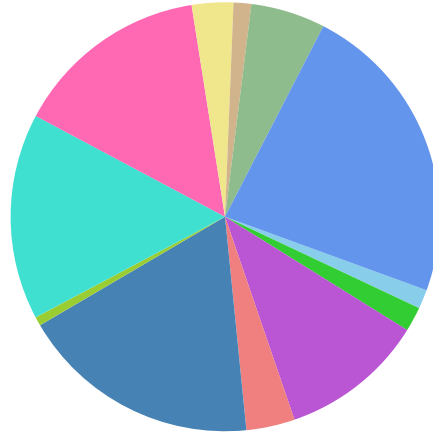
Distribution of Capital Needs by Building System

Building System	Estimated Cost	Percentage of Total Cost
B20 Exterior Enclosure	\$175,184	1.44 %
B30 Roofing	\$224,589	1.85 %
C20 Interior Finishes	\$1,321,510	10.90 %
D20 Plumbing	\$443,748	3.66 %
D30 HVAC	\$2,200,894	18.15 %
D40 Fire Protection Systems	\$81,124	0.67 %
D50 Electrical Systems	\$1,886,133	15.56 %
D60 Communication Systems	\$1,783,917	14.71 %
D70 Security Systems	\$378,849	3.12 %
D80 Automation Systems	\$162,248	1.34 %
E10 Equipment	\$680,630	5.61 %
E20 Furnishings	\$2,785,798	22.98 %
Total	\$12,124,625	100 %

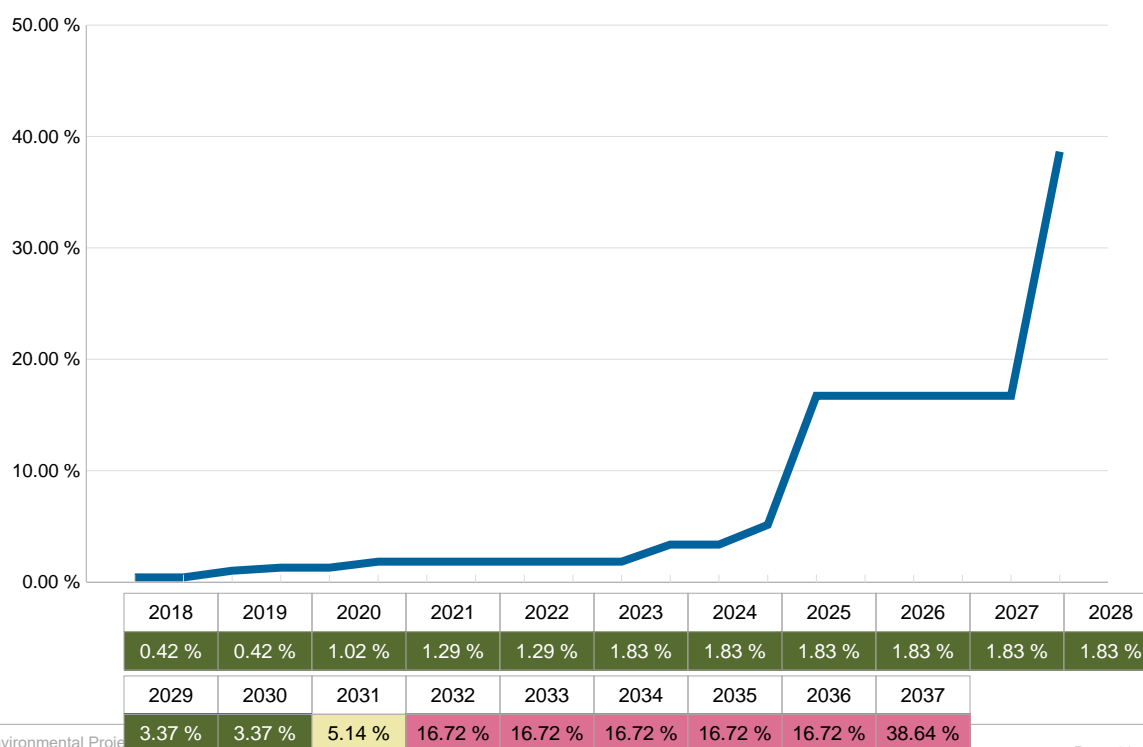
Cumulative Effects of FCI Over the Study Period

The Chart below indicates the cumulative effects of the FCI ratio over the study period assuming the required funds and expenditures are NOT provided to address the identified works and deferred maintenance each year.

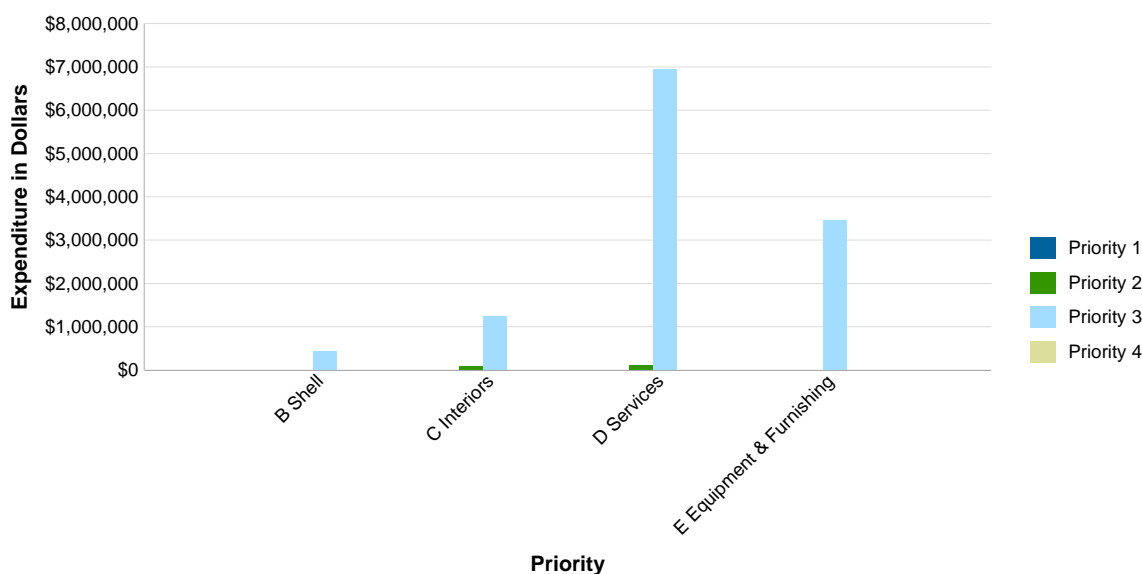
Planning Horizon Needs by System and Priority

The chart below illustrates the breakdown of expenditure according the priority coding providing an opportunity to strategically plan and effectively direct funding to the highest priority.

Building System	Priority 1	Priority 2	Priority 3	Priority 4	Total
B Shell	\$0	\$0	\$430,126	\$0	\$430,126
C Interiors	\$0	\$82,746	\$1,238,763	\$0	\$1,321,510
D Services	\$0	\$102,643	\$6,936,913	\$0	\$7,039,556
E Equipment & Furnishing	\$0	\$0	\$3,466,429	\$0	\$3,466,429
Total	\$0	\$185,389	\$12,072,232	\$0	\$12,257,621

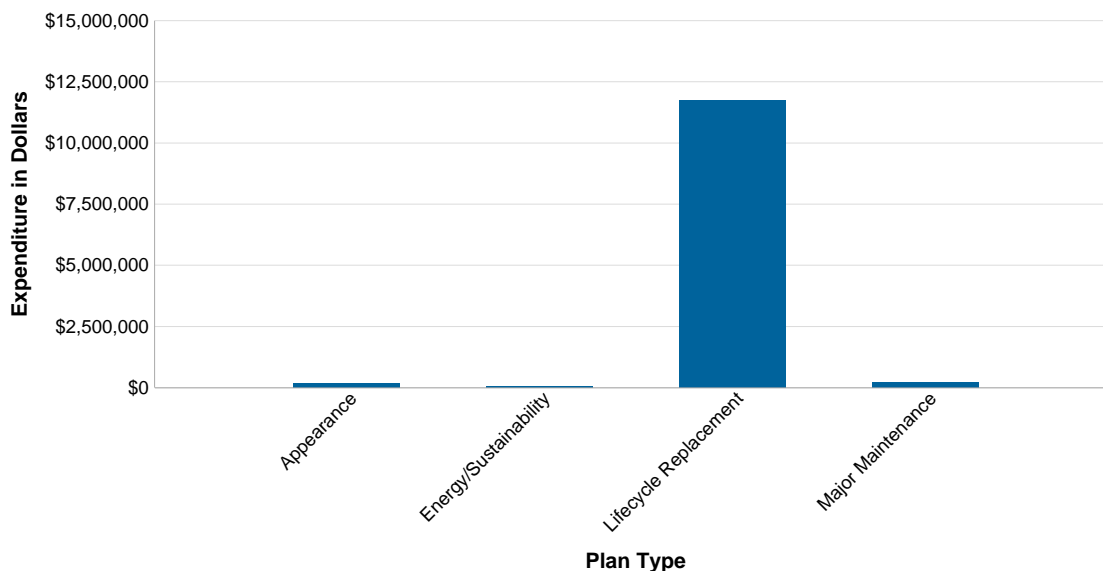
Planning Horizon Needs by Category

The chart below illustrates the breakdown of expenditure according to the Plan Type or deficiency categories providing an opportunity to strategically plan and effectively direct funding.

Building System	Total Cost
Appearance	\$189,019
Energy/Sustainability	\$62,643
Lifecycle Replacement	\$11,760,422
Major Maintenance	\$245,537
Total	\$12,257,621

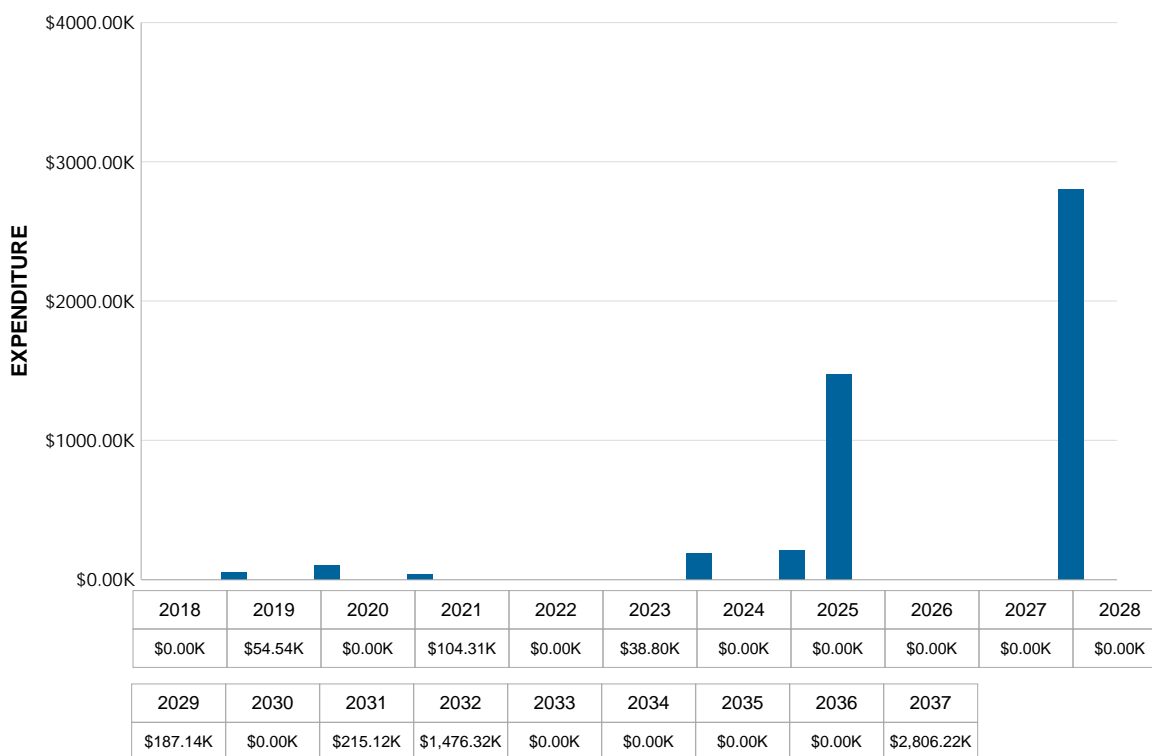
Expenditure Forecast Over Study Period

The building expenditure summary section provides an executive overview of the findings from the assessment. The chart below provides a summary of yearly anticipated expenditures over the study period for the Kingston High School South Building building. In addition, we have scheduled key findings highlighting key items of greater than \$5,000 and their anticipated failure year. Further details of these expenditures are included within each respective report section and within the expenditure forecast, in Appendix A of this report. The results illustrate a total anticipated expenditure over the study period of approximately \$4,882,452.

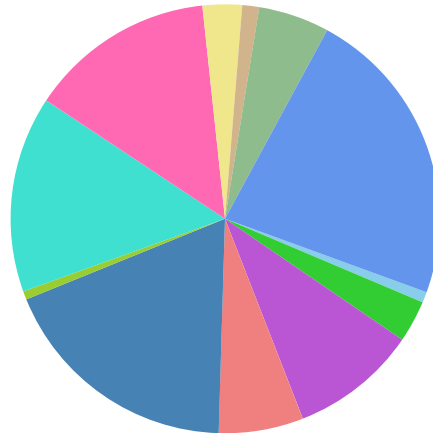
Distribution of Capital Needs by Building System

Building System	Estimated Cost	Percentage of Total Cost
B20 Exterior Enclosure	\$39,656	0.81 %
B30 Roofing	\$154,502	3.16 %
C20 Interior Finishes	\$466,916	9.56 %
D20 Plumbing	\$311,492	6.38 %
D30 HVAC	\$897,926	18.39 %
D40 Fire Protection Systems	\$31,087	0.64 %
D50 Electrical Systems	\$722,773	14.80 %
D60 Communication Systems	\$683,603	14.00 %
D70 Security Systems	\$145,176	2.97 %
D80 Automation Systems	\$62,174	1.27 %
E10 Equipment	\$260,820	5.34 %
E20 Furnishings	\$1,106,328	22.66 %
Total	\$4,882,452	100 %

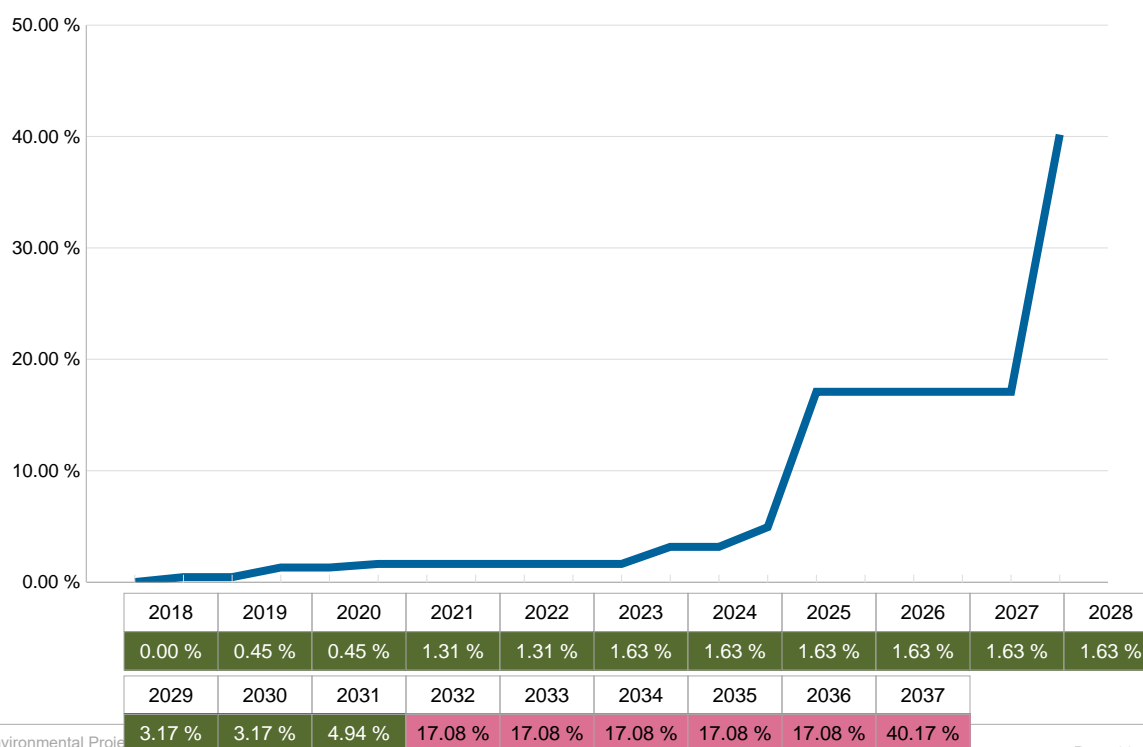
Cumulative Effects of FCI Over the Study Period

The Chart below indicates the cumulative effects of the FCI ratio over the study period assuming the required funds and expenditures are NOT provided to address the identified works and deferred maintenance each year.

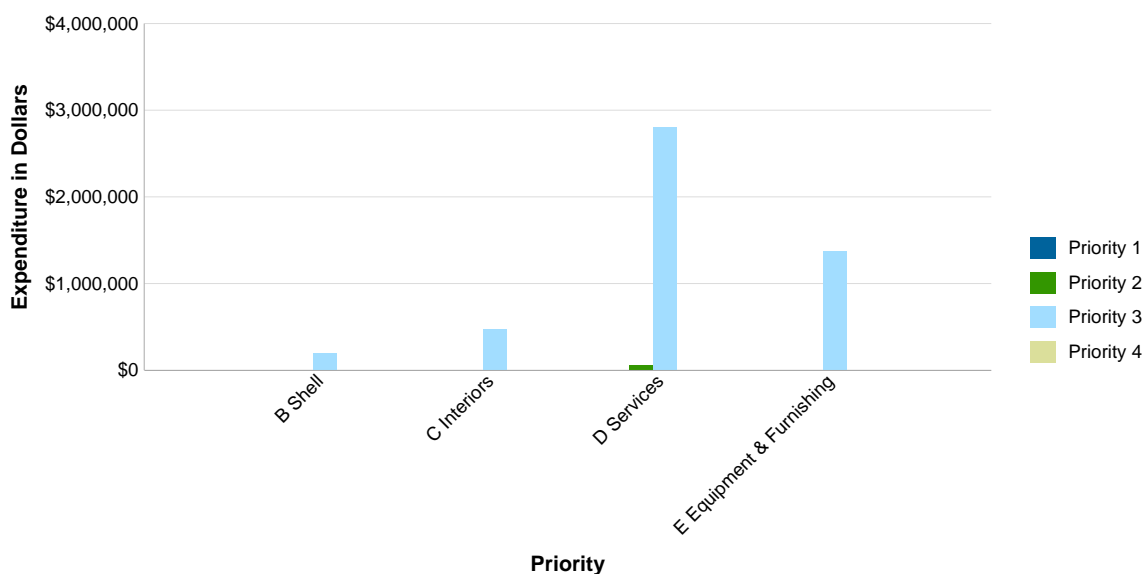
Planning Horizon Needs by System and Priority

The chart below illustrates the breakdown of expenditure according the priority coding providing an opportunity to strategically plan and effectively direct funding to the highest priority.

Building System	Priority 1	Priority 2	Priority 3	Priority 4	Total
B Shell	\$0	\$0	\$194,159	\$0	\$194,159
C Interiors	\$0	\$0	\$466,916	\$0	\$466,916
D Services	\$0	\$54,535	\$2,799,695	\$0	\$2,854,230
E Equipment & Furnishing	\$0	\$0	\$1,367,148	\$0	\$1,367,148
Total	\$0	\$54,535	\$4,827,917	\$0	\$4,882,452

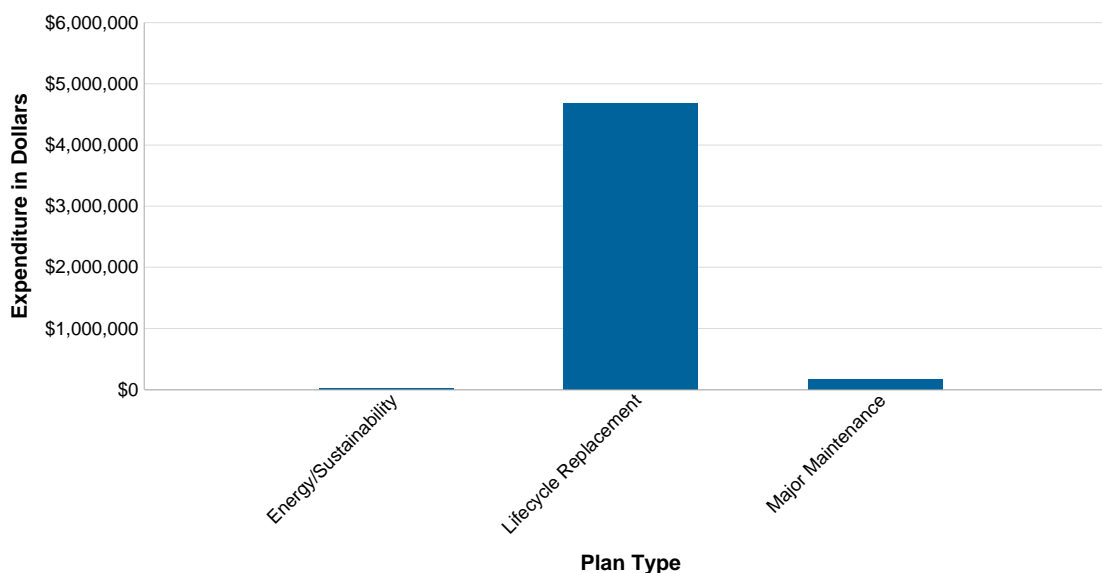
Planning Horizon Needs by Category

The chart below illustrates the breakdown of expenditure according to the Plan Type or deficiency categories providing an opportunity to strategically plan and effectively direct funding.

Building System	Total Cost
Energy/Sustainability	\$24,785
Lifecycle Replacement	\$4,684,811
Major Maintenance	\$172,856
Total	\$4,882,452

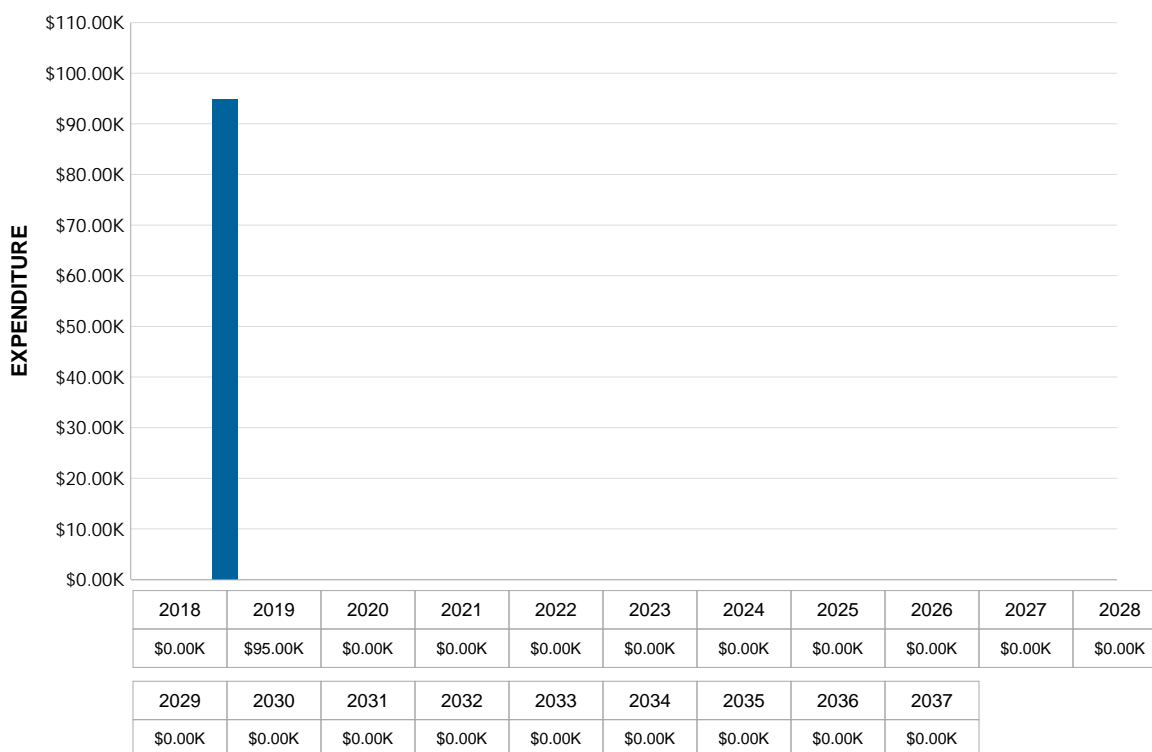
Expenditure Forecast Over Study Period

The building expenditure summary section provides an executive overview of the findings from the assessment. The chart below provides a summary of yearly anticipated expenditures over the study period for the Kingston High School Site building. In addition, we have scheduled key findings highlighting key items of greater than \$5,000 and their anticipated failure year. Further details of these expenditures are included within each respective report section and within the expenditure forecast, in Appendix A of this report. The results illustrate a total anticipated expenditure over the study period of approximately \$95,000.

- G Building Sitework: Import topsoil/mulch (approximately 2,000 CY) and selective planting. at an estimated cost of \$95,000 in year 2019
1. All costs presented in present day values
 2. Costs represent total anticipated values over the 10 year study period
 3. Budget for additional project costs of between 25% - 30% to allow for professional fees and general contractor overhead/profit and management costs

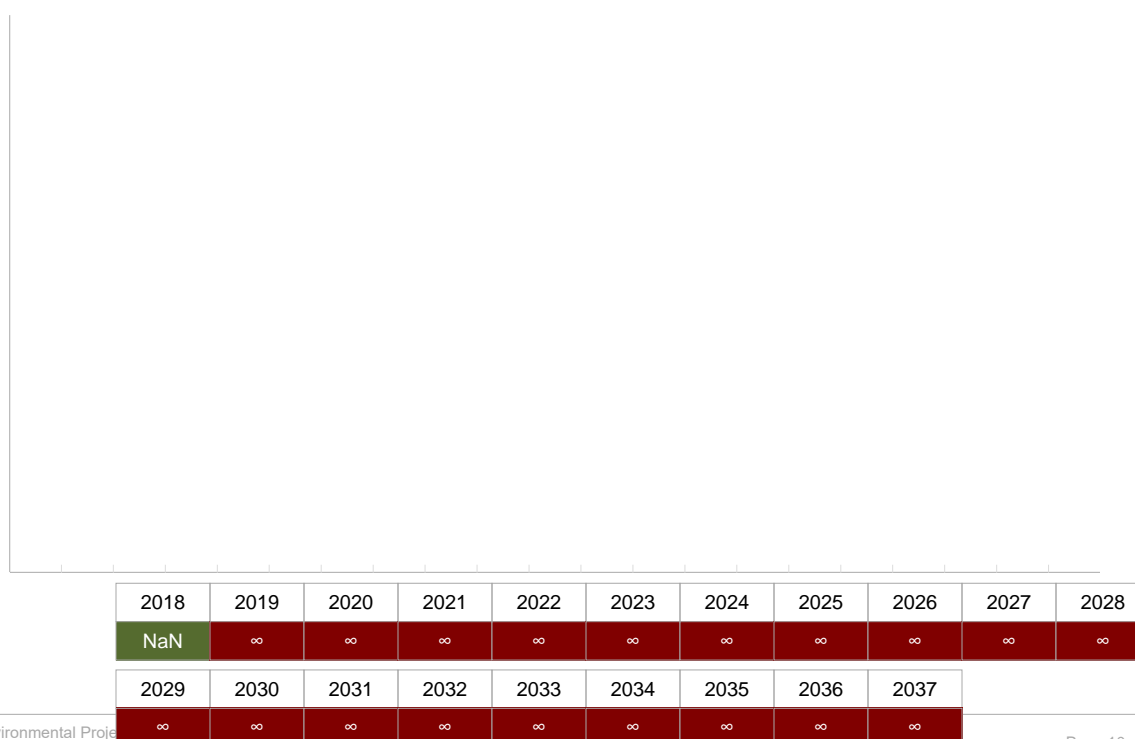
Cumulative Effects of FCI Over the Study Period

The Chart below indicates the cumulative effects of the FCI ratio over the study period assuming the required funds and expenditures are NOT provided to address the identified works and deferred maintenance each year.

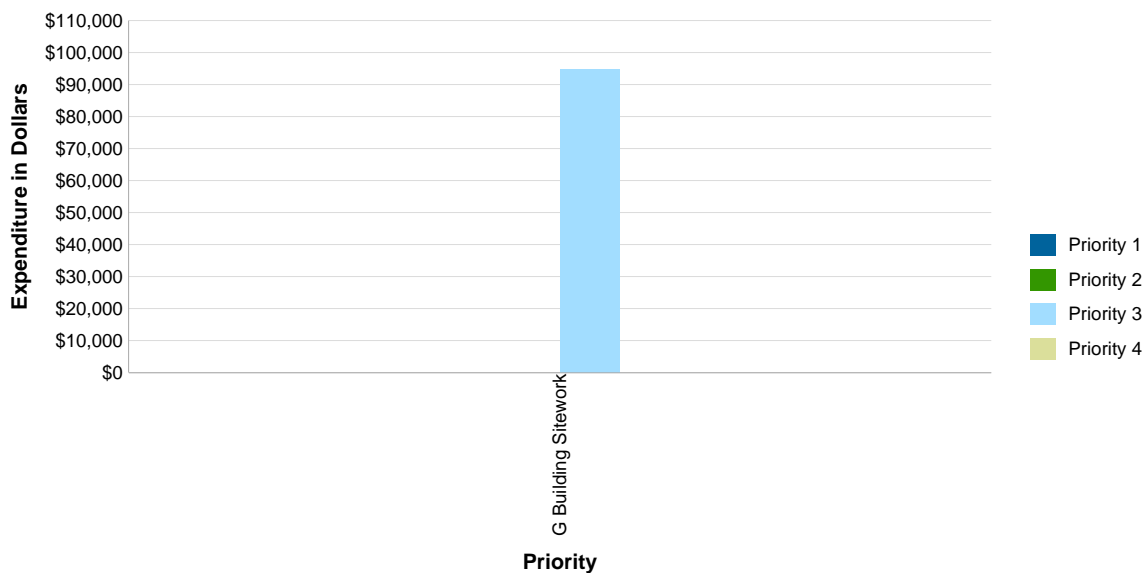
Planning Horizon Needs by System and Priority

The chart below illustrates the breakdown of expenditure according the priority coding providing an opportunity to strategically plan and effectively direct funding to the highest priority.

Building System	Priority 1	Priority 2	Priority 3	Priority 4	Total
G Building Sitework	\$0	\$0	\$95,000	\$0	\$95,000
Total	\$0	\$0	\$95,000	\$0	\$95,000

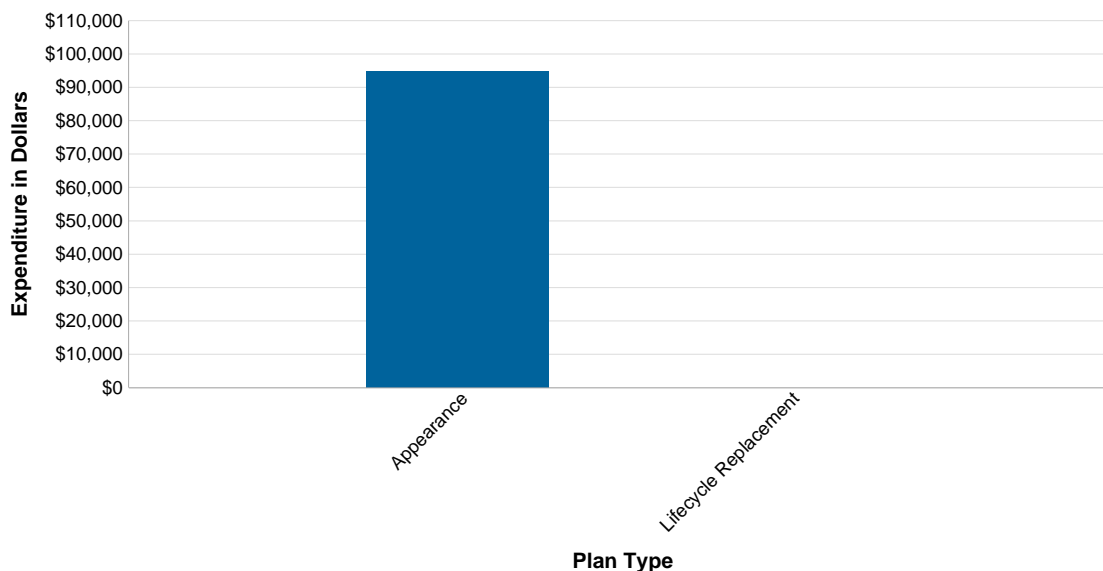
Planning Horizon Needs by Category

The chart below illustrates the breakdown of expenditure according to the Plan Type or deficiency categories providing an opportunity to strategically plan and effectively direct funding.

Building System	Total Cost
Appearance	\$95,000
Lifecycle Replacement	\$0
Total	\$95,000

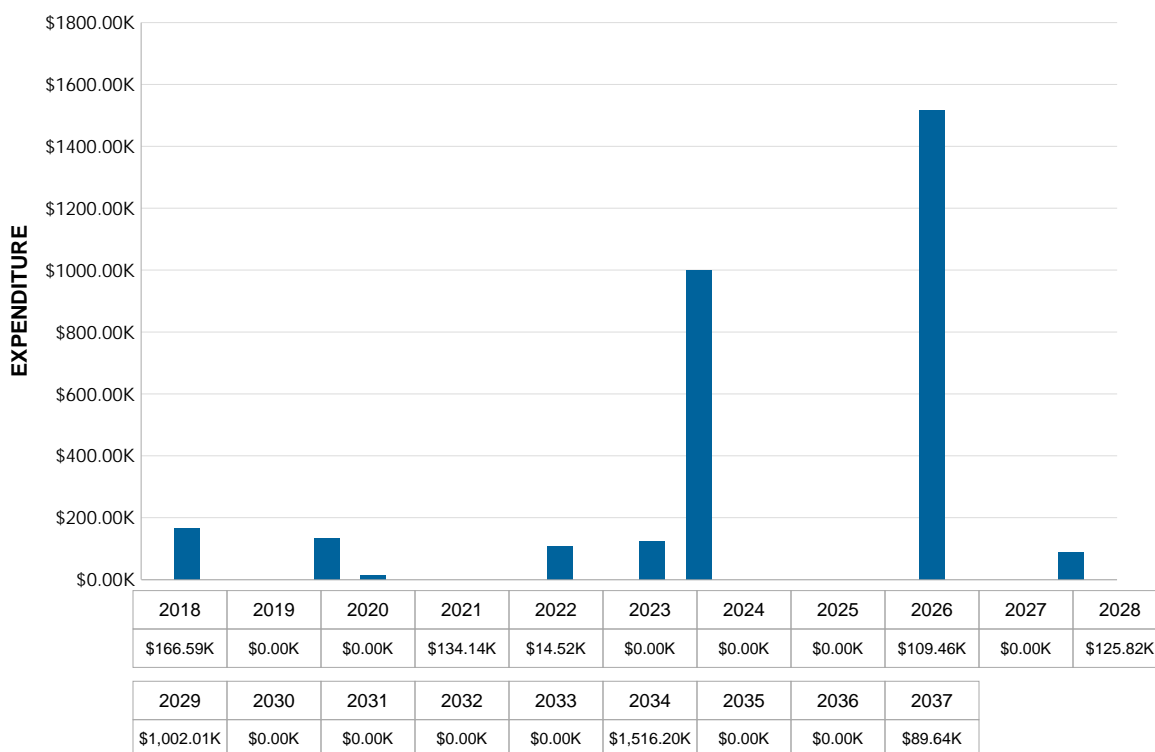
Expenditure Forecast Over Study Period

The building expenditure summary section provides an executive overview of the findings from the assessment. The chart below provides a summary of yearly anticipated expenditures over the study period for the North Kitsap High School 100 Building building. In addition, we have scheduled key findings highlighting key items of greater than \$5,000 and their anticipated failure year. Further details of these expenditures are included within each respective report section and within the expenditure forecast, in Appendix A of this report. The results illustrate a total anticipated expenditure over the study period of approximately \$3,158,373.

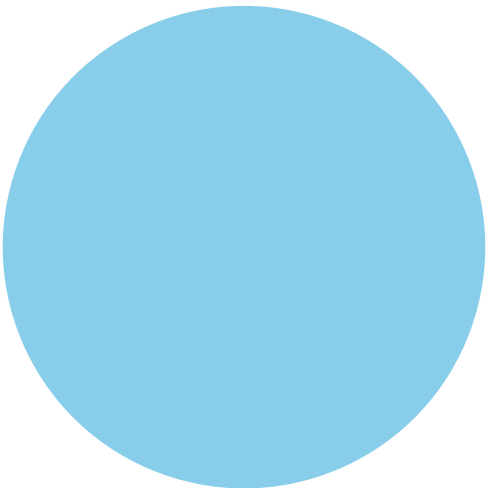
Distribution of Immediate Needs by Building System

Building System	Estimated Cost	Percentage of Total Cost
Domestic Water Distribution	\$166,591	100.00 %
Total	\$166,591	100 %

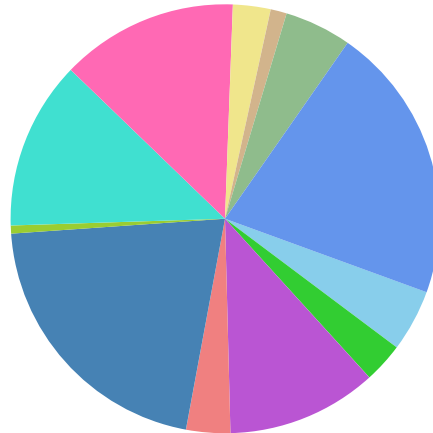
Distribution of Capital Needs by Building System

Building System	Estimated Cost	Percentage of Total Cost
B20 Exterior Enclosure	\$140,001	4.68 %
B30 Roofing	\$90,365	3.02 %
C20 Interior Finishes	\$339,432	11.35 %
D20 Plumbing	\$99,456	3.32 %
D30 HVAC	\$627,420	20.97 %
D40 Fire Protection Systems	\$18,182	0.61 %
D50 Electrical Systems	\$380,367	12.71 %
D60 Communication Systems	\$399,822	13.36 %
D70 Security Systems	\$84,910	2.84 %
D80 Automation Systems	\$36,364	1.22 %
E10 Equipment	\$151,092	5.05 %
E20 Furnishings	\$624,370	20.87 %
Total	\$2,991,782	100 %

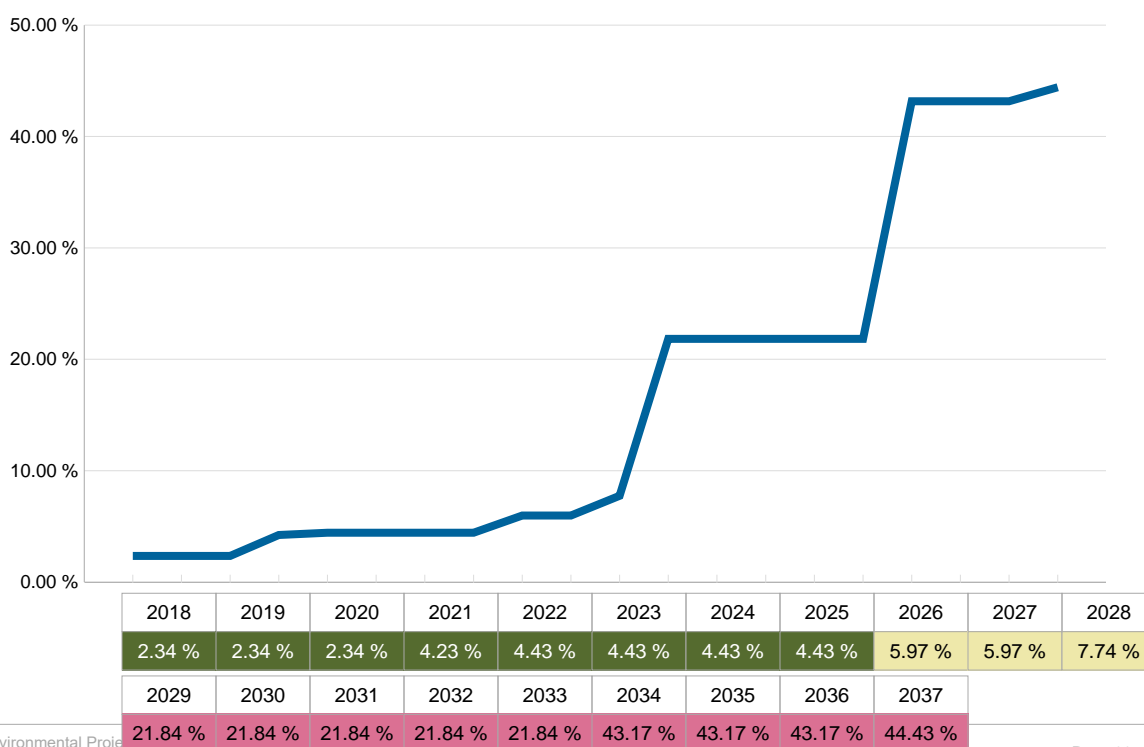
Cumulative Effects of FCI Over the Study Period

The Chart below indicates the cumulative effects of the FCI ratio over the study period assuming the required funds and expenditures are NOT provided to address the identified works and deferred maintenance each year.
