Facilities Condition Assessment Report

I. FCA Executive Summary

North Kitsap School District

Breidablik Elementary School Main
25142 Waghorn Rd NW
Poulsbo, WA

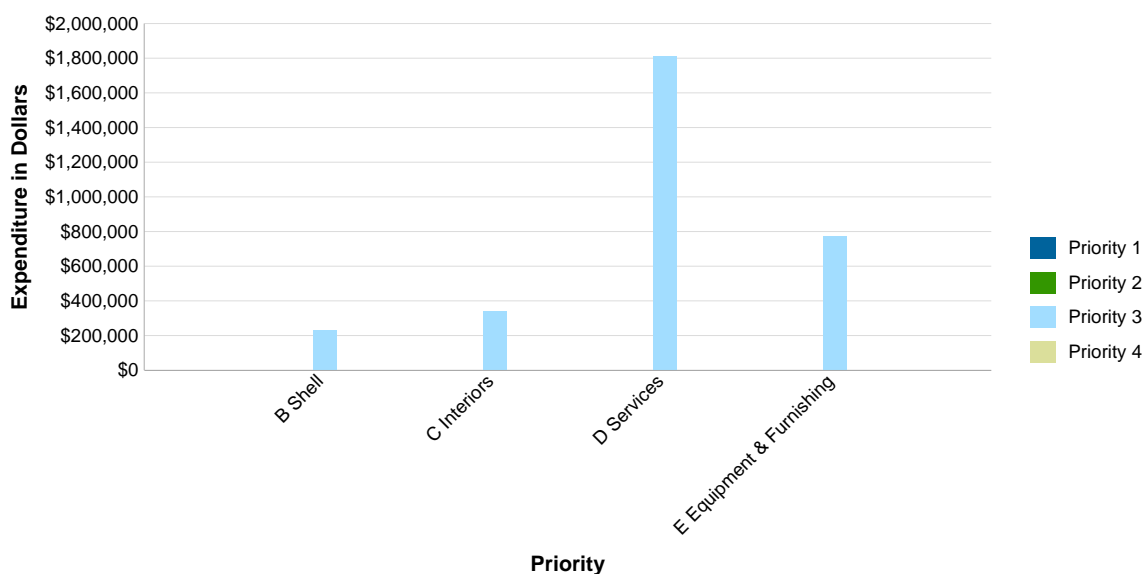
Planning Horizon Needs by System and Priority

The chart below illustrates the breakdown of expenditure according the priority coding providing an opportunity to strategically plan and effectively direct funding to the highest priority.

Building System	Priority 1	Priority 2	Priority 3	Priority 4	Total
B Shell	\$0	\$0	\$230,366	\$0	\$230,366
C Interiors	\$0	\$0	\$339,432	\$0	\$339,432
D Services	\$0	\$0	\$1,813,112	\$0	\$1,813,112
E Equipment & Furnishing	\$0	\$0	\$775,462	\$0	\$775,462
Total	\$0	\$0	\$3,158,373	\$0	\$3,158,373

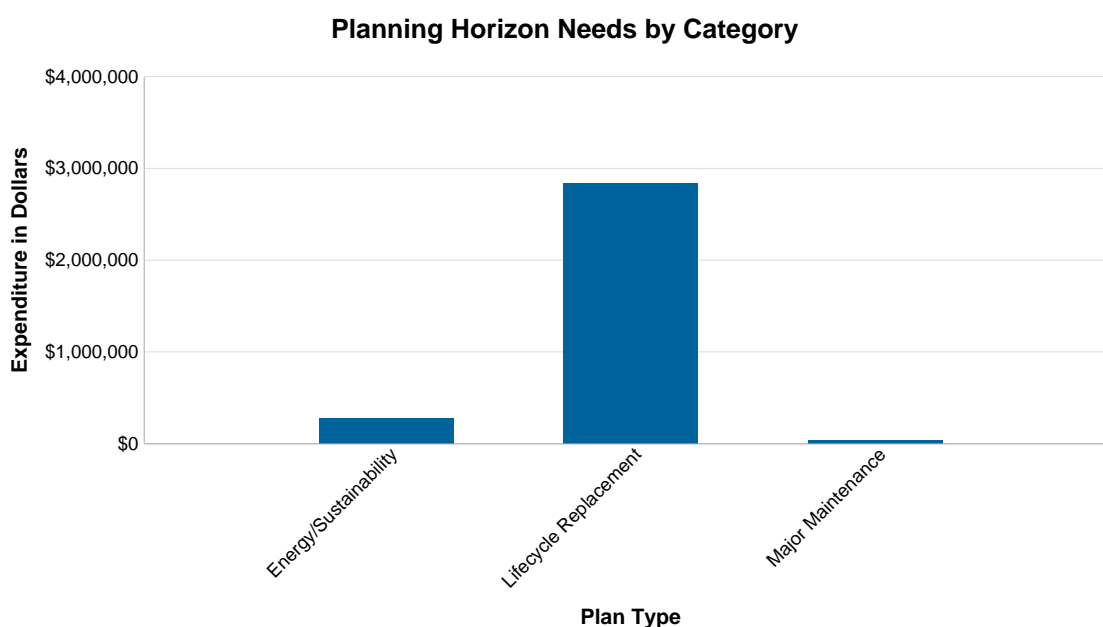
The chart below illustrates the breakdown of expenditure according to the Plan Type or deficiency categories providing an opportunity to strategically plan and effectively direct funding.

Building System	Total Cost
Energy/Sustainability	\$280,229
Lifecycle Replacement	\$2,843,119
Major Maintenance	\$35,025
Total	\$3,158,373

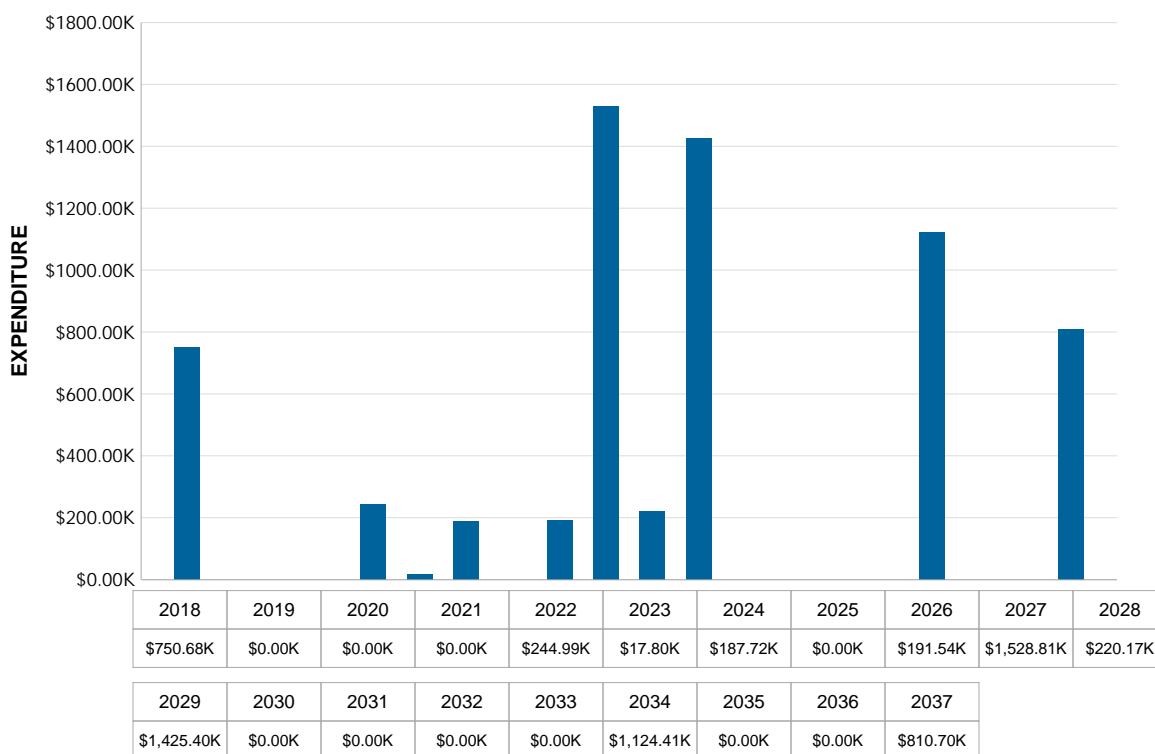
Expenditure Forecast Over Study Period

The building expenditure summary section provides an executive overview of the findings from the assessment. The chart below provides a summary of yearly anticipated expenditures over the study period for the North Kitsap High School Gym building. In addition, we have scheduled key findings highlighting key items of greater than \$5,000 and their anticipated failure year. Further details of these expenditures are included within each respective report section and within the expenditure forecast, in Appendix A of this report. The results illustrate a total anticipated expenditure over the study period of approximately \$6,502,226.

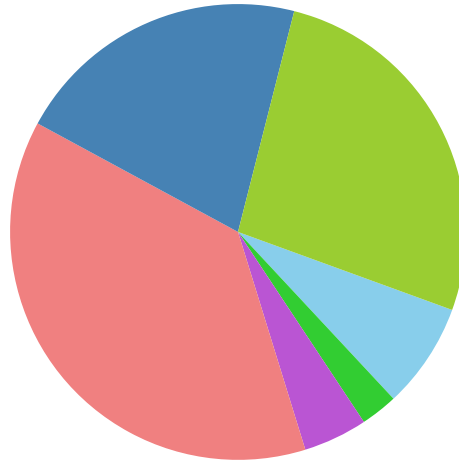
Distribution of Immediate Needs by Building System

■ Cooling Systems
 ■ Electrical Service and Distribution
 ■ Facility HVAC Distribution Systems
■ Heating Systems
 ■ Roof Coverings
 ■ Ventilation

Building System	Estimated Cost	Percentage of Total Cost
Cooling Systems	\$56,300	7.50 %
Electrical Service and Distribution	\$19,727	2.63 %
Facility HVAC Distribution Systems	\$34,090	4.54 %
Heating Systems	\$282,853	37.68 %
Roof Coverings	\$158,130	21.06 %
Ventilation	\$199,584	26.59 %
Total	\$750,684	100 %

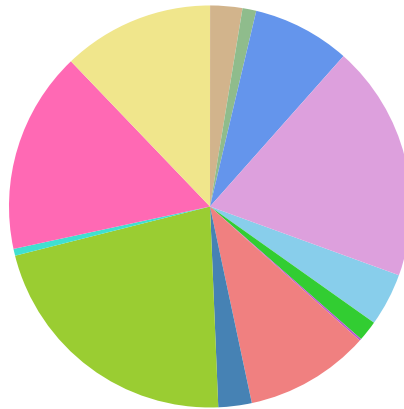
Distribution of Capital Needs by Building System

Building System	Estimated Cost	Percentage of Total Cost
B20 Exterior Enclosure	\$244,991	4.26 %
B30 Roofing	\$95,133	1.65 %
C10 Interior Construction	\$8,900	0.15 %
C20 Interior Finishes	\$577,470	10.04 %
D20 Plumbing	\$153,994	2.68 %
D30 HVAC	\$1,249,135	21.72 %
D40 Fire Protection Systems	\$31,817	0.55 %
D50 Electrical Systems	\$933,511	16.23 %
D60 Communication Systems	\$699,656	12.16 %
D70 Security Systems	\$148,585	2.58 %
D80 Automation Systems	\$63,634	1.11 %
E10 Equipment	\$452,120	7.86 %
E20 Furnishings	\$1,092,596	19.00 %
Total	\$5,751,542	100 %

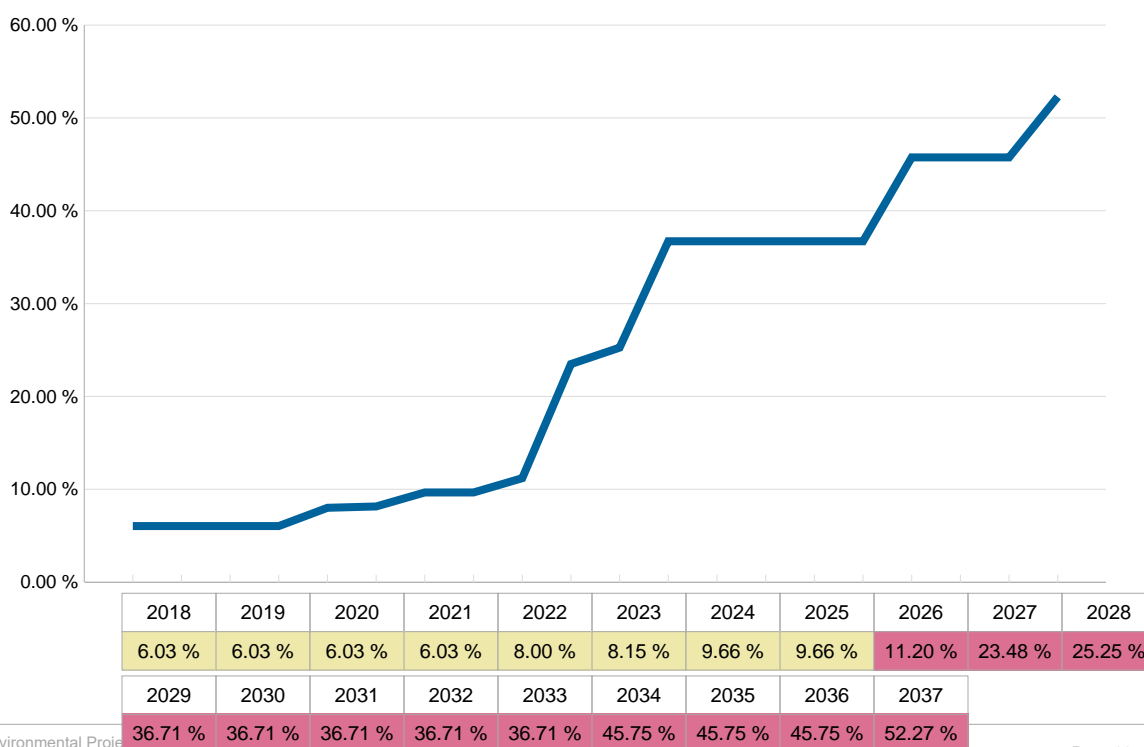
Cumulative Effects of FCI Over the Study Period

The Chart below indicates the cumulative effects of the FCI ratio over the study period assuming the required funds and expenditures are NOT provided to address the identified works and deferred maintenance each year.

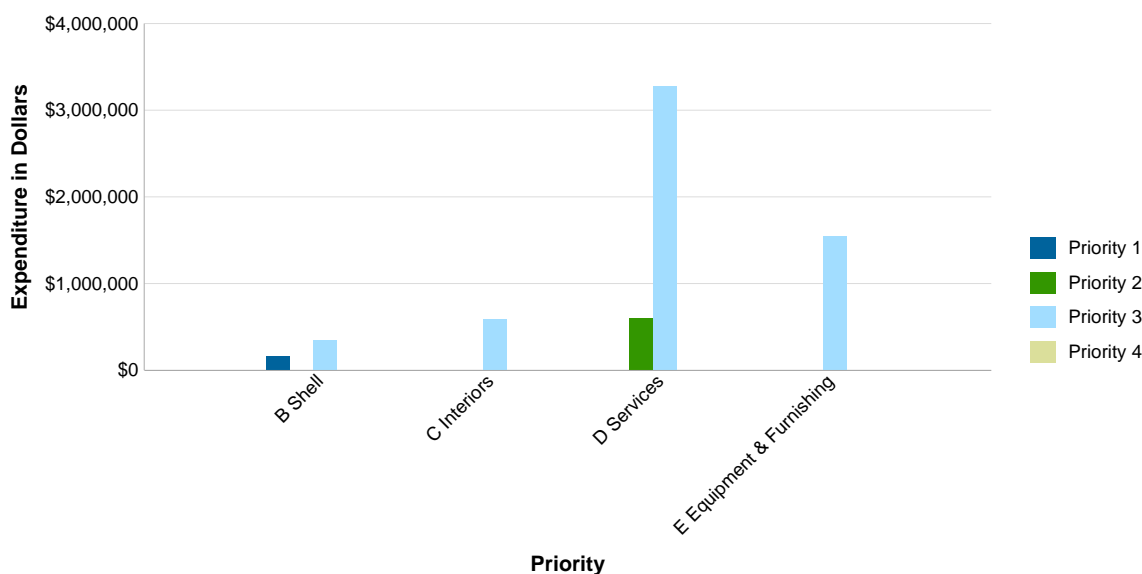
Planning Horizon Needs by System and Priority

The chart below illustrates the breakdown of expenditure according the priority coding providing an opportunity to strategically plan and effectively direct funding to the highest priority.

Building System	Priority 1	Priority 2	Priority 3	Priority 4	Total
B Shell	\$158,130	\$0	\$340,124	\$0	\$498,254
C Interiors	\$0	\$0	\$586,370	\$0	\$586,370
D Services	\$0	\$592,554	\$3,280,333	\$0	\$3,872,886
E Equipment & Furnishing	\$0	\$0	\$1,544,715	\$0	\$1,544,715
Total	\$158,130	\$592,554	\$5,751,542	\$0	\$6,502,226

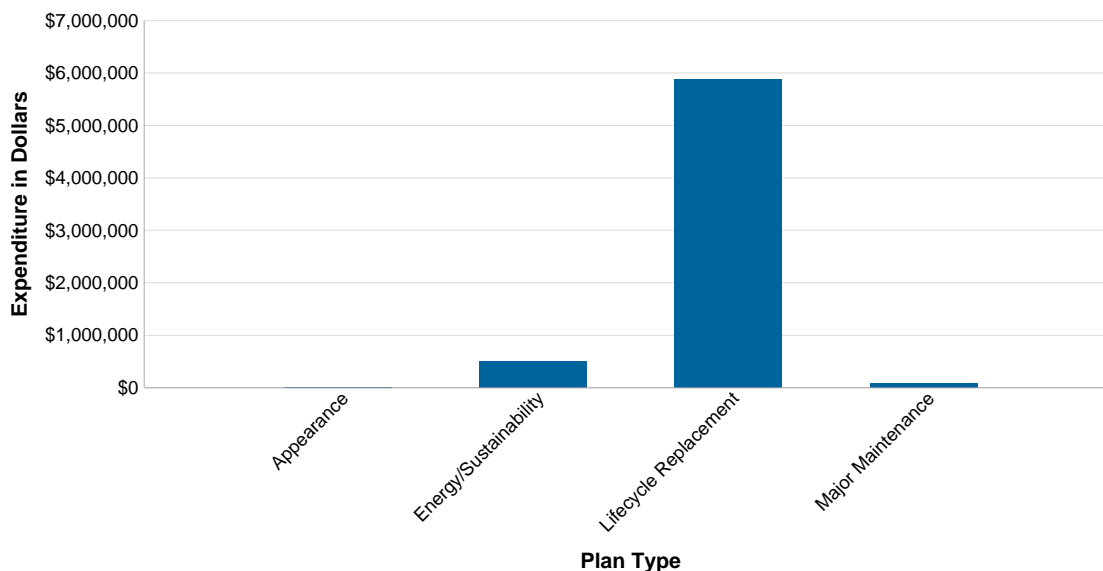
Planning Horizon Needs by Category

The chart below illustrates the breakdown of expenditure according to the Plan Type or deficiency categories providing an opportunity to strategically plan and effectively direct funding.

Building System	Total Cost
Appearance	\$8,900
Energy/Sustainability	\$511,027
Lifecycle Replacement	\$5,891,872
Major Maintenance	\$90,427
Total	\$6,502,226

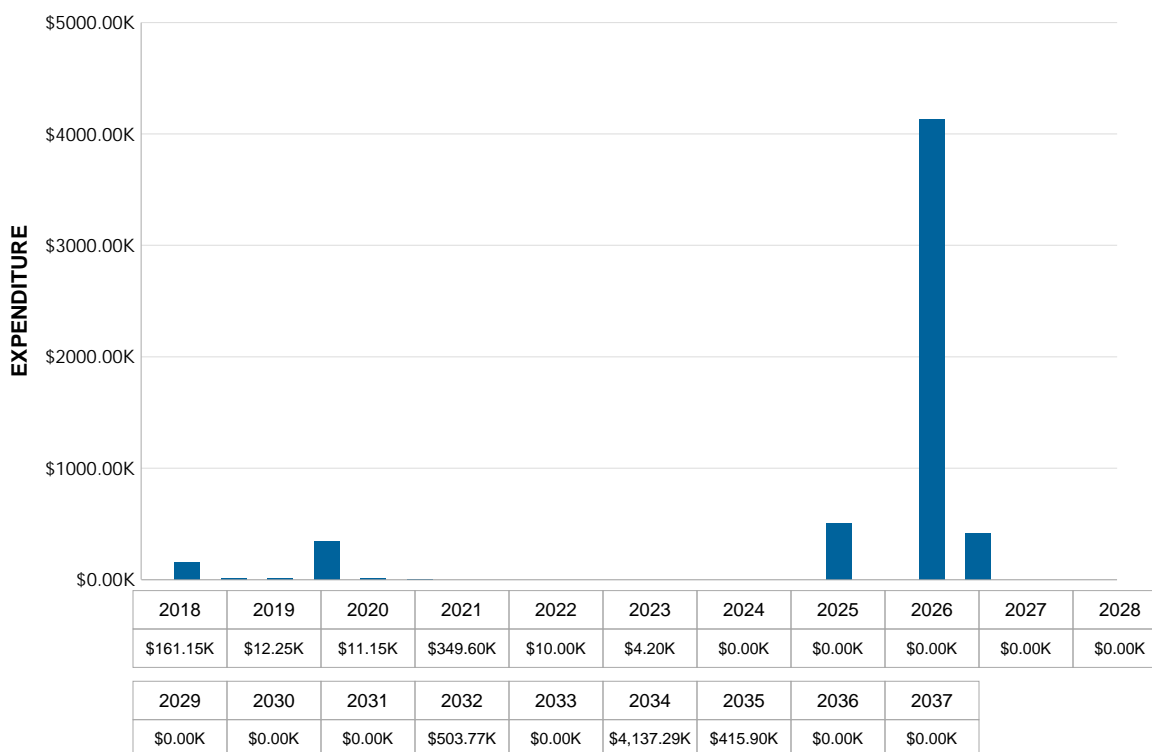
Expenditure Forecast Over Study Period

The building expenditure summary section provides an executive overview of the findings from the assessment. The chart below provides a summary of yearly anticipated expenditures over the study period for the North Kitsap High School Main building. In addition, we have scheduled key findings highlighting key items of greater than \$5,000 and their anticipated failure year. Further details of these expenditures are included within each respective report section and within the expenditure forecast, in Appendix A of this report. The results illustrate a total anticipated expenditure over the study period of approximately \$5,605,312.

- B Shell: Replace roof at Foreign Language and Math/Science wings. at an estimated cost of \$224,800 in year 2021
- B Shell: Replace Roofing at an estimated cost of \$415,905 in year 2035

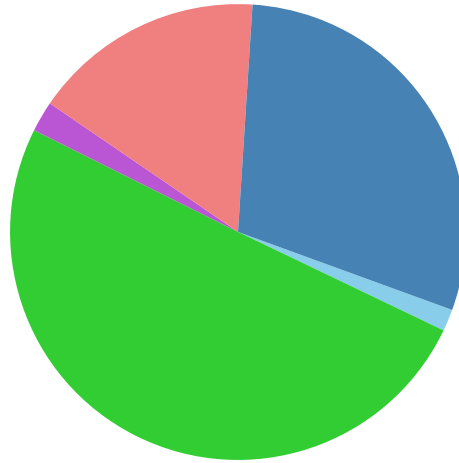
Distribution of Immediate Needs by Building System

Building System	Estimated Cost	Percentage of Total Cost
Commercial Equipment	\$2,500	1.55 %
Facility HVAC Distribution Systems	\$81,000	50.26 %
Fire Suppression	\$3,500	2.17 %
Heating Systems	\$26,550	16.48 %
Ventilation	\$47,600	29.54 %
Total	\$161,150	100 %

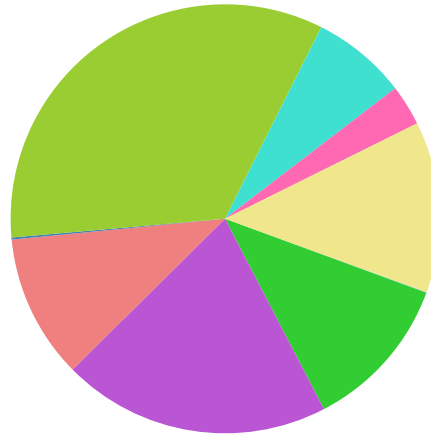
Distribution of Capital Needs by Building System

Building System	Estimated Cost	Percentage of Total Cost
B20 Exterior Enclosure	\$2,650	0.05 %
B30 Roofing	\$640,705	11.77 %
C20 Interior Finishes	\$1,100,658	20.22 %
D20 Plumbing	\$591,195	10.86 %
D30 HVAC	\$8,500	0.16 %
D60 Communication Systems	\$1,840,189	33.80 %
D70 Security Systems	\$390,800	7.18 %
D80 Automation Systems	\$167,366	3.07 %
E10 Equipment	\$702,100	12.90 %
Total	\$5,444,162	100 %

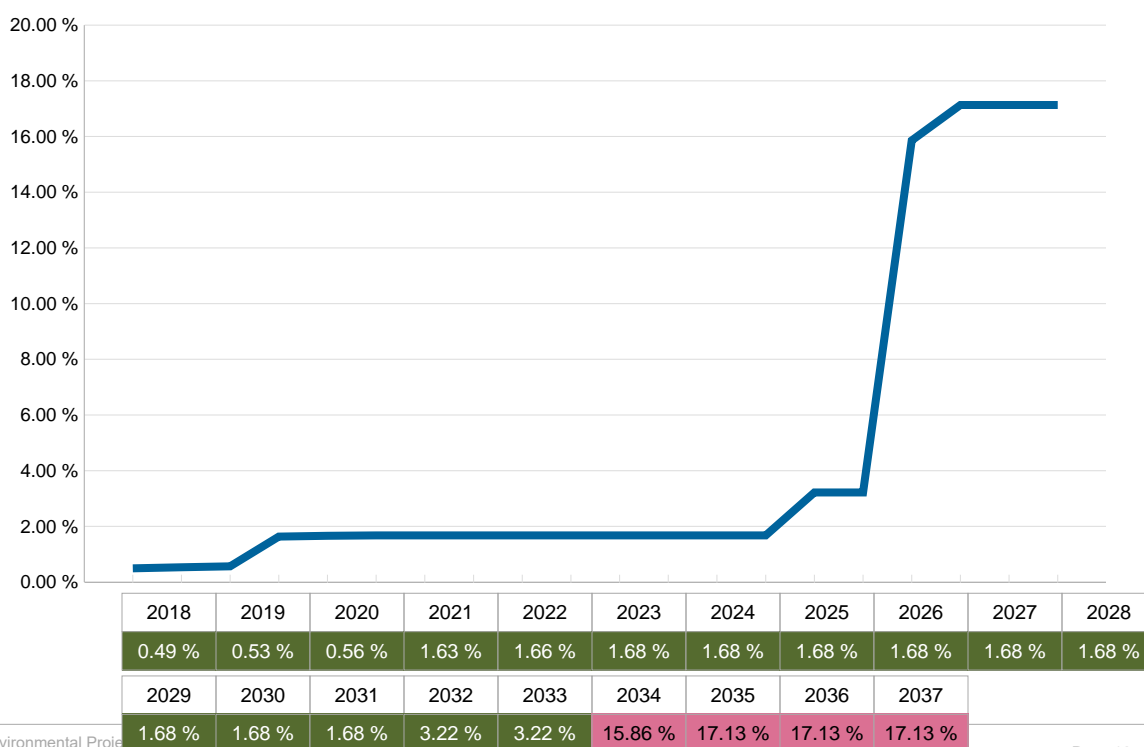
Cumulative Effects of FCI Over the Study Period

The Chart below indicates the cumulative effects of the FCI ratio over the study period assuming the required funds and expenditures are NOT provided to address the identified works and deferred maintenance each year.

$$\text{FCI} = \frac{\text{Maintenance + Lifecycle Renewal} + \text{Plant Adaptation (TC)}}{\text{Current Replacement Value of the Facility(s) (CRV)}}$$

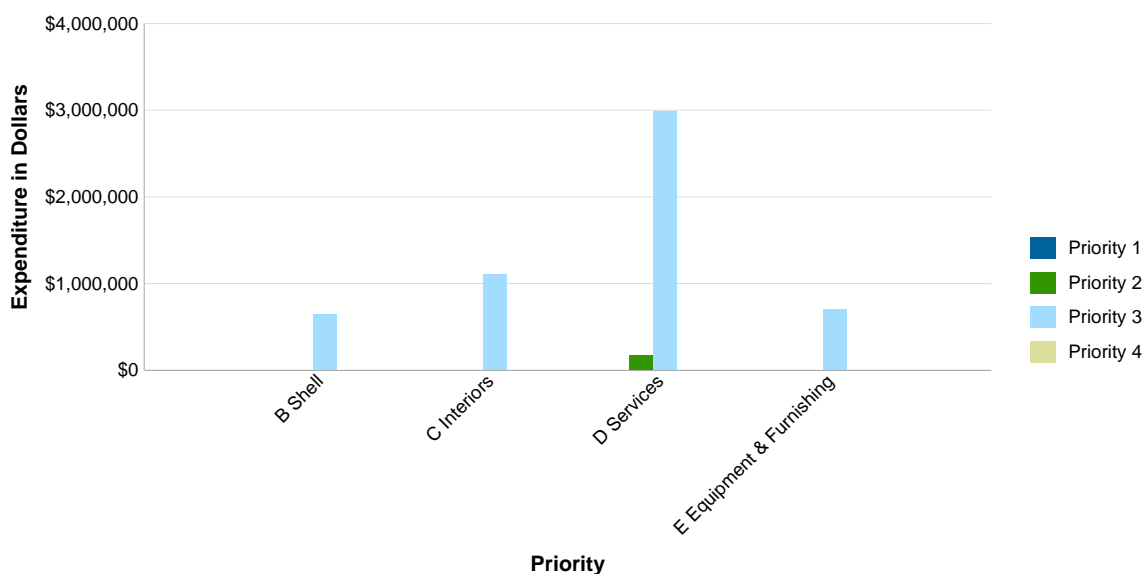
Planning Horizon Needs by System and Priority

The chart below illustrates the breakdown of expenditure according the priority coding providing an opportunity to strategically plan and effectively direct funding to the highest priority.

Building System	Priority 1	Priority 2	Priority 3	Priority 4	Total
B Shell	\$0	\$0	\$643,355	\$0	\$643,355
C Interiors	\$0	\$0	\$1,100,658	\$0	\$1,100,658
D Services	\$0	\$167,150	\$2,989,549	\$0	\$3,156,699
E Equipment & Furnishing	\$0	\$0	\$704,600	\$0	\$704,600
Total	\$0	\$167,150	\$5,438,162	\$0	\$5,605,312

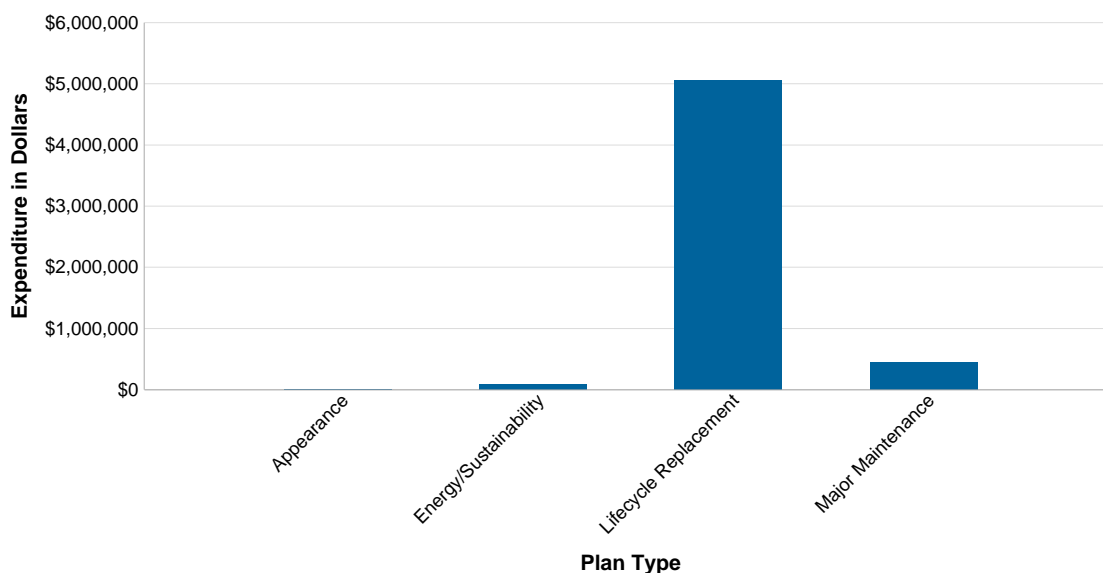
Planning Horizon Needs by Category

The chart below illustrates the breakdown of expenditure according to the Plan Type or deficiency categories providing an opportunity to strategically plan and effectively direct funding.

Building System	Total Cost
Appearance	\$13,600
Energy/Sustainability	\$88,500
Lifecycle Replacement	\$5,056,964
Major Maintenance	\$446,249
Total	\$5,605,312

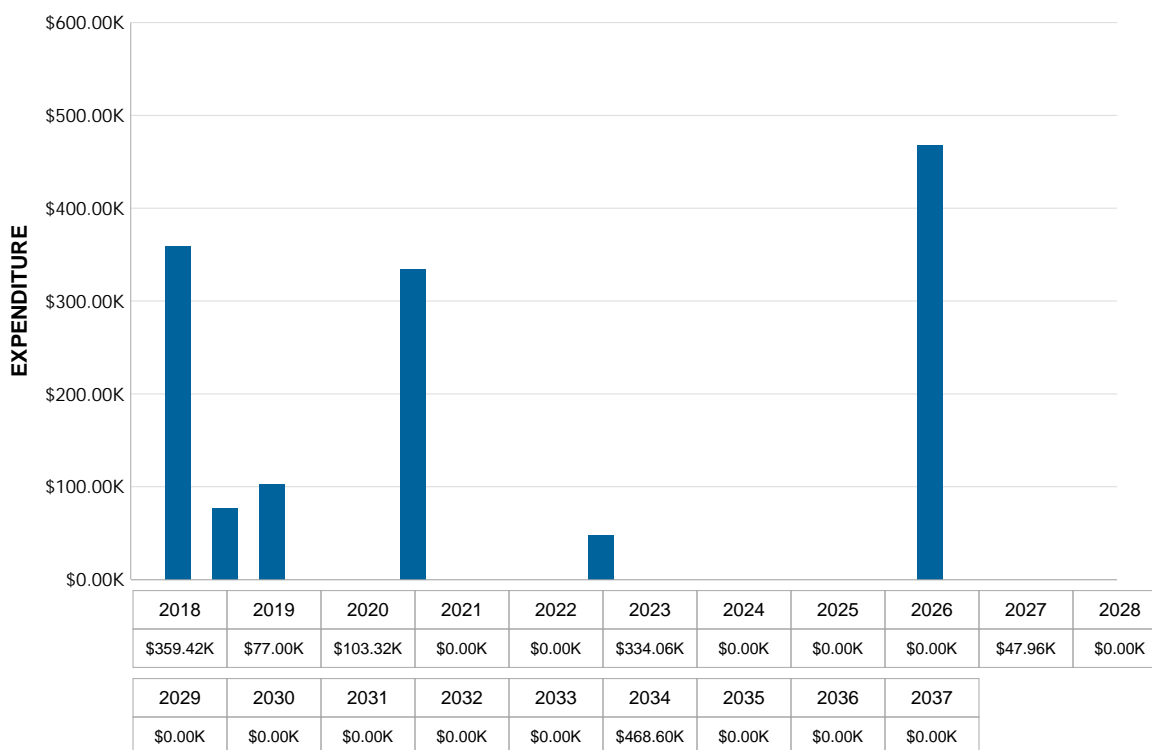
Expenditure Forecast Over Study Period

The building expenditure summary section provides an executive overview of the findings from the assessment. The chart below provides a summary of yearly anticipated expenditures over the study period for the North Kitsap High School Music building. In addition, we have scheduled key findings highlighting key items of greater than \$5,000 and their anticipated failure year. Further details of these expenditures are included within each respective report section and within the expenditure forecast, in Appendix A of this report. The results illustrate a total anticipated expenditure over the study period of approximately \$1,390,353.

- B Shell: Replace Exterior Walls at an estimated cost of \$74,906 in year 2018
- B Shell: Replace Roofing at an estimated cost of \$48,348 in year 2019

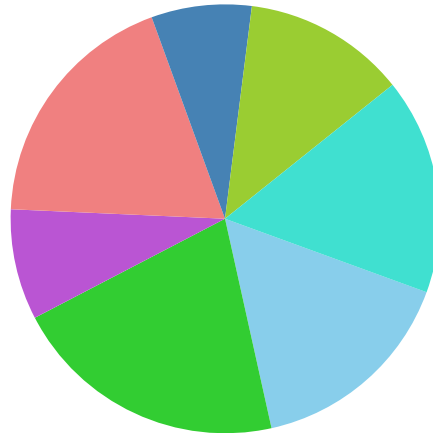
Distribution of Immediate Needs by Building System

Building System	Estimated Cost	Percentage of Total Cost
Entertainment and Recreational Equipment	\$57,395	15.97 %
Exterior Walls	\$74,906	20.84 %
Facility HVAC Distribution Systems	\$30,000	8.35 %
Flooring	\$67,318	18.73 %
Heating Systems	\$27,174	7.56 %
Suspended Ceiling Construction	\$44,068	12.26 %
Wall Finishes	\$58,563	16.29 %
Total	\$359,423	100 %

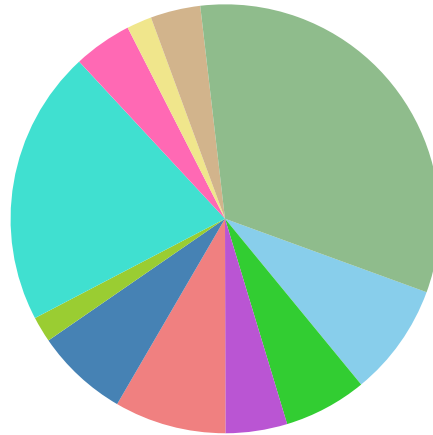
Distribution of Capital Needs by Building System

Building System	Estimated Cost	Percentage of Total Cost
B30 Roofing	\$87,649	8.50 %
C10 Interior Construction	\$64,594	6.27 %
C20 Interior Finishes	\$47,959	4.65 %
D20 Plumbing	\$86,804	8.42 %
D30 HVAC	\$72,246	7.01 %
D50 Electrical Systems	\$20,000	1.94 %
D60 Communication Systems	\$213,919	20.75 %
D70 Security Systems	\$45,430	4.41 %
D80 Automation Systems	\$19,456	1.89 %
E10 Equipment	\$38,815	3.77 %
E20 Furnishings	\$334,060	32.40 %
Total	\$1,030,931	100 %

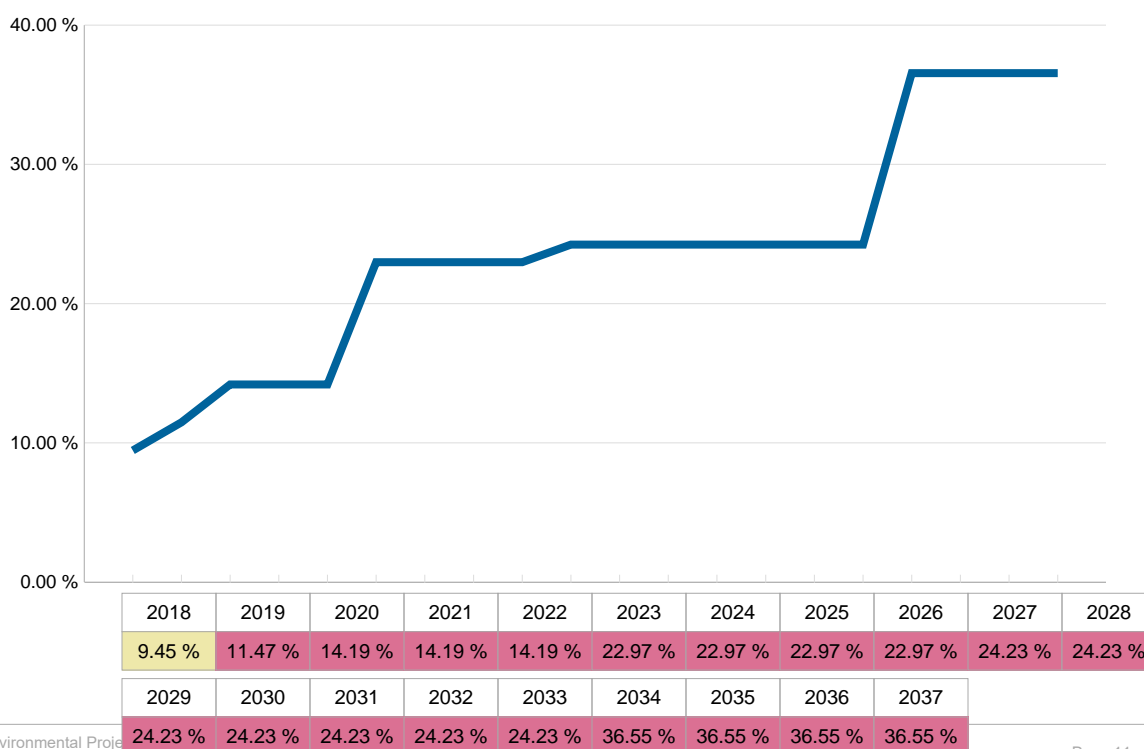
Cumulative Effects of FCI Over the Study Period

The Chart below indicates the cumulative effects of the FCI ratio over the study period assuming the required funds and expenditures are NOT provided to address the identified works and deferred maintenance each year.

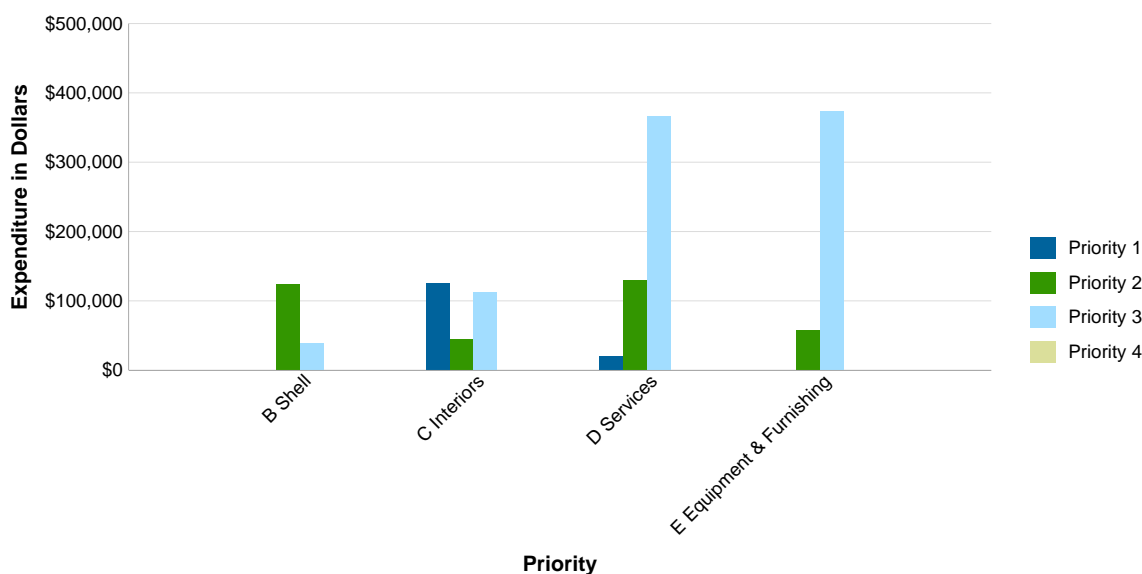
Planning Horizon Needs by System and Priority

The chart below illustrates the breakdown of expenditure according the priority coding providing an opportunity to strategically plan and effectively direct funding to the highest priority.

Building System	Priority 1	Priority 2	Priority 3	Priority 4	Total
B Shell	\$0	\$123,254	\$39,301	\$0	\$162,555
C Interiors	\$125,880	\$44,068	\$112,553	\$0	\$282,501
D Services	\$20,000	\$129,419	\$365,609	\$0	\$515,028
E Equipment & Furnishing	\$0	\$57,395	\$372,874	\$0	\$430,269
Total	\$145,880	\$354,136	\$890,337	\$0	\$1,390,353

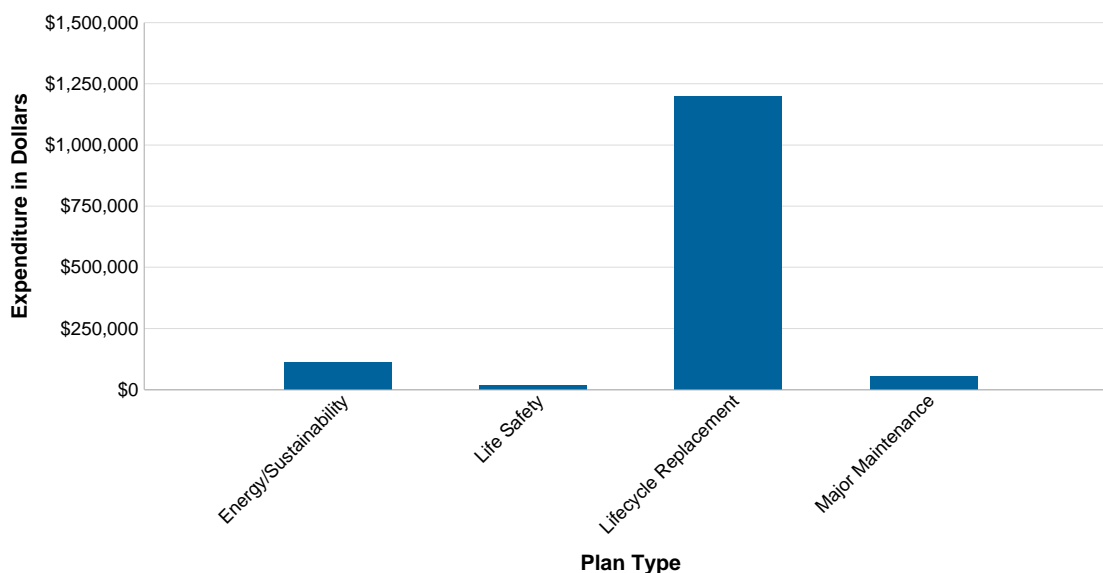
Planning Horizon Needs by Category

The chart below illustrates the breakdown of expenditure according to the Plan Type or deficiency categories providing an opportunity to strategically plan and effectively direct funding.

Building System	Total Cost
Energy/Sustainability	\$112,490
Life Safety	\$20,000
Lifecycle Replacement	\$1,201,213
Major Maintenance	\$56,650
Total	\$1,390,353

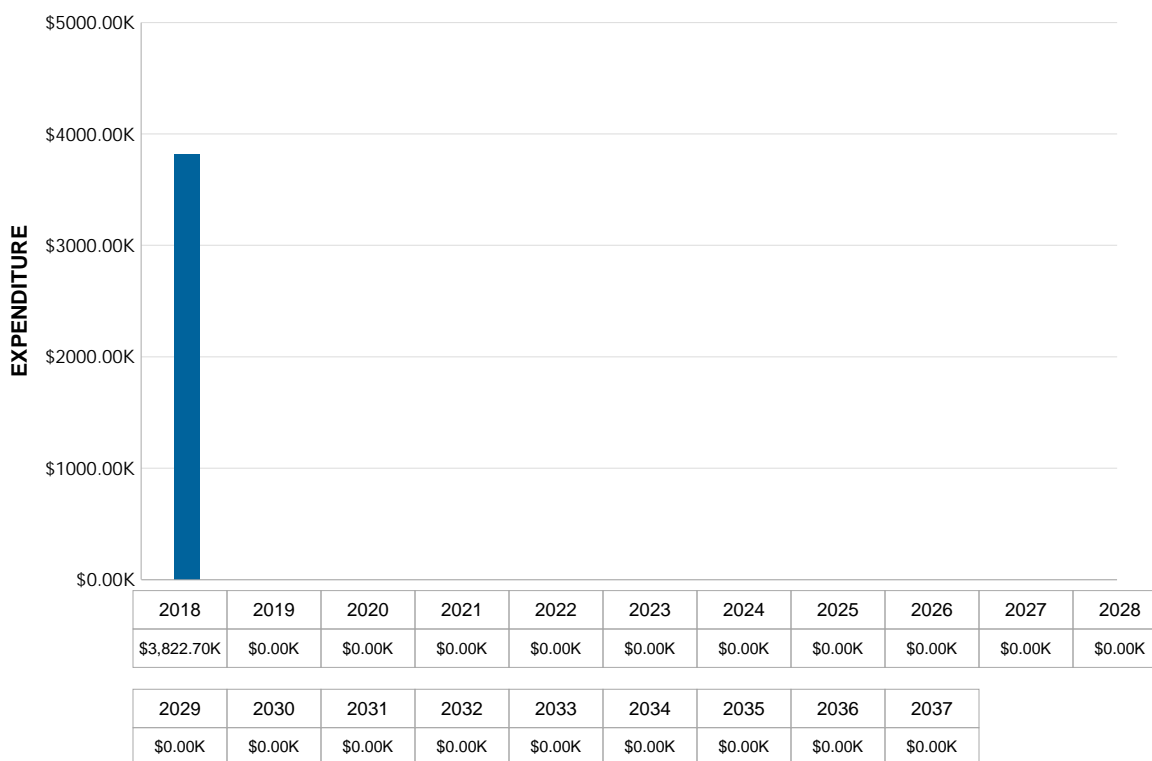
Expenditure Forecast Over Study Period

The building expenditure summary section provides an executive overview of the findings from the assessment. The chart below provides a summary of yearly anticipated expenditures over the study period for the North Kitsap High School Old Vocational building. In addition, we have scheduled key findings highlighting key items of greater than \$5,000 and their anticipated failure year. Further details of these expenditures are included within each respective report section and within the expenditure forecast, in Appendix A of this report. The results illustrate a total anticipated expenditure over the study period of approximately \$3,822,697.

- B Shell: Replace roof deck and finishes. at an estimated cost of \$353,474 in year 2018
- B Shell: Replace Exterior Walls at an estimated cost of \$104,042 in year 2018

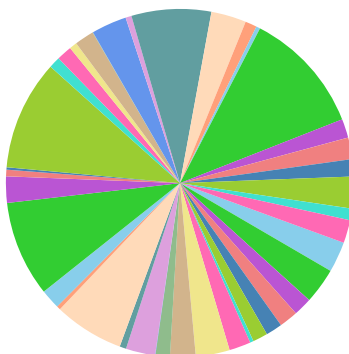
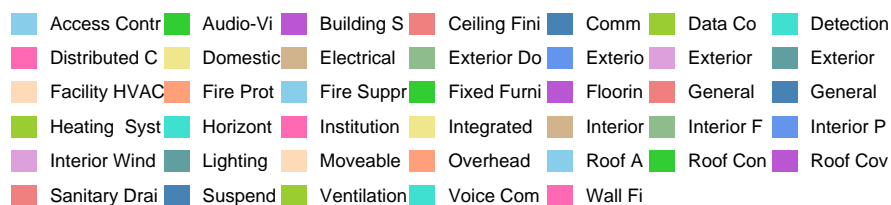
Distribution of Immediate Needs by Building System

Building System	Estimated Cost	Percentage of Total Cost
Access Control and Intrusion Detection	\$108,907	2.85 %
Audio-Video Communications	\$126,607	3.31 %
Building Support Plumbing Systems	\$65,398	1.71 %
Ceiling Finishes	\$66,614	1.74 %
Commercial Equipment	\$58,372	1.53 %
Data Communications	\$52,967	1.39 %
Detection and Alarm	\$12,431	0.33 %
Distributed Communications and Monitoring	\$76,478	2.00 %
Domestic Water Distribution	\$120,430	3.15 %
Electrical Service and Distribution	\$90,530	2.37 %
Exterior Doors and Grilles	\$51,210	1.34 %
Exterior Louvers and Vents	\$1,351	0.04 %
Exterior Walls	\$104,042	2.72 %
Exterior Windows	\$23,241	0.61 %

Facility HVAC Distribution Systems	\$247,945	6.49 %
Fire Protection Specialties	\$13,512	0.35 %
Fire Suppression	\$69,857	1.83 %
Fixed Furnishings	\$339,557	8.88 %
Flooring	\$93,503	2.45 %
General Purpose Electrical Power	\$23,241	0.61 %
General Service Compressed-Air	\$8,513	0.22 %
Heating Systems	\$389,816	10.20 %
Horizontal Openings	\$40,401	1.06 %
Institutional Equipment	\$53,913	1.41 %
Integrated Automation Facility Controls	\$27,024	0.71 %
Interior Doors	\$68,641	1.80 %
Interior Fabrications	\$1,486	0.04 %
Interior Partitions	\$125,391	3.28 %
Interior Windows	\$21,079	0.55 %
Lighting	\$282,671	7.39 %
Moveable Furnishings	\$124,446	3.26 %
Overhead Exterior Enclosures	\$41,076	1.07 %
Roof Appurtenances	\$14,188	0.37 %
Roof Construction	\$437,383	11.44 %
Roof Coverings	\$67,155	1.76 %
Sanitary Drainage	\$76,420	2.00 %
Suspended Ceiling Construction	\$61,209	1.60 %
Ventilation	\$113,273	2.96 %
Voice Communications	\$41,076	1.07 %

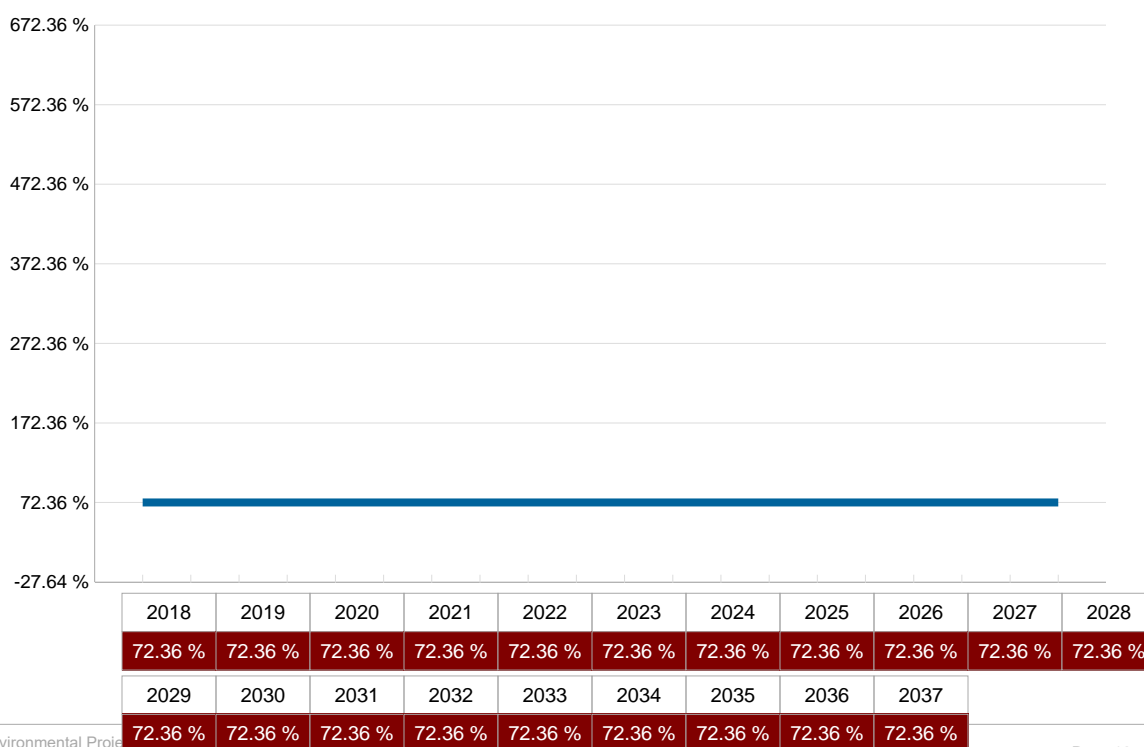
Cumulative Effects of FCI Over the Study Period

The Chart below indicates the cumulative effects of the FCI ratio over the study period assuming the required funds and expenditures are NOT provided to address the identified works and deferred maintenance each year.

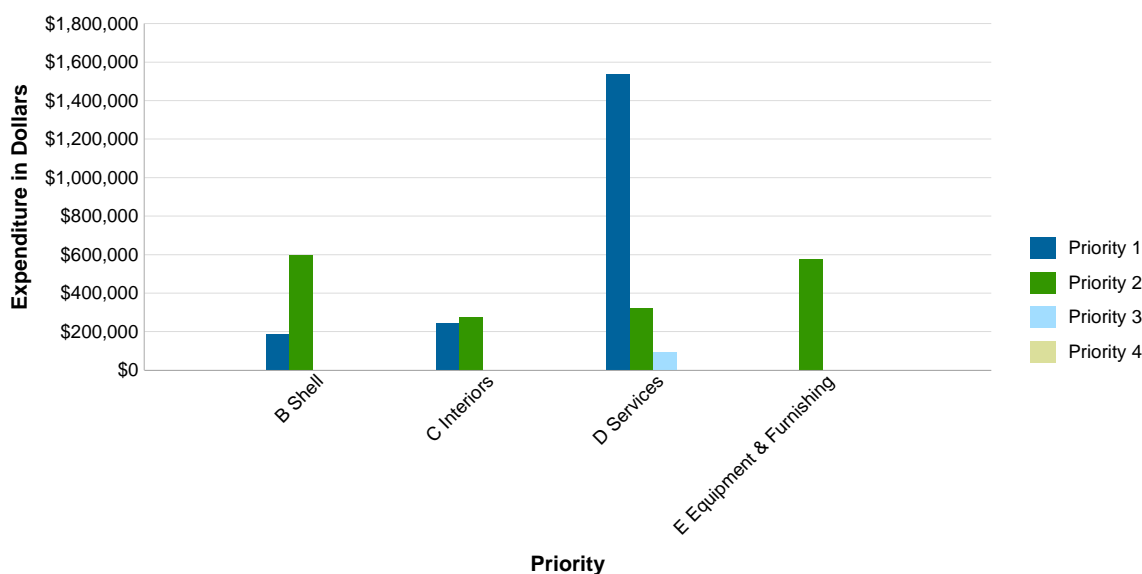
Planning Horizon Needs by System and Priority

The chart below illustrates the breakdown of expenditure according the priority coding providing an opportunity to strategically plan and effectively direct funding to the highest priority.

Building System	Priority 1	Priority 2	Priority 3	Priority 4	Total
B Shell	\$186,060	\$593,988	\$0	\$0	\$780,048
C Interiors	\$242,946	\$276,320	\$0	\$0	\$519,266
D Services	\$1,534,423	\$321,893	\$90,780	\$0	\$1,947,096
E Equipment & Furnishing	\$0	\$576,287	\$0	\$0	\$576,287
Total	\$1,963,429	\$1,768,488	\$90,780	\$0	\$3,822,697

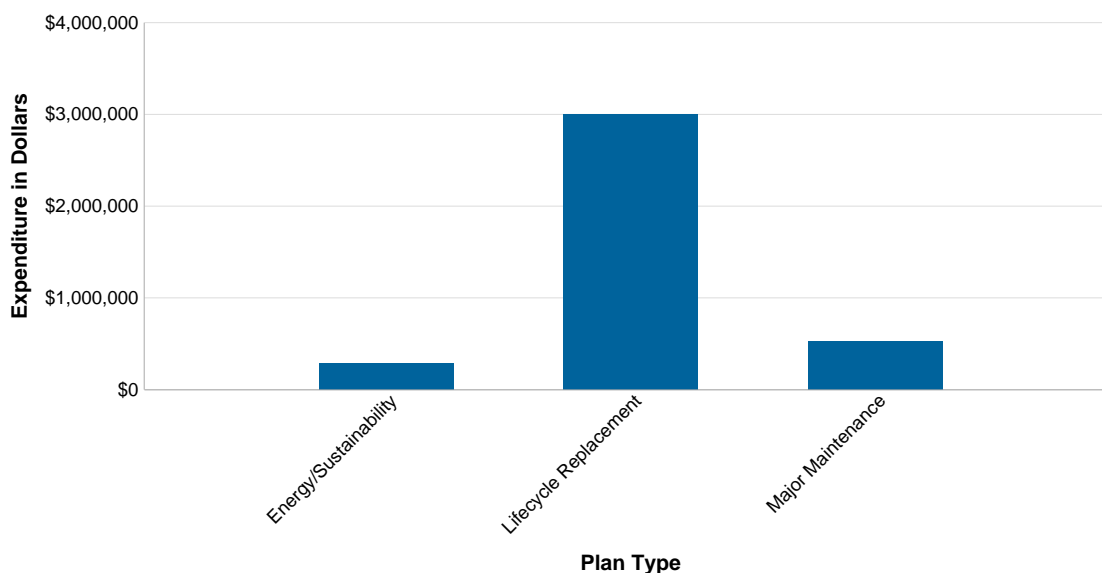
Planning Horizon Needs by Category

The chart below illustrates the breakdown of expenditure according to the Plan Type or deficiency categories providing an opportunity to strategically plan and effectively direct funding.

Building System	Total Cost
Energy/Sustainability	\$285,609
Lifecycle Replacement	\$3,008,177
Major Maintenance	\$528,911
Total	\$3,822,697

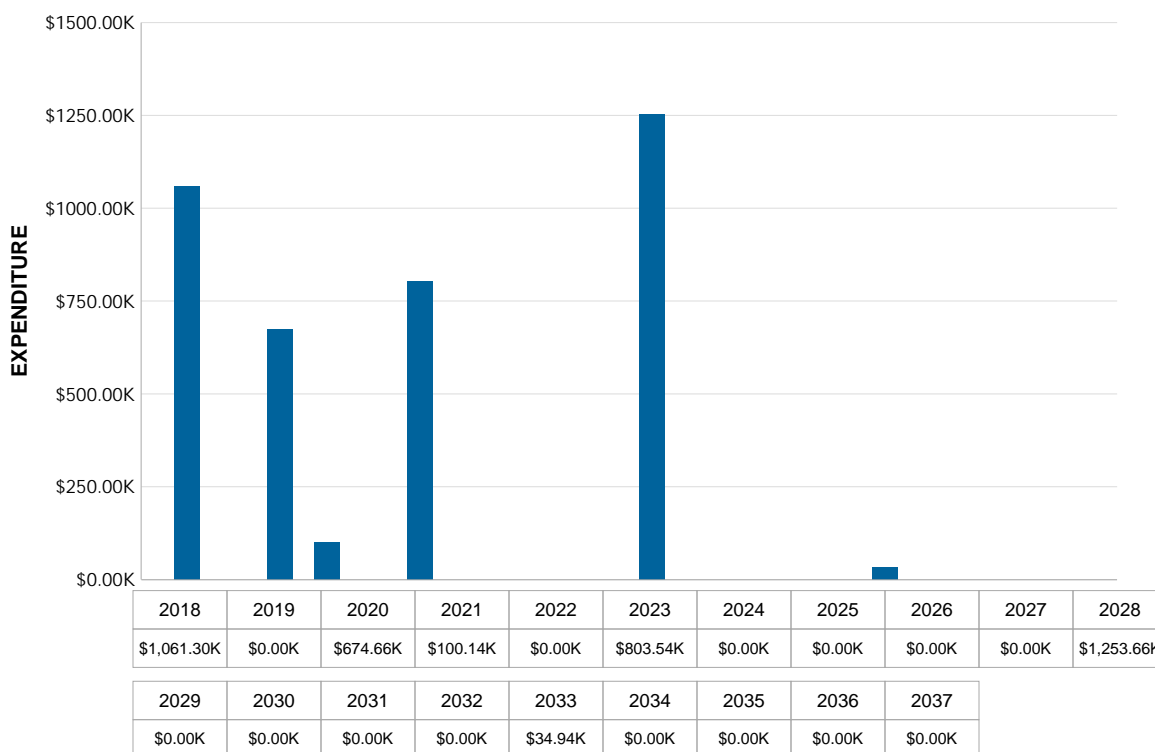
Expenditure Forecast Over Study Period

The building expenditure summary section provides an executive overview of the findings from the assessment. The chart below provides a summary of yearly anticipated expenditures over the study period for the North Kitsap High School Technology building. In addition, we have scheduled key findings highlighting key items of greater than \$5,000 and their anticipated failure year. Further details of these expenditures are included within each respective report section and within the expenditure forecast, in Appendix A of this report. The results illustrate a total anticipated expenditure over the study period of approximately \$3,928,241.

- B Shell: Replace Roofing at an estimated cost of \$100,951 in year 2018
- B Shell: Paint and repair façade. at an estimated cost of \$18,687 in year 2023

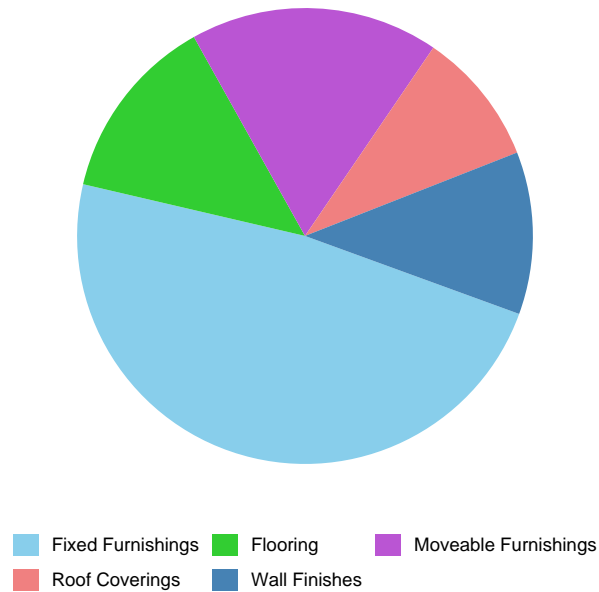
Distribution of Immediate Needs by Building System

Building System	Estimated Cost	Percentage of Total Cost
Fixed Furnishings	\$510,441	48.10 %
Flooring	\$140,559	13.24 %
Moveable Furnishings	\$187,074	17.63 %
Roof Coverings	\$100,951	9.51 %
Wall Finishes	\$122,278	11.52 %
Total	\$1,061,302	100 %

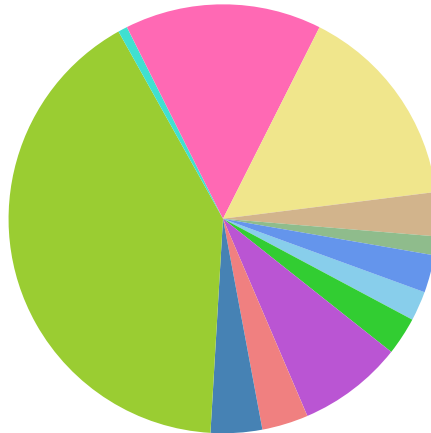
Distribution of Capital Needs by Building System

Building System	Estimated Cost	Percentage of Total Cost
B20 Exterior Enclosure	\$64,186	2.24 %
B30 Roofing	\$82,060	2.86 %
C10 Interior Construction	\$226,885	7.91 %
C20 Interior Finishes	\$100,138	3.49 %
D20 Plumbing	\$111,107	3.88 %
D30 HVAC	\$1,174,137	40.95 %
D40 Fire Protection Systems	\$20,312	0.71 %
D50 Electrical Systems	\$424,927	14.82 %
D60 Communication Systems	\$446,661	15.58 %
D70 Security Systems	\$94,857	3.31 %
D80 Automation Systems	\$40,624	1.42 %
E10 Equipment	\$81,045	2.83 %
Total	\$2,866,939	100 %

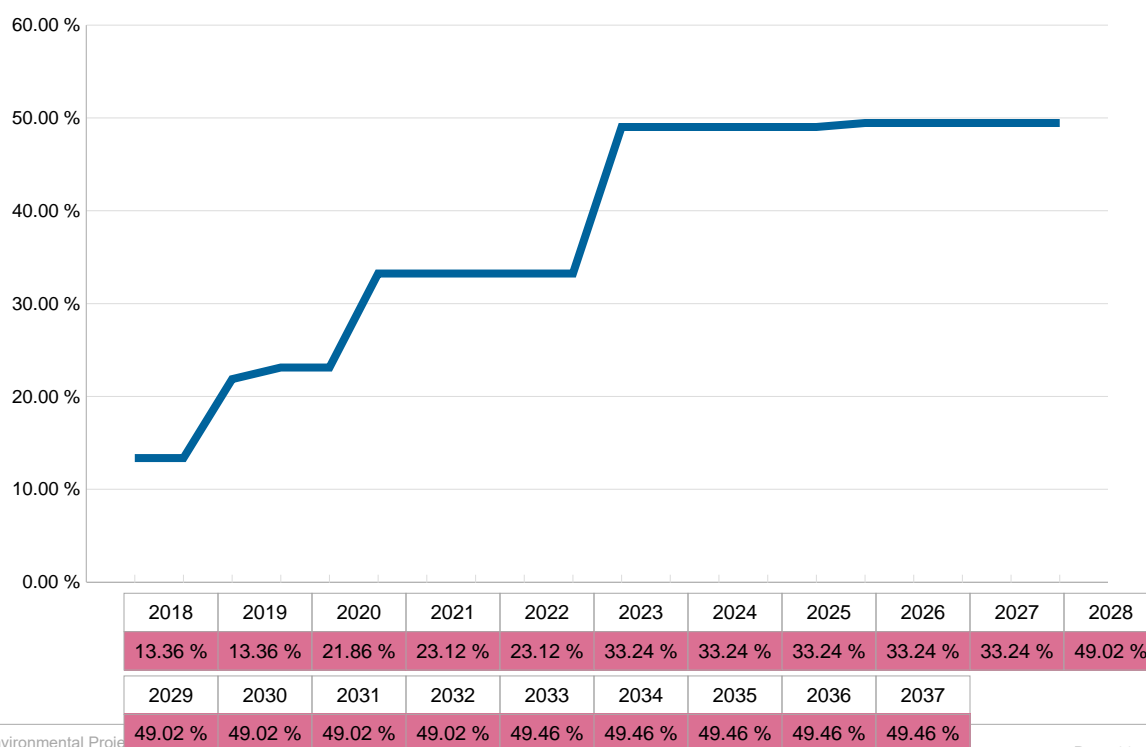
Cumulative Effects of FCI Over the Study Period

The Chart below indicates the cumulative effects of the FCI ratio over the study period assuming the required funds and expenditures are NOT provided to address the identified works and deferred maintenance each year.

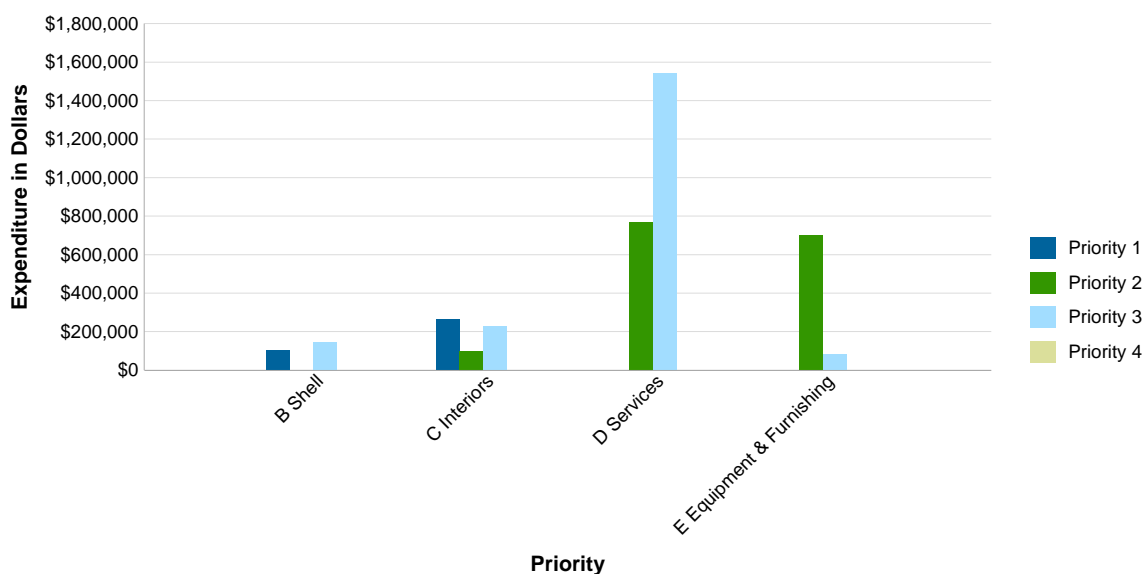
Planning Horizon Needs by System and Priority

The chart below illustrates the breakdown of expenditure according the priority coding providing an opportunity to strategically plan and effectively direct funding to the highest priority.

Building System	Priority 1	Priority 2	Priority 3	Priority 4	Total
B Shell	\$100,951	\$0	\$146,246	\$0	\$247,197
C Interiors	\$262,837	\$100,138	\$226,885	\$0	\$589,860
D Services	\$0	\$769,522	\$1,543,103	\$0	\$2,312,624
E Equipment & Furnishing	\$0	\$697,514	\$81,045	\$0	\$778,559
Total	\$363,788	\$1,567,174	\$1,997,279	\$0	\$3,928,241
