Facilities Condition Assessment Report

I. FCA Executive Summary

North Kitsap School District

Breidablik Elementary School Main
25142 Waghorn Rd NW
Poulsbo, WA

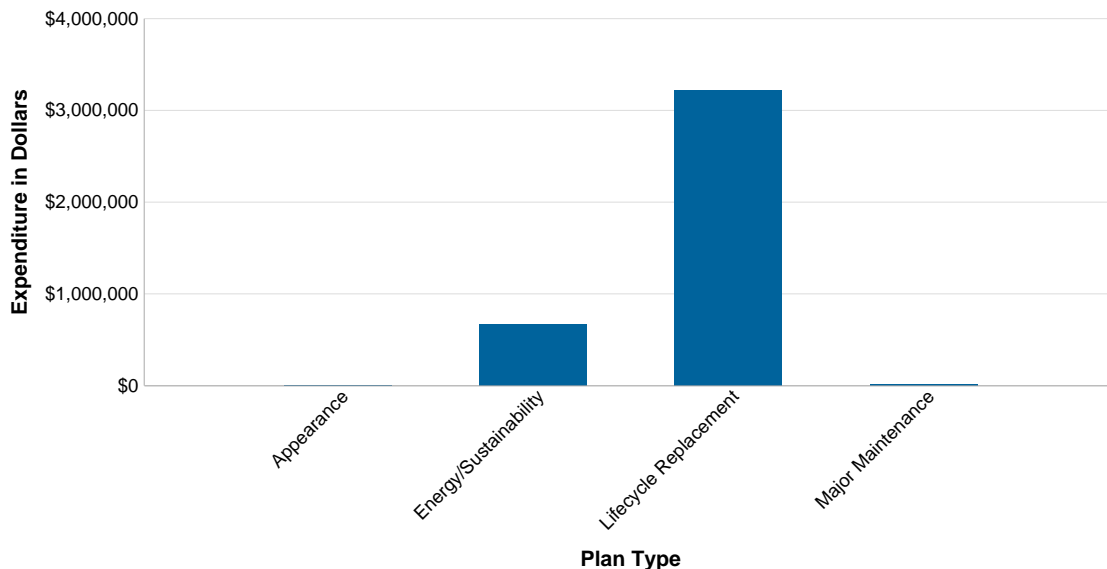
Planning Horizon Needs by Category

The chart below illustrates the breakdown of expenditure according to the Plan Type or deficiency categories providing an opportunity to strategically plan and effectively direct funding.

Building System	Total Cost
Appearance	\$10,562
Energy/Sustainability	\$674,665
Lifecycle Replacement	\$3,224,327
Major Maintenance	\$18,687
Total	\$3,928,241

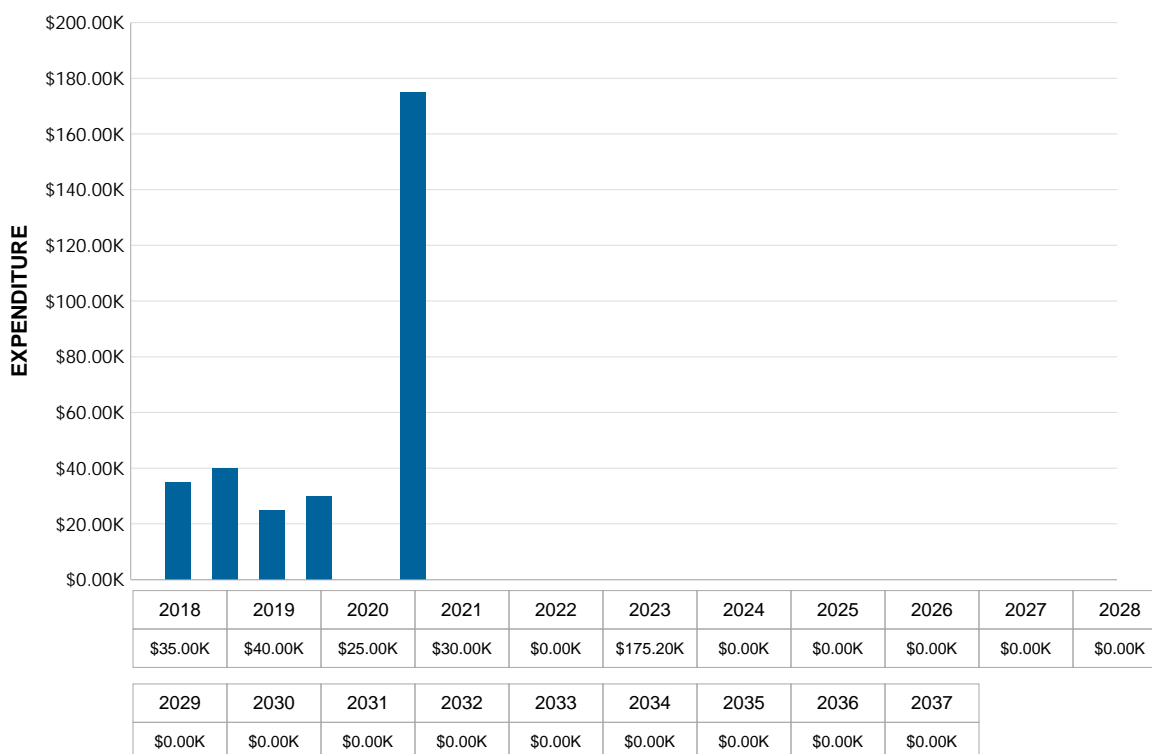
Expenditure Forecast Over Study Period

The building expenditure summary section provides an executive overview of the findings from the assessment. The chart below provides a summary of yearly anticipated expenditures over the study period for the North Kitsap High School Site building. In addition, we have scheduled key findings highlighting key items of greater than \$5,000 and their anticipated failure year. Further details of these expenditures are included within each respective report section and within the expenditure forecast, in Appendix A of this report. The results illustrate a total anticipated expenditure over the study period of approximately \$305,200.

- G Building Sitework: Re-feed and re-valve irrigation system for fields. at an estimated cost of \$20,000 in year 2018
- G Building Sitework: Perform exterior lighting study and design per IESNA recommendations. at an estimated cost of \$15,000 in year 2018

- G Building Sitework: Repair and re-surface tennis courts. Repair fencing. at an estimated cost of \$25,000 in year 2021
- G Building Sitework: Maintenance and selective planting. Aerate/topdress/overseed. at an estimated cost of \$5,000 in year 2021

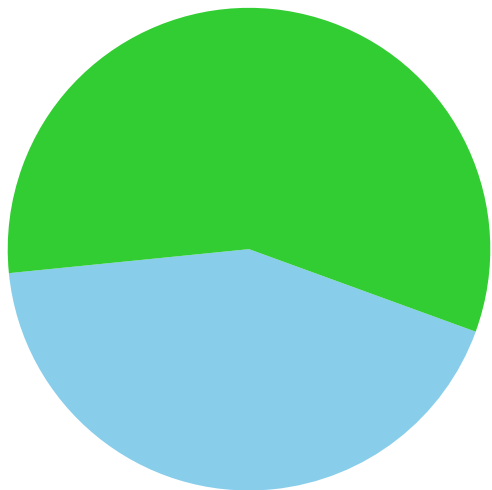
Distribution of Immediate Needs by Building System

Site Lighting Water Utilities

Building System	Estimated Cost	Percentage of Total Cost
Site Lighting	\$15,000	42.86 %
Water Utilities	\$20,000	57.14 %
Total	\$35,000	100 %

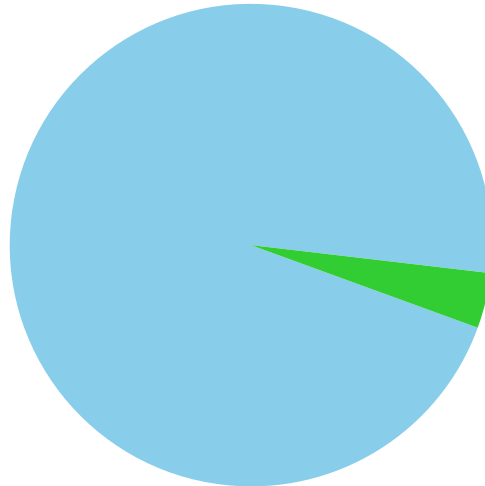
Distribution of Capital Needs by Building System

■ G20 Site Improvements ■ G30 Site Civil/Mechanical Utilities

Building System	Estimated Cost	Percentage of Total Cost
G20 Site Improvements	\$260,200	96.30 %
G30 Site Civil/Mechanical Utilities	\$10,000	3.70 %
Total	\$270,200	100 %

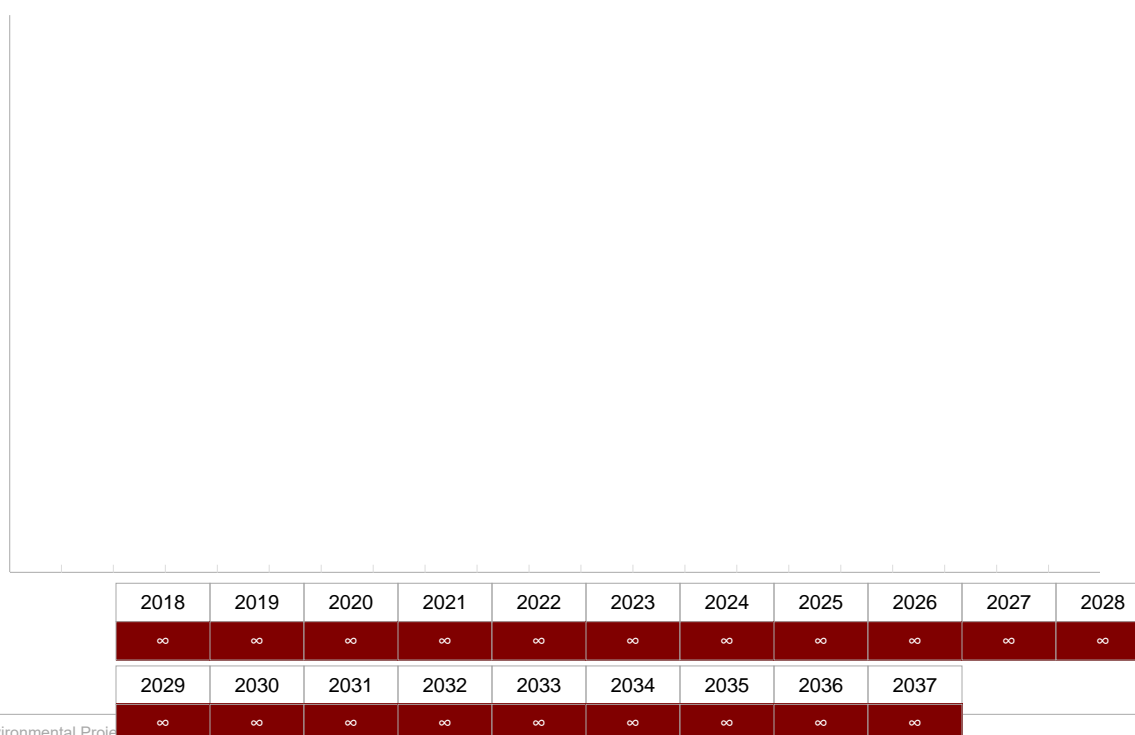
Cumulative Effects of FCI Over the Study Period

The Chart below indicates the cumulative effects of the FCI ratio over the study period assuming the required funds and expenditures are NOT provided to address the identified works and deferred maintenance each year.

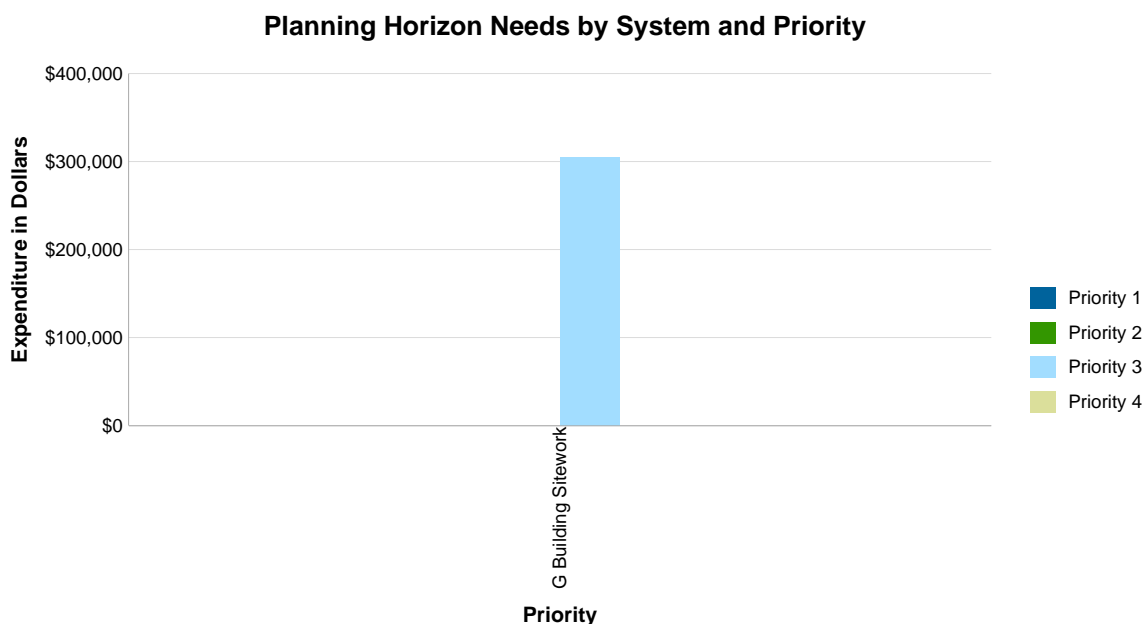
The chart below illustrates the breakdown of expenditure according the priority coding providing an opportunity to strategically plan and effectively direct funding to the highest priority.

Building System	Priority 1	Priority 2	Priority 3	Priority 4	Total
G Building Sitework	\$0	\$0	\$305,200	\$0	\$305,200
Total	\$0	\$0	\$305,200	\$0	\$305,200

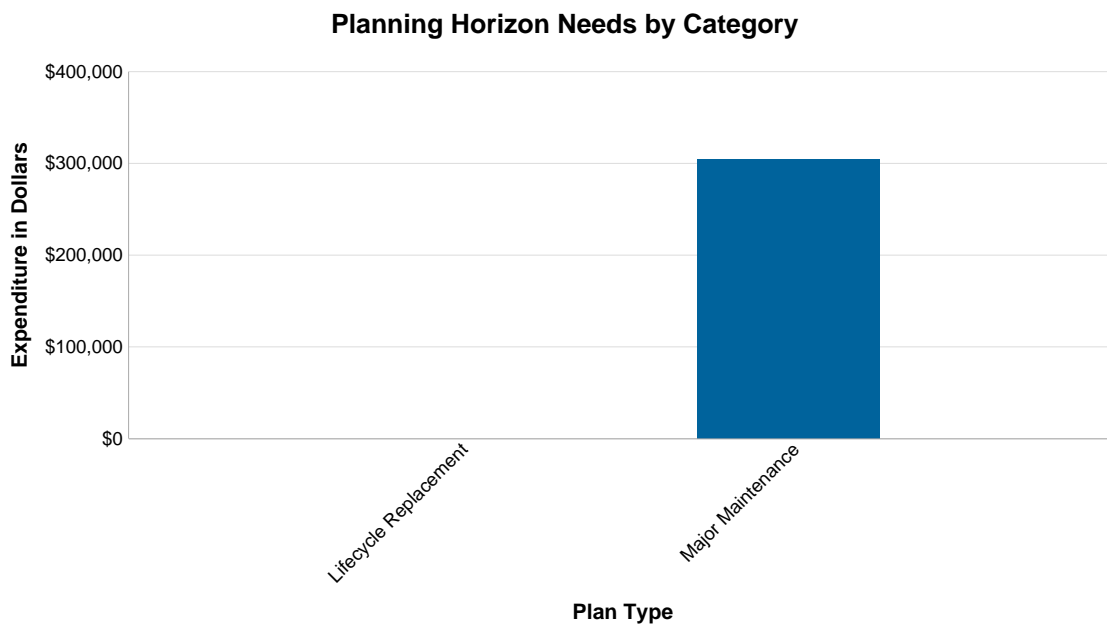
The chart below illustrates the breakdown of expenditure according to the Plan Type or deficiency categories providing an opportunity to strategically plan and effectively direct funding.

Building System	Total Cost
Lifecycle Replacement	\$0
Major Maintenance	\$305,200
Total	\$305,200

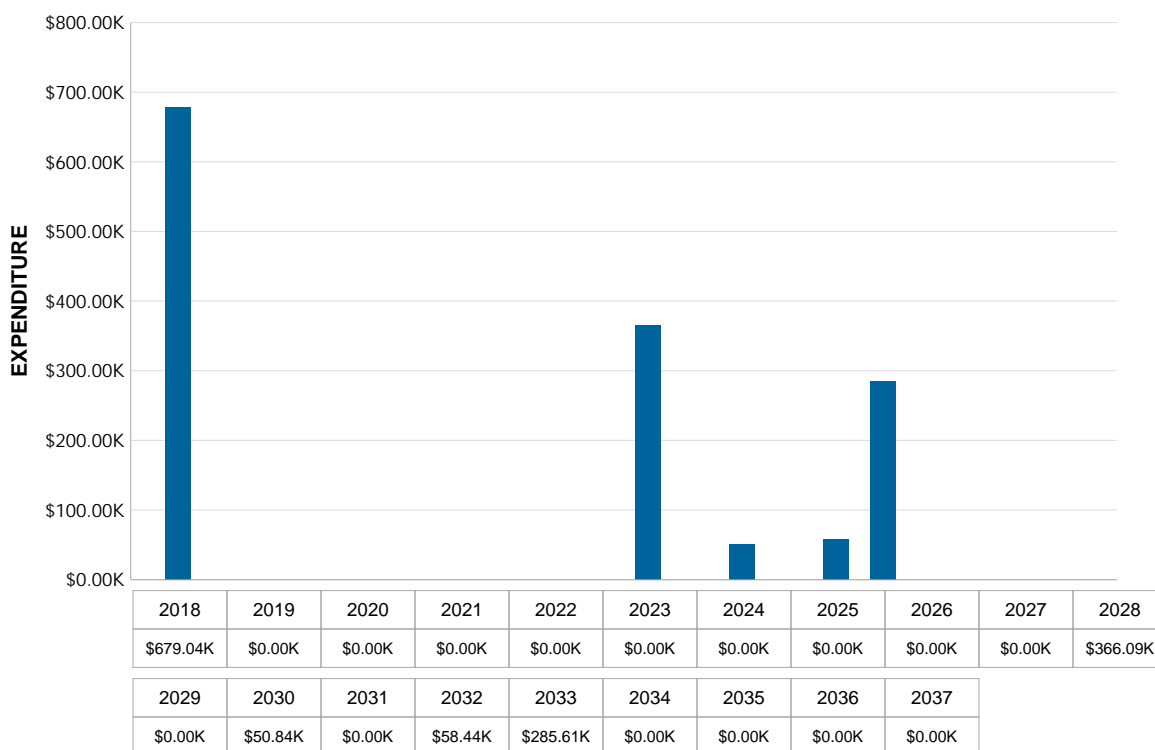
Expenditure Forecast Over Study Period

The building expenditure summary section provides an executive overview of the findings from the assessment. The chart below provides a summary of yearly anticipated expenditures over the study period for the PAL Program Main building. In addition, we have scheduled key findings highlighting key items of greater than \$5,000 and their anticipated failure year. Further details of these expenditures are included within each respective report section and within the expenditure forecast, in Appendix A of this report. The results illustrate a total anticipated expenditure over the study period of approximately \$1,440,016.

- B Shell: Replace Exterior Walls at an estimated cost of \$65,027 in year 2018
- B Shell: Replace Exterior Windows at an estimated cost of \$14,525 in year 2018

- D Services: Replace all cabinet radiators with high efficiency units that are controlled via DDC system at an estimated cost of \$270,000 in year 2018

- D Services: Replace all HVAC ductwork with new. at an estimated cost of \$72,205 in year 2018
- D Services: Upgrade energy controls to expandable DDC type at an estimated cost of \$51,515 in year 2018

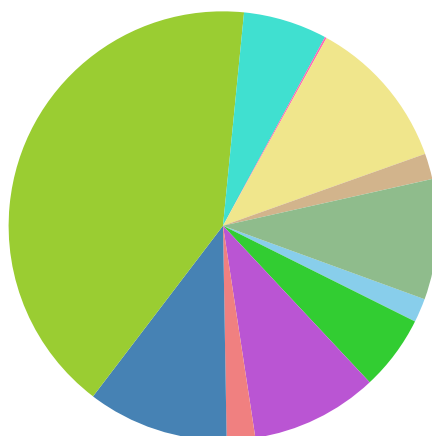
Distribution of Immediate Needs by Building System

Building System	Estimated Cost	Percentage of Total Cost
Building Support Plumbing Systems	\$12,256	1.80 %
Domestic Water Distribution	\$38,425	5.66 %
Exterior Walls	\$65,027	9.58 %
Exterior Windows	\$14,525	2.14 %
Facility HVAC Distribution Systems	\$72,205	10.63 %
Heating Systems	\$279,712	41.19 %
Interior Doors	\$42,901	6.32 %
Interior Fabrications	\$929	0.14 %
Interior Partitions	\$78,370	11.54 %
Interior Windows	\$13,174	1.94 %
Ventilation	\$61,515	9.06 %
Total	\$679,037	100 %

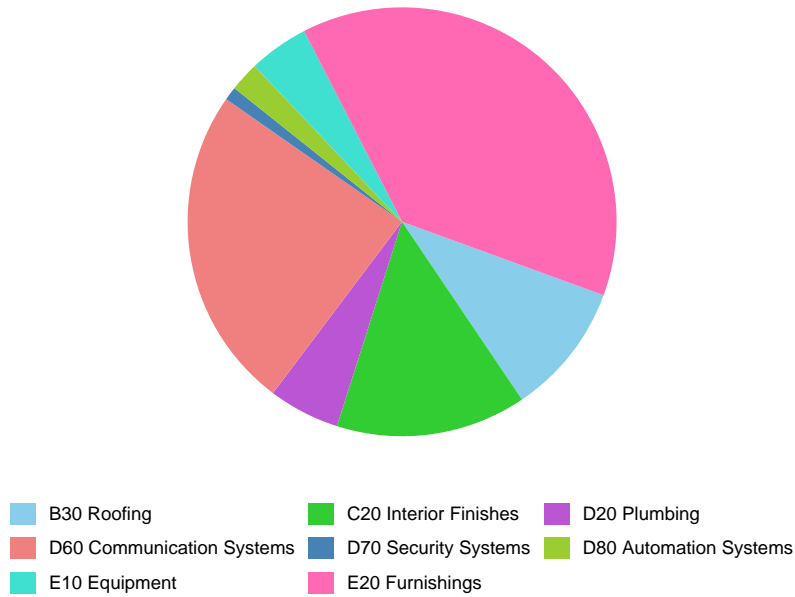
Distribution of Capital Needs by Building System

Building System	Estimated Cost	Percentage of Total Cost
B30 Roofing	\$76,089	10.00 %
C20 Interior Finishes	\$109,278	14.36 %
D20 Plumbing	\$40,874	5.37 %
D60 Communication Systems	\$185,706	24.40 %
D70 Security Systems	\$7,769	1.02 %
D80 Automation Systems	\$16,890	2.22 %
E10 Equipment	\$34,371	4.52 %
E20 Furnishings	\$290,001	38.11 %
Total	\$760,979	100 %

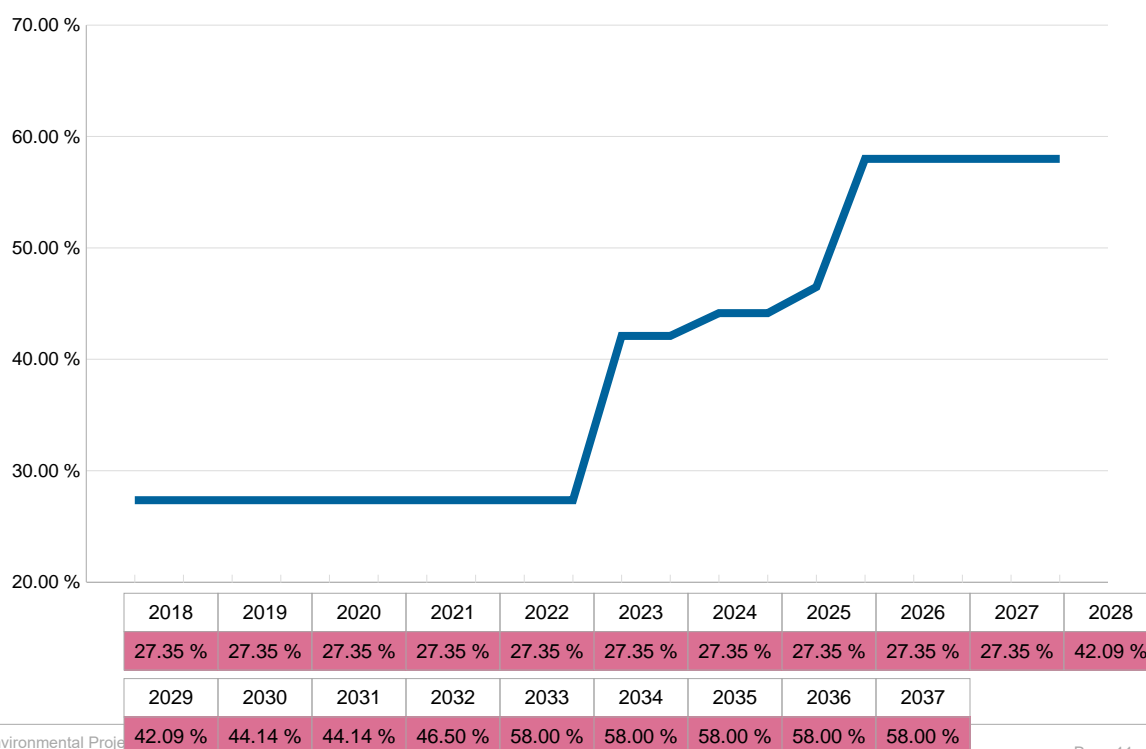
Cumulative Effects of FCI Over the Study Period

The Chart below indicates the cumulative effects of the FCI ratio over the study period assuming the required funds and expenditures are NOT provided to address the identified works and deferred maintenance each year.

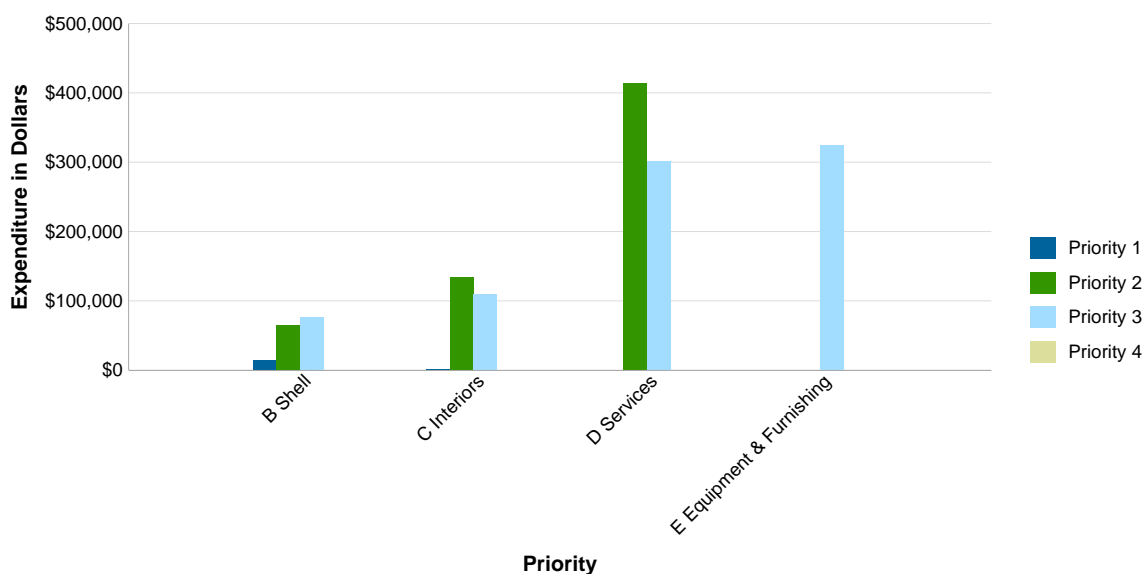
Planning Horizon Needs by System and Priority

The chart below illustrates the breakdown of expenditure according the priority coding providing an opportunity to strategically plan and effectively direct funding to the highest priority.

Building System	Priority 1	Priority 2	Priority 3	Priority 4	Total
B Shell	\$14,525	\$65,027	\$76,089	\$0	\$155,641
C Interiors	\$929	\$134,444	\$109,278	\$0	\$244,652
D Services	\$0	\$413,431	\$301,920	\$0	\$715,351
E Equipment & Furnishing	\$0	\$0	\$324,372	\$0	\$324,372
Total	\$15,454	\$612,902	\$811,660	\$0	\$1,440,016

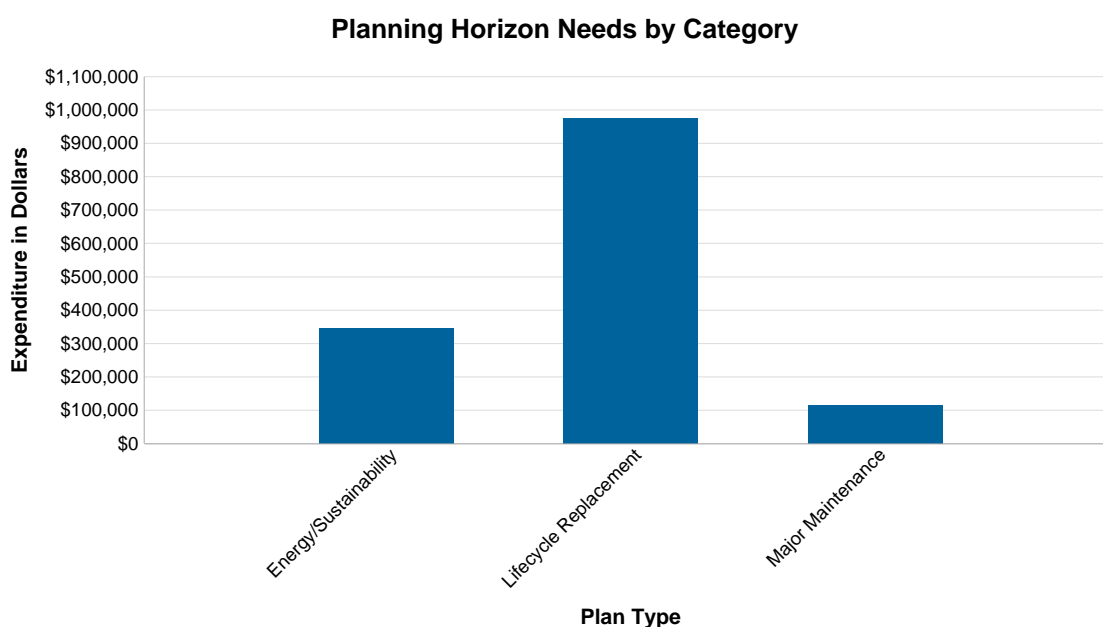
The chart below illustrates the breakdown of expenditure according to the Plan Type or deficiency categories providing an opportunity to strategically plan and effectively direct funding.

Building System	Total Cost
Energy/Sustainability	\$347,982
Lifecycle Replacement	\$975,904
Major Maintenance	\$116,130
Total	\$1,440,016

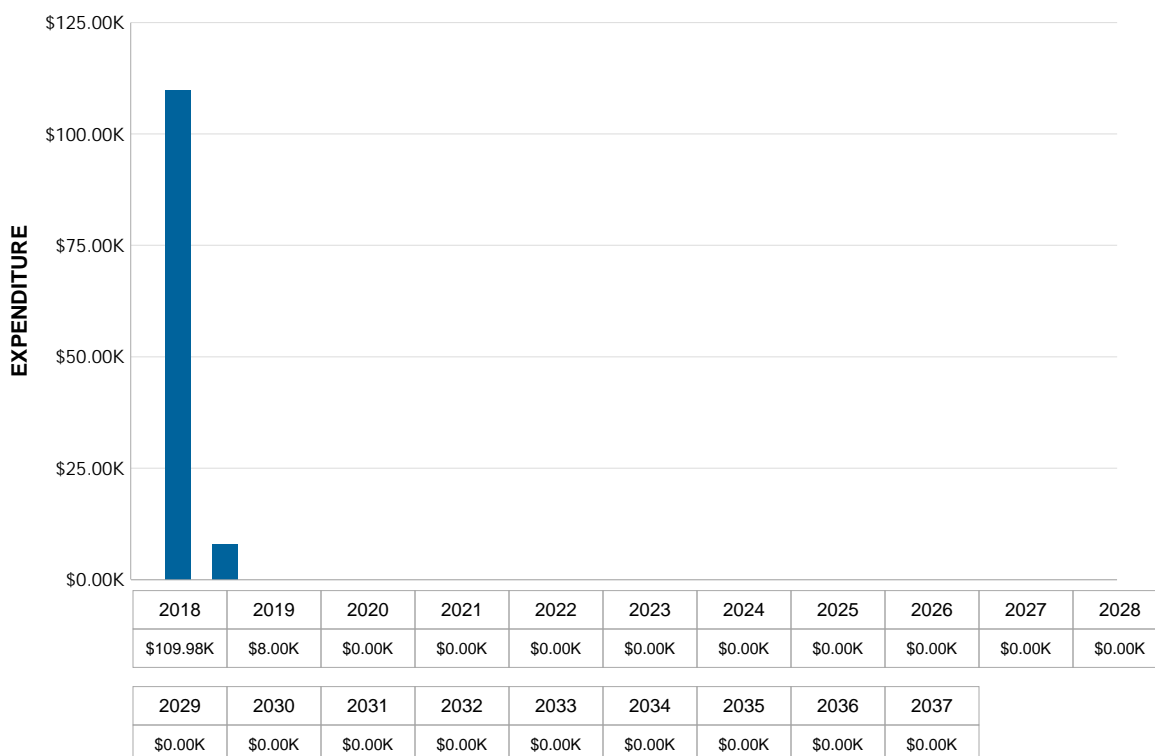
Expenditure Forecast Over Study Period

The building expenditure summary section provides an executive overview of the findings from the assessment. The chart below provides a summary of yearly anticipated expenditures over the study period for the PAL Program Site building. In addition, we have scheduled key findings highlighting key items of greater than \$5,000 and their anticipated failure year. Further details of these expenditures are included within each respective report section and within the expenditure forecast, in Appendix A of this report. The results illustrate a total anticipated expenditure over the study period of approximately \$117,980.

- G Building Sitework: Remove and selectively grade. Replace asphalt and gravel paving. at an estimated cost of \$109,980 in year 2018
- G Building Sitework: Remove existing asphalt/gravel and re-pave. at an estimated cost of \$8,000 in year 2019

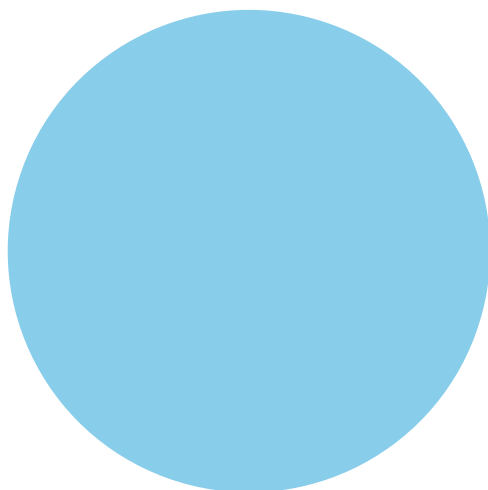
Distribution of Immediate Needs by Building System

■ Roadways

Building System	Estimated Cost	Percentage of Total Cost
Roadways	\$109,980	100.00 %
Total	\$109,980	100 %

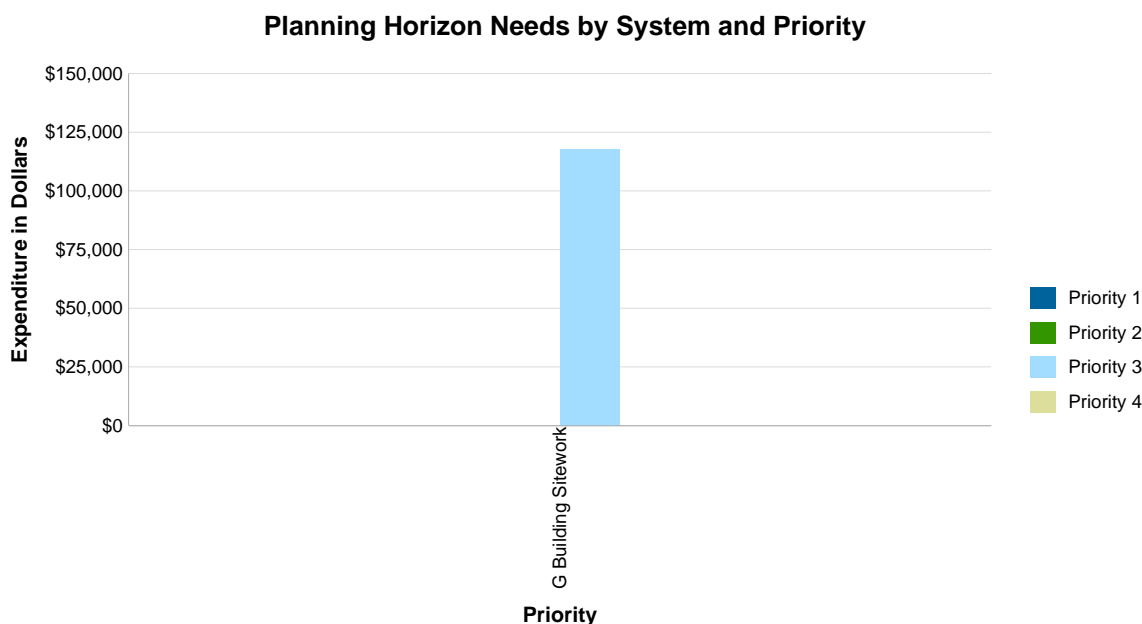
The chart below illustrates the breakdown of expenditure according the priority coding providing an opportunity to strategically plan and effectively direct funding to the highest priority.

Building System	Priority 1	Priority 2	Priority 3	Priority 4	Total
G Building Sitework	\$0	\$0	\$117,980	\$0	\$117,980
Total	\$0	\$0	\$117,980	\$0	\$117,980

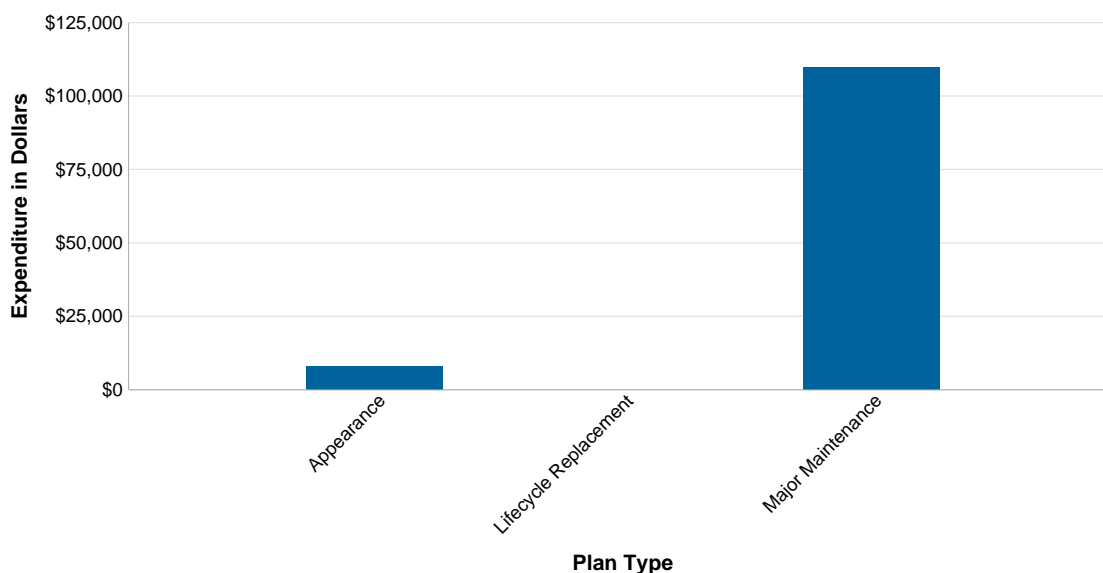
Planning Horizon Needs by Category

The chart below illustrates the breakdown of expenditure according to the Plan Type or deficiency categories providing an opportunity to strategically plan and effectively direct funding.

Building System	Total Cost
Appearance	\$8,000
Lifecycle Replacement	\$0
Major Maintenance	\$109,980
Total	\$117,980

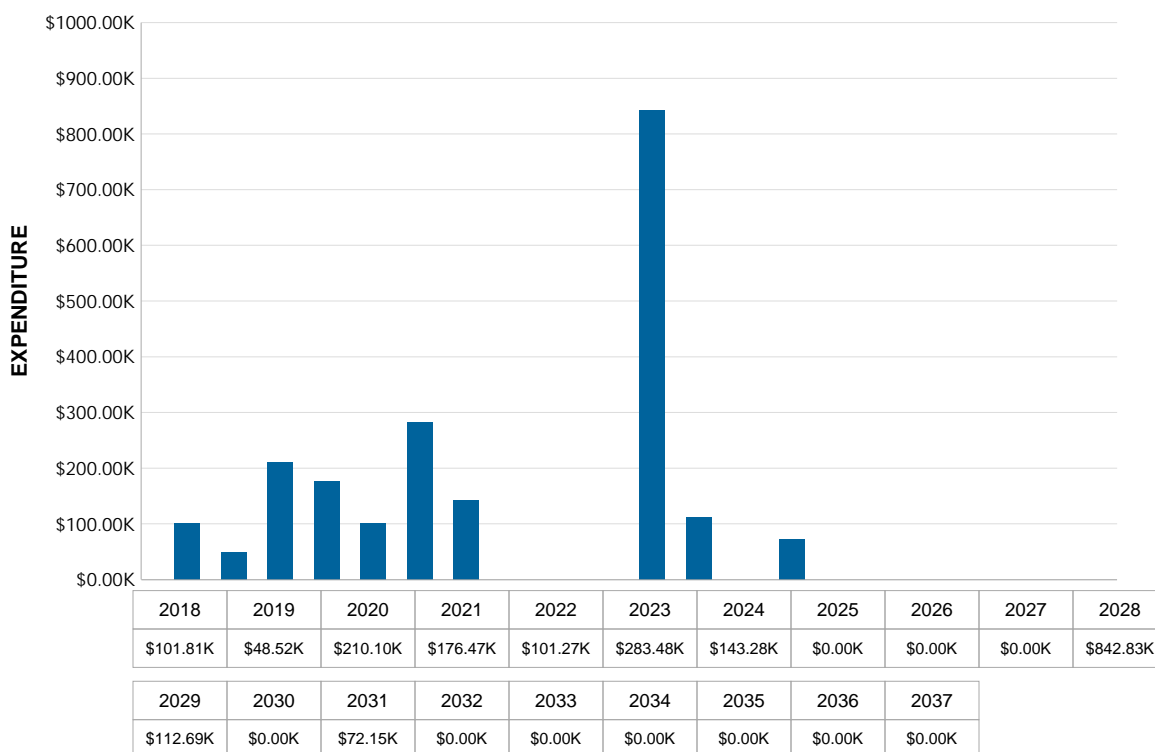
Expenditure Forecast Over Study Period

The building expenditure summary section provides an executive overview of the findings from the assessment. The chart below provides a summary of yearly anticipated expenditures over the study period for the Facilities/Maintenance Department Main building. In addition, we have scheduled key findings highlighting key items of greater than \$5,000 and their anticipated failure year. Further details of these expenditures are included within each respective report section and within the expenditure forecast, in Appendix A of this report. The results illustrate a total anticipated expenditure over the study period of approximately \$2,092,614.

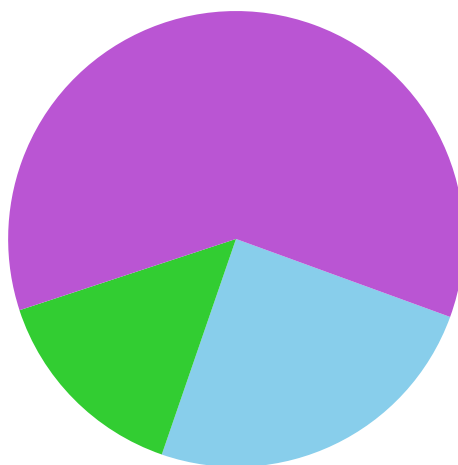
Distribution of Immediate Needs by Building System

■ Exterior Windows
 ■ Lighting
 ■ Roof Coverings

Building System	Estimated Cost	Percentage of Total Cost
Exterior Windows	\$25,172	24.72 %
Lighting	\$14,928	14.66 %
Roof Coverings	\$61,712	60.61 %
Total	\$101,812	100 %

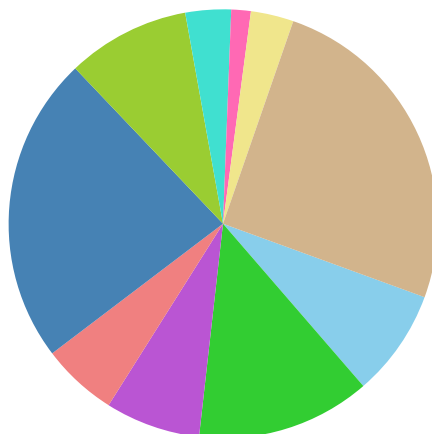
Distribution of Capital Needs by Building System

B20 Exterior Enclos C20 Interior Finishes D20 Plumbing D30 HVAC
 D50 Electrical Syste D60 Communication Syst D70 Security Syste D80 Automation Syst
 E10 Equipment E20 Furnishings

Building System	Estimated Cost	Percentage of Total Cost
B20 Exterior Enclosure	\$161,213	8.10 %
C20 Interior Finishes	\$261,527	13.14 %
D20 Plumbing	\$142,700	7.17 %
D30 HVAC	\$113,828	5.72 %
D50 Electrical Systems	\$462,264	23.22 %
D60 Communication Systems	\$184,694	9.28 %
D70 Security Systems	\$68,345	3.43 %
D80 Automation Systems	\$29,270	1.47 %
E10 Equipment	\$64,394	3.23 %
E20 Furnishings	\$502,566	25.24 %
Total	\$1,990,802	100 %

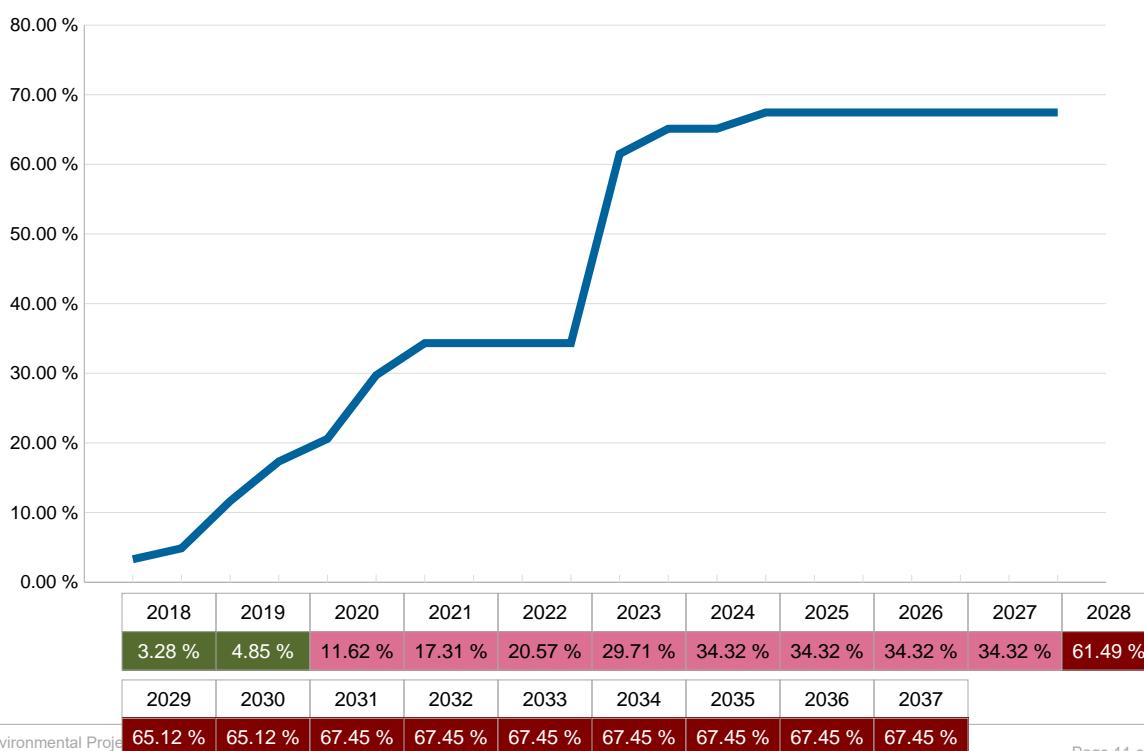
Cumulative Effects of FCI Over the Study Period

The Chart below indicates the cumulative effects of the FCI ratio over the study period assuming the required funds and expenditures are NOT provided to address the identified works and deferred maintenance each year.

In this report we have calculated the Facility Condition Index (FCI) which is used in Facilities Management to provide a benchmark to compare the relative condition of a group of facilities. The FCI is primarily used to support asset management initiatives of federal, state, and local government facilities organizations. The FCI is the ratio of accumulated Total Cost (TC) (Maintenance, Lifecycle Renewal and Plant Adaptation) to the Current Replacement Value (CRV) for a constructed asset calculated by dividing the TC by the CRV. The range is from zero for a newly constructed asset, to one for a constructed asset with a TC value equal to its CRV. Acceptable ranges vary by "Asset Type", but as a general guideline the FCI scoring system is as follows:

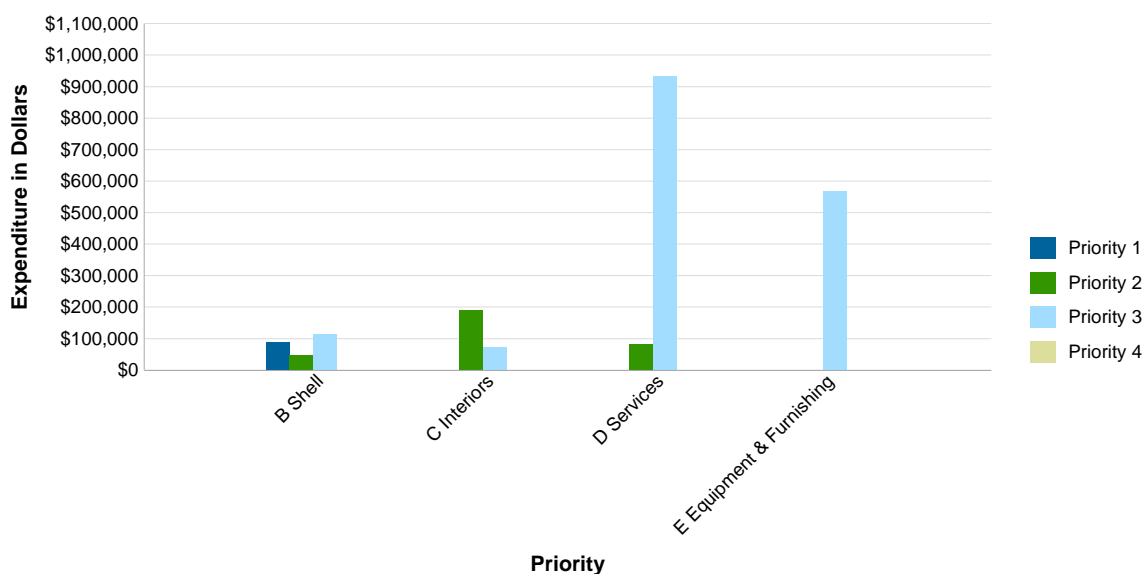
Planning Horizon Needs by System and Priority

The chart below illustrates the breakdown of expenditure according the priority coding providing an opportunity to strategically plan and effectively direct funding to the highest priority.

Building System	Priority 1	Priority 2	Priority 3	Priority 4	Total
B Shell	\$86,885	\$48,524	\$112,690	\$0	\$248,098
C Interiors	\$0	\$189,377	\$72,151	\$0	\$261,527
D Services	\$0	\$83,273	\$932,756	\$0	\$1,016,029
E Equipment & Furnishing	\$0	\$0	\$566,960	\$0	\$566,960
Total	\$86,885	\$321,174	\$1,684,556	\$0	\$2,092,614

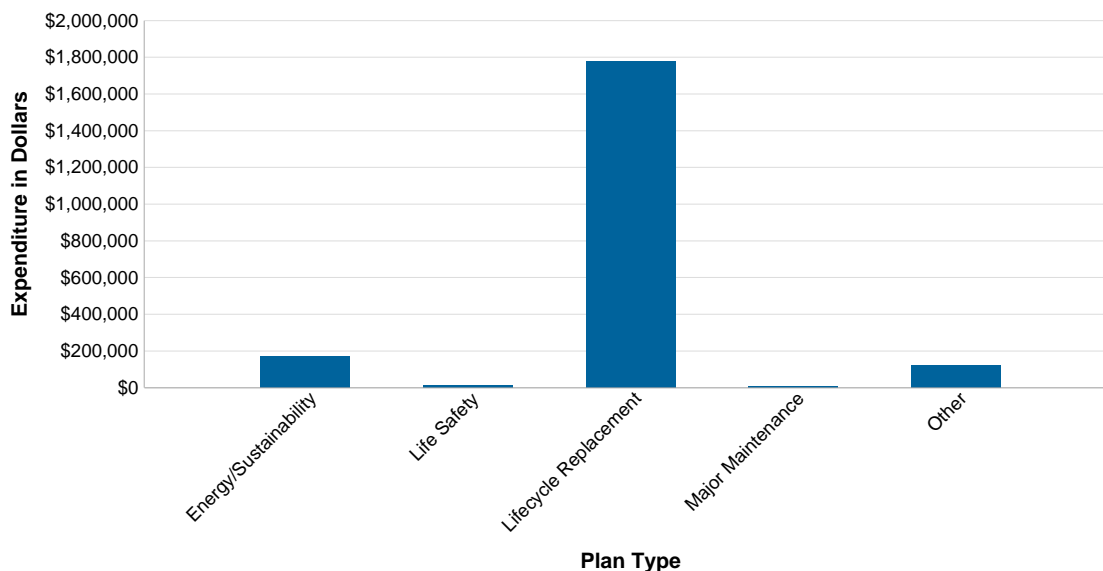
Planning Horizon Needs by Category

The chart below illustrates the breakdown of expenditure according to the Plan Type or deficiency categories providing an opportunity to strategically plan and effectively direct funding.

Building System	Total Cost
Energy/Sustainability	\$169,547
Life Safety	\$14,928
Lifecycle Replacement	\$1,779,212
Major Maintenance	\$6,928
Other	\$122,000
Total	\$2,092,614

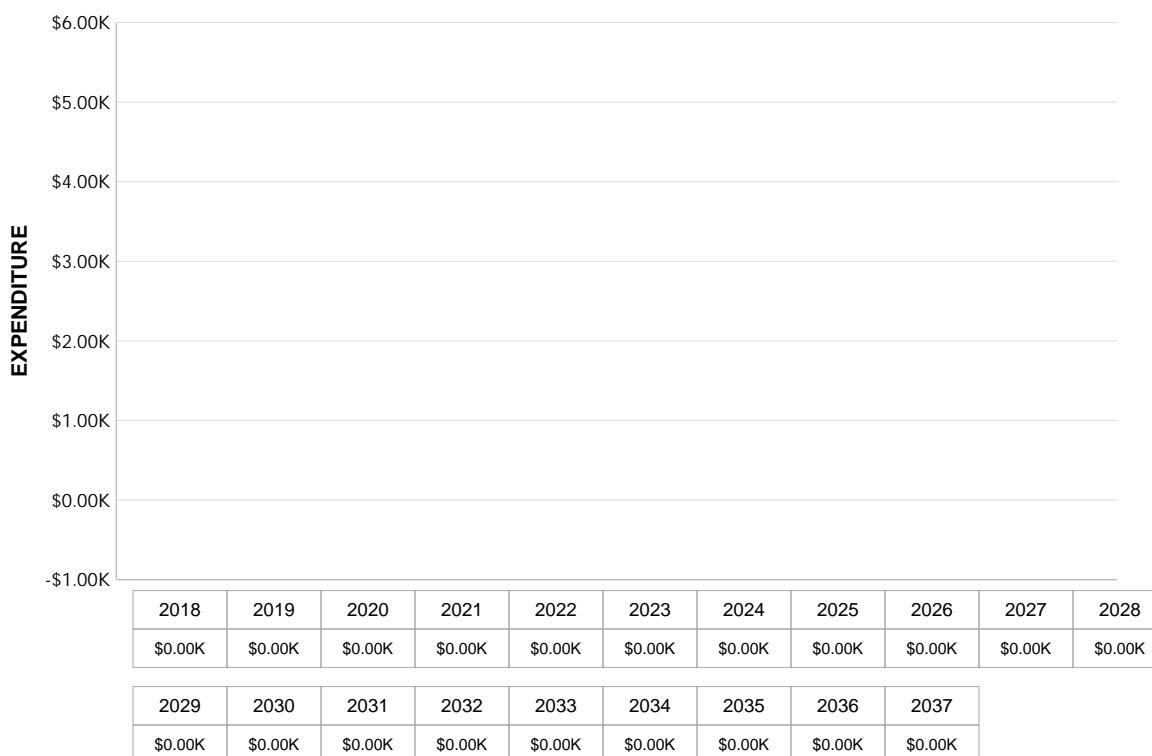
Expenditure Forecast Over Study Period

The building expenditure summary section provides an executive overview of the findings from the assessment. The chart below provides a summary of yearly anticipated expenditures over the study period for the Facilities/Maintenance Department Site building. In addition, we have scheduled key findings highlighting key items of greater than \$5,000 and their anticipated failure year. Further details of these expenditures are included within each respective report section and within the expenditure forecast, in Appendix A of this report. The results illustrate a total anticipated expenditure over the study period of approximately \$0.

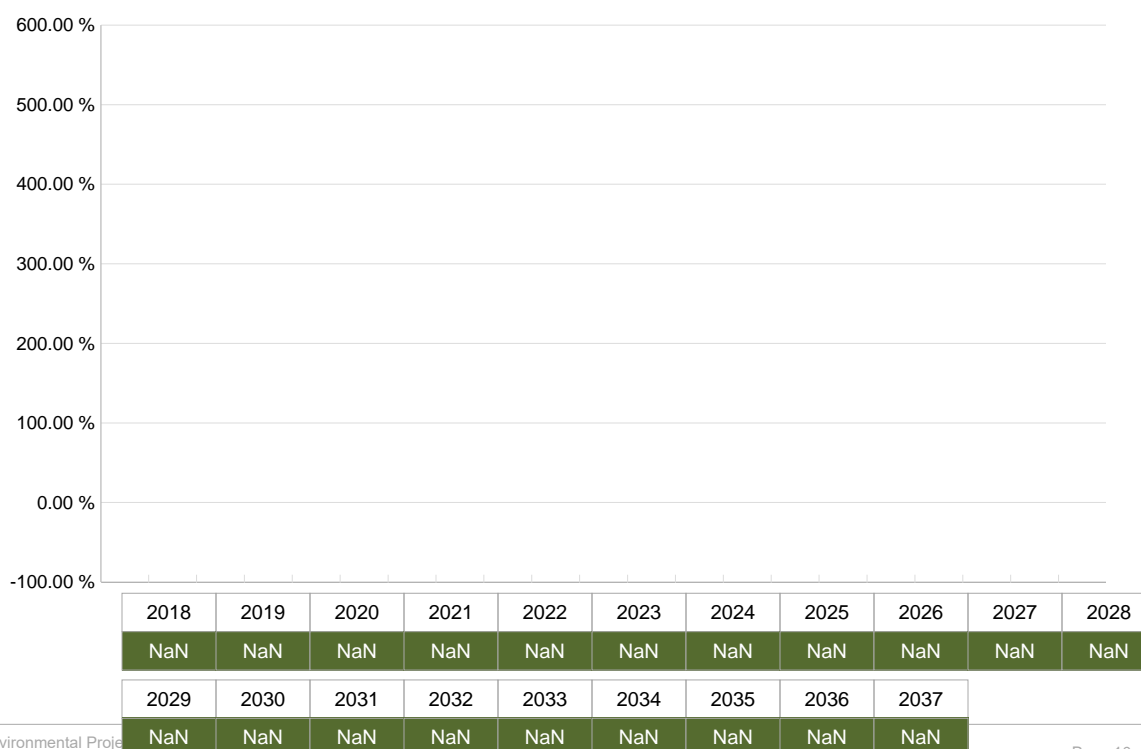
Cumulative Effects of FCI Over the Study Period

The Chart below indicates the cumulative effects of the FCI ratio over the study period assuming the required funds and expenditures are NOT provided to address the identified works and deferred maintenance each year.

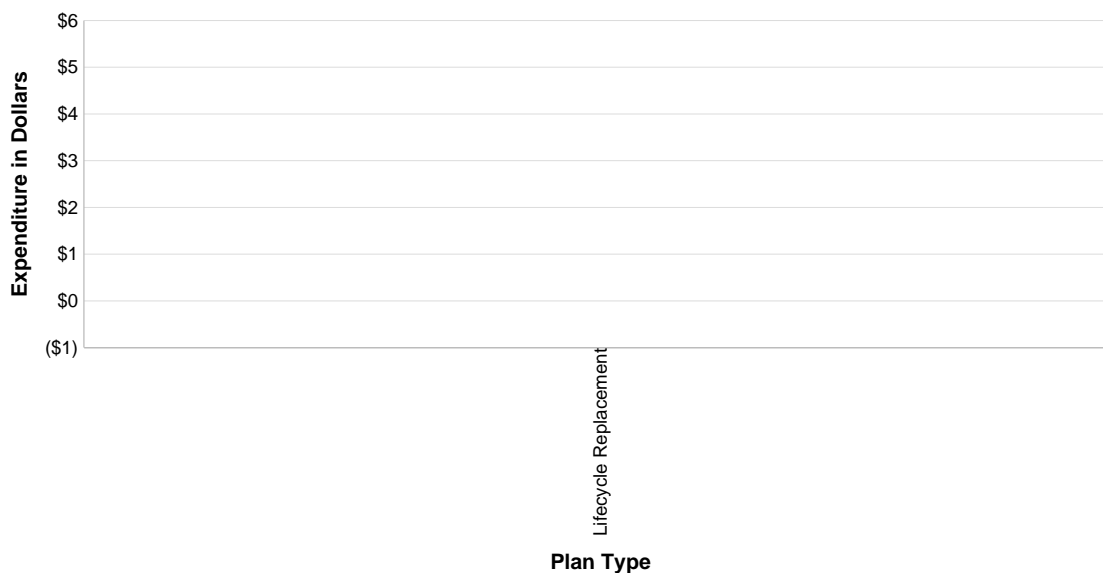
Planning Horizon Needs by Category

The chart below illustrates the breakdown of expenditure according to the Plan Type or deficiency categories providing an opportunity to strategically plan and effectively direct funding.

Building System	Total Cost
Lifecycle Replacement	\$0
Total	\$0

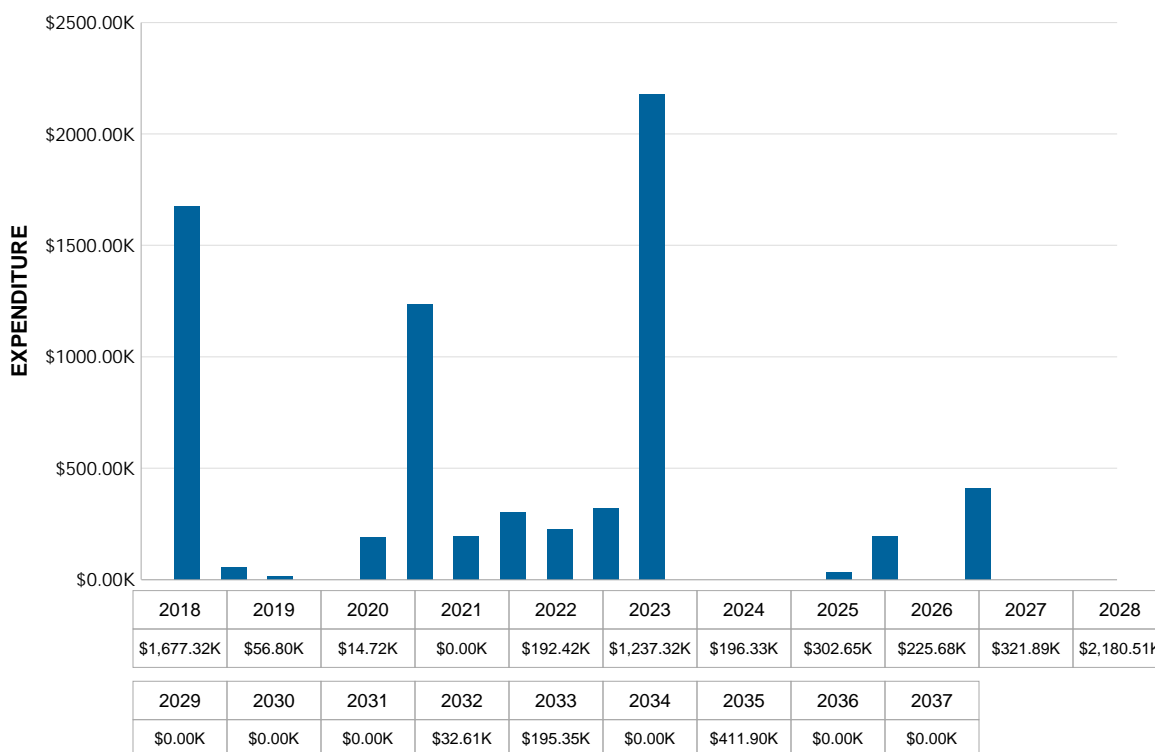
Expenditure Forecast Over Study Period

The building expenditure summary section provides an executive overview of the findings from the assessment. The chart below provides a summary of yearly anticipated expenditures over the study period for the North Kitsap Community Center Main building. In addition, we have scheduled key findings highlighting key items of greater than \$5,000 and their anticipated failure year. Further details of these expenditures are included within each respective report section and within the expenditure forecast, in Appendix A of this report. The results illustrate a total anticipated expenditure over the study period of approximately \$7,045,504.

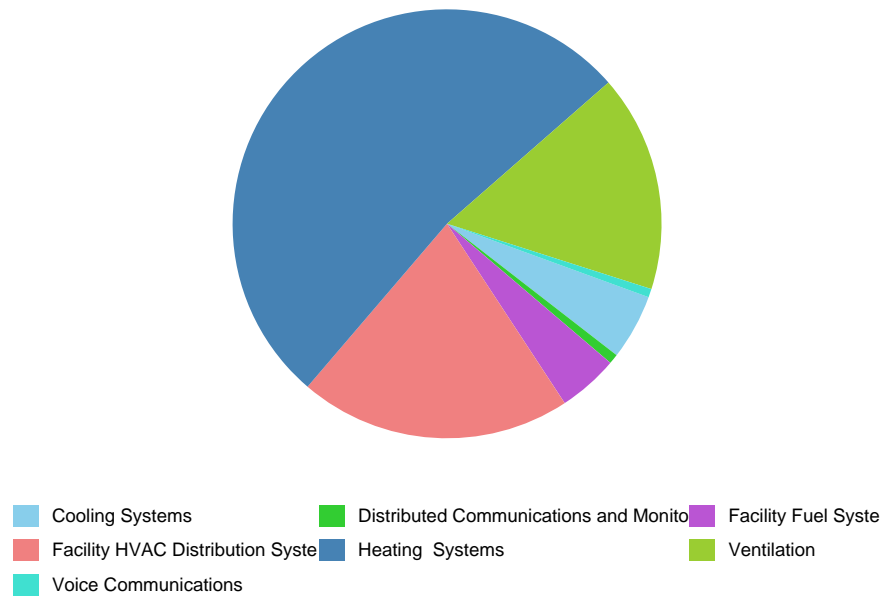
Distribution of Immediate Needs by Building System

Building System	Estimated Cost	Percentage of Total Cost
Cooling Systems	\$82,837	4.94 %
Distributed Communications and Monitoring	\$12,320	0.73 %
Facility Fuel Systems	\$75,988	4.53 %
Facility HVAC Distribution Systems	\$344,067	20.51 %
Heating Systems	\$876,964	52.28 %
Ventilation	\$274,496	16.37 %
Voice Communications	\$10,650	0.63 %
Total	\$1,677,322	100 %

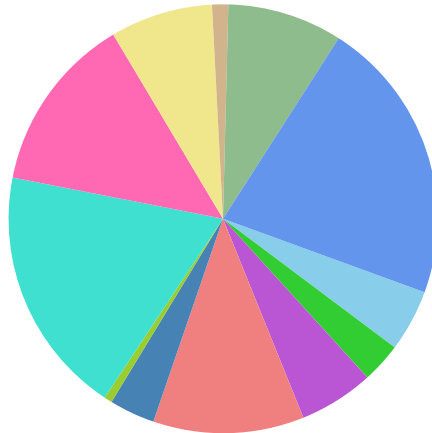
Distribution of Capital Needs by Building System

Building System	Estimated Cost	Percentage of Total Cost
B20 Exterior Enclosure	\$251,120	4.68 %
B30 Roofing	\$162,087	3.02 %
C10 Interior Construction	\$302,649	5.64 %
C20 Interior Finishes	\$610,886	11.38 %
D20 Plumbing	\$184,193	3.43 %
D40 Fire Protection Systems	\$32,613	0.61 %
D50 Electrical Systems	\$1,007,865	18.77 %
D60 Communication Systems	\$717,160	13.36 %
D70 Security Systems	\$415,163	7.73 %
D80 Automation Systems	\$65,226	1.22 %
E10 Equipment	\$466,040	8.68 %
E20 Furnishings	\$1,153,180	21.48 %
Total	\$5,368,182	100 %

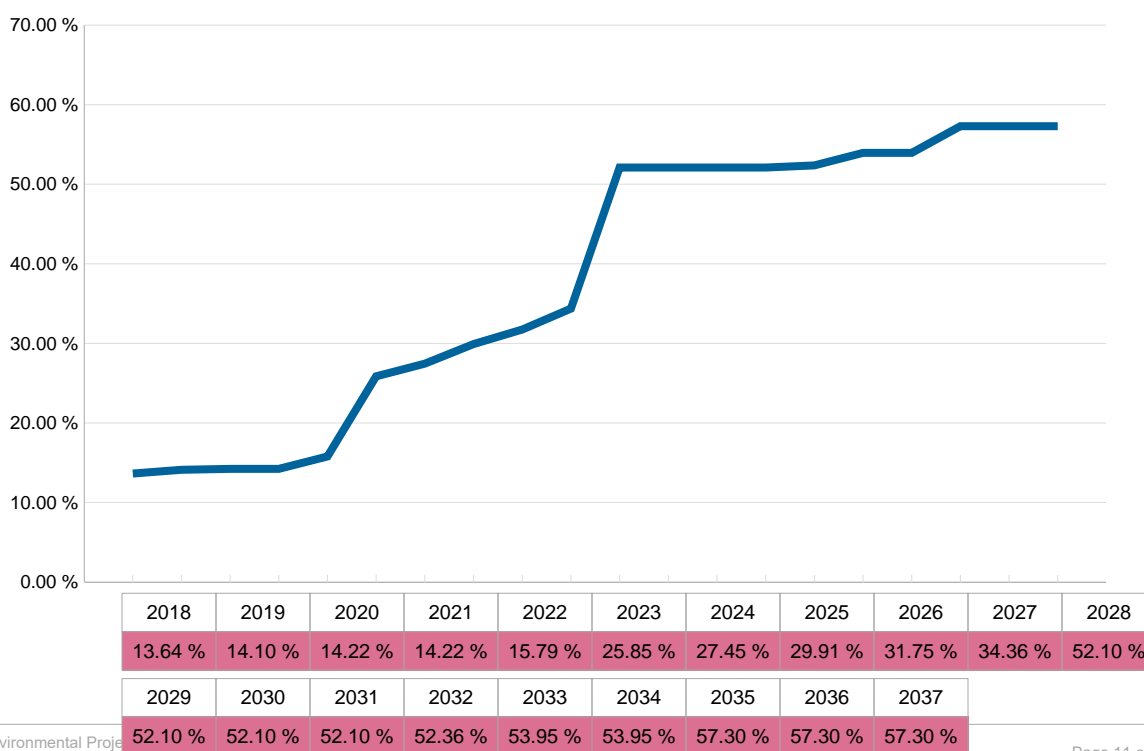
Cumulative Effects of FCI Over the Study Period

The Chart below indicates the cumulative effects of the FCI ratio over the study period assuming the required funds and expenditures are NOT provided to address the identified works and deferred maintenance each year.
