Facilities Condition Assessment Report

I. FCA Executive Summary

North Kitsap School District

Breidablik Elementary School Main
25142 Waghorn Rd NW
Poulsbo, WA

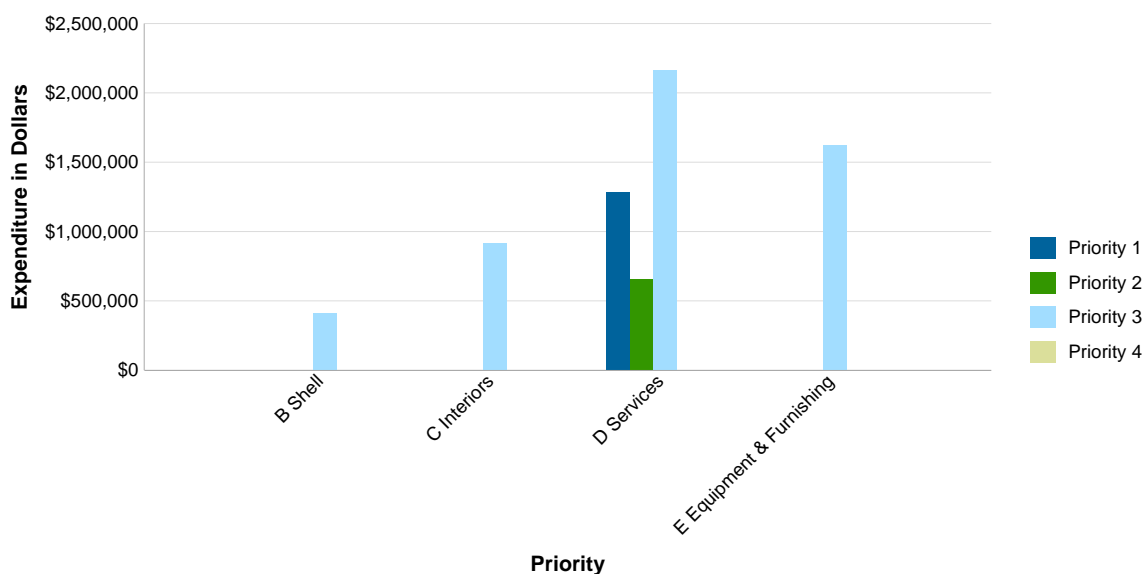
Planning Horizon Needs by System and Priority

The chart below illustrates the breakdown of expenditure according the priority coding providing an opportunity to strategically plan and effectively direct funding to the highest priority.

Building System	Priority 1	Priority 2	Priority 3	Priority 4	Total
B Shell	\$0	\$0	\$413,207	\$0	\$413,207
C Interiors	\$0	\$0	\$913,534	\$0	\$913,534
D Services	\$1,280,386	\$655,793	\$2,163,364	\$0	\$4,099,543
E Equipment & Furnishing	\$0	\$0	\$1,619,220	\$0	\$1,619,220
Total	\$1,280,386	\$655,793	\$5,109,325	\$0	\$7,045,504

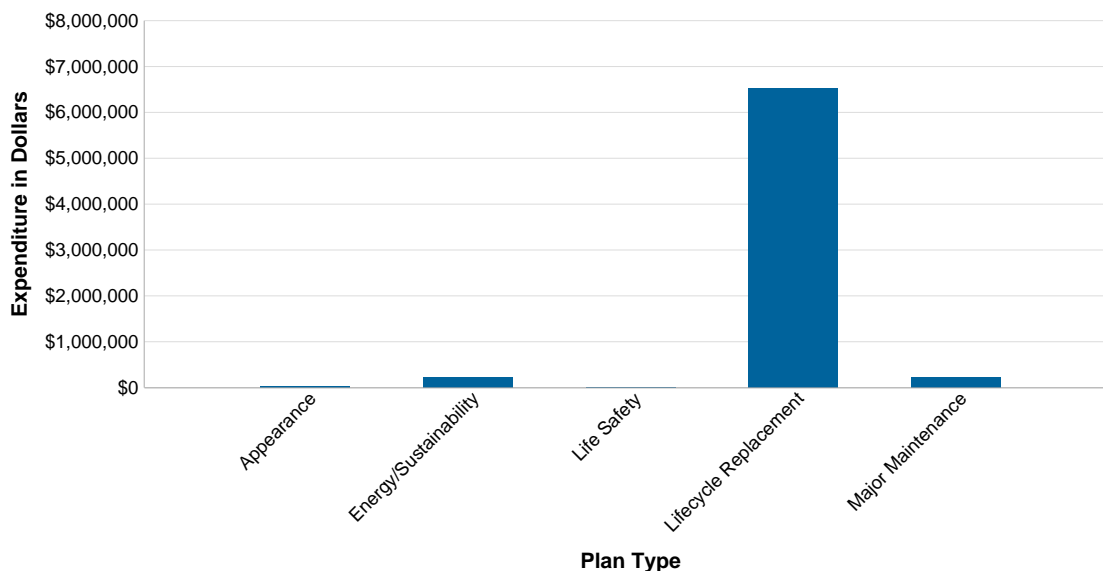
Planning Horizon Needs by Category

The chart below illustrates the breakdown of expenditure according to the Plan Type or deficiency categories providing an opportunity to strategically plan and effectively direct funding.

Building System	Total Cost
Appearance	\$28,091
Energy/Sustainability	\$236,399
Life Safety	\$12,320
Lifecycle Replacement	\$6,530,427
Major Maintenance	\$238,267
Total	\$7,045,504

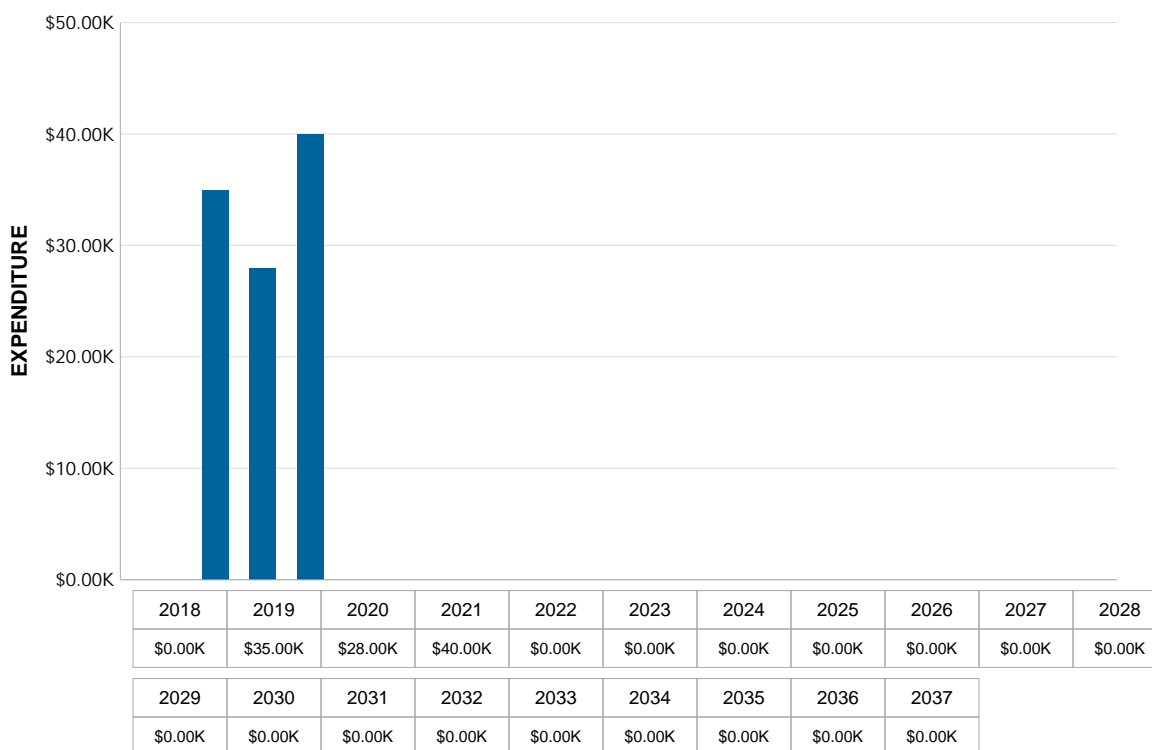
Expenditure Forecast Over Study Period

The building expenditure summary section provides an executive overview of the findings from the assessment. The chart below provides a summary of yearly anticipated expenditures over the study period for the North Kitsap Community Center Site building. In addition, we have scheduled key findings highlighting key items of greater than \$5,000 and their anticipated failure year. Further details of these expenditures are included within each respective report section and within the expenditure forecast, in Appendix A of this report. The results illustrate a total anticipated expenditure over the study period of approximately \$103,000.

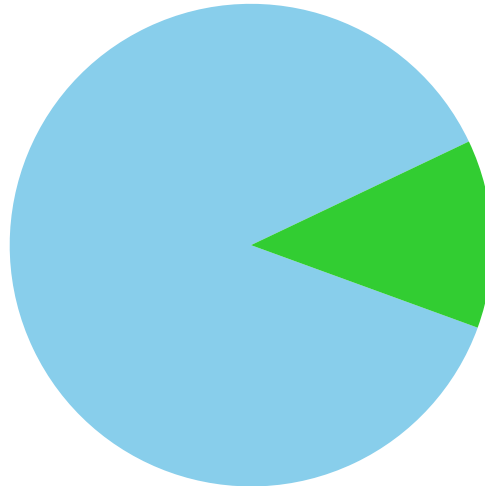
Distribution of Capital Needs by Building System

■ G20 Site Improvements ■ G30 Site Civil/Mechanical Utilities

Building System	Estimated Cost	Percentage of Total Cost
G20 Site Improvements	\$90,000	87.38 %
G30 Site Civil/Mechanical Utilities	\$13,000	12.62 %
Total	\$103,000	100 %

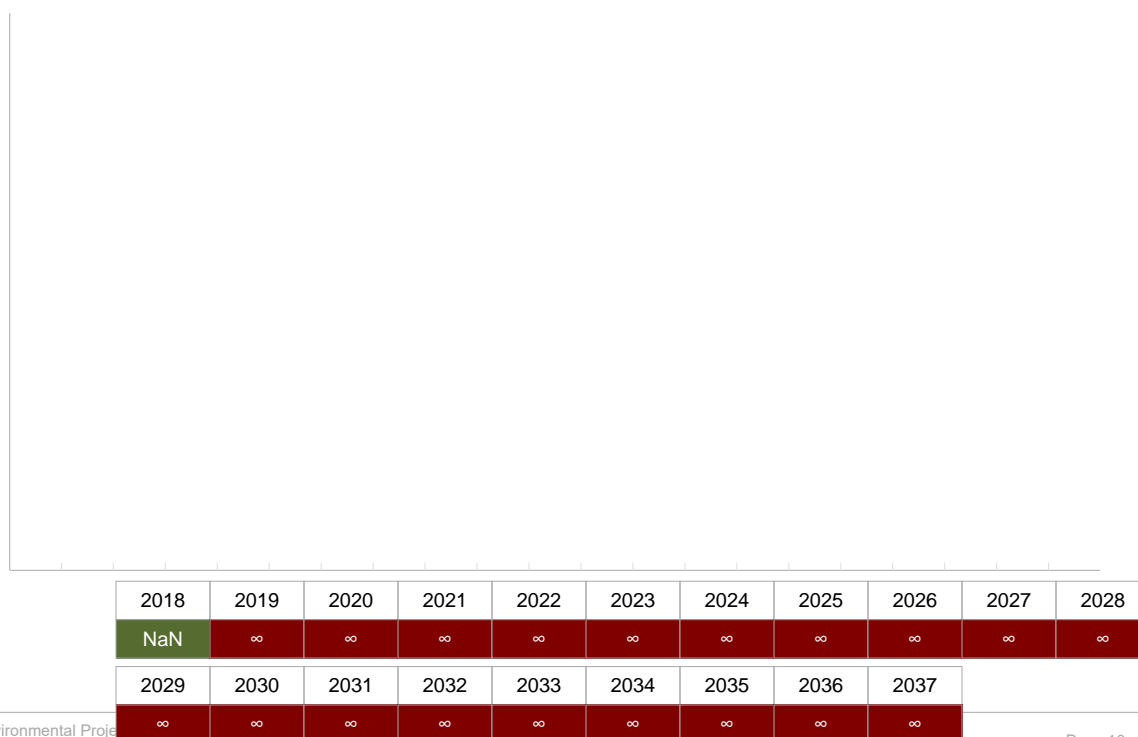
Cumulative Effects of FCI Over the Study Period

The Chart below indicates the cumulative effects of the FCI ratio over the study period assuming the required funds and expenditures are NOT provided to address the identified works and deferred maintenance each year.

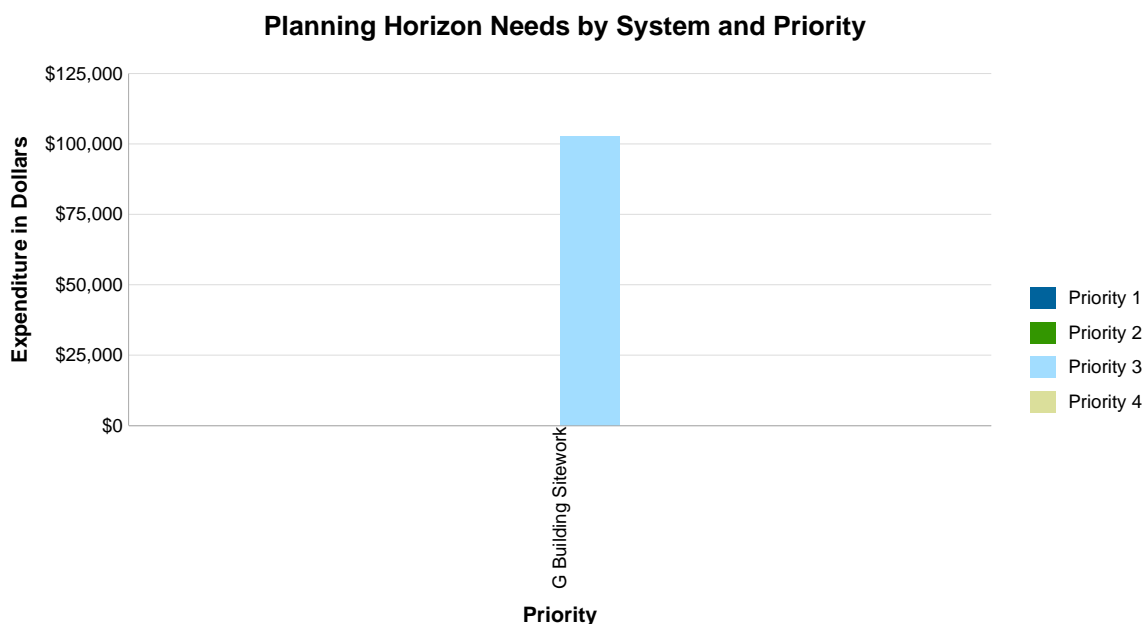
The chart below illustrates the breakdown of expenditure according the priority coding providing an opportunity to strategically plan and effectively direct funding to the highest priority.

Building System	Priority 1	Priority 2	Priority 3	Priority 4	Total
G Building Sitework	\$0	\$0	\$103,000	\$0	\$103,000
Total	\$0	\$0	\$103,000	\$0	\$103,000

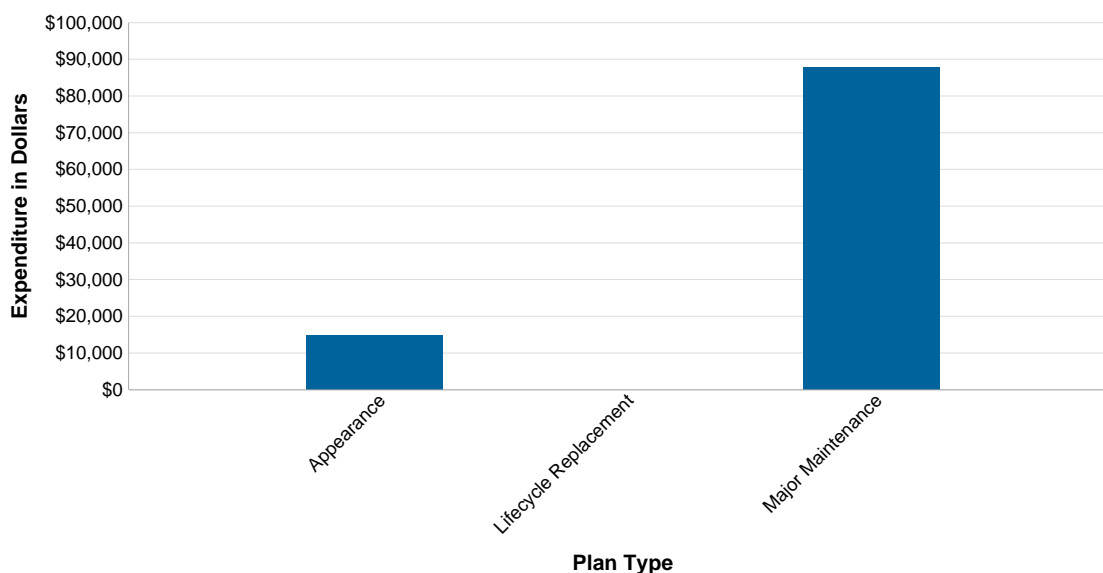
Planning Horizon Needs by Category

The chart below illustrates the breakdown of expenditure according to the Plan Type or deficiency categories providing an opportunity to strategically plan and effectively direct funding.

Building System	Total Cost
Appearance	\$15,000
Lifecycle Replacement	\$0
Major Maintenance	\$88,000
Total	\$103,000

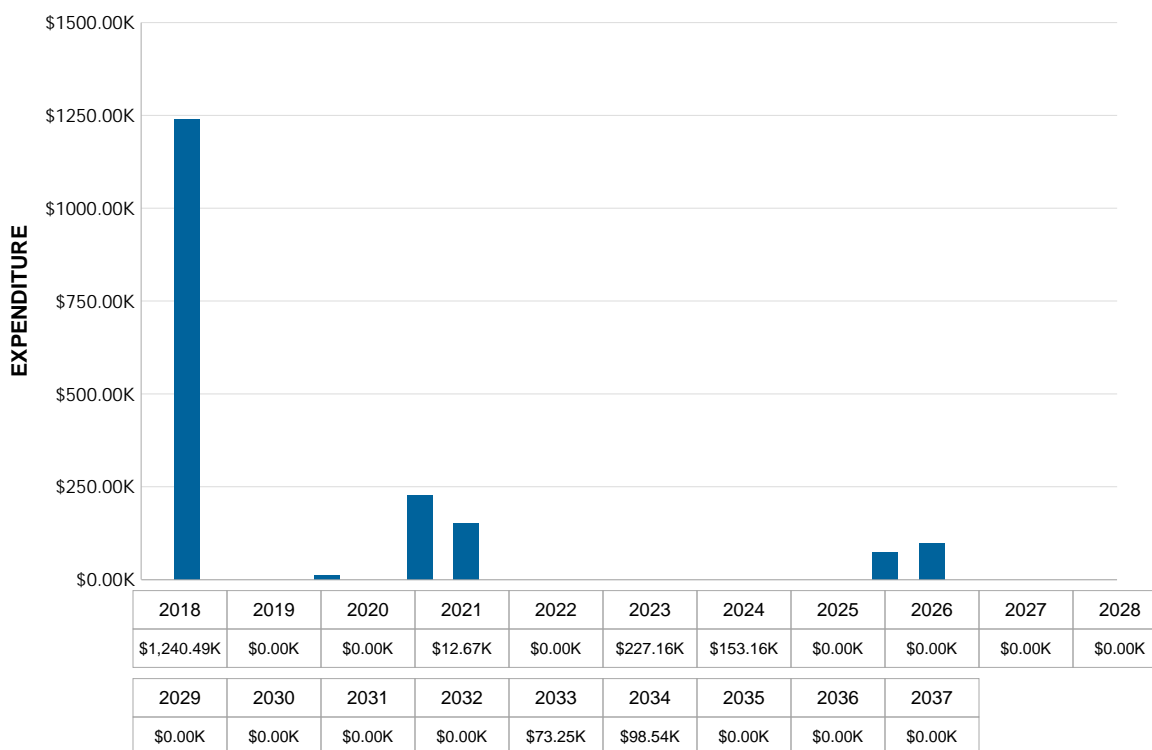
Expenditure Forecast Over Study Period

The building expenditure summary section provides an executive overview of the findings from the assessment. The chart below provides a summary of yearly anticipated expenditures over the study period for the North Kitsap Stadium Stadium building. In addition, we have scheduled key findings highlighting key items of greater than \$5,000 and their anticipated failure year. Further details of these expenditures are included within each respective report section and within the expenditure forecast, in Appendix A of this report. The results illustrate a total anticipated expenditure over the study period of approximately \$1,805,274.

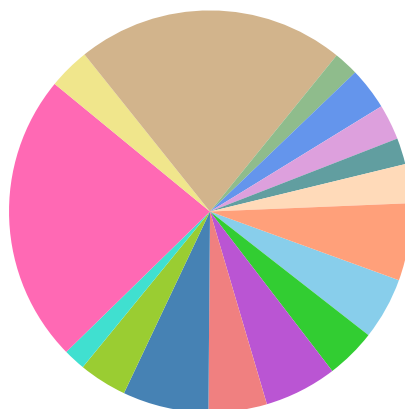
Distribution of Immediate Needs by Building System

Building System	Estimated Cost	Percentage of Total Cost
Building Support Plumbing Systems	\$61,942	4.99 %
Data Communications	\$50,168	4.04 %
Distributed Communications and Monitoring	\$72,437	5.84 %
Domestic Water Distribution	\$58,231	4.69 %
Electrical Service and Distribution	\$85,747	6.91 %
Electronic Surveillance	\$47,993	3.87 %
General Purpose Electrical Power	\$22,013	1.77 %
Heating Systems	\$288,467	23.25 %
Interior Doors	\$41,300	3.33 %
Lighting	\$267,734	21.58 %
Overhead Exterior Enclosures	\$24,715	1.99 %
Sanitary Drainage	\$42,233	3.40 %
Stairs	\$35,322	2.85 %
Ventilation	\$26,236	2.11 %

Voice Communications	\$38,906	3.14 %
Wall Finishes	\$77,044	6.21 %
Total	\$1,240,488	100 %

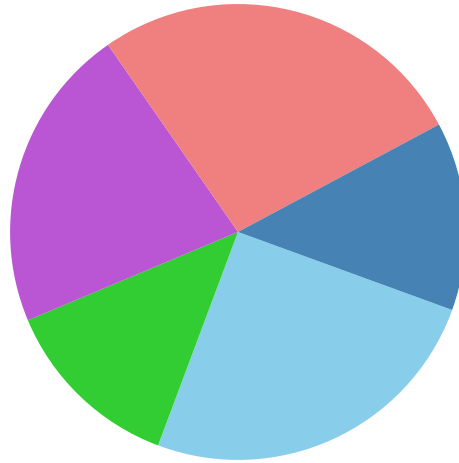
Distribution of Capital Needs by Building System

■ B20 Exterior Enclosure
 ■ B30 Roofing
 ■ C10 Interior Construction
■ C20 Interior Finishes
 ■ E10 Equipment

Building System	Estimated Cost	Percentage of Total Cost
B20 Exterior Enclosure	\$142,027	25.15 %
B30 Roofing	\$73,251	12.97 %
C10 Interior Construction	\$122,343	21.66 %
C20 Interior Finishes	\$151,656	26.85 %
E10 Equipment	\$75,508	13.37 %
Total	\$564,786	100 %

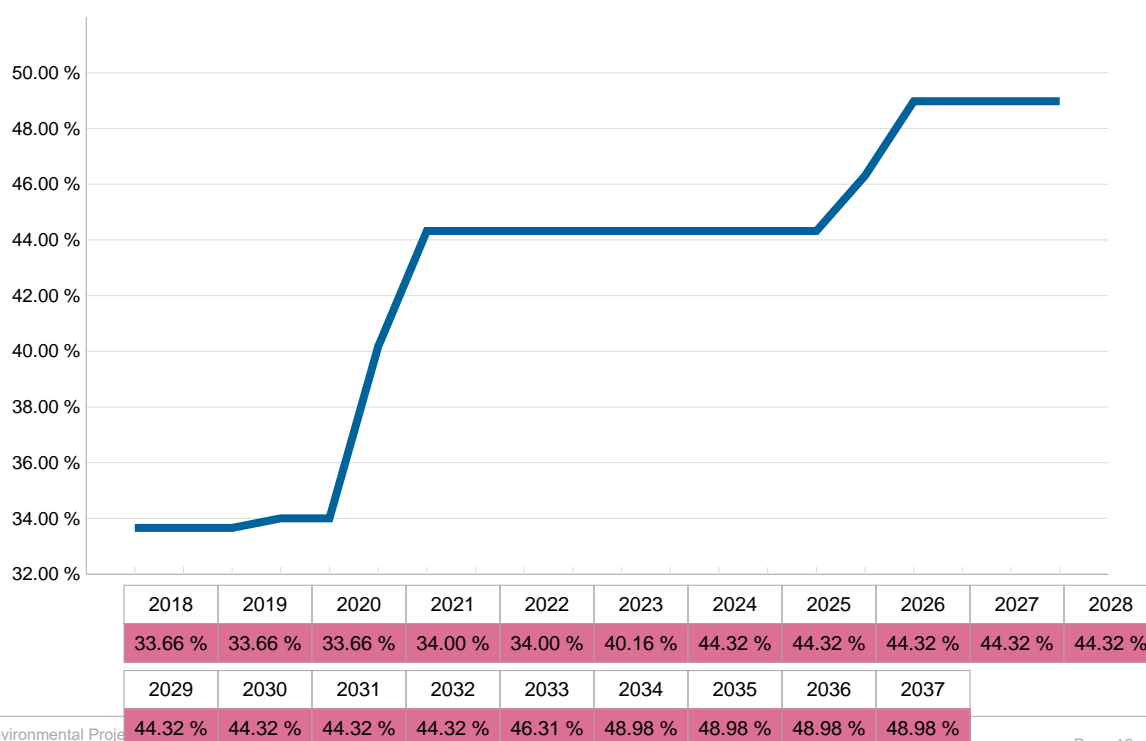
Cumulative Effects of FCI Over the Study Period

The Chart below indicates the cumulative effects of the FCI ratio over the study period assuming the required funds and expenditures are NOT provided to address the identified works and deferred maintenance each year.

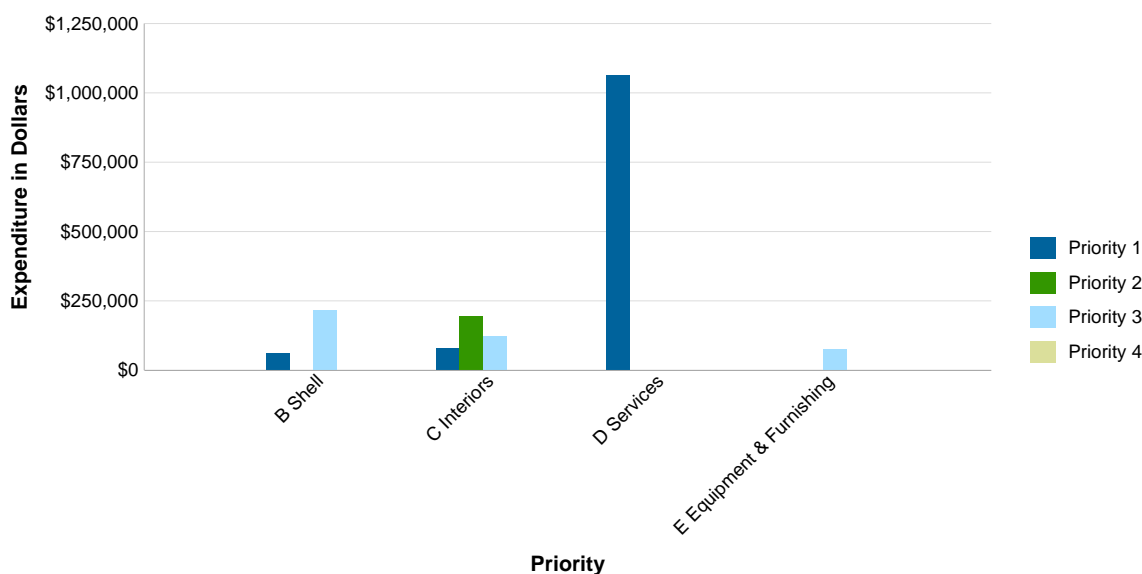
Planning Horizon Needs by System and Priority

The chart below illustrates the breakdown of expenditure according the priority coding providing an opportunity to strategically plan and effectively direct funding to the highest priority.

Building System	Priority 1	Priority 2	Priority 3	Priority 4	Total
B Shell	\$60,038	\$0	\$215,279	\$0	\$275,316
C Interiors	\$77,044	\$192,957	\$122,343	\$0	\$392,343
D Services	\$1,062,106	\$0	\$0	\$0	\$1,062,106
E Equipment & Furnishing	\$0	\$0	\$75,508	\$0	\$75,508
Total	\$1,199,188	\$192,957	\$413,129	\$0	\$1,805,274

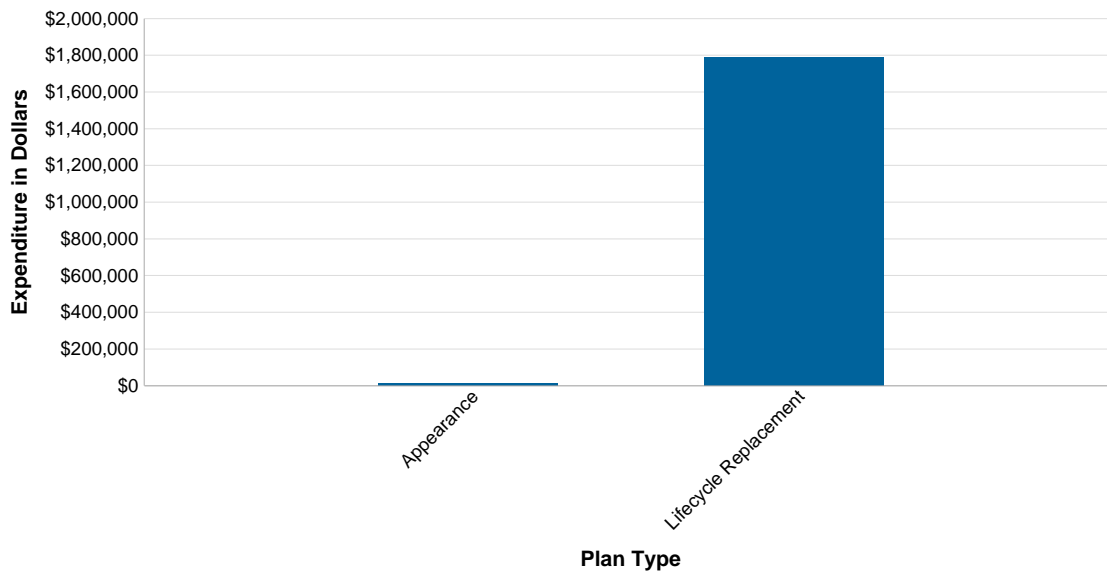
Planning Horizon Needs by Category

The chart below illustrates the breakdown of expenditure according to the Plan Type or deficiency categories providing an opportunity to strategically plan and effectively direct funding.

Building System	Total Cost
Appearance	\$12,670
Lifecycle Replacement	\$1,792,604
Total	\$1,805,274

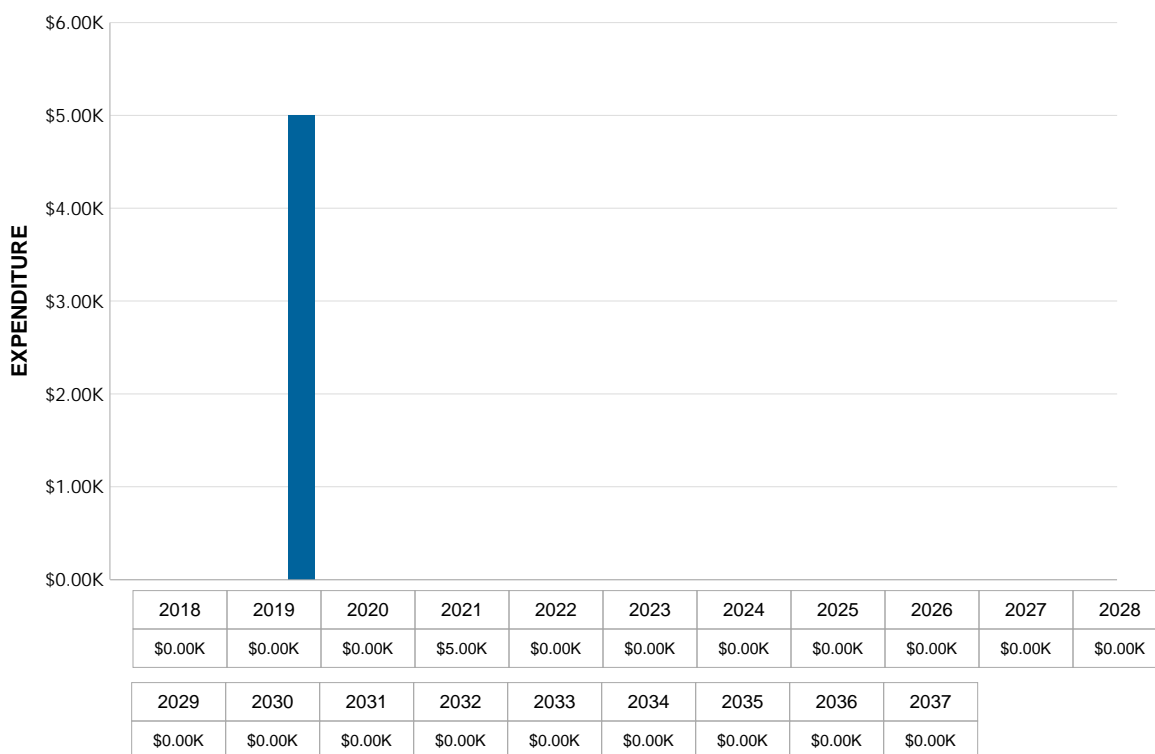
Expenditure Forecast Over Study Period

The building expenditure summary section provides an executive overview of the findings from the assessment. The chart below provides a summary of yearly anticipated expenditures over the study period for the North Kitsap Stadium Site building. In addition, we have scheduled key findings highlighting key items of greater than \$5,000 and their anticipated failure year. Further details of these expenditures are included within each respective report section and within the expenditure forecast, in Appendix A of this report. The results illustrate a total anticipated expenditure over the study period of approximately \$5,000.

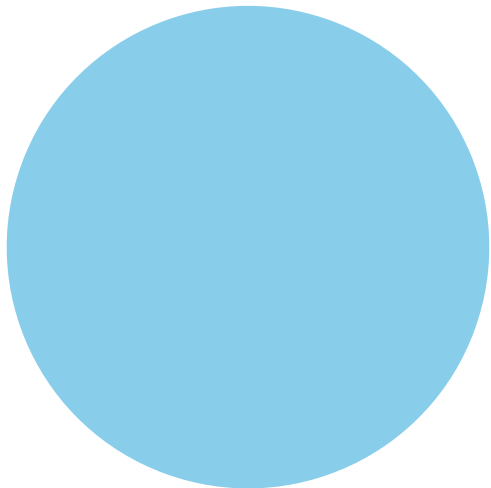
Distribution of Capital Needs by Building System

G20 Site Improvements

Building System	Estimated Cost	Percentage of Total Cost
G20 Site Improvements	\$5,000	100.00 %
Total	\$5,000	100 %

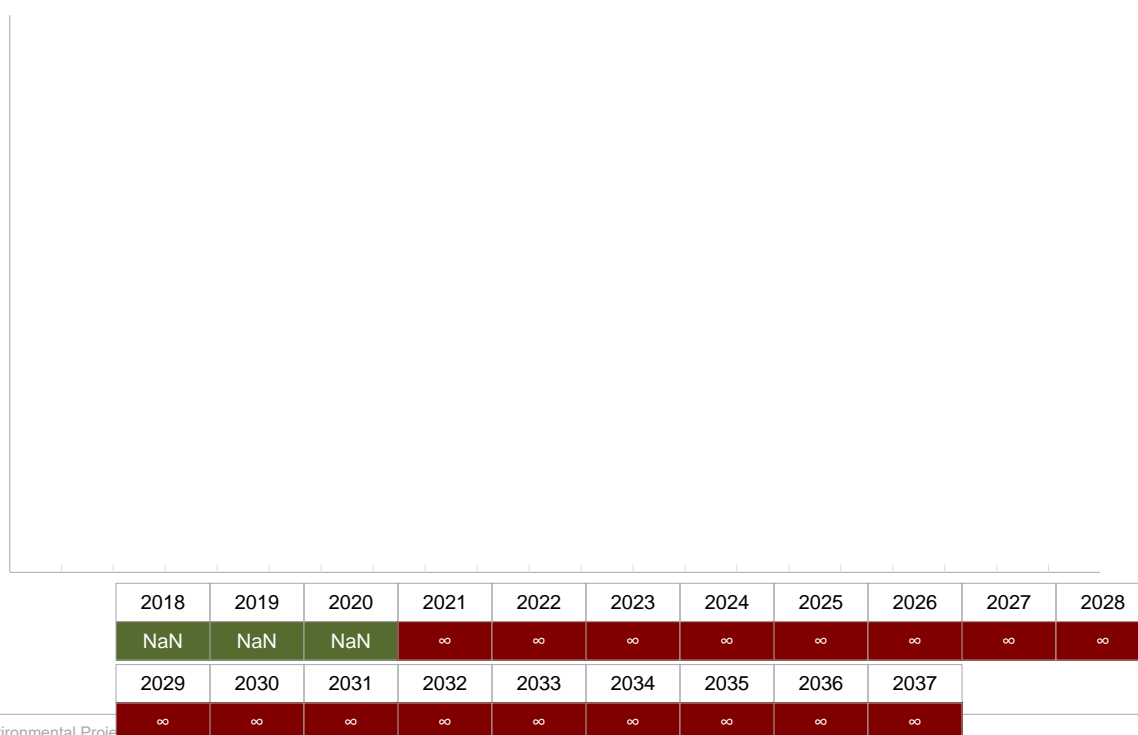
Cumulative Effects of FCI Over the Study Period

The Chart below indicates the cumulative effects of the FCI ratio over the study period assuming the required funds and expenditures are NOT provided to address the identified works and deferred maintenance each year.

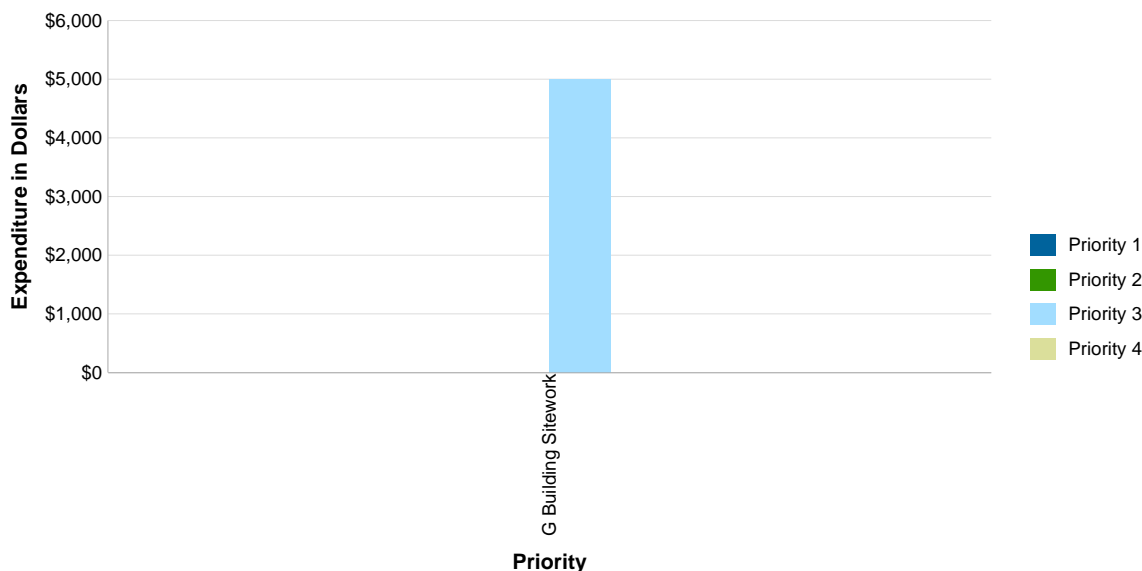
Planning Horizon Needs by System and Priority

The chart below illustrates the breakdown of expenditure according the priority coding providing an opportunity to strategically plan and effectively direct funding to the highest priority.

Building System	Priority 1	Priority 2	Priority 3	Priority 4	Total
G Building Sitework	\$0	\$0	\$5,000	\$0	\$5,000
Total	\$0	\$0	\$5,000	\$0	\$5,000

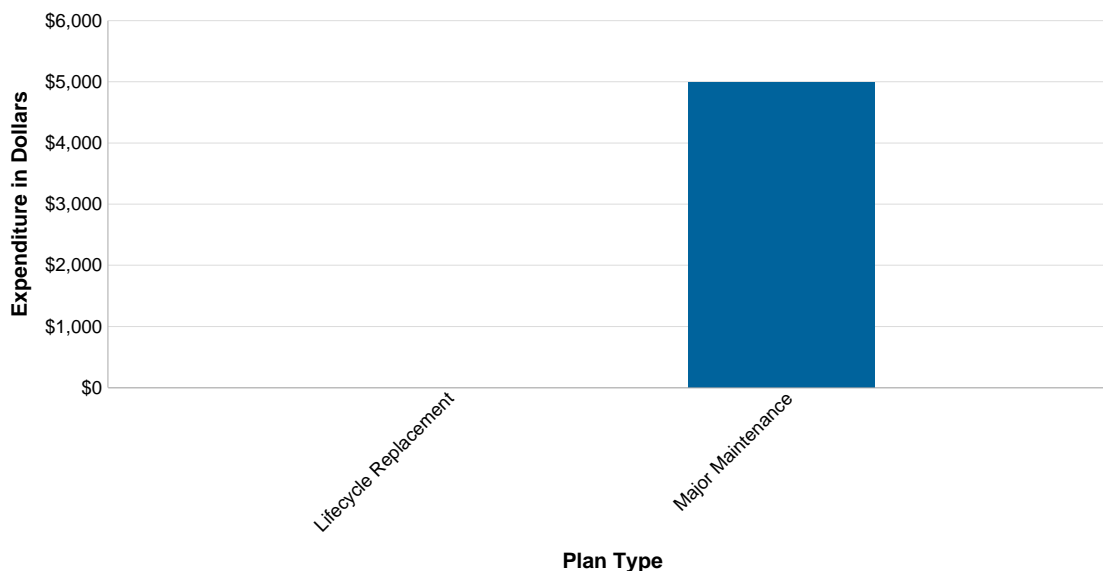
Planning Horizon Needs by Category

The chart below illustrates the breakdown of expenditure according to the Plan Type or deficiency categories providing an opportunity to strategically plan and effectively direct funding.

Building System	Total Cost
Lifecycle Replacement	\$0
Major Maintenance	\$5,000
Total	\$5,000

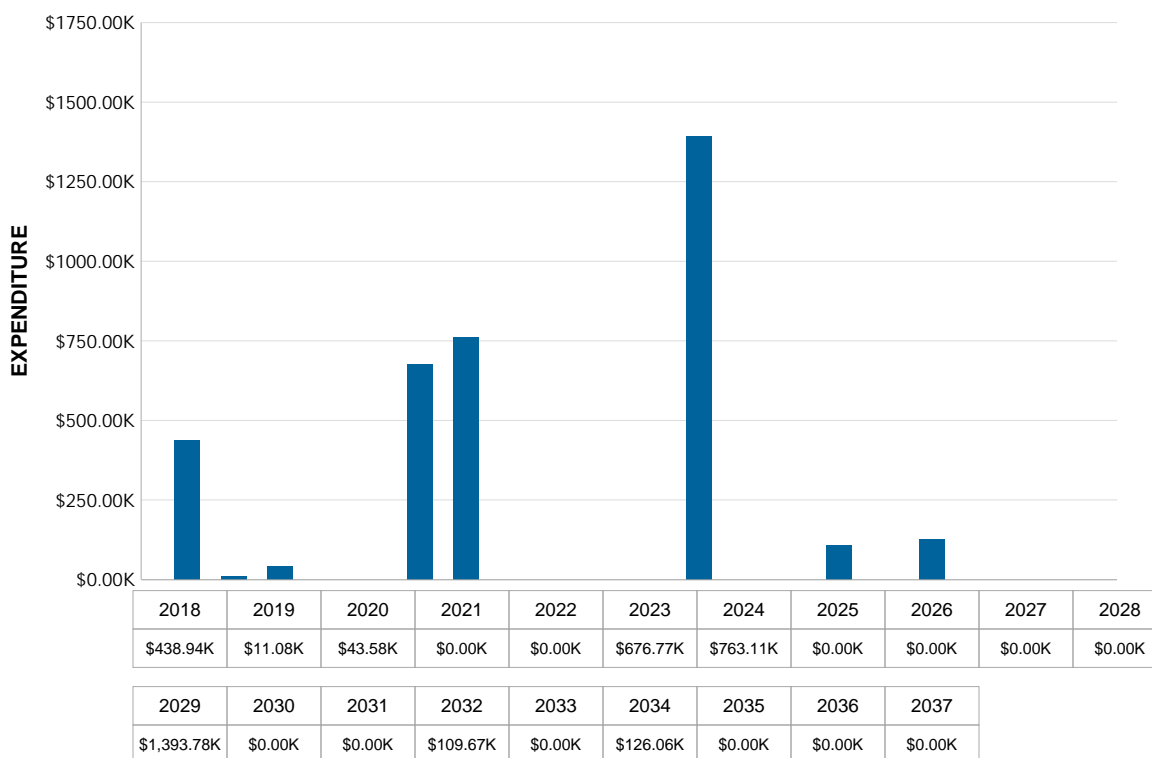
Expenditure Forecast Over Study Period

The building expenditure summary section provides an executive overview of the findings from the assessment. The chart below provides a summary of yearly anticipated expenditures over the study period for the Student Support Center Admin building. In addition, we have scheduled key findings highlighting key items of greater than \$5,000 and their anticipated failure year. Further details of these expenditures are included within each respective report section and within the expenditure forecast, in Appendix A of this report. The results illustrate a total anticipated expenditure over the study period of approximately \$3,562,982.

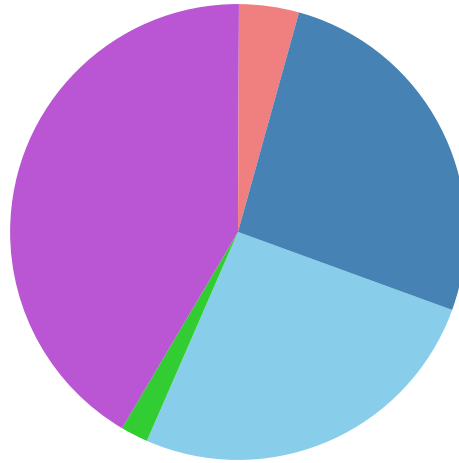
Distribution of Immediate Needs by Building System

Building System	Estimated Cost	Percentage of Total Cost
Cooling Systems	\$114,085	25.99 %
Facility HVAC Distribution Systems	\$8,550	1.95 %
Heating Systems	\$182,483	41.57 %
Sanitary Drainage	\$18,643	4.25 %
Ventilation	\$115,174	26.24 %
Total	\$438,936	100 %

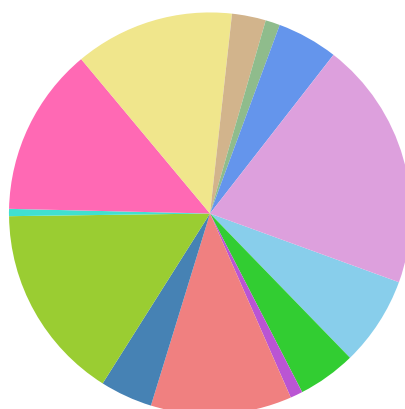
Distribution of Capital Needs by Building System

Building System	Estimated Cost	Percentage of Total Cost
B20 Exterior Enclosure	\$224,510	7.19 %
B30 Roofing	\$146,195	4.68 %
C10 Interior Construction	\$31,137	1.00 %
C20 Interior Finishes	\$353,958	11.33 %
D20 Plumbing	\$131,745	4.22 %
D30 HVAC	\$494,227	15.82 %
D40 Fire Protection Systems	\$18,217	0.58 %
D50 Electrical Systems	\$423,545	13.56 %
D60 Communication Systems	\$400,592	12.82 %
D70 Security Systems	\$85,073	2.72 %
D80 Automation Systems	\$36,434	1.17 %
E10 Equipment	\$152,841	4.89 %
E20 Furnishings	\$625,572	20.02 %
Total	\$3,124,047	100 %

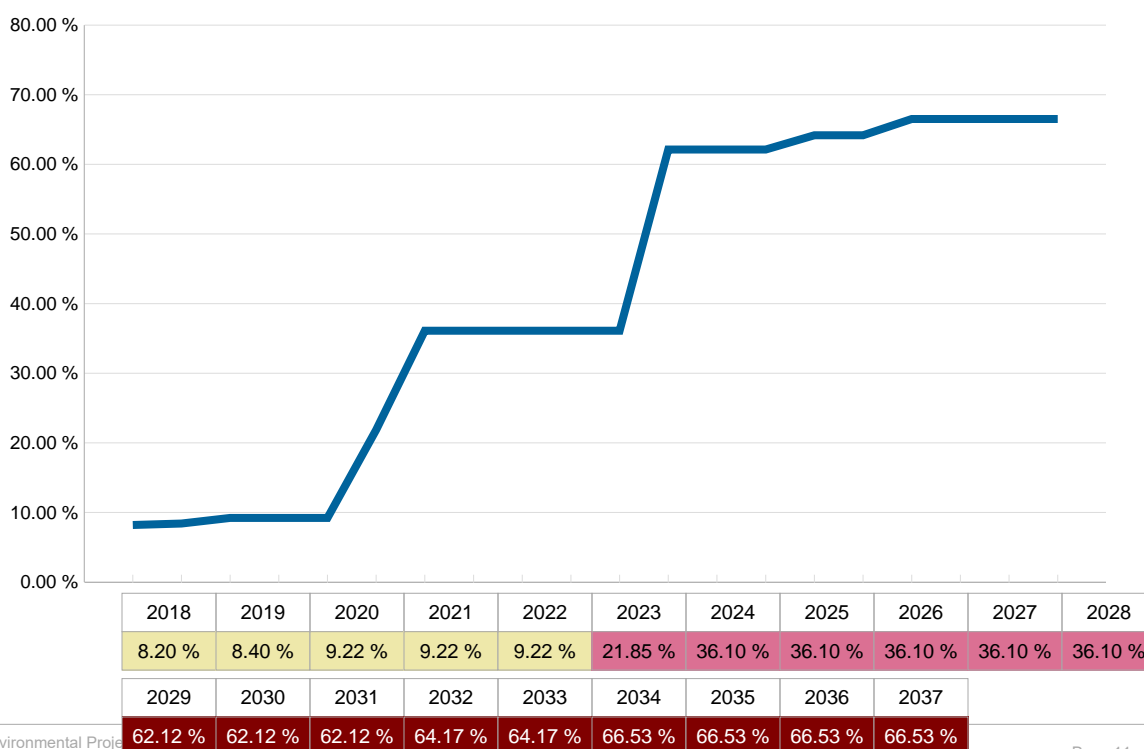
Cumulative Effects of FCI Over the Study Period

The Chart below indicates the cumulative effects of the FCI ratio over the study period assuming the required funds and expenditures are NOT provided to address the identified works and deferred maintenance each year.

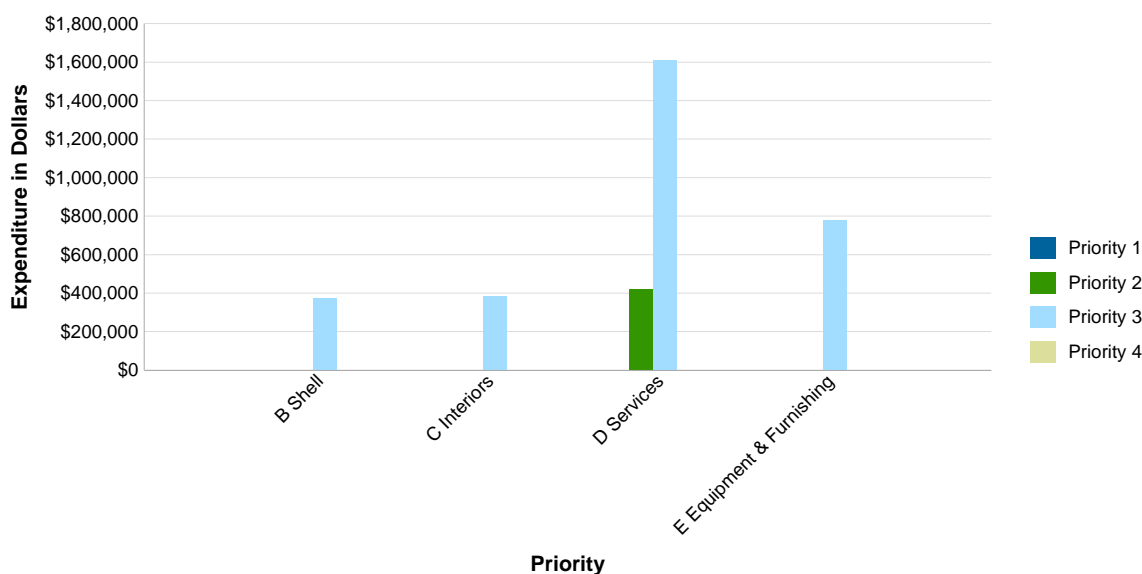
Planning Horizon Needs by System and Priority

The chart below illustrates the breakdown of expenditure according the priority coding providing an opportunity to strategically plan and effectively direct funding to the highest priority.

Building System	Priority 1	Priority 2	Priority 3	Priority 4	Total
B Shell	\$0	\$0	\$370,705	\$0	\$370,705
C Interiors	\$0	\$0	\$385,095	\$0	\$385,095
D Services	\$0	\$420,292	\$1,608,477	\$0	\$2,028,769
E Equipment & Furnishing	\$0	\$0	\$778,412	\$0	\$778,412
Total	\$0	\$420,292	\$3,142,690	\$0	\$3,562,982

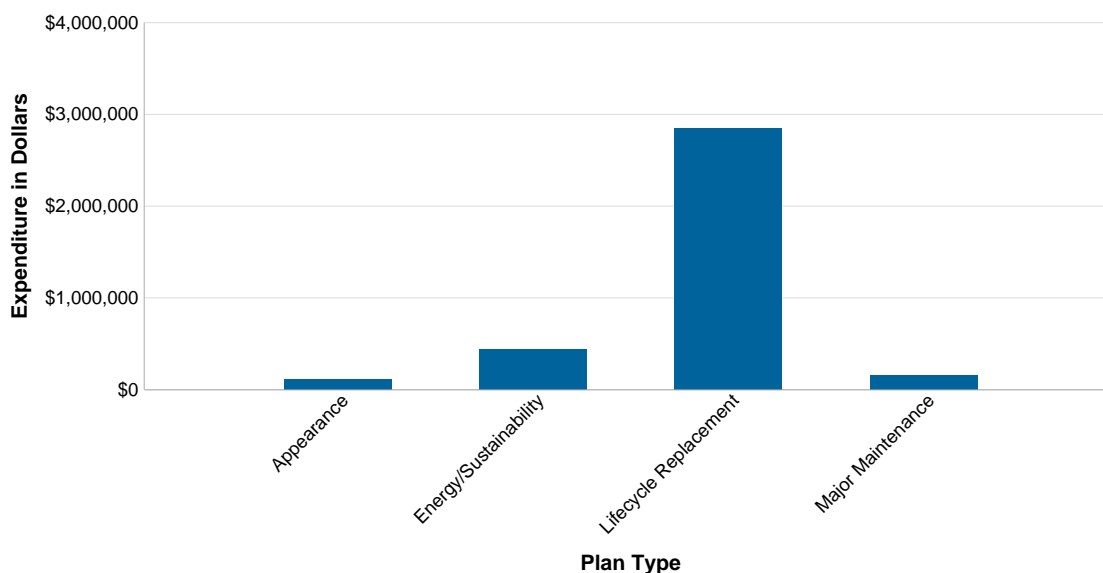
Planning Horizon Needs by Category

The chart below illustrates the breakdown of expenditure according to the Plan Type or deficiency categories providing an opportunity to strategically plan and effectively direct funding.

Building System	Total Cost
Appearance	\$119,418
Energy/Sustainability	\$440,317
Lifecycle Replacement	\$2,845,678
Major Maintenance	\$157,570
Total	\$3,562,982

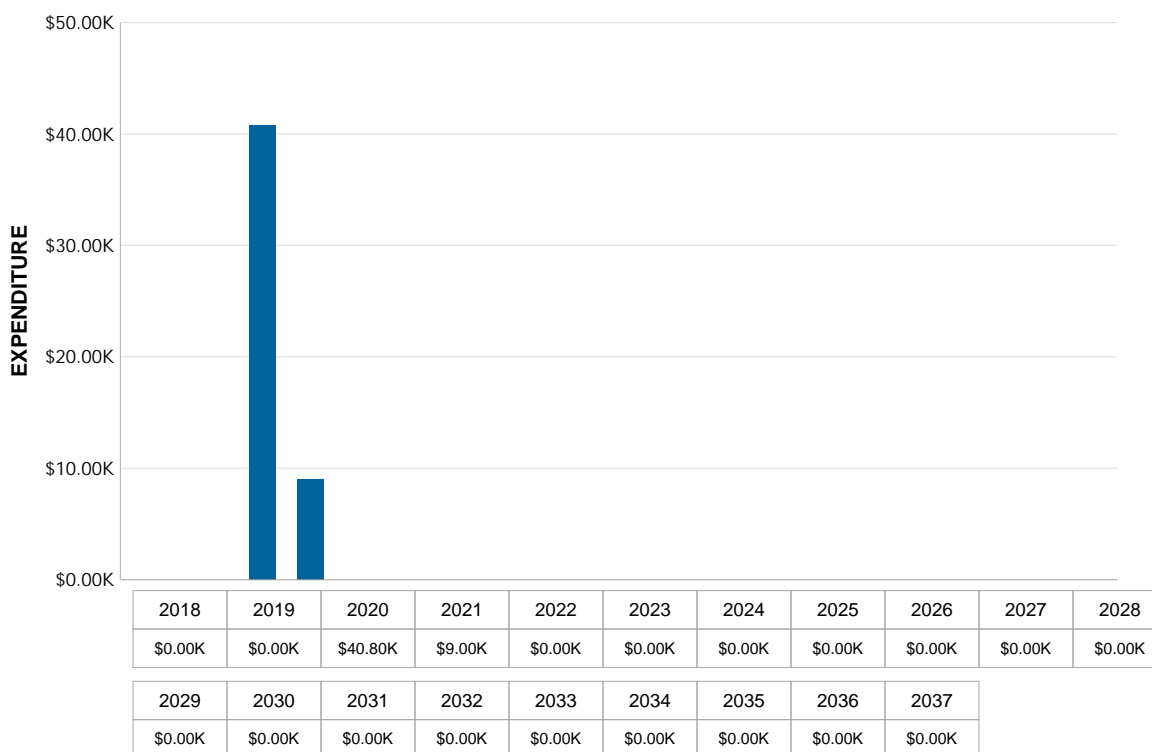
Expenditure Forecast Over Study Period

The building expenditure summary section provides an executive overview of the findings from the assessment. The chart below provides a summary of yearly anticipated expenditures over the study period for the Student Support Center Site building. In addition, we have scheduled key findings highlighting key items of greater than \$5,000 and their anticipated failure year. Further details of these expenditures are included within each respective report section and within the expenditure forecast, in Appendix A of this report. The results illustrate a total anticipated expenditure over the study period of approximately \$49,800.

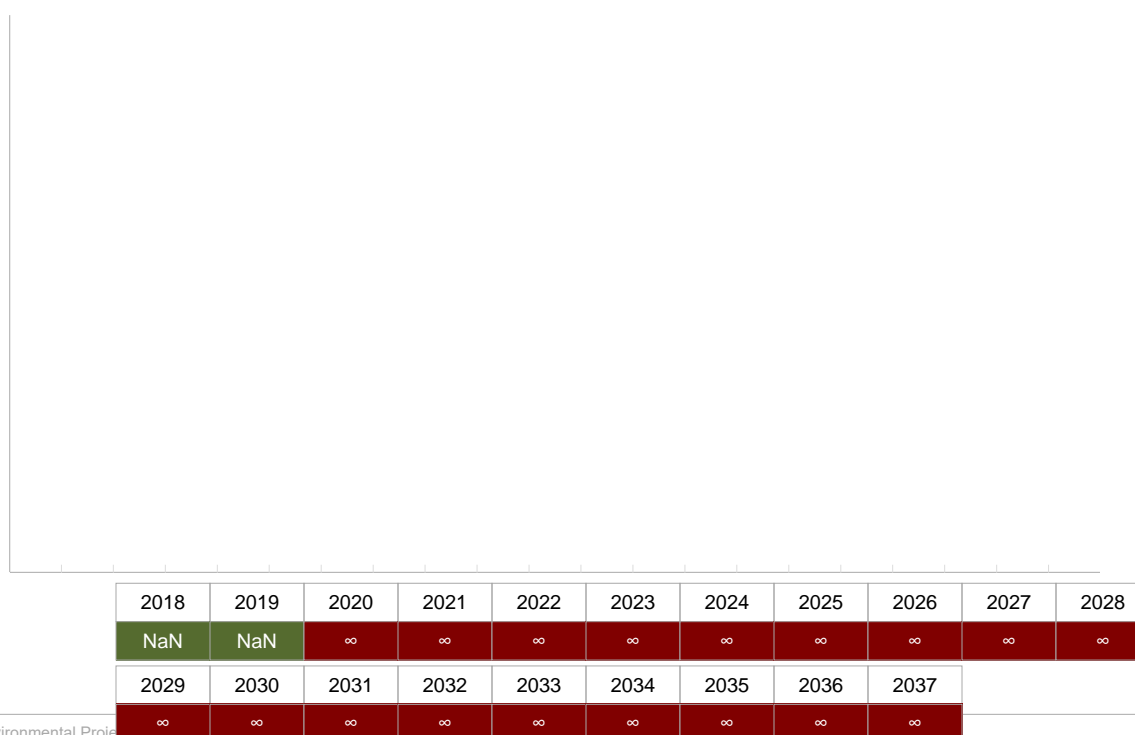
Cumulative Effects of FCI Over the Study Period

The Chart below indicates the cumulative effects of the FCI ratio over the study period assuming the required funds and expenditures are NOT provided to address the identified works and deferred maintenance each year.

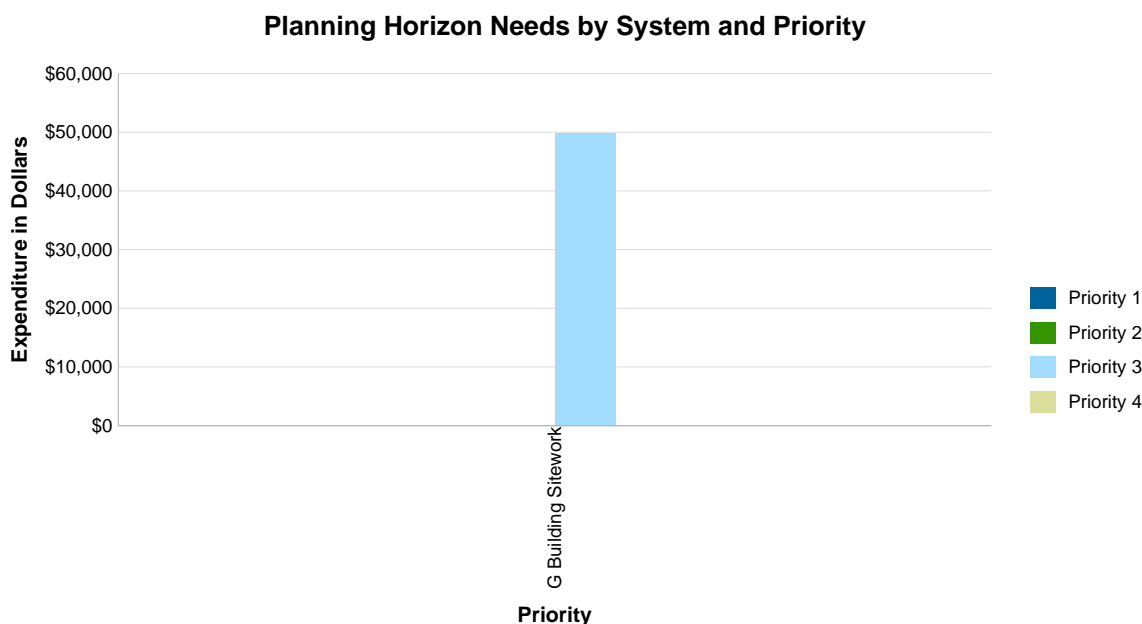
The chart below illustrates the breakdown of expenditure according the priority coding providing an opportunity to strategically plan and effectively direct funding to the highest priority.

Building System	Priority 1	Priority 2	Priority 3	Priority 4	Total
G Building Sitework	\$0	\$0	\$49,800	\$0	\$49,800
Total	\$0	\$0	\$49,800	\$0	\$49,800

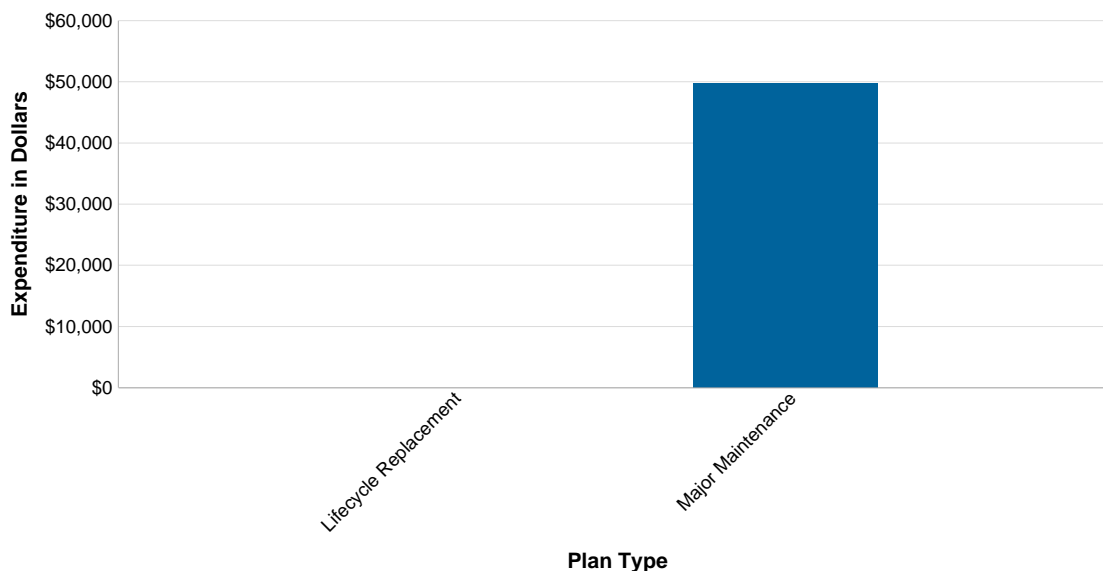
Planning Horizon Needs by Category

The chart below illustrates the breakdown of expenditure according to the Plan Type or deficiency categories providing an opportunity to strategically plan and effectively direct funding.

Building System	Total Cost
Lifecycle Replacement	\$0
Major Maintenance	\$49,800
Total	\$49,800

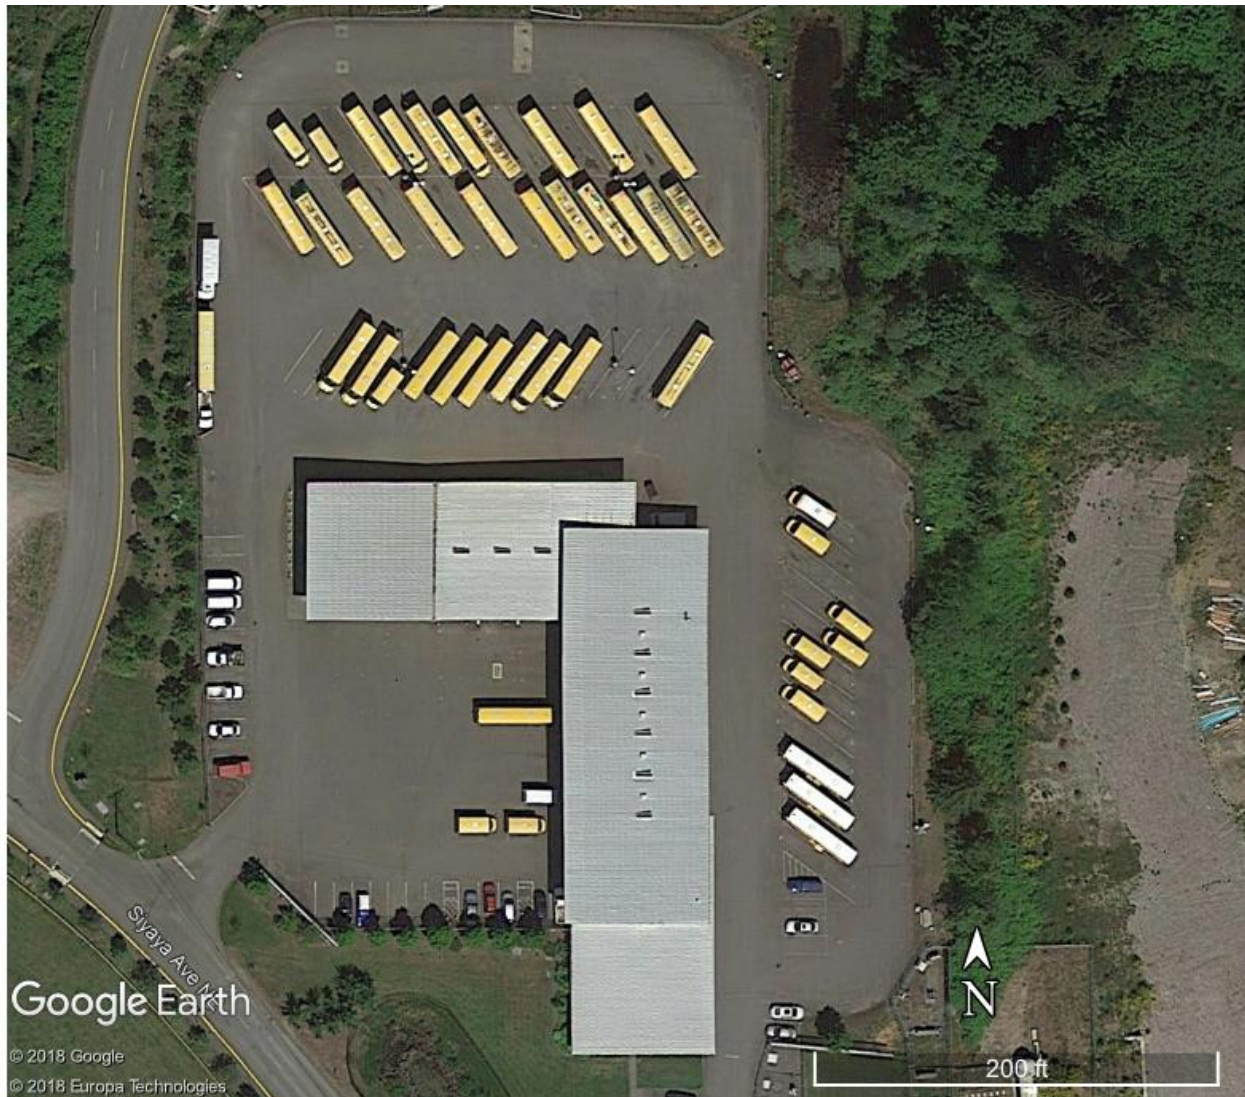
Site plan

Facility 2018-2023 FCI	Program Served	Original Construction	Year Mod/Add	GSF	No. Buildings
0.17	Transportation Center	1997	N/A	29,843	1
