Facilities Condition Assessment Report

I. FCA Executive Summary

North Kitsap School District

Breidablik Elementary School Main
25142 Waghorn Rd NW
Poulsbo, WA

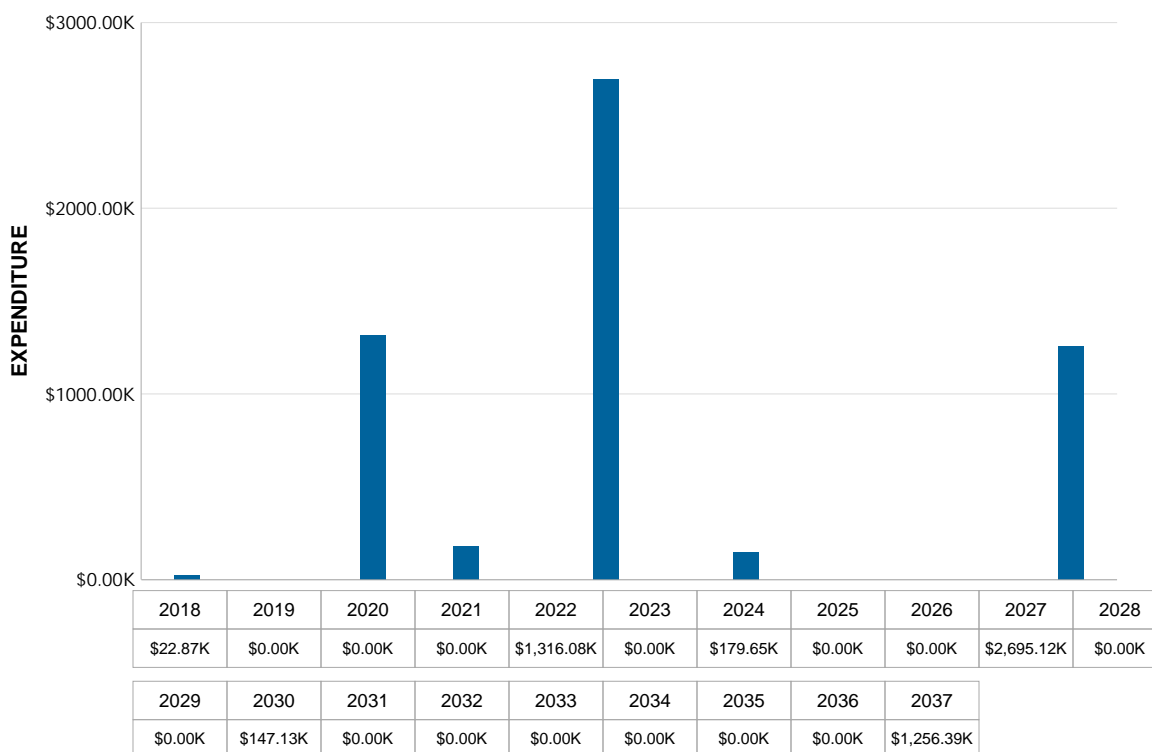
Expenditure Forecast Over Study Period

The building expenditure summary section provides an executive overview of the findings from the assessment. The chart below provides a summary of yearly anticipated expenditures over the study period for the Transportation Center Main building. In addition, we have scheduled key findings highlighting key items of greater than \$5,000 and their anticipated failure year. Further details of these expenditures are included within each respective report section and within the expenditure forecast, in Appendix A of this report. The results illustrate a total anticipated expenditure over the study period of approximately \$5,617,234.

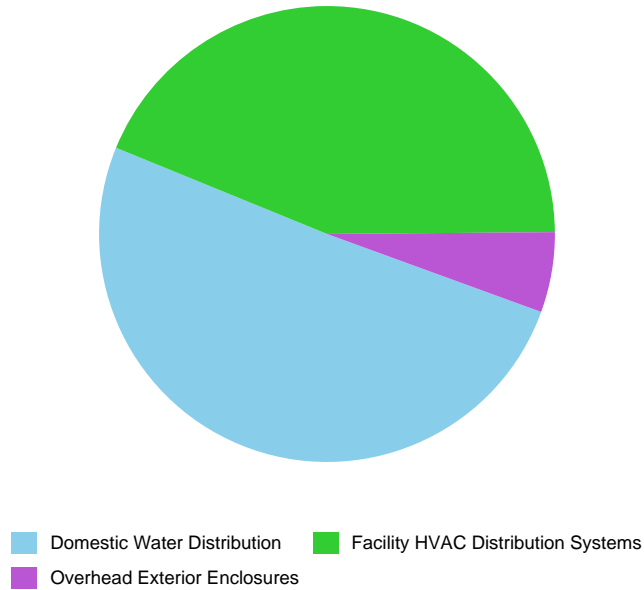
Distribution of Immediate Needs by Building System

Building System	Estimated Cost	Percentage of Total Cost
Domestic Water Distribution	\$11,575	50.62 %
Facility HVAC Distribution Systems	\$9,990	43.69 %
Overhead Exterior Enclosures	\$1,300	5.69 %
Total	\$22,865	100 %

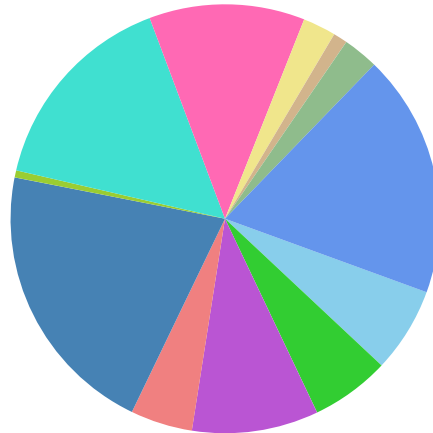
Distribution of Capital Needs by Building System

Building System	Estimated Cost	Percentage of Total Cost
B30 Roofing	\$359,608	6.43 %
C10 Interior Construction	\$333,346	5.96 %
C20 Interior Finishes	\$533,294	9.53 %
D20 Plumbing	\$261,723	4.68 %
D30 HVAC	\$1,171,636	20.94 %
D40 Fire Protection Systems	\$29,843	0.53 %
D50 Electrical Systems	\$875,594	15.65 %
D60 Communication Systems	\$656,248	11.73 %
D70 Security Systems	\$139,367	2.49 %
D80 Automation Systems	\$59,686	1.07 %
E10 Equipment	\$149,215	2.67 %
E20 Furnishings	\$1,024,809	18.32 %
Total	\$5,594,369	100 %

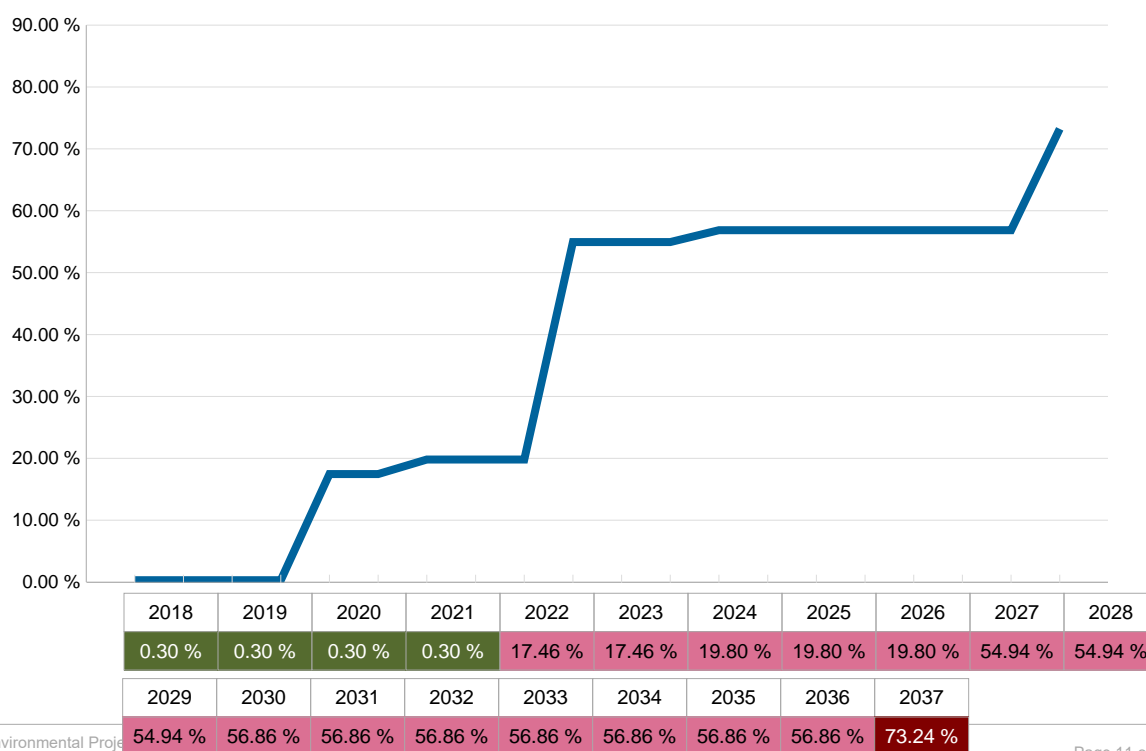
Cumulative Effects of FCI Over the Study Period

The Chart below indicates the cumulative effects of the FCI ratio over the study period assuming the required funds and expenditures are NOT provided to address the identified works and deferred maintenance each year.

In this report we have calculated the Facility Condition Index (FCI) which is used in Facilities Management to provide a benchmark to compare the relative condition of a group of facilities. The FCI is primarily used to support asset management initiatives of federal, state, and local government facilities organizations. The FCI is the ratio of accumulated Total Cost (TC) (Maintenance, Lifecycle Renewal and Plant Adaptation) to the Current Replacement Value (CRV) for a constructed asset calculated by dividing the TC by the CRV. The range is from zero for a newly constructed asset, to one for a constructed asset with a TC value equal to its CRV. Acceptable ranges vary by "Asset Type", but as a general guideline the FCI scoring system is as follows:

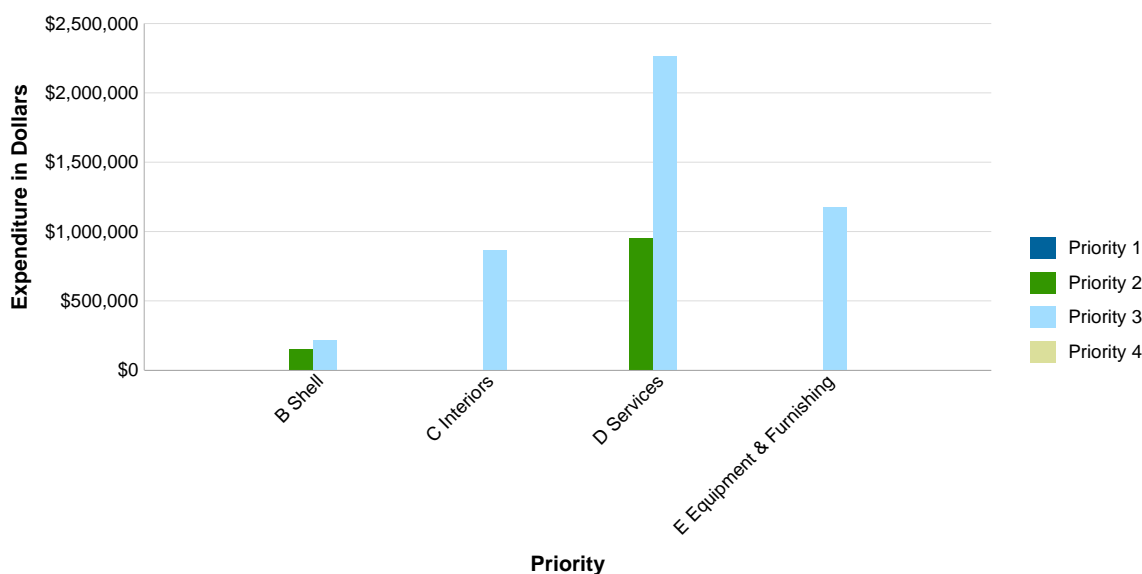
Planning Horizon Needs by System and Priority

The chart below illustrates the breakdown of expenditure according the priority coding providing an opportunity to strategically plan and effectively direct funding to the highest priority.

Building System	Priority 1	Priority 2	Priority 3	Priority 4	Total
B Shell	\$0	\$148,320	\$212,588	\$0	\$360,908
C Interiors	\$0	\$0	\$866,641	\$0	\$866,641
D Services	\$0	\$950,045	\$2,265,617	\$0	\$3,215,661
E Equipment & Furnishing	\$0	\$0	\$1,174,024	\$0	\$1,174,024
Total	\$0	\$1,098,364	\$4,518,870	\$0	\$5,617,234

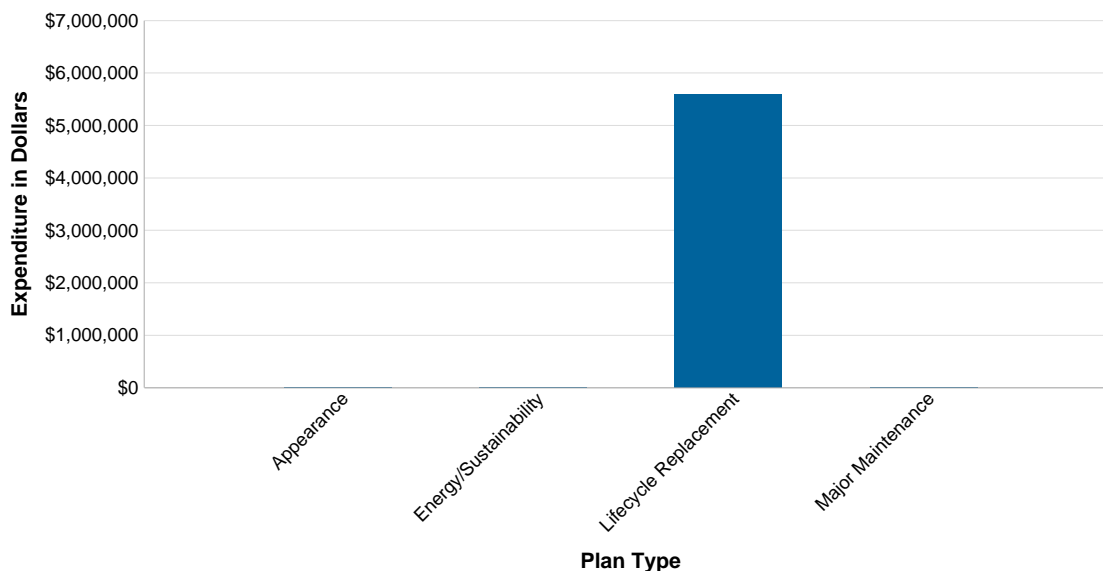
Planning Horizon Needs by Category

The chart below illustrates the breakdown of expenditure according to the Plan Type or deficiency categories providing an opportunity to strategically plan and effectively direct funding.

Building System	Total Cost
Appearance	\$1,300
Energy/Sustainability	\$11,575
Lifecycle Replacement	\$5,594,369
Major Maintenance	\$9,990
Total	\$5,617,234

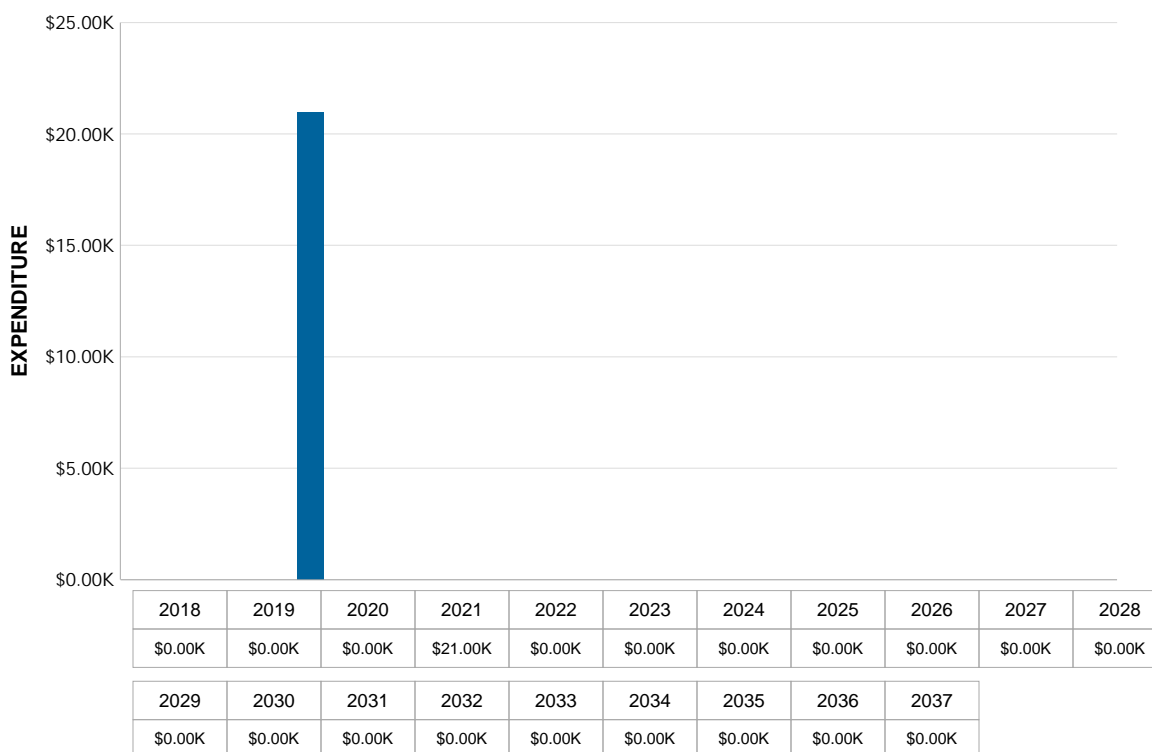
Expenditure Forecast Over Study Period

The building expenditure summary section provides an executive overview of the findings from the assessment. The chart below provides a summary of yearly anticipated expenditures over the study period for the Transportation Center Site building. In addition, we have scheduled key findings highlighting key items of greater than \$5,000 and their anticipated failure year. Further details of these expenditures are included within each respective report section and within the expenditure forecast, in Appendix A of this report. The results illustrate a total anticipated expenditure over the study period of approximately \$21,000.

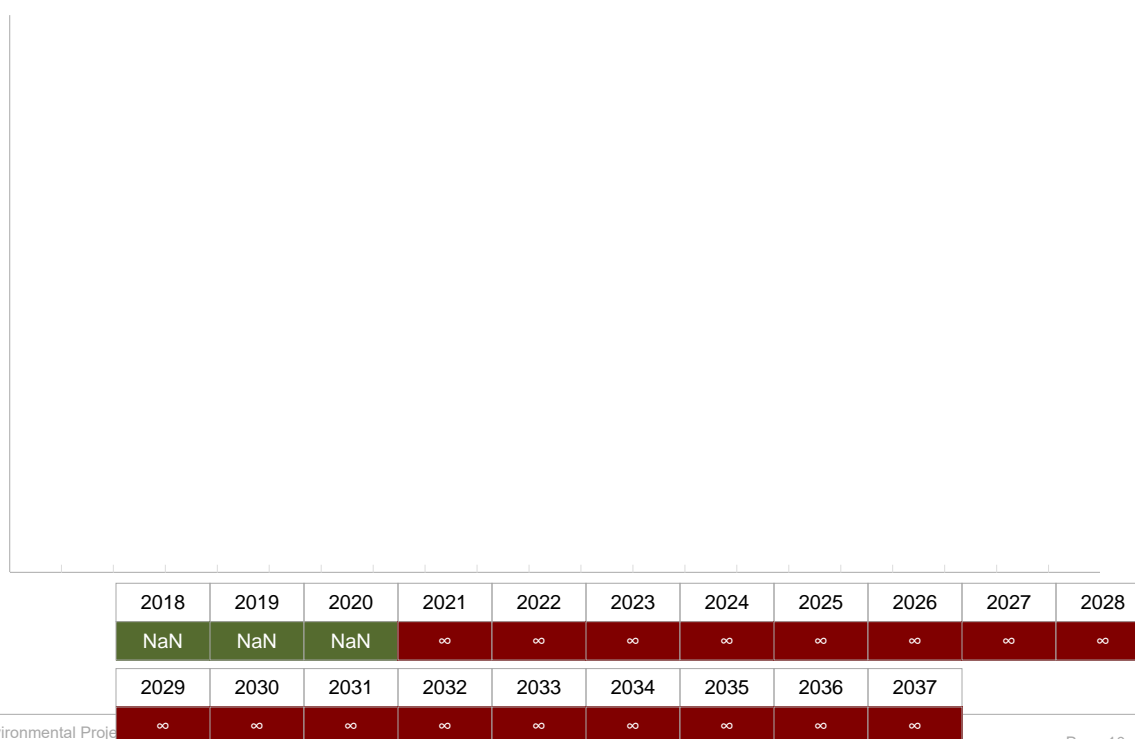
Cumulative Effects of FCI Over the Study Period

The Chart below indicates the cumulative effects of the FCI ratio over the study period assuming the required funds and expenditures are NOT provided to address the identified works and deferred maintenance each year.

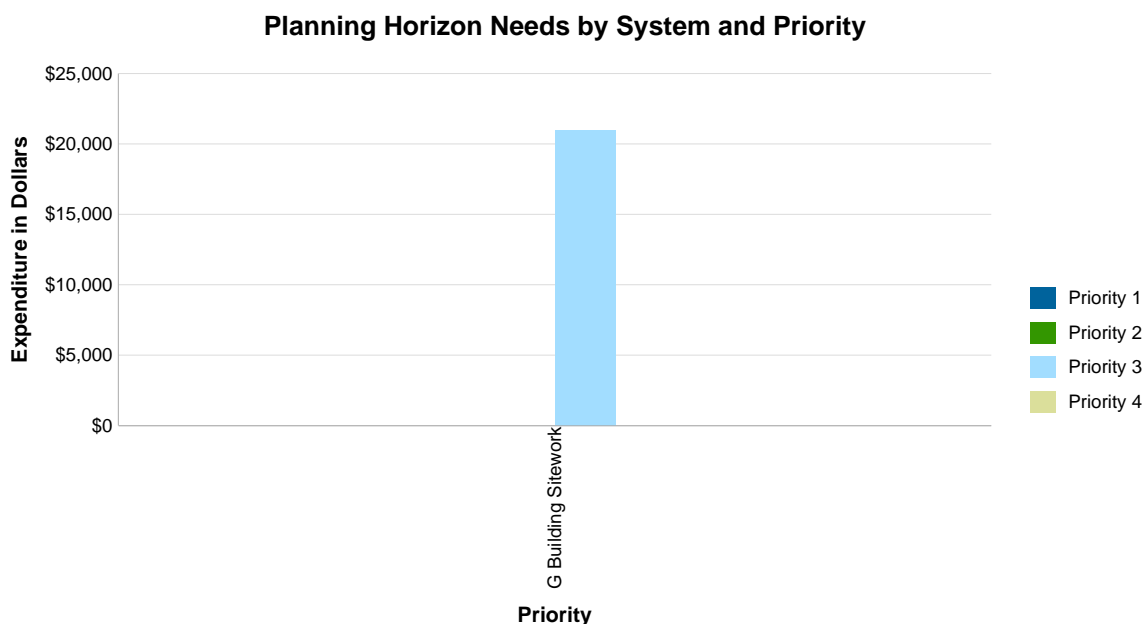
The chart below illustrates the breakdown of expenditure according the priority coding providing an opportunity to strategically plan and effectively direct funding to the highest priority.

Building System	Priority 1	Priority 2	Priority 3	Priority 4	Total
G Building Sitework	\$0	\$0	\$21,000	\$0	\$21,000
Total	\$0	\$0	\$21,000	\$0	\$21,000

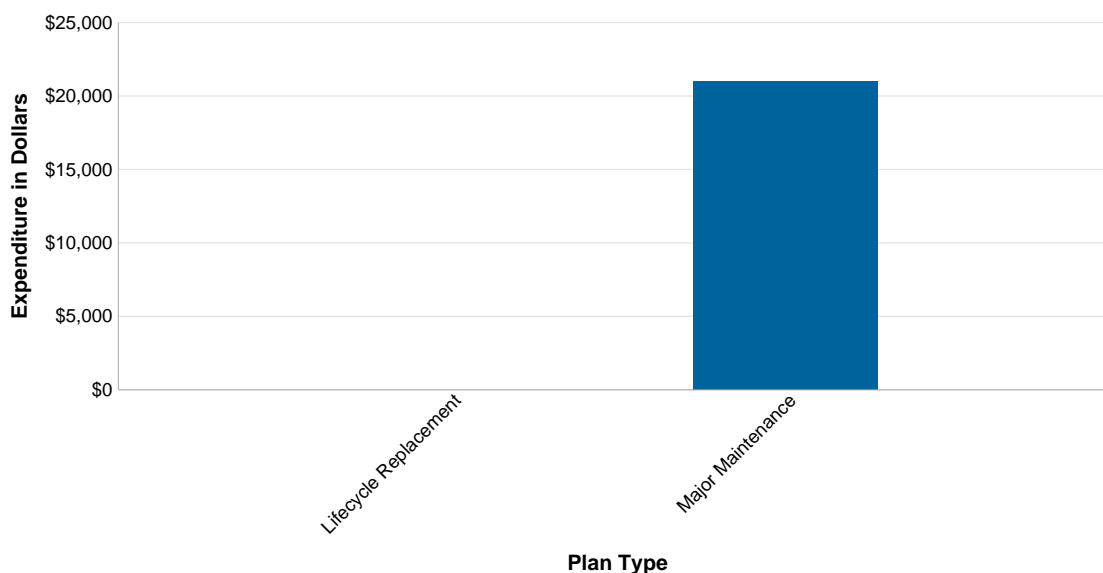
Planning Horizon Needs by Category

The chart below illustrates the breakdown of expenditure according to the Plan Type or deficiency categories providing an opportunity to strategically plan and effectively direct funding.

Building System	Total Cost
Lifecycle Replacement	\$0
Major Maintenance	\$21,000
Total	\$21,000
