mahlum

FACILITY ASSESSMENT REPORT  
HILLSBORO SCHOOL DISTRICT  
HILLSBORO, OREGON

6 APRIL 2012

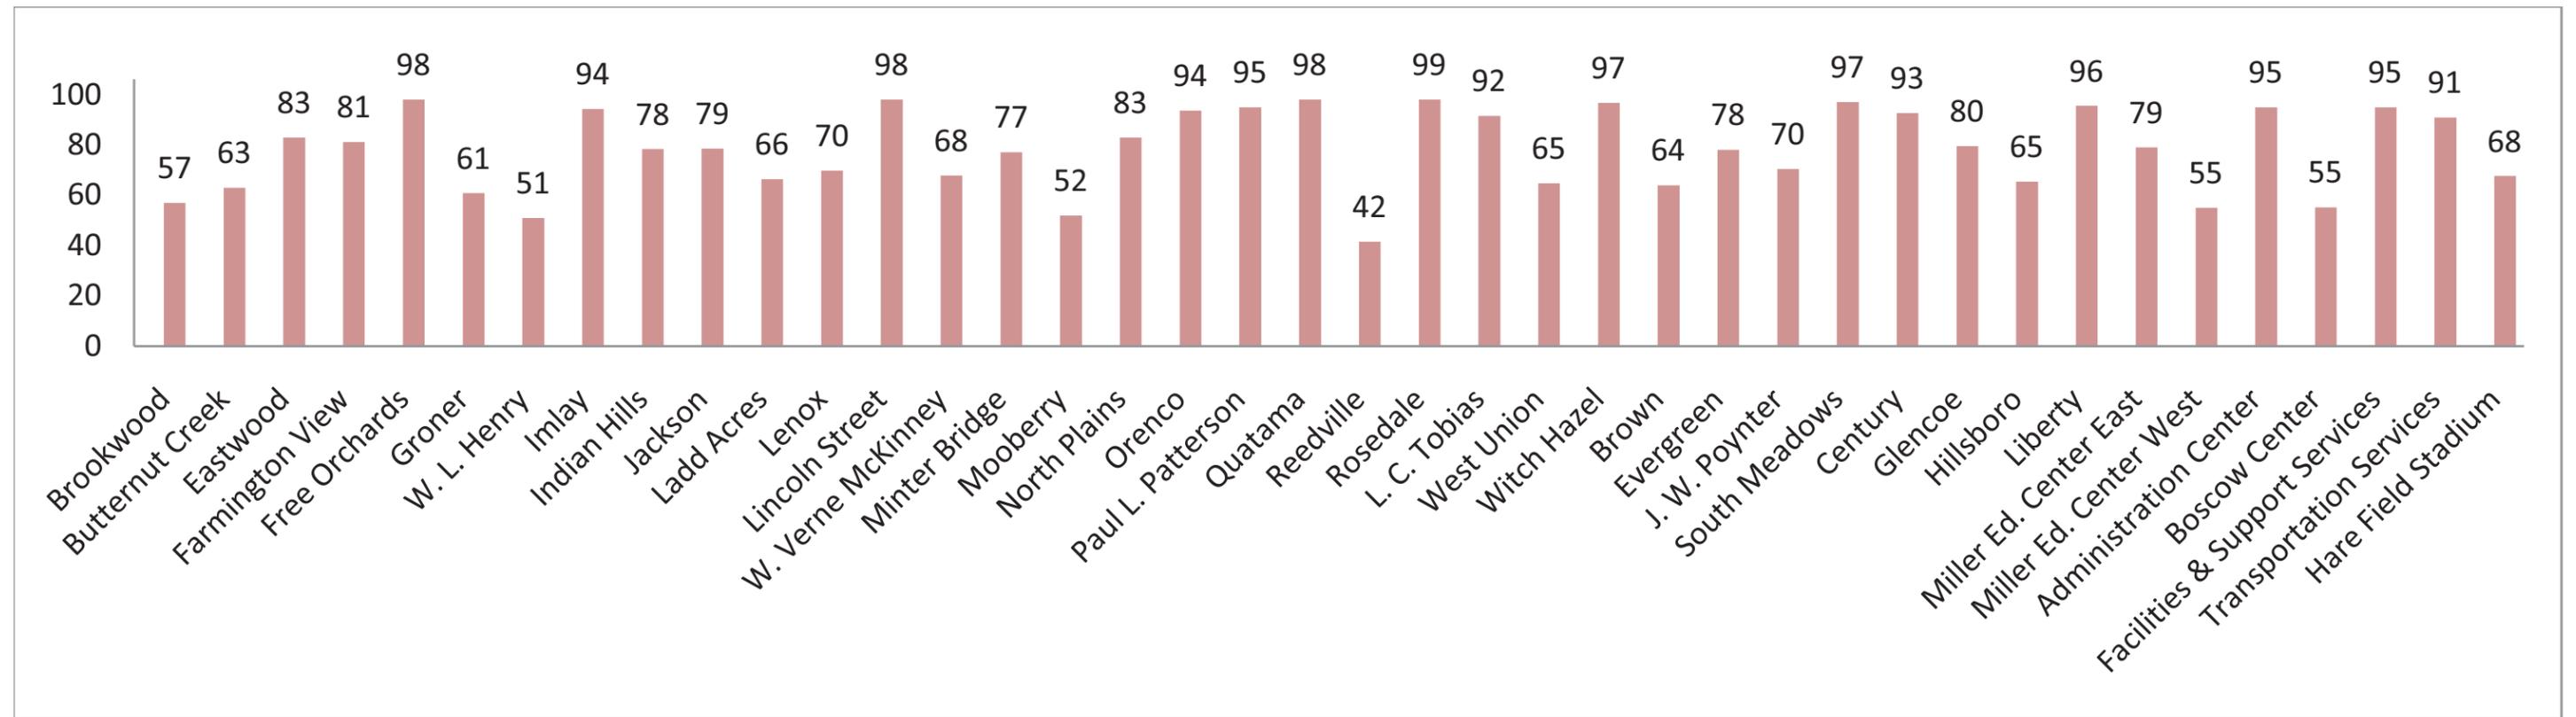
FACILITY ASSESSMENT SUMMARY

SCHOOL	DATE OF CONSTR.	AREA					RATING SCORE	BUILDING RATING
		PRIMARY STRUCTURE	SECONDARY STRUCTURE	SERVICE SYSTEMS	SAFETY STANDARDS	FUNCTIONAL STANDARDS		
<b>Elementary Schools</b>								
Brookwood	1953	32.0	5.0	10.0	3.0	7.0	57	Modernization
Butternut Creek	1977	19.5	6.2	24.4	4.5	8.4	63	Modernization
Eastwood	1977	33.3	7.8	26.9	4.5	10.4	83	Minor Modernization
Farmington View	1940	30.1	8.5	29.0	3.5	10.0	81	Minor Modernization
Free Orchards	2008	39.0	9.0	33.0	5.0	12.0	98	Satisfactory
Groner	1957	25.5	6.4	16.3	3.0	9.6	61	Modernization

AREA	EXPLANATION	HIGHEST POSSIBLE BUILDING RATING FOR EACH AREA
Primary Structure:	Foundation System, Column and Exterior Wall System, Floor System, and Roof System	40
Secondary Structure:	Ceiling System, Interior Walls and Partitions, Window System, and Door System	9
Service Systems:	Cooling and Ventilation, Heating, Plumbing, and Electrical	34
Safety Standards:	Overall Safety Standards	5
Functional Standards:	Assignable Space, Adaptability, and Suitability	12
<b>POSSIBLE BUILDING RATING TOTAL</b>		<b>100</b>
BUILDING RATING	EXPLANATION	
95 - 100 points:	Satisfactory	
75 - 94 points:	Remodeling C (Minor Modernization; less than 25% of replacement cost)	
55 - 74 points:	Remodeling B (Modernization; 25% - 50% of replacement cost)	
35 - 54 points:	Remodeling A (Major Modernization; over 50% of replacement cost)	
0 - 34 points:	Demolition (System is unsatisfactory and cannot be remodeled)

The numerical rating given to each building is related to a percentage of replacement cost to fully upgrade the building to a 50-year standard. A score 95 to 100 points is satisfactory (no immediate upgrades are required at the time of the study), a score of 75 to 94 points required restoration, (spending less than 25 percent of replacement cost), a score of 55 to 74 point represents major modernization (spending between 25 to 50 percent of replacement cost), a score of 35 to 54 points represents major remodeling (spending more than 50 percent of replacement cost) and a score of under 34 points denotes the systems are unsatisfactory and it may be more cost effective to replace the school.

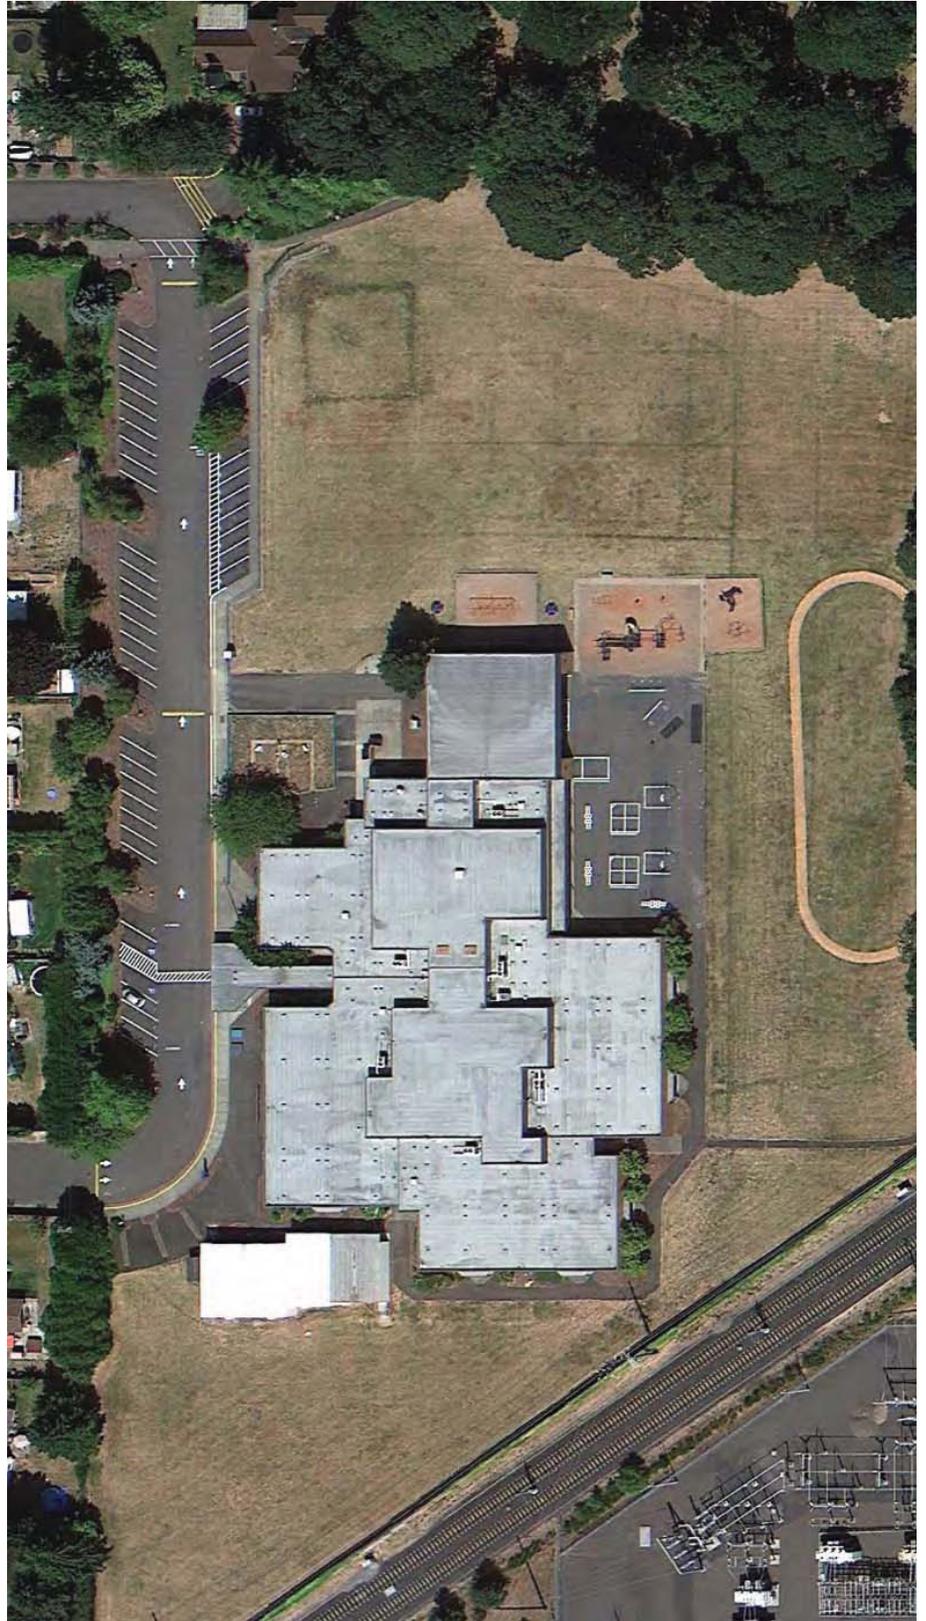
Eastwood Elementary | Floor Plan

NOTE: NO ROOM NUMBERS ESTABLISHED

PORTABLE CLASSROOMS

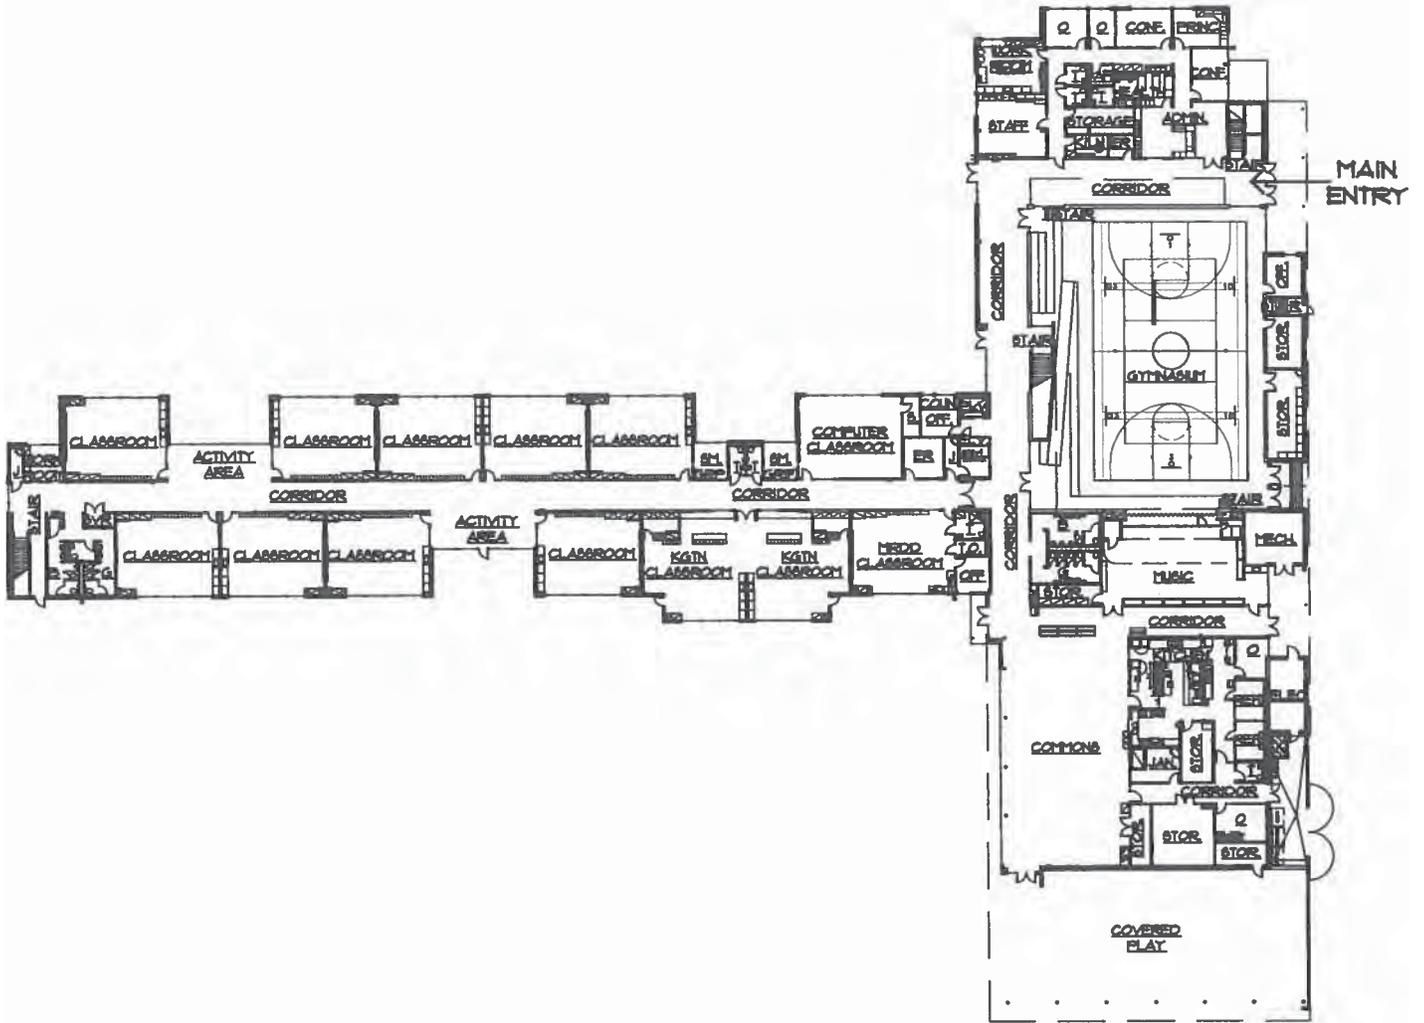
FLOOR PLAN - MAIN LEVEL

FREE ORCHARDS ELEMENTARY SCHOOL - 247  
2499 S BEECH STREET  
CORNELIUS OR 97113

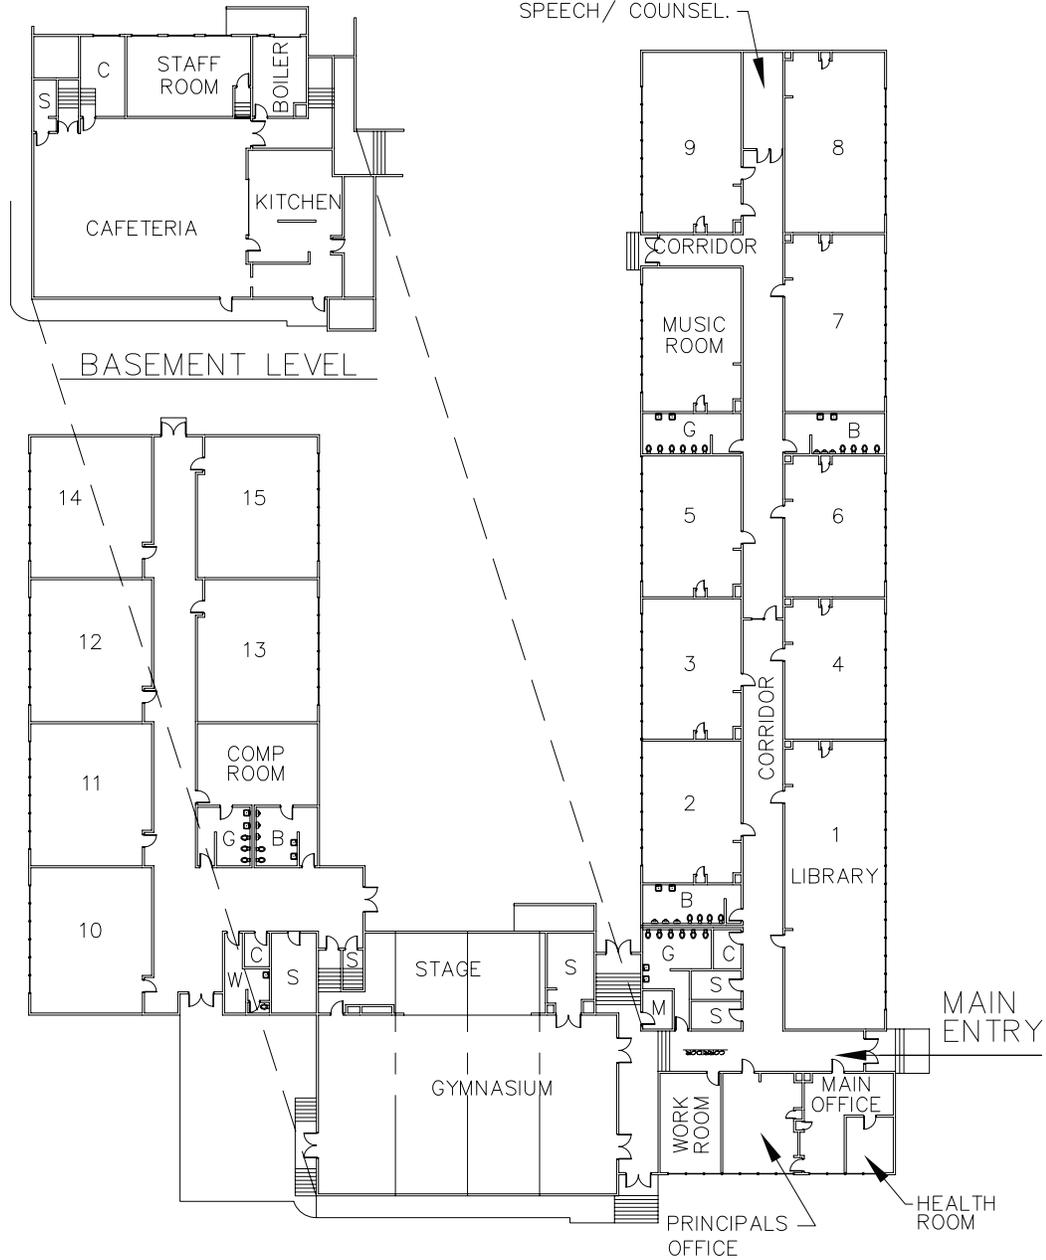
Groner Elementary | Floor Plan

NOTE:  
NUMBERED ROOMS  
ARE CLASSROOMS

:: The primary structure is wood stud walls on continuous concrete foundation with a concrete slab. The roof is a combination of wood joists and trusses.

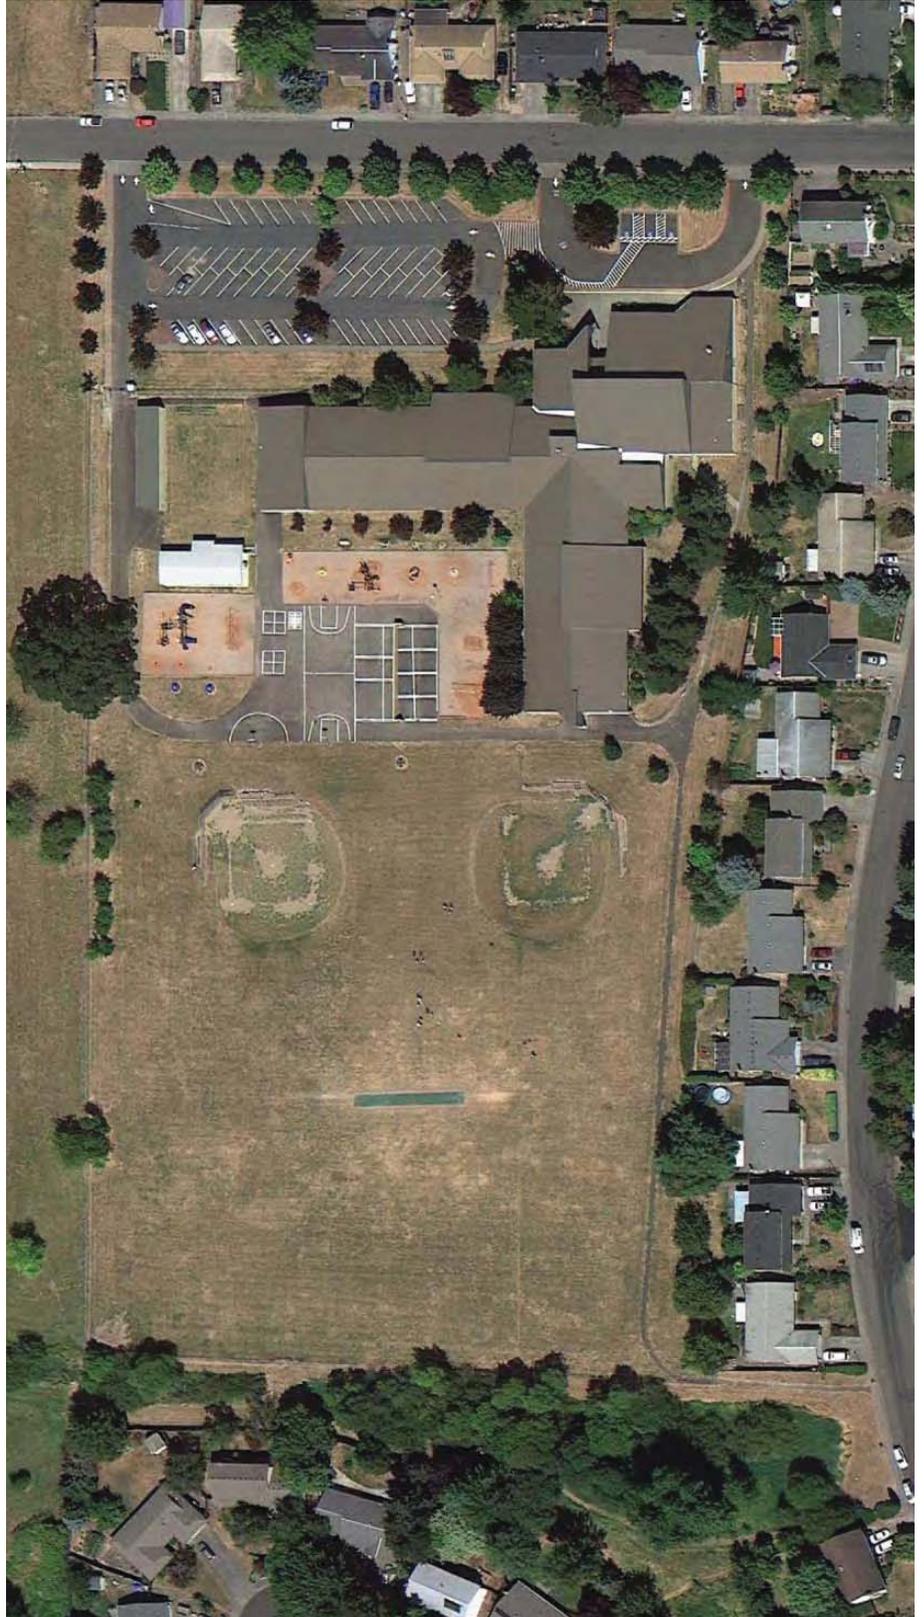
Indian Hills Elementary | Floor Plan

NOTE:  
NUMBERED ROOMS  
ARE CLASSROOMS  
EXCEPT ROOM 1

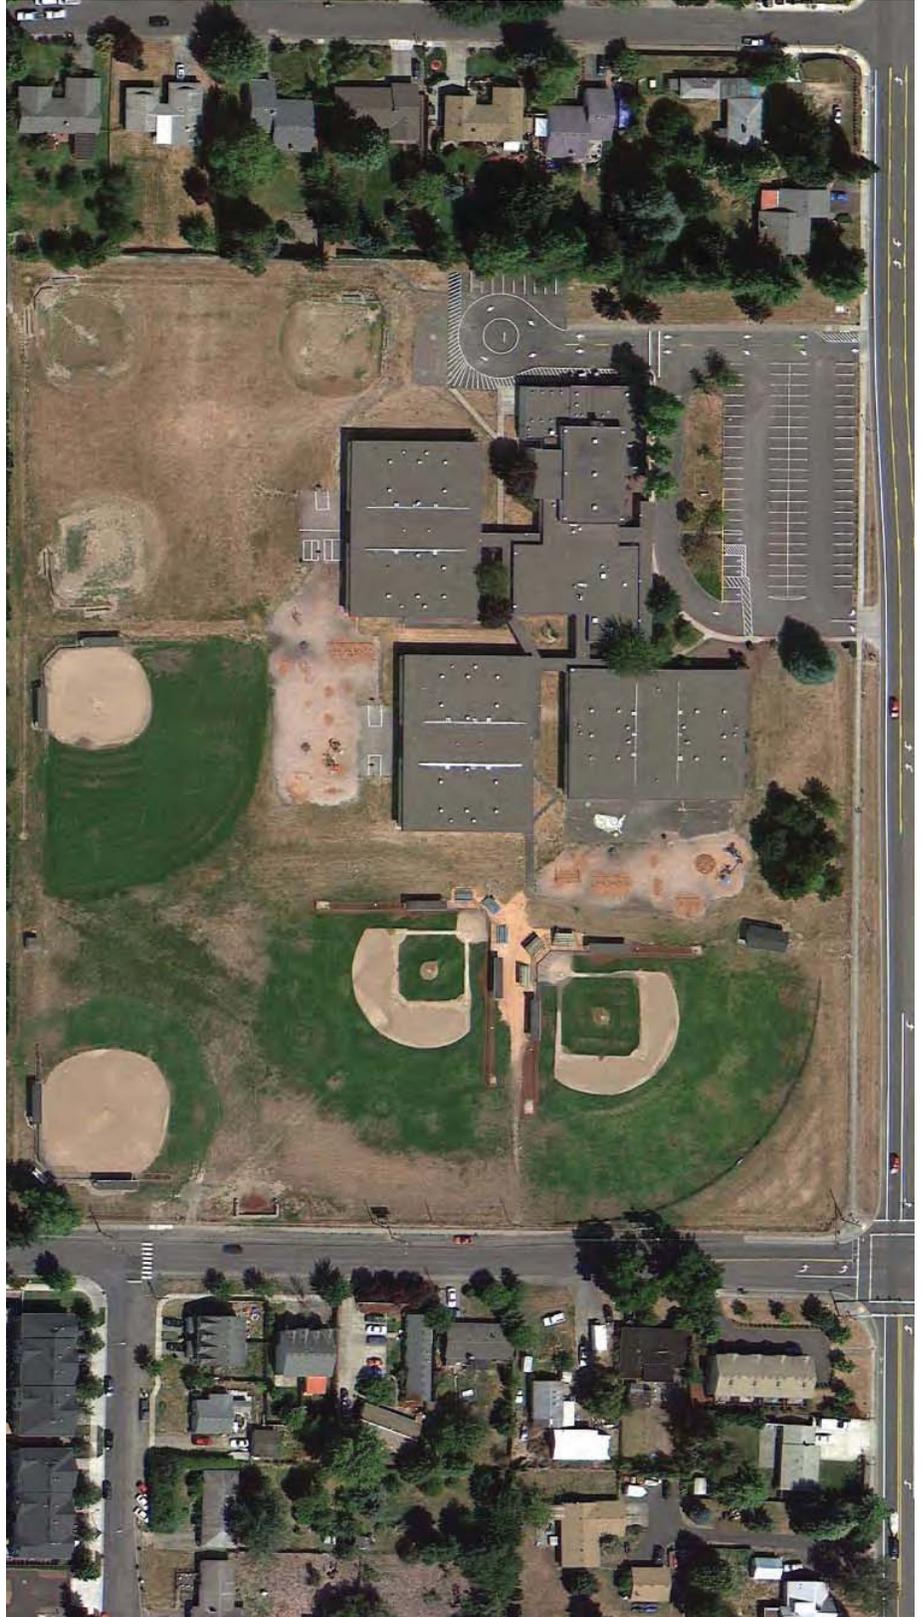
NOTE:  
 ROOMS ONLY HAVE 1 TO 4 ON DOORS.  
 PODS ARE IDENTIFIED BY THE NUMBER  
 OF STARS ON THE ENTRY AREA.

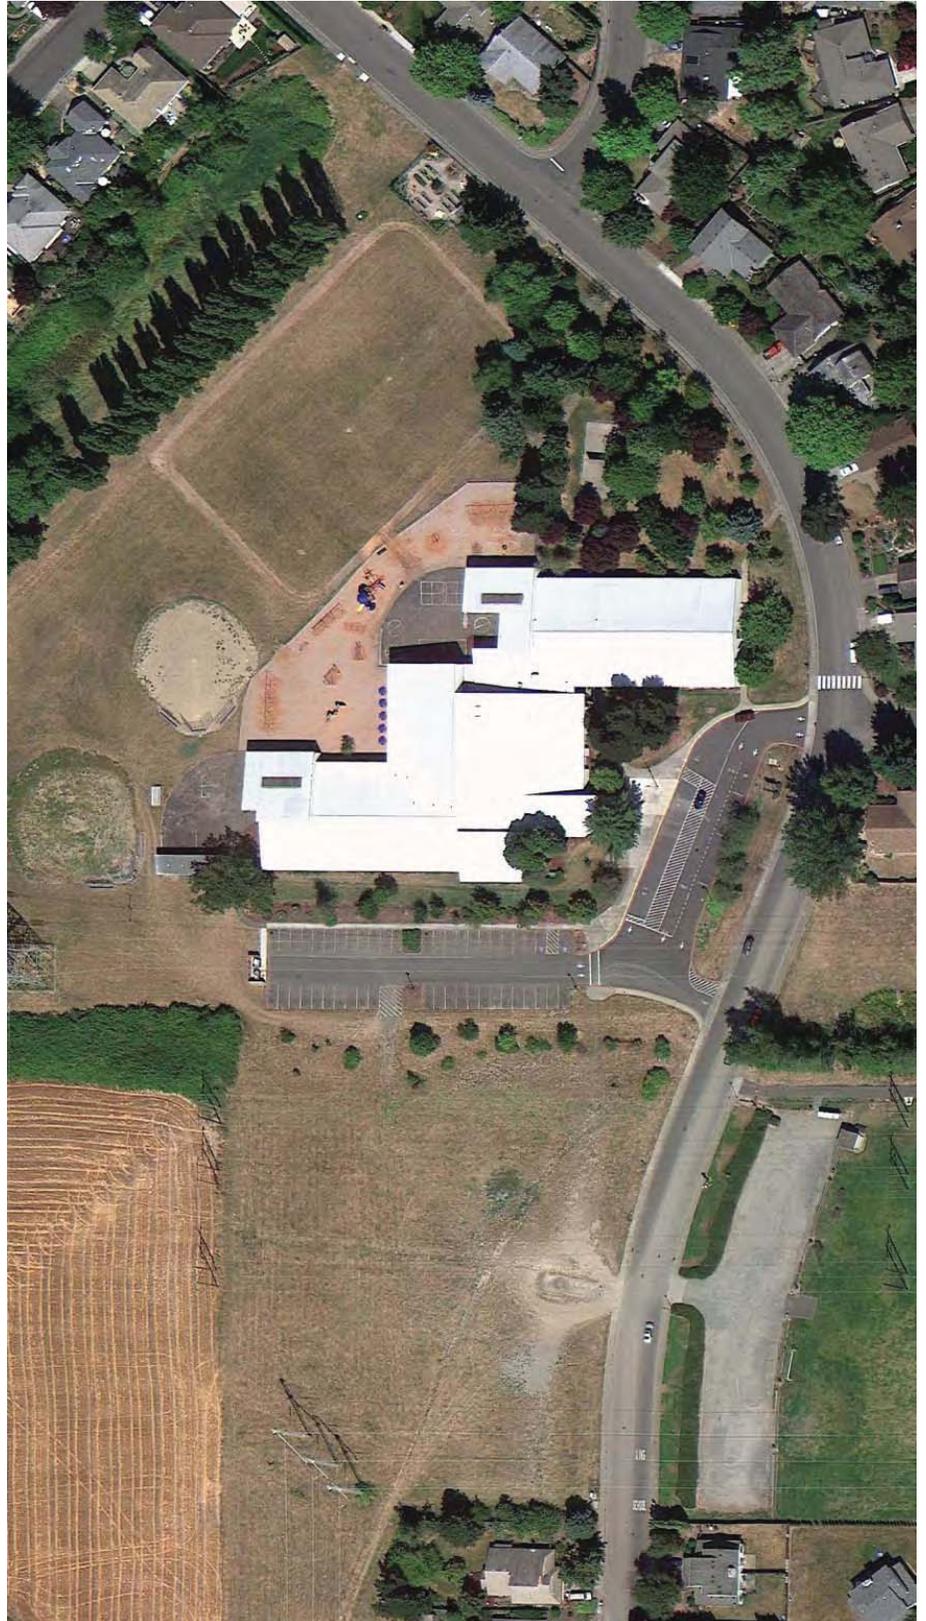
NOTES  
NO PORTABLES  
NO NATURAL GAS

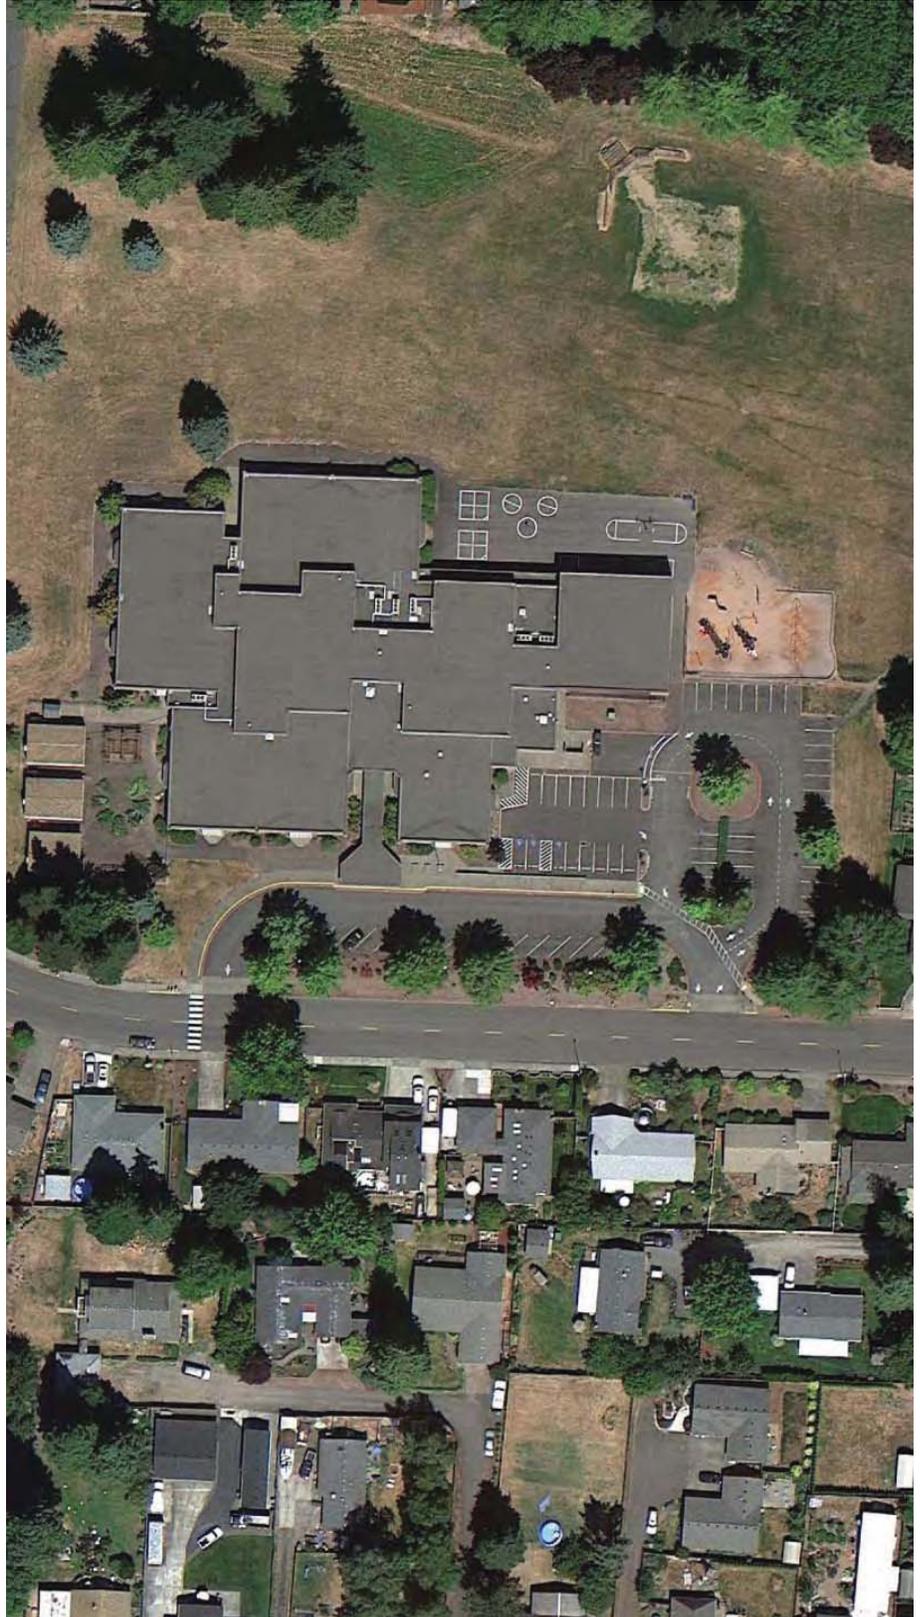
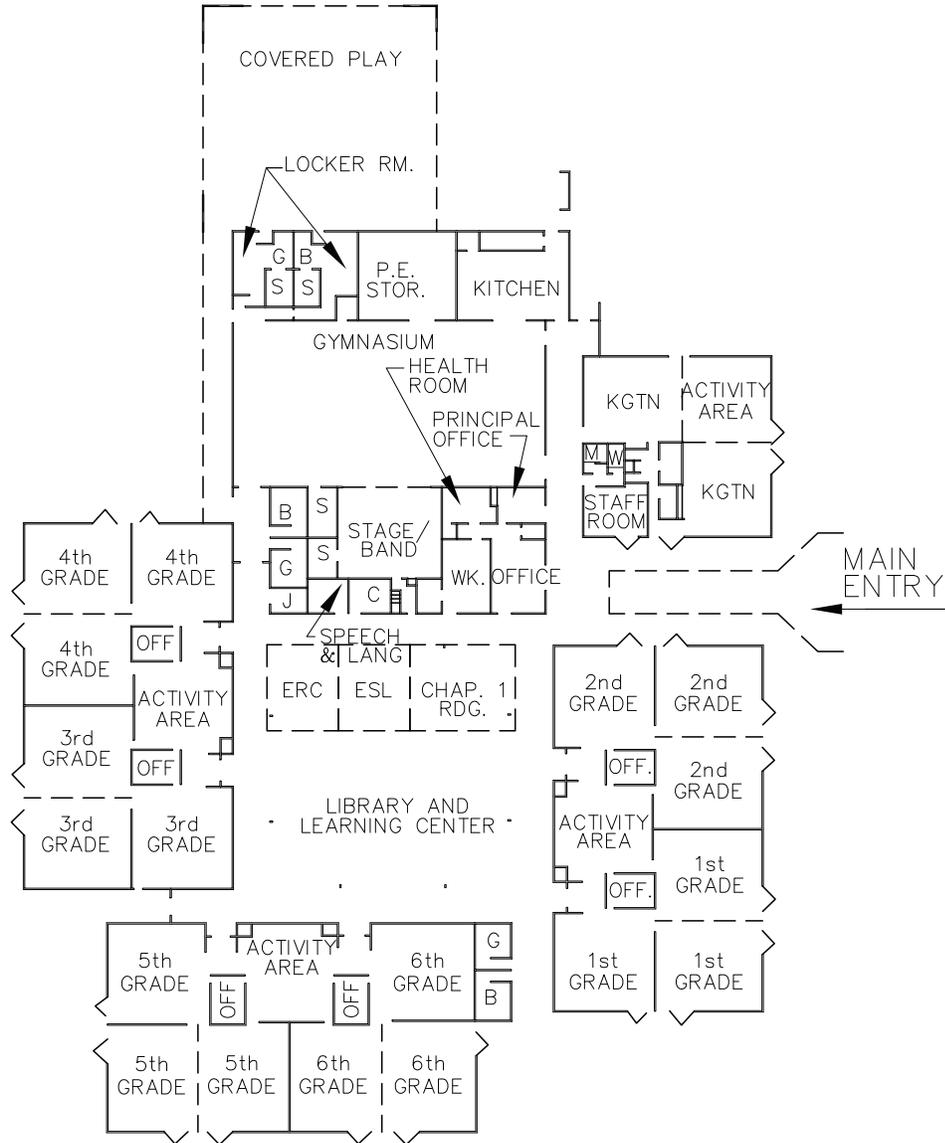
W. Verne McKinney Elementary | Floor Plan

NOTES:  
 NO ROOM NUMBERS ESTABLISHED  
 ROOM DESCRIPTIONS MAY  
 CHANGE ANNUALLY

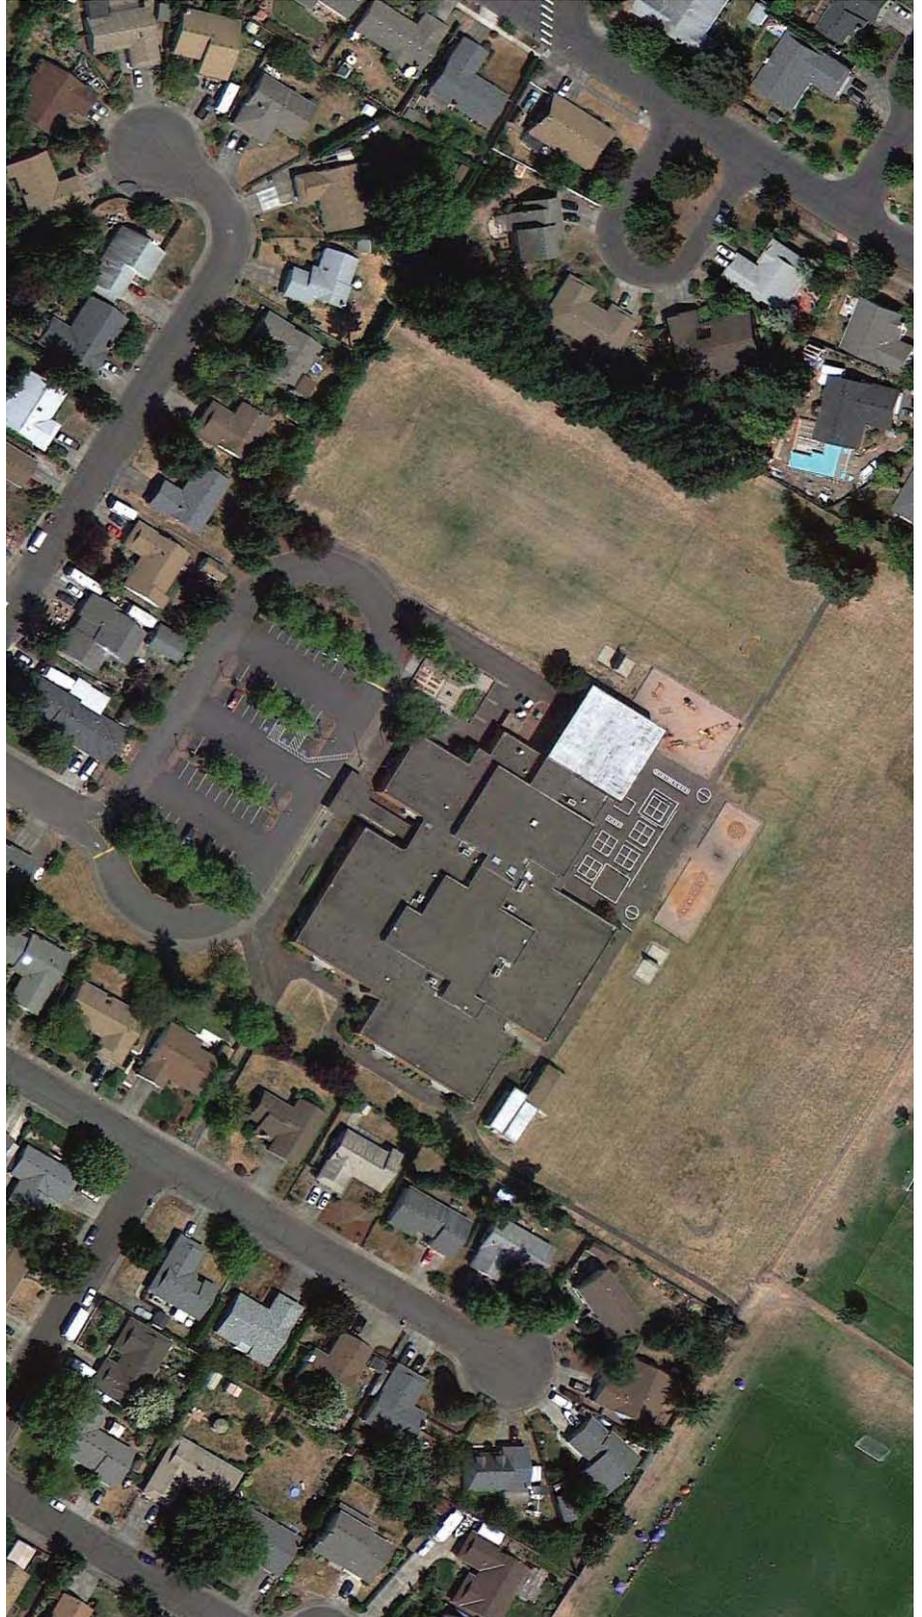
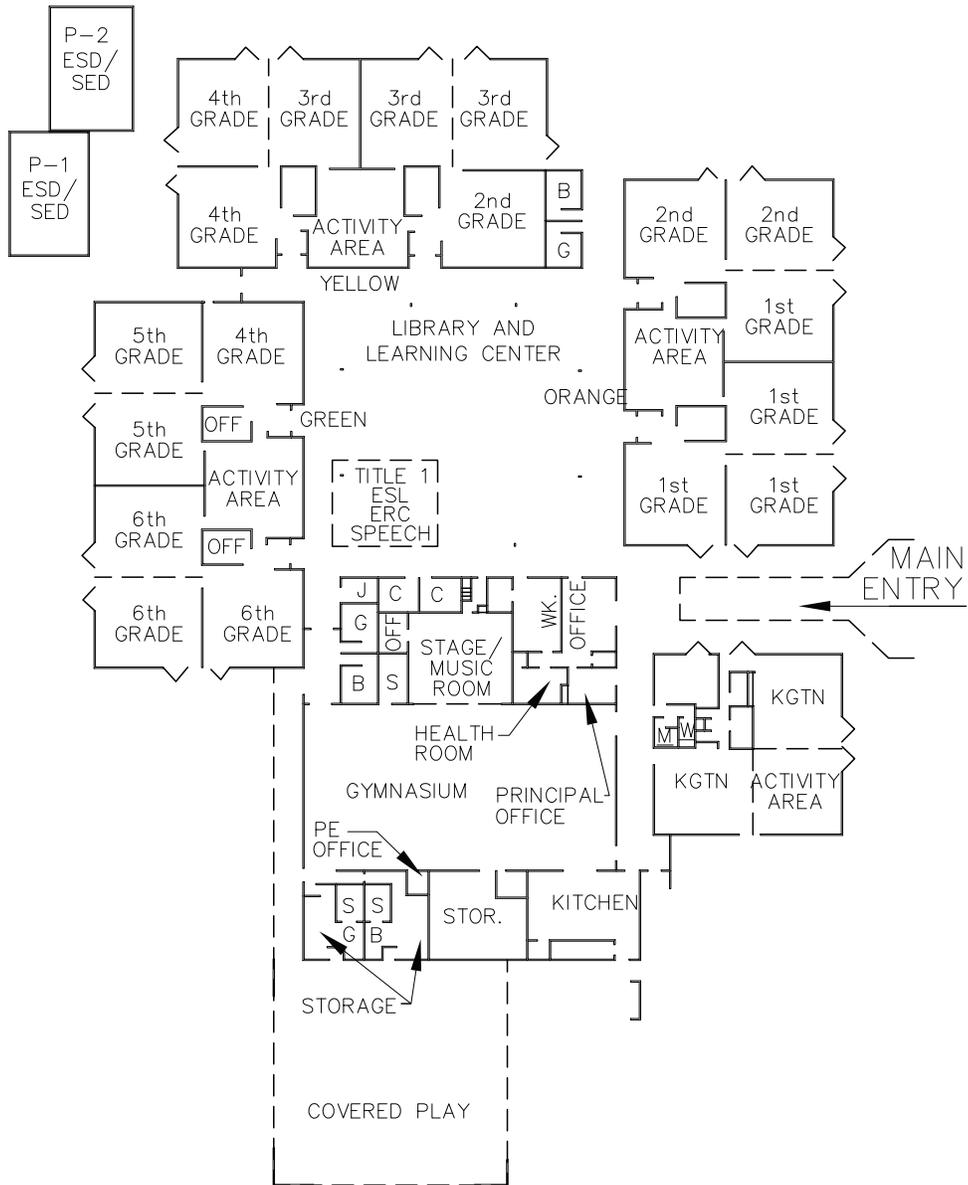
Minter Bridge Elementary | Floor Plan

NOTES:  
NO ROOM NUMBERS ESTABLISHED  
ROOM DESCRIPTIONS MAY  
CHANGE ANNUALLY

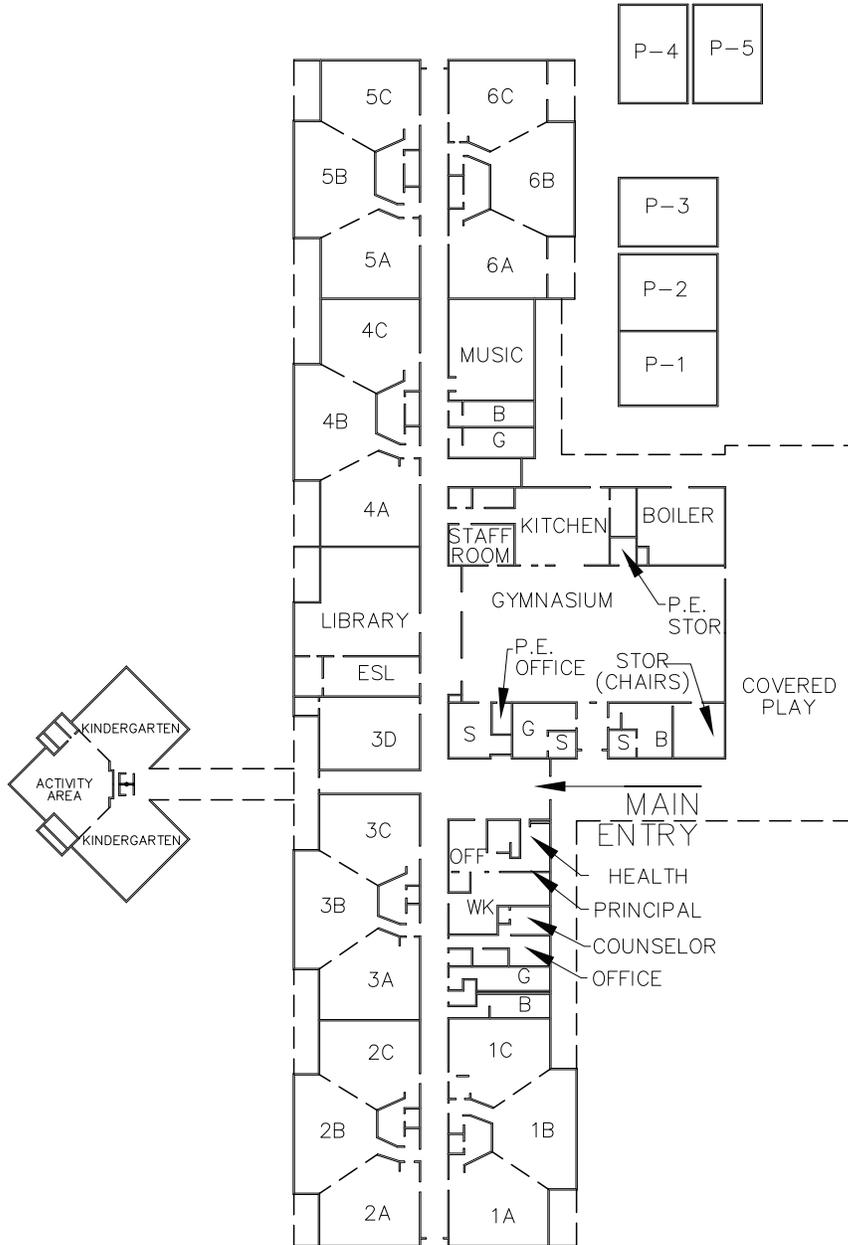
Mooberry Elementary | Floor Plan

NOTE:  
 NUMBERED ROOMS  
 ARE CLASSROOMS

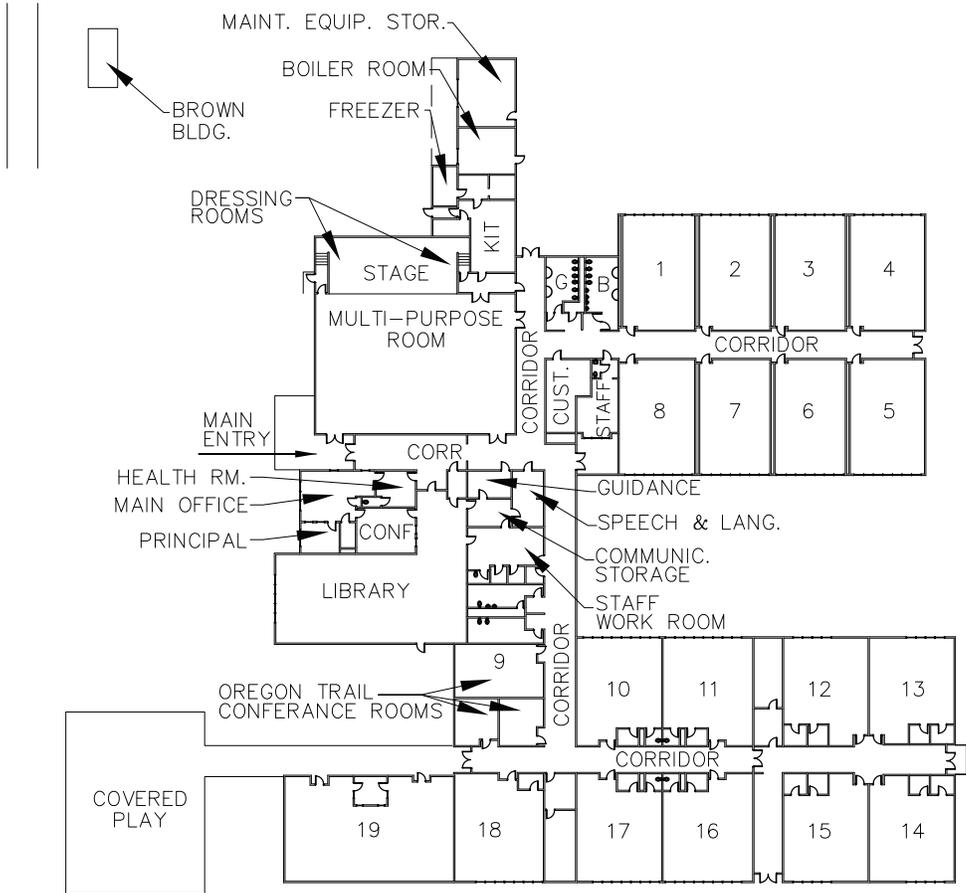
NOTE:  
NUMBERED ROOMS  
ARE CLASSROOMS

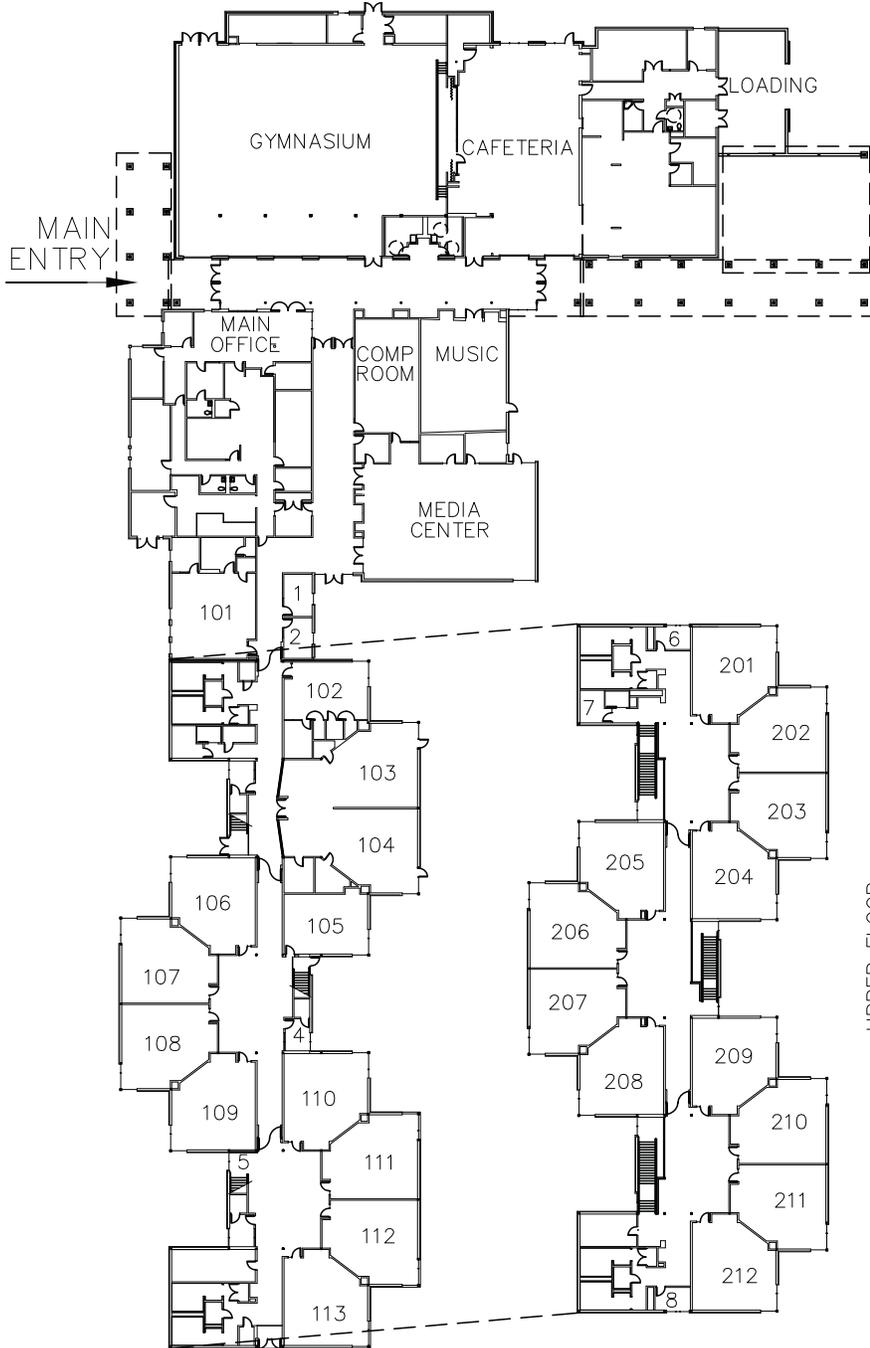
NOTES:

1xx & 2xx NUMBERS ARE CLASSROOMS  
1x & 2x NUMBERS ARE SMALL  
GROUP AREAS

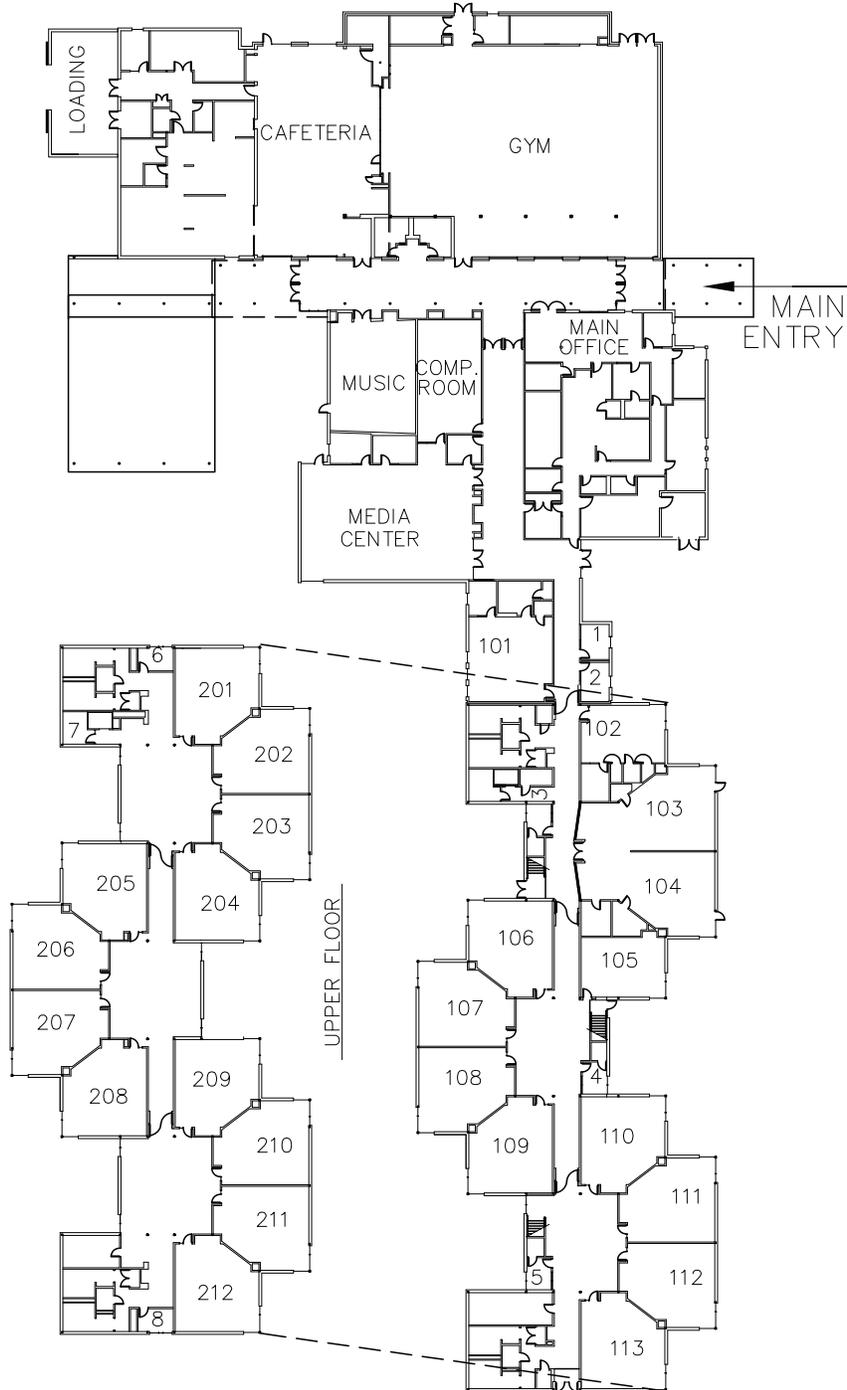
NOTES:

1xx & 2xx NUMBERS ARE CLASSROOMS  
1x & 2x NUMBERS ARE SMALL  
GROUP AREAS

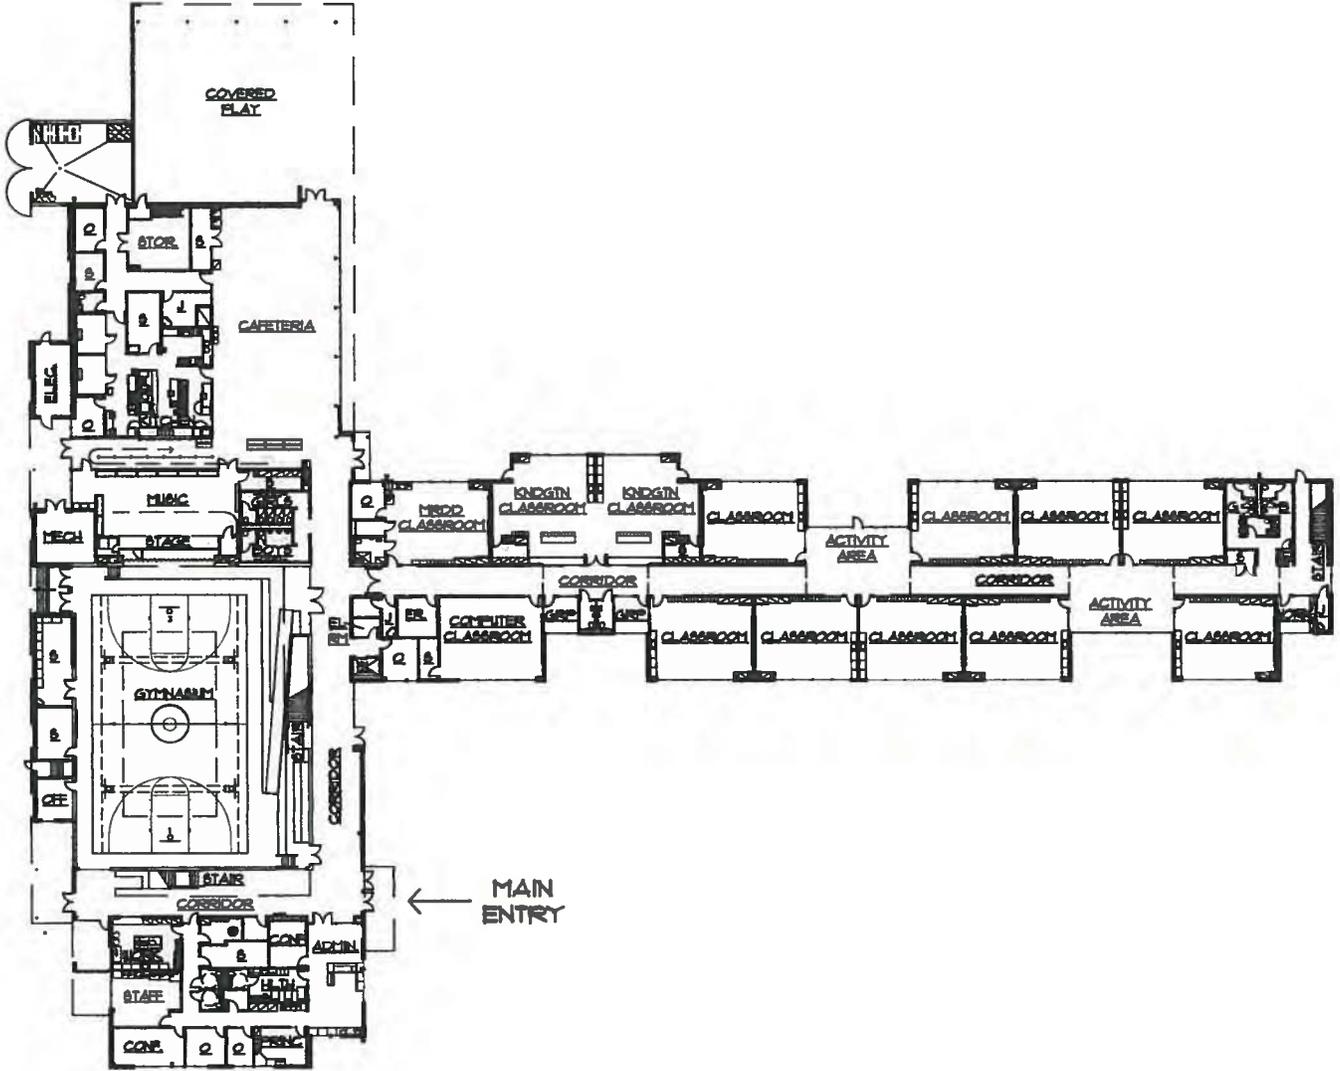
Quatama Elementary | Floor Plan

FLOOR PLAN - MAIN LEVEL

QUATAMA ELEMENTARY SCHOOL - 195  
6905 NE CAMPUS WAY  
HILLSBORO OR 97124
