mahlum

FACILITY ASSESSMENT REPORT  
HILLSBORO SCHOOL DISTRICT  
HILLSBORO, OREGON

6 APRIL 2012

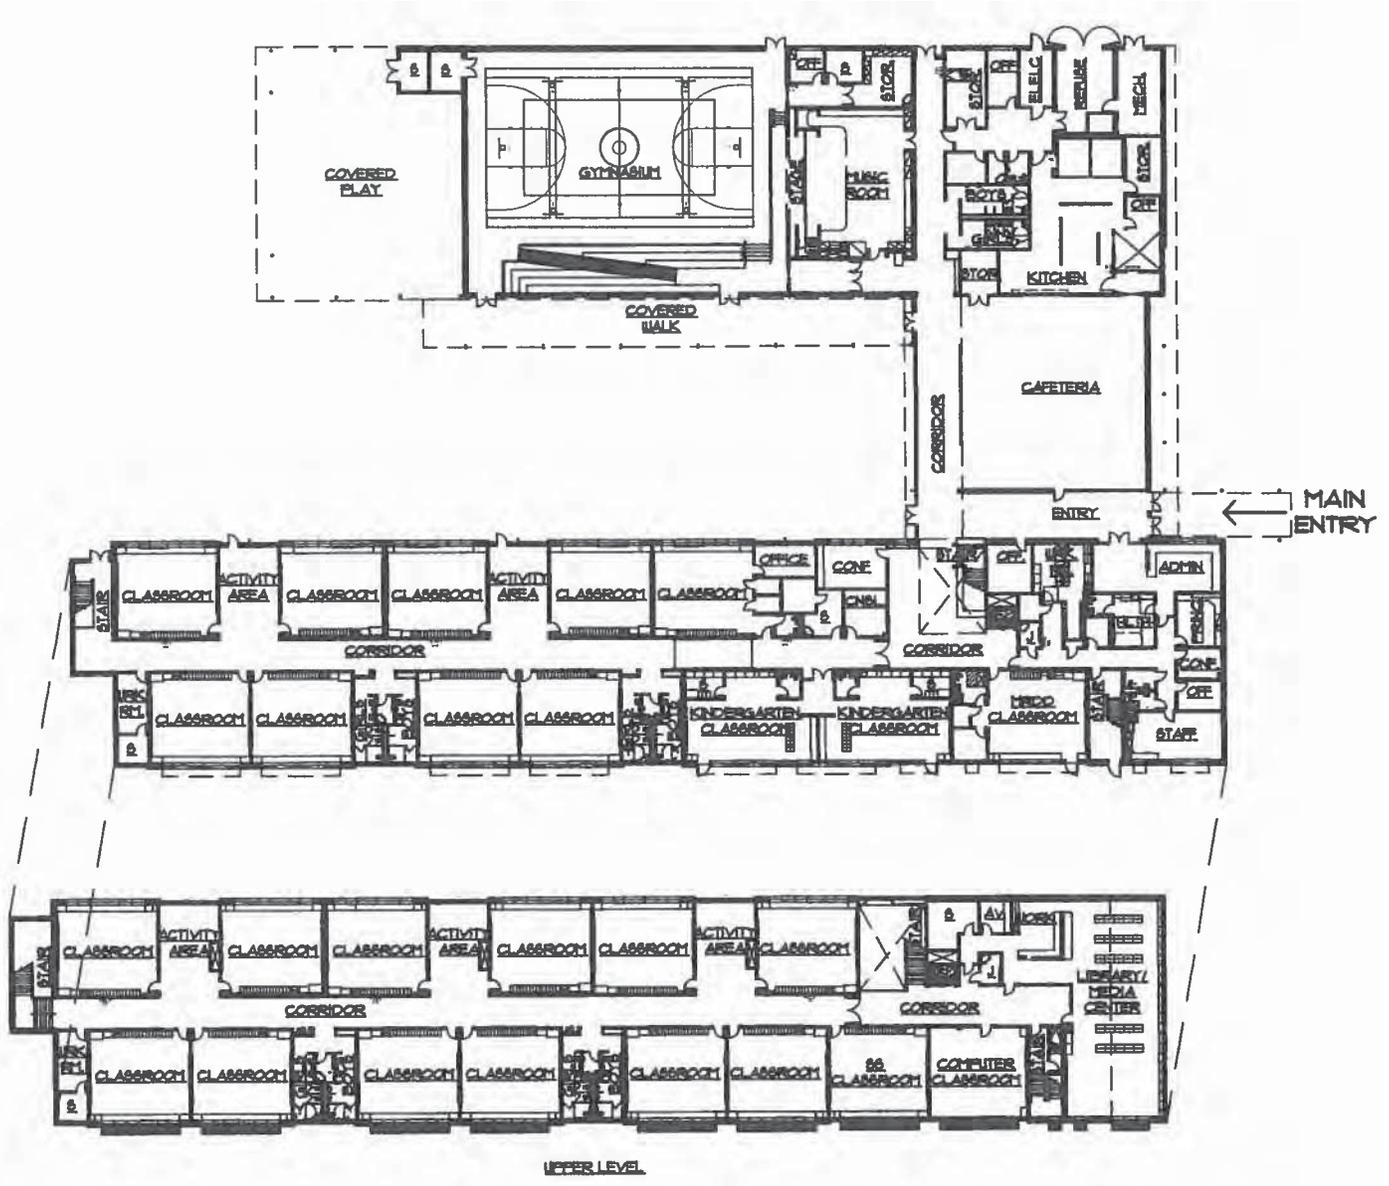
FLOOR PLAN

ROSEDALE ELEMENTARY SCHOOL -212  
3901 SW 229TH AVENUE  
HILLSBORO OR 97107

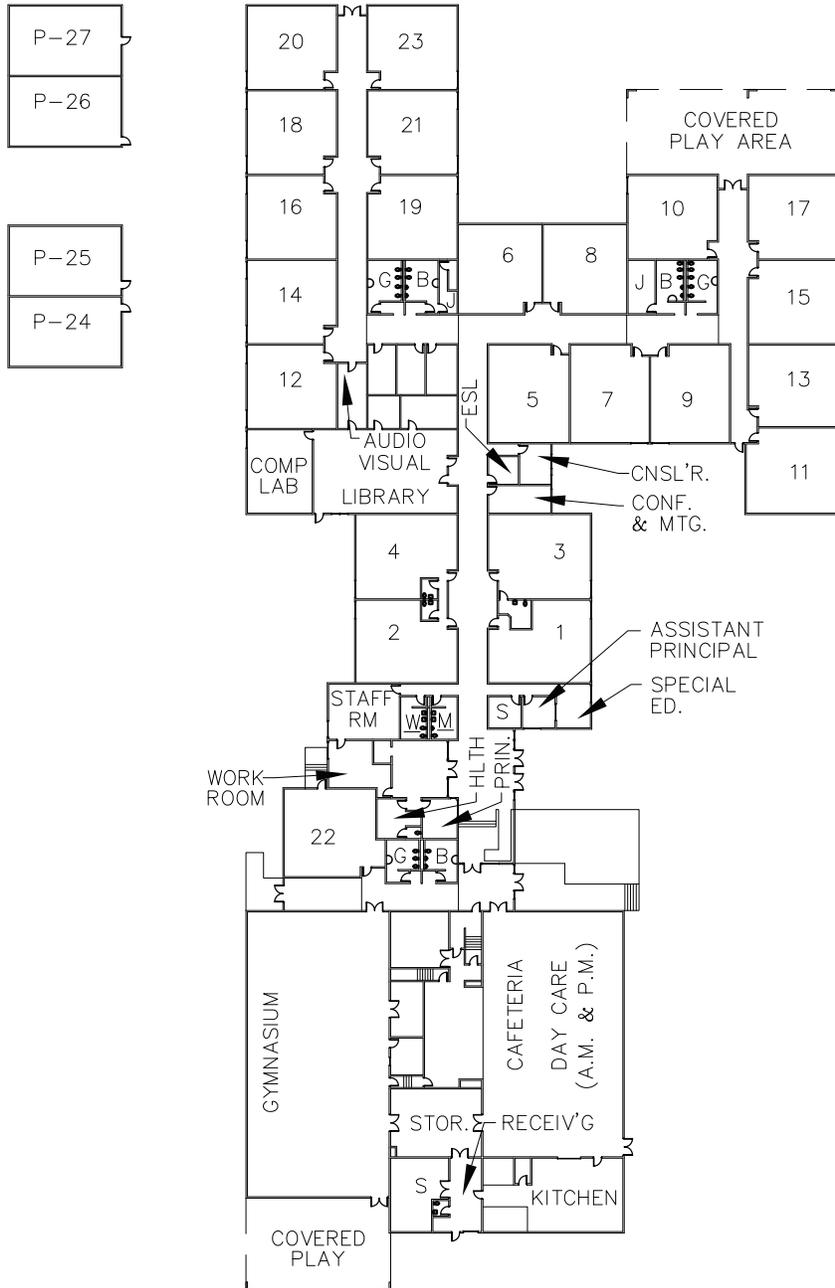
NOTE: \_\_\_\_\_  
 NUMBERED ROOMS 0 50  
 ARE CLASSROOMS SCALE

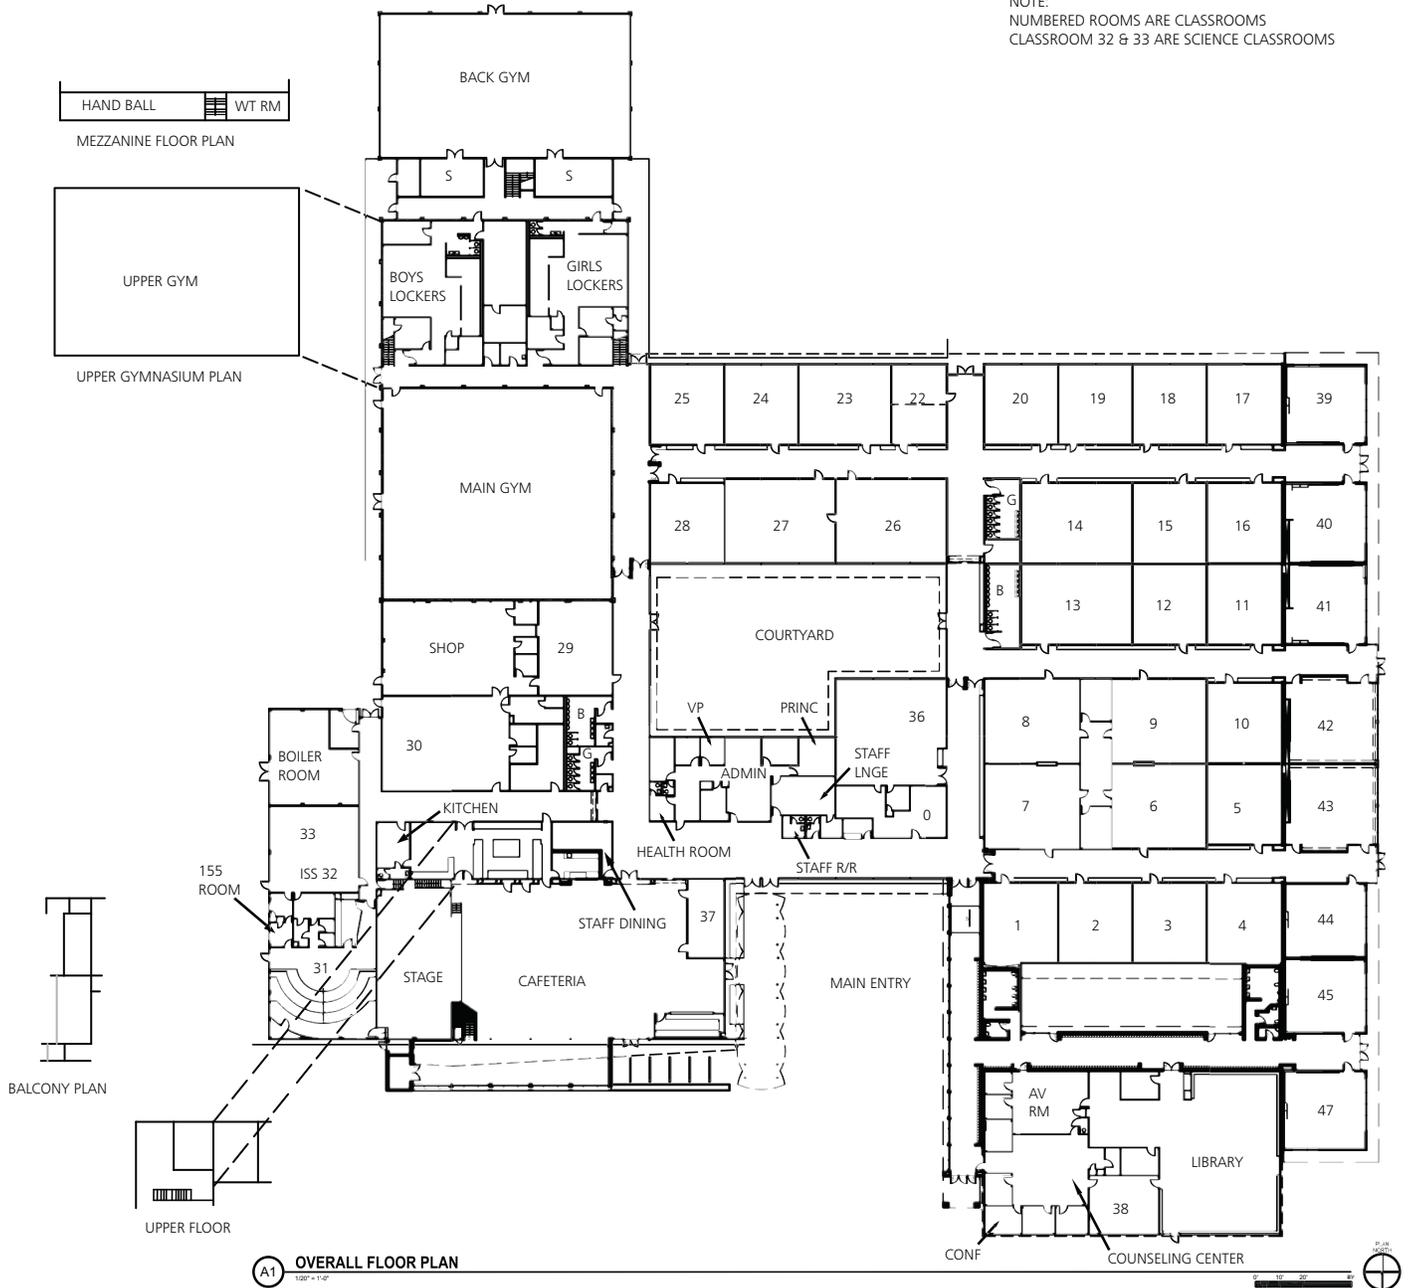
A1 OVERALL FLOOR PLAN  
1/8" = 1'-0"

R. A. Brown Middle | Floor Plan

NOTE:  
 NUMBERED ROOMS ARE CLASSROOMS  
 CLASSROOM 32 & 33 ARE SCIENCE CLASSROOMS

R. A. BROWN MIDDLE SCHOOL

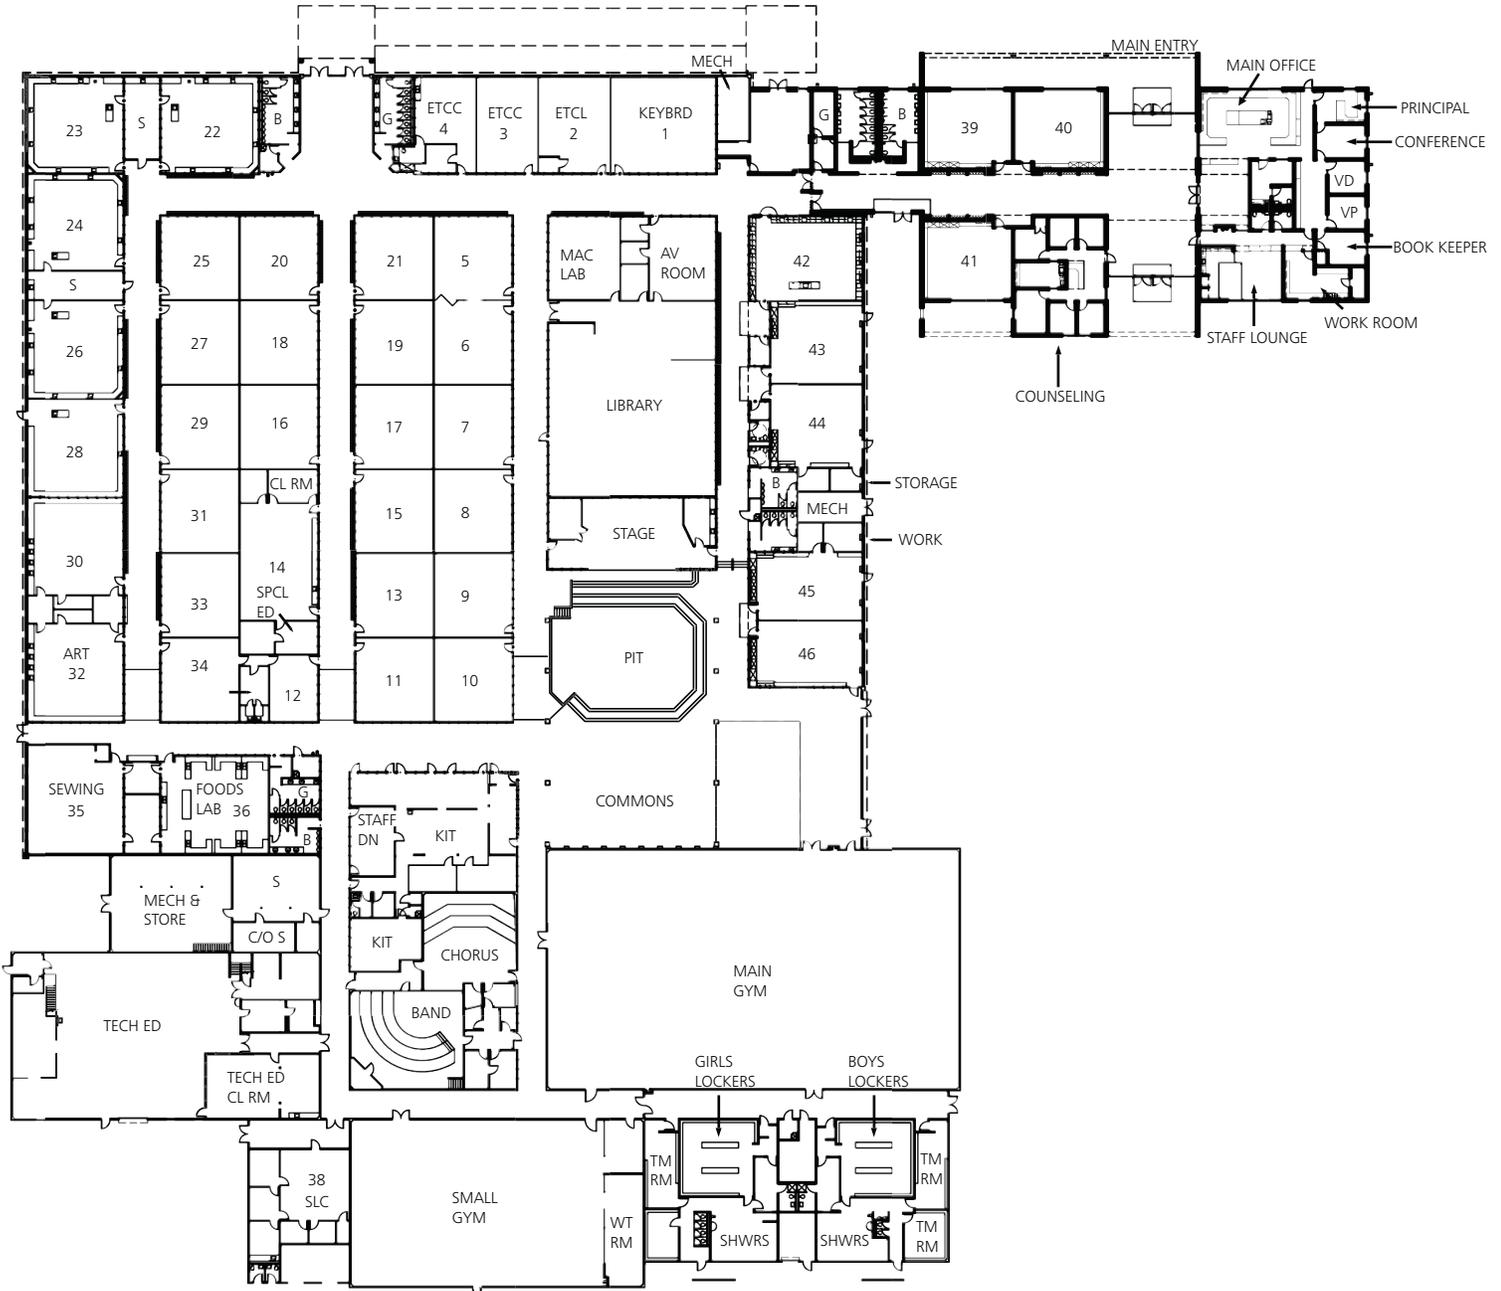
A1 OVERALL FLOOR PLAN  
1/20" = 1'-0"

Evergreen Middle | Floor Plan

NOTES:  
NUMBERED ROOMS ARE CLASSROOMS

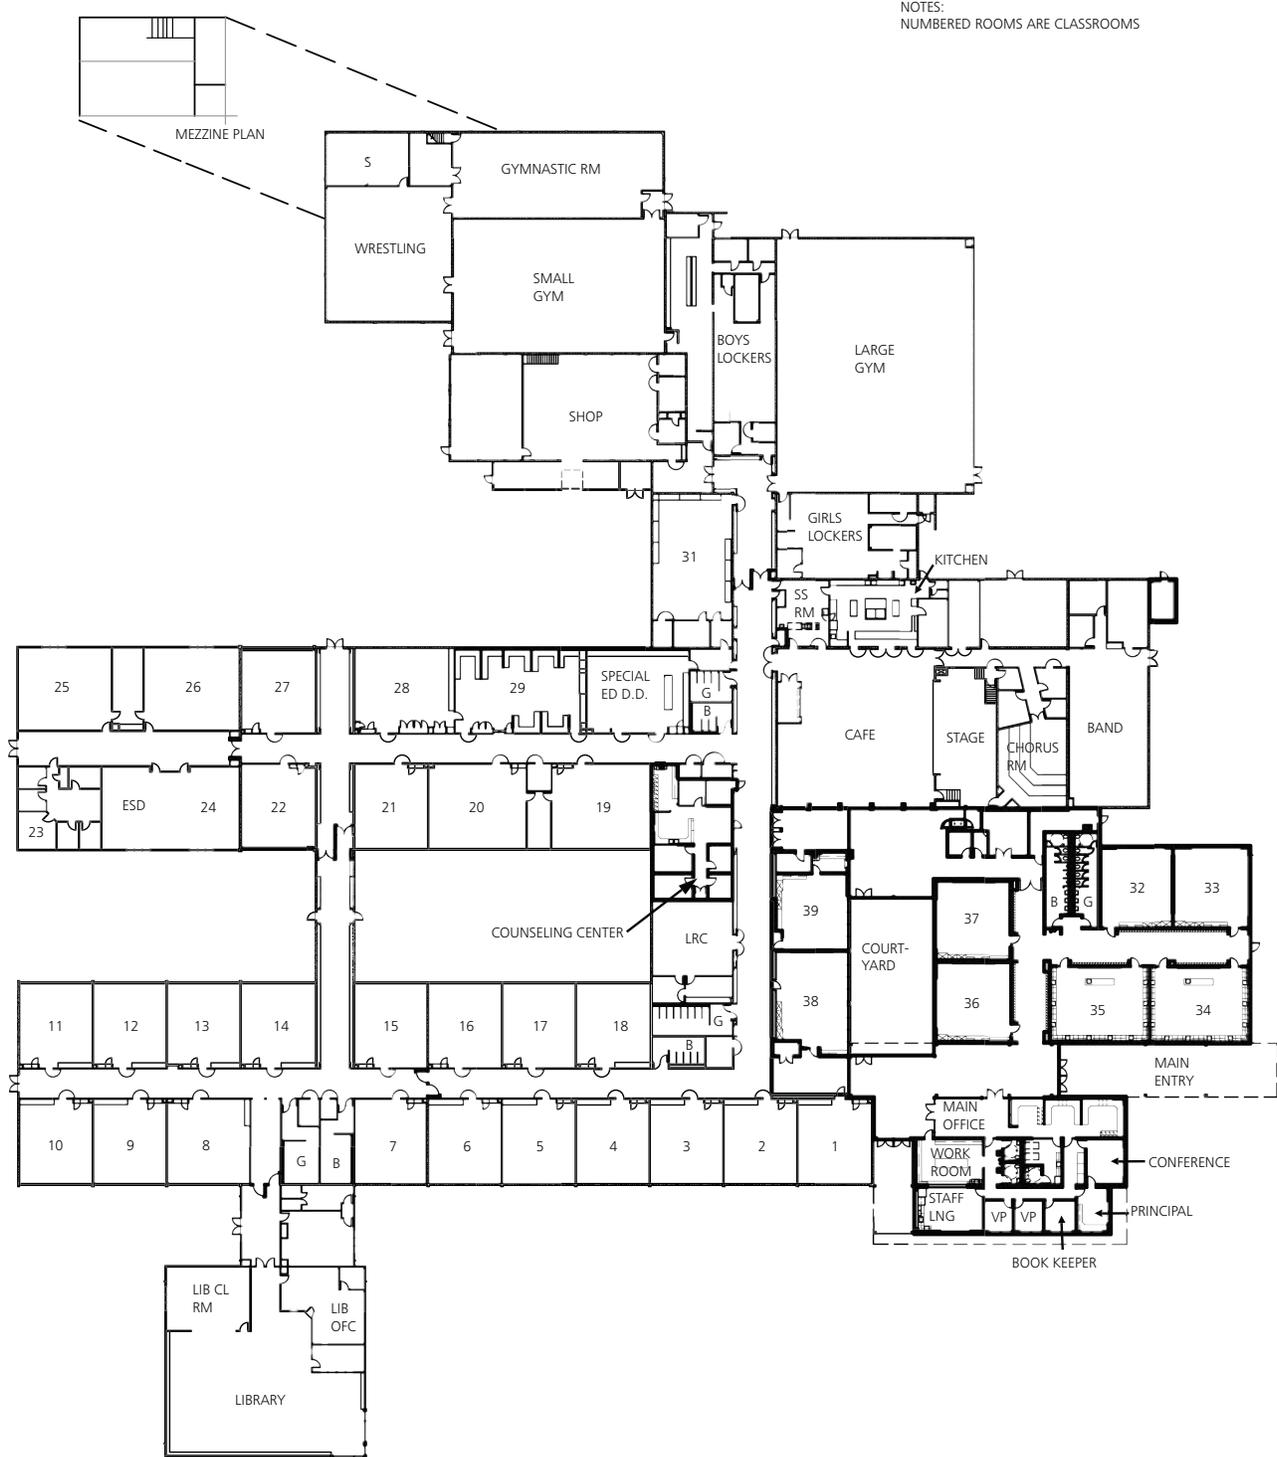
A1 OVERALL FLOOR PLAN  
1" = 20'-0"

J. W. Poynter Middle | Floor Plan

NOTES:  
NUMBERED ROOMS ARE CLASSROOMS

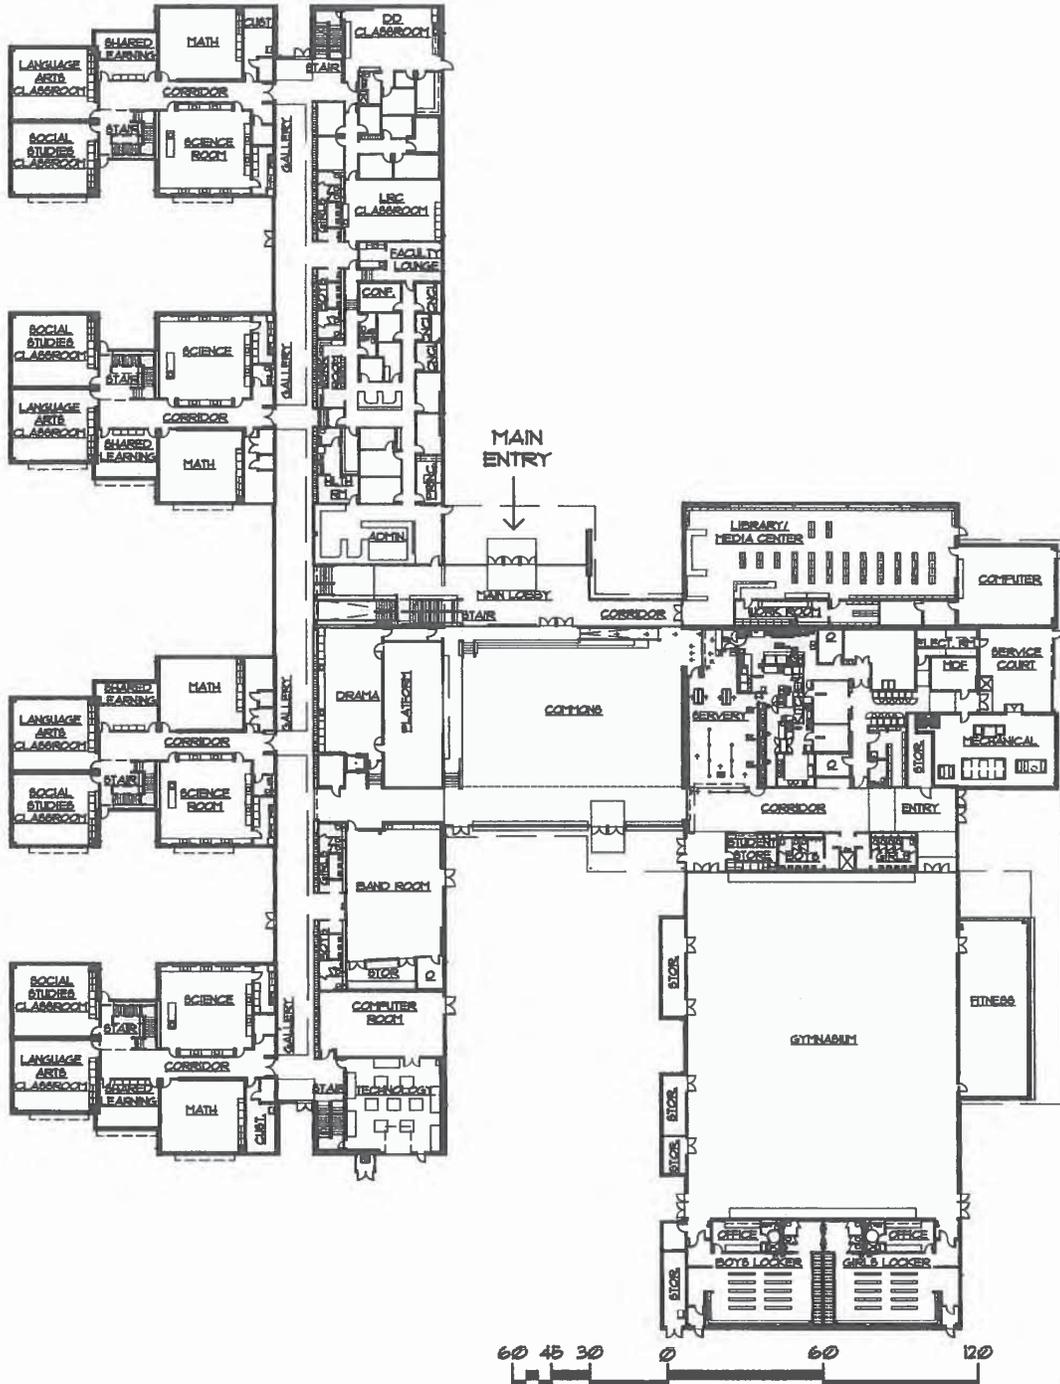
FLOOR PLAN

SOUTH MEADOWS MIDDLE SCHOOL - 514  
4690 SE DAVIS ROAD  
HILLSBORO OR 97123

South Meadows Middle | Floor Plan

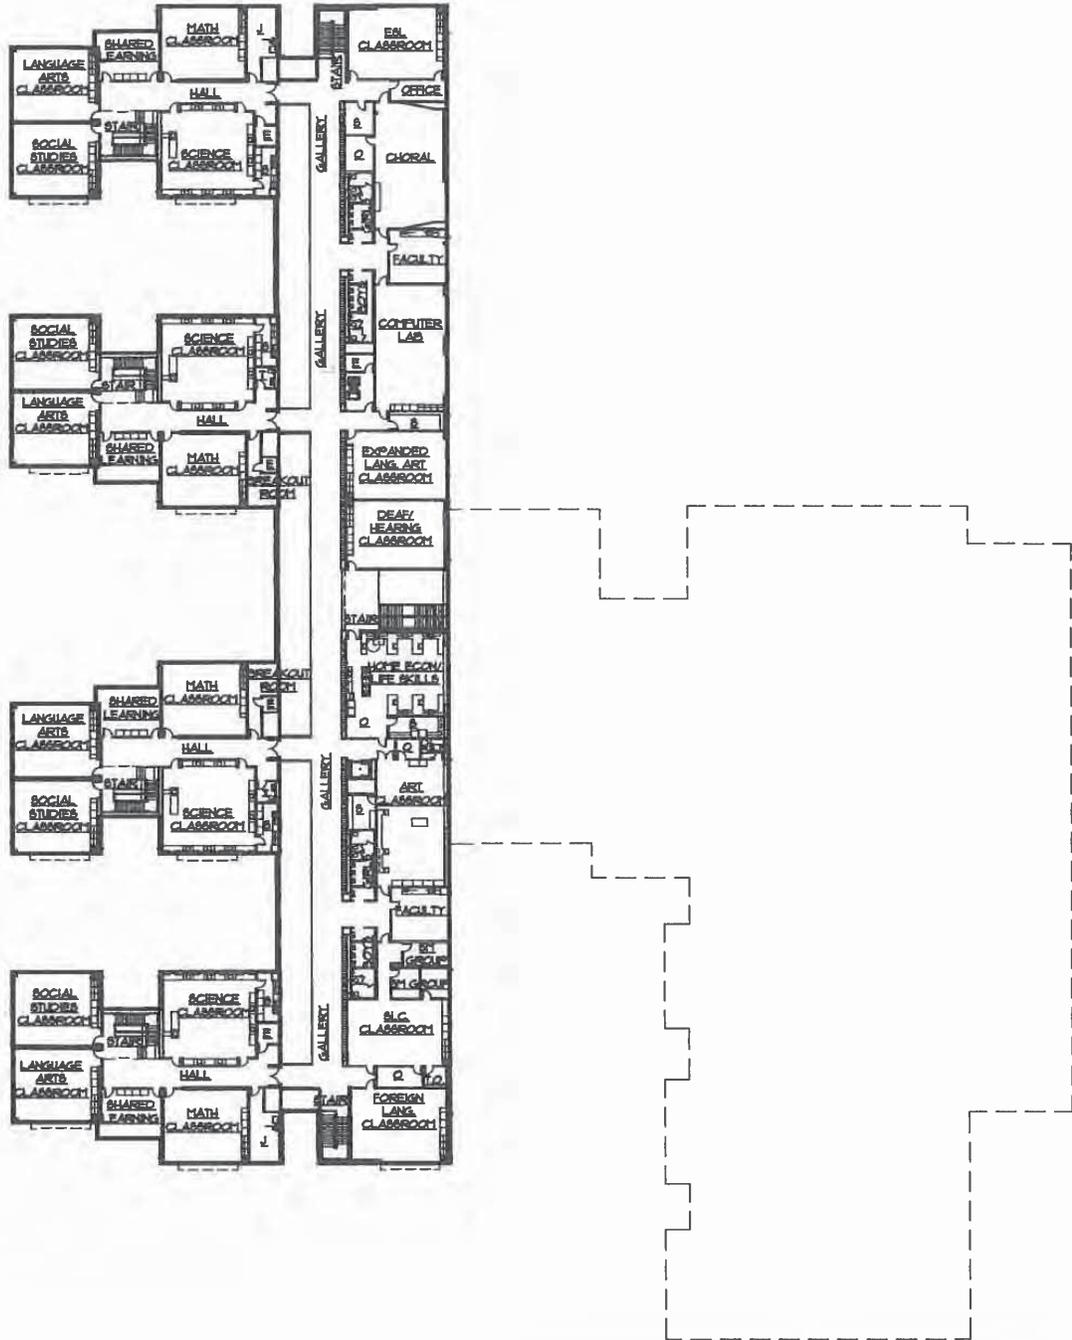
FLOOR PLAN - UPPER LEVEL

SOUTH MEADOWS MIDDLE SCHOOL - 514  
4690 SE DAVIS ROAD  
HILLSBORO OR 97123

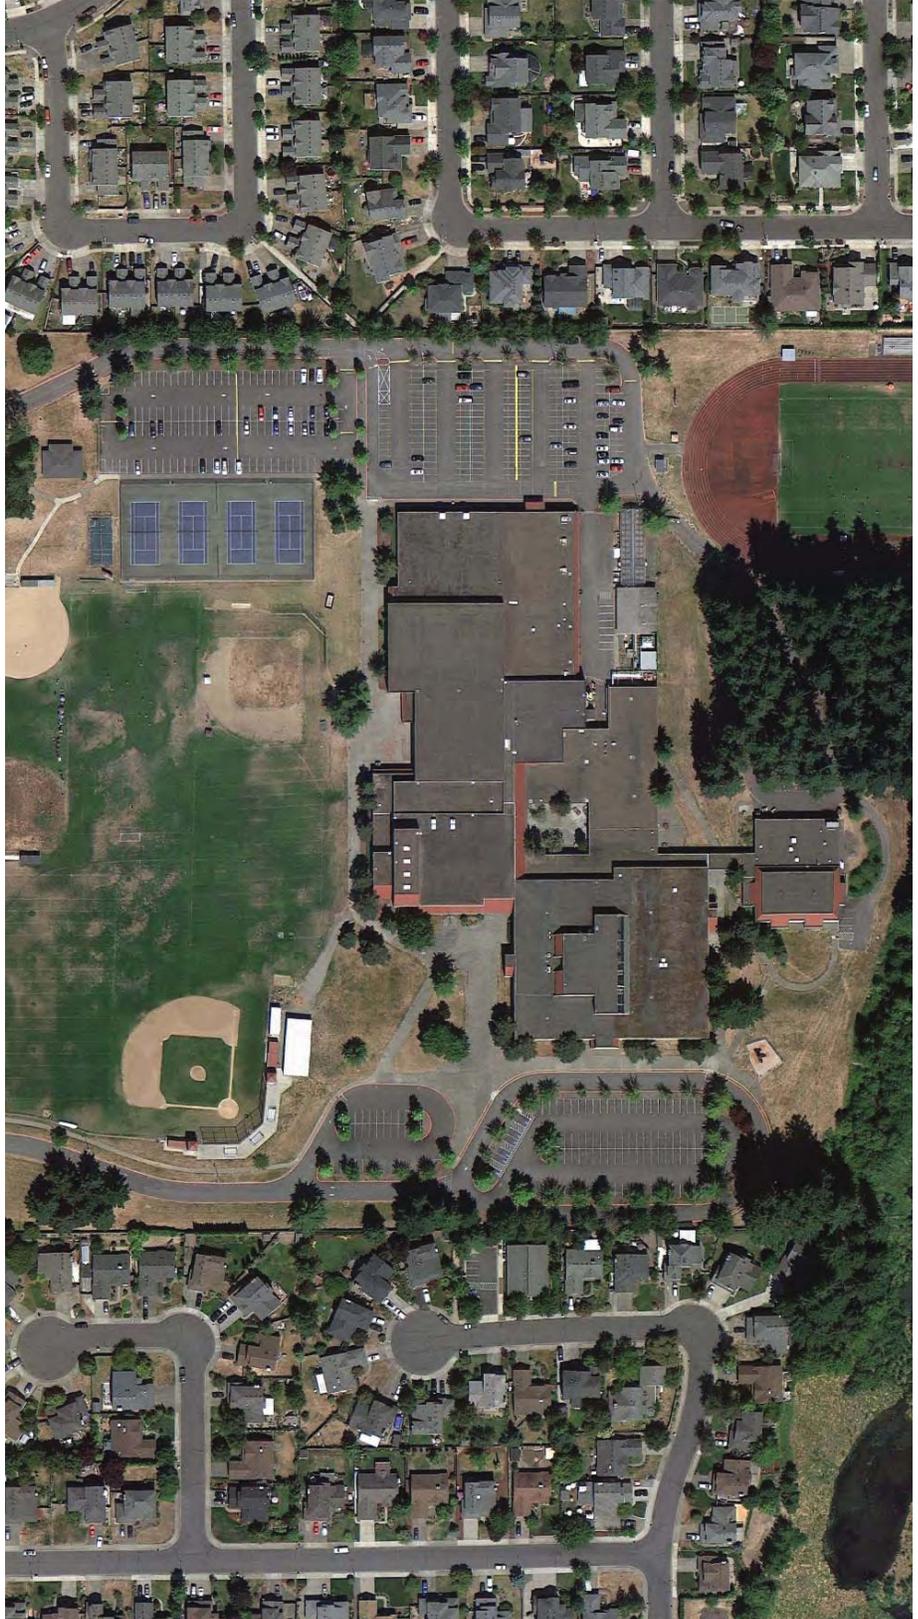
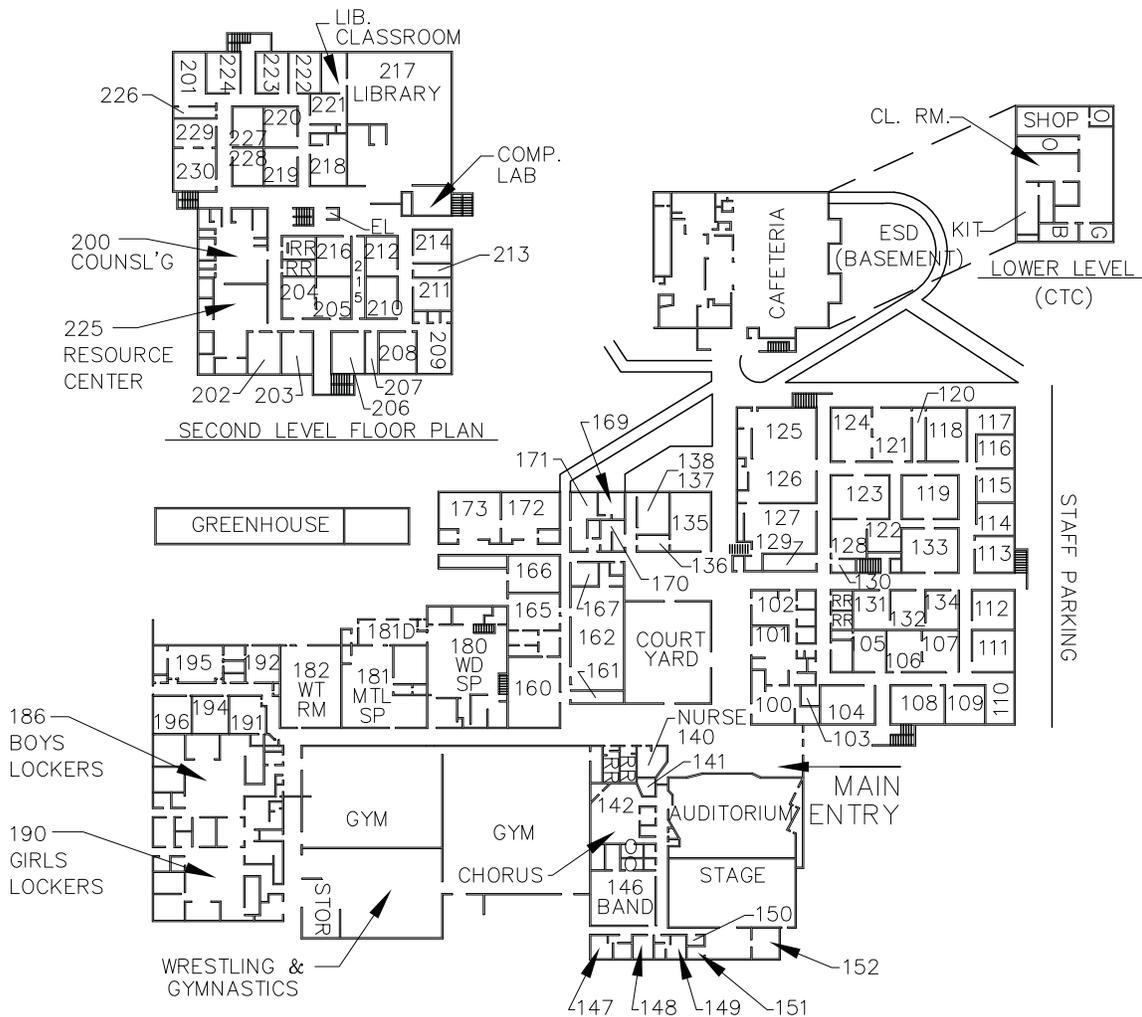
Glencoe High | Floor Plans

NOTE: \_\_\_\_\_  
 NUMBERED ROOMS  
 ARE CLASSROOMS

0 50  
 SCALE

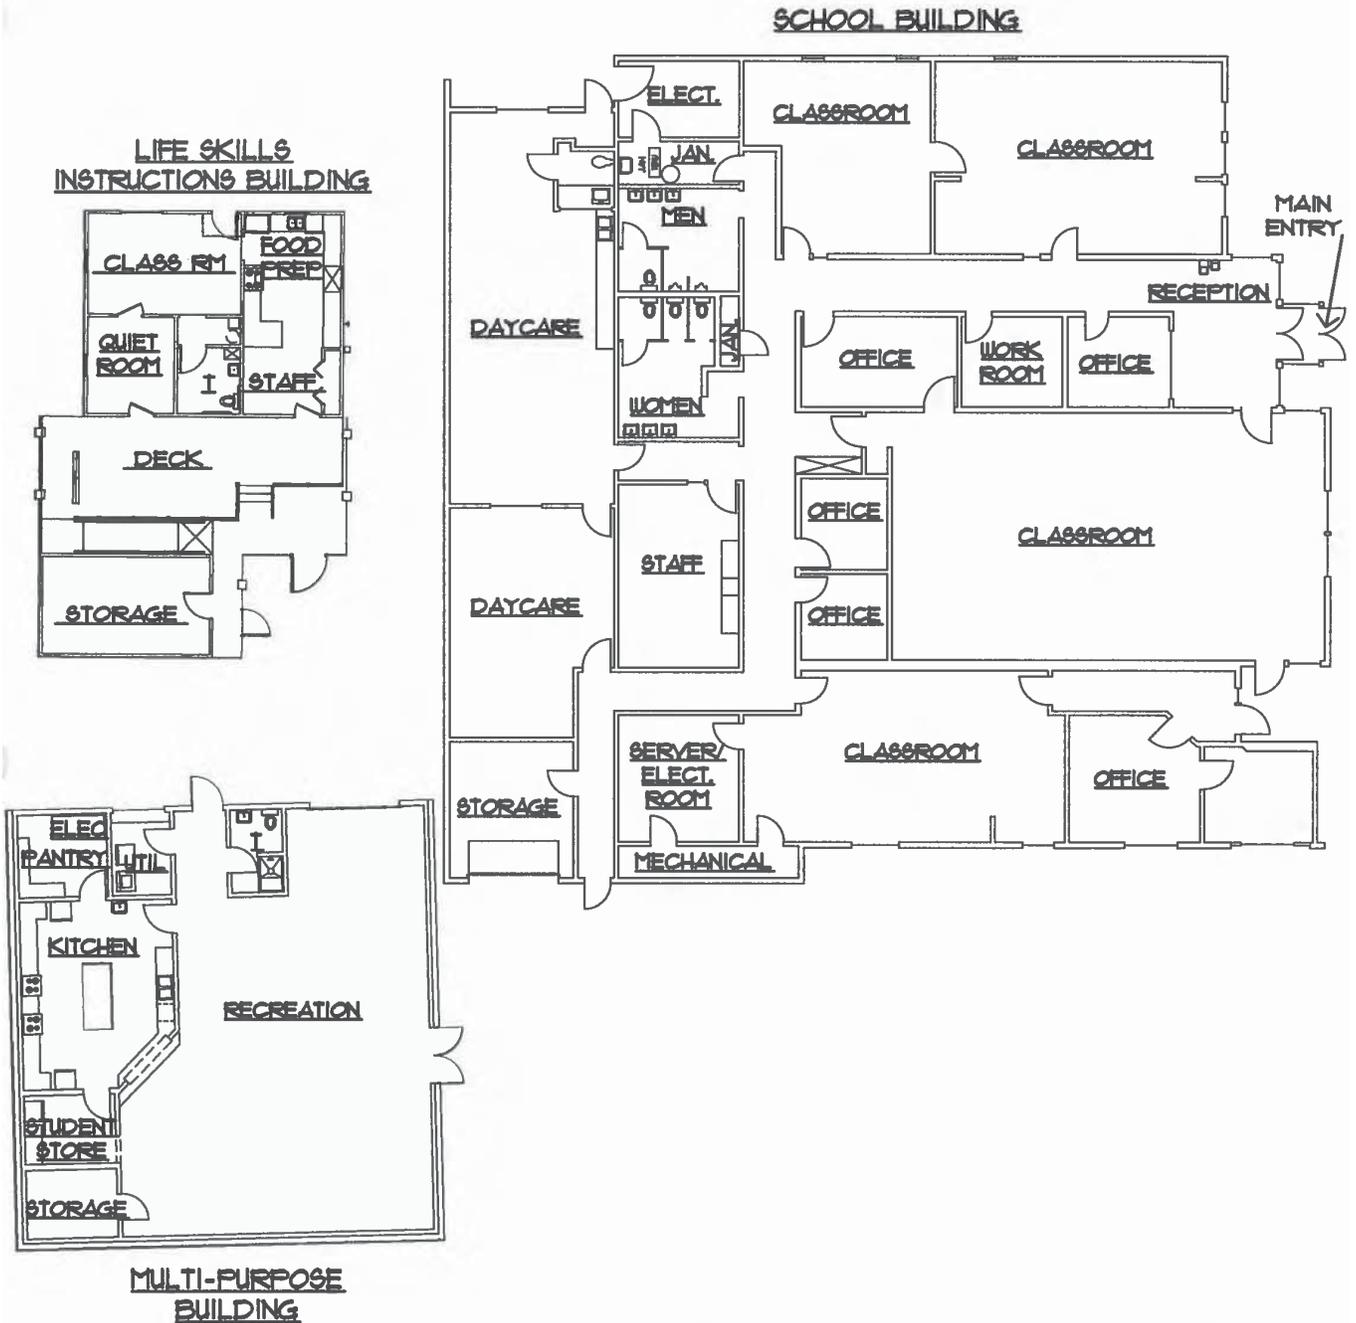
**FLOOR PLAN**

MILLER EDUCATION CENTER ALTERNATIVE  
 HIGH SCHOOL, WEST BUILDING - 650  
 215 SE 6TH AVENUE  
 HILLSBORO OR 97123

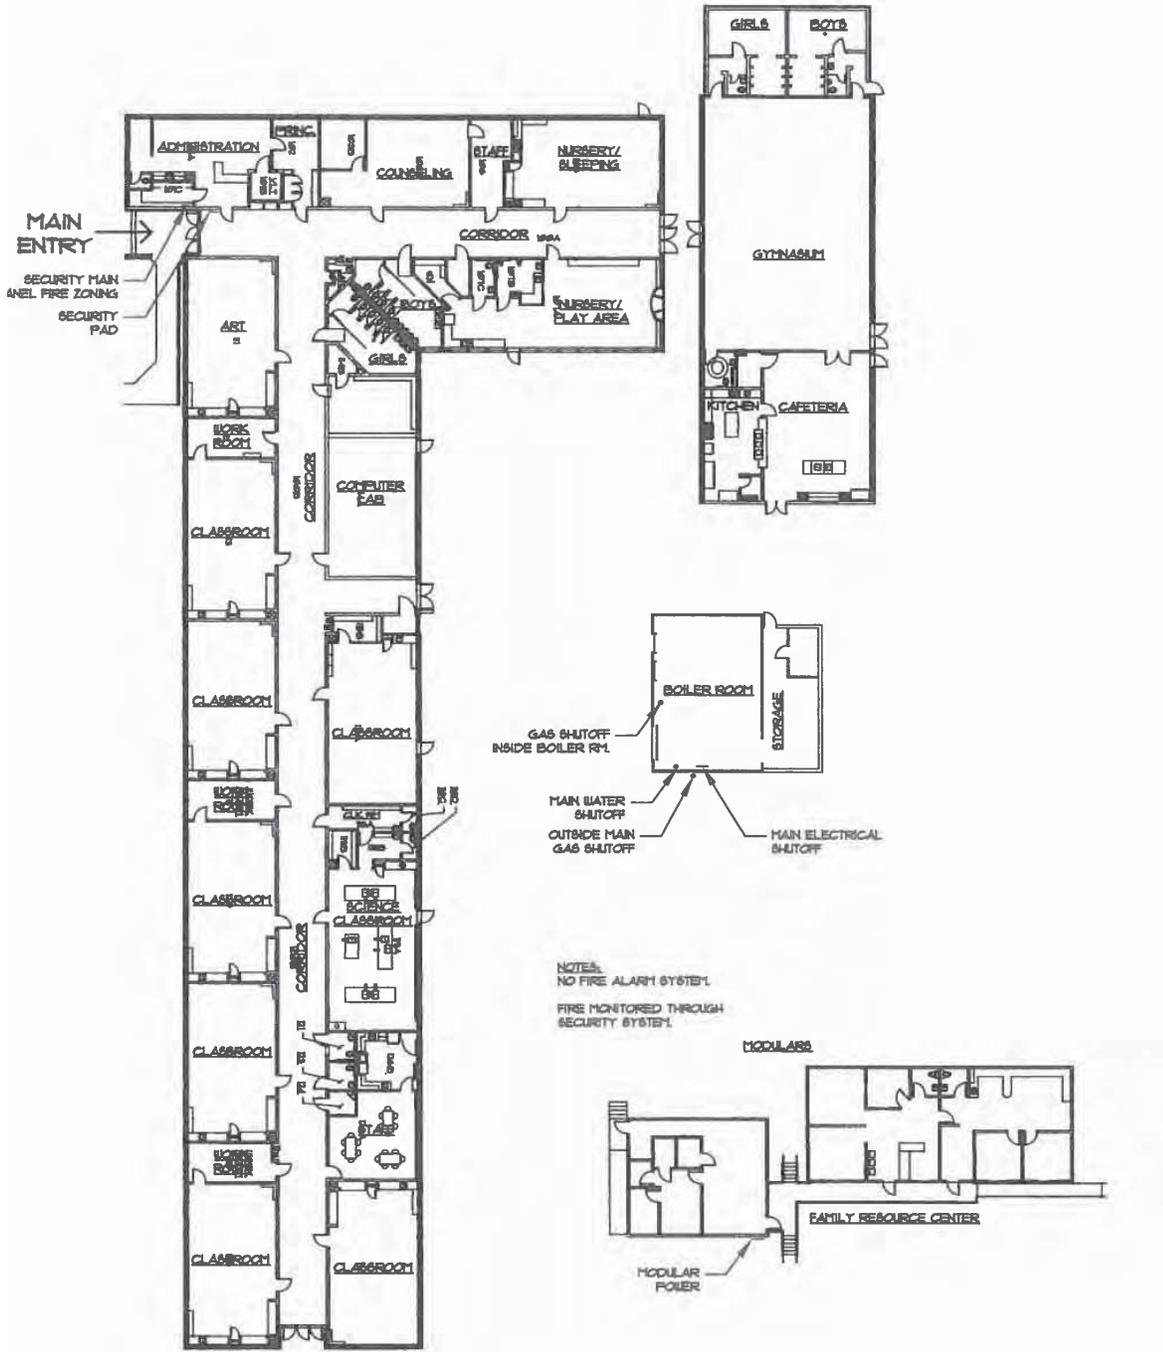
GAS SHUTOFF INSIDE BOILER RM.  
 MAIN WATER SHUTOFF  
 OUTSIDE MAIN GAS SHUTOFF  
 MAIN ELECTRICAL SHUTOFF

NOTES:  
 NO FIRE ALARM SYSTEM!  
 FIRE MONITORED THROUGH SECURITY SYSTEM!

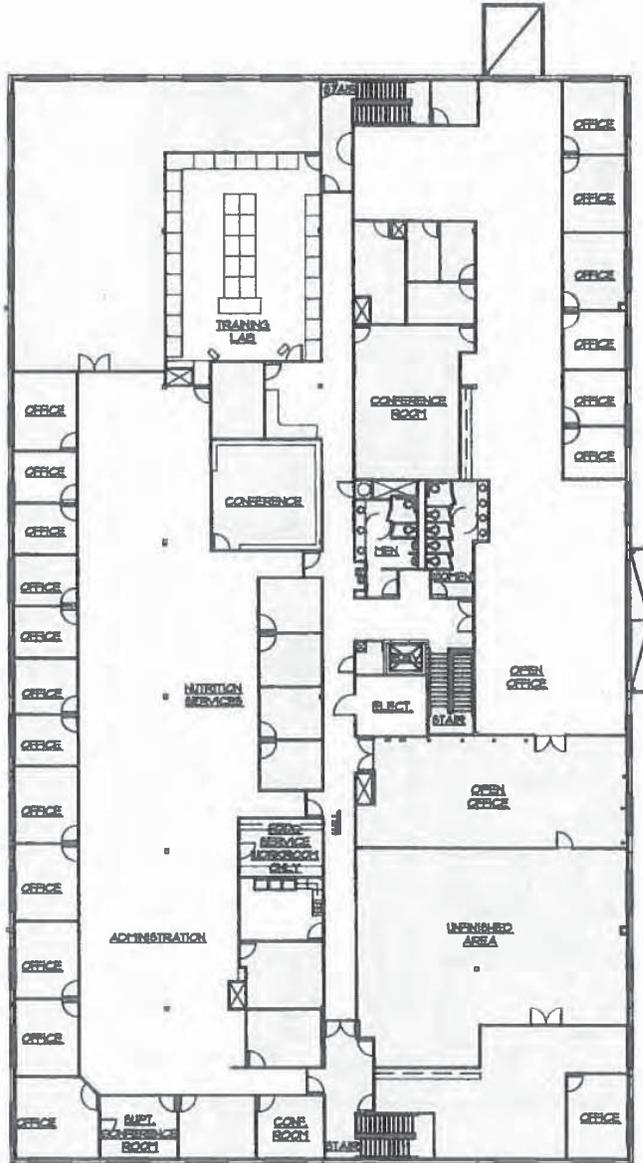
FLOOR PLAN - UPPER LEVEL

ADMINISTRATION CENTER  
3003 NE 49TH PLACE  
HILLSBORO OR 97123

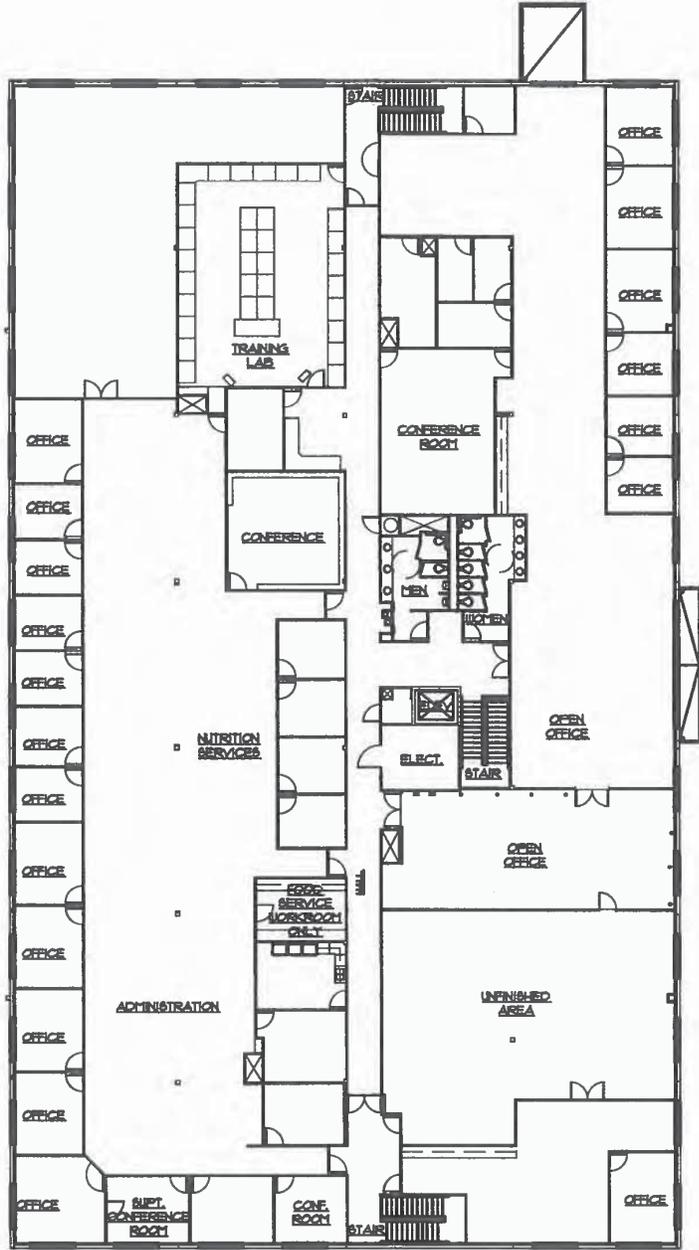
FLOOR PLAN - UPPER LEVEL

ADMINISTRATION CENTER  
3083 NE 49TH PLACE  
HILLSBORO OR 97123

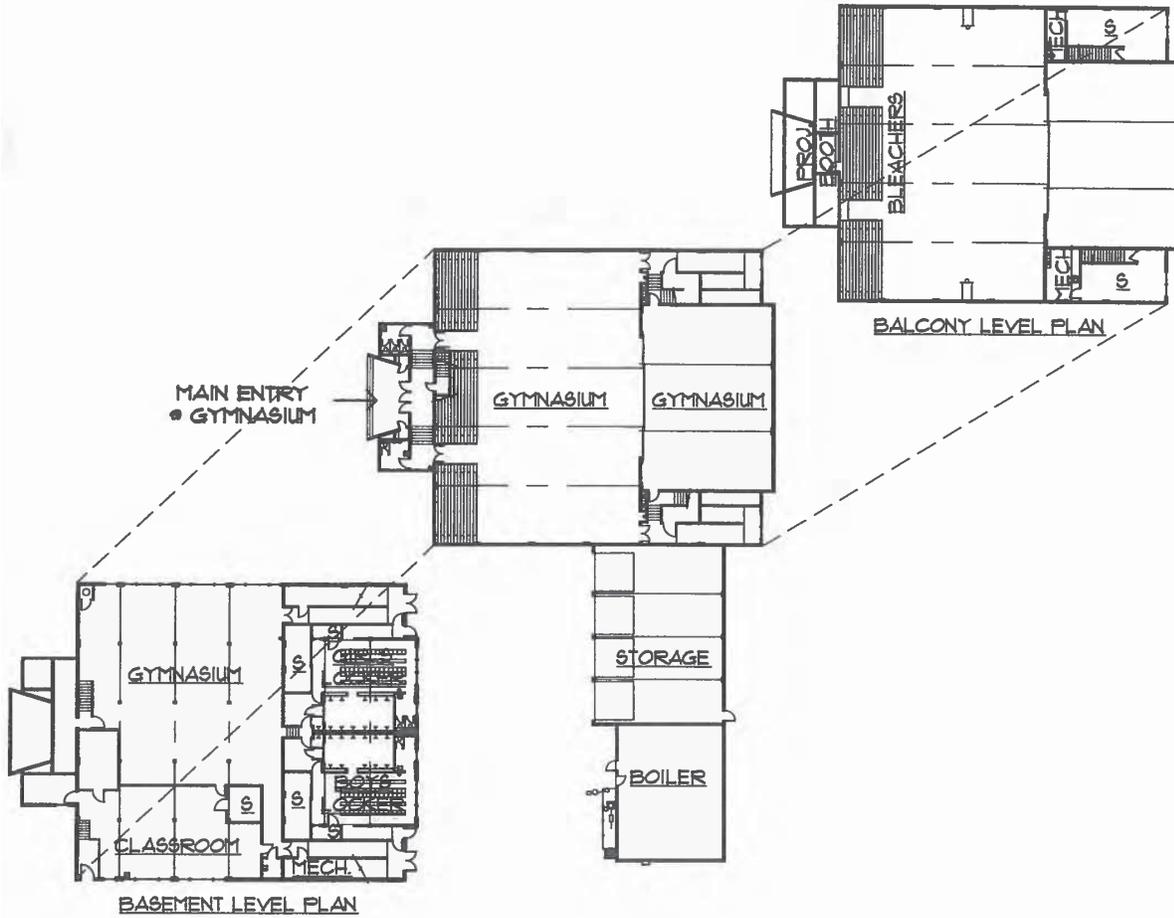
FLOOR PLAN

PETER L. BOSCOW CENTER  
452 NE THIRD AVENUE  
HILLSBORO OR 97124
