FACILITY ASSESSMENT REPORT
HILLSBORO SCHOOL DISTRICT
HILLSBORO, OREGON

6 APRIL 2012

2011 FACILITY ASSESSMENT UPDATE

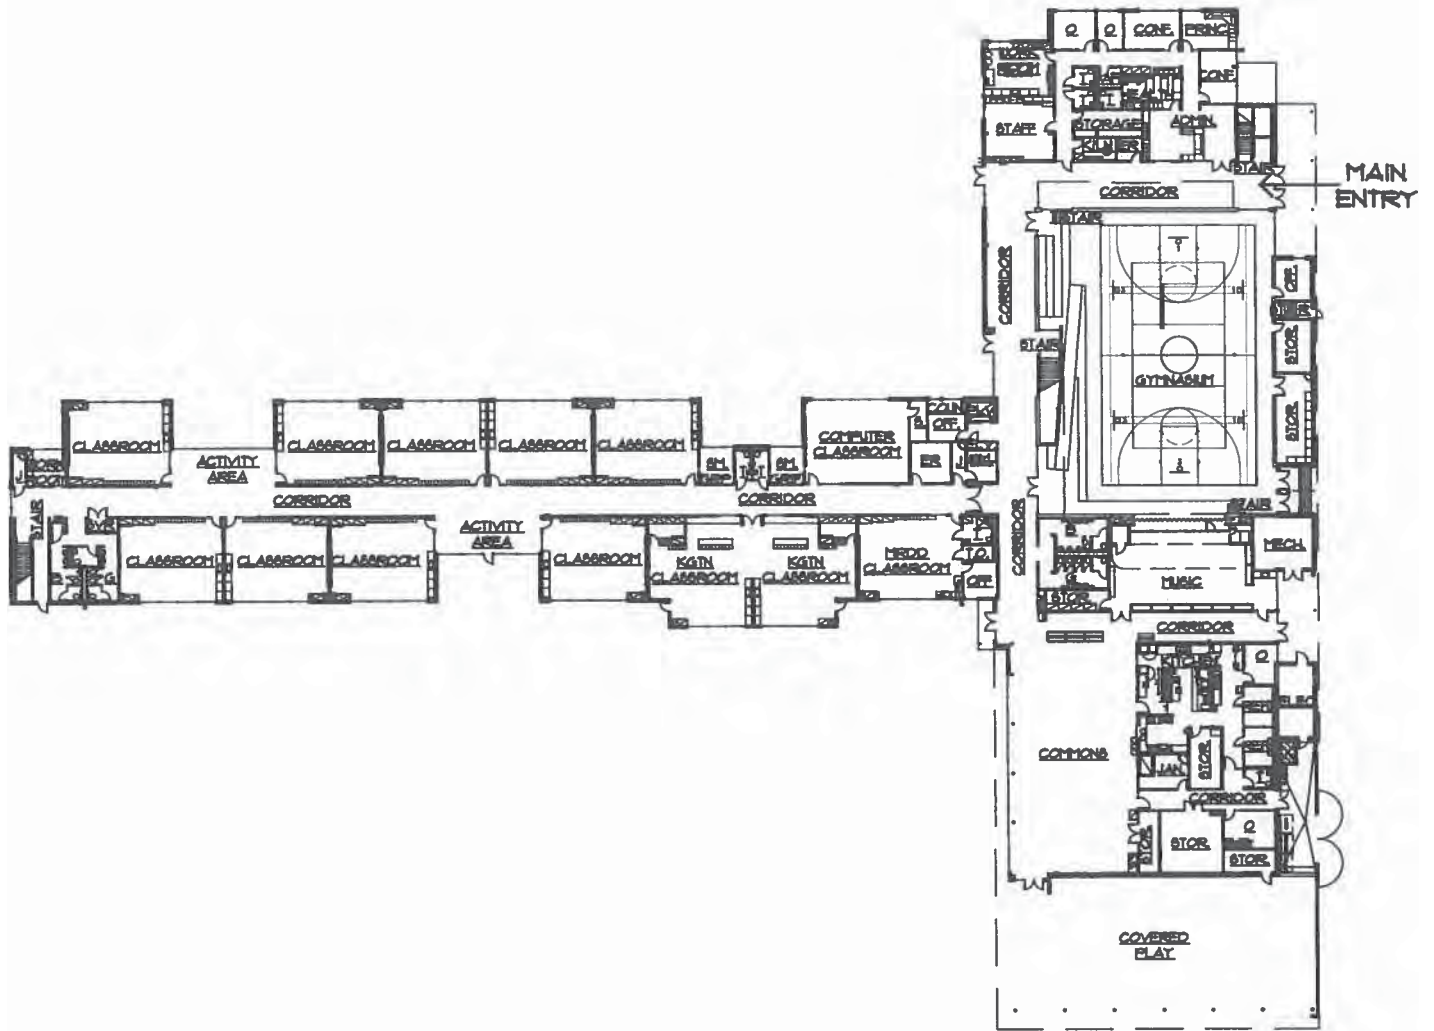
60 45 30 0 60 120
FLOOR PLAN - MAIN LEVEL

FREE ORCHARDS ELEMENTARY SCHOOL - 247
2499 S BEECH STREET
CORNELIUS OR 97113

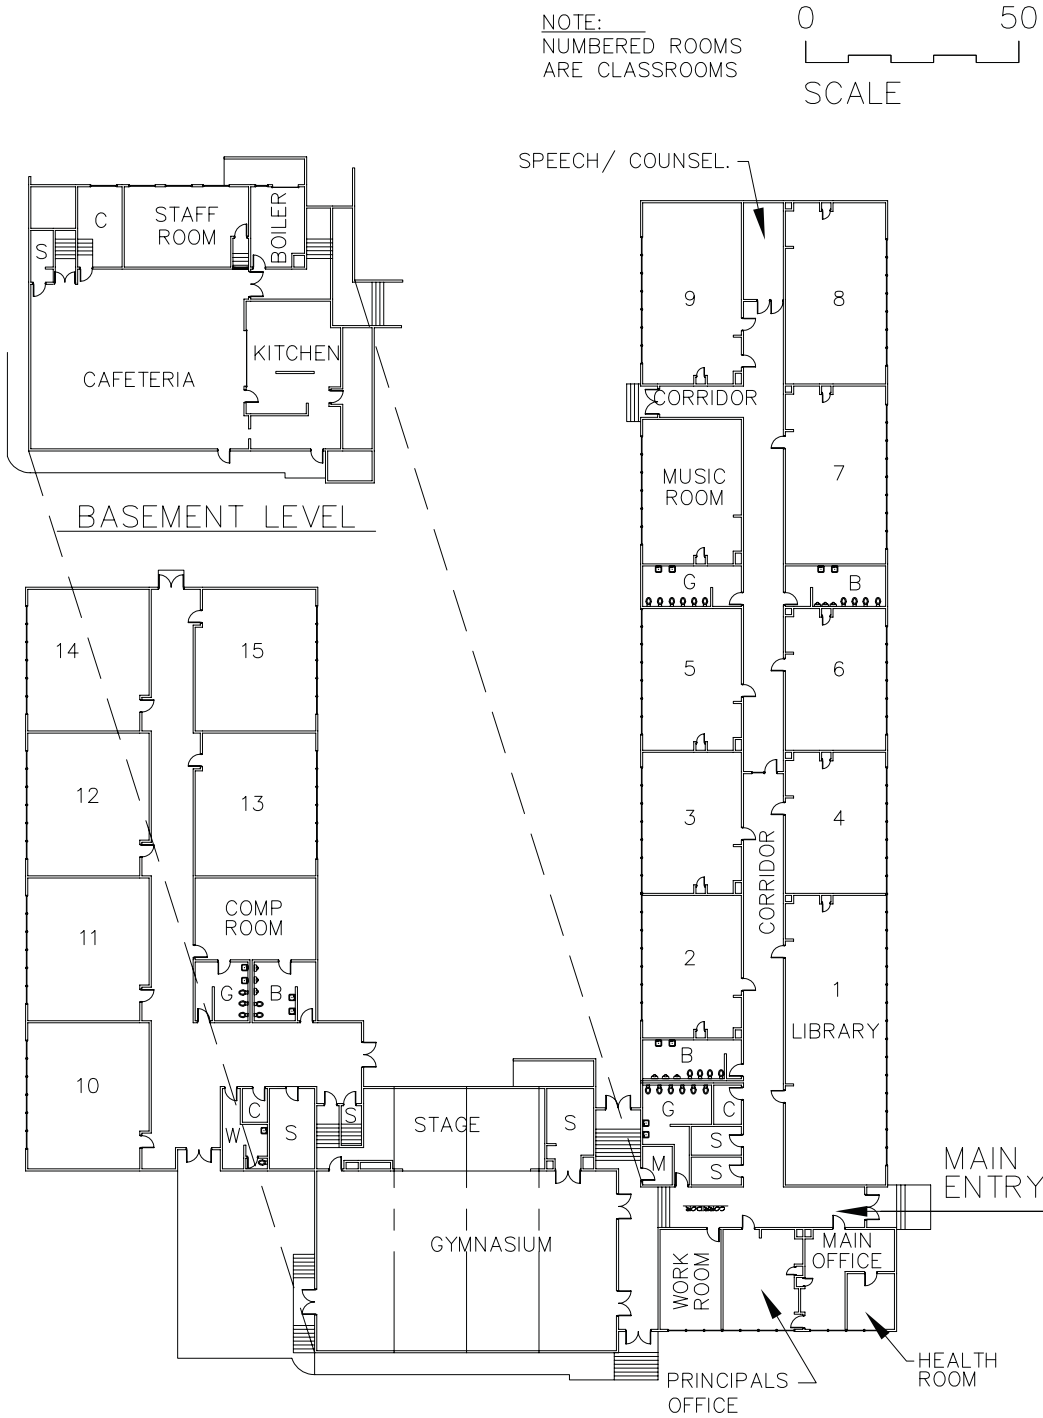
Groner Elementary | Floor Plan

- :: The primary structure is wood stud walls on continuous concrete foundation with a concrete slab. The roof is a combination of wood joists and trusses.

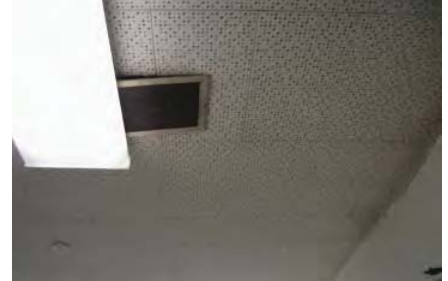
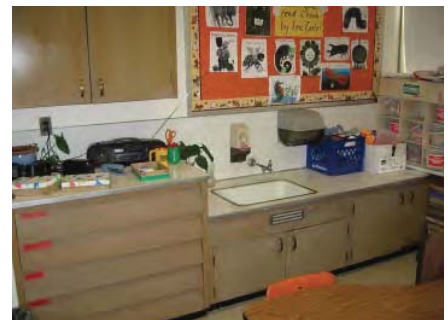
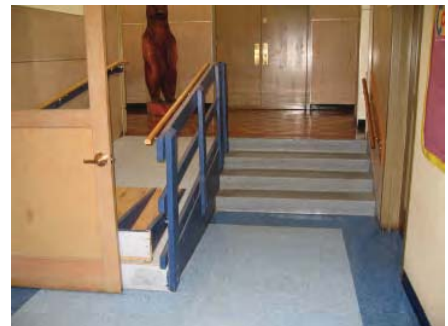
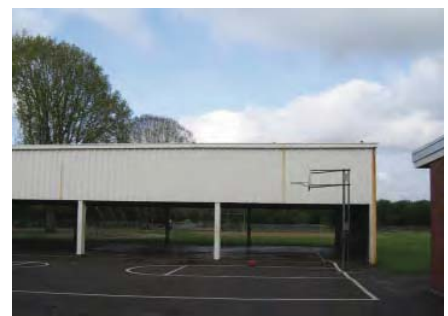
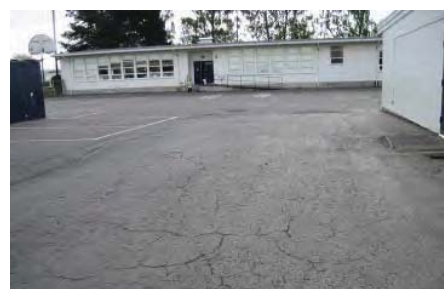
- Natural gas fired high efficiency boilers; 2009
- DDC control system
- Classrooms unit ventilators replaced; 2009
- Unit ventilators provide hydronic hot water heating
- Music room is off of the system, it has electric heat
- System is problematic in gym

- Fan noise in unit ventilators in west wing is problematic
- Air circulation and ventilation in room 9 is a concern

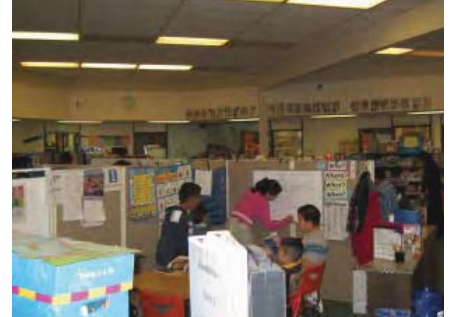
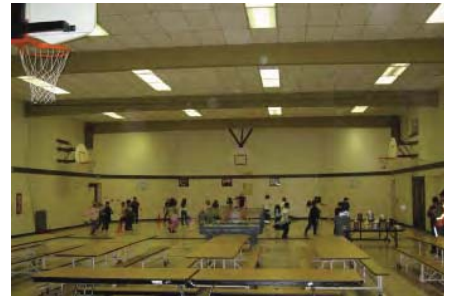
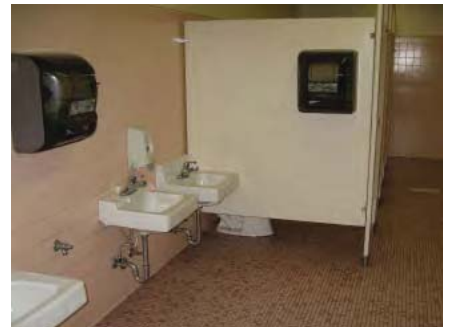
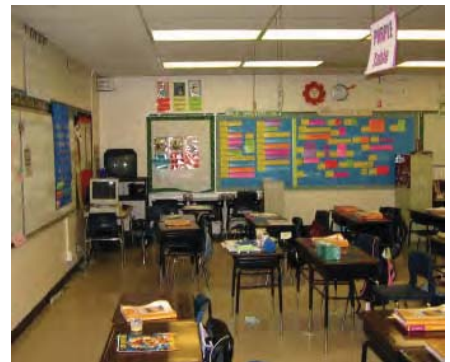
- :: Cooling system
 - School has partial cooling system, kitchen and staff lounge only have A/C.
 - cooling added to new make-up air unit in kitchen; 2010
 - Remodeled staff lounge had split system heat pump; 2010
- :: Heating system
 - Natural gas fire hydronic hot water boiler
 - multi-zoned air handlers, with pneumatic controls
- :: Plumbing
 - New low flow toilets in 2005
 - New staff toilet adjacent to staff lounge is ADA compliant, with low flow fixtures
- :: Electrical system
 - 208Y/120 volt, 1000 amp switchboard.
 - New panels in kitchen; 2010
 - Lighting system upgraded to electronic ballasts and T8 lamps; 2006
 - Occupancy sensor system installed; 2006
 - Multi-purpose/Gymnasium egress lighting upgraded; 2010
 - Library egress lighting not on emergency power.

- Exit landing lighting fixtures, other than Multi-purpose/Gymnasium, not on emergency power.
- Electrical clocks do not work consistently
