ASBESTOS HAZARD EMERGENCY RESPONSE ACT (AHERA) THREE-YEAR REINSPECTION REPORT – SPRING 2021

MAINTENANCE AND TRANSPORTATION
8291 WARNER AVENUE
HUNTINGTON BEACH, CALIFORNIA 92647

MS. KIM SLACK, DIRECTOR OF MAINTENANCE
OCEAN VIEW SCHOOL DISTRICT
8291 WARNER AVENUE
HUNTINGTON BEACH, CA 92647

July 2021

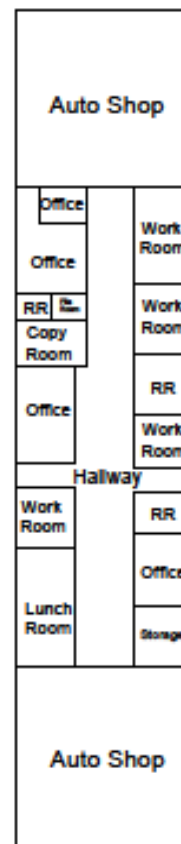
Figure 1

Site Map (First Floor)

Ocean View School District
Maintenance and Transportation
18940 B Lane
Huntington Beach, CA 92647
