ASBESTOS HAZARD EMERGENCY RESPONSE ACT (AHERA) THREE-YEAR REINSPECTION REPORT – SPRING 2021

HOPE VIEW ELEMENTARY SCHOOL
17622 FLINTSTONE LANE
HUNTINGTON BEACH, CALIFORNIA 92647

MS. KIM SLACK, DIRECTOR OF MAINTENANCE
OCEAN VIEW SCHOOL DISTRICT
8291 WARNER AVENUE
HUNTINGTON BEACH, CA 92647

July 2021

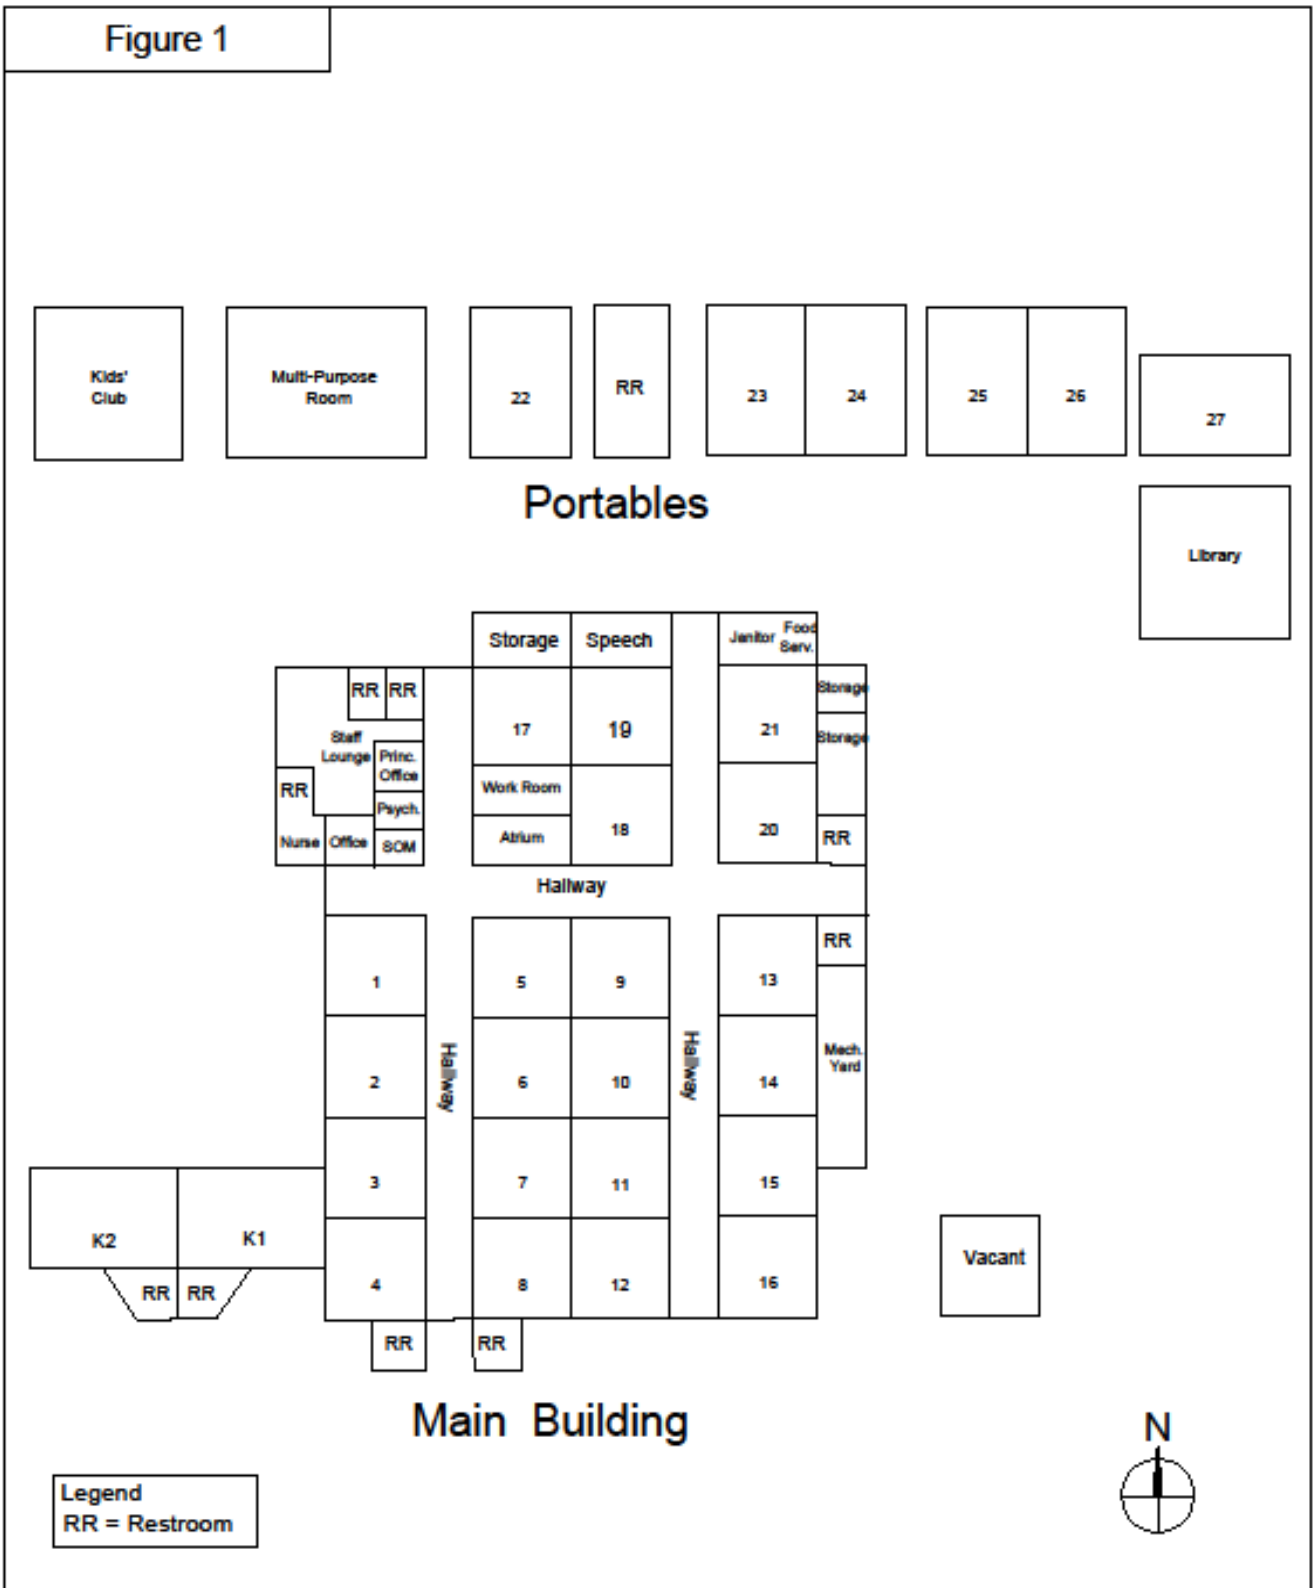
Figure 1

Campus Site Map

Ocean View School District
 Hope View School
 17622 Flintstone Lane
 Huntington Beach, CA 92647
