ASBESTOS HAZARD EMERGENCY RESPONSE ACT (AHERA) THREE-YEAR REINSPECTION REPORT – SPRING 2021

VILLAGE VIEW ELEMENTARY SCHOOL
5361 SISSON DRIVE
HUNTINGTON BEACH, CALIFORNIA 92649

July 2021

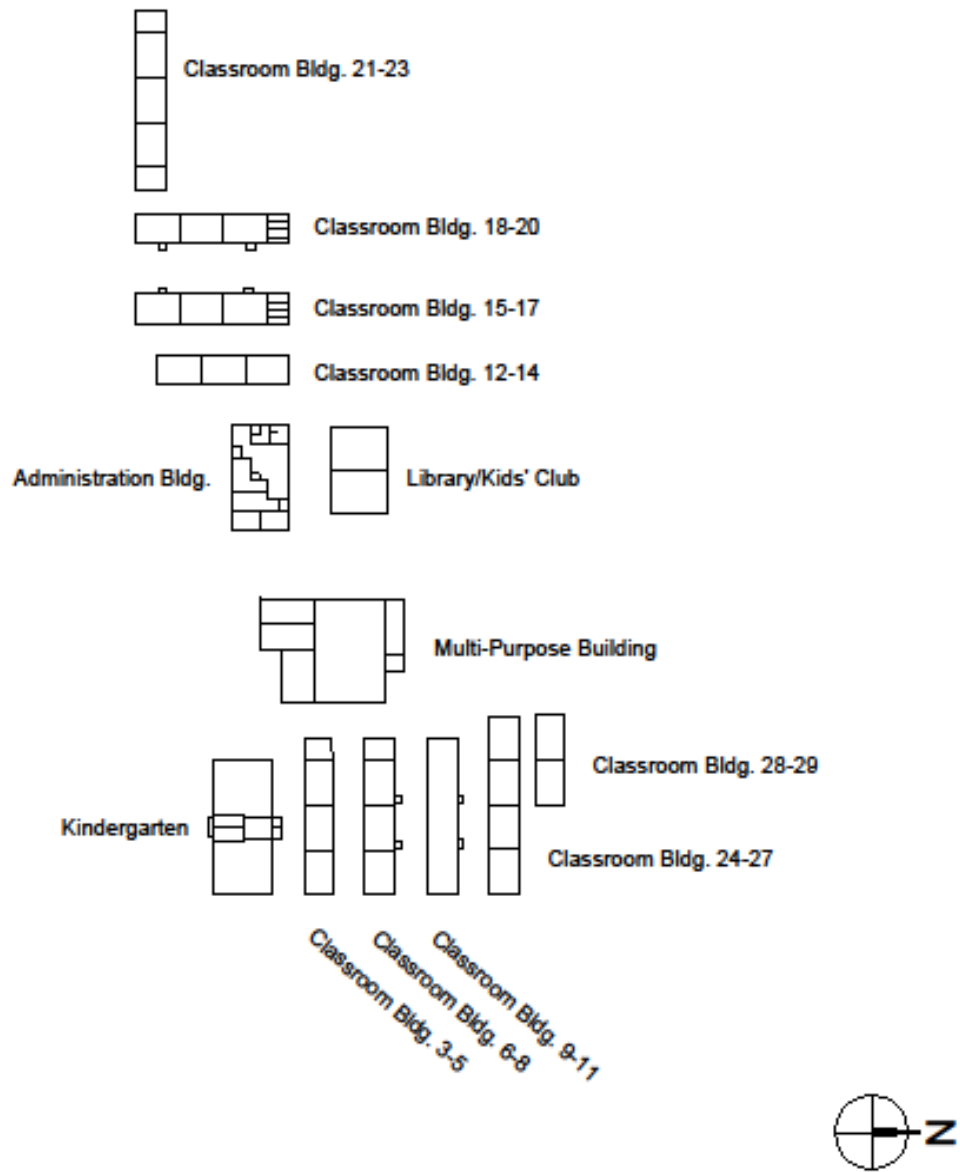
Figure 1

Campus Site Map
