A report titled "Facility Condition Assessment" for the BUUSD Central Office was distributed.

FACILITY CONDITION ASSESSMENT

**Vermont Agency of Education_FCA Phase Two
1 National Life Drive, Davis 5
Montpelier, VT 05620-2501**

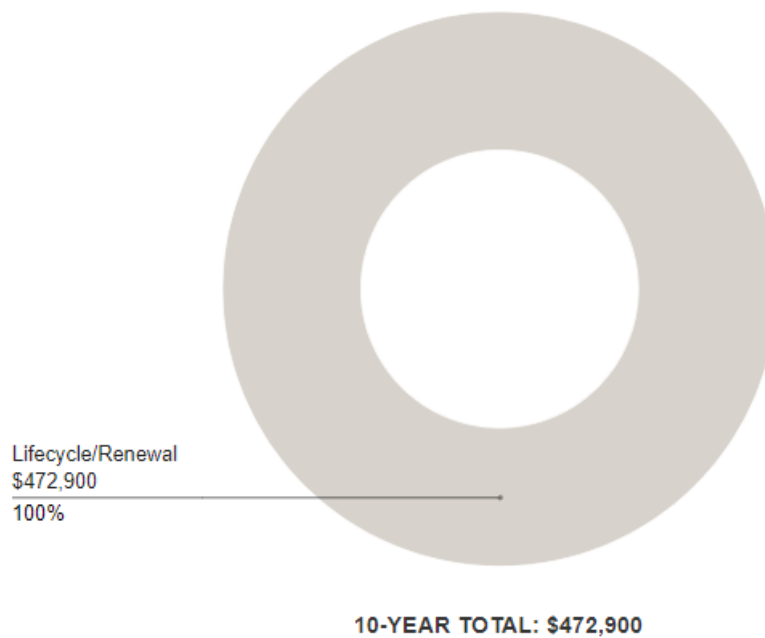
Plan Type Distribution (by Cost)

Plan Type Descriptions		
Safety	■	An observed or reported unsafe condition that if left unaddressed could result in injury; a system or component that presents potential liability risk.
Performance/Integrity	■	Component or system has failed, is almost failing, performs unreliably, does not perform as intended, and/or poses risk to overall system stability.
Accessibility	■	Does not meet ADA, UFAS, Safety and/or other handicap accessibility requirements.
Environmental	■	Improvements to air or water quality, including removal of hazardous materials from the building or site.
Retrofit/Adaptation	■	Components, systems, or spaces recommended for upgrades in in order to meet current standards, facility usage, or client/occupant needs.
Lifecycle/Renewal	■	Any component or system that is not currently deficient or problematic but for which future replacement or repair is anticipated and budgeted.
