**ADDENDUM NO. 1**  
(Issued May 3, 2024)  
**Request for Qualifications and Proposals**  
**for Hazardous Material Abatement Consulting Services**

# **ASBESTOS HAZARD EMERGENCY RESPONSE ACT (AHERA) INSPECTION REPORT**

**McClymonds High School (303)**

**PSI Project No. 05821834-303**

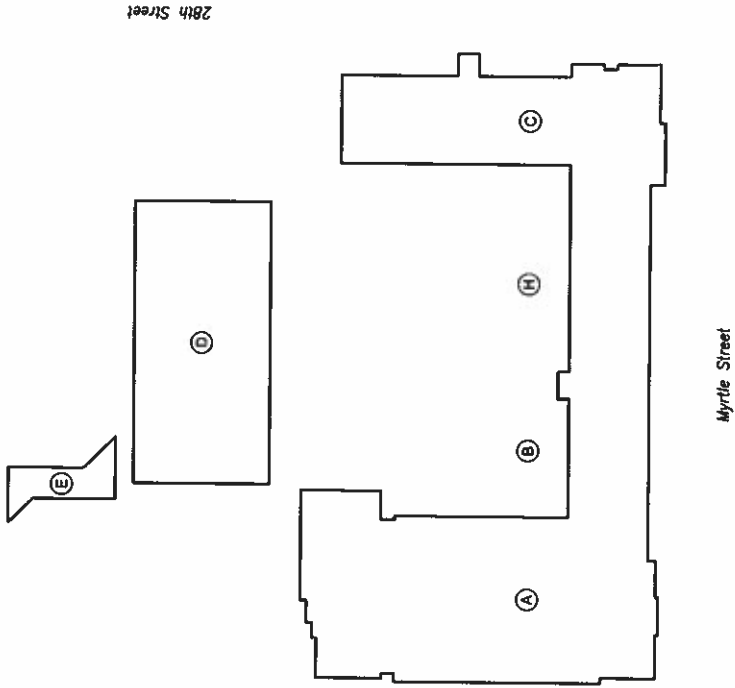
# McClymonds High School

Project Name: Oakland Unified School District A+HERA Reinspection Project for 2019	Drawn By: M.G.	Date:	File No.:1804-303	Figure No.:
Title: McClymonds High School Site Plan	Approved By: L.J.S.	Project No.:05821834		1

During the AHERA inspection, ACBM was classified into homogeneous areas (HA) or unified sampling areas (USA). The ACBM in each HA/USA that was visually similar in color, texture and general appearance was assumed to have likely been installed at the same time. The location of homogeneous materials was also noted on the attached drawings.
