GEOTECHNICAL ENGINEERING STUDY

Newark Memorial High School-Athletic Field Improvements
39375 Cedar Blvd
Newark, California 94560

GEO-ENGINEERING SOLUTIONS, INC.
2570 San Ramon Valley Boulevard, Suite A102
San Ramon, California 94583
Project No. 142-1485

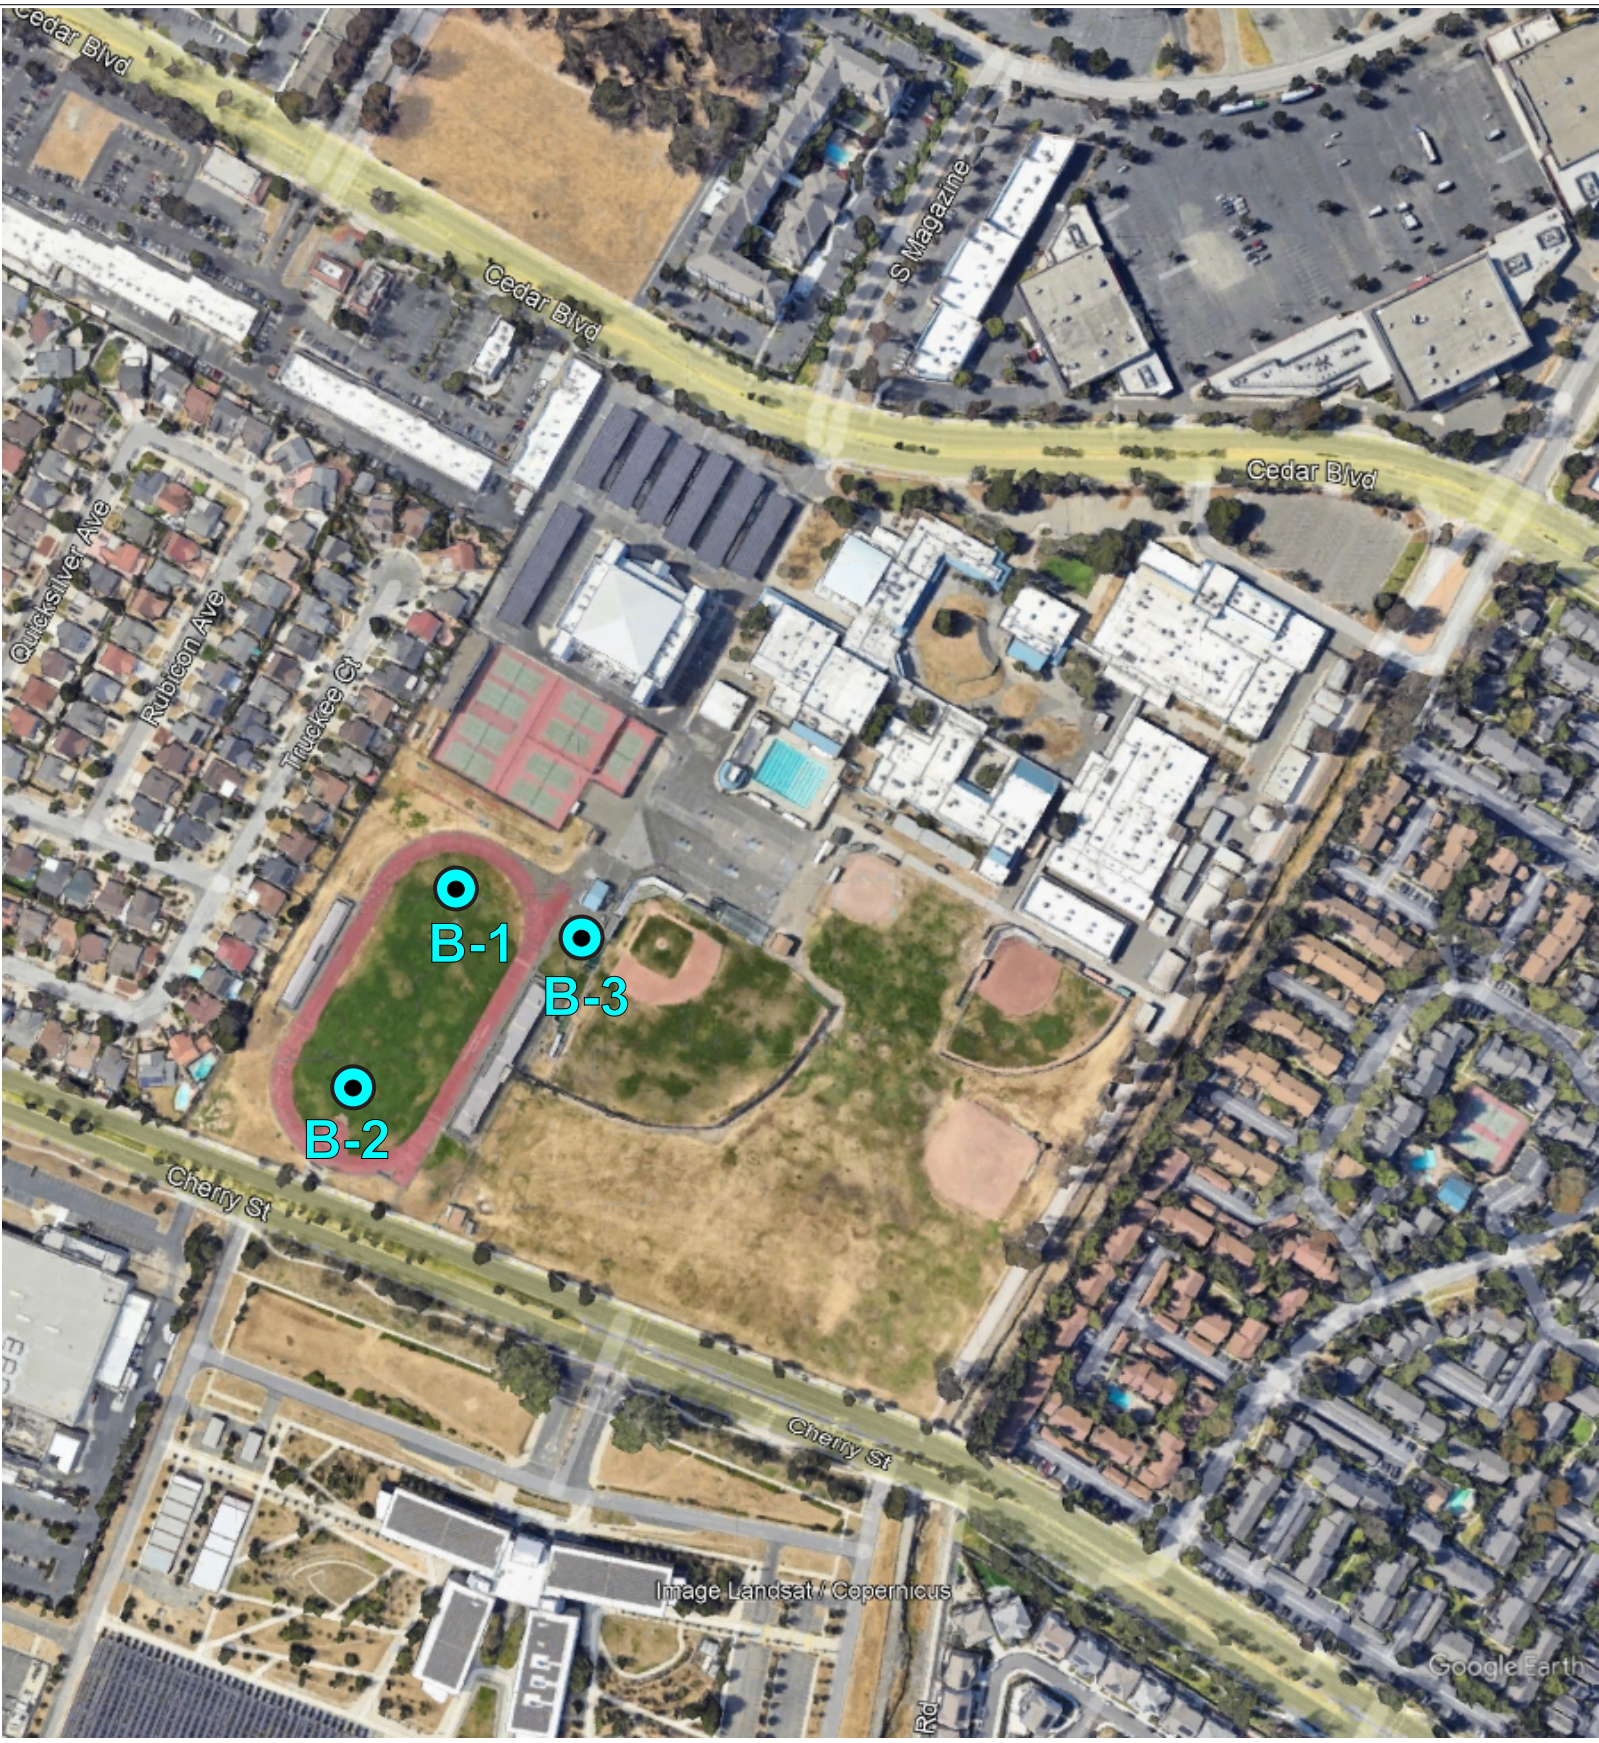
Site Map and Boring Locations	Figure 2
-------------------------------	----------

Approximate Boring Location

A total of 3 borings were drilled at the site on May 3, 2023 at the approximate locations shown on Figure 2-*Site Map and Boring Locations*. The borings were drilled by California Geotech Services, LLC to a maximum depth of approximately 30 feet below existing ground surface across the project site using a truck mounted, CME-55 drill rig equipped with four-inch diameter solid flight augers.

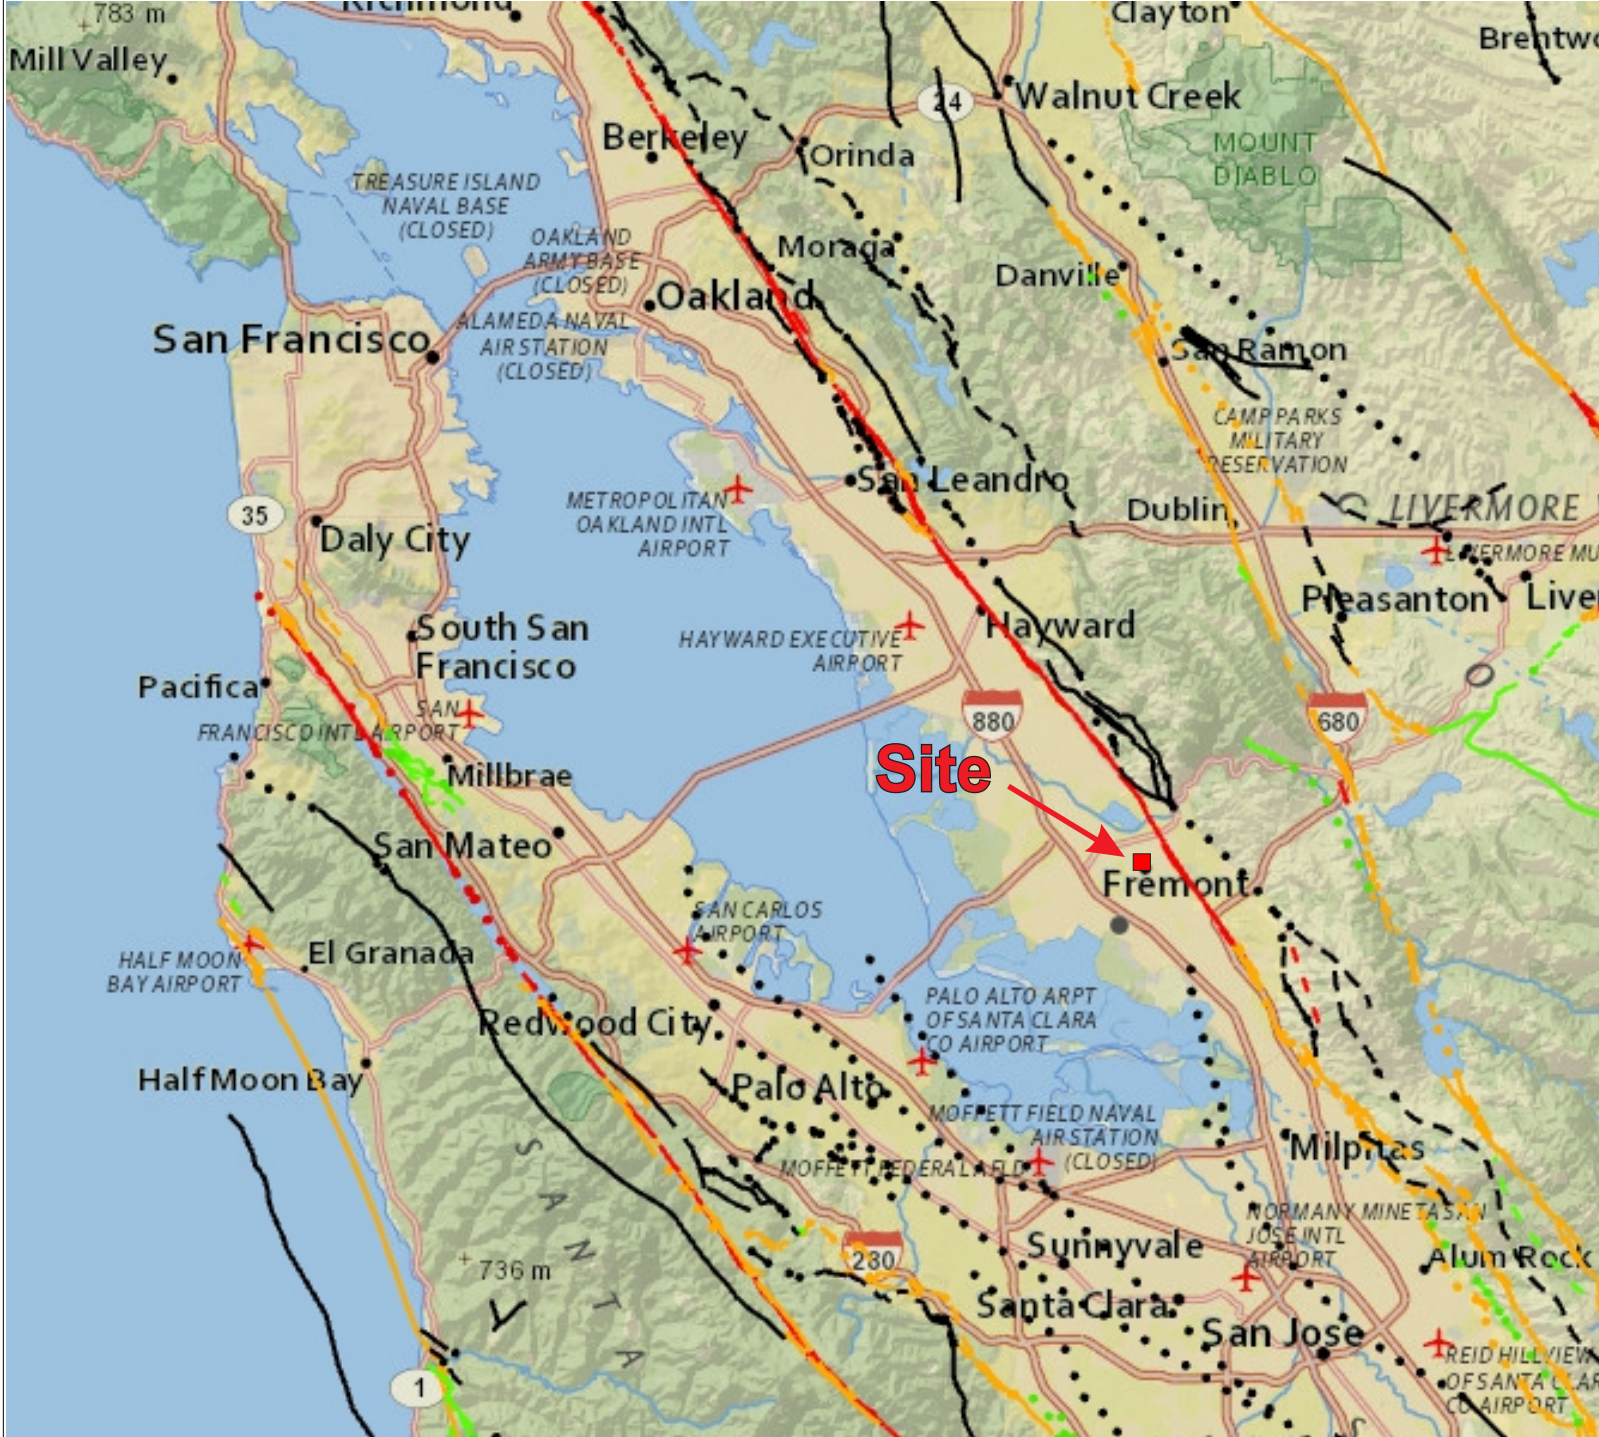
Figure 4

Regional Fault Map

The subject property is in a seismically active region dominated by the Hayward Fault, which is located approximately 3 miles (4.8 km) to the east of the subject property. Other major faults within the vicinity of the site include the San Andreas Fault, located about 18 miles (29 km) west of the site, the northern portion of the Calaveras Fault, located 9 miles (14.5 km) east of the site. Other active faults include the Mt. Diablo Thrust Fault, located approximately 27.5 miles (44.25 km) northeast of the site, the Concord-Green Valley Fault, located approximately 32 miles (51.5 km) north of the site, and the Greenville-North (Clayton-Marsh Creek) Fault, located approximately 42 miles (67.6 km) northeast of the site. The site location relative to active and potentially active faults in the San Francisco Bay Area is shown on Figure 4-*Regional Fault Map*. A discussion of these faults, follows.

The site is not currently mapped or within a designated Earthquake Fault Zone as defined by the State (Hart and Bryant, 1997). The closest Earthquake Fault Zones are associated with the Hayward Fault, about 3 miles east of the site, as shown on Figure 4. Since the site is not within or near an A-P Earthquake Fault Zone, the potential for fault ground rupture and fault creep hazards are judged to be very low.

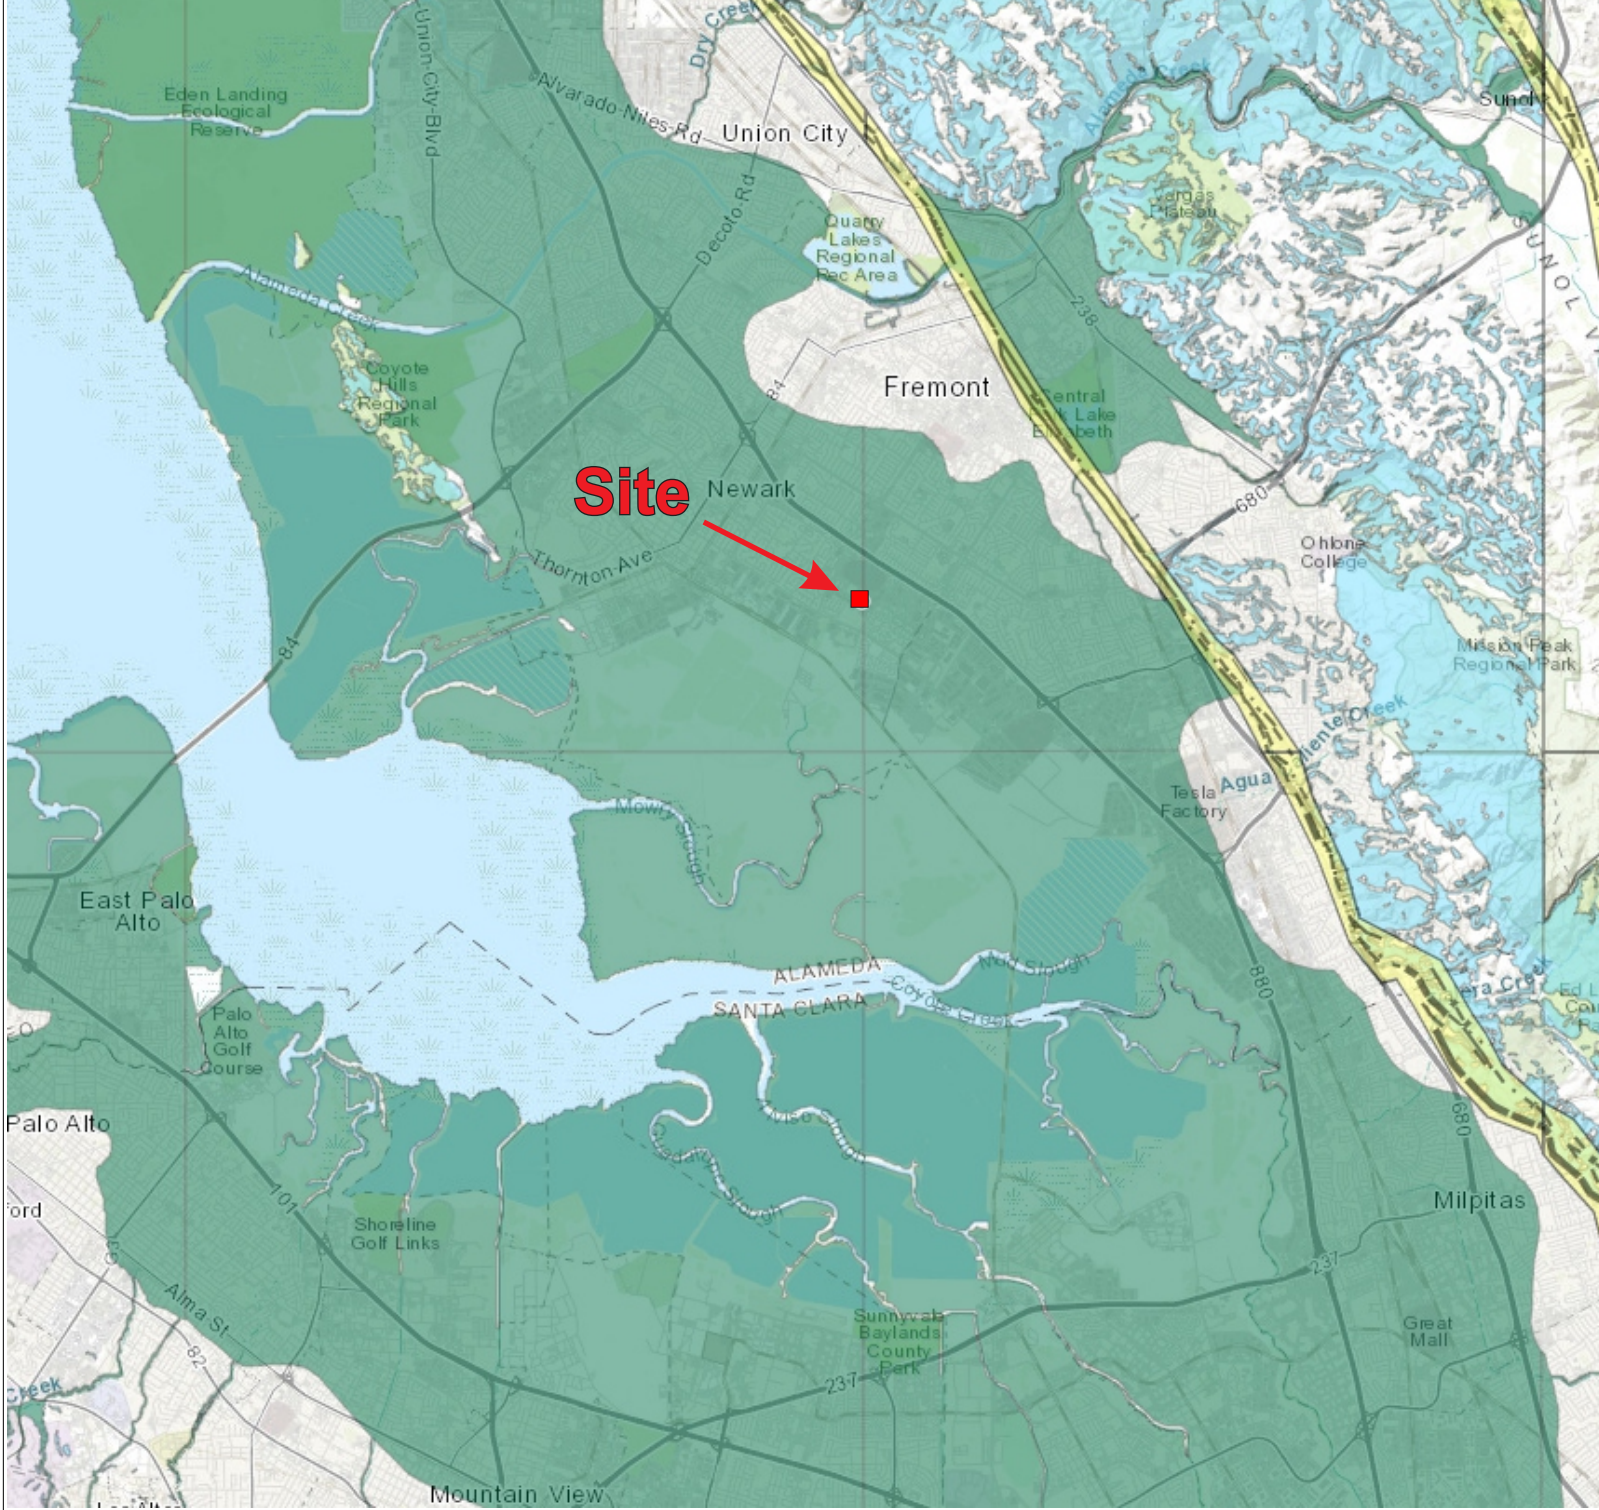
Liquefaction Zones
 Areas where historical occurrence of liquefaction, or local geological, geotechnical and ground water conditions indicate a potential for permanent ground displacements such that mitigation as defined in Public Resources Code Section 2693(c) would be required.

Seismic Hazard and AP Fault Zone Map

The site is mapped by the CGS as being in a liquefaction hazard zone, as shown on Figure 5-*Seismic Hazard and AP Fault Zone Map*. Within the upper 30 feet explored, the site was underlain by stiff to medium stiff silty and sandy clay with high plasticity clay (CL) to 30 feet below ground surface. Groundwater was encountered in borings B-1 and B-3 at 7 feet below ground surface and in boring B-2 at 12 feet below ground surface. Based on the clay soil characteristics we anticipate the liquefaction potential of the site subsurface soils to be very low. Due to the very stiff nature of the subsurface soils, the lack of liquefaction-susceptible subsurface soils, the potential for lateral spreading is also considered to be very low to nil.

Landslides can occur under a variety of loading conditions, including both static and seismic, but involve sloping ground. As shown on Figure 5 the subject site is not adjacent to an “earthquake-induced landslide zone.” The site and immediate vicinity are moderately sloping and do not exhibit landslide features as determined by our geologic site reconnaissance and literature review. Therefore, except for possible minor surface sloughing of the perimeter cut slopes after sustained rainfall events, the site is not susceptible to land sliding.

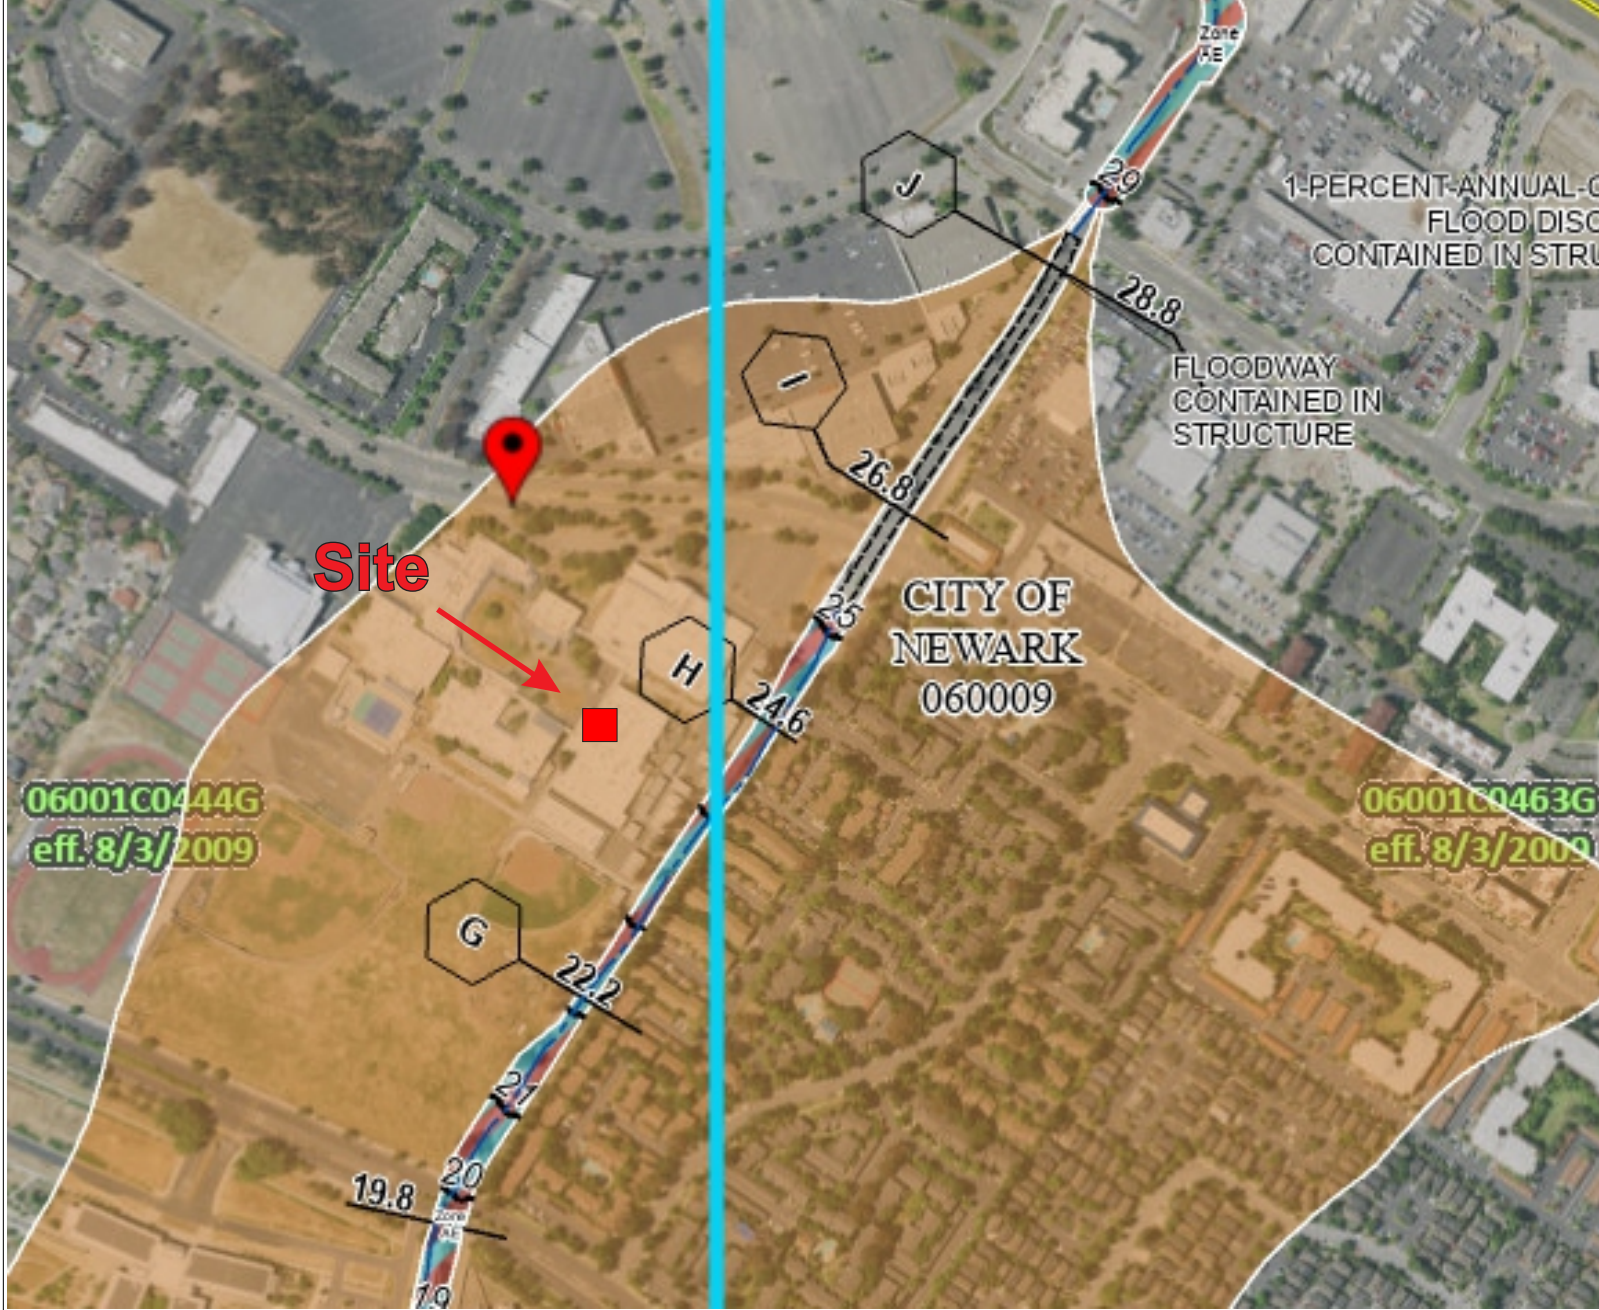
Figure 6

Flood Hazard Map

The site is located in a mapped area of flooding hazard, as shown on Figure 6-*Flood Hazard Map*, based on the FIRM (2009) map produced for the site vicinity. The site is located in a dotted Zone X, which delineates areas determined to be inside the 0.2% Annual Chance Flood Hazard.

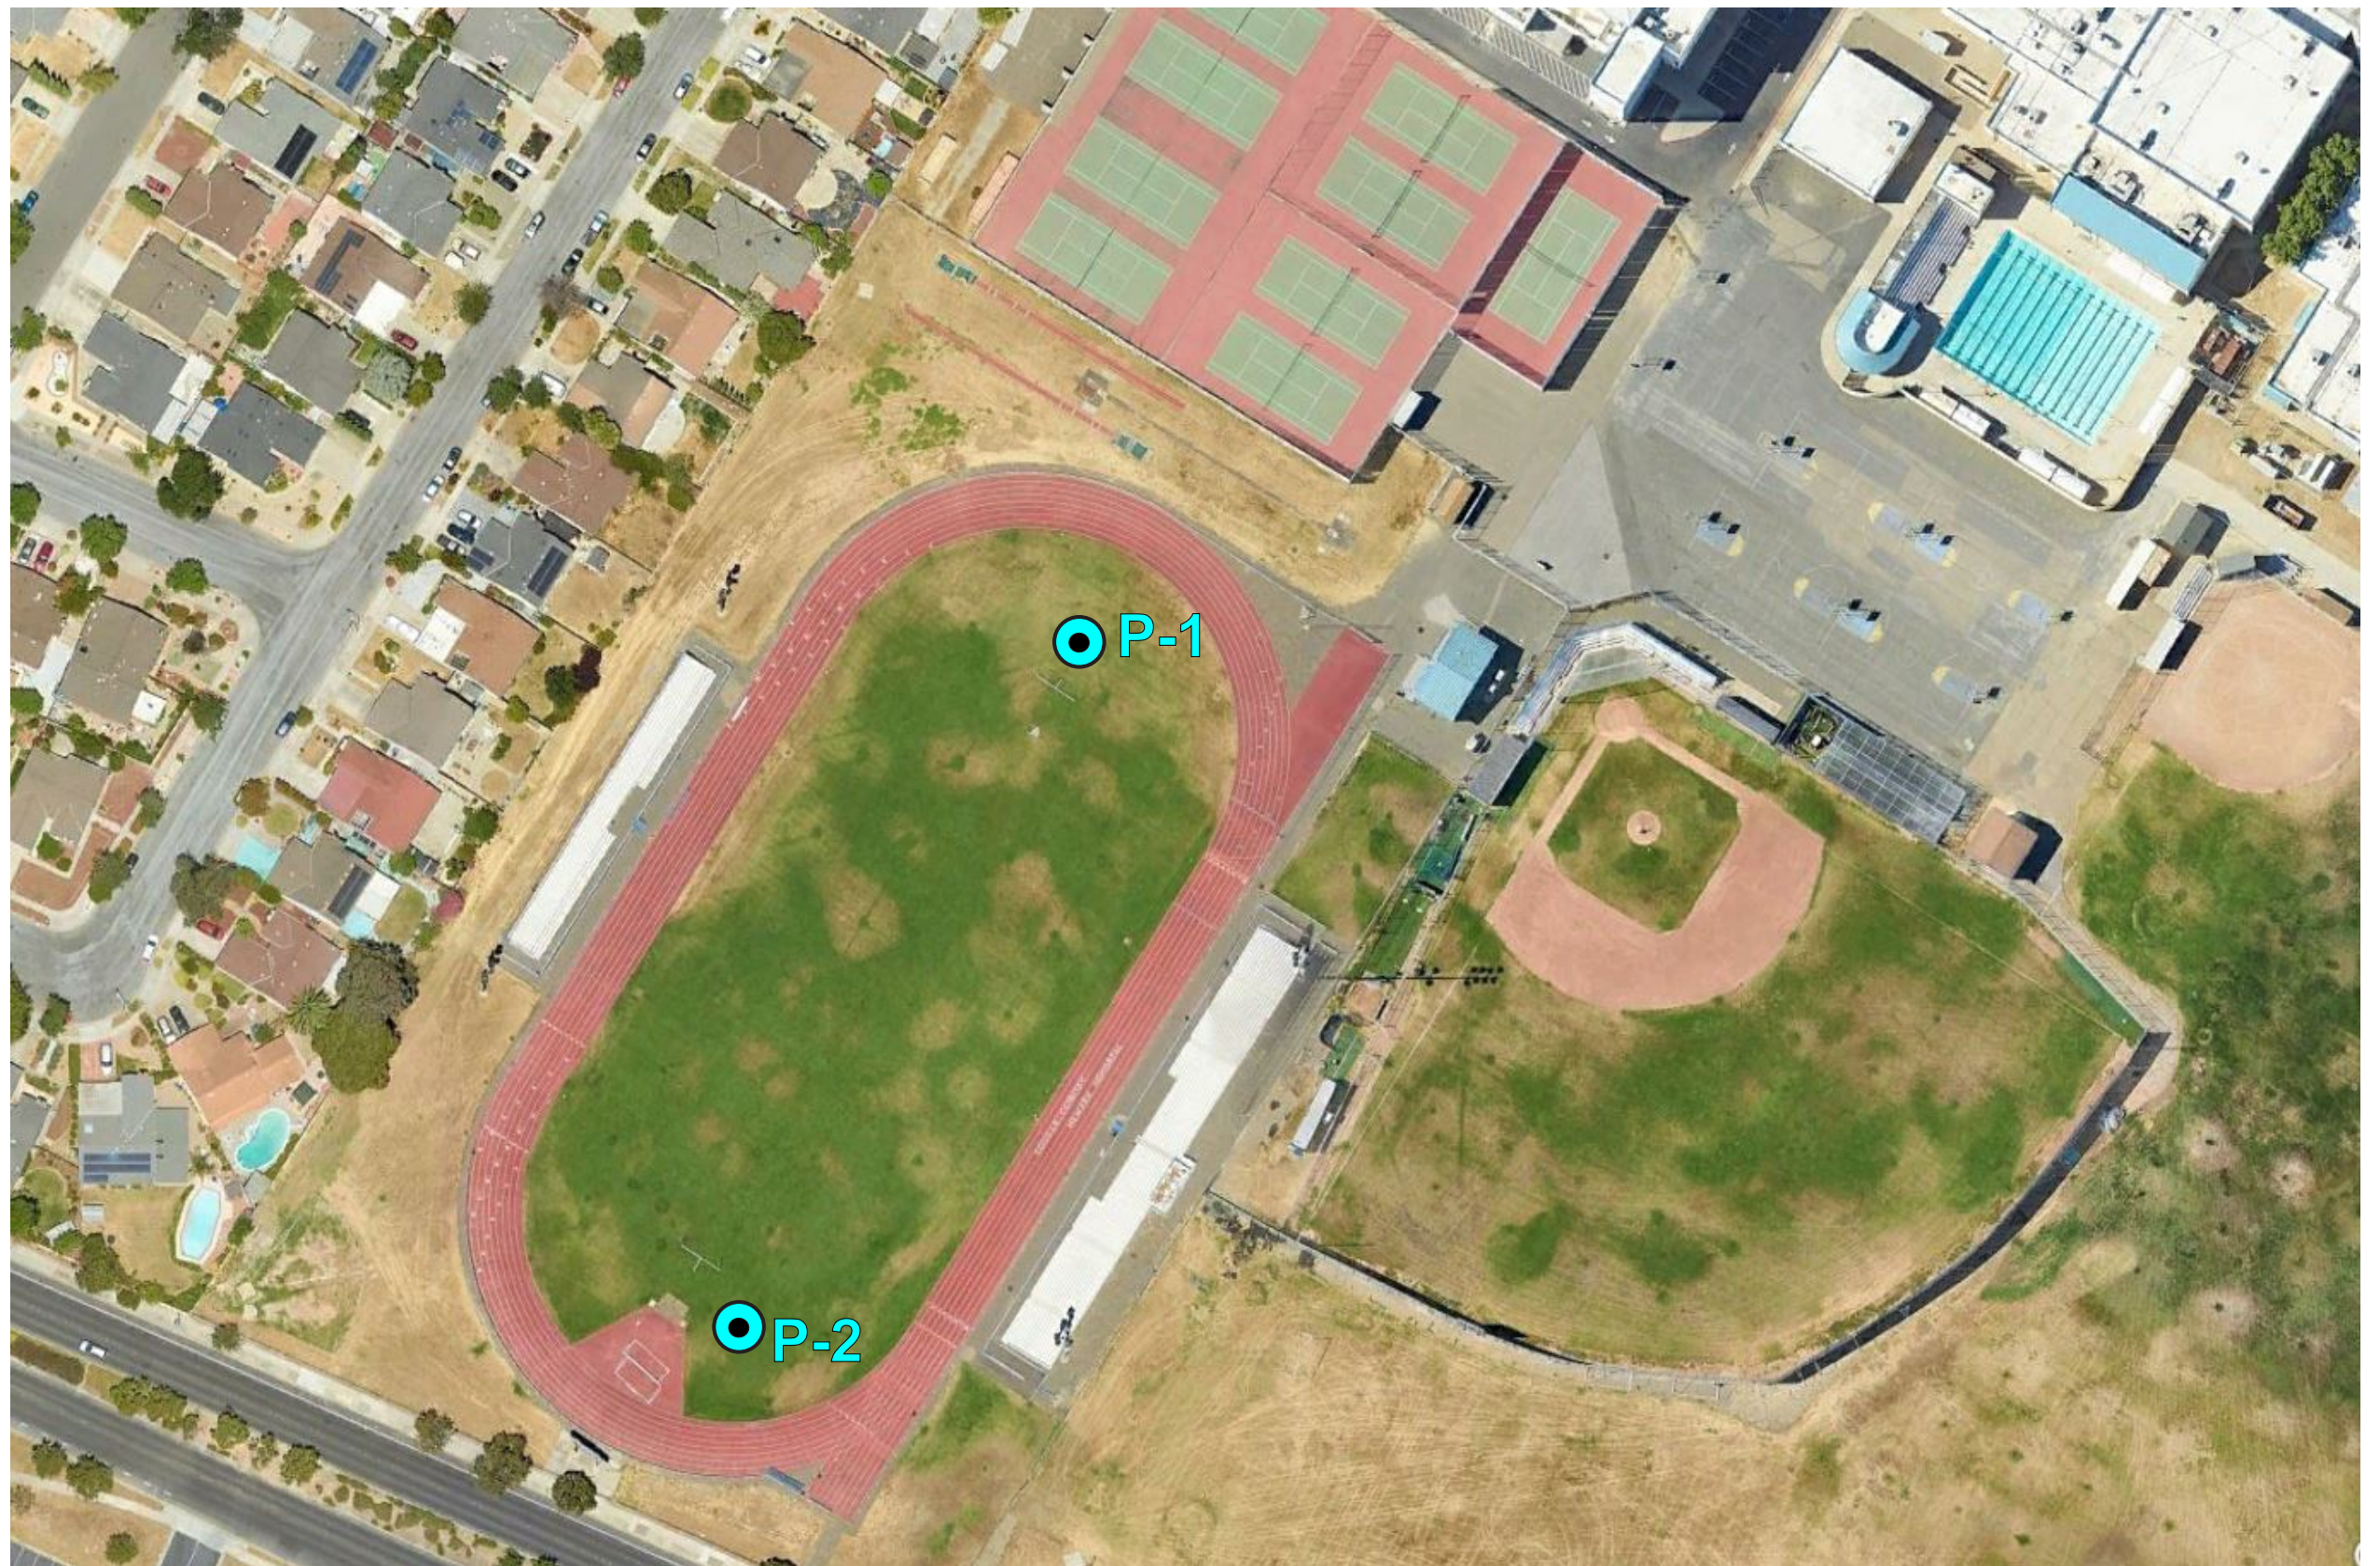
Figure 7

Approximate percolation test locations (Geo-Eng 2023)

We conducted two infiltration tests as shown on Figure 7, Percolation Testing Map. The infiltration tests were completed using a double ring infiltrometer, consisting of two concentric metal rings. During testing the rings were driven two inches into the ground and filled with water three times in order to saturate the soil. The drop in water level in the interior ring was measured in 15-minute increments over a 60-minute period and used to calculate an infiltration rate. The infiltration rate is determined as the amount of water per surface area and time unit that penetrates the soil. Measurements were taken until the rate at which the water level dropped became consistent.

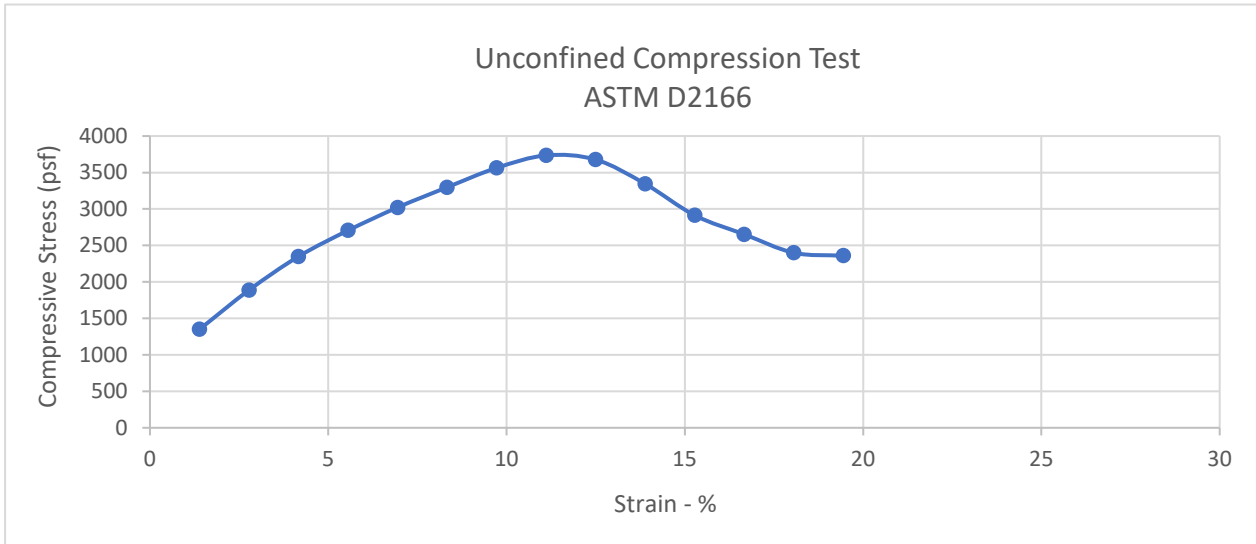
Unconfined Compression Test

Test Methods: ASTM D2166

Speciman Failure Photograph		Speciman Test Data		
		Moisture Content:	%	18.2%
		Dry Density:	pcf	104.0
		Diameter:	in.	2.40
		Height:	in.	4.5
		Height/ Diameter Ratio:		1.875
		Calculated Saturation:	%	79%
		Calculated Void Ratio:		0.619596
		Assumed Specific Gravity:		2.7
		Failure Strain:	%	11.11
		Unconfined Compressive Strength:	(psf)	3734.84
		Undrained Shear Strength	(psf)	1867.42
		Strain Rate:	in/min	0.0625
		Remarks:		
Sample Type:	Mod Cal	Sample Location:	B1-1 @ 3'	
Description:	Brown Sandy CLAY	LL:	PL:	PI:
Moisture Density Data		Water Content	0.182	
Number of Rings	1	Total Density (Mg/m ³)	1.971	
Mass of Moist Sample + Rings (g)	1176.7	Dry Density (Mg/m ³)	1.667	
Specimen Diameter (mm)	62	Total Unit Weight (lbs/ft ³)	122.978	
Specimen Height (mm)	152	Dry Unit Weight (lbs/ft ³)	104.026	
Total Ring Mass (g)	272.3	Saturation	0.794	
Soil Mass (g)	904.4	Void Ratio	0.620	
Soil Volume (cm ³)	458.90	Porosity	0.383

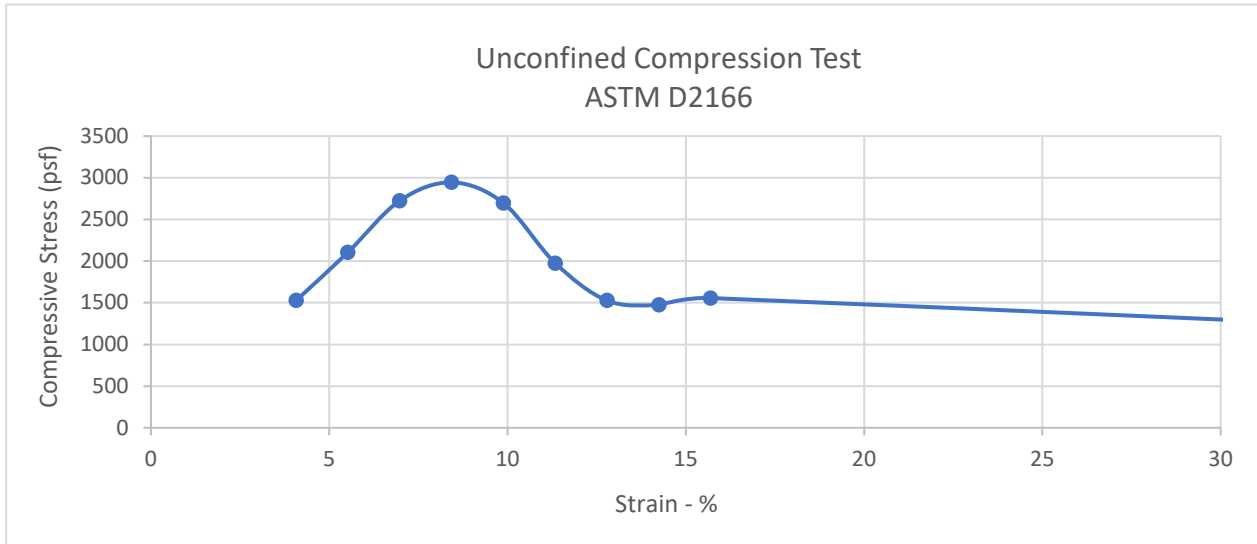
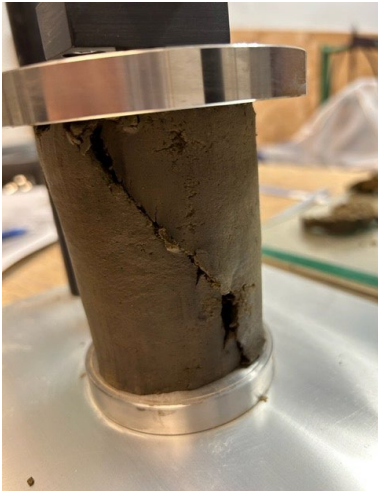
Unconfined Compression Test

Test Methods: ASTM D2166

Speciman Failure Photograph	Speciman Test Data

Moisture Content:	%	12.6%
	Dry Density:	pcf	#DIV/0!
	Diameter:	in.	2.40
	Height:	in.	4.3
	Height/ Diameter Ratio:		1.792
	Calculated Saturation:	%	#DIV/0!
	Calculated Void Ratio:		#DIV/0!
	Assumed Specific Gravity:		2.7
	Failure Strain:	%	8.43
	Unconfined Compressive Strength:	(psf)	2943.90
	Undrained Shear Strength	(psf)	1471.95
	Strain Rate:	in/min	0.0625
Remarks:

Sample Type:	Mod Cal	Sample Location:	B2-2 @5'
Description:	Brown Sandy CLAY	LL:	PL:
		PI:

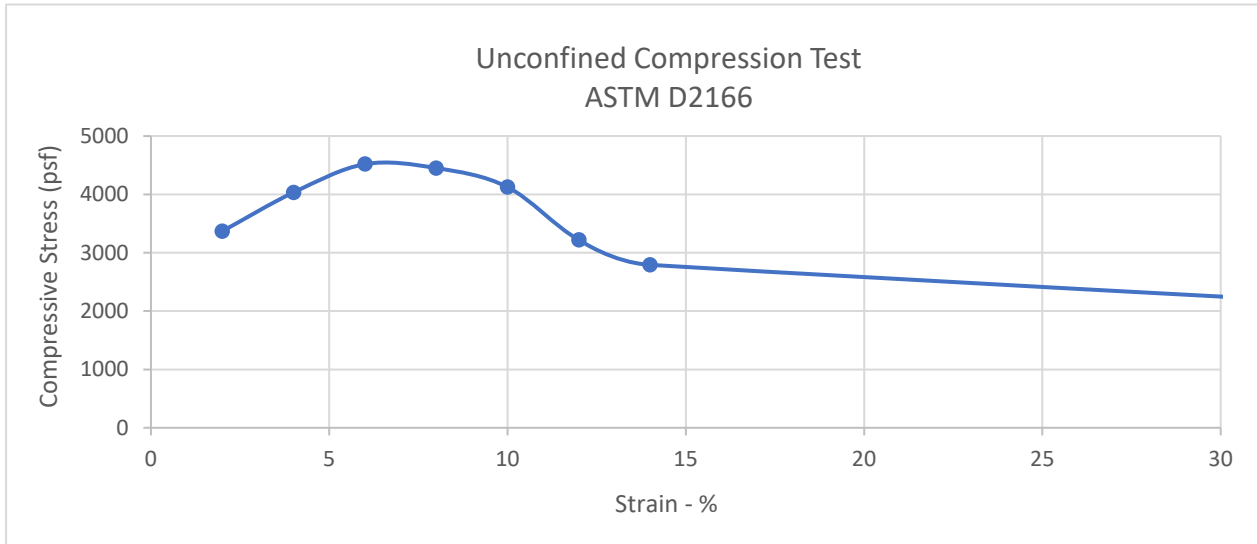
Unconfined Compression Test

Test Methods: ASTM D2166

Speciman Failure Photograph	Speciman Test Data		
	Moisture Content:	%	12.9%
	Dry Density:	pcf	118.1
	Diameter:	in.	2.40
	Height:	in.	3.1
	Height/ Diameter Ratio:		1.302
	Calculated Saturation:	%	81%
	Calculated Void Ratio:		0.426831
	Assumed Specific Gravity:		2.7
	Failure Strain:	%	6
	Unconfined Compressive Strength:	(psf)	4518.09
	Undrained Shear Strength	(psf)	2259.05
	Strain Rate:	in/min	0.0625
	Remarks:

Sample Type:	Mod Cal	Sample Location:	B1-1 @ 3'		
Description:	Brown Sandy CLAY	LL:	PL:	PI:
