FACILITY CONDITION ASSESSMENT & NETZERO ENERGY AUDIT

Frances C. Richmond Middle School 63 Lyme Road Hanover, New Hampshire 03755

Bureau Veritas 10461 Mill Run Circle, Suite 1100 Owings Mills, Maryland 21117 800.733.0660 www.us.bureauveritas.com

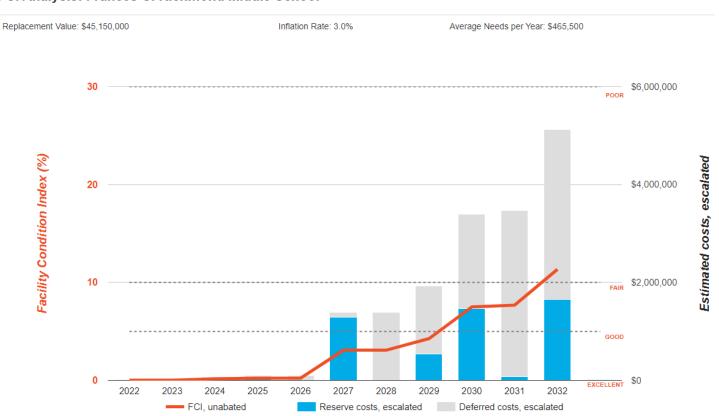
FCI Analysis: Frances C. Richmond Middle School

Needs by Year with Unaddressed FCI Over Time

FCI Analysis Frances C. Richmond Middle School(2005)					
Replacement Value \$ 45,150,000	Total SF 105,000	Cost/SF \$ 430			
	Est	Reserve Cost	FCI		
Current		\$ 5,000	0.0 %		
3-Year		\$ 100,400	0.2 %		
5-Year		\$ 1,389,700	3.1 %		
10-Year		\$ 5,119,500	11.3 %

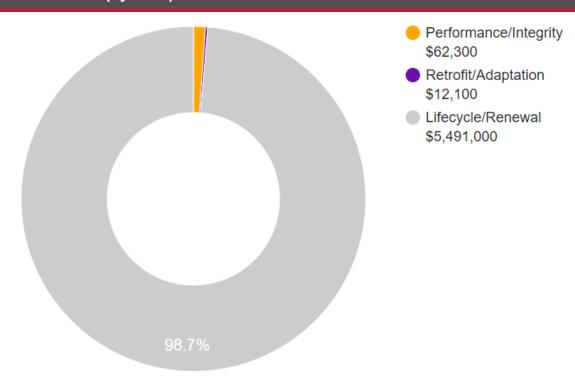
Plan Type Distribution (by Cost)

10-YEAR TOTAL: \$5,565,400

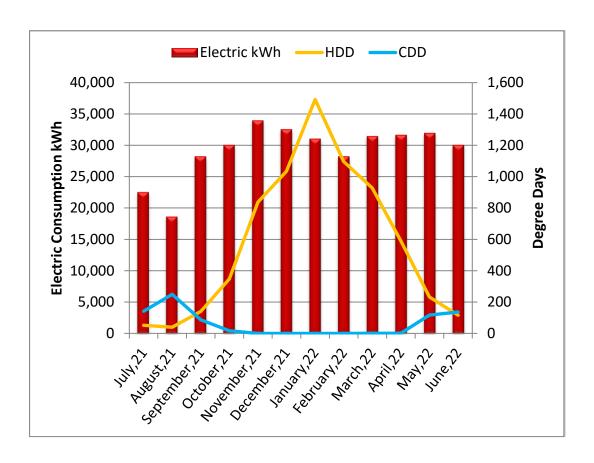
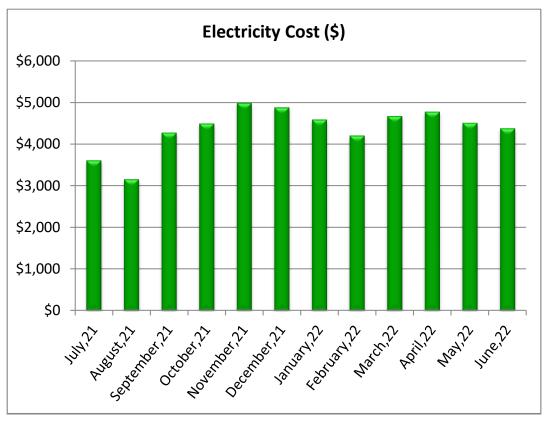
Electricity Consumption & Cost Data			
Billing Month	Consumption (kWh)	Unit Cost (per kWh)	Total Cost
July, 2021	22,500	\$0.16	\$3,607
August, 2021	18,600	\$0.17	\$3,154
September, 2021	28,200	\$0.15	\$4,274
October, 2021	30,000	\$0.15	\$4,493
November, 2021	33,900	\$0.15	\$4,987
December, 2021	32,500	\$0.15	\$4,881
January, 2022	31,000	\$0.15	\$4,588
February, 2022	28,200	\$0.15	\$4,203
March, 2022	31,400	\$0.15	\$4,671
April, 2022	31,600	\$0.15	\$4,776
May, 2022	31,900	\$0.14	\$4,506
June, 2022	30,000	\$0.15	\$4,375
TOTAL/AVERAGE	349,800	\$0.15	\$52,514

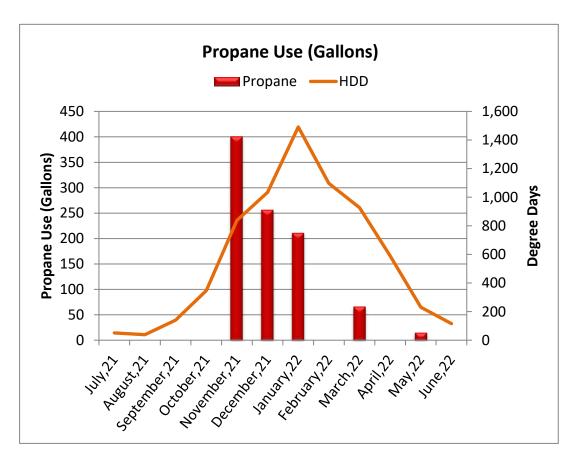
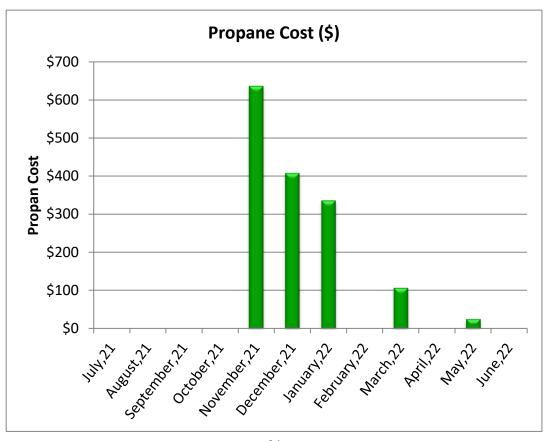
Propane Consumption & Cost Data			
Delivery Month	Delivery (gallons)	Unit Cost (per gallon)	Total Cost
July, 2021	0	0	\$0
August, 2021	0	0	\$0
September, 2021	0	0	\$0
October, 2021	0	0	\$0
November, 2021	400	1.59	\$636
December, 2021	256	1.59	\$408
January, 2022	211	1.59	\$336
February, 2022	0	0	\$0
March, 2022	67	1.59	\$107
April, 2022	0	0	\$0
May, 2022	16	1.59	\$25
June, 2022	0	0	\$0
Total	951	1.59	\$1,511

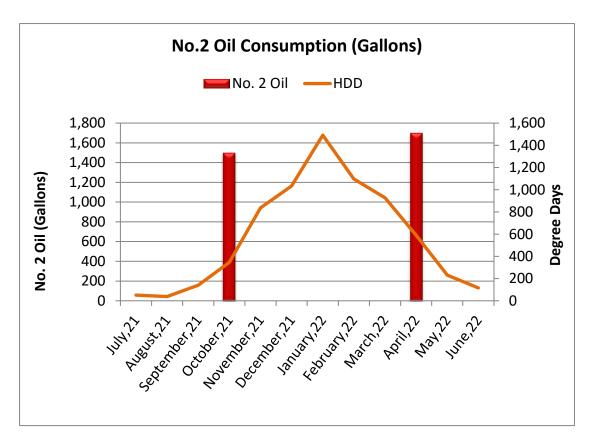
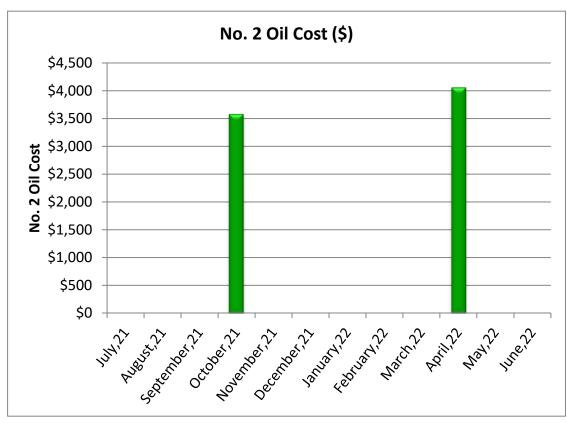
Fuel Oil Consumption & Cost Data			
Delivery Month	Delivery (gallons)	Unit Cost (per gallon)	Total Cost
July, 2021	0	0	\$0
August, 2021	0	0	\$0
September, 2021	0	0	\$0
October, 2021	1,500	\$2.38	\$3,575
November, 2021	0	0	\$0
December, 2021	0	0	\$0
January, 2022	0	0	\$0
February, 2022	0	0	\$0
March, 2022	0	0	\$0
April, 2022	1,700	\$2.38	\$4,052
May, 2022	0	0	\$0
June, 2022	0	0	\$0
Total	3,200	\$2.38	\$7,628

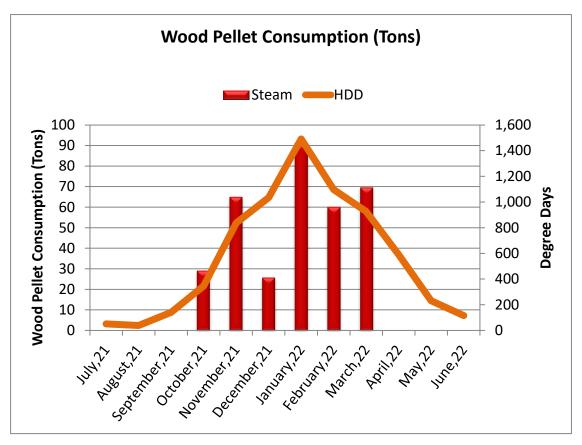
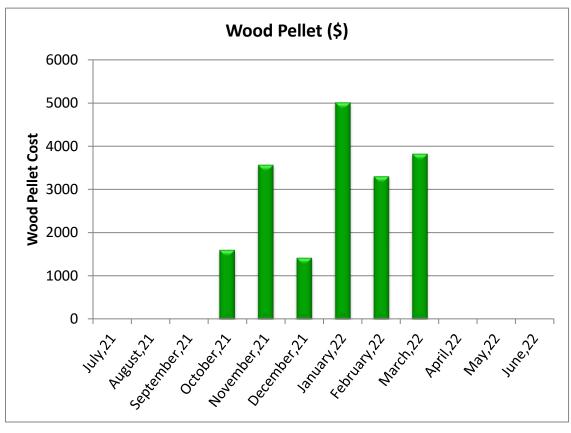
Wood Pellet Consumption & Cost Data			
Delivery Month	Delivery (Tons)	Unit Cost (per Ton)	Total Cost
July, 2021	0	0	0
August, 2021	0	0	\$0
September, 2021	0	0	\$0
October, 2021	29	\$55.00	\$1,602
November, 2021	65	\$55.00	\$3,573
December, 2021	26	\$55.00	\$1,421
January, 2022	91	\$55.00	\$5,014
February, 2022	60	\$55.00	\$3,304
March, 2022	70	\$55.00	\$3,826
April, 2022	0	0	\$0
May, 2022	0	0	\$0
June, 2022	0	0	\$0
Total	341	\$55.00	\$18,741

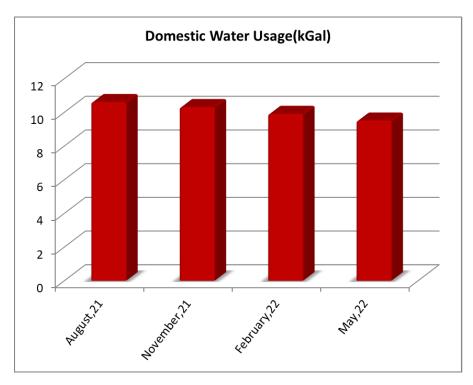
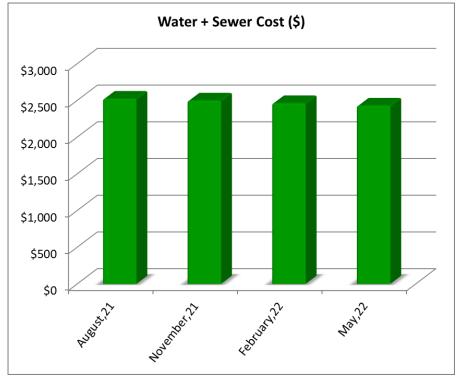
Based on the 2021-2022 water and sewer usage and costs provided, the average blended price paid during the year was \$32.87 per kilogallon. The total annual consumption for the 12-month period analyzed is 301 kilogallons for a total cost of \$9,909.

Water & Sewer Consumption & Cost Data			
Billing Month	Consumption (kGal)	Unit Cost (per kGal)	Total Cost
August,21	79	\$31.81	\$2,522
November,21	77	\$32.41	\$2,497
February,22	74	\$33.25	\$2,462
May,22	71	\$34.17	\$2,428
TOTAL/AVERAGE	301	\$32.87	\$9,909

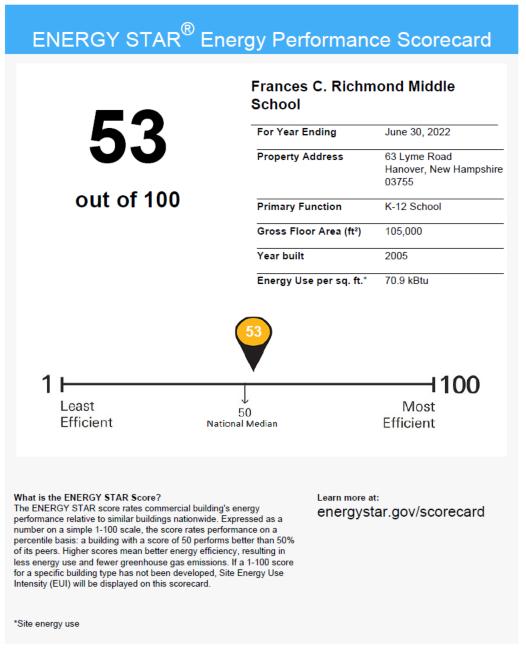
Energy Star Portfolio Manager Facility Summary

Bureau Veritas uses the Portfolio Manager tool developed by the Federal Environmental Protection Agency to track relative energy uses of buildings by property type. This tool allows the input of a facility's historic utility data to be compared with normalized data of a large database of its peer facilities.

Based on this analysis, Frances C. Richmond Middle School is performing at the national average level.

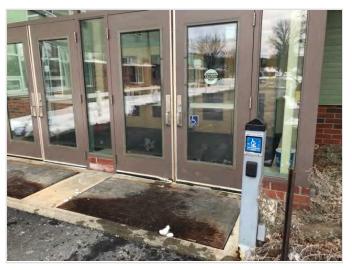
AUTOMATIC DOOR OPENER

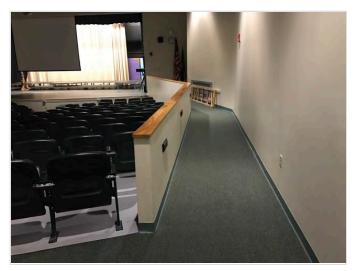
ACCESSIBLE INTERIOR RAMP

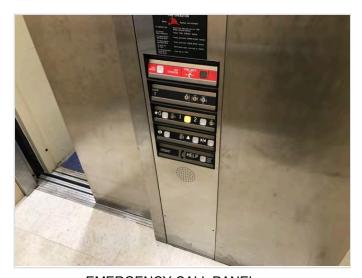
EMERGENCY CALL PANEL
