Newton Schools
Long-Range Facilities Master Plan
Update

Newton, MA
November 2011

VOLUME II

HMFH Architects, Inc.

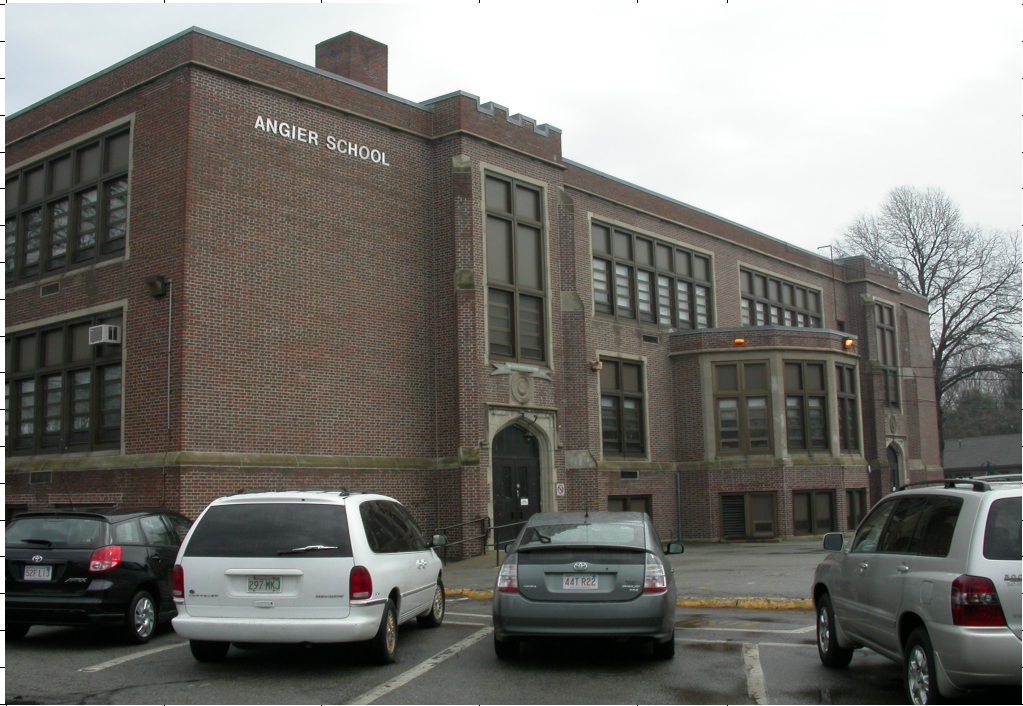
Newton Schools Study - Facility Assessment							
ANGIER SCHOOL							
1697 Beacon Steet							
BUILDING DATA:							
	site area:	1.98 Acres					
	zoning district:	PUB					
	building area:	51,300 gross square feet					
	number of floors:	3					
	historical status:	unknown					
	year built:	1919					
	additions/renovations/upgrades:	1936					
	assessment value:	n/a					
Key to Rating:							
1 = New or in good condition with ordinary maintenance required							
2 = Good condition with minor repairs required							
3 = Fair condition with repairs or replacement required							
4 = Poor condition with replacement required

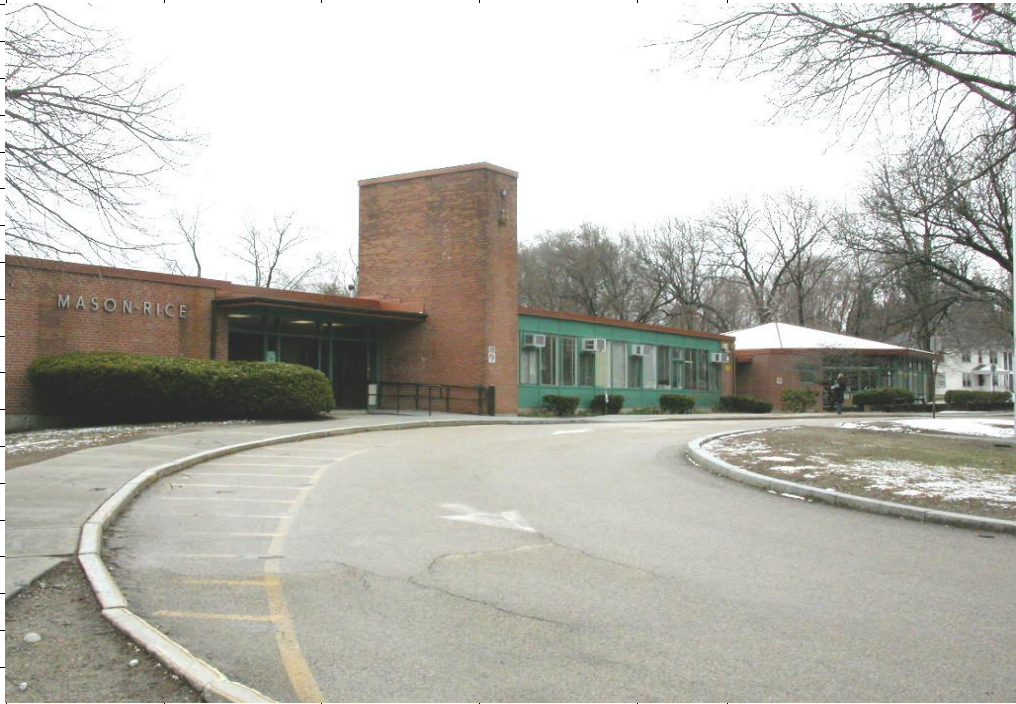
Newton Schools Study - Facility Assessment							
MASON-RICE SCHOOL							
149 PLEASANT STREET							
BUILDING DATA:							
	site area:	3.99 acres					
	zoning district:	PUB					
	building area:	39,000 gross square feet					
	number of floors:	2					
	historical status:	None					
	year built:	1959					
	additions/renovations/upgrades:						
	assessment value:	n/a					
Key to Rating:							
1 = New or in good condition with ordinary maintenance required							
2 = Good condition with minor repairs required							
3 = Fair condition with repairs or replacement required							
4 = Poor condition with replacement required

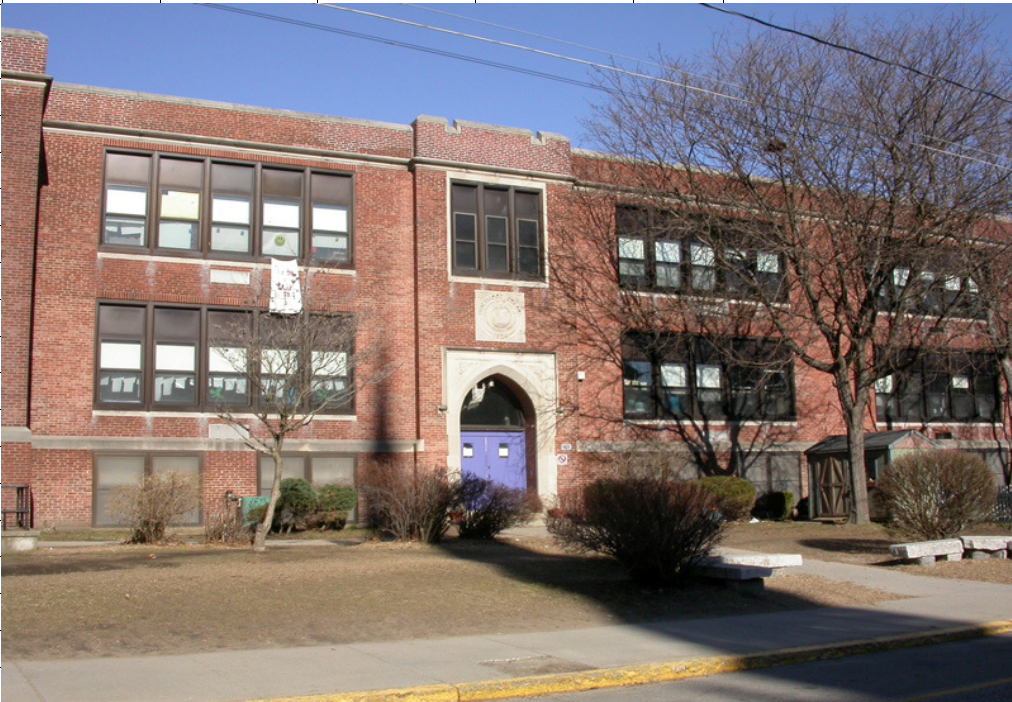
Newton Schools Study - Facility Assessment							
UNDERWOOD SCHOOL							
101 VERNON STREET							
BUILDING DATA:							
	site area:	1 acre					
	zoning district:	PUB					
	building area:	43,300 gross square feet					
	number of floors:	3					
	historical status:	None					
	year built:	1924					
	additions/renovations/upgrades:	1978 (elevator, entry, small rooms)					
	assessment value:	n/a					
Key to Rating:							
1 = New or in good condition with ordinary maintenance required							
2 = Good condition with minor repairs required							
3 = Fair condition with repairs or replacement required							
4 = Poor condition with replacement required

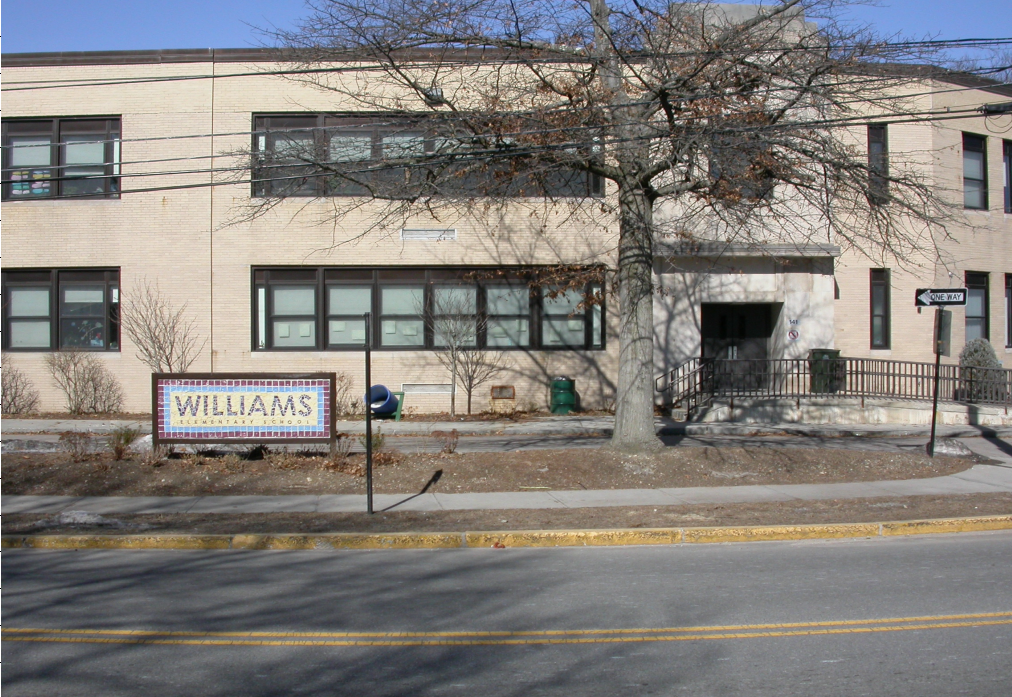
Newton Schools Study - Facility Assessment									
WILLIAMS SCHOOL									
141 GROVE STREET									
BUILDING DATA:									
	site area:	2 acres							
	zoning district:	PUB							
	building area:	41,700 gross square feet							
	number of floors:	2							
	historical status:	None							
	year built:	1950							
	additions/renovations/upgrades:	2001							
	assessment value:	n/a							
Key to Rating:									
1 = New or in good condition with ordinary maintenance required									
2 = Good condition with minor repairs required									
3 = Fair condition with repairs or replacement required									
4 = Poor condition with replacement required

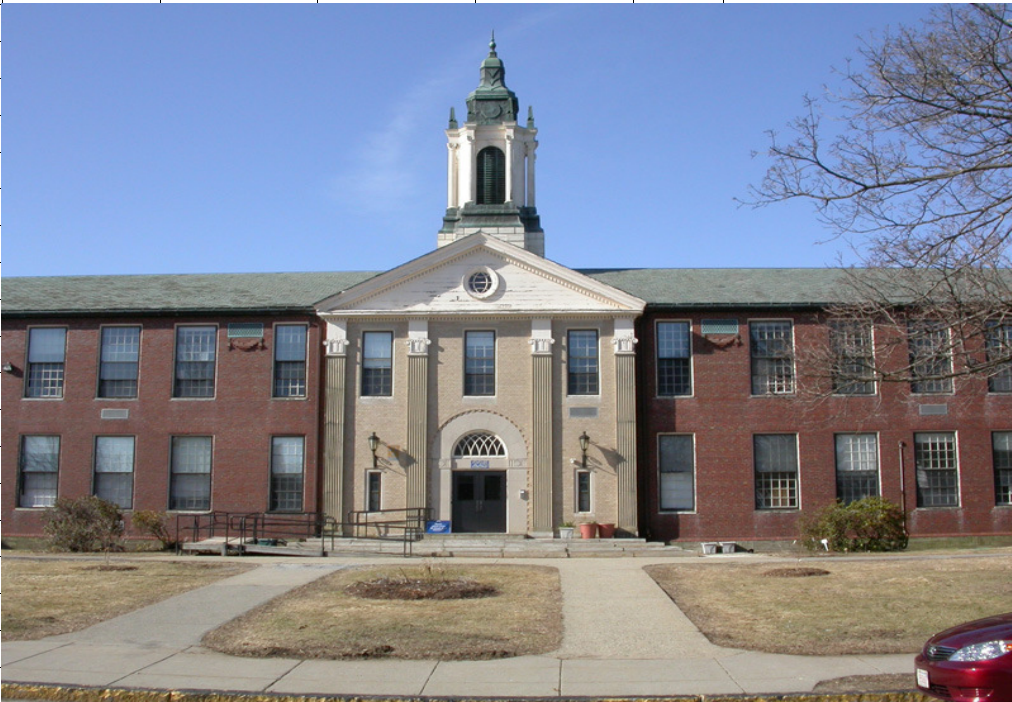
Newton Schools Study - Facility Assessment							
CARR SCHOOL							
225 NEVADA STREET							
BUILDING DATA:							
	site area:	4.85 acres					
	zoning district:	PUB					
	building area:	49,000 gross square feet					
	number of floors:	2					
	historical status:	None					
	year built:	1936					
	additions/renovations/upgrades:	1960					
	assessment value:	n/a					
Key to Rating:							
1 = New or in good condition with ordinary maintenance required							
2 = Good condition with minor repairs required							
3 = Fair condition with repairs or replacement required							
4 = Poor condition with replacement required
