Newton Schools

Long-Range Facilities Master Plan

Newton, MA

VOLUME II

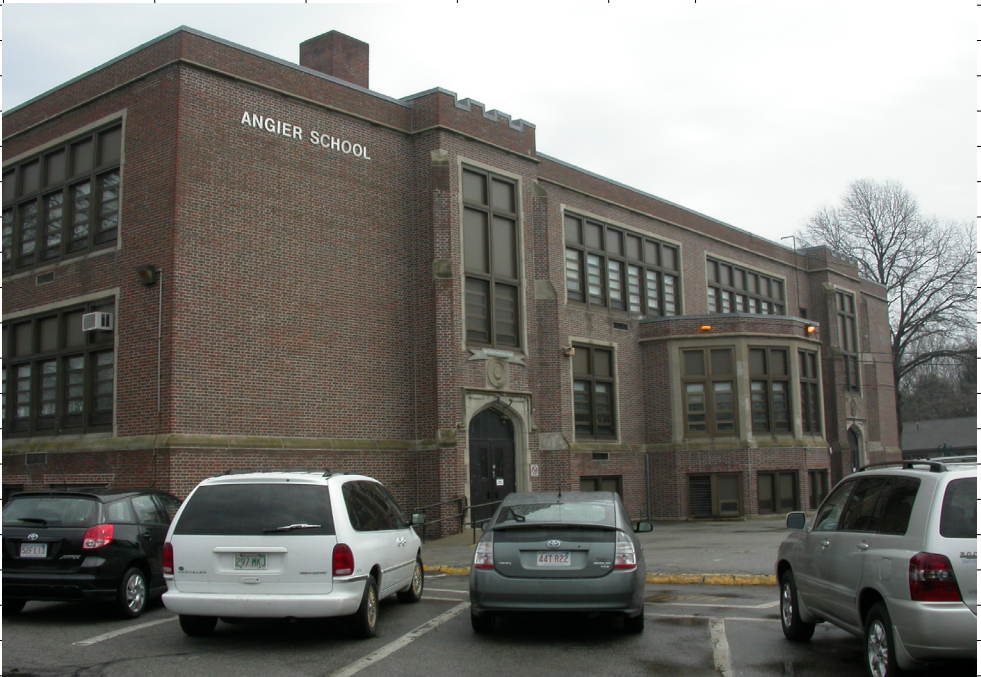
Newton Schools Study - Facility Assessment							
ANGIER SCHOOL							
1697 Beacon Steet							
BUILDING DATA:							
	site area:	1.98 Acres					
	zoning district:	PUB					
	building area:	51,300 gross square feet					
	number of floors:	3					
	historical status:	unknown					
	year built:	1919					
	additions/renovations/upgrades:	1936					
	assessment value:	n/a					
Key to Rating:							
1 = New or in good condition with ordinary maintenance required							
2 = Good condition with minor repairs required							
3 = Fair condition with repairs or replacement required							
4 = Poor condition with replacement required

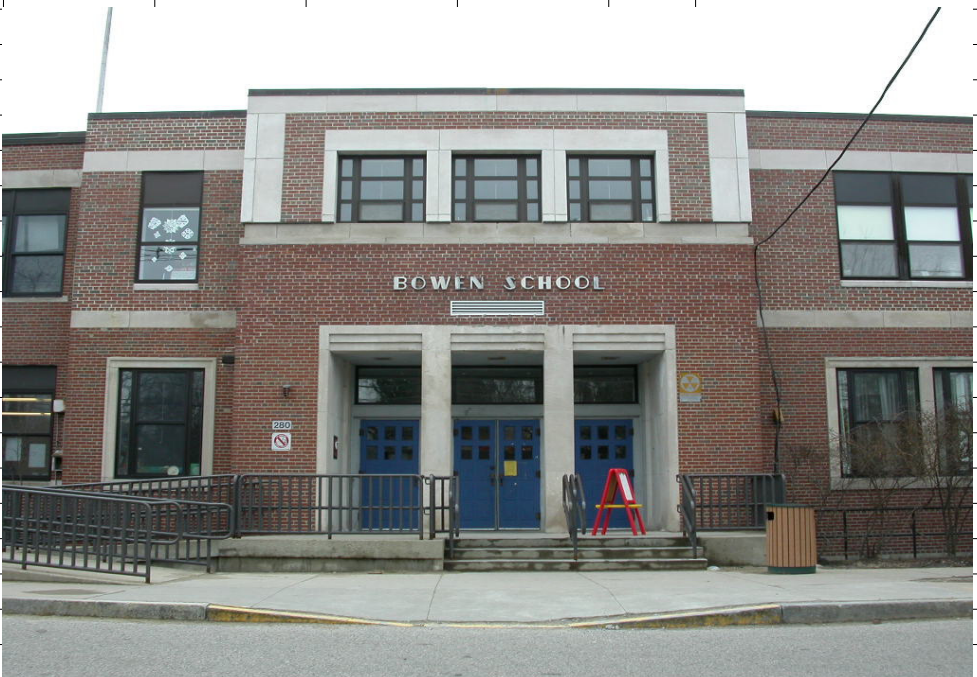
Newton Schools Study - Facility Assessment									
BOWEN SCHOOL									
280 CYPRESS STREET									
BUILDING DATA:									
	site area:	11.54 acres							
	zoning district:	PUB							
	building area:	63,915 gross square feet							
	number of floors:	3							
	historical status:	None							
	year built:	1952							
	additions/renovations/upgrades:	1989, 2000							
	assessment value:	n/a							
Key to Rating:									
1 = New or in good condition with ordinary maintenance required									
2 = Good condition with minor repairs required									
3 = Fair condition with repairs or replacement required									
4 = Poor condition with replacement required

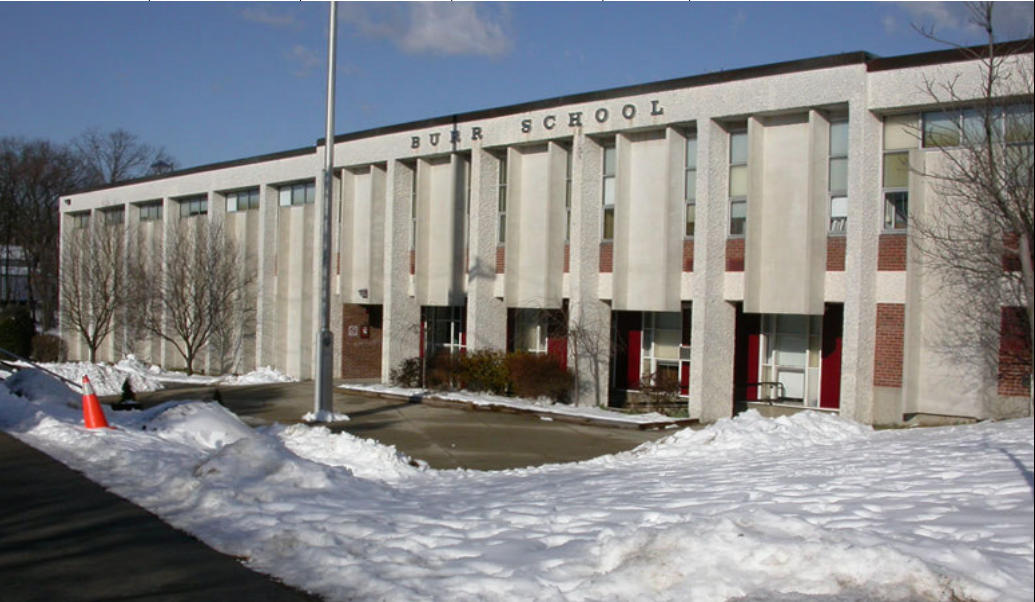
Newton Schools Study - Facility Assessment							
Burr School							
171 Pine Street							
BUILDING DATA:							
	site area:	8.65 acres					
	zoning district:	PUB					
	building area:	53,000 gross square feet					
	number of floors:	2					
	historical status:	None					
	year built:	1967					
	additions/renovations/upgrades:	1998 (walls at 2nd floor classrooms)					
	assessment value:	n/a					
Key to Rating:							
1 = New or in good condition with ordinary maintenance required							
2 = Good condition with minor repairs required							
3 = Fair condition with repairs or replacement required							
4 = Poor condition with replacement required

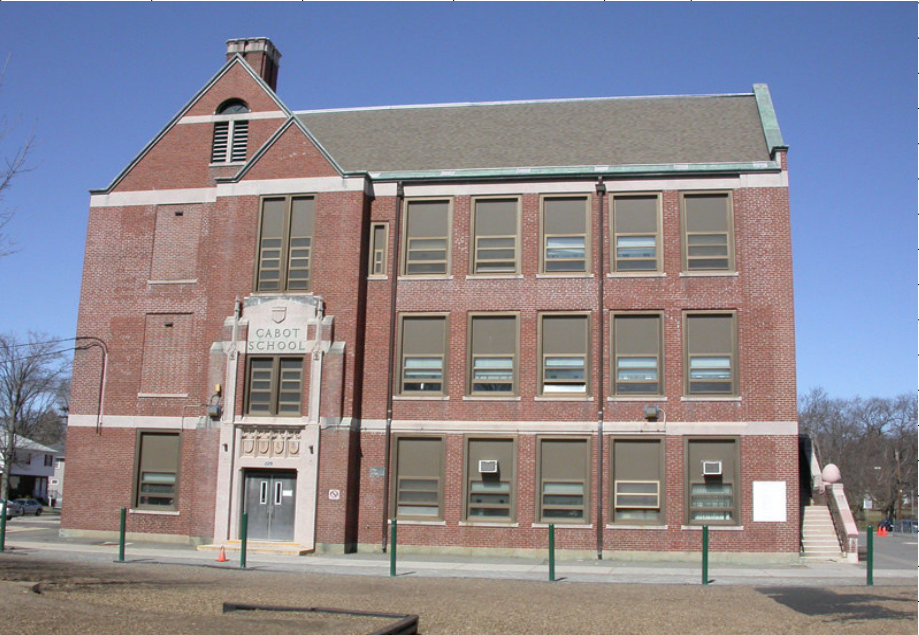
Newton Schools Study - Facility Assessment							
CABOT SCHOOL							
229 CABOT STREET							
BUILDING DATA:							
	site area:	1 acre					
	zoning district:	PUB					
	building area:	41,000 gross square feet					
	number of floors:	3					
	historical status:	None					
	year built:	1929					
	additions/renovations/upgrades:	1957, 1991-modulars					
	assessment value:	n/a					
Key to Rating:							
1 = New or in good condition with ordinary maintenance required							
2 = Good condition with minor repairs required							
3 = Fair condition with repairs or replacement required							
4 = Poor condition with replacement required

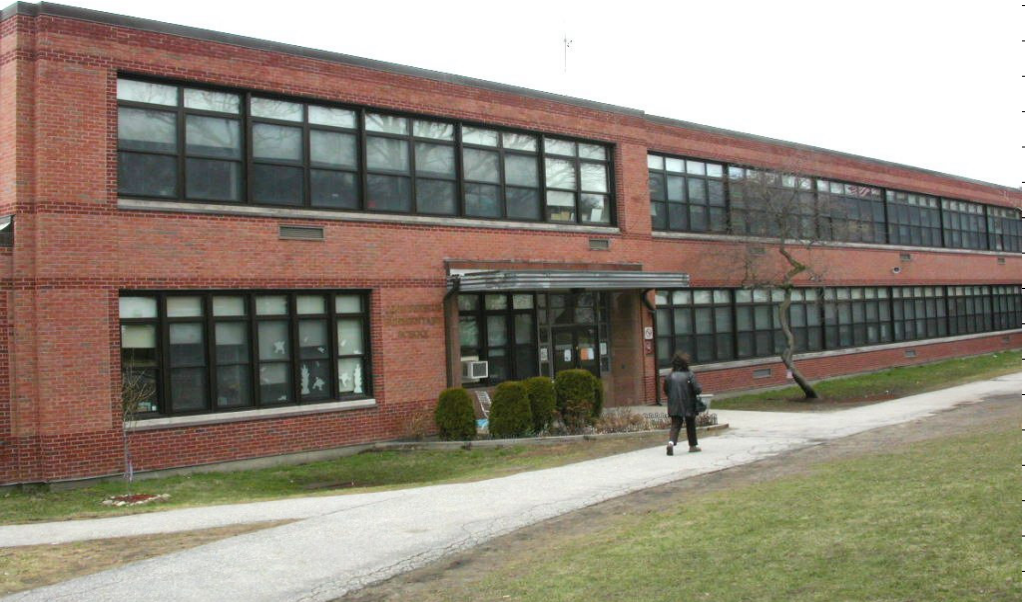
Newton Schools Study - Facility Assessment							
COUNTRYSIDE SCHOOL							
191 DEDHAM STREET							
BUILDING DATA:							
	site area:	7.39 acres					
	zoning district:	PUB					
	building area:	65,000 gross sq. ft.					
	number of floors:	3					
	historical status:	None					
	year built:	1953					
	additions/renovations/upgrades:	1958, 1988, (1991-M, 1999-M)					
	assessment value:	n/a					
Key to Rating:							
1 = New or in good condition with ordinary maintenance required							
2 = Good condition with minor repairs required							
3 = Fair condition with repairs or replacement required							
4 = Poor condition with replacement required

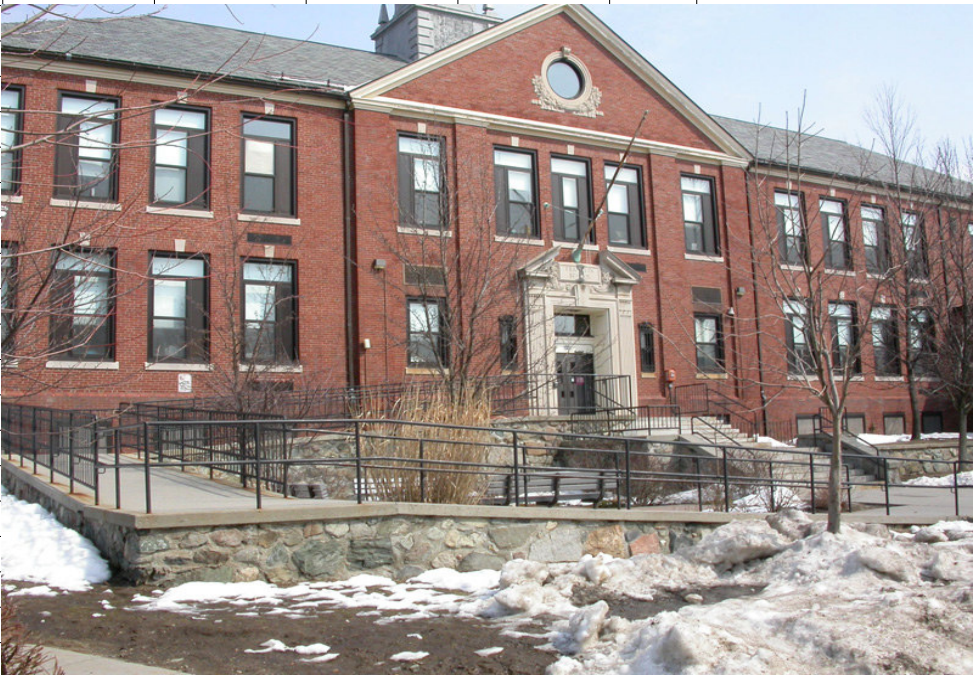
Newton Schools Study - Facility Assessment							
FRANKLIN SCHOOL							
125 DERBY STREET							
BUILDING DATA:							
	site area:	5.45 Acres					
	zoning district:	PUB					
	building area:	56,764 gross square feet					
	number of floors:	3					
	historical status:	None					
	year built:	1939					
	additions/renovations/upgrades:	1950, 1953					
	assessment value:	n/a					
Key to Rating:							
1 = New or in good condition with ordinary maintenance required							
2 = Good condition with minor repairs required							
3 = Fair condition with repairs or replacement required							
4 = Poor condition with replacement required

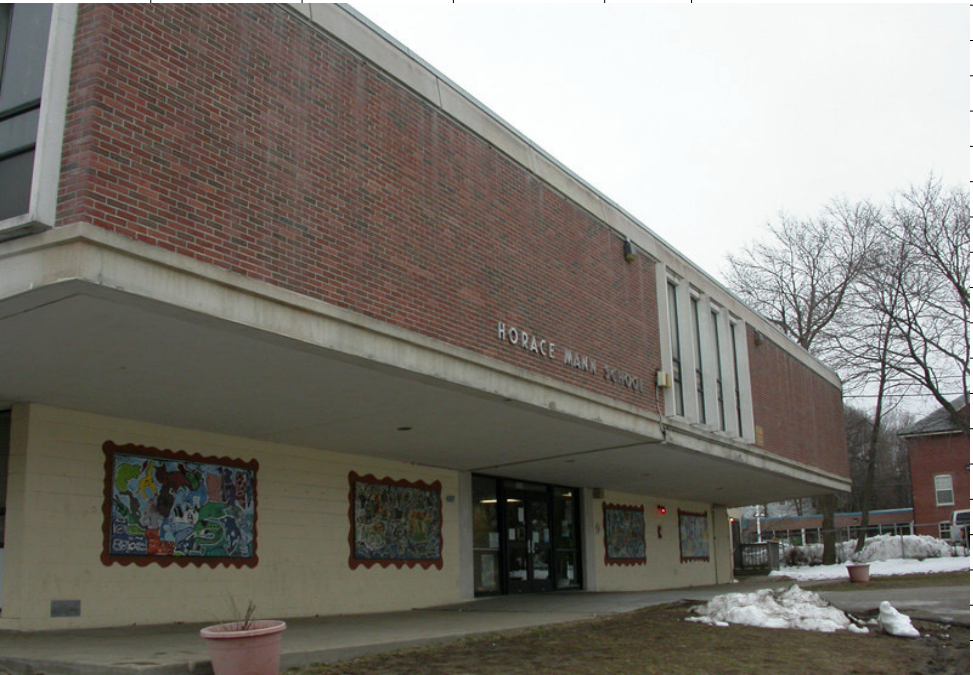
Newton Schools Study - Facility Assessment							
HORACE MANN SCHOOL							
687 WATERTOWN ST							
BUILDING DATA:							
	site area:	1.59 Acres					
	zoning district:	PUB					
	building area:	37,500 gross square feet					
	number of floors:	3					
	historical status:	None					
	year built:	1965					
	additions/renovations/upgrades:	2001-enclosed operable w/ walls					
	assessment value:	n/a					
Key to Rating:							
1 = New or in good condition with ordinary maintenance required							
2 = Good condition with minor repairs required							
3 = Fair condition with repairs or replacement required							
4 = Poor condition with replacement required

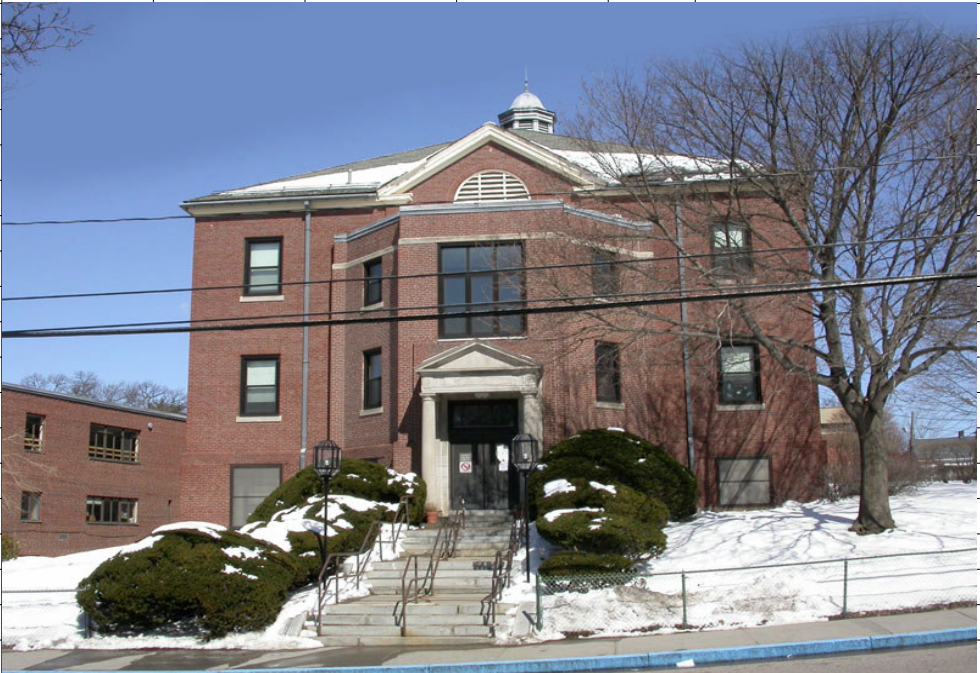
Newton Schools Study - Facility Assessment							
LINCOLN-ELIOT SCHOOL							
191 PEARL STREET							
BUILDING DATA:							
	site area:	4 acres					
	zoning district:	PUB					
	building area:	51,074 Gross Square Feet					
	number of floors:	2/3					
	historical status:	None					
	year built:	1939					
	additions/renovations/upgrades:	1965, 1974					
	assessment value:	n/a					
Key to Rating:							
1 = New or in good condition with ordinary maintenance required							
2 = Good condition with minor repairs required							
3 = Fair condition with repairs or replacement required							
4 = Poor condition with replacement required

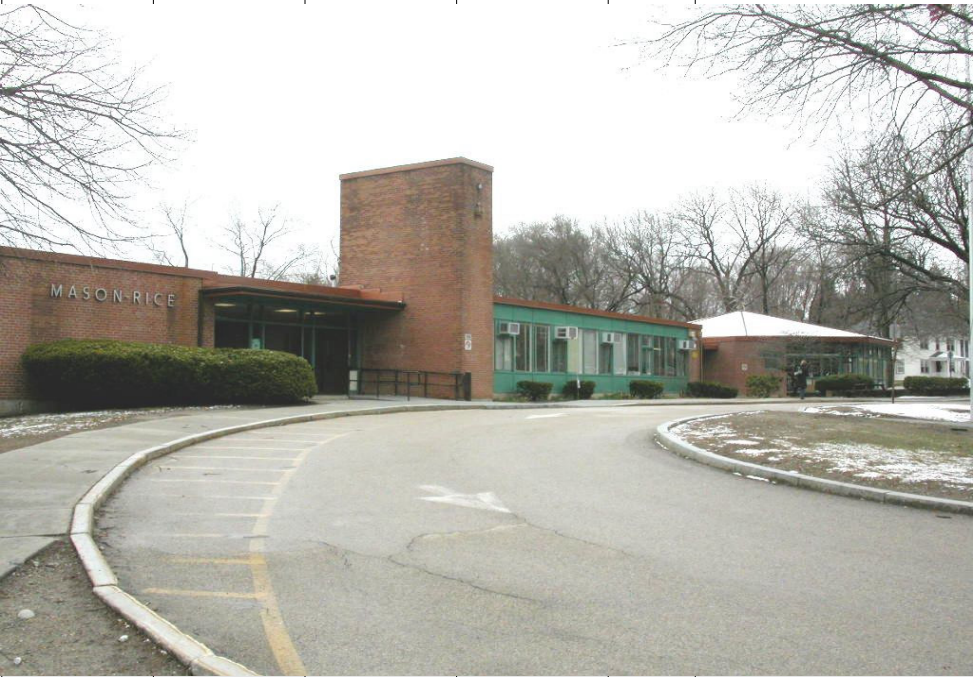
Newton Schools Study - Facility Assessment							
MASON-RICE SCHOOL							
149 PLEASANT STREET							
BUILDING DATA:							
	site area:	3.99 acres					
	zoning district:	PUB					
	building area:	39,000 gross square feet					
	number of floors:	2					
	historical status:	None					
	year built:	1959					
	additions/renovations/upgrades:						
	assessment value:	n/a					
Key to Rating:							
1 = New or in good condition with ordinary maintenance required							
2 = Good condition with minor repairs required							
3 = Fair condition with repairs or replacement required							
4 = Poor condition with replacement required

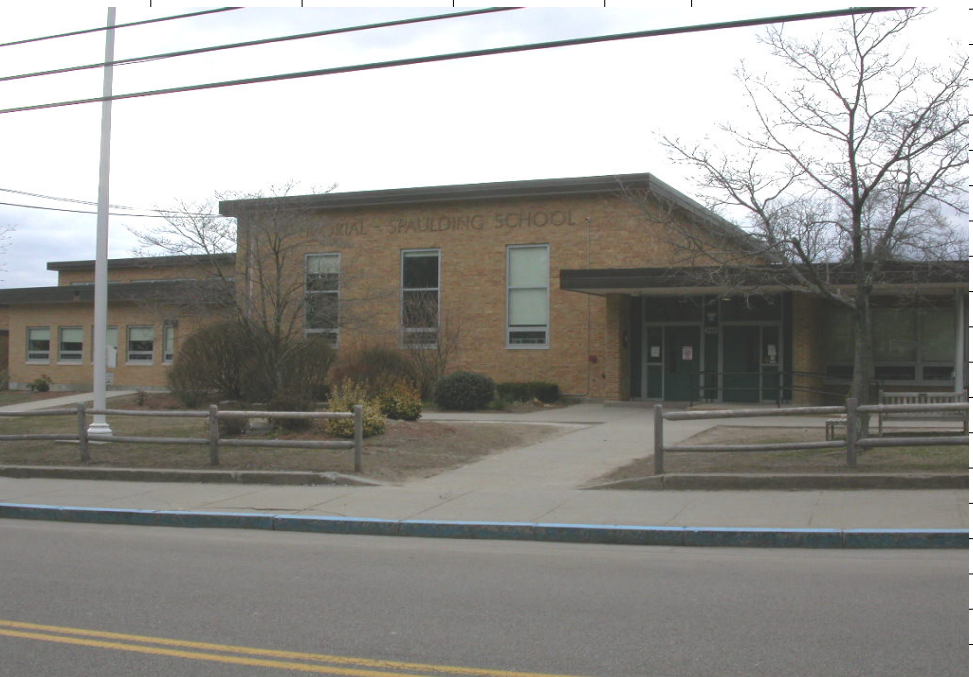
Newton Schools Study - Facility Assessment									
MEMORIAL-SPAULDING SCHOOL									
250 BROOKLINE STREET									
BUILDING DATA:									
	site area:	5.59 acres							
	zoning district:	PUB							
	building area:	68,775 gross square feet							
	number of floors:	2							
	historical status:	None							
	year built:	1954							
	additions/renovations/upgrades:	1959, 2002							
	assessment value:	n/a							
Key to Rating:									
1 = New or in good condition with ordinary maintenance required									
2 = Good condition with minor repairs required									
3 = Fair condition with repairs or replacement required									
4 = Poor condition with replacement required

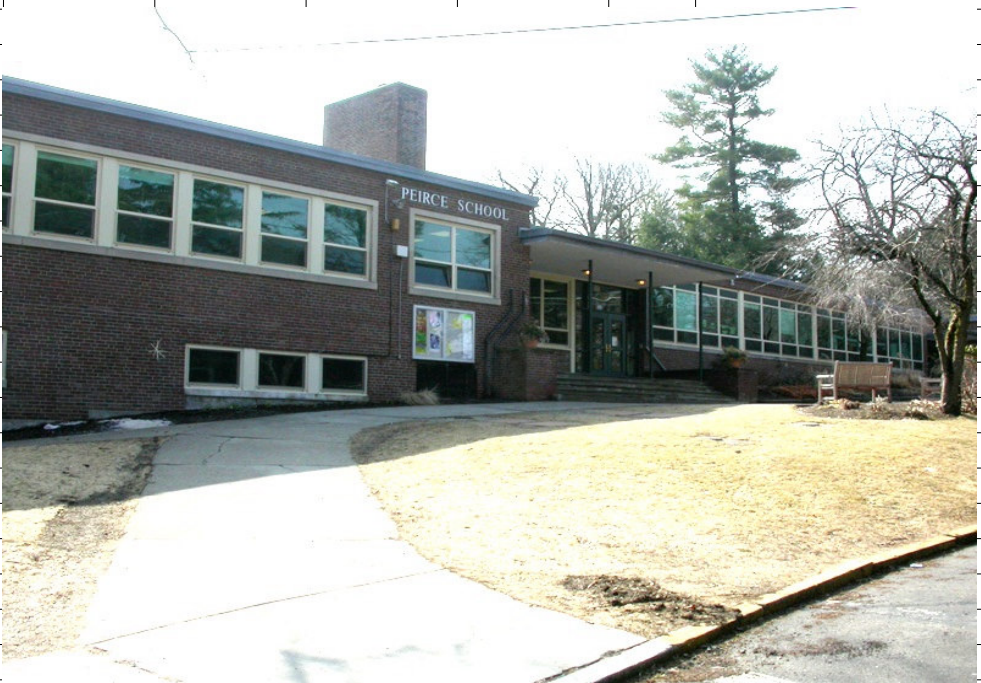
Newton Schools Study - Facility Assessment								
PEIRCE SCHOOL								
170 TEMPLE STREET								
BUILDING DATA:								
	site area:	3.68 acres						
	zoning district:	PUB						
	building area:	33,800 gross square feet						
	number of floors:	2						
	historical status:	None						
	year built:	1951						
	additions/renovations/upgrades:	1955						
	assessment value:	n/a						
Key to Rating:								
1 = New or in good condition with ordinary maintenance required								
2 = Good condition with minor repairs required								
3 = Fair condition with repairs or replacement required								
4 = Poor condition with replacement required

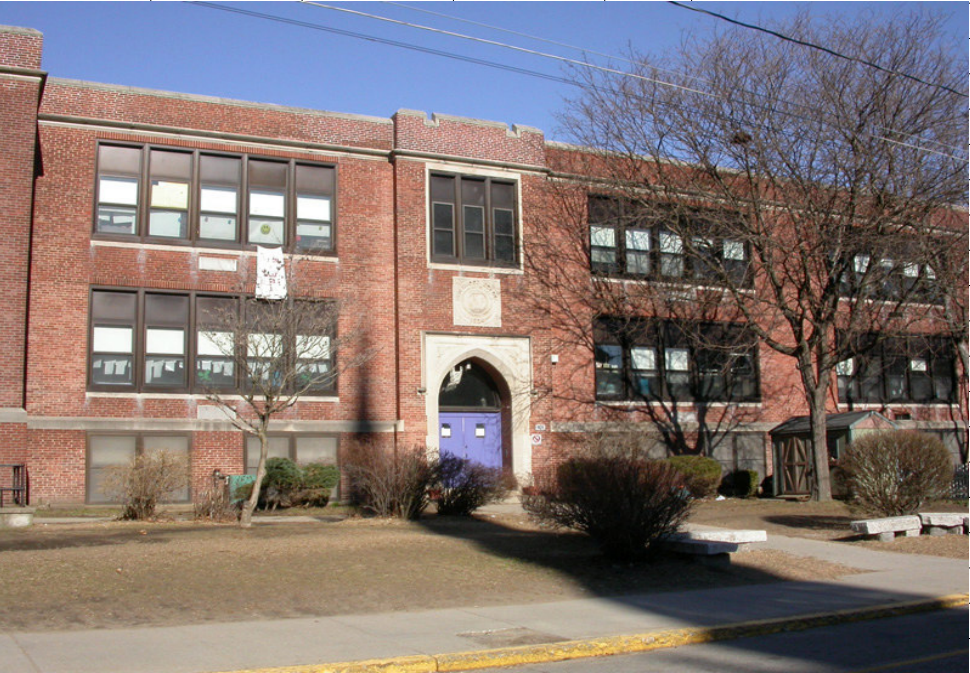
Newton Schools Study - Facility Assessment							
UNDERWOOD SCHOOL							
101 VERNON STREET							
BUILDING DATA:							
	site area:	1 acre					
	zoning district:	PUB					
	building area:	43,300 gross square feet					
	number of floors:	3					
	historical status:	None					
	year built:	1924					
	additions/renovations/upgrades:	1978 (elevator, entry, small rooms)					
	assessment value:	n/a					
Key to Rating:							
1 = New or in good condition with ordinary maintenance required							
2 = Good condition with minor repairs required							
3 = Fair condition with repairs or replacement required							
4 = Poor condition with replacement required

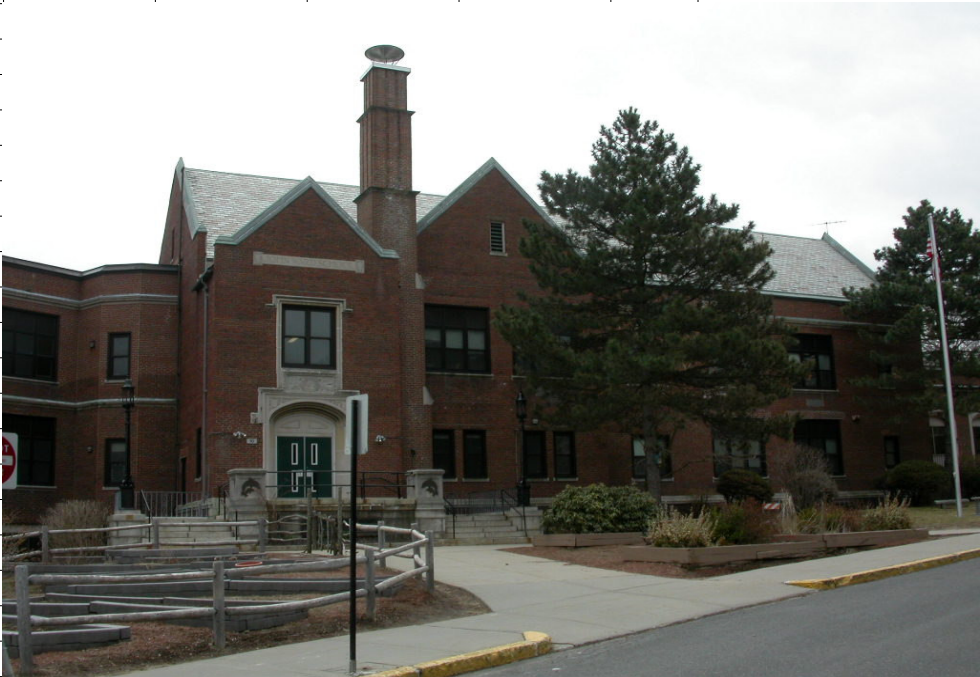
Newton Schools Study - Facility Assessment							
WARD ELEMENTARY SCHOOL							
10 DOLPHIN ROAD							
BUILDING DATA:							
	site area:	3.16 acres					
	zoning district:	PUB					
	building area:	38,000 gross square feet					
	number of floors:	3					
	historical status:	None					
	year built:	1928					
	additions/renovations/upgrades:	1950, 1954					
	assessment value:	n/a					
Key to Rating:							
1 = New or in good condition with ordinary maintenance required							
2 = Good condition with minor repairs required							
3 = Fair condition with repairs or replacement required							
4 = Poor condition with replacement required

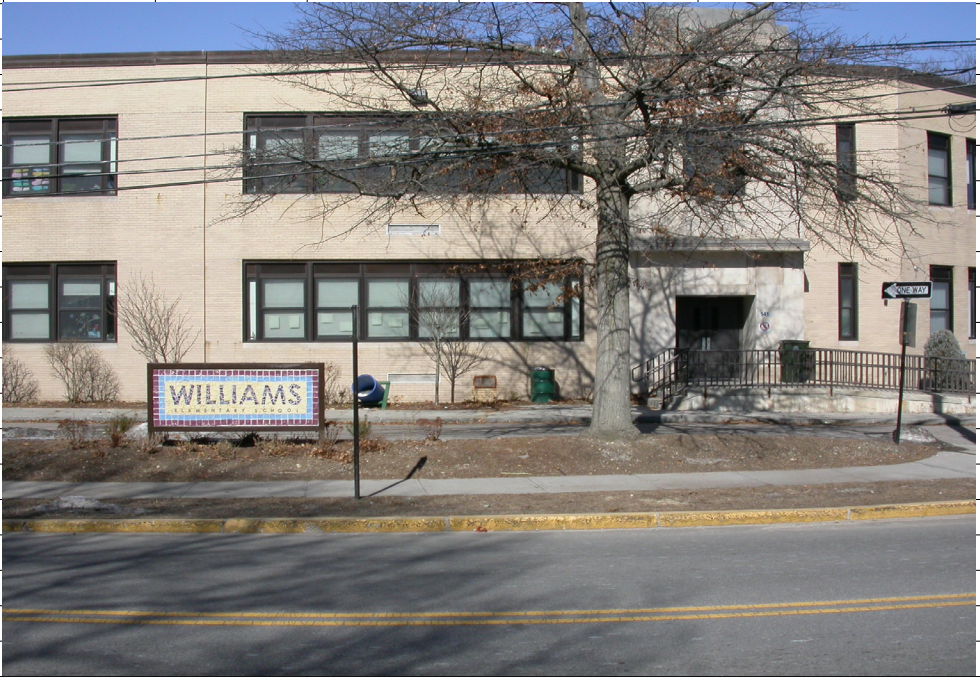
Newton Schools Study - Facility Assessment							
WILLIAMS SCHOOL							
141 GROVE STREET							
BUILDING DATA:							
	site area:	2 acres					
	zoning district:	PUB					
	building area:	41,700 gross square feet					
	number of floors:	2					
	historical status:	None					
	year built:	1950					
	additions/renovations/upgrades:	2001					
	assessment value:	n/a					
Key to Rating:							
1 = New or in good condition with ordinary maintenance required							
2 = Good condition with minor repairs required							
3 = Fair condition with repairs or replacement required							
4 = Poor condition with replacement required

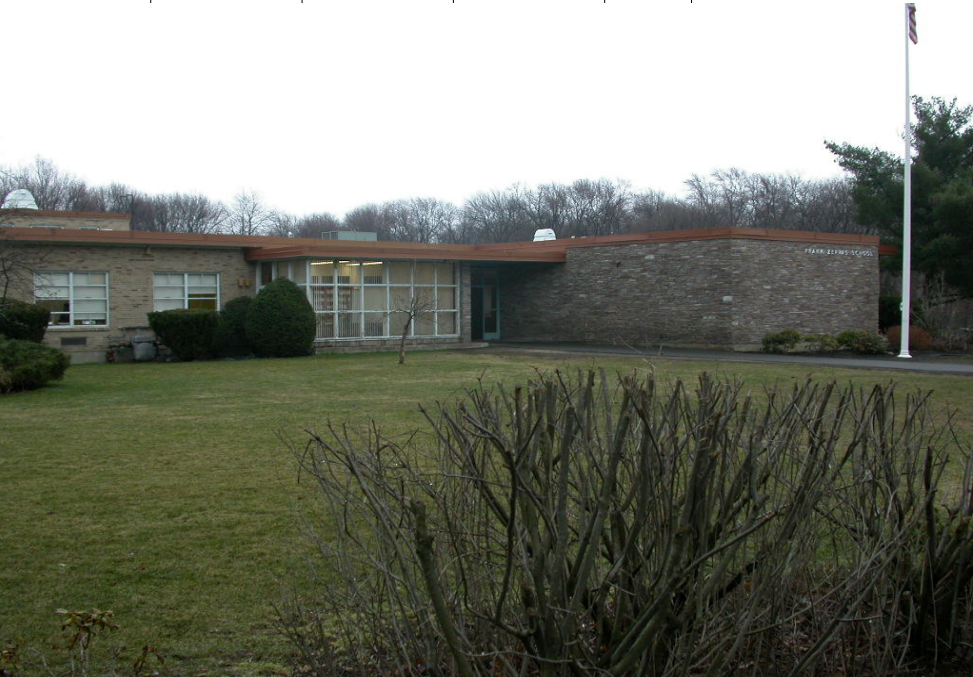
Newton Schools Study - Facility Assessment							
ZERVAS SCHOOL							
30 BEETHOVEN AVENUE							
BUILDING DATA:							
	site area:	5.28 acres					
	zoning district:	PUB					
	building area:	30,646 gross sq. ft.					
	number of floors:	1					
	historical status:	None					
	year built:	1954					
	additions/renovations/upgrades:	1999 modulars					
	assessment value:	n/a					
Key to Rating:							
1 = New or in good condition with ordinary maintenance required							
2 = Good condition with minor repairs required							
3 = Fair condition with repairs or replacement required							
4 = Poor condition with replacement required

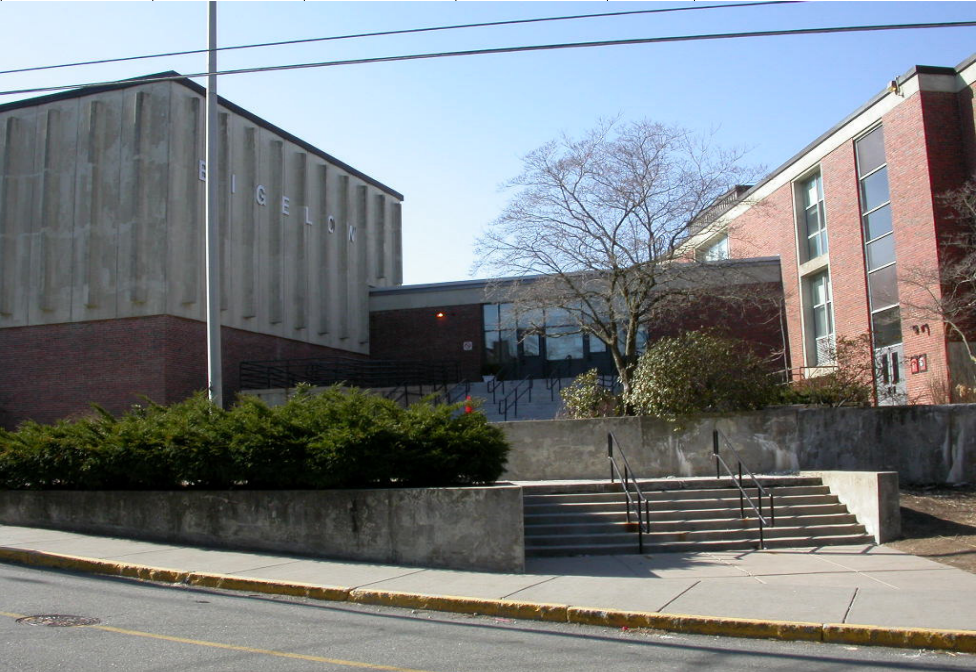
Newton Schools Study - Facility Assessment								
BIGELOW MIDDLE SCHOOL

42 VERNON STREET								
BUILDING DATA:								
	site area:	2.81 Acres						
	zoning district:	PUB						
	building area:	92,500 gross square feet						
	number of floors:	3						
	historical status:	None						
	year built:	1967						
	additions/renovations/upgrades:	1993 (opened as MS)						
	assessment value:	n/a						
Key to Rating:								
1 = New or in good condition with ordinary maintenance required								
2 = Good condition with minor repairs required								
3 = Fair condition with repairs or replacement required								
4 = Poor condition with replacement required

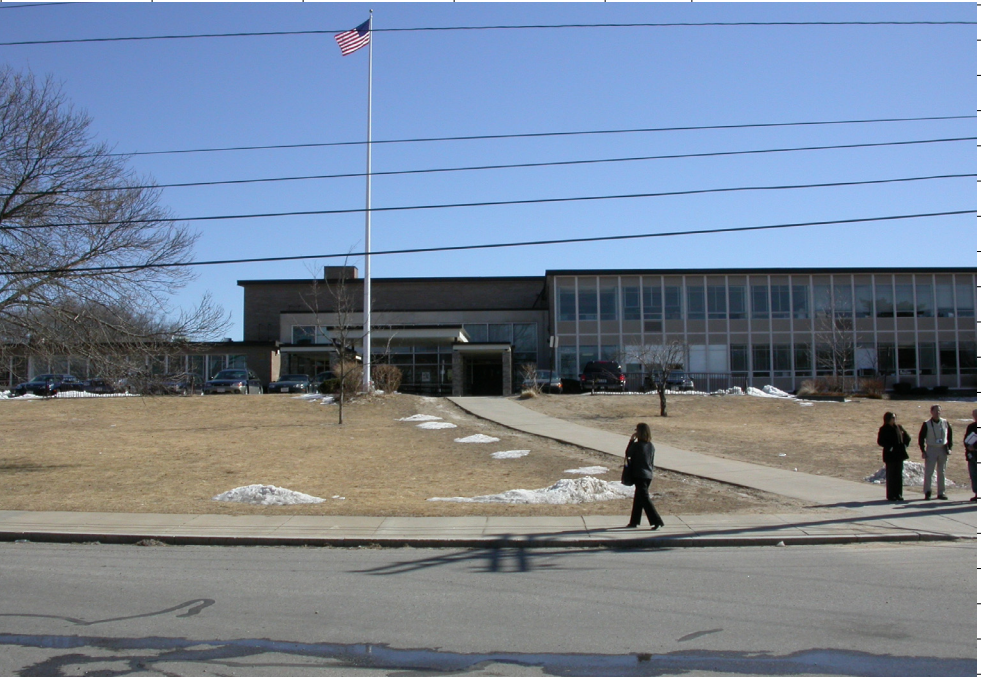
Newton Schools Study - Facility Assessment								
BROWN MIDDLE SCHOOL

125 Meadowbrook Road								
BUILDING DATA:								
site area:		8.27 Acres						
zoning district:		PUB						
building area:		146,000 gross square feet						
number of floors:		2						
historical status:		None						
year built:		1956						
additions/renovations/upgrades:		1962, 1982, 1997						
assessment value:		n/a						
Key to Rating:								
1 = New or in good condition with ordinary maintenance required								
2 = Good condition with minor repairs required								
3 = Fair condition with repairs or replacement required								
4 = Poor condition with replacement required

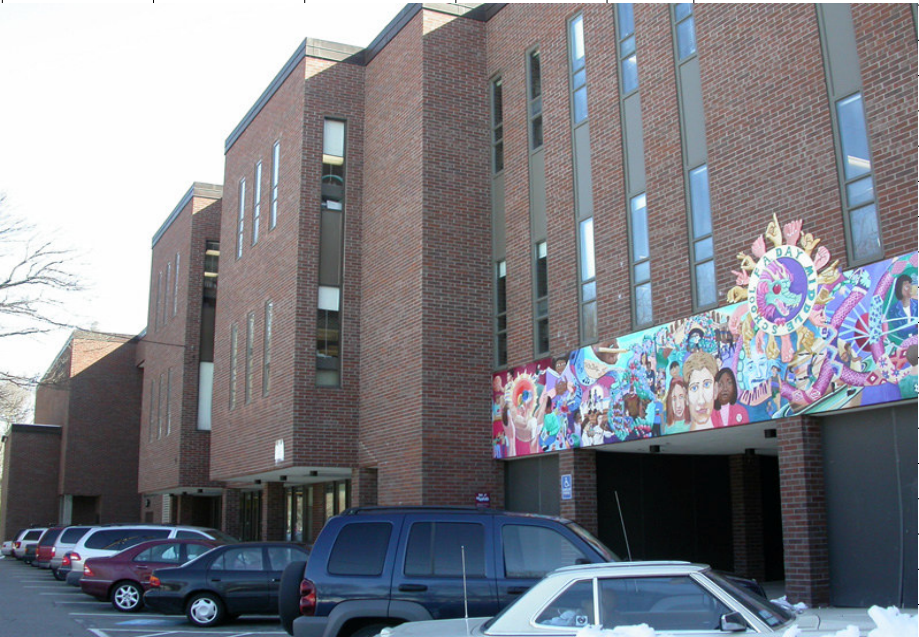
Newton Schools Study - Facility Assessment							
DAY MIDDLE SCHOOL							
21 MINOT PLACE							
BUILDING DATA:							
	site area:	8.57 Acres					
	zoning district:	PUB					
	building area:	145,600 gross square feet					
	number of floors:	3					
	historical status:	None					
	year built:	1971					
	additions/renovations/upgrades:	1997					
	assessment value:	n/a					
Key to Rating:							
1 = New or in good condition with ordinary maintenance required							
2 = Good condition with minor repairs required							
3 = Fair condition with repairs or replacement required							
4 = Poor condition with replacement required

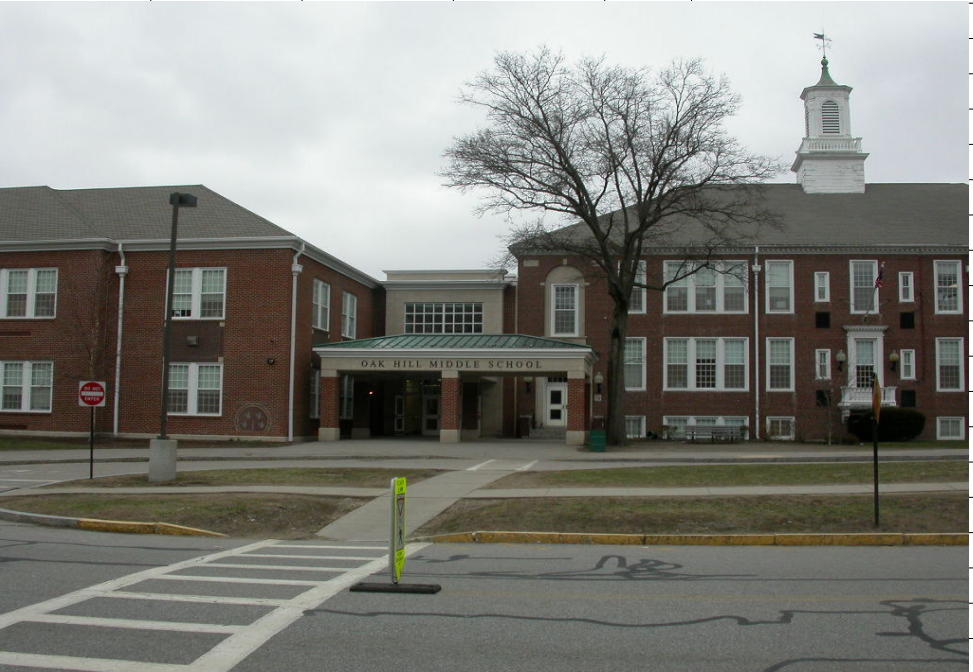
Newton Schools Study - Facility Assessment								
OAK HILL MIDDLE SCHOOL

130 WHEELER ROAD								
BUILDING DATA:								
	site area:	8.04 acres						
	zoning district:	PUB						
	building area:	91,000 gross square feet						
	number of floors:	3						
	historical status:	None						
	year built:	1936						
	additions/renovations/upgrades:	1960, 1997 (opened as MS)						
	assessment value:	n/a						
Key to Rating:								
1 = New or in good condition with ordinary maintenance required								
2 = Good condition with minor repairs required								
3 = Fair condition with repairs or replacement required								
4 = Poor condition with replacement required

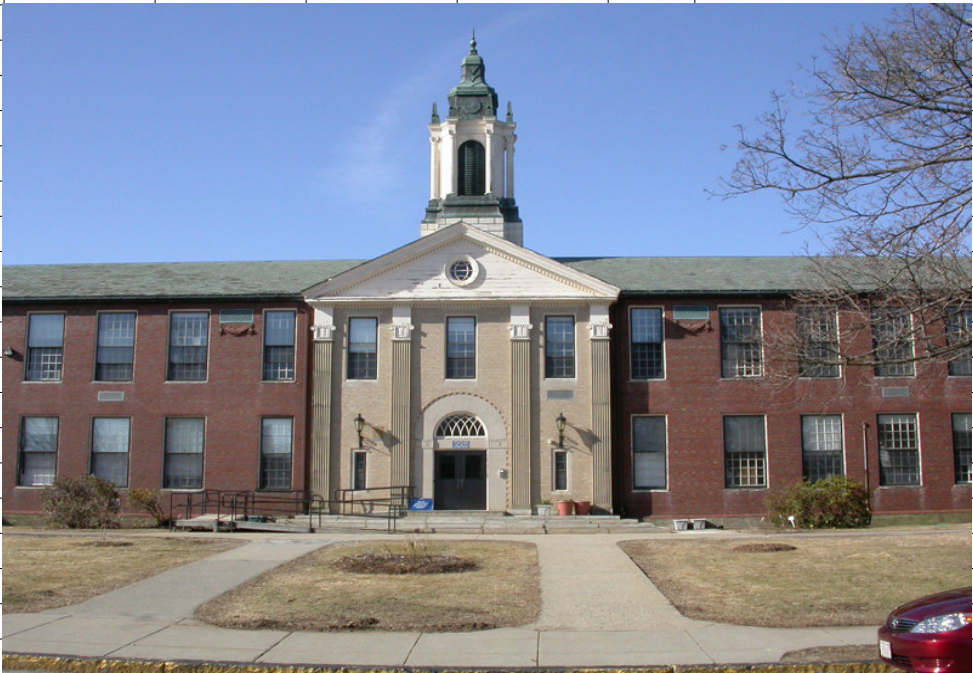
Newton Schools Study - Facility Assessment							
CARR SCHOOL							
225 NEVADA STREET							
BUILDING DATA:							
	site area:	4.85 acres					
	zoning district:	PUB					
	building area:	49,000 gross square feet					
	number of floors:	2					
	historical status:	None					
	year built:	1936					
	additions/renovations/upgrades:	1960					
	assessment value:	n/a					
Key to Rating:							
1 = New or in good condition with ordinary maintenance required							
2 = Good condition with minor repairs required							
3 = Fair condition with repairs or replacement required							
4 = Poor condition with replacement required

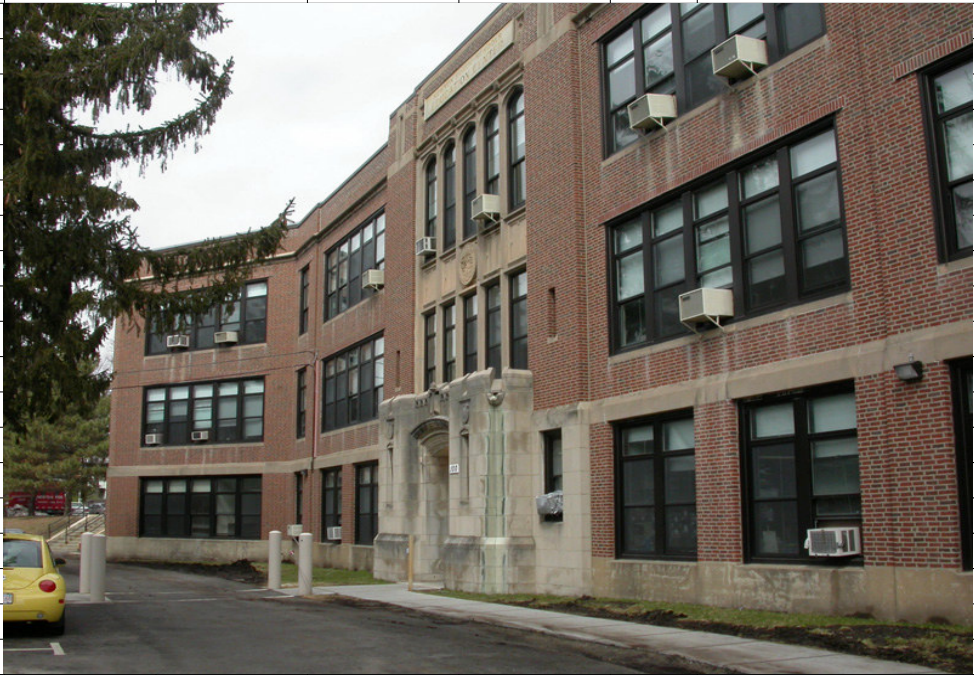
Newton Schools Study - Facility Assessment							
EDUCATION CENTER							
100 WALNUT STREET							
BUILDING DATA:							
	site area:	3.78 acres					
	zoning district:	PUB					
	building area:	70,000 gross square feet					
	number of floors:	3					
	historical status:	None					
	year built:	1928					
	additions/renovations/upgrades:	1934-add, 1966-renov, 1980s-mods					
	assessment value:	n/a					
Key to Rating:							
1 = New or in good condition with ordinary maintenance required							
2 = Good condition with minor repairs required							
3 = Fair condition with repairs or replacement required							
4 = Poor condition with replacement required
