June 2019 | Dam Inundation Study

HAMILTON HIGH SCHOOL EXPANSION

Hamilton Unified School District

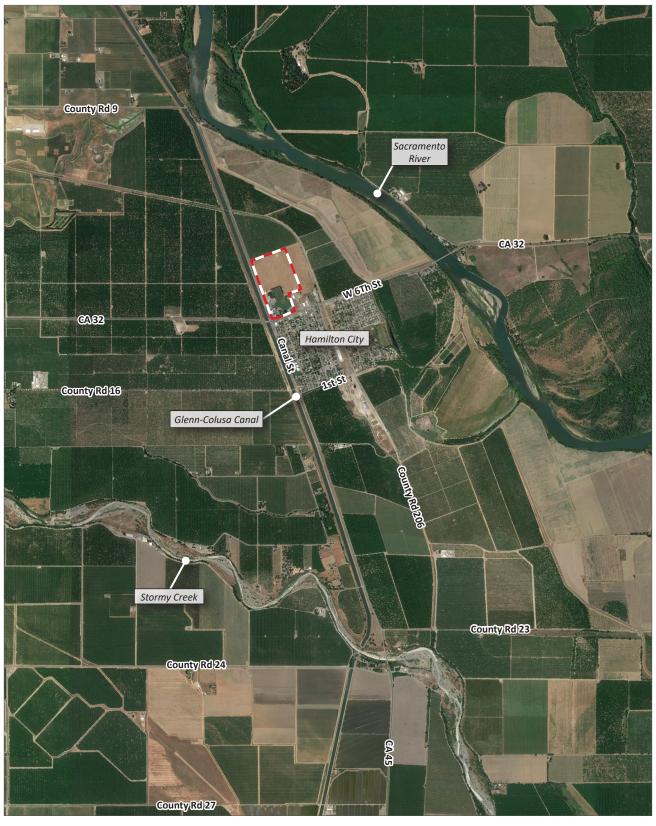
Figure 1
Site Location and Vicinity

Project Boundary

The District intends to modernize the existing Hamilton High School, which is located at 620 Canal Street, Hamilton City, Glenn County, California. As part of the proposed project, the District would acquire an approximately 45-acre property adjacent to the existing school; construct new playing fields, a gymnasium and parking lot on the expanded site; modernize existing buildings; and plan future construction of new classroom buildings. The 45-acre project site is bounded by agricultural land to the north, commercial/agricultural properties (Westermann Farms and Dollar General) to the east, West 6th Street/State Route 32 (SR-32) to the south, and Canal Street/State Route 45 (SR-45) and the Glenn-Colusa Canal to the west (Figure 1). The site location and vicinity are shown on Figure 1, and an aerial photograph of the school site is shown on Figure 2.
