FACILITY CONDITION ASSESSMENT

Richmond Public Schools
301 North Ninth Street
Richmond, VA 23219

Martin L. King, Jr. Middle School
1000 Mosby Street
Richmond, VA 23223

May 15, 2024

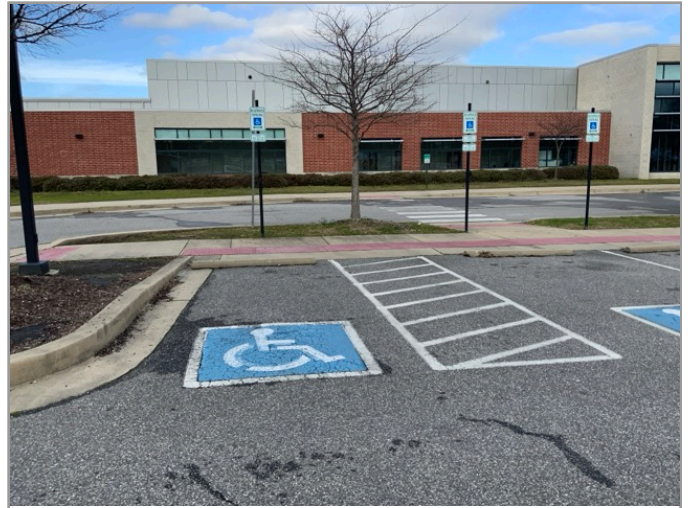
Parking

OVERVIEW OF ACCESSIBLE PARKING AREA

CLOSE-UP OF STALL

Question		Yes	No	NA	Comments
1	Does the required number of standard ADA designated spaces appear to be provided ?	✗			
2	Does the required number of van-accessible designated spaces appear to be provided ?	✗			
3	Are accessible spaces on the shortest accessible route to an accessible building entrance ?	✗			
4	Does parking signage include the International Symbol of Accessibility ?	✗			
5	Does each accessible space have an adjacent access aisle ?	✗			
6	Do parking spaces and access aisles appear to be relatively level and without obstruction ?	✗

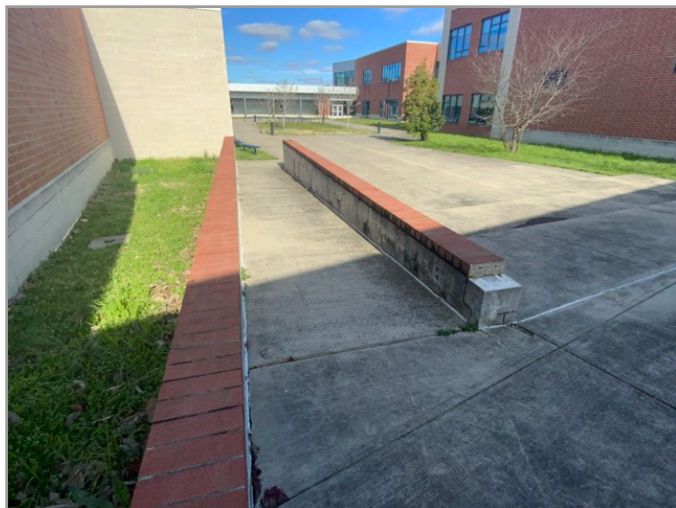
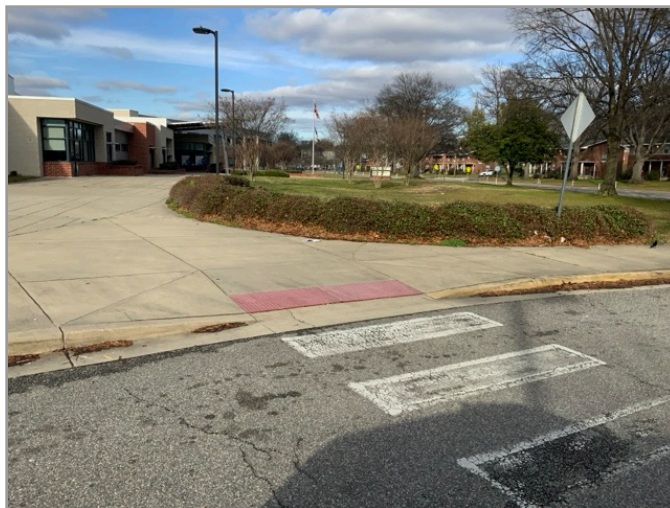
Exterior Accessible Route

ACCESSIBLE RAMP

CURB CUT

Question		Yes	No	NA	Comments
1	Is an accessible route present from public transportation stops and municipal sidewalks on or immediately adjacent to the property ?	✗			
2	Does a minimum of one accessible route appear to connect all public areas on the exterior, such as parking and other outdoor amenities, to accessible building entrances ?	✗			
3	Are curb ramps present at transitions through raised curbs on all accessible routes?	✗			
4	Do curb ramps appear to have compliant slopes for all components ?	✗			
5	Do ramp runs on an accessible route appear to have compliant slopes ?	✗			
6	Do ramp runs on an accessible route appear to have a compliant rise and width ?	✗

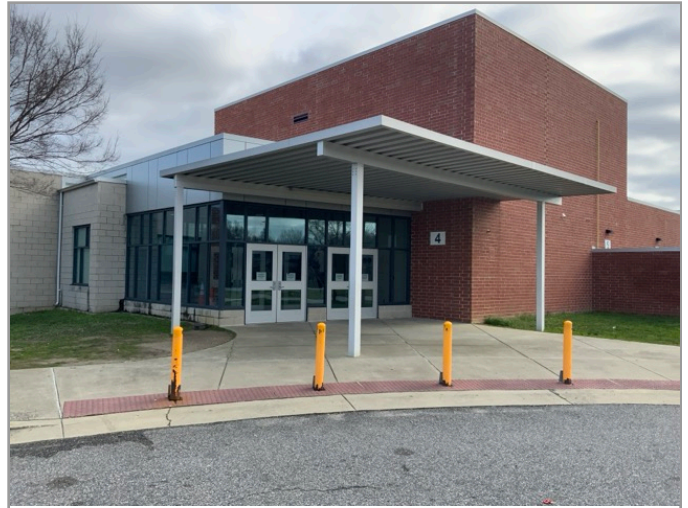
Building Entrances

MAIN ENTRANCE

ADDITIONAL ENTRANCE

Question		Yes	No	NA	Comments
1	Do a sufficient number of accessible entrances appear to be provided ?	✗			
2	If the main entrance is not accessible, is an alternate accessible entrance provided?	✗			
3	Is signage provided indicating the location of alternate accessible entrances ?	✗			
4	Do doors at accessible entrances appear to have compliant maneuvering clearance area on each side ?	✗			
5	Do doors at accessible entrances appear to have compliant hardware ?	✗			
6	Do doors at accessible entrances appear to have a compliant clear opening width ?	✗

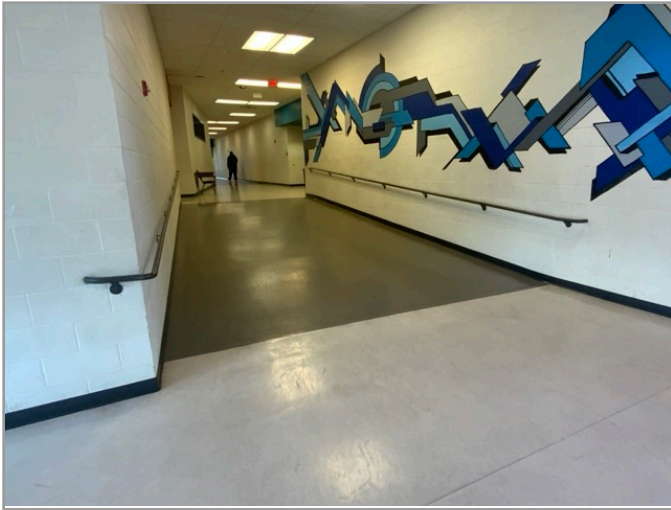
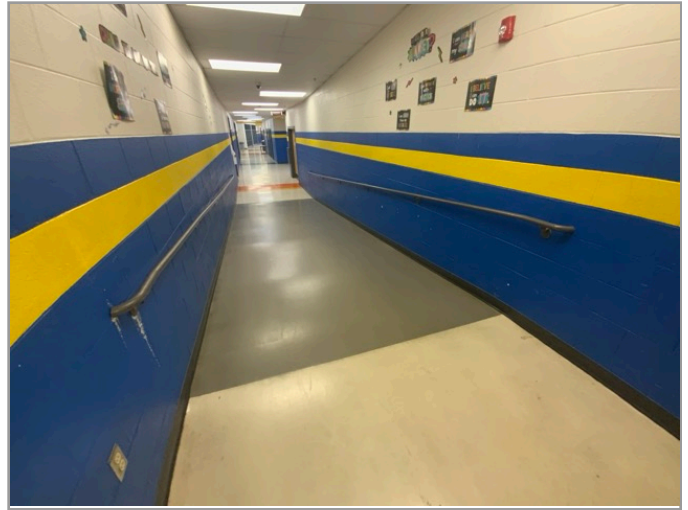
Interior Accessible Route

ACCESSIBLE INTERIOR RAMP

Question		Yes	No	NA	Comments
1	Does an accessible route appear to connect all public areas inside the building ?	✘			
2	Do accessible routes appear free of obstructions and/or protruding objects ?	✘			
3	Do ramps on accessible routes appear to have compliant slopes ?	✘			
4	Do ramp runs on an accessible route appear to have a compliant rise and width ?	✘			
5	Do ramps on accessible routes appear to have compliant end and intermediate landings ?	✘			
6	Do ramps on accessible routes appear to have compliant handrails ?	✘

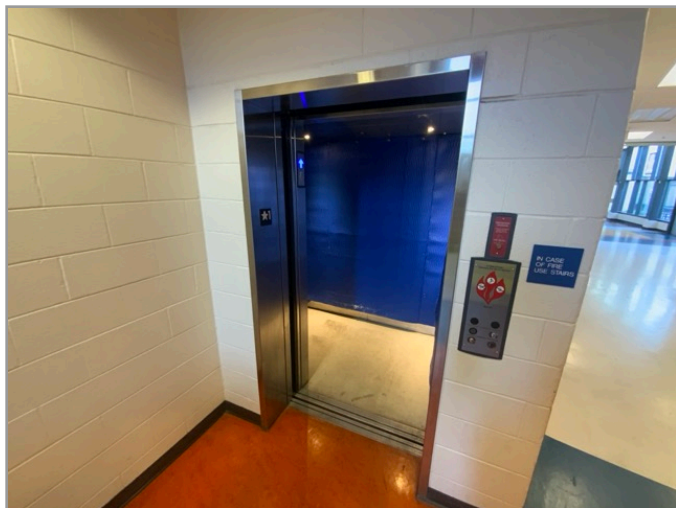
LOBBY LOOKING AT CABS

Question		Yes	No	NA	Comments
1	Are hallway call buttons configured with the "UP" button above the "DOWN" button?	✗			
2	Is accessible floor identification signage present on the hoistway sidewalls on each level ?	✗			
3	Do the elevators have audible and visual arrival indicators at the lobby and hallway entrances?	✗			
4	Do the elevator hoistway and car interior appear to have a minimum compliant clear floor area ?	✗			
5	Do the elevator car doors have automatic re-opening devices to prevent closure on obstructions?	✗			
6	Do elevator car control buttons appear to be mounted at a compliant height ?	✗

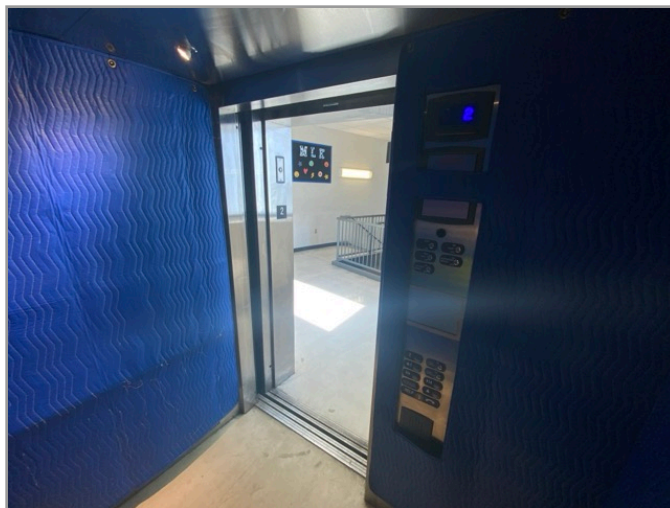
IN-CAB CONTROLS

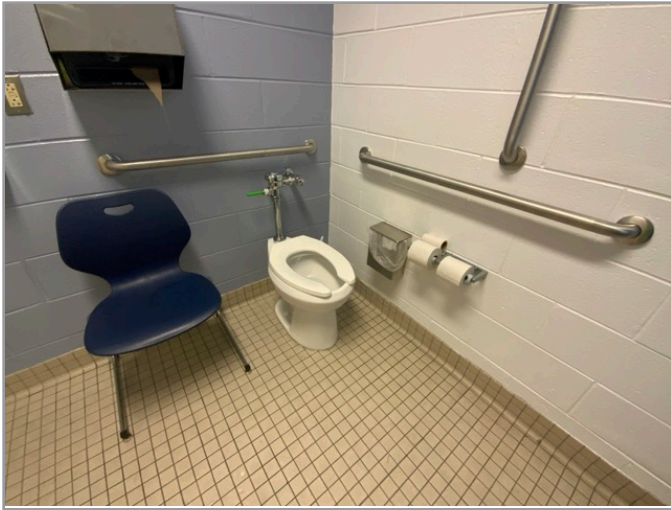
TOILET STALL OVERVIEW

Question		Yes	No	NA	Comments
1	Do publicly accessible toilet rooms appear to have a minimum compliant floor area ?	✗			
2	Does the lavatory appear to be mounted at a compliant height and with compliant knee area ?	✗			
3	Does the lavatory faucet have compliant handles ?	✗			
4	Is the plumbing piping under lavatories configured to protect against contact ?	✗			
5	Are grab bars provided at compliant locations around the toilet ?	✗			
6	Do toilet stall doors appear to provide the minimum compliant clear width ?	✗

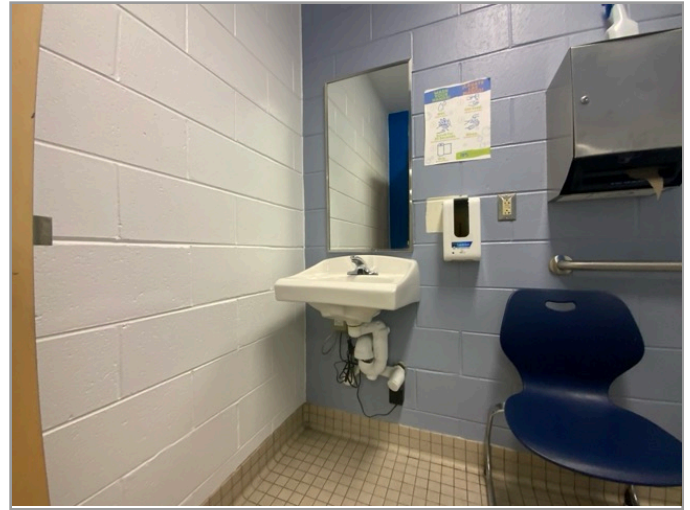
SINK, FAUCET HANDLES AND ACCESSORIES

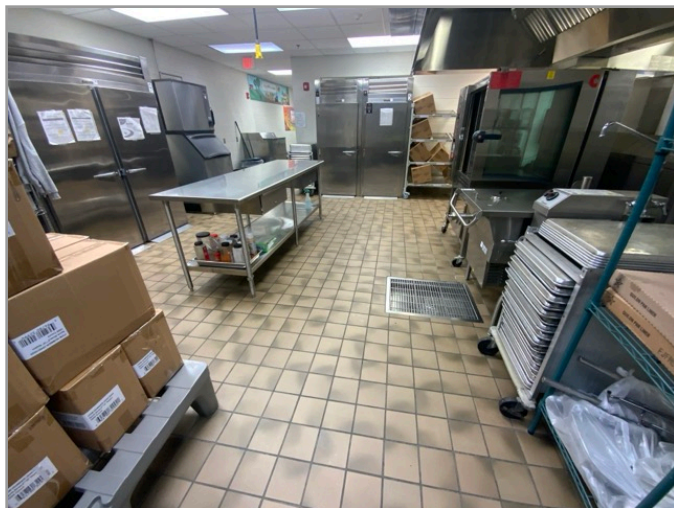
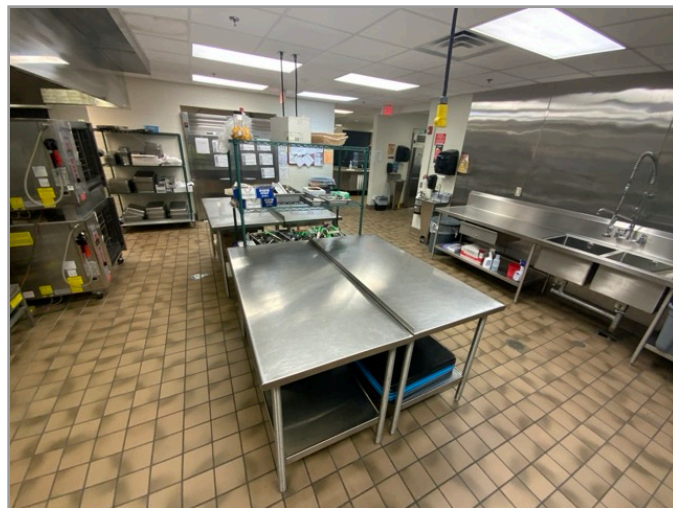
KITCHEN OVERVIEW

Question		Yes	No	NA	Comments
1	Do kitchens/kitchenettes appear to have a minimum compliant path of travel or area of maneuverability ?	✗			
2	Are the appliances centered for a parallel or forward approach with adequate clear floor space ?	✗			
3	Is there an accessible countertop/preparation space of proper width and height ?	✗			
4	Is there an accessible sink space of proper width and height ?	✗			
5	Does the sink faucet have compliant handles ?	✗			
6	Is the plumbing piping under the sink configured to protect against contact ?	✗
