# FACILITY CONDITION ASSESSMENT

**Richmond Public Schools**  
301 North Ninth Street  
Richmond, VA 23219

Martin L. King, Jr. Middle School  
1000 Mosby Street  
Richmond, VA 23223

*May 15, 2024*

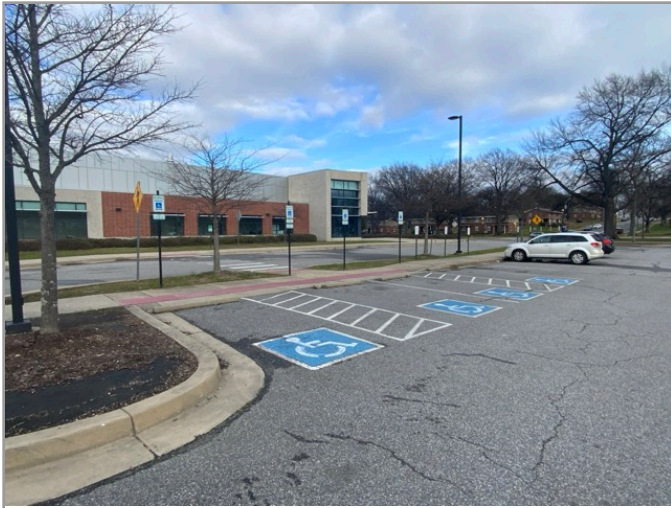
OVERVIEW OF ACCESSIBLE PARKING AREA

Question		Yes	No	NA	Comments
1	Does the required number of standard ADA designated spaces appear to be provided ?	✘			
2	Does the required number of van-accessible designated spaces appear to be provided ?	✘			
3	Are accessible spaces on the shortest accessible route to an accessible building entrance ?	✘			
4	Does parking signage include the International Symbol of Accessibility ?	✘			
5	Does each accessible space have an adjacent access aisle ?	✘			
6	Do parking spaces and access aisles appear to be relatively level and without obstruction ?	✘

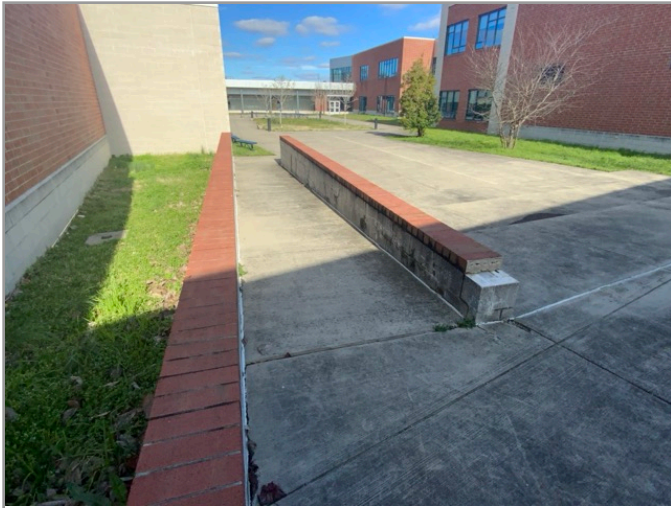
ACCESSIBLE RAMP

Question		Yes	No	NA	Comments
1	Is an accessible route present from public transportation stops and municipal sidewalks on or immediately adjacent to the property ?	X			
2	Does a minimum of one accessible route appear to connect all public areas on the exterior, such as parking and other outdoor amenities, to accessible building entrances ?	X			
3	Are curb ramps present at transitions through raised curbs on all accessible routes?	X			
4	Do curb ramps appear to have compliant slopes for all components ?	X			
5	Do ramp runs on an accessible route appear to have compliant slopes ?	X			
6	Do ramp runs on an accessible route appear to have a compliant rise and width ?	X

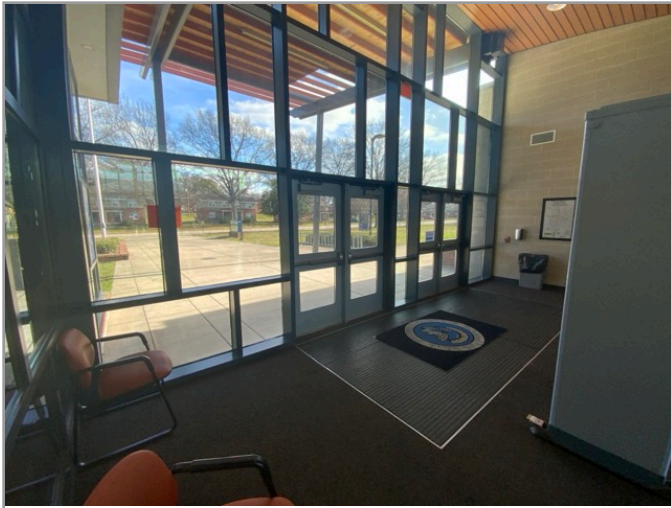
MAIN ENTRANCE

Question		Yes	No	NA	Comments
1	Do a sufficient number of accessible entrances appear to be provided ?	X			
2	If the main entrance is not accessible, is an alternate accessible entrance provided?	X			
3	Is signage provided indicating the location of alternate accessible entrances ?	X			
4	Do doors at accessible entrances appear to have compliant maneuvering clearance area on each side ?	X			
5	Do doors at accessible entrances appear to have compliant hardware ?	X			
6	Do doors at accessible entrances appear to have a compliant clear opening width ?	X

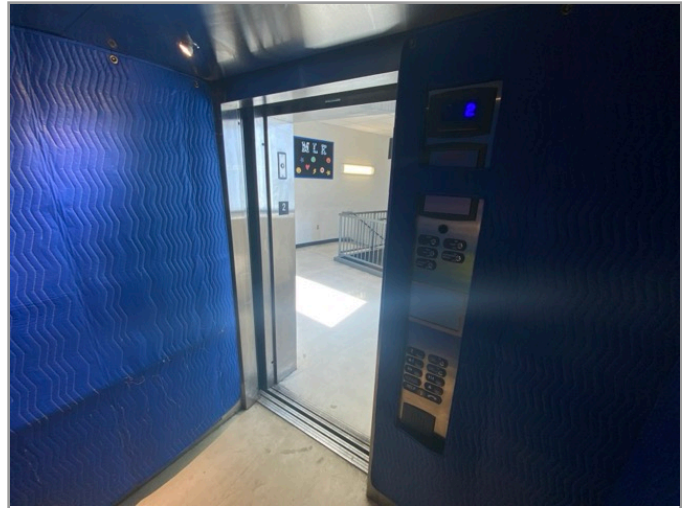
IN-CAB CONTROLS

Question		Yes	No	NA	Comments
1	Are hallway call buttons configured with the "UP" button above the "DOWN" button?	✗			
2	Is accessible floor identification signage present on the hoistway sidewalls on each level ?	✗			
3	Do the elevators have audible and visual arrival indicators at the lobby and hallway entrances?	✗			
4	Do the elevator hoistway and car interior appear to have a minimum compliant clear floor area ?	✗			
5	Do the elevator car doors have automatic re-opening devices to prevent closure on obstructions?	✗			
6	Do elevator car control buttons appear to be mounted at a compliant height ?	✗

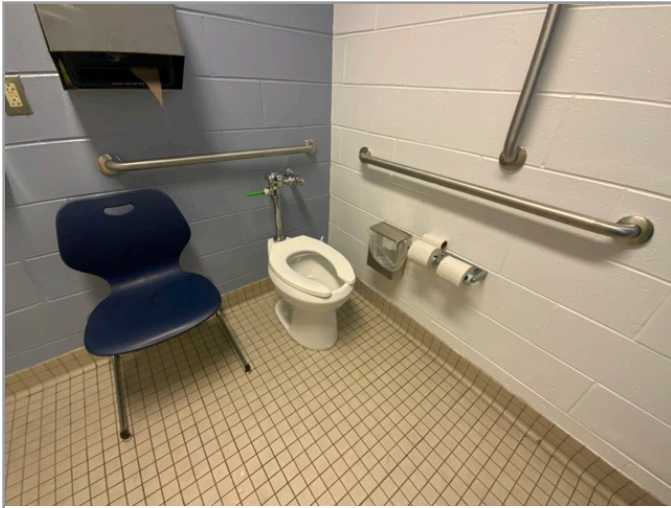
TOILET STALL OVERVIEW

Question		Yes	No	NA	Comments
1	Do publicly accessible toilet rooms appear to have a minimum compliant floor area ?	✗			
2	Does the lavatory appear to be mounted at a compliant height and with compliant knee area ?	✗			
3	Does the lavatory faucet have compliant handles ?	✗			
4	Is the plumbing piping under lavatories configured to protect against contact ?	✗			
5	Are grab bars provided at compliant locations around the toilet ?	✗			
6	Do toilet stall doors appear to provide the minimum compliant clear width ?	✗

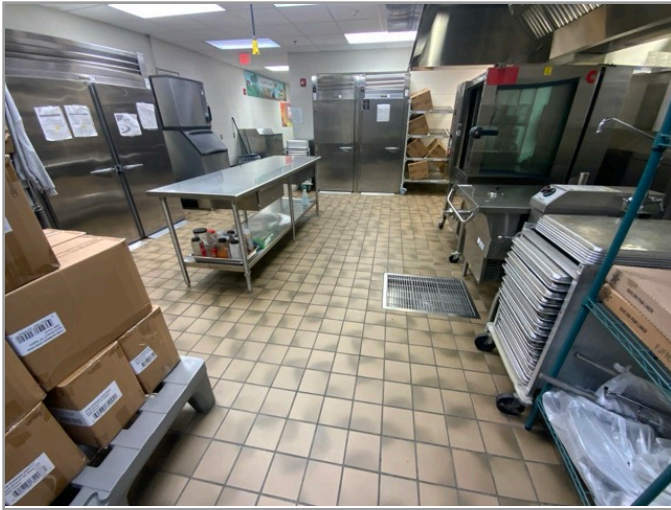
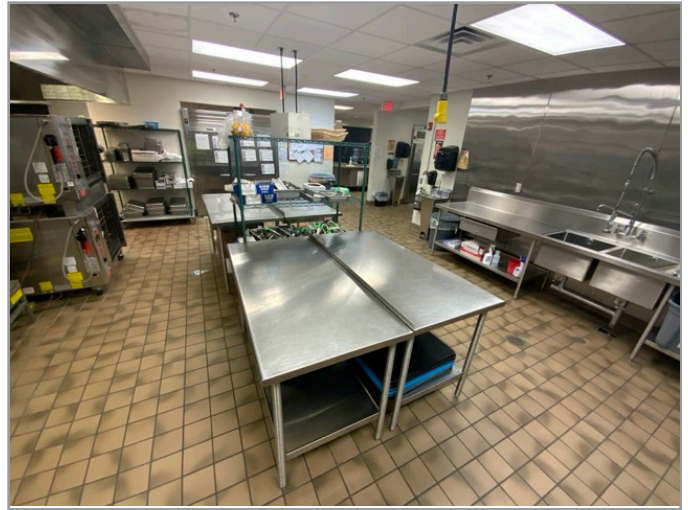
KITCHEN OVERVIEW

Question		Yes	No	NA	Comments
1	Do kitchens/kitchenettes appear to have a minimum compliant path of travel or area of maneuverability ?	✗			
2	Are the appliances centered for a parallel or forward approach with adequate clear floor space ?	✗			
3	Is there an accessible countertop/preparation space of proper width and height ?	✗			
4	Is there an accessible sink space of proper width and height ?	✗			
5	Does the sink faucet have compliant handles ?	✗			
6	Is the plumbing piping under the sink configured to protect against contact ?	✗
