North Stratfield Elementary School

Fairfield Public Schools Recommissioning (RCx) and Testing, Adjusting, & Balancing (TAB) Study van Zelm Project # 2020102.00 (12-NSES) November 04, 2022

FAIRFIELD PUBLIC SCHOOLS RECOMMISSIONING (RCx) AND TESTING, ADJUSTING, & BALANCING (TAB) STUDY

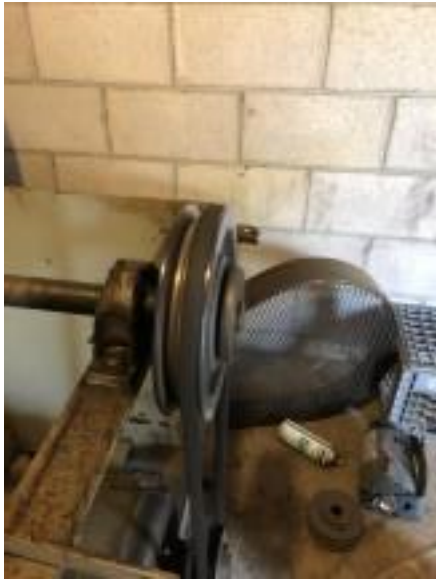
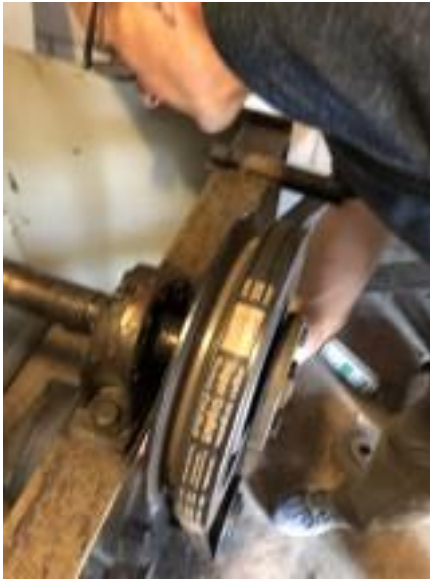
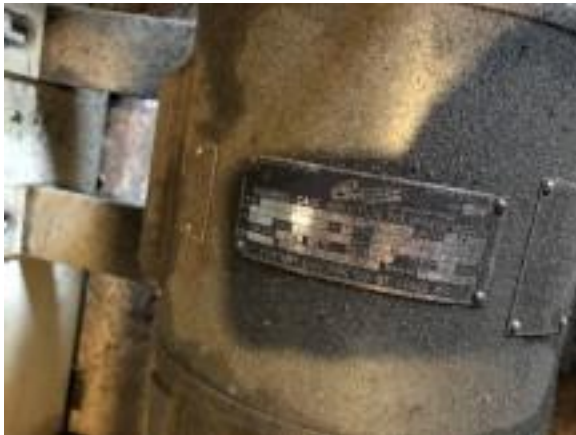
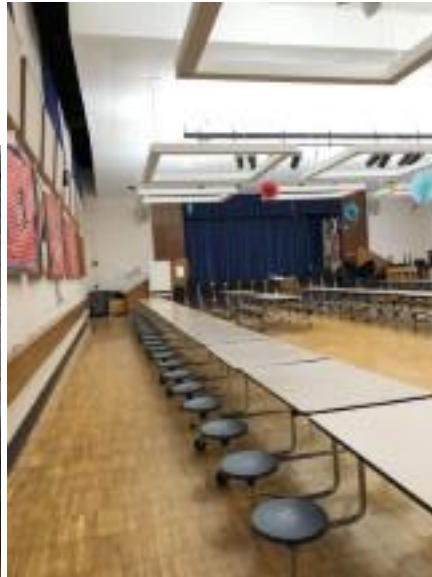
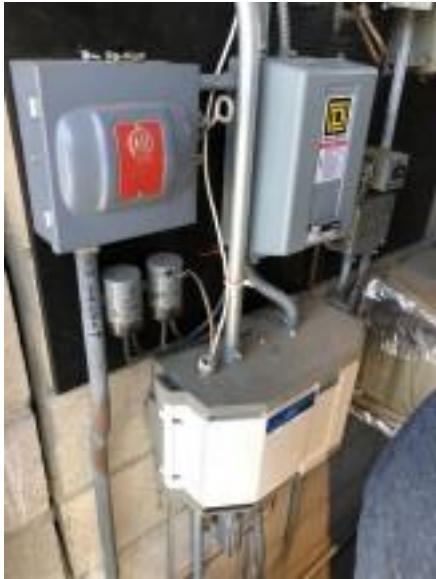
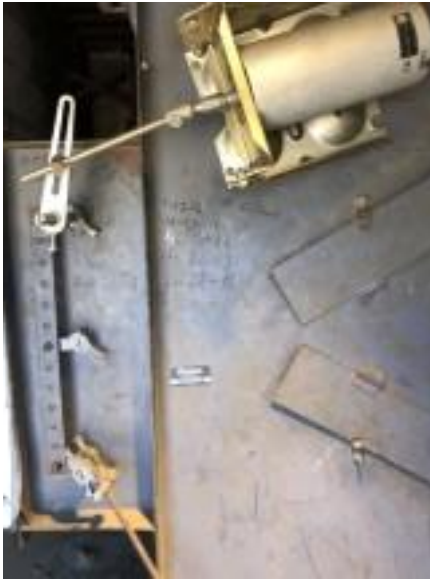
Photos

| <u>Unit Tag</u> | <u>HV-1 / EF-9</u> | <u>Addition comments descriptions</u> |
| Heating Coil Condition | Not accessible and assumed very dirty | |
| Notes: | Very old and should be replaced | |
