Washington Elementary

General Conditions

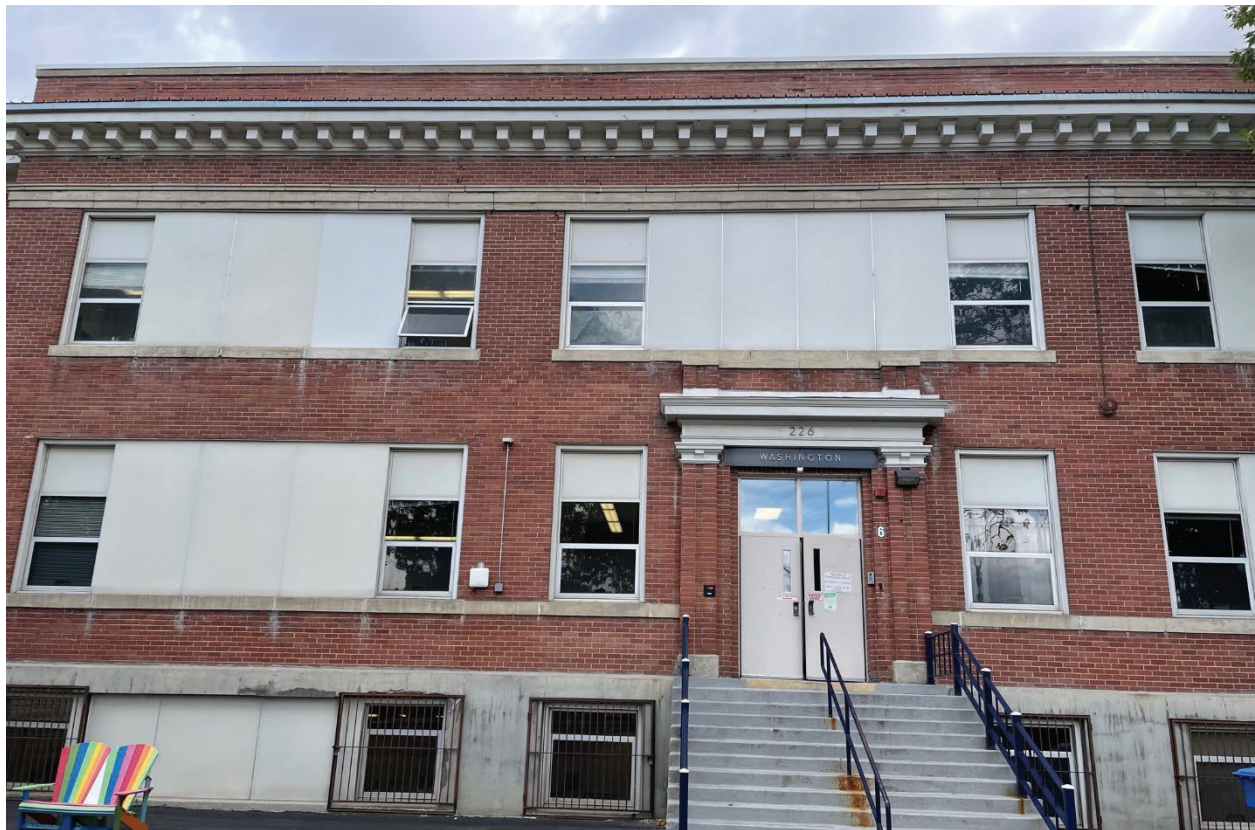
Washington Elementary is a three-story school that was built 1920. It is approximately 27,000 square feet of classroom, gymnasium administrative and auxiliary spaces. The facility has undergone two additions to the original 1920 school building. A classroom addition was added in the 50's and a small gymnasium kitchen nook was added in the 70's.

The school as presently configured is not ADA accessible. The various levels in the school, the access to the school from the exterior, the restroom facilities and general access paths are not ADA compliant which can result in costly lawsuits.

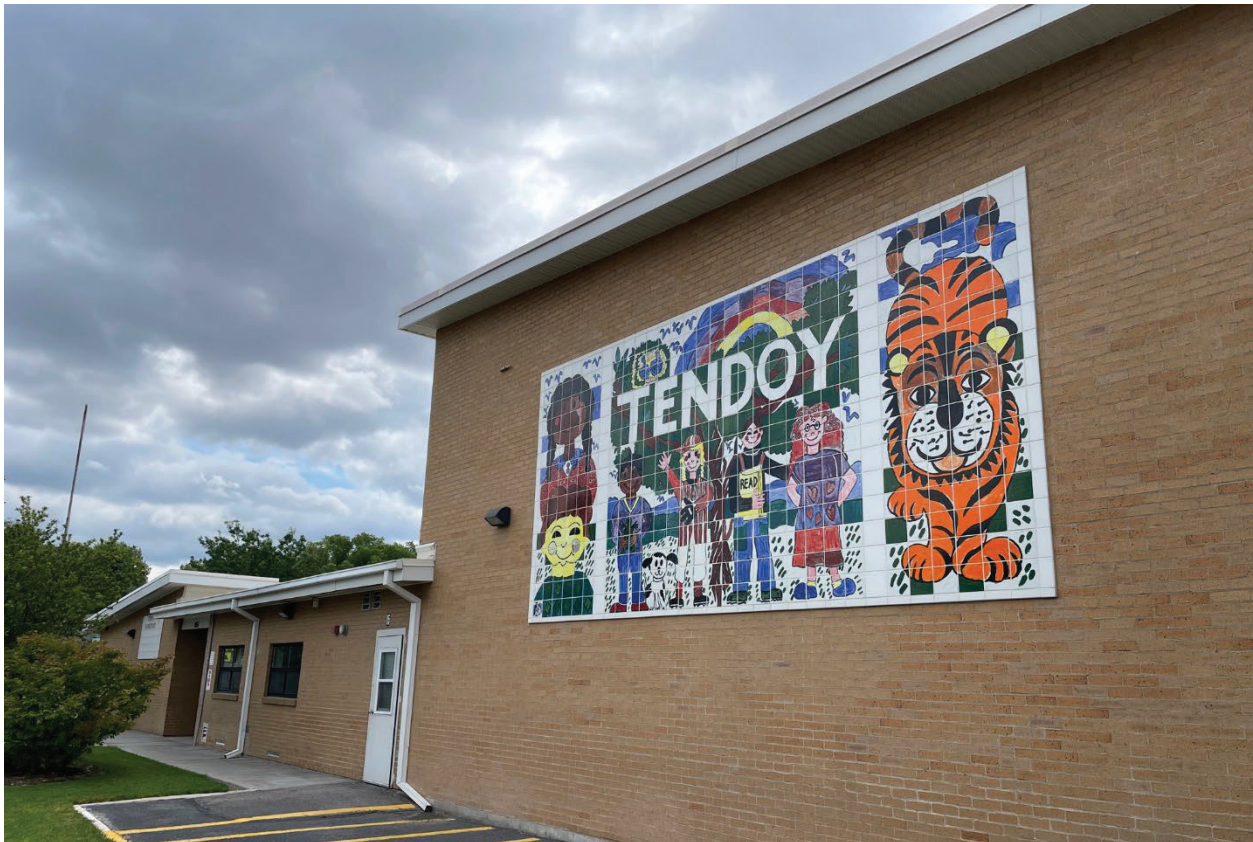
Most of the classrooms are located along a single main corridor, as such these classrooms have windows for daylight. The window sizes were typically reduced during the energy crises in the 80's and so the views and amount of daylighting are limited.
