Pierpont Elementary School  
c/o Ventura Unified School District  
ATTN: Ray Richards, Bond Construction Project Manager  
255 W. Stanley Avenue  
Ventura, CA 93003  
Via Email: Ray.Richards@venturausd.org

**LIMITED ASBESTOS SURVEY: 1254 Marthas Vineyard Court, Ventura, CA 93001**

**1.0 SAMPLING FOR ASBESTOS AND PLM ANALYSIS RESULTS**

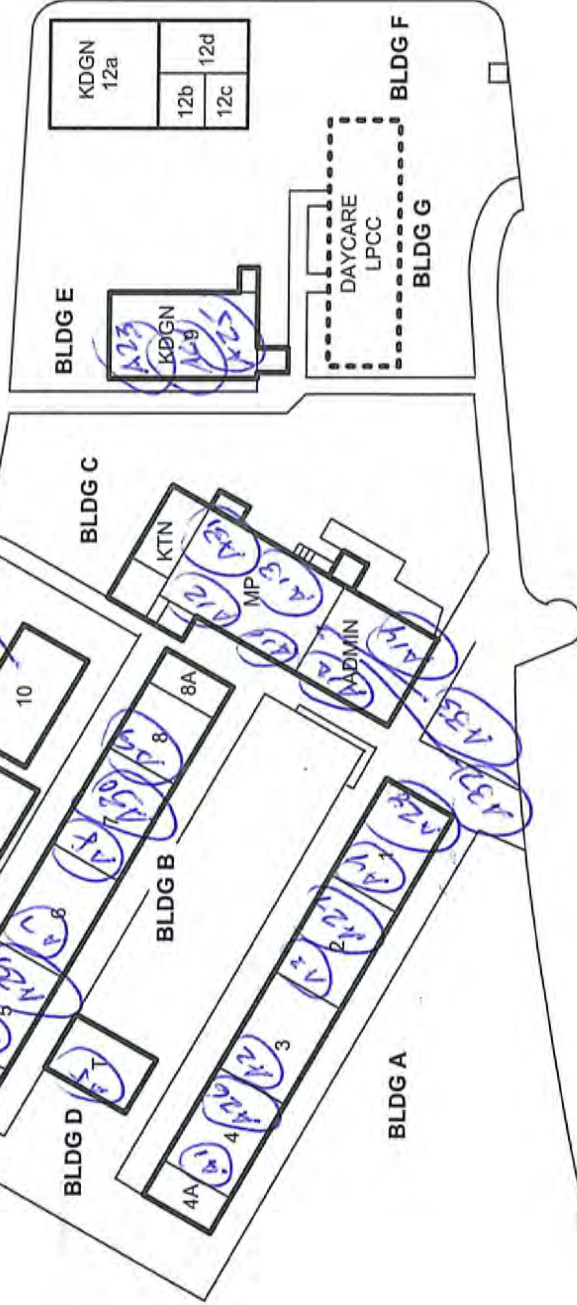
**PIERPONT ELEMENTARY SCHOOL**  
**1254 MARTHA'S VINEYARD COURT**

SITE ACREAGE: 2.8 SCALE: 1" = 60' 0"
