**AHERA ASBESTOS  
INSPECTION REPORT**

**KYRENE DE LA COLINA ELEMENTARY SCHOOL  
13612 SOUTH 36<sup>TH</sup> STREET  
PHOENIX, ARIZONA 85044**

Dominion Project Number: AZ1418.39

AHERA Inspection Date: May 20, 2025

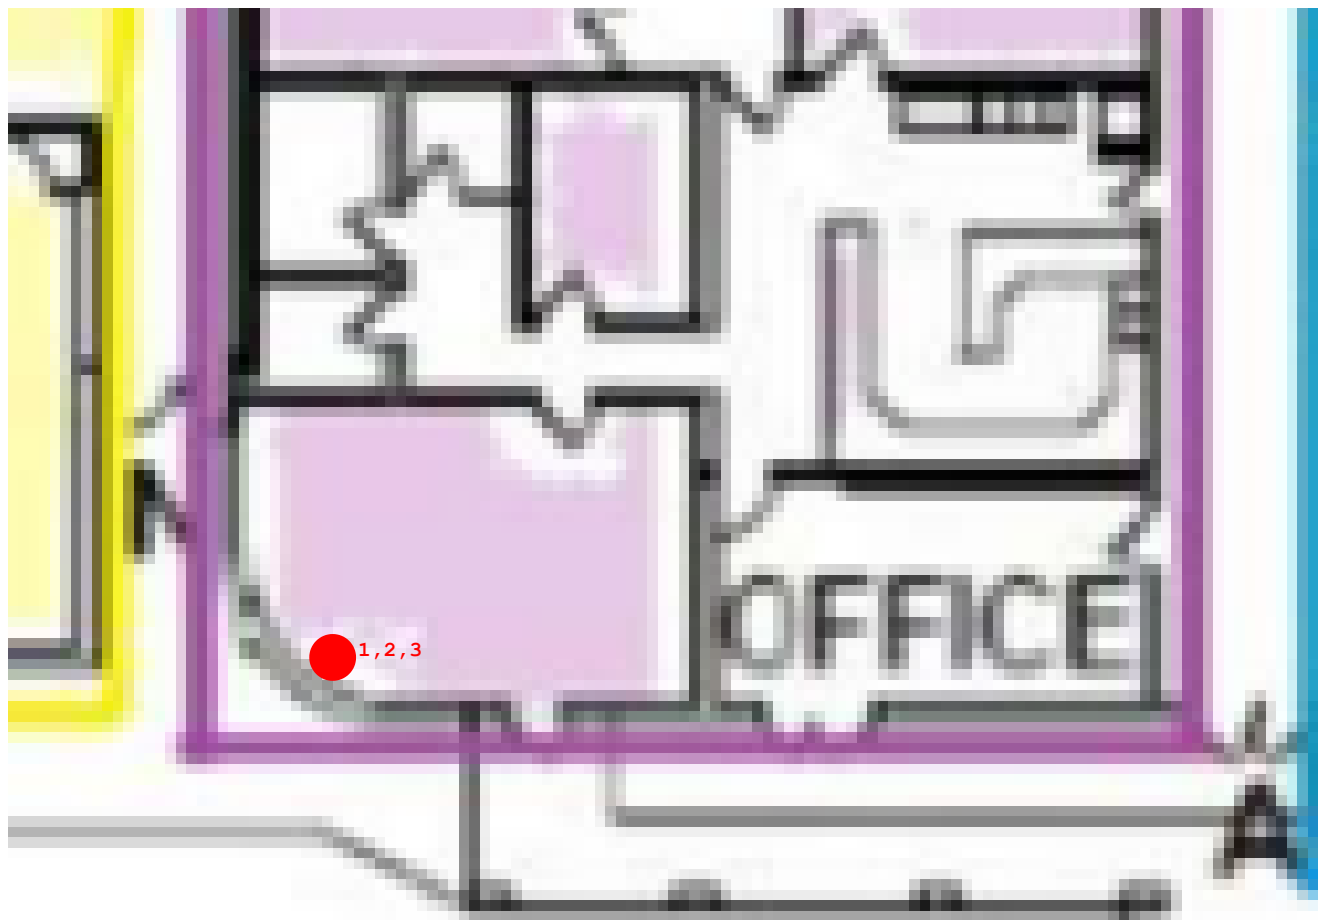
PLM Bulk Sample Location Map (3 of 4)  
Kyrene de la Colina Elementary School  
13612 S 36th St Phoenix, AZ 85044

Teacher's Lounge
