**AHERA ASBESTOS  
INSPECTION REPORT**

**KYRENE DE LA ESTRELLA ELEMENTARY SCHOOL  
2620 EAST LIBERTY LANE  
PHOENIX, ARIZONA 85048**

Dominion Environmental Consultants, Inc.  
20045 North 19<sup>th</sup> Avenue, Building 7  
Phoenix, Arizona 85027  
(623) 516-1415

Dominion Project Number: AZ1418.41

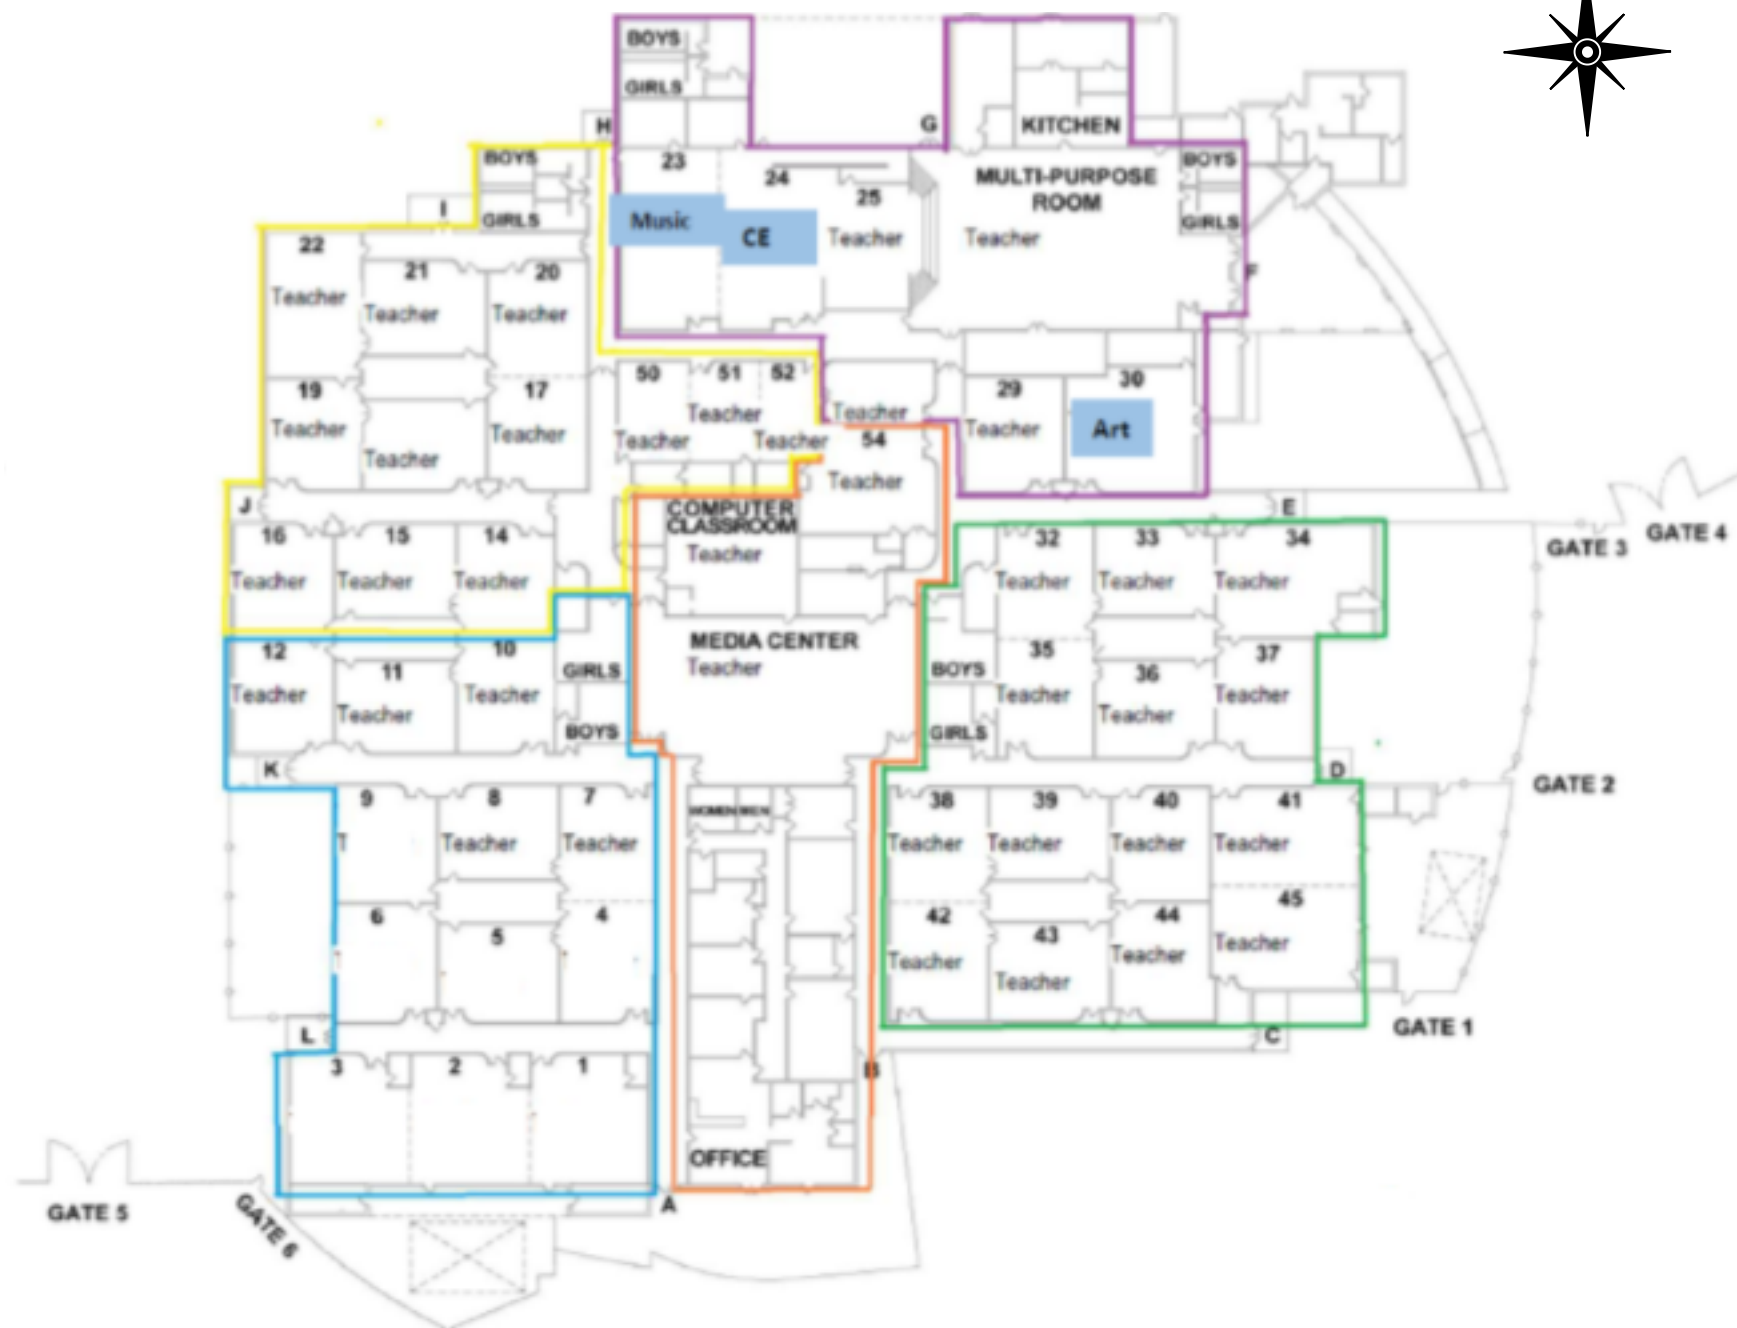
Site Plan  
Kyrene De La Estrella Elementary School  
2620 E Liberty Ln, Phoenix, AZ 85048

Main Building

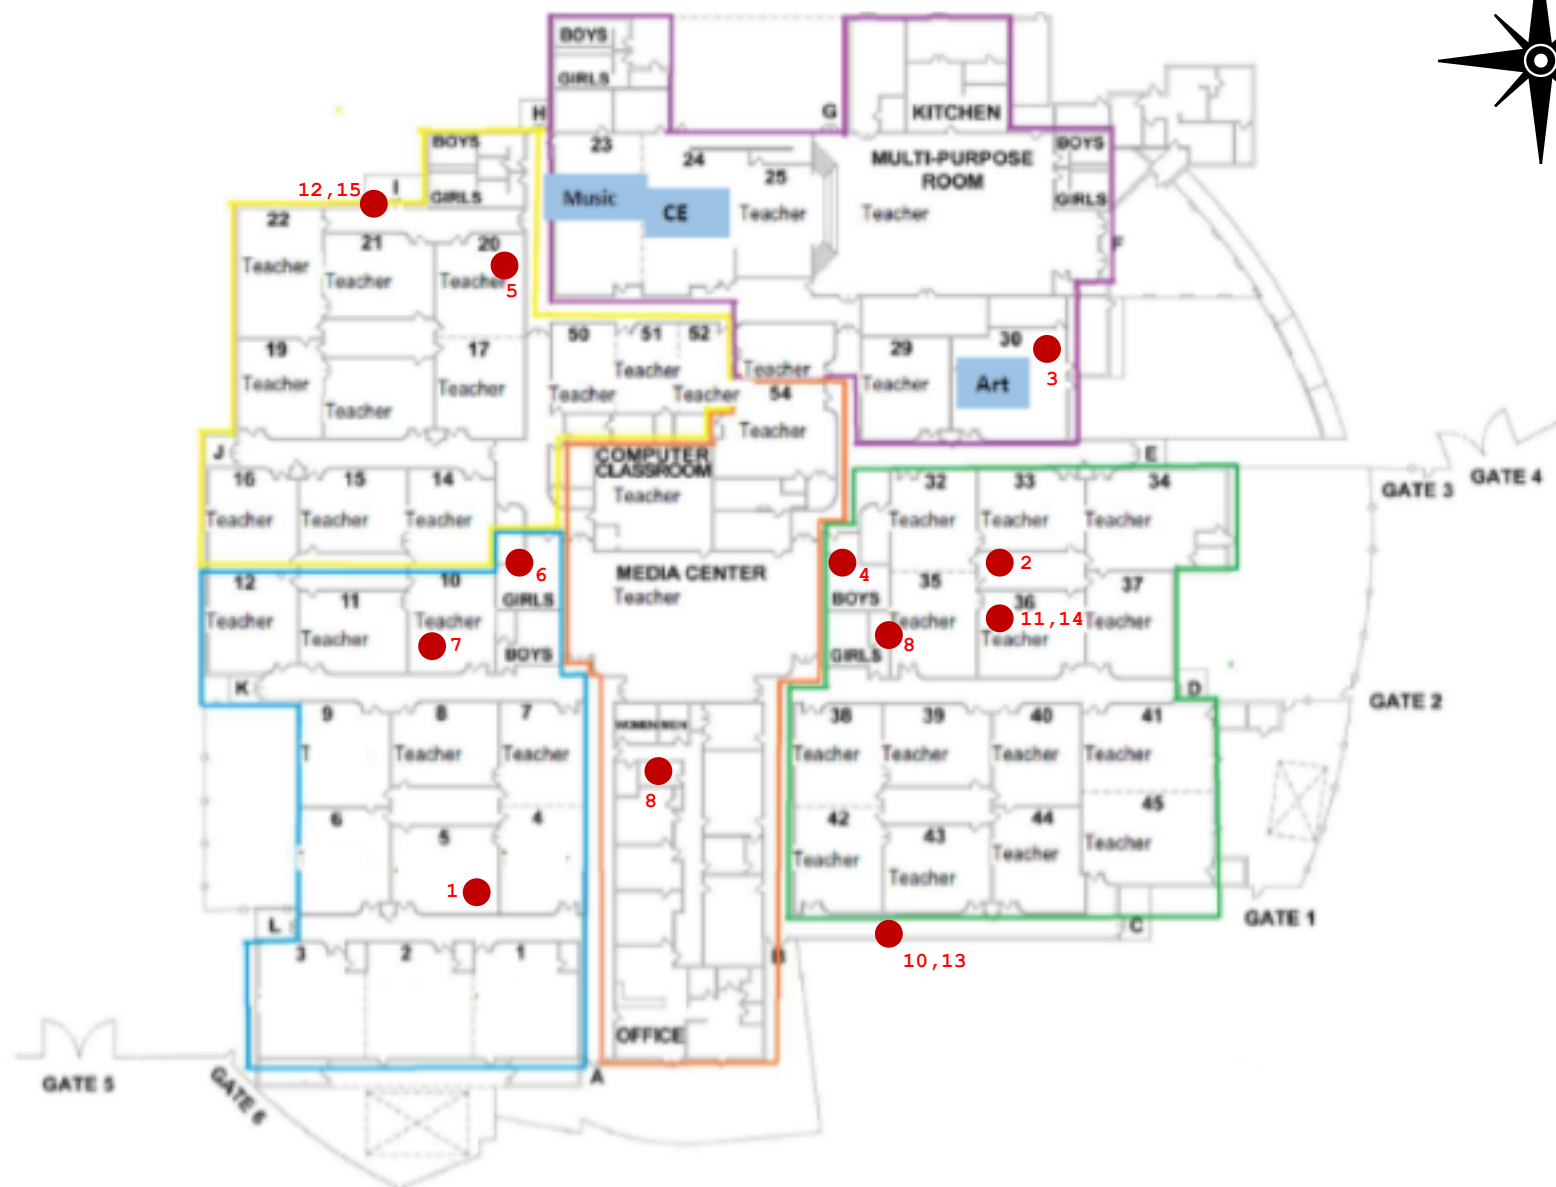
PLM Bulk Sample Location Map  
Kyrene De La Estrella Elementary School  
2620 E Liberty Ln, Phoenix, AZ 85048

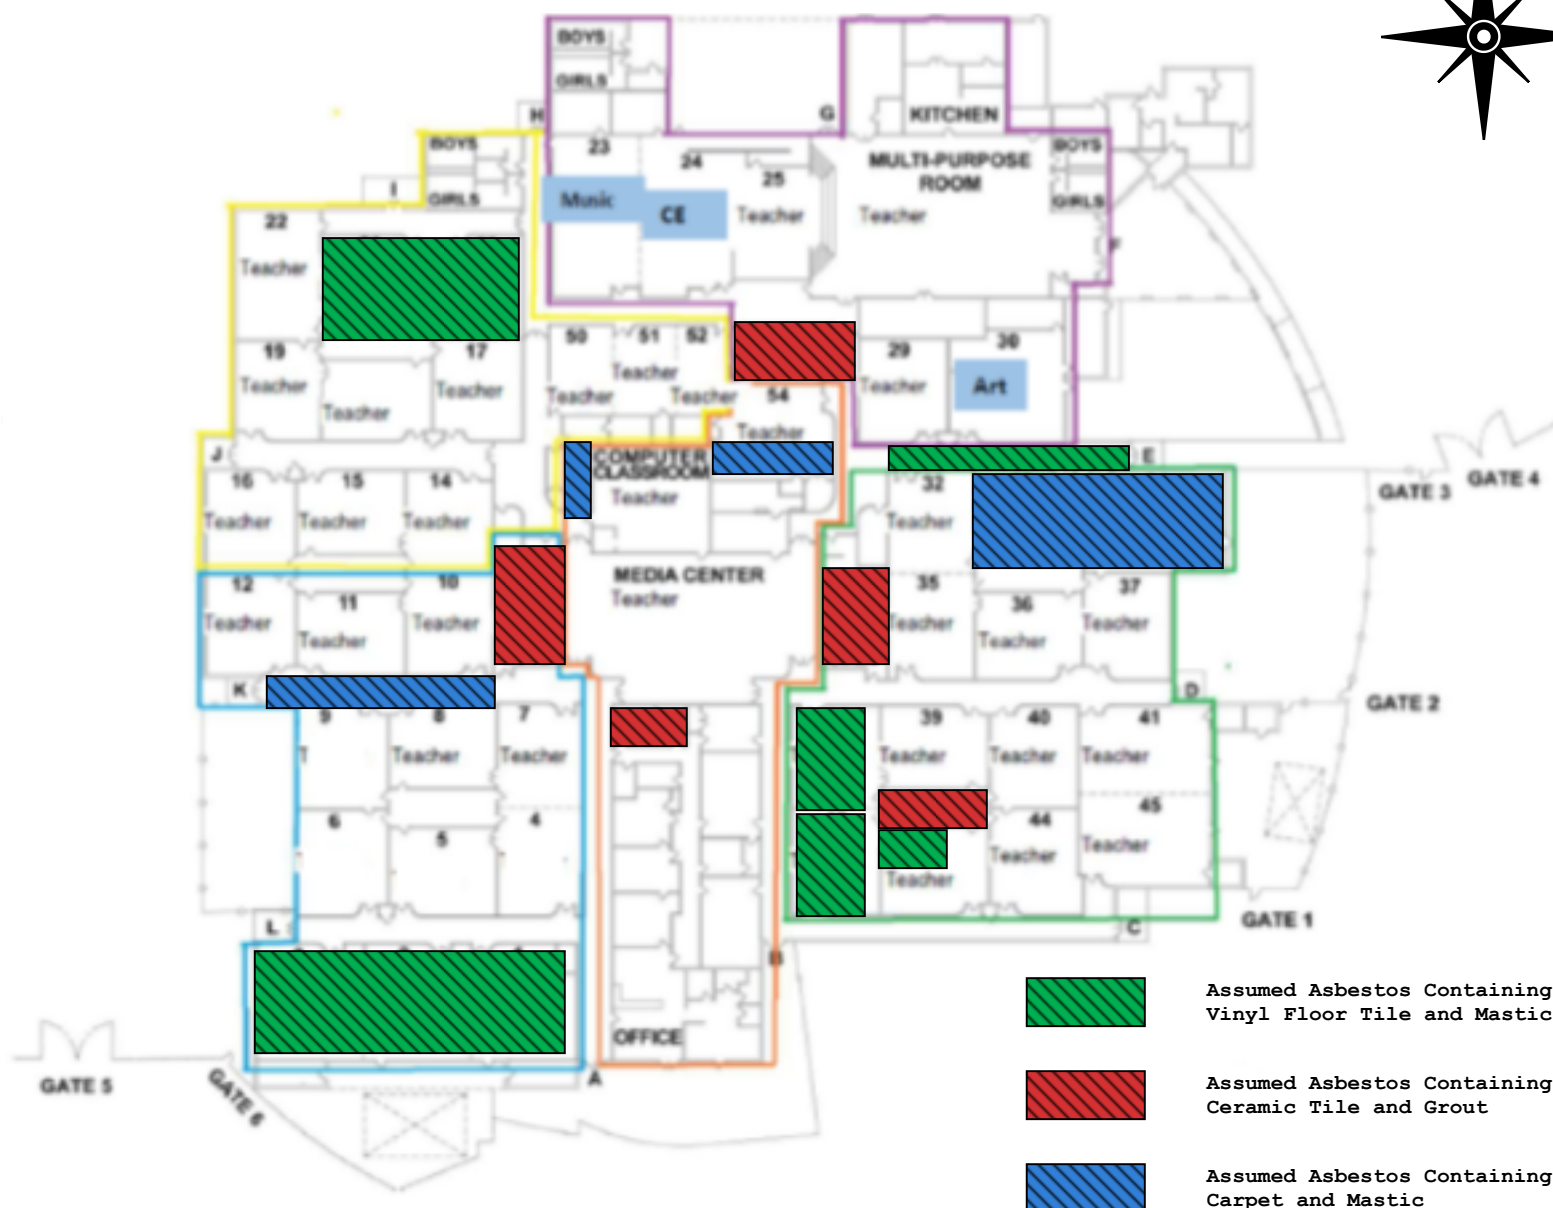
Assumed ACBM Location Map (1 of 3)  
Kyrene De La Estrella Elementary School  
2620 E Liberty Ln, Phoenix, AZ 85048

Main Building

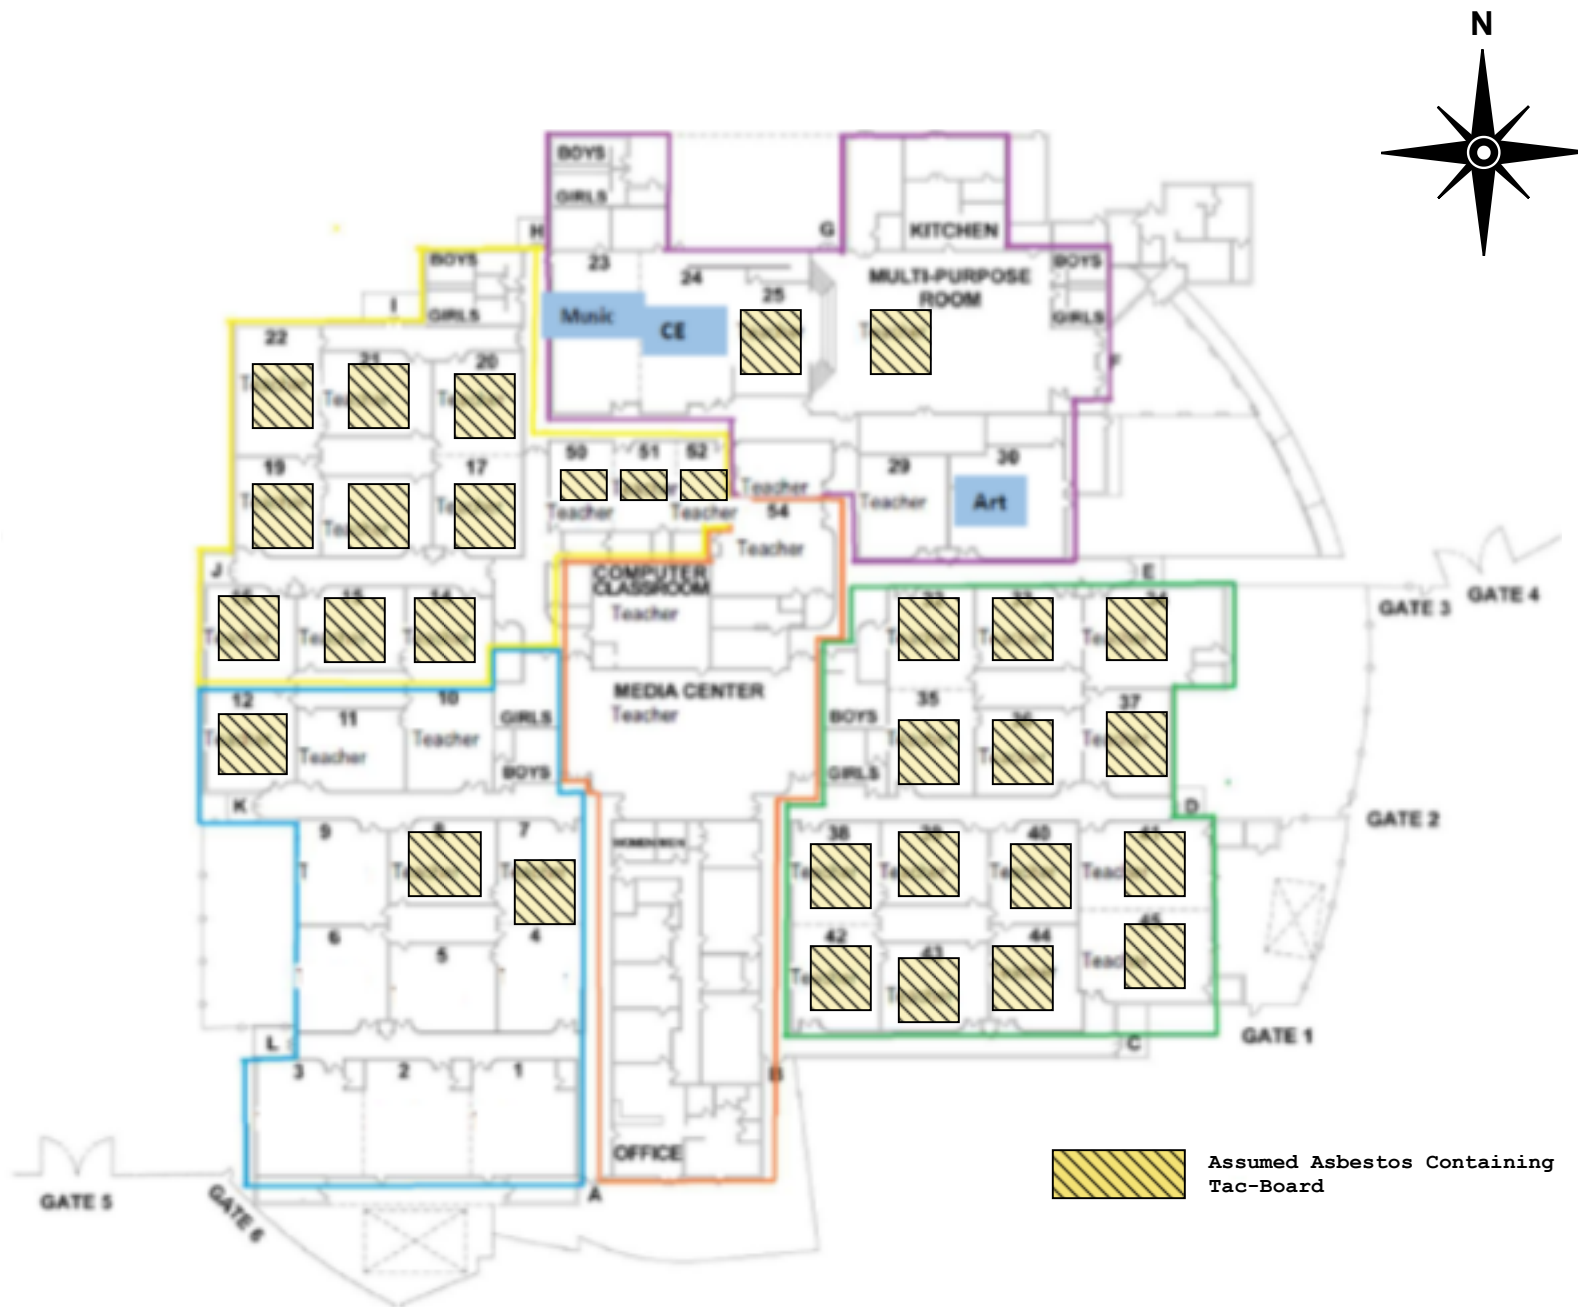
Assumed ACBM Location Map (2 of 3)  
 Kyrene De La Estrella Elementary School  
 2620 E Liberty Ln, Phoenix, AZ 85048

Main Building

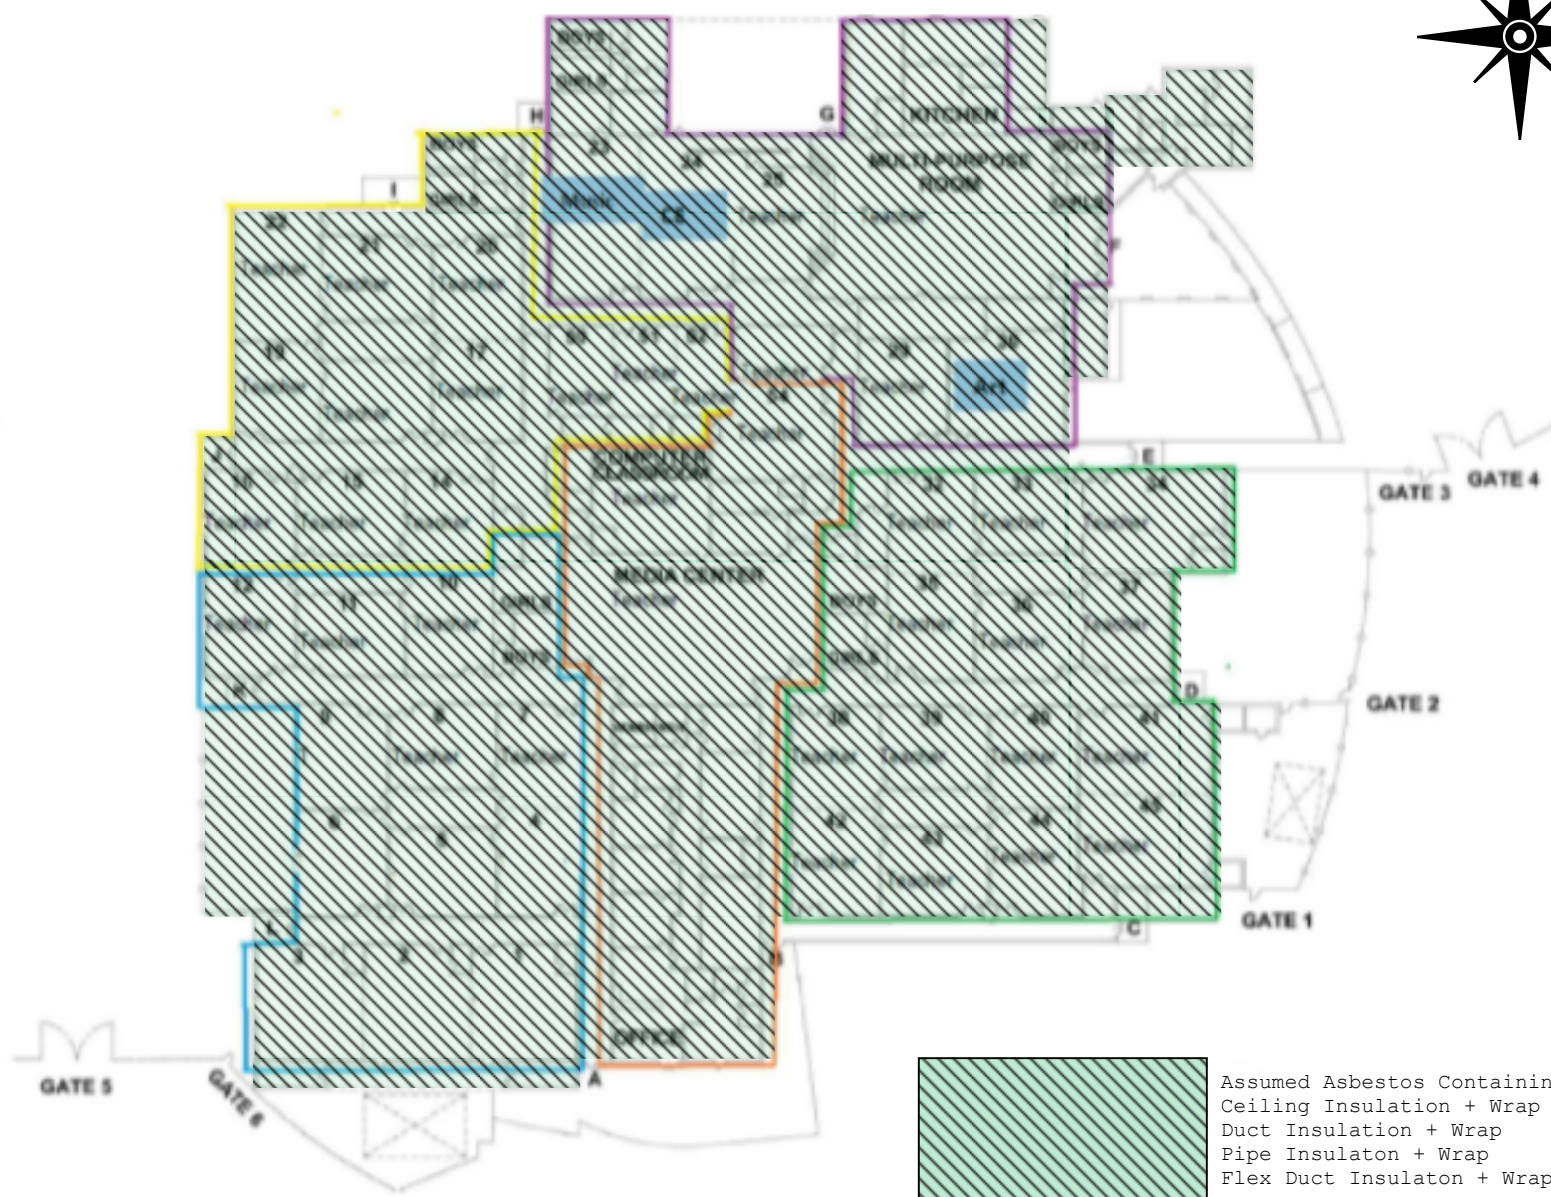
Assumed ACBM Location Map (3 of 3)  
Kyrene De La Estrella Elementary School  
2620 E Liberty Ln, Phoenix, AZ 85048
