# NEW HARTFORD PUBLIC SCHOOLS

## SCHOOL UTILIZATION STUDY– FACILITY CONDITIONS

March 11, 2025

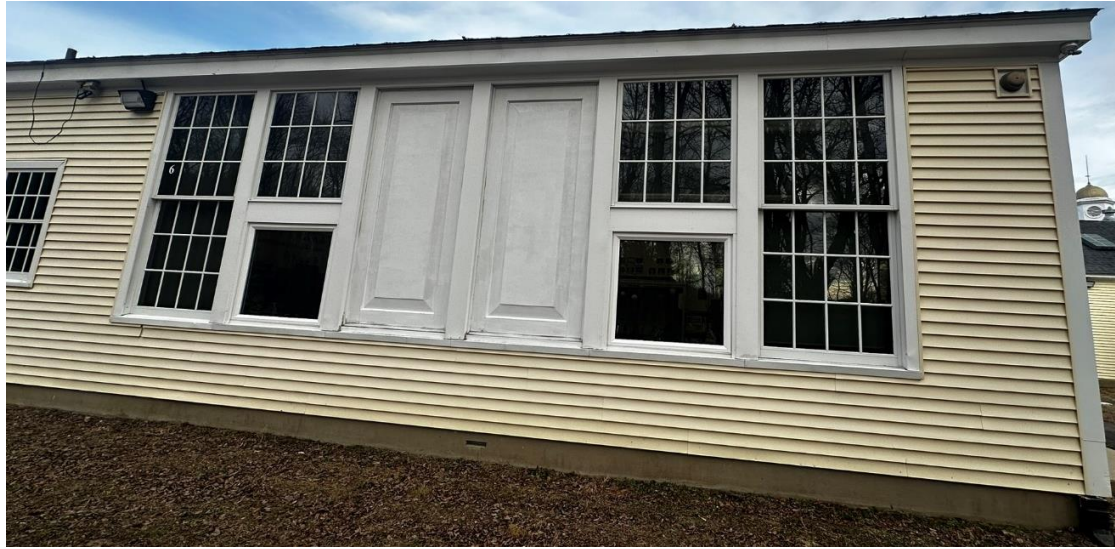
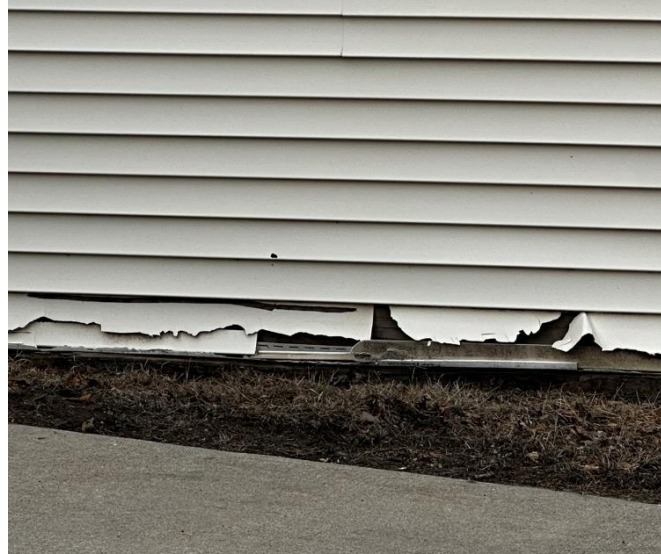
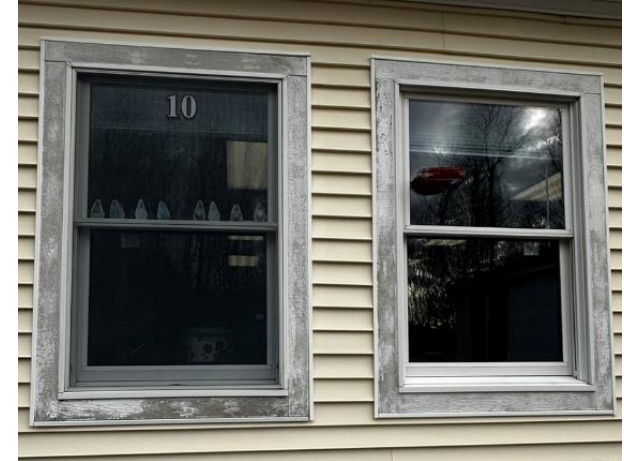
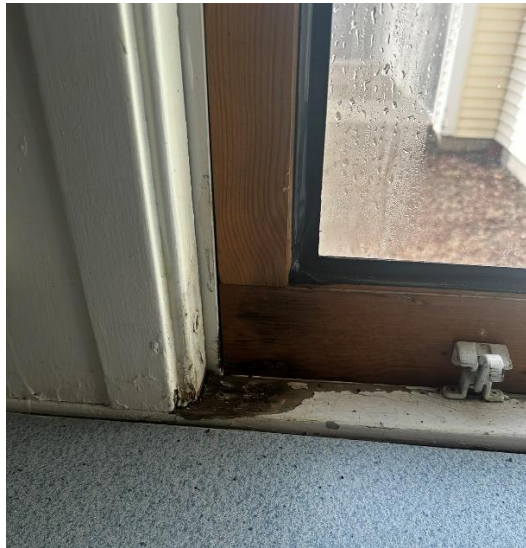
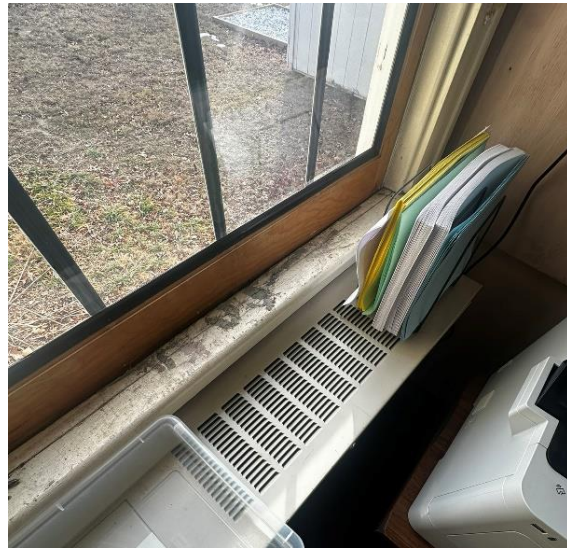
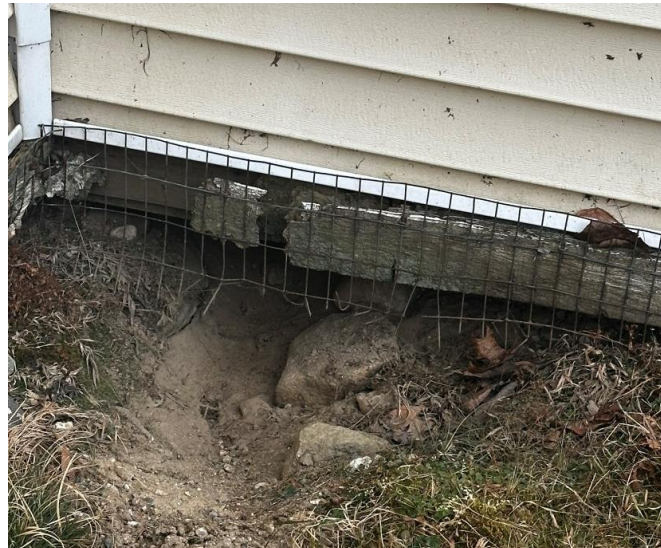
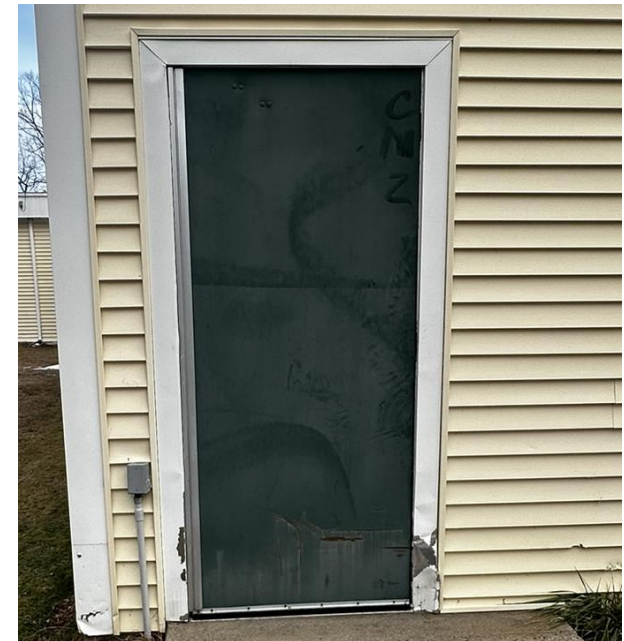
## Architectural: Exterior

| TAG NO. | ASSESSMENT | SYSTEM / CODE REF. | RANKING | | | | | CORRECTIVE ACTION | ITIMIZED ESTIMATED COST | REMARKS | |
|---|---|---|---|---|---|---|---|---|---|---|---|
| A01 | The siding is in need of repairs and at 25+/- years old, it could be replaced | General | | 3 | | | | Replace siding | \$ 243,000 | Hazmat potential - There may be lead, asbestos or PCBs | <input type="checkbox"/> |
| A02 | The foundation detail protrudes past face of wall and may invite water into building | General | | 3 | | | | Provide flashing detail at perimeter | \$ 7,900 | | <input type="checkbox"/> |
| A04 | Wood fascias soffits and roof trim are rotting, or paint is failing | General | | 3 | | | | Remove all decayed wood and replace wood details in kind, paint | \$ 15,800 | Hazmat potential - There may be lead, asbestos or PCBs | <input type="checkbox"/> |
| A05 | The windows are nearing the end of their useful life | General | | 3 | | | | Replace windows with double glazed aluminum systems, include trim and sills | \$ 356,375 | Hazmat potential - There may be lead, asbestos or PCBs | <input type="checkbox"/> |
| A06 | Roofs are nearing end of useful life | General | | | 2 | | | Replace with asphalt shingles at sloped roof and membrane at flat roofs | \$ 646,905 | Hazmat potential - There may be lead, asbestos or PCBs | <input type="checkbox"/> |
| A07 | Gutters and downspouts are not consistently installed throughout the perimeter and many are nearing the end of their useful life | General | | | 2 | | | Replace and provide at full perimeter | \$ 23,000 | | <input type="checkbox"/> |
| A08 | The chimney masonry is in need of repair and vegetation removal | General | | | 2 | | | Patch, repair, or replace brick and repoint as necessary. | \$ 5,400 | | |
| A09 | Door trim is in disrepair or needs some replacement | General | | 3 | | | | Replace | \$ 4,500 | | |
| A10 | Hollow metal frames are beginning to rust | General | | 3 | | | | Scrape prime and paint | \$ 1,800 | | |

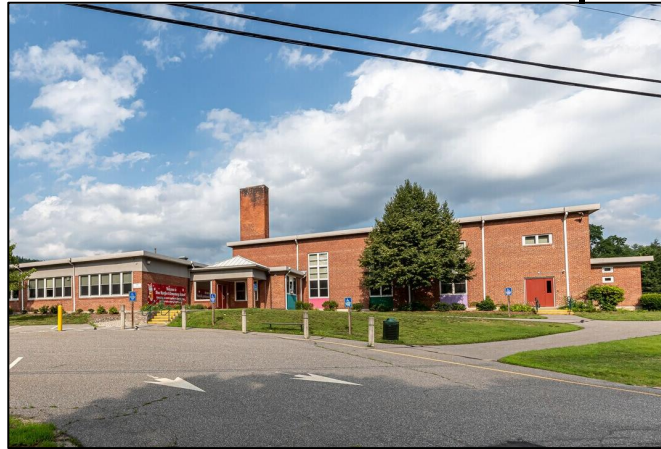
**New Hartford Elementary**

$$\frac{\$12,435,601}{\$23,405,000} = 53\%$$

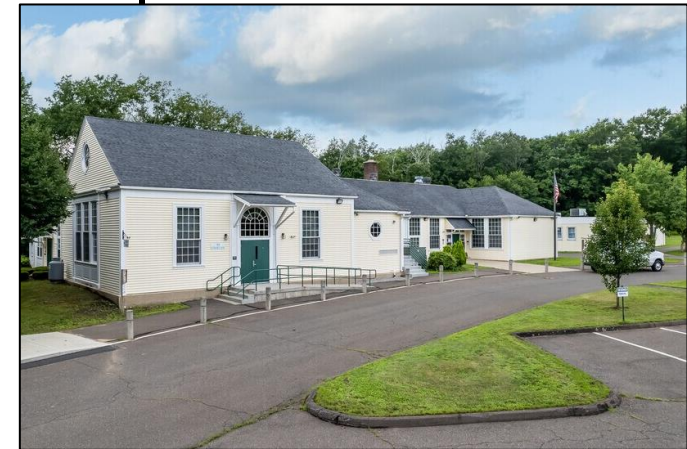
**Bakerville School**

$$\frac{\$11,693,692}{\$18,483,000} = 63\%$$
