# NEW HARTFORD PUBLIC SCHOOLS

## SCHOOL UTILIZATION STUDY– FACILITY CONDITIONS

March 11, 2025  
(updated March 25, 2025)

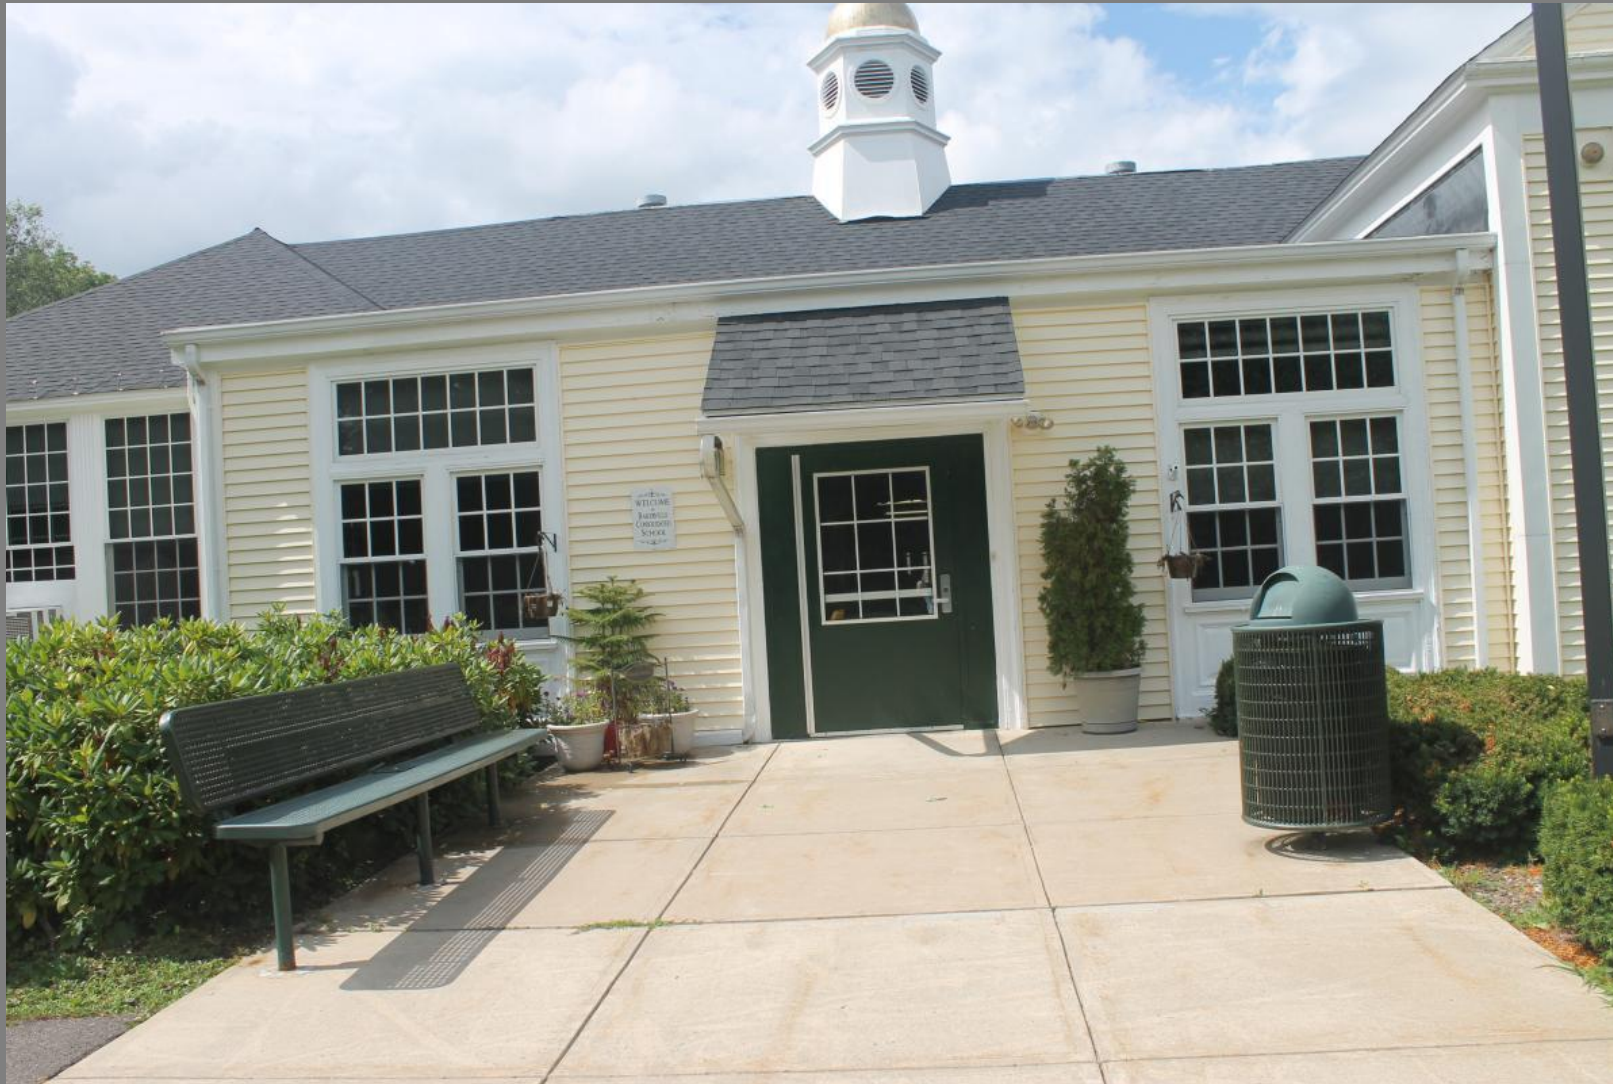
# Bakerville School

- Constructed in 1941
- Renovations/Additions in 1949, 1954, 2002
- 18,483 gross square feet
- Serves grades K-2

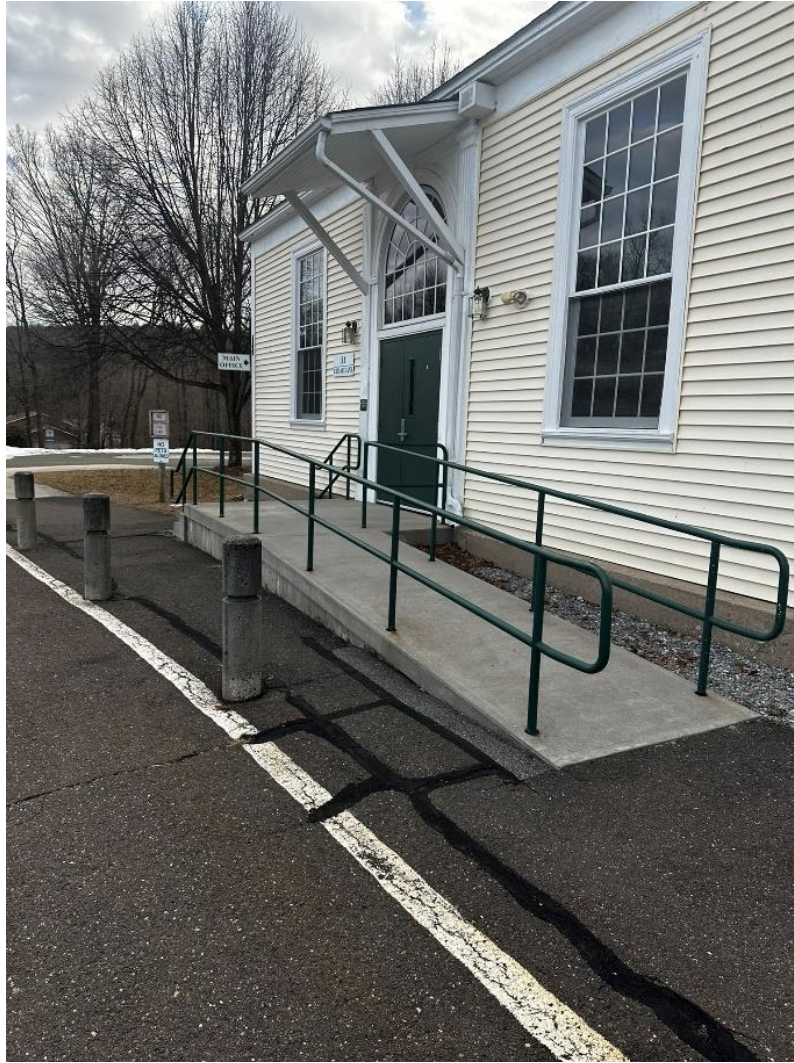
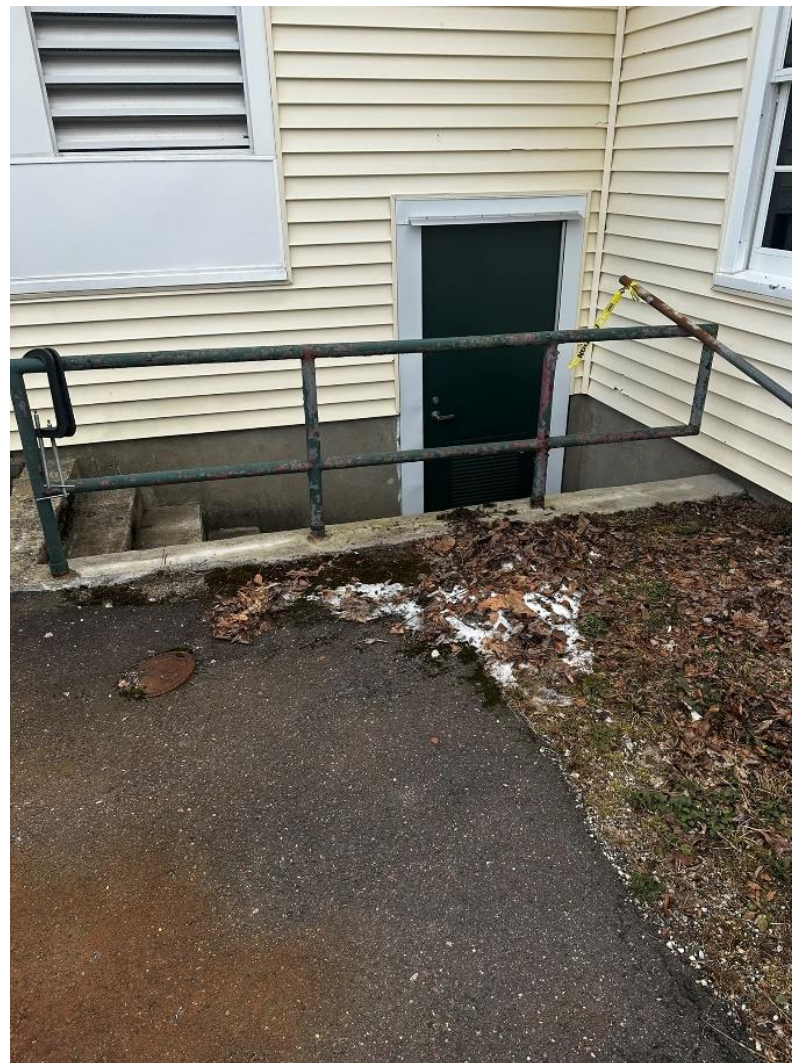
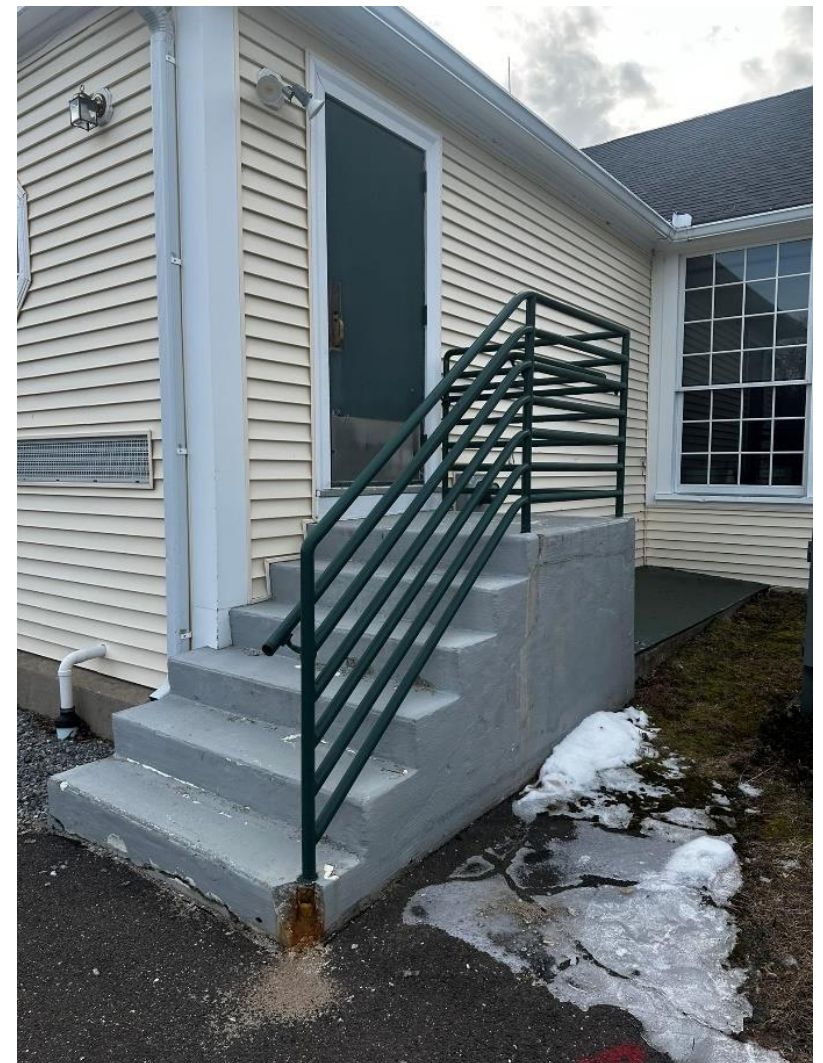
## Site/Civil

| TAG NO. | ASSESSMENT | SYSTEM / CODE REF. | RANKING | | | | | | CORRECTIVE ACTION | ITIMIZED ESTIMATED COST | REMARKS | |
|---|---|---|---|---|---|---|---|---|---|---|---|--|
| S03 | Exterior stairs from the faculty work room (old stage) are missing hand rails | 505.10 (ADA)<br>1012.8 (IBC)<br>A117.1 (ICC) | | | 2 | | | Provide compliant handrails | \$ 5,000 | | <input type="checkbox"/> | |

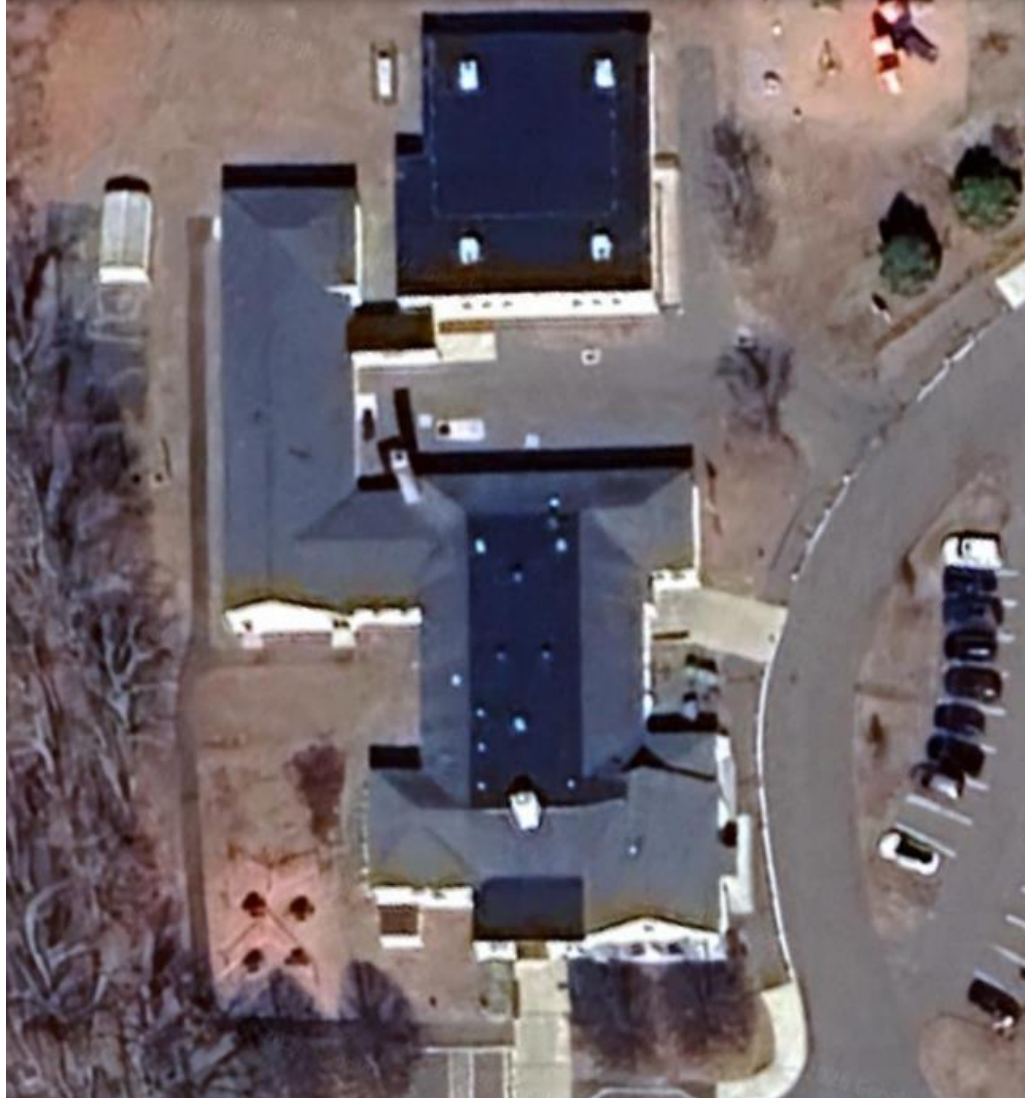
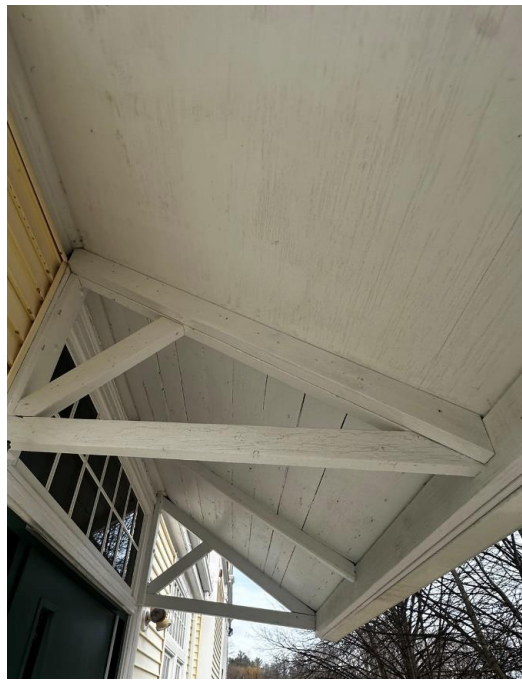
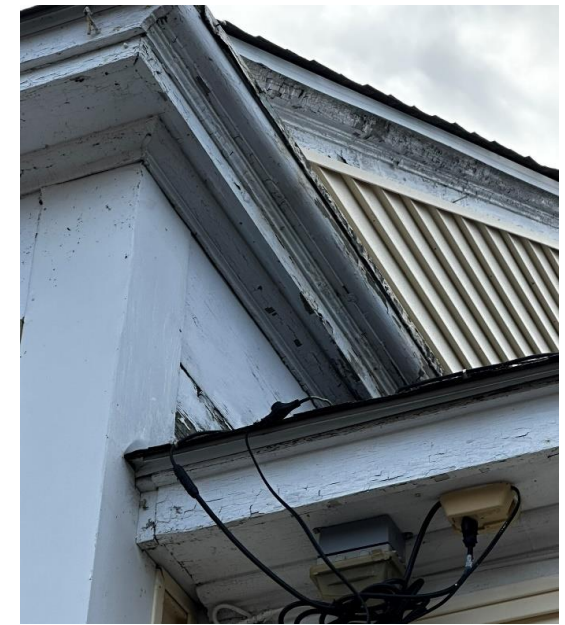
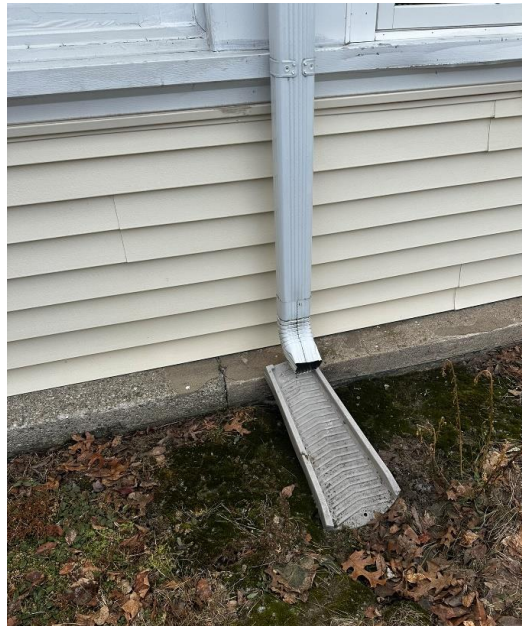
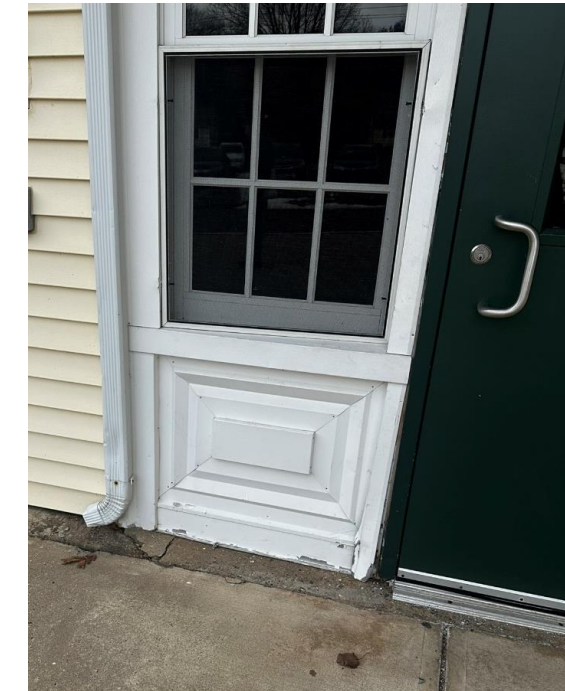
## Architectural: Exterior

| TAG NO. | ASSESSMENT | SYSTEM / CODE REF. | RANKING | | | | | CORRECTIVE ACTION | ITIMIZED ESTIMATED COST | REMARKS | |
|---|---|---|---|---|---|---|---|---|---|---|---|
| A01 | The siding is in need of repairs and at 25+/- years old, it could be replaced | General | | 3 | | | | Replace siding | \$ 243,000 | Hazmat potential - There may be lead, asbestos or PCBs | <input type="checkbox"/> |
| A02 | The foundation detail protrudes past face of wall and may invite water into building | General | | 3 | | | | Provide flashing detail at perimeter | \$ 7,900 | | <input type="checkbox"/> |
| A04 | Wood fascias soffits and roof trim are rotting, or paint is failing | General | | 3 | | | | Remove all decayed wood and replace wood details in kind, paint | \$ 15,800 | Hazmat potential - There may be lead, asbestos or PCBs | <input type="checkbox"/> |
| A05 | The windows are nearing the end of their useful life | General | | 3 | | | | Replace windows with double glazed aluminum systems, include trim and sills | \$ 356,375 | Hazmat potential - There may be lead, asbestos or PCBs | <input type="checkbox"/> |
| A06 | Roofs are nearing end of useful life | General | | | 2 | | | Replace with asphalt shingles at sloped roof and membrane at flat roofs | \$ 646,905 | Hazmat potential - There may be lead, asbestos or PCBs | <input type="checkbox"/> |
| A07 | Gutters and downspouts are not consistently installed throughout the perimeter and many are nearing the end of their useful life | General | | | 2 | | | Replace and provide at full perimeter | \$ 23,000 | | <input type="checkbox"/> |
| A08 | The chimney masonry is in need of repair and vegetation removal | General | | | 2 | | | Patch, repair, or replace brick and repoint as necessary. | \$ 5,400 | | |

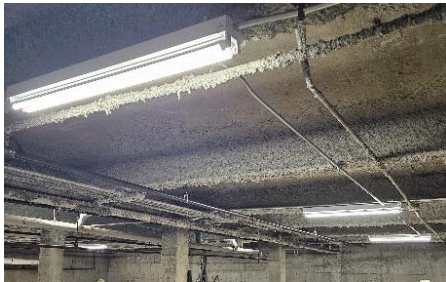
## Electrical

| TAG NO. | ASSESSMENT | SYSTEM / CODE REF. | RANKING | | | | CORRECTIVE ACTION | ITIMIZED ESIMATED COST | REMARKS |
|---|---|---|---|---|---|---|---|---|---|
| E01 | Replace electrical main switch & main distribution panel manufactured by Federal Pacific in poor condition | General | | | 2 | | Remove and replace 400A, 208V, 3 phase main service switch, feeder to remain. Remove and replace 400A, 120/208V, 3 phase main distribution panel and feeder. Terminate existing branch circuits to new circuit breakers in panel as required. | \$ 40,000 | |
| E02 | Replace (3) electrical panels manufactured by Federal Pacific in poor condition | General | | | 2 | | Remove and replace (3) 120/208V, 3 phase panels and feeders. Terminate existing branch circuits to new circuit breakers in panels as required. | \$ 40,000 | |

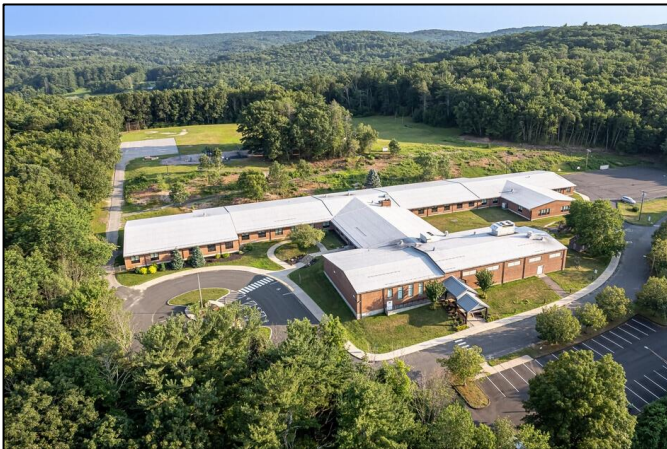
**Antolini School**

$$\frac{\$12,827,337}{\$58,177,000} = 22\%$$

FCI is a nationally recognized metric used to evaluate the overall physical condition of a building in a clear and objective manner.

$$\left[ \frac{\text{Total cost of repairs}}{\text{Current replacement value}} \right] \times 100 = \text{FCI\%}$$

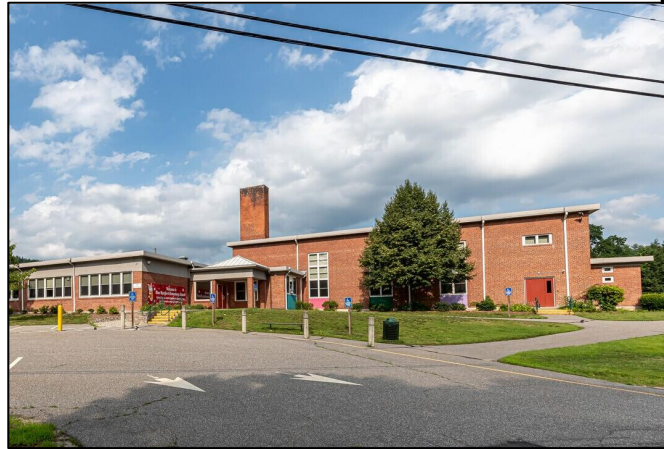
**New Hartford Elementary**

$$\frac{\$13,448,101}{\$23,405,000} = 57\%$$

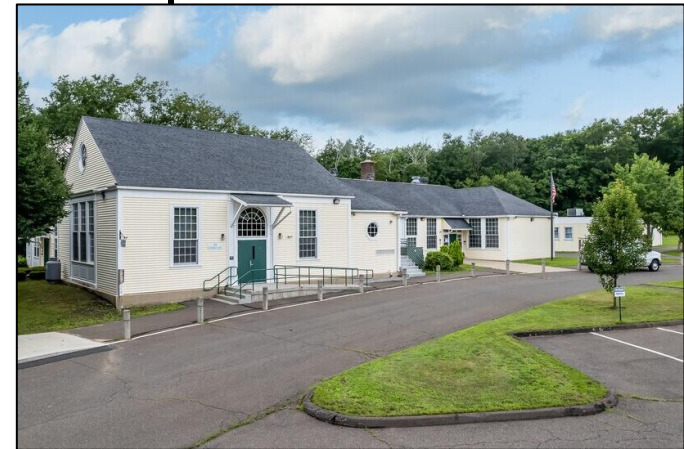
**Bakerville School**

$$\frac{\$12,756,817}{\$18,483,000} = 69\%$$
