# PINE PLAINS CENTRAL SCHOOL DISTRICT

Five-Year Capital Facilities Plan

# Five-Year Capital Facilities Plan

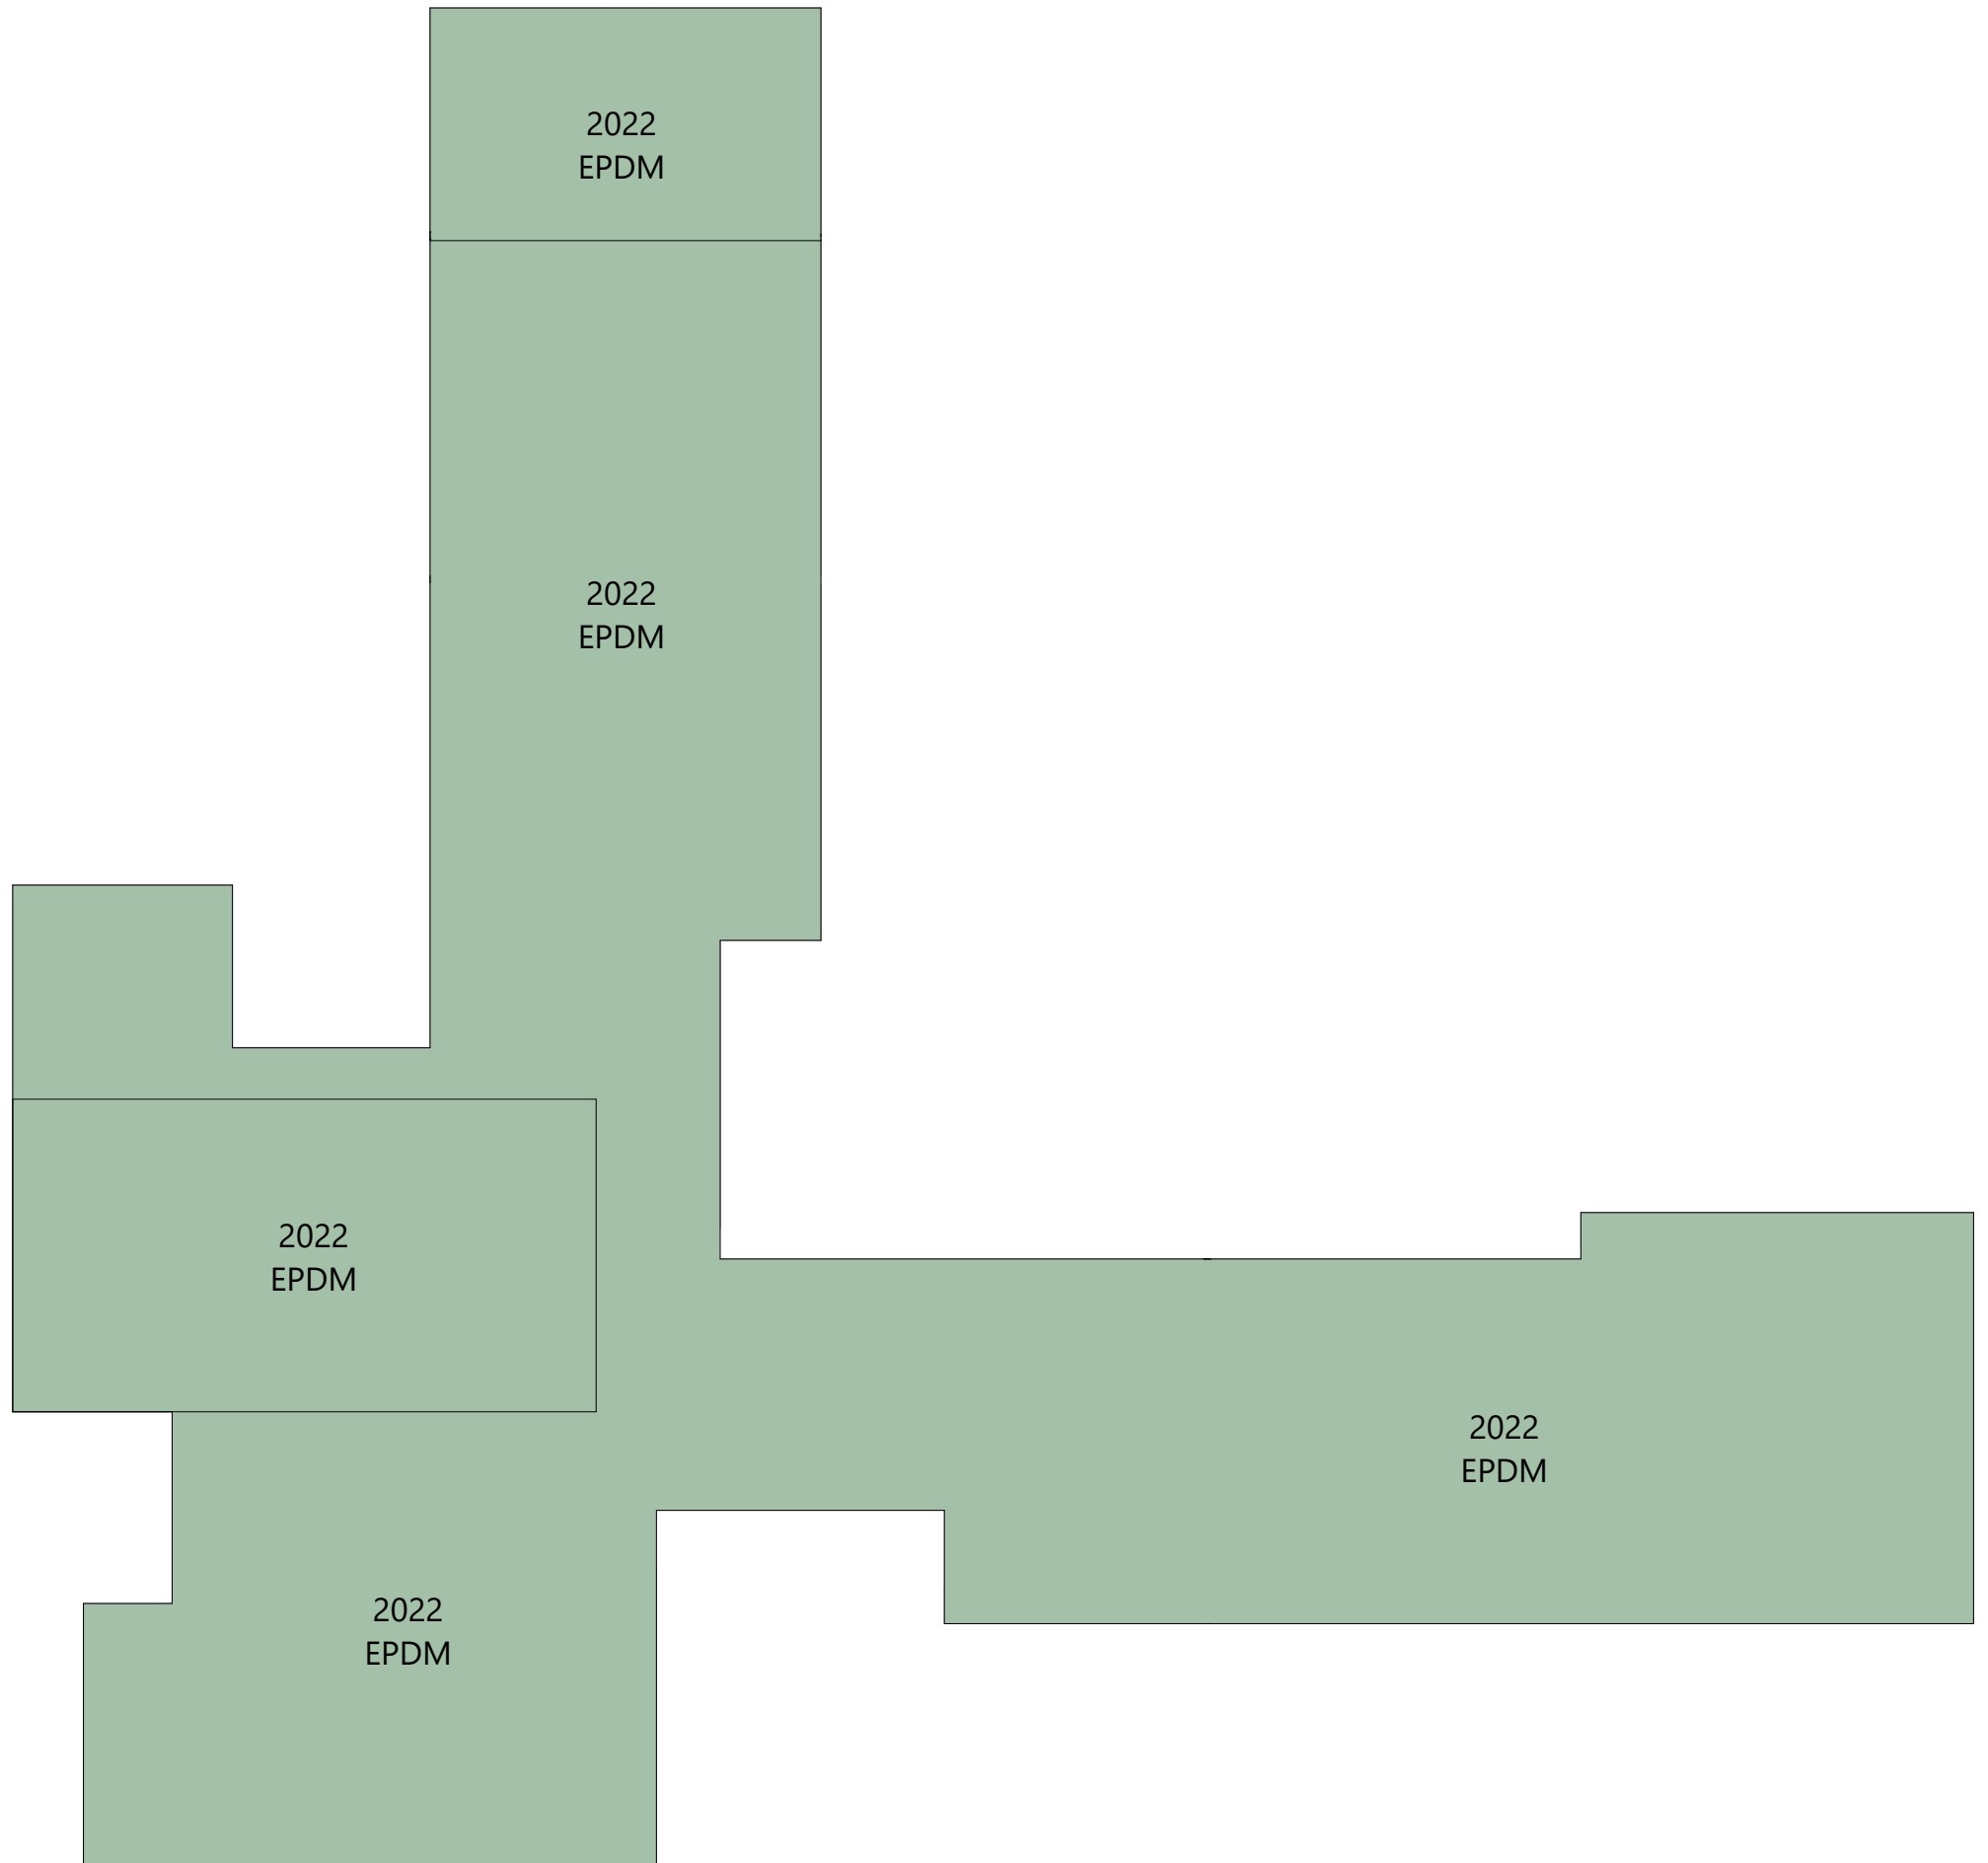
WARRANTY STATUS

- GOOD - TYPE 1
- GOOD - TYPE 2
- MINIMAL - TYPE 1
- MINIMAL - TYPE 2
- EXPIRED - TYPE 1
- EXPIRED - TYPE 2
