Folsom Cordova Unified School District Folsom Measure G Facilities Master Plan

November 19, 2015

Executive Summary

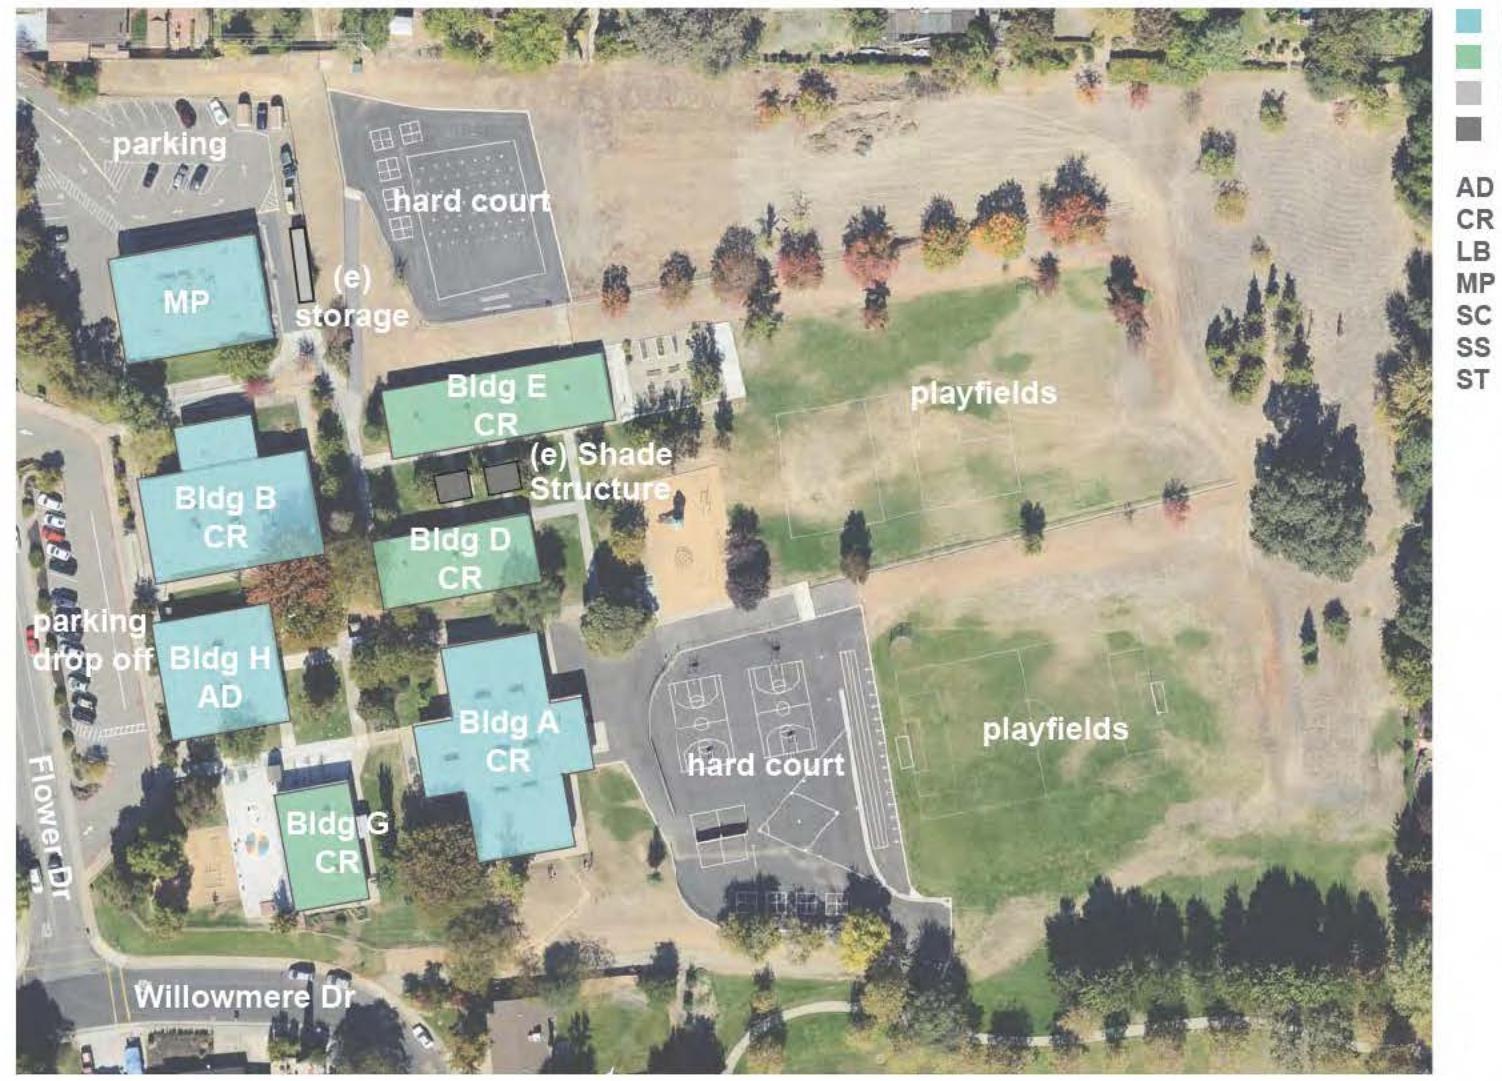
Existing Site Plan

Set on a site which terraces downward from north to south vertically about forty feet the core of this campus, consisting of three permanent buildings, was constructed in 1965. These three single story buildings are clad in cement plaster and have low slope roofs which were re-roofed in 2002 with a single-ply membrane system. Portable classroom wings D, E, and G were originally placed in the 1980's and then replaced in 2000 and 2002. A modular multi-use building with no restrooms or raised platform was added in 1989.

Due to the nature of the site, buildings are set at varying elevations, creating numerous stair and ramp systems which in many cases do not comply with current disabled access codes. The disabled path of travel from the parking lot to the buildings at various levels is circuitous and needs to be improved and supplemented by more direct routes. As the buildings step down the site so do the hard courts and turf fields. The upper and lower hard court areas are in generally fair condition while the condition of the fields are in generally poor condition as are the irrigation systems which serve them. An emergency vehicle access lane off of Willowmere Drive was improved in the 2002 modernization which was approved by the local fire authority at the time. However, this fire lane does not meet current fire lane dimensional requirements and will come under scrutiny when new building footprint is proposed for this site.

The three core permanent buildings are in good condition having been extensively renovated in a 2002 modernization. Interior and exterior finishes were significantly improved then and the buildings have held up well. The three groupings of portable buildings, which include seven classrooms, two kindergartens, and a set of restrooms are in adequate shape having been replaced in 2000 and 2002. Also in the 2002 modernization, restrooms in all three permanent buildings were improved to current disabled accessible code requirement and generally meet today's standards. However, many door landings and walkways to the buildings are non-conforming and must be replaced to provide a compliant disabled accessible path of travel.

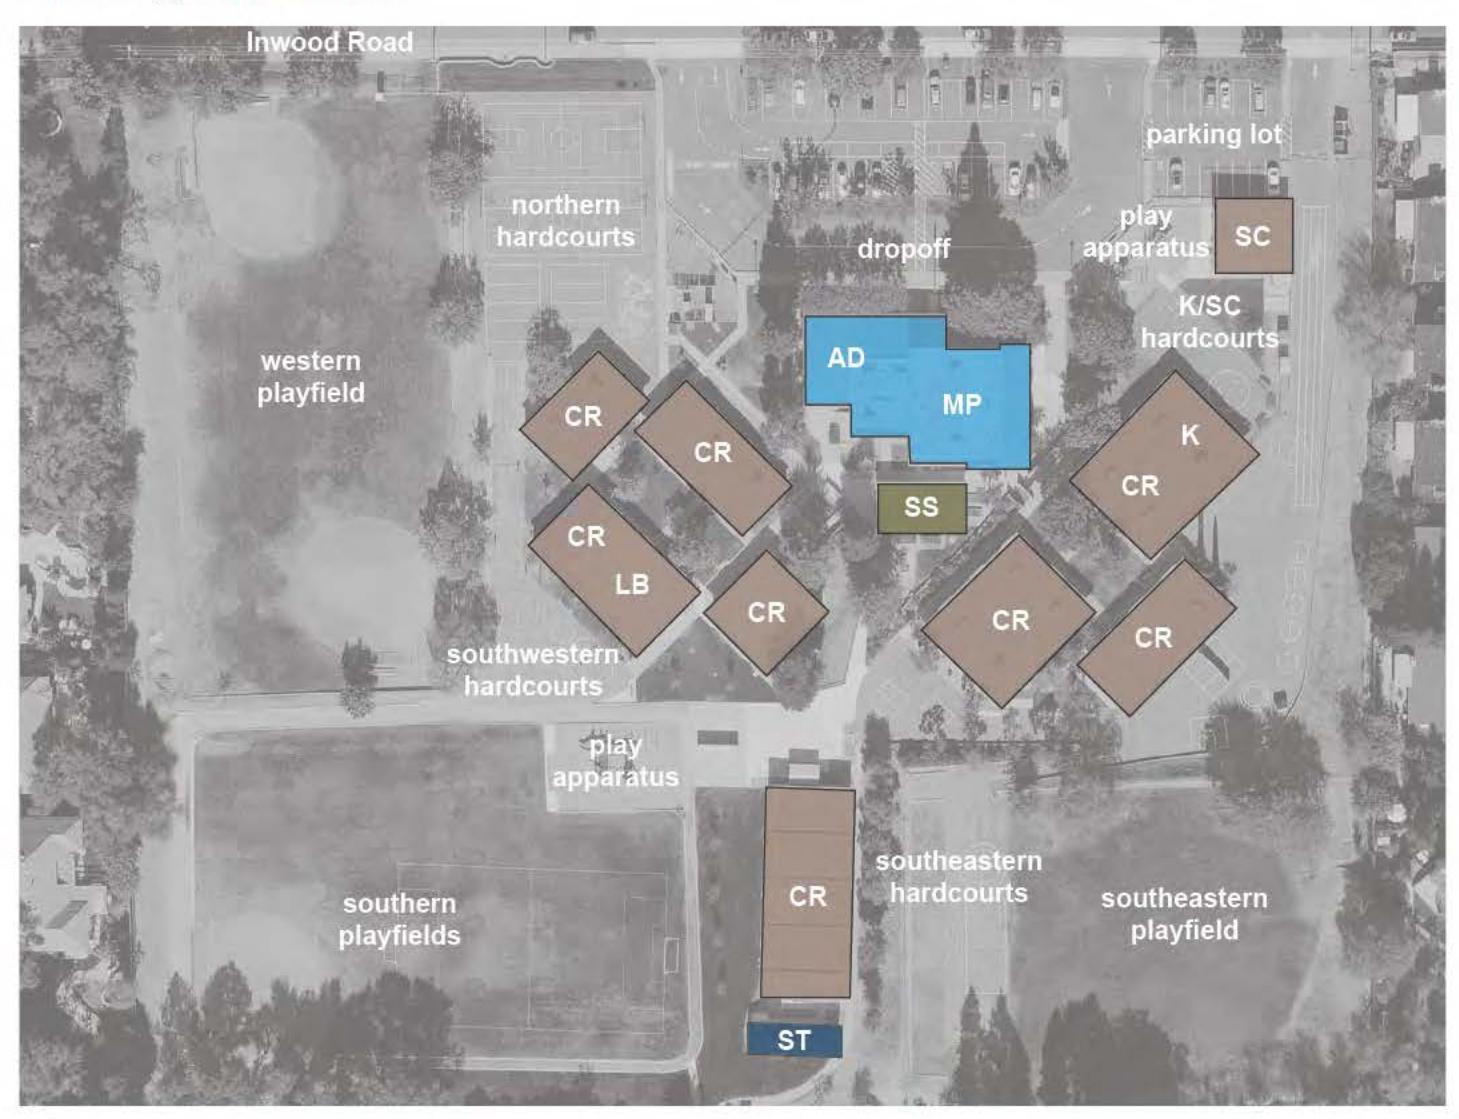
Existing Site Plan

This campus has been well maintained, but is showing wear of being a 28 year old campus. The asphalt paving has been patched and repaired over time, but is showing wear in many areas. Replacement should be considered.

The construction of the original campus predates accessibility codes. The accessible parking stalls, loading areas, many walks, exterior ramps and stairways do not meet current accessibility requirements. These need to be removed and replaced to provide adequate path of travel.

The Administration/Multipurpose building is in reasonably good condition for its age. It has received general maintenance over the years, but is due for refreshing both on the interior and exterior. Painting, flooring, finishes and casework are all due for replacement.

All of the classrooms are housed in portable buildings. For their age, the portables are generally in satisfactory condition. At 26-28 years, the buildings are quite old and approaching the end of their serviceable lifespan. These buildings should be replaced rather than spending considerable dollars modernizing them.

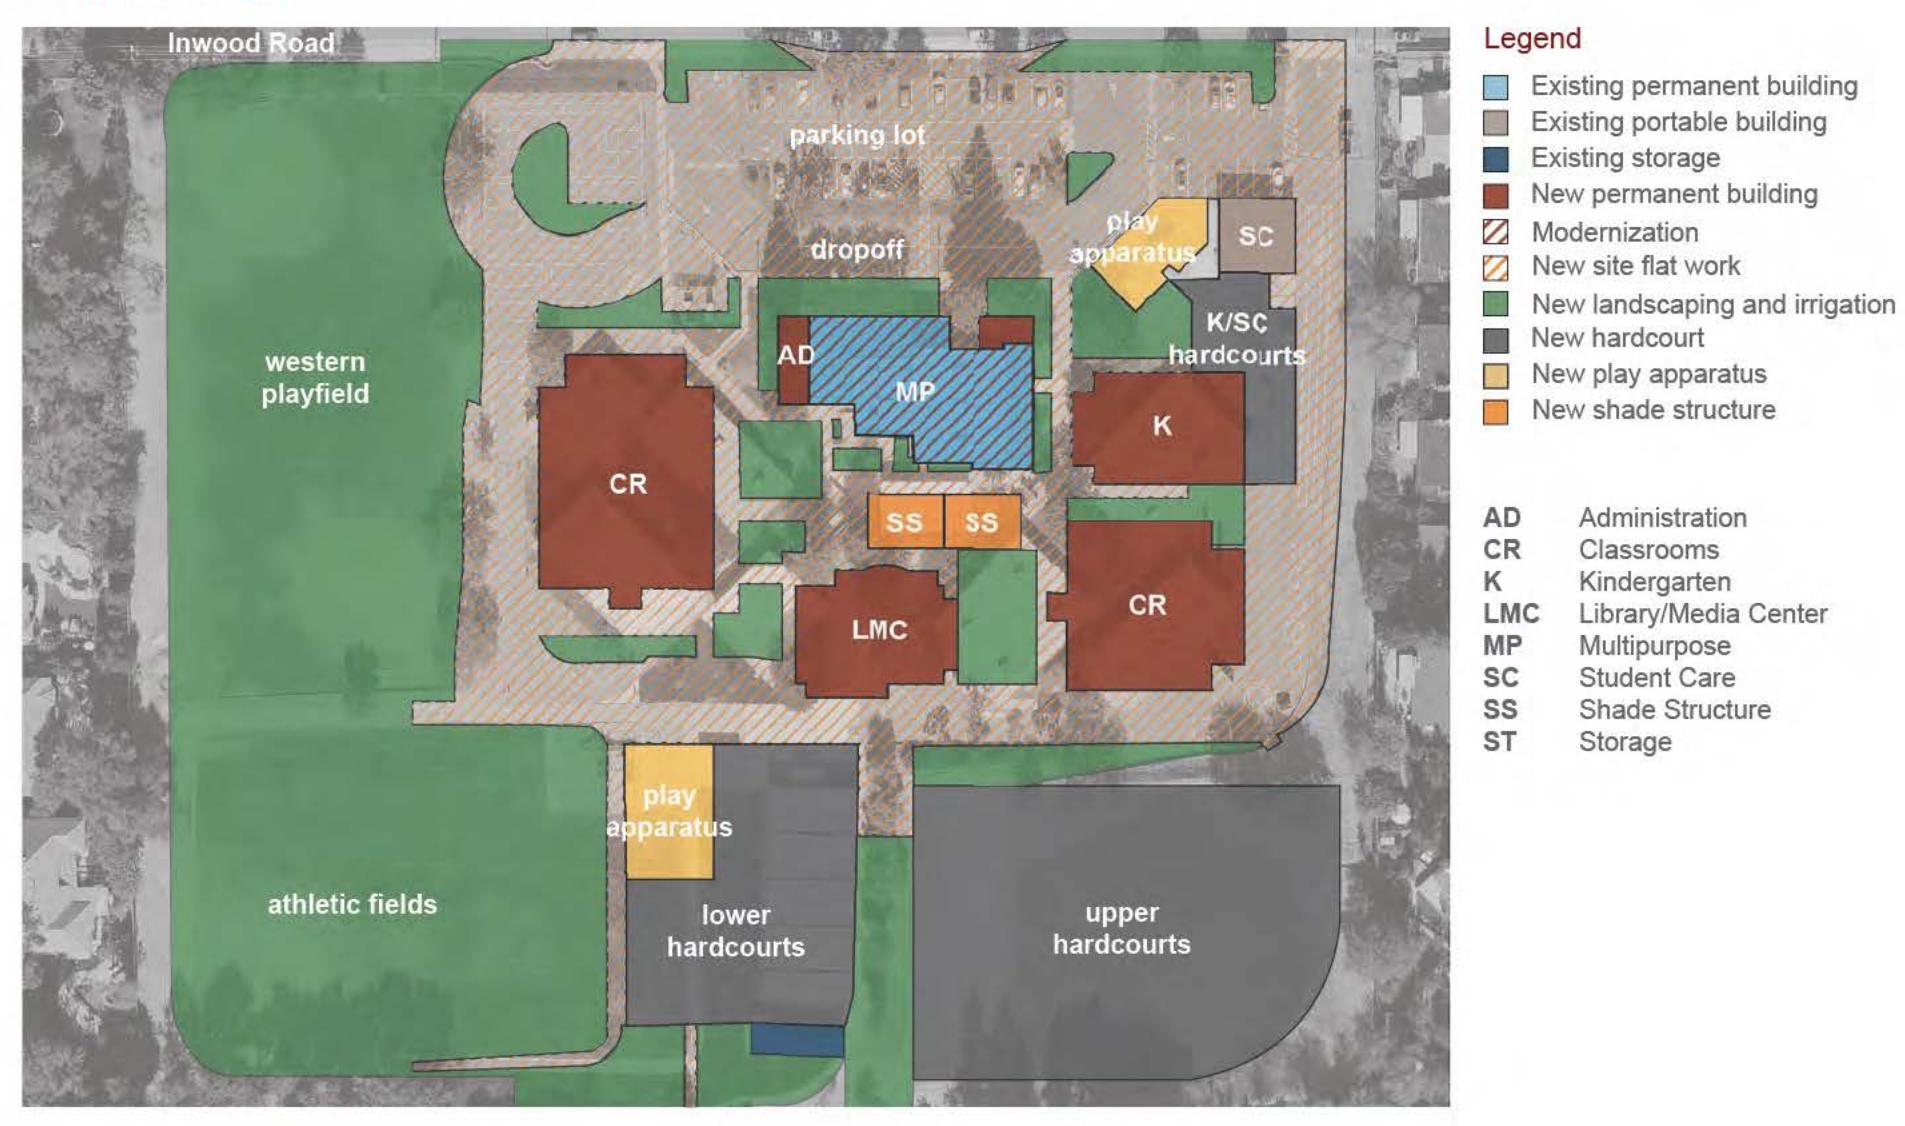
Master Plan

- · Refresh landscaping and modify irrigation for water efficiency
- Replace portables with . permanent buildings
- Revise hardcourt areas
- Add EMS to campus .
- · Add fencing/gate control at campus perimeter
- Upgrade data infrastructure
- Upgrade classrooms to 21st • century standards
- Install VoIP telephone system
