IAQ & MOLD AIR SAMPLING REPORT

LINCOLNSHIRE-PRAIRIE VIEW SCHOOL DISTRICT #103

HALF DAY SCHOOL 239 Olde Half Day Road Lincolnshire, IL 60069

MEC PROJECT #: 17-12-968-I.H.

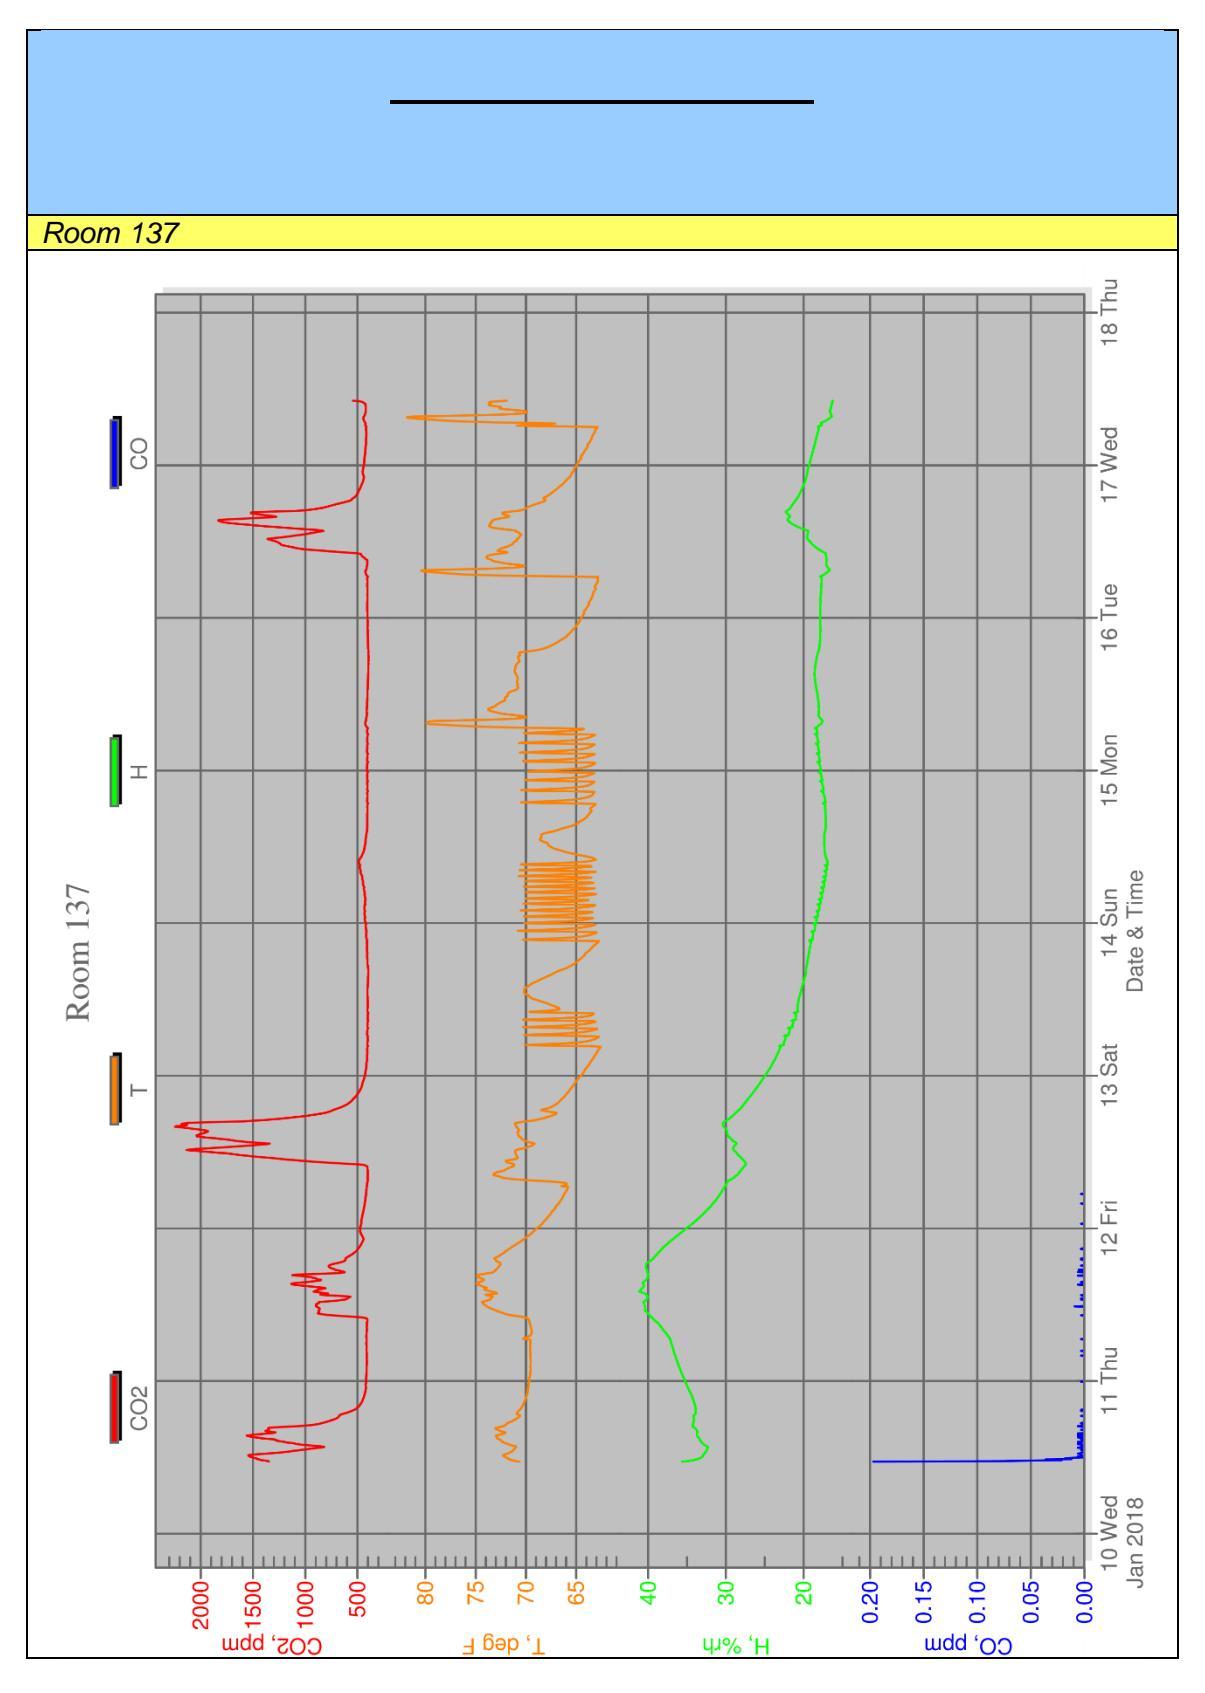
Graph Statistics Room 137									
	CO2	т	Н	СО					
Avg	576 ppm	68.3 deg F	24.3 %rh	0.0 ppm					
Max	2245 ppm	81.8 deg F	41.1 %rh	0.2 ppm					
Max Date	01/12/2018	01/17/2018	01/11/2018	01/10/2018					
Max Time	15:59:21	07:29:01	14:04:25	11:19:30					
Min	395 ppm	62.6 deg F	16.2 %rh	0.0 ppm					
Min Date	01/15/2018	01/13/2018	01/17/2018	01/10/2018					
Min Time	18:44:07	04:34:18	10:04:01	11:59:29					
TWA (8 hr)	1120			0.0					
TWA Start Date	01/10/2018			01/10/2018					
TWA Start Time	11:14:30			11:14:30					
TWA End Time	10:09:01			10:09:01

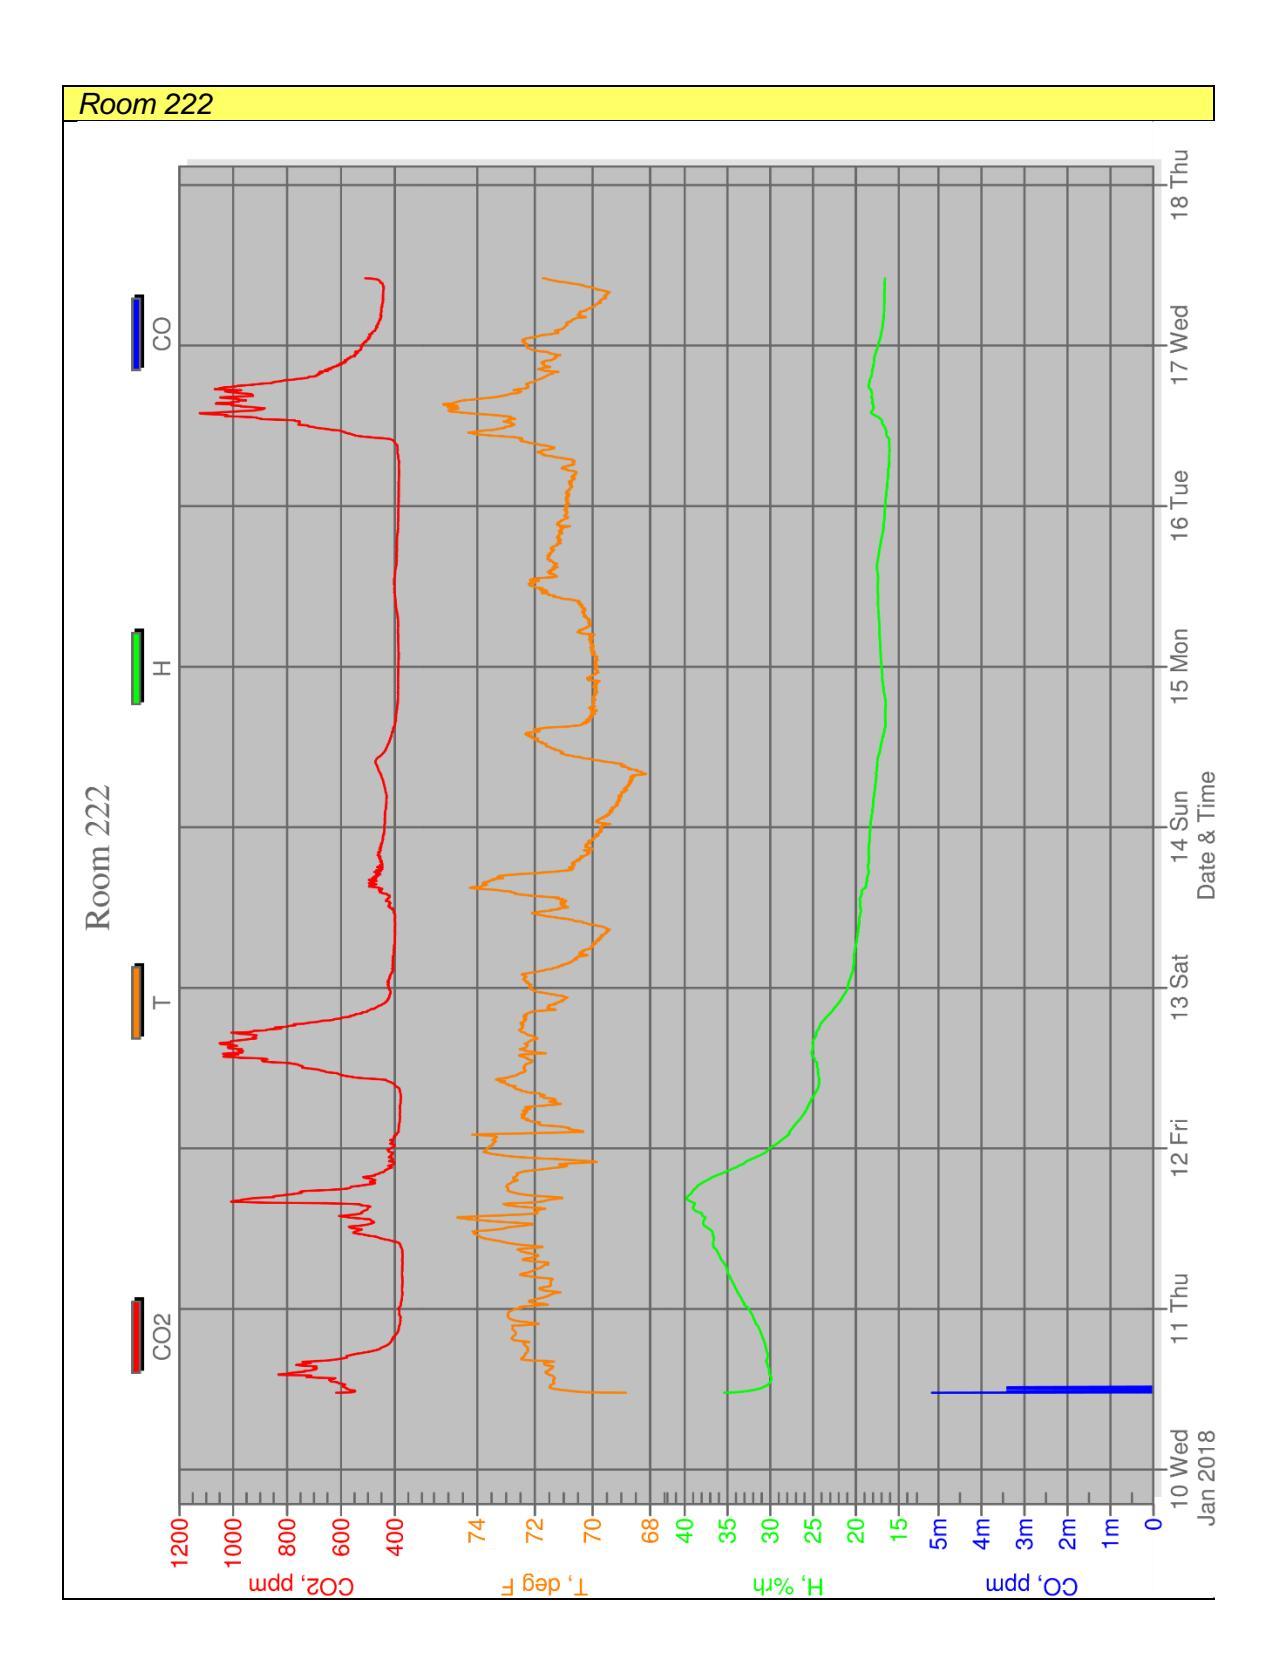
Graph Statistics Room 222									
	CO2	т	Н	CO					
Avg	484 ppm	71.4 deg F	22.3 %rh	0.0 ppm					
Max	1124 ppm	75.2 deg F	39.8 %rh	0.0 ppm					
Max Date	01/16/2018	01/16/2018	01/11/2018	01/10/2018					
Max Time	13:53:26	15:13:26	16:28:29	11:28:29					
Min	371 ppm	68.1 deg F	16.1 %rh	0.0 ppm					
Min Date	01/11/2018	01/14/2018	01/16/2018	01/10/2018					
Min Time	06:48:29	07:58:28	08:28:27	11:33:29					
TWA (8 hr)	600			0.0					
TWA Start Date	01/10/2018			01/10/2018					
TWA Start Time	11:23:29			11:23:29					
TWA End Time	10:03:26			10:03:26
