Hazardous Materials Survey Report Highland/Spectrum School 2021 Highland Boulevard, Hayward, CA 94542

> February 28, 2024 Project No. 240041002

Vista Environmental Consulting (Vista) performed pre-demolition hazardous materials survey at Highland Spectrum School, 2021 Highland Boulevard, Hayward, CA 94542 (Project Site). The survey was performed to identify and sample accessible, suspect asbestos-containing materials, representative building components for the presence of lead-containing surface coatings/lead-based paints (LCSC/LBP), Polychlorinated Biphenyls (PCBs) in light fixture ballasts, and other hazardous materials that may be in the path the demolition project. Vista performed the survey on January 25 & 26, 2024.

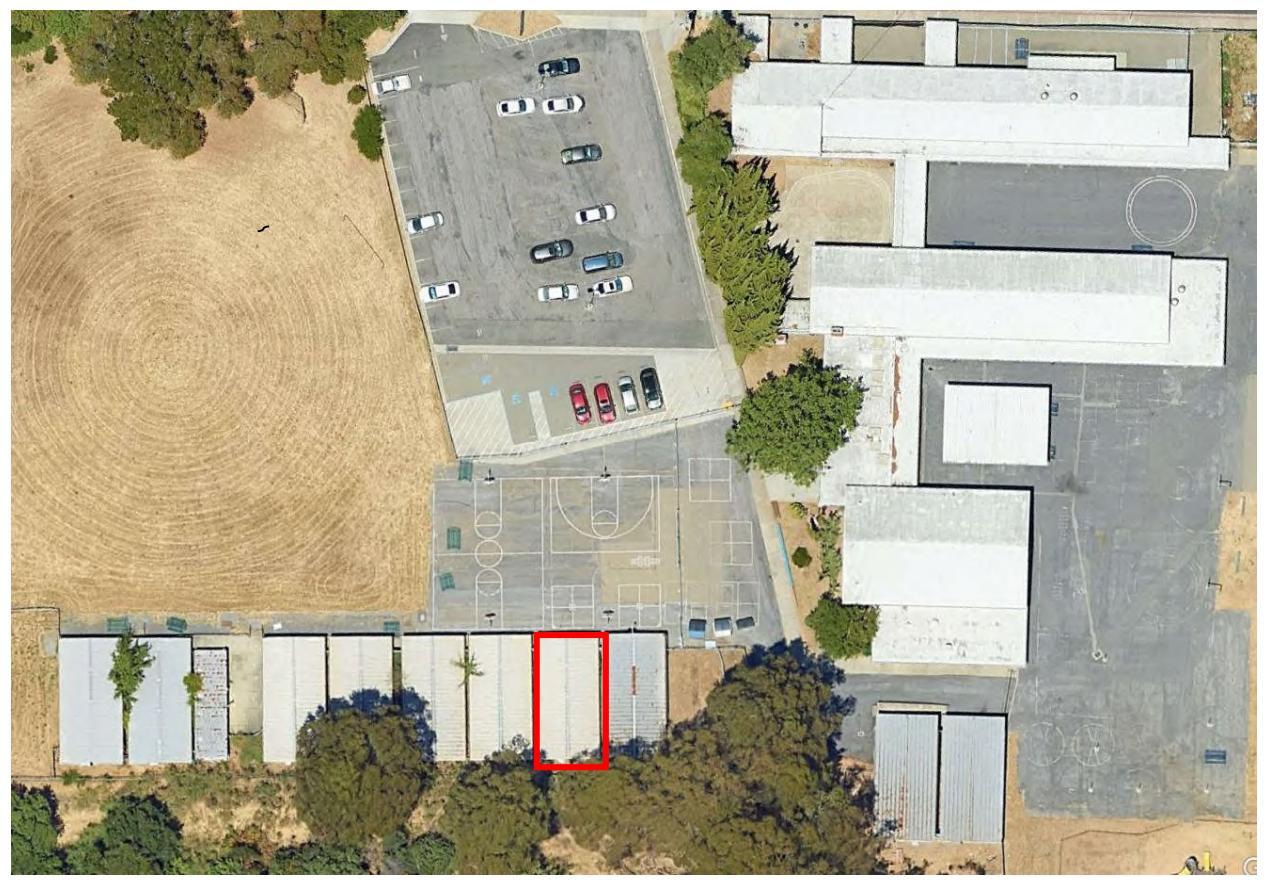
HIGHLAND/SPECTRUM SCHOOL PORTABLE 16

MATERIAL	CONTAMINANT	ESTIMATED QUANTITY
Fluorescent Tubes (4' Length)	Universal Waste	40
Other Non-Incandescent Lamps	Universal Waste	1
Light Fixture Ballasts	Polychlorinated Biphenyls	20
HVAC Unit	Ozone Depleting Chemicals	1

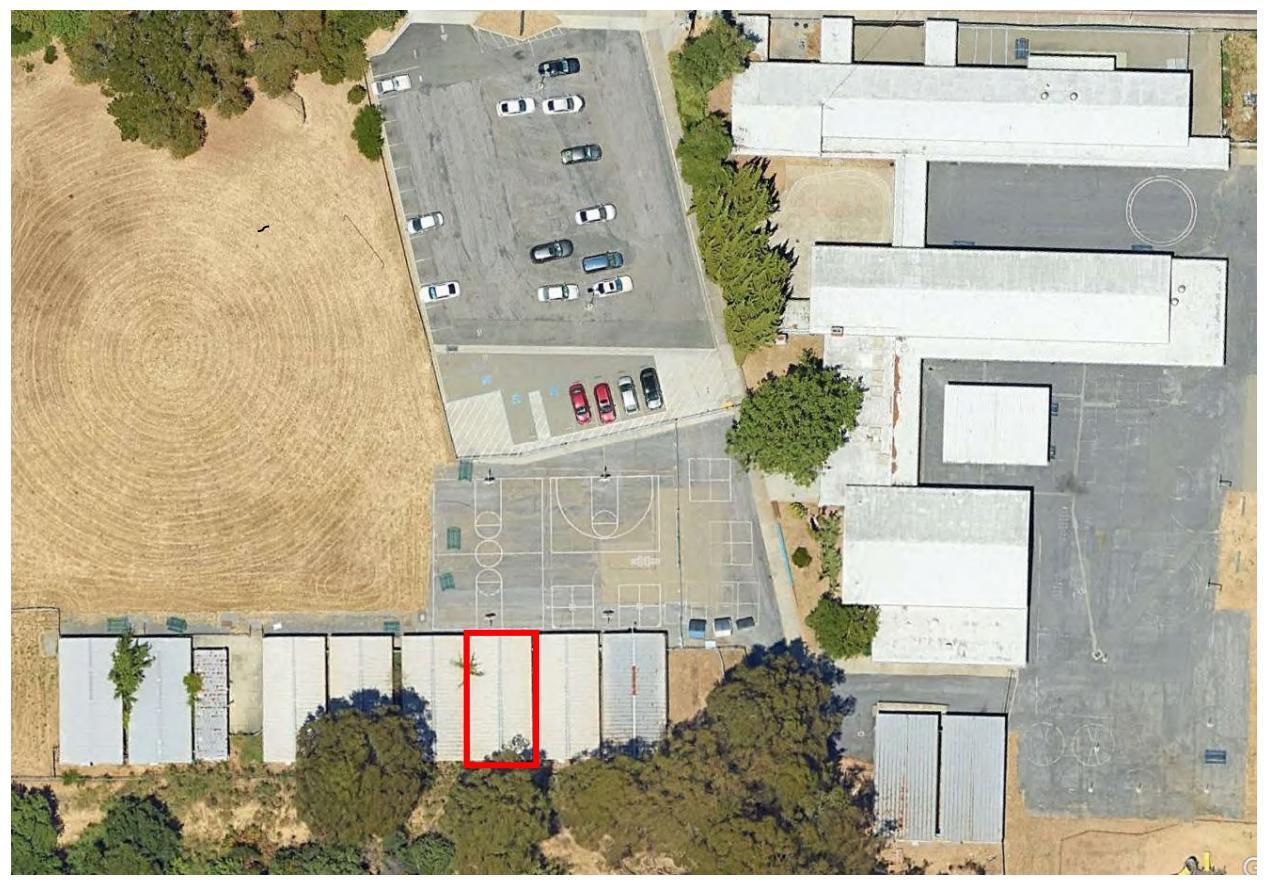
HIGHLAND/SPECTRUM SCHOOL PORTABLE 17

MATERIAL	CONTAMINANT	ESTIMATED QUANTITY
Fluorescent Tubes (4' Length)	Universal Waste	40
Other Non-Incandescent Lamps	Universal Waste	1
Light Fixture Ballasts	Polychlorinated Biphenyls	20
HVAC Unit	Ozone Depleting Chemicals	1

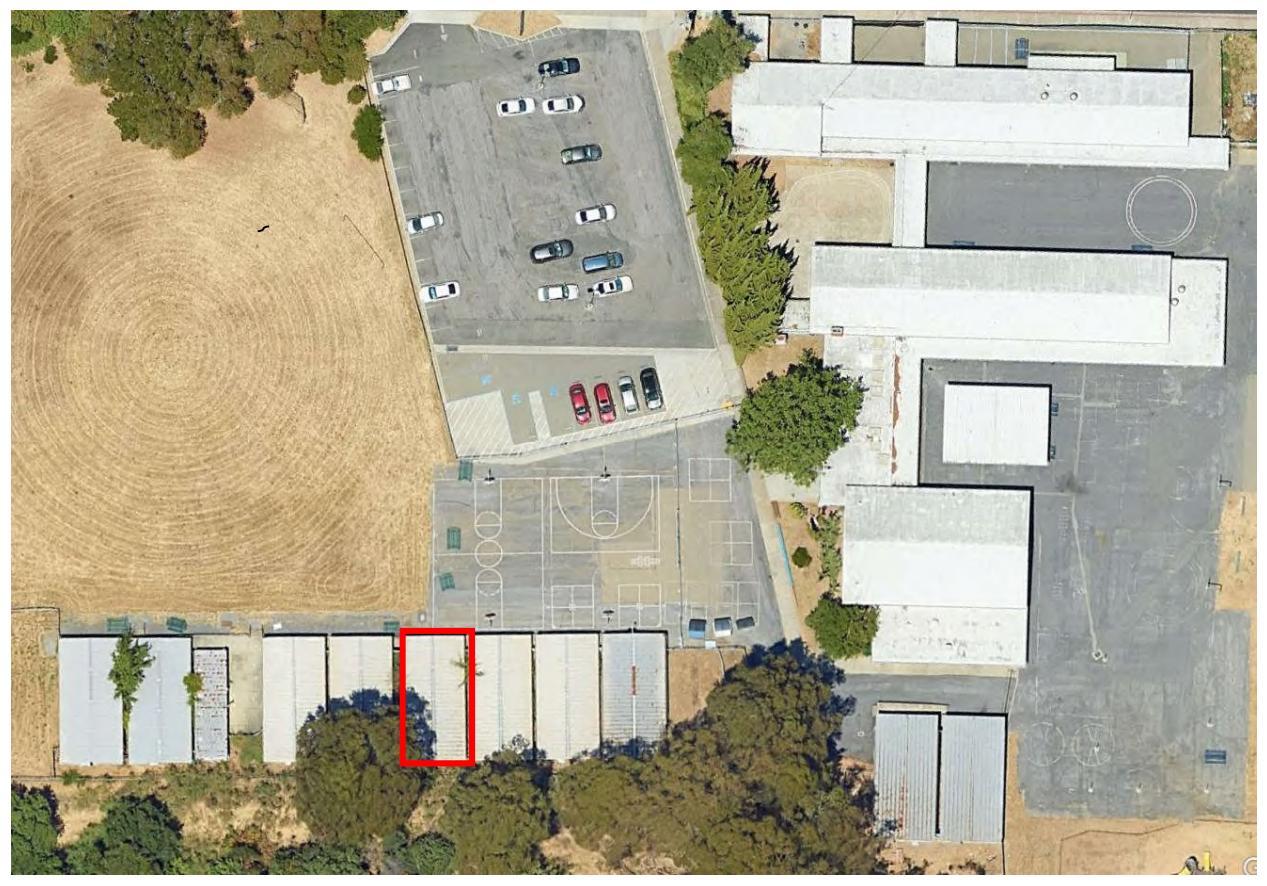
HIGHLAND/SPECTRUM SCHOOL PORTABLE 18

MATERIAL	CONTAMINANT	ESTIMATED QUANTITY		
Fluorescent Tubes (4' Length)	Universal Waste	40		
Other Non-Incandescent Lamps	Universal Waste	1		
Light Fixture Ballasts	Polychlorinated Biphenyls	20		
HVAC Unit	Ozone Depleting Chemicals	1

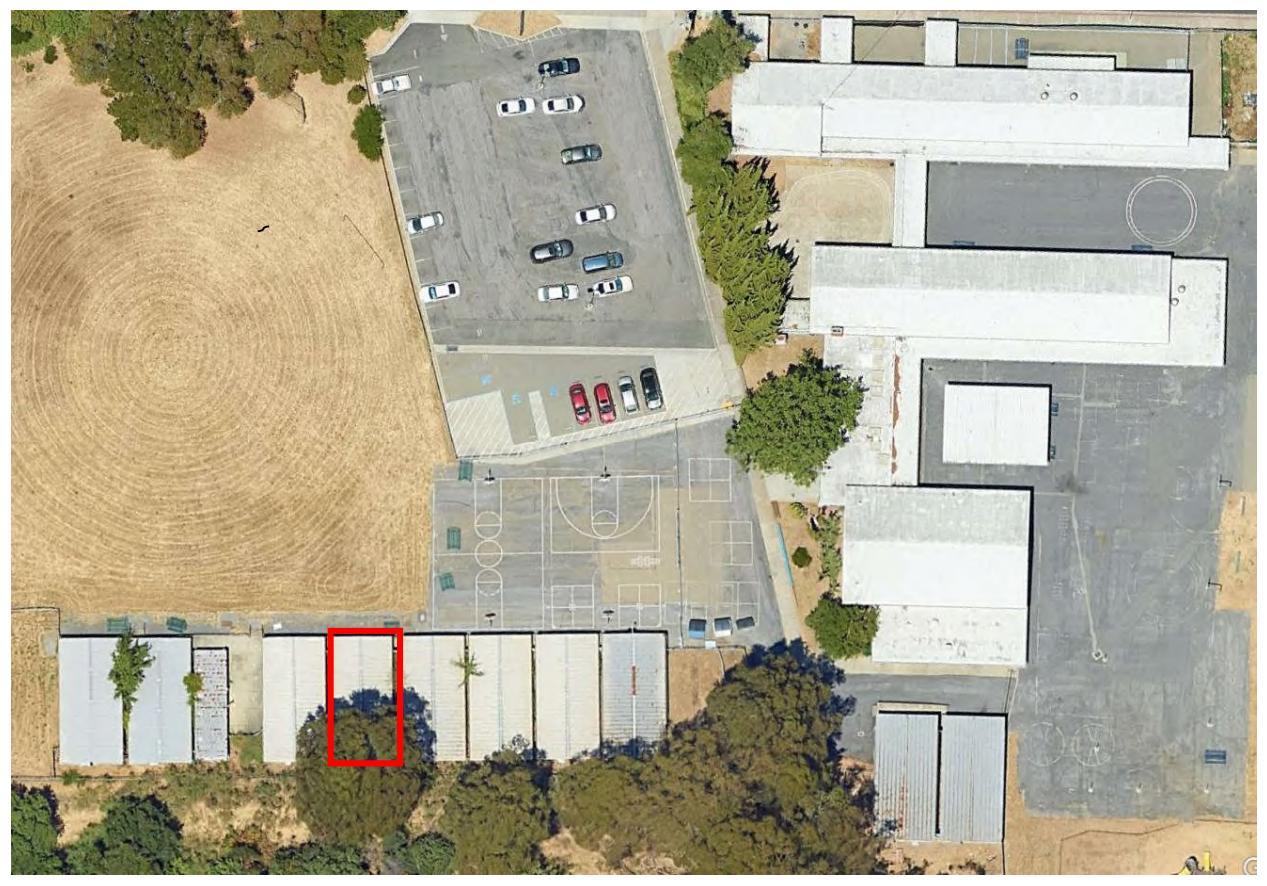
HIGHLAND/SPECTRUM SCHOOL PORTABLE 19

MATERIAL	CONTAMINANT	ESTIMATED QUANTITY
Fluorescent Tubes (4' Length)	Universal Waste	40
Other Non-Incandescent Lamps	Universal Waste	1
Light Fixture Ballasts	Polychlorinated Biphenyls	20
HVAC Unit	Ozone Depleting Chemicals	1
