Mill Hill Elementary School

Fairfield Public Schools Recommissioning (RCx) and Testing, Adjusting, & Balancing (TAB) Study van Zelm Project # 2020102.00 (16-MHES)

FAIRFIELD PUBLIC SCHOOLS RECOMMISSIONING (RCX) AND TESTING, ADJUSTING, & BALANCING (TAB) STUDY

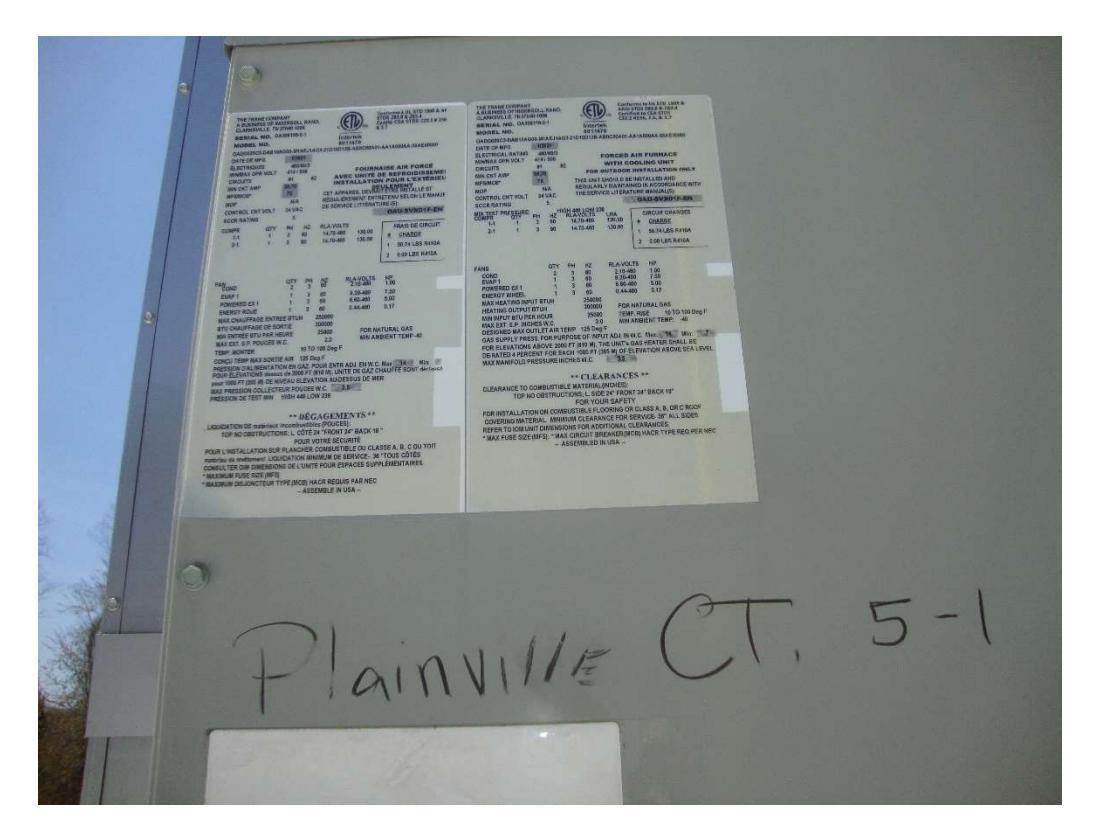
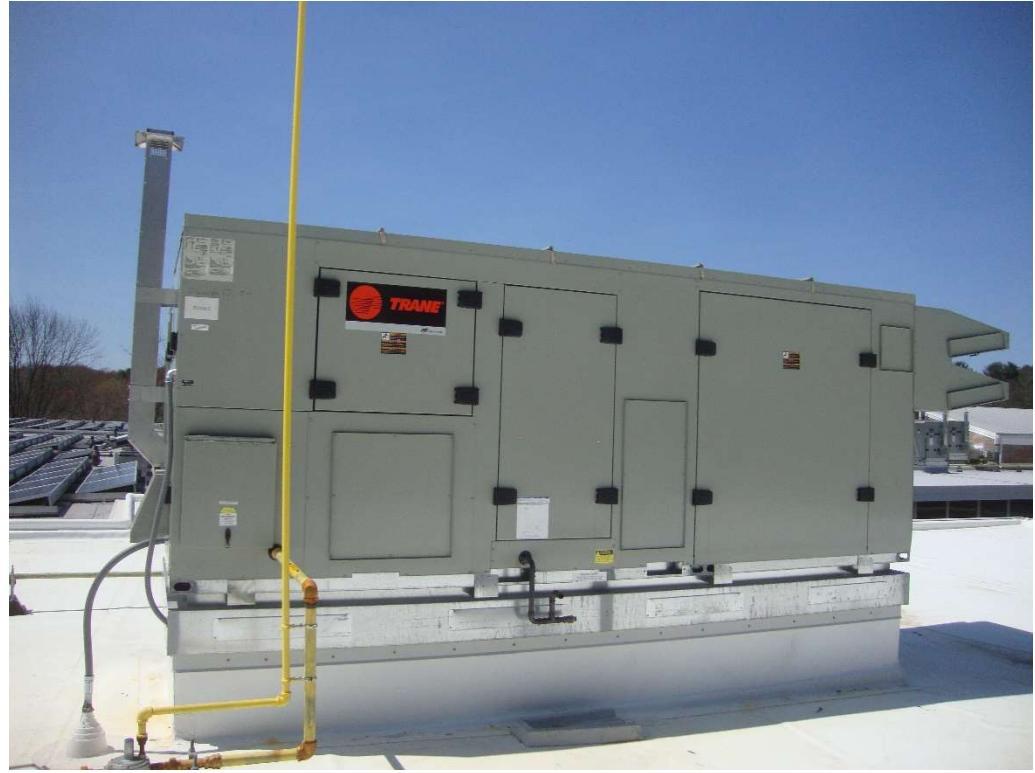
DOAS-5

NOTES: 3/15/21 - HAD BRIAN INSTALL U.V. LIGHTS (4) PER UNIT ON BOTH DOAS #5 & #6 UNITS, TESTED/OK.FOUND OVERSTROKE OF 2MM ON ERV BYPASS DAMPERS CAUSING RETAINING CICLIPS TO POP OUT, READJUSTED DAMPERS, FOUND AND REINSTALLED CLIPS. UNIT HAS A FROSTSAT ALARM PREVENTING COMPRESSOR ENGAGEMENT, CONFIRMED AUTO RESET FROSTSTAT IS CLOSED, CONFIRMED XM-30 MODULE IS RECOGNIZED BY UC-600 CONTROLLER, WILL ADDRESS AT COOLING STARTUP.

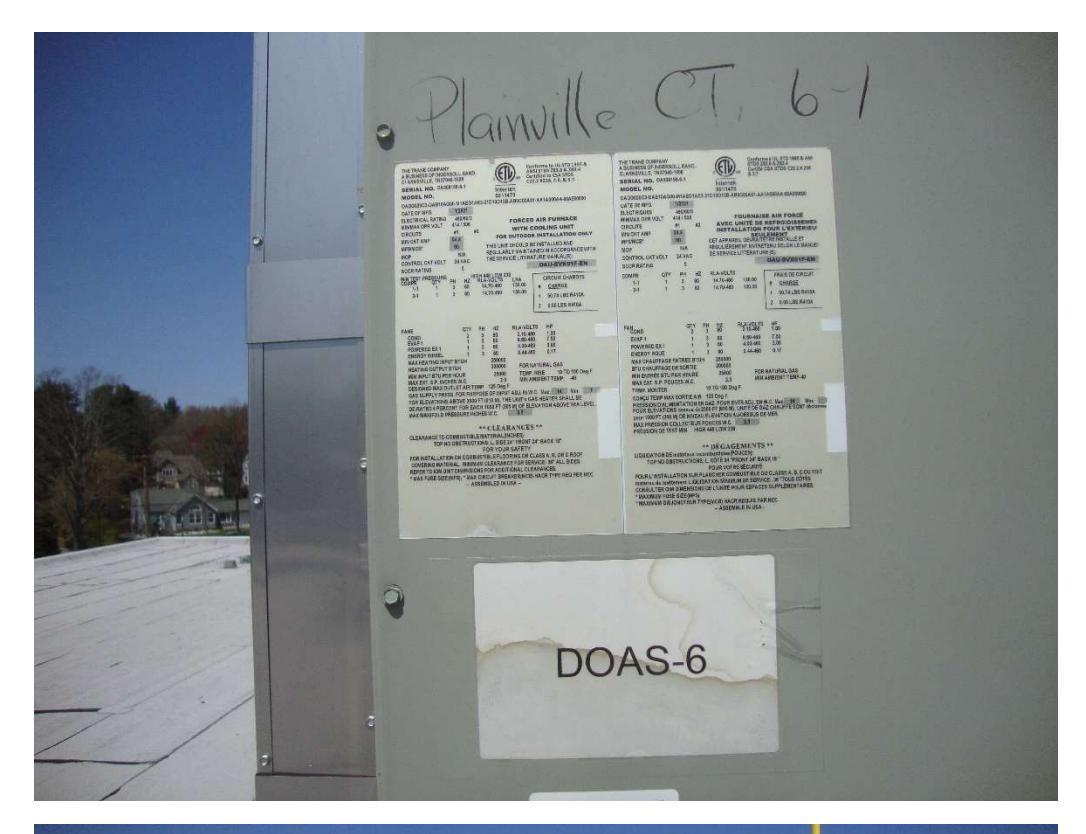
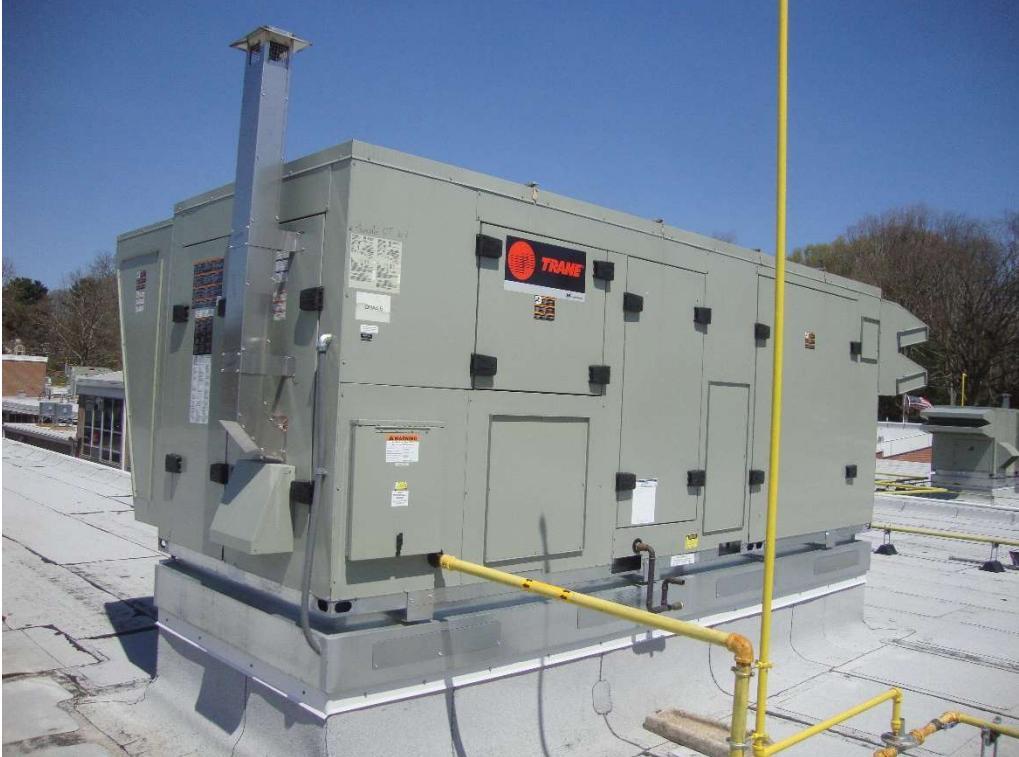
DOAS-6

OA @ 100% Open, HGRH @ 25%, 328/84 @ 13.3 Amps avg @ comps, 11.6 Superheat, 4.3 Subcool, 56° DAT, 74° RAT, 0.457 Static S/F Pressure, ERV Bypass Damper 100% open, ERV E/F Bypass Damper 0% open, ERV Off

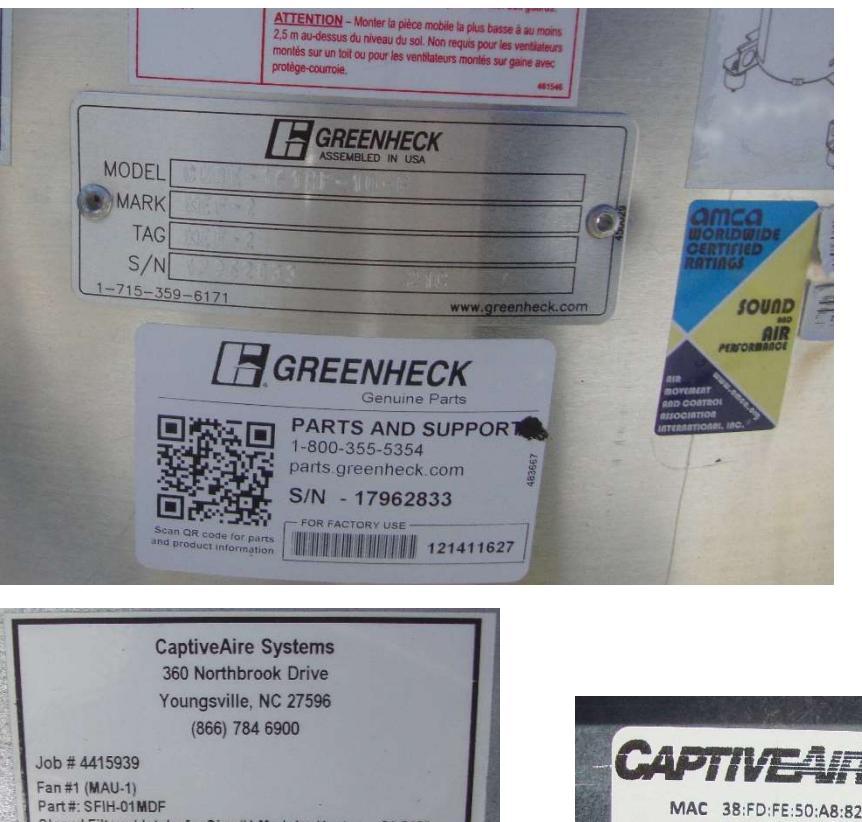
MAU-1

Part#: SFIH-01MDF Sloped Filtered Intake for Size #1 Modular Heater. 21.813" Wide x 43.375" Long x 23.375" High. Includes 2" MV EZ Kleen Metal Mesh Filters.

Filters: 3 Of 9154 MV EZ Kleen Metal Mesh

MV EZ Kleen Metal Mesh Filter. 16"x 20"x 2" Used for heater and supply fan intakes. (3412)
