School Name: **Stillwater Middle School (SMS)**
 Date: **11/2/2018, 12/4/2018, 12/18/2018**

Stillwater Middle School
 First Floor
 Lead in Drinking Water
 Project #19054

Stillwater Middle School
 Lower Level
 Lead in Drinking Water
 Project #19054

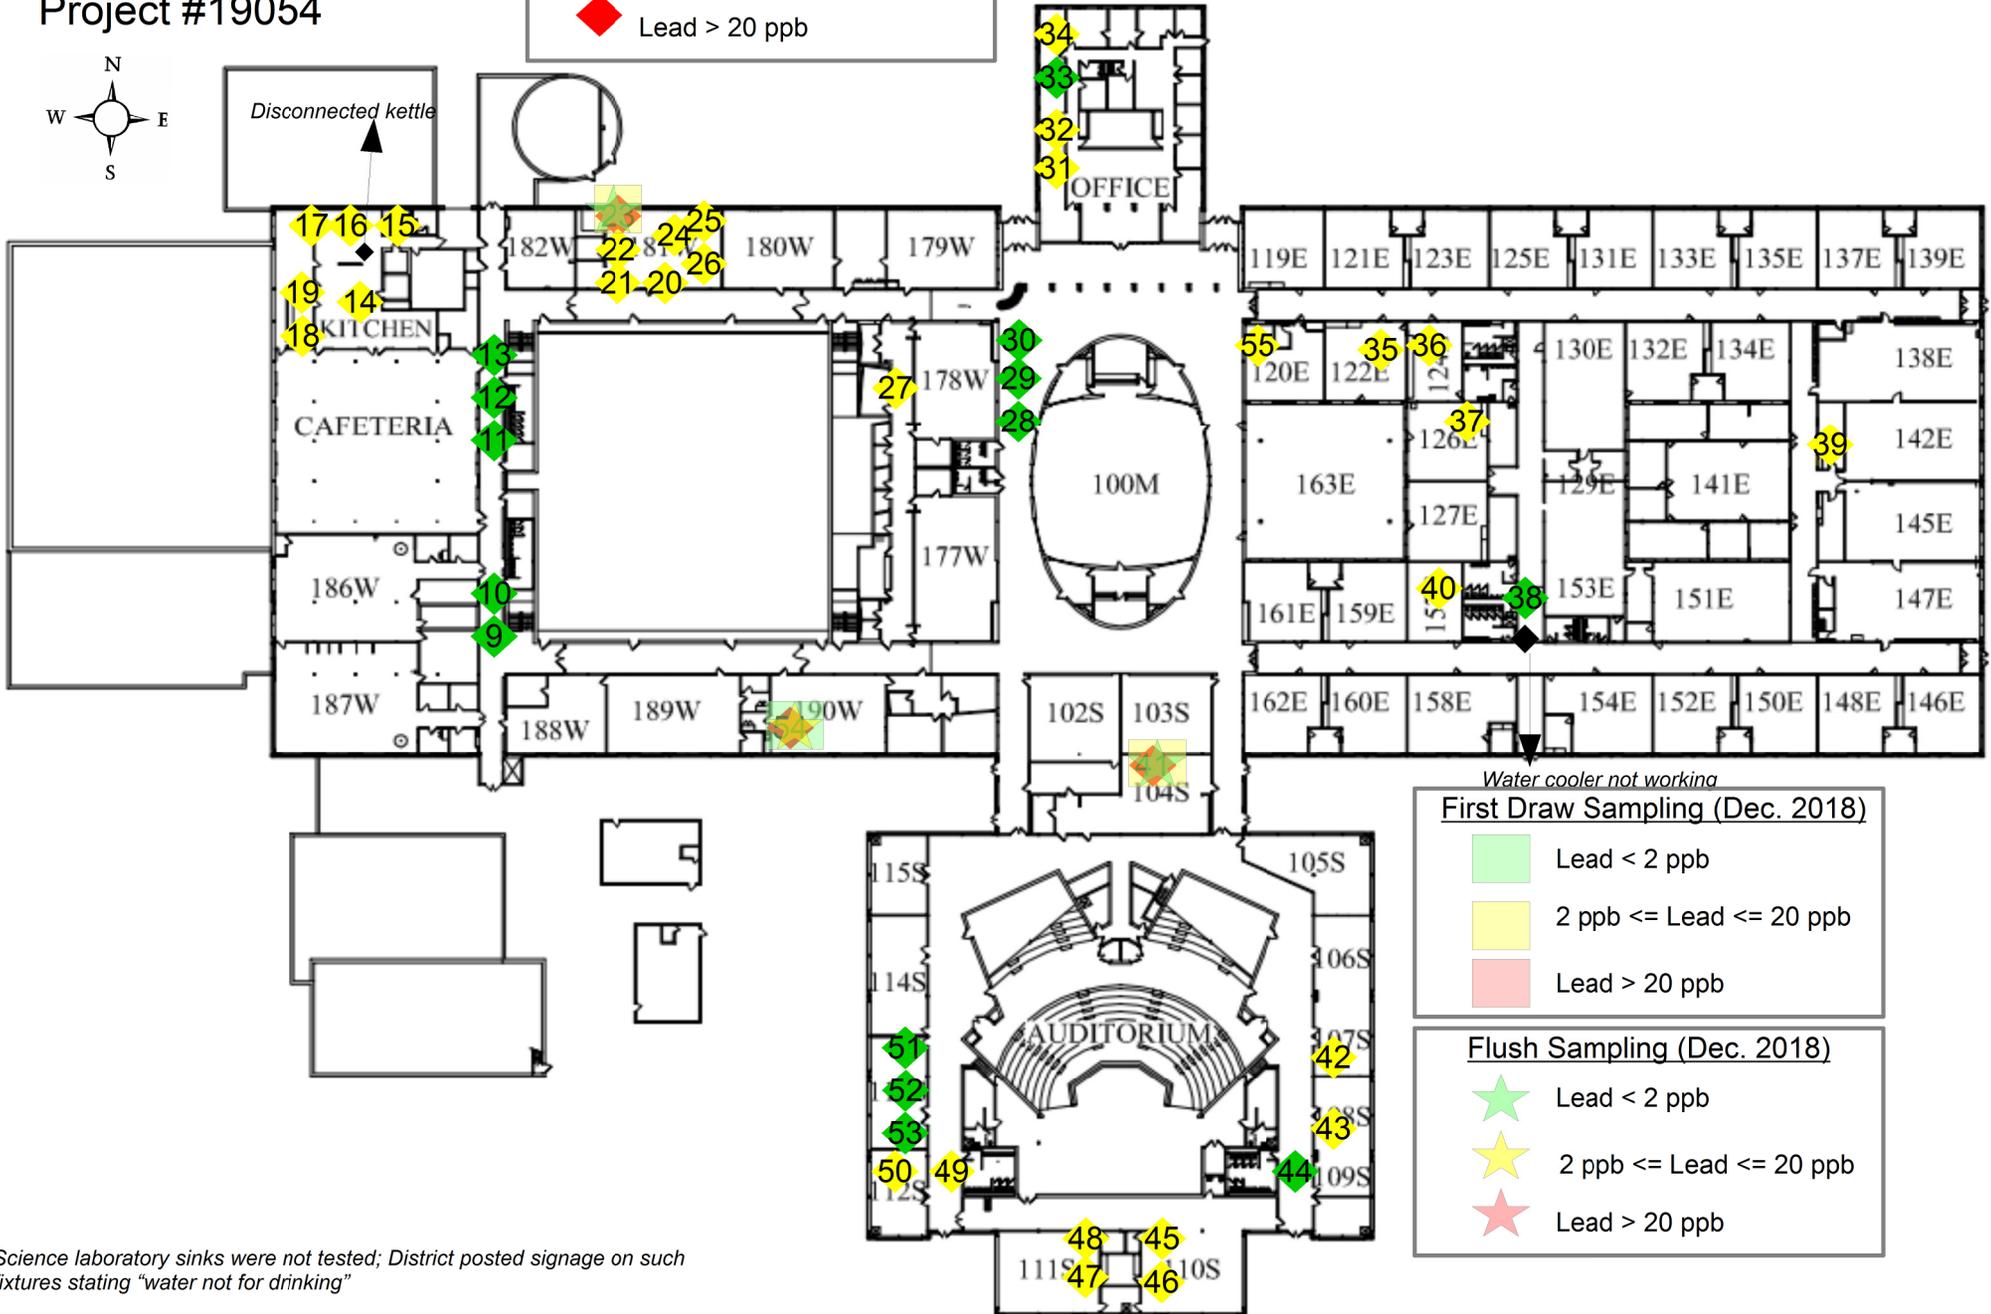
First Draw Sampling (Nov. 2018)

- ◆ Lead < 2 ppb
- ◆ 2 ppb <= Lead <= 20 ppb
- ◆ Lead > 20 ppb

First Draw Sampling (Dec. 2018)

- Lead < 2 ppb
- 2 ppb <= Lead <= 20 ppb
- Lead > 20 ppb

Flush Sampling (Dec. 2018)

- ★ Lead < 2 ppb
- ★ 2 ppb <= Lead <= 20 ppb
- ★ Lead > 20 ppb

Science laboratory sinks were not tested; District posted signage on such fixtures stating "water not for drinking"

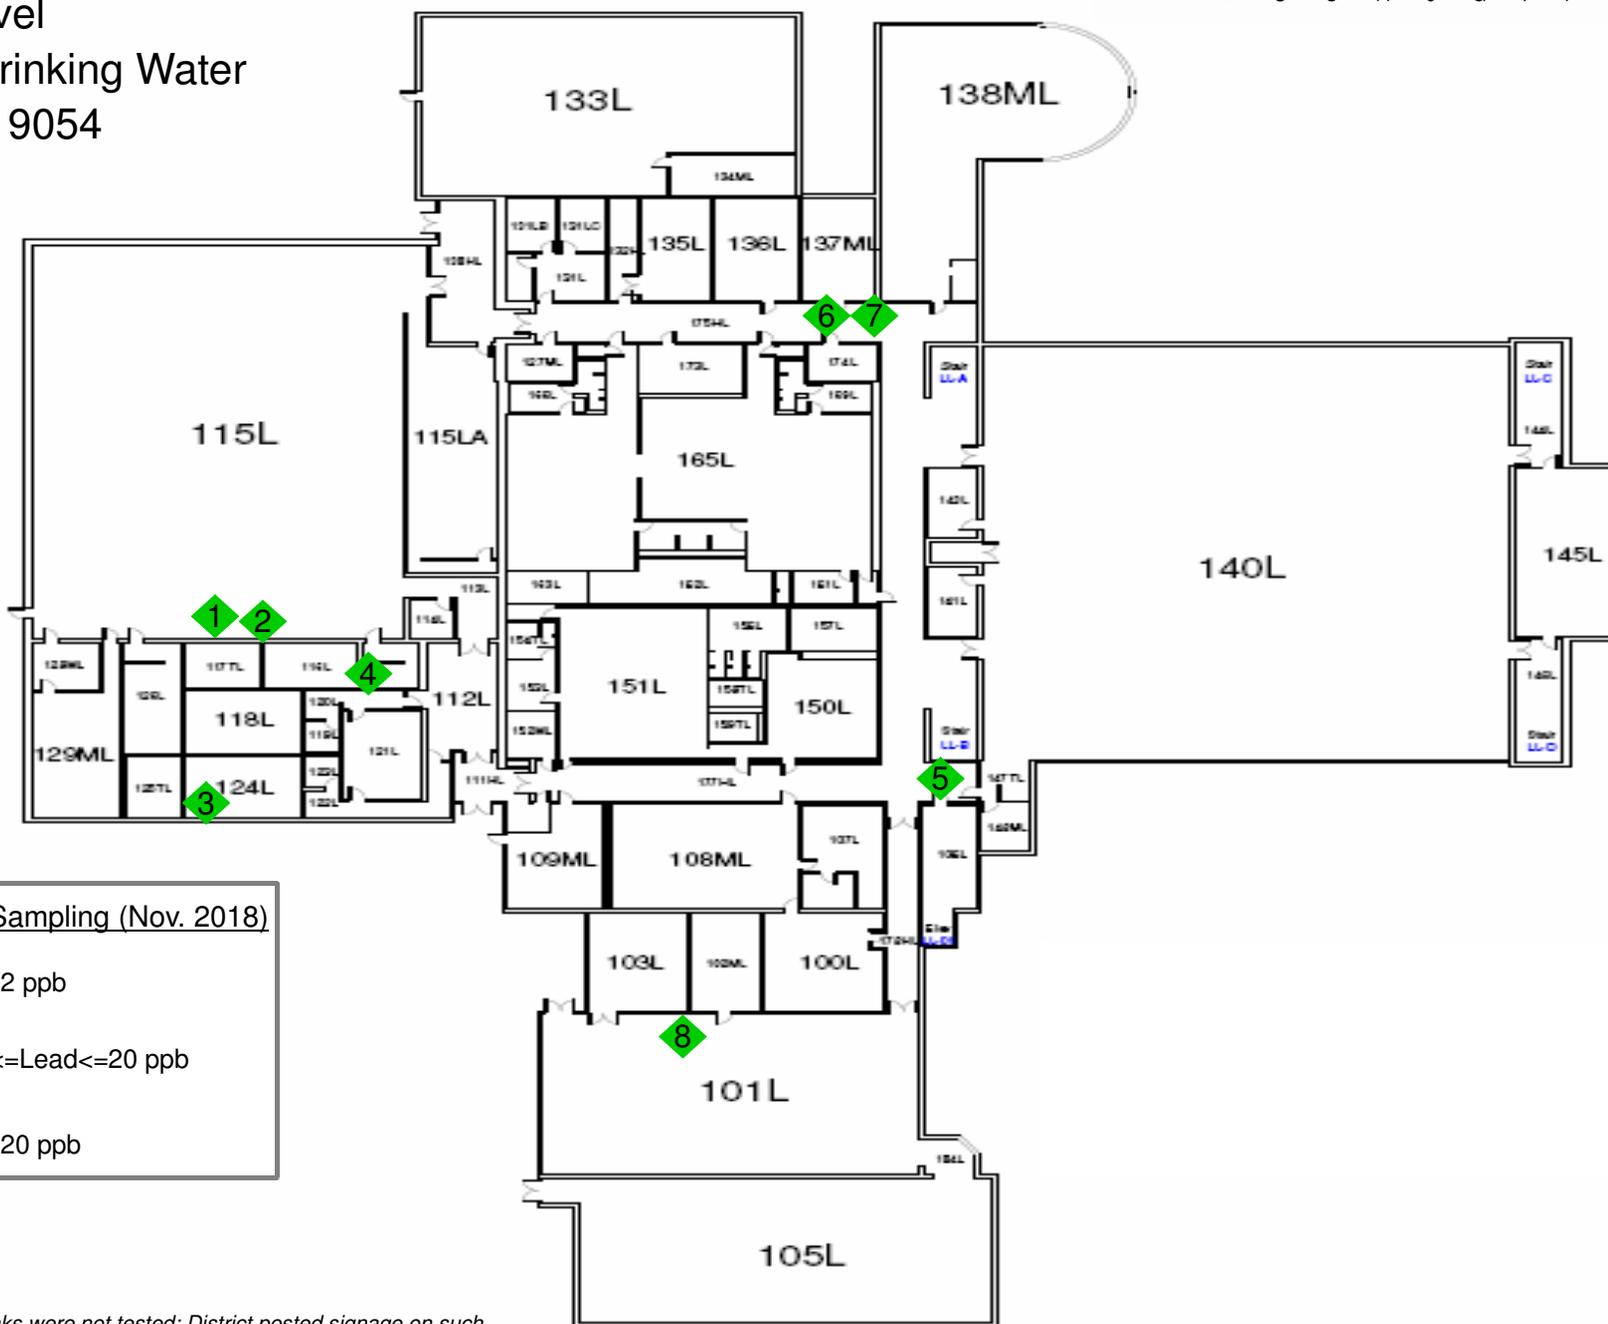
First Draw Sampling (Nov. 2018)

- ◆ Lead < 2 ppb
- ◆ 2 ppb <= Lead <= 20 ppb
- ◆ Lead > 20 ppb

Science laboratory sinks were not tested; District posted signage on such fixtures stating "water not for drinking"
