High School Facilities Study and Assessment for

Madison Metropolitan School District

PRA Project No. 180223-01 | January 9, 2019

EAST HIGH SCHOOL

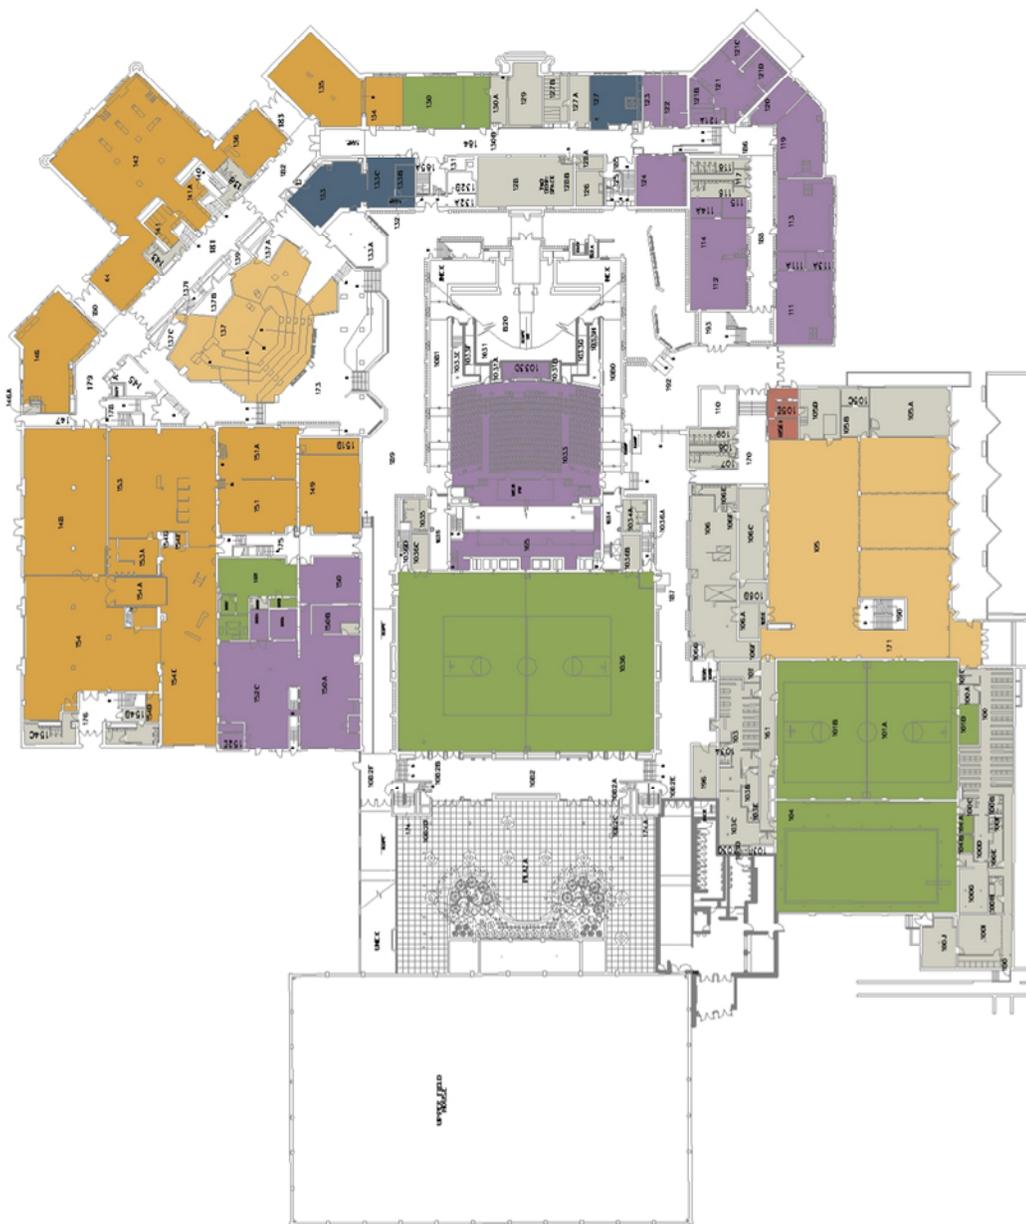
GROUND FLOOR

- OFFICE / ADMIN
- SERVICE / RESTROOMS
- PHYSICAL EDUCATION
- GENERAL CLASSROOMS
- SPECIAL EDUCATION
- ARTS
- IMC / LIBRARY
- STUDENT COMMONS / CAFETERIA
- OTHER SPECIALS

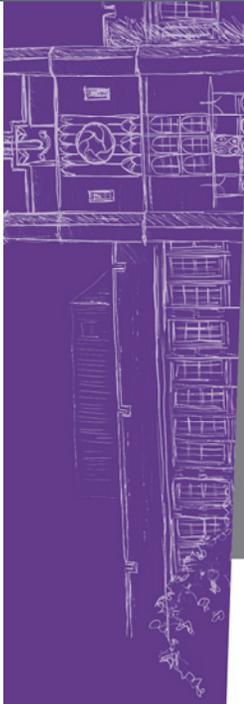
THIRD FLOOR PLAN - PROPOSED

- 2 LIBRARY**
Renovations will be made to combine existing library spaces into one upgraded facility. In order to achieve this, a portion of the existing corridor will be utilized to tie these spaces together. In effect, the corridor will be re-routed around the library in order to maintain student circulation. Modernizations will be made to the Library that will incorporate flexibility and collaboration through the use of finishes, furniture, and technology.

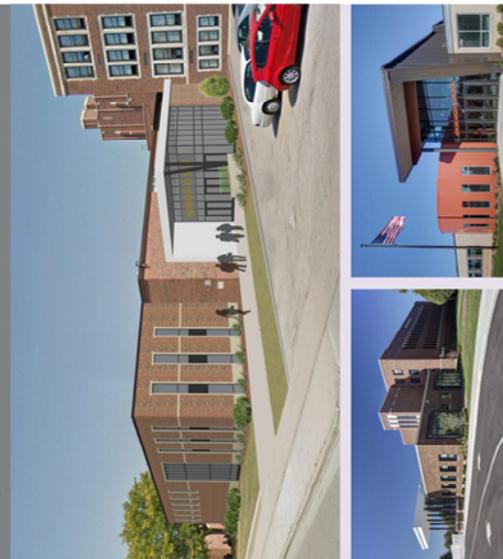
1 MAIN ENTRY

- 1 MAIN ENTRY**
An addition and renovation of existing spaces will combine the office and the Welcome Center into one area of the building that is easily accessible to the public. A new, emphasized main entry will also be a part of the addition to allow the student, staff, and visitor access to the building to be easily identifiable and reflect importance.

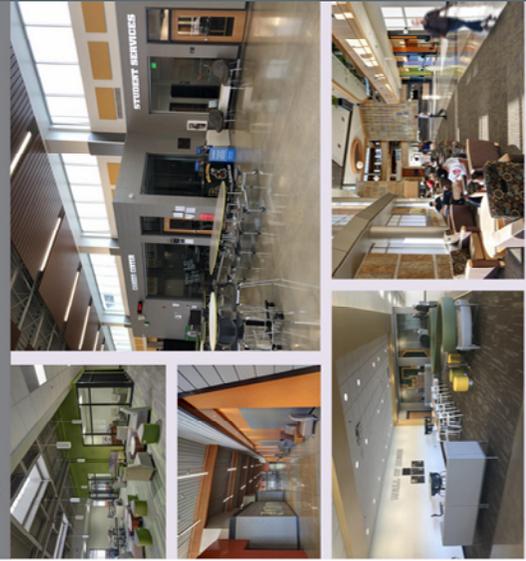
3 STUDENT SERVICES

- 3 STUDENT SERVICES**
This space will be relocated to the existing music department area of the building. Renovations to the area will include incorporating collaborative spaces for students and staff, flexibility of space for program needs, and adding a stairwell for public access.

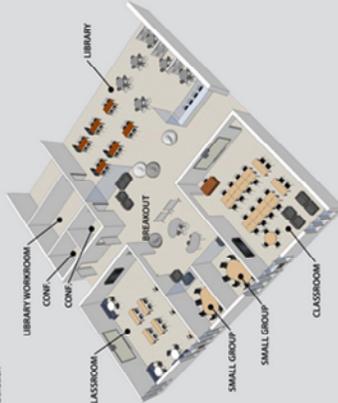
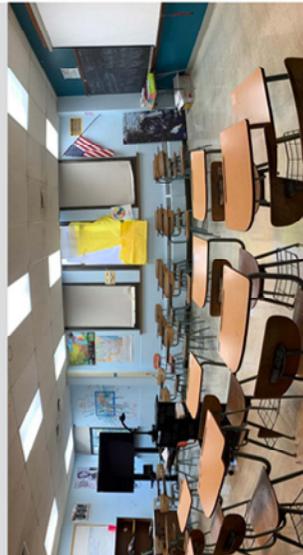
EXISTING CLASSROOM

- Non-flexible, non-economically friendly furniture
- Ease of flexibility as a whole is lacking
- Lack of variety in furniture types and styles
- Existing walls are instead of slides
- Dated finishes (flooring, walls, ceilings, etc.)

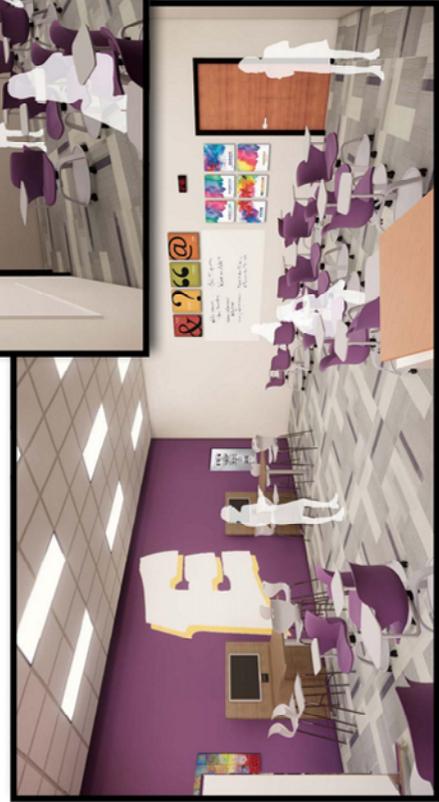
RENOVATED CLASSROOM EXAMPLE

- Updated finishes - variety throughout, mobile, flexible, ergonomically friendly
- Flexibility of space is built in through variety and mobility of furniture
- Furniture will be upgraded
- Teaching wall will be upgraded - white board instead of chalk board, mobile technology can be continued to be used
- Upgrades to finishes will be implemented, while keeping important architectural features (i.e. brick wall) - new flooring, new wall finishes / paint, new ceiling, etc.
