# High School Facilities Study and Assessment for

Madison Metropolitan School District

PRA Project No. 180223-01 | January 9, 2019

## ROBERT M. LA FOLLETTE HIGH SCHOOL

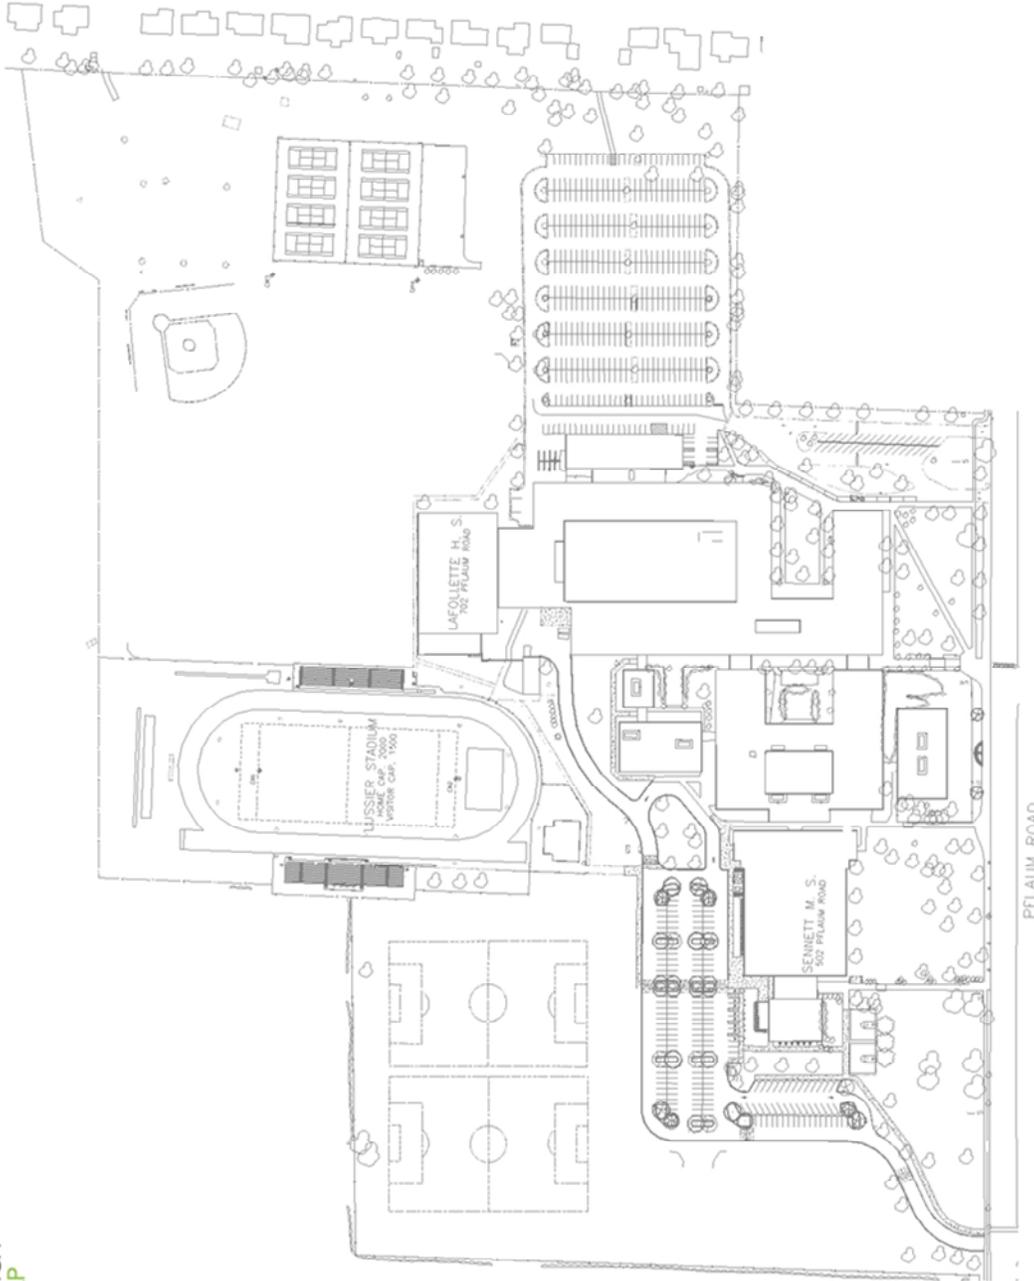
SITE PLAN

To provide an understanding of the property and extents of the site and building. A site plan identifies the attributes about the property and surrounding existing conditions.

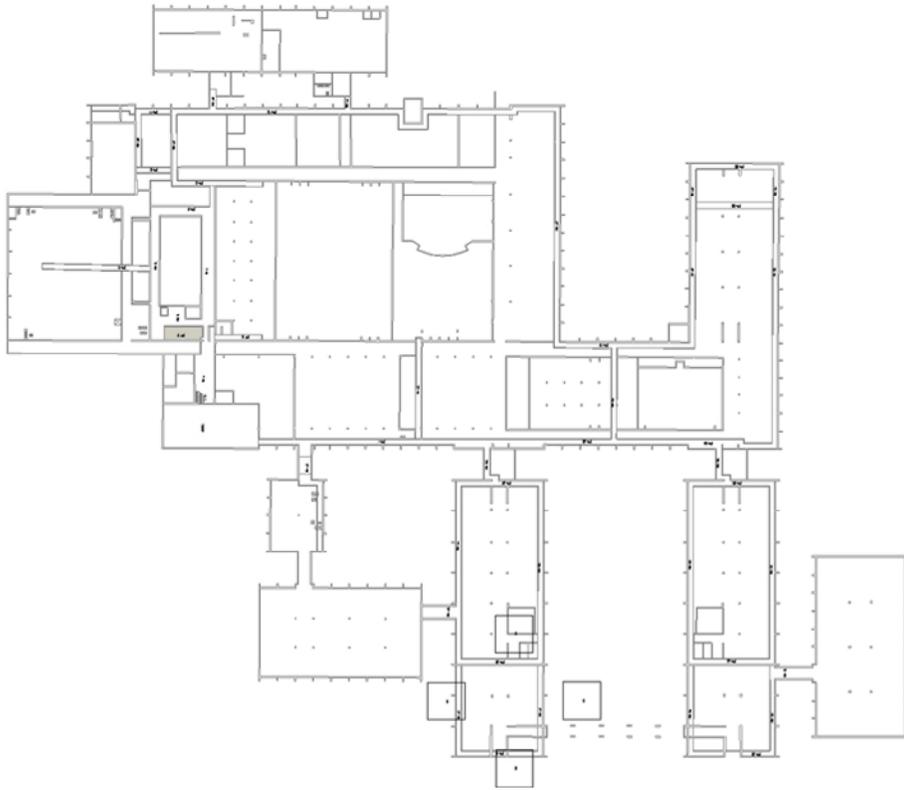
BASEMENT FLOOR PLAN

To evaluate the educational use of the building. Understanding where academic and support spaces are located allows for planning of the building to be used most effectively.

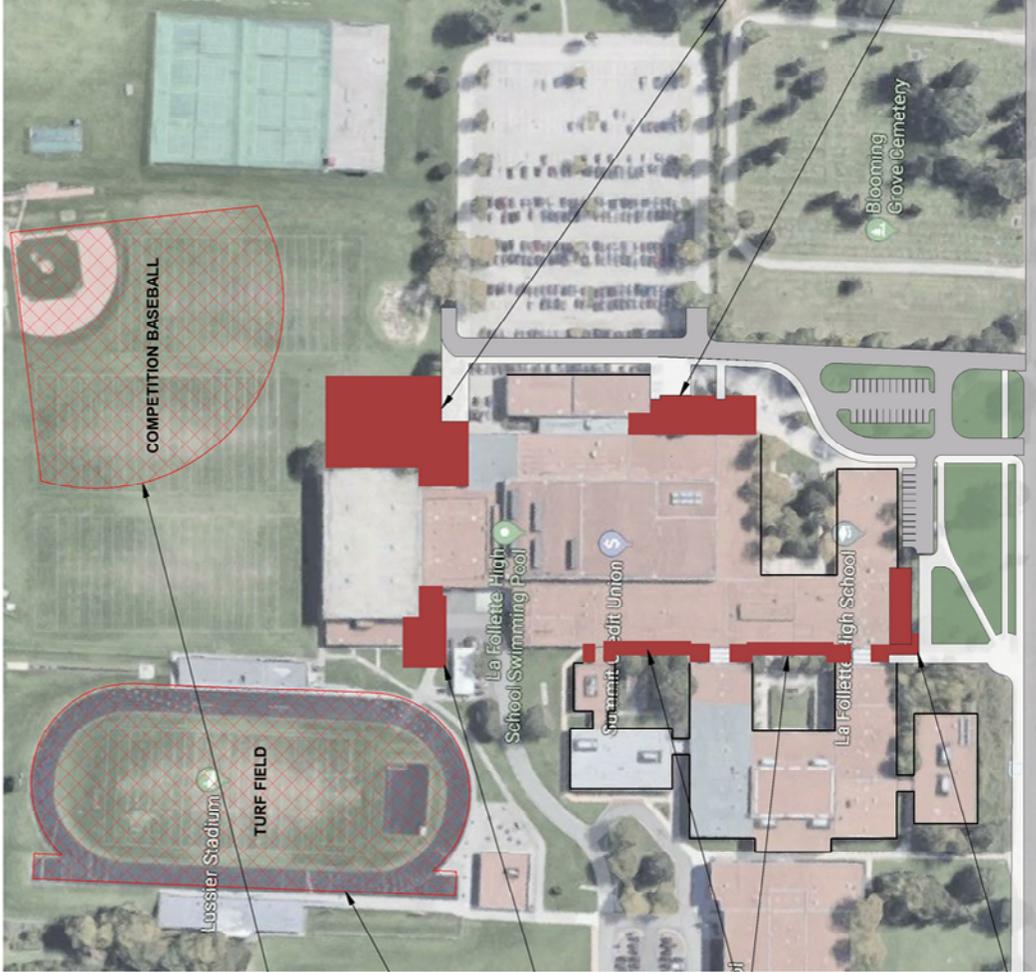
**Proposed Design Recommendations**

**Corridor, Circulation and Commons Additions and Renovations**  
Additions to the existing courtyards will create an enclosed corridor to help alleviate one of the most congested circulation spine of the school. Renovation to the existing corridors and commons adjacent to these additions are also proposed to address circulation flow.

**Main Entrance Addition**  
An addition and renovation of existing space will combine the office and Welcome Center into one area of the building that is easily accessible to the public. A new, emphasized main entry will also be a part of the addition to allow the student, staff and visitor access to the building to be easily identifiable and reflect importance.

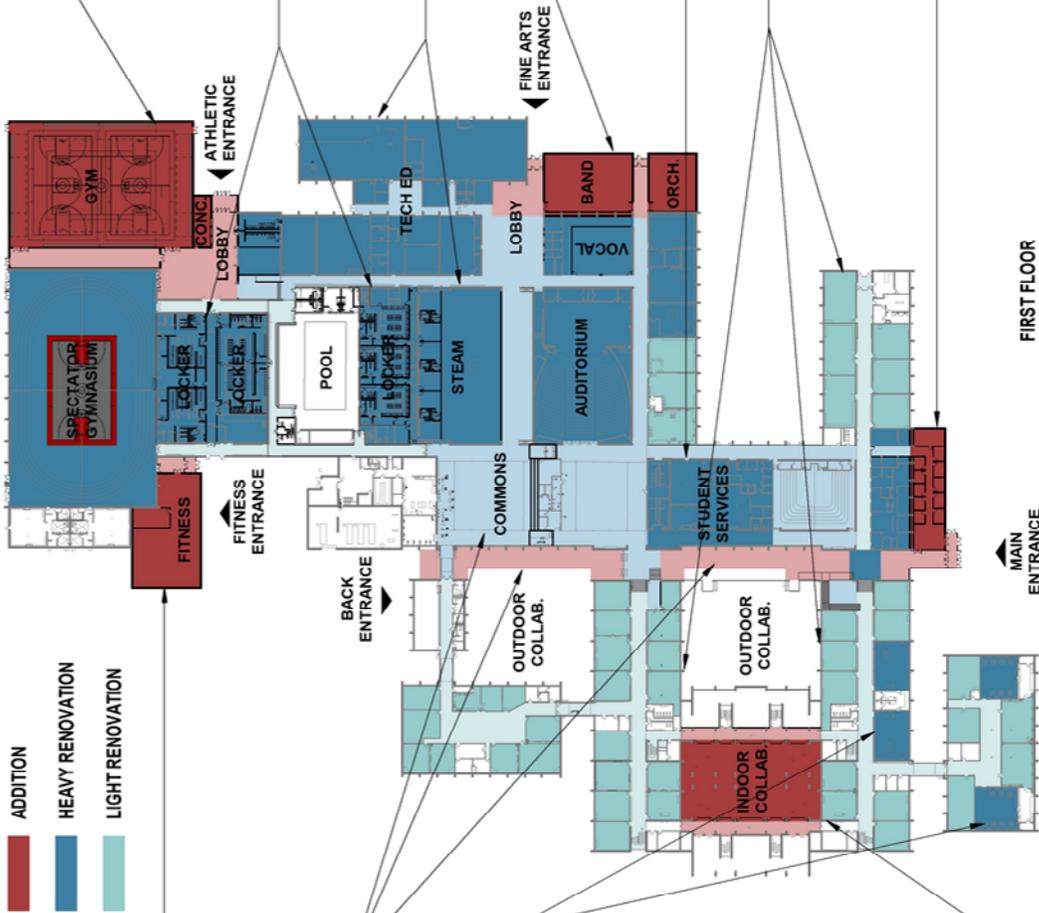
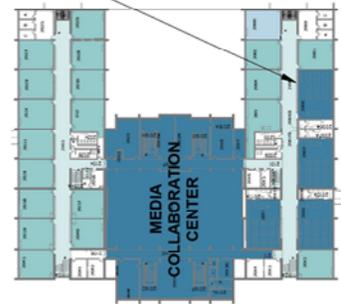
FLOOR PLANS - PROPOSED

**Science Classrooms Renovations**  
 Existing science classrooms will have heavy renovations that include the following:  
 - Provide variety of furniture and flexibility of furniture where applicable.  
 - Updating finishes to provide a more modern learning environment.  
 - Updated technology and additional white board space for instruction.  
 - Provide adequate resources: gas, water, electrical, etc.  
 - Provide possibility for collaboration between rooms.

**Collaboration Renovations**  
 The existing "pit" area will be enclosed to create a more usable collaborative space for students. Through use of flexible furniture and upgraded technology, this space will allow flexibility of spaces to meet the needs of any size group.

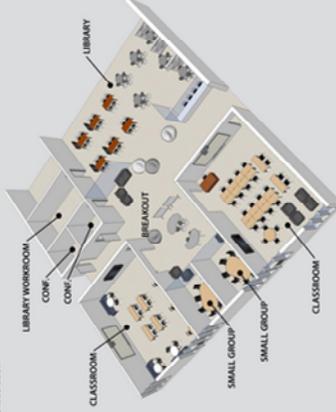
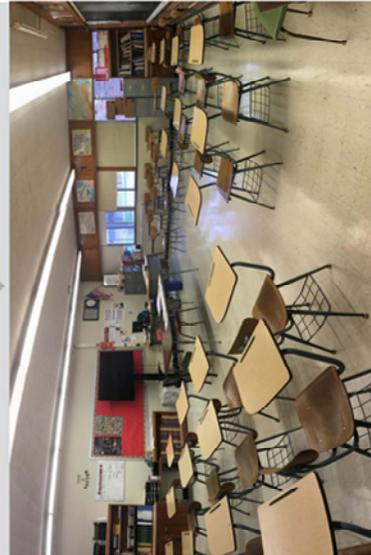
### EXISTING CLASSROOM

- Non-flexible, non-ergonomically friendly furniture
- Lack of flexibility of a wall to be used as a whiteboard
- Teaching walls are in need of upgrades
- Dated finishes (flooring, walls, ceilings, etc.)

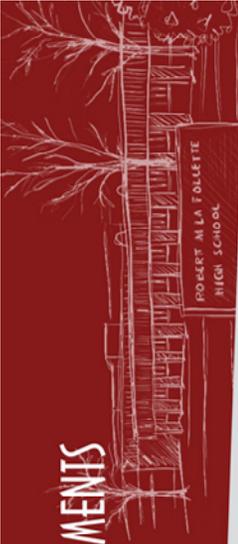
**EXISTING SCIENCE CLASSROOMS**

- Space is static - does not offer opportunities for flexibility
- Space is very underused
- Furniture is dated and does not offer any adjustment
- Non-flexible, non-ergonomically friendly furniture
- Lighting in need of upgrading to LED
- Heating walls are in need of upgrades
- Dated finishes (flooring, walls, ceilings, etc.)

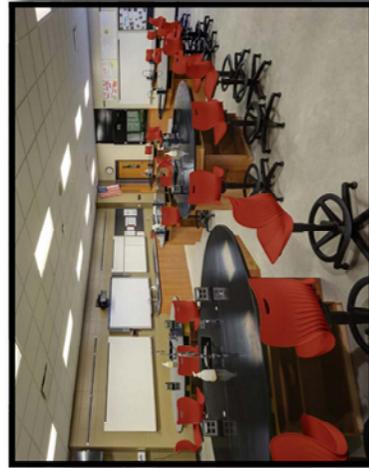
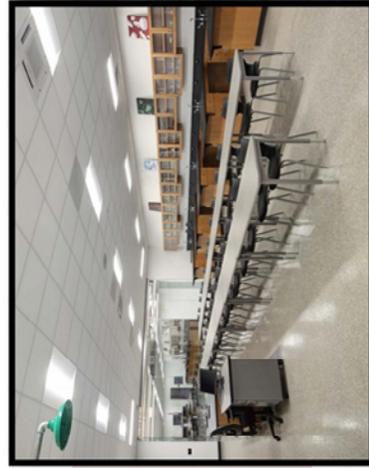
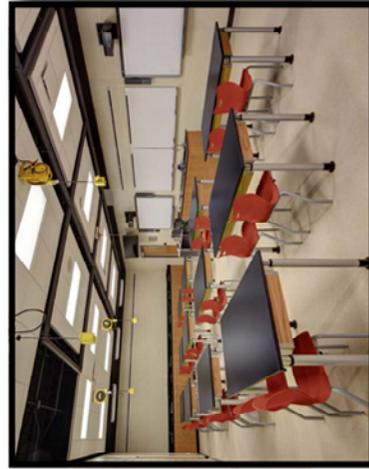
**EXAMPLE SCIENCE CLASSROOM UPGRADES**

- Providing variety of furniture and flexibility of furniture where applicable
- Updating finishes to provide a more modern learning environment
- Updated technology and additional white board space for instruction
- Provide adequate resource gas, water, electrical, etc.
- Provide possibility for collaboration between rooms

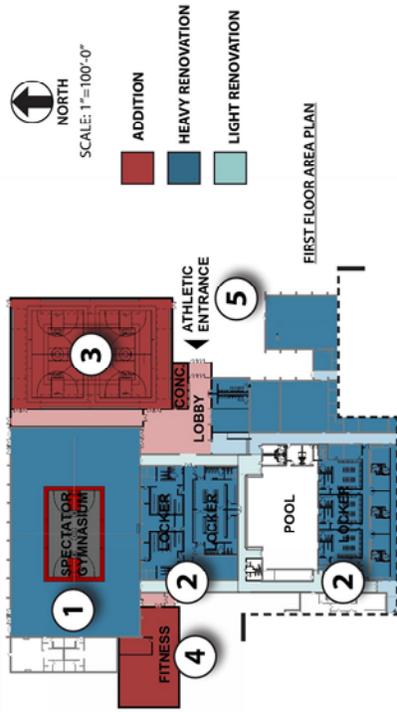
Additions and renovations will be made to the athletic facilities within the school in order to group spaces together in an intentional way to allow for after school use as well as community use. Improvements will be made to the exterior athletic facilities as well.

- 1 SPECTATOR GYM**
  - Bleachers to seat 2,000 will be added
  - New main spectator court
  - Finishes to be upgraded
- 2 LOCKERS**
  - Existing lockers will be upgraded
  - Additional lockers will be added
- 3 AUXILIARY GYM**
  - New Auxiliary Gym will be added to replace existing Auxiliary Gym, as it will be renovated into STEAM space
- 4 FITNESS CENTER**
  - New fitness space to be added
- 5 ATHLETIC ENTRY**
  - Identifiable entry for athletic events
- 6 SITE**
  - Upgrades to:
    - Competition baseball field
    - Football field and track rebuilt to accommodate regulation soccer - rebuilt as turf field
