High School Facilities Study and Assessment for

Madison Metropolitan School District

PRA Project No. 180223-01 | January 9, 2019

ROBERT M. LA FOLLETTE HIGH SCHOOL

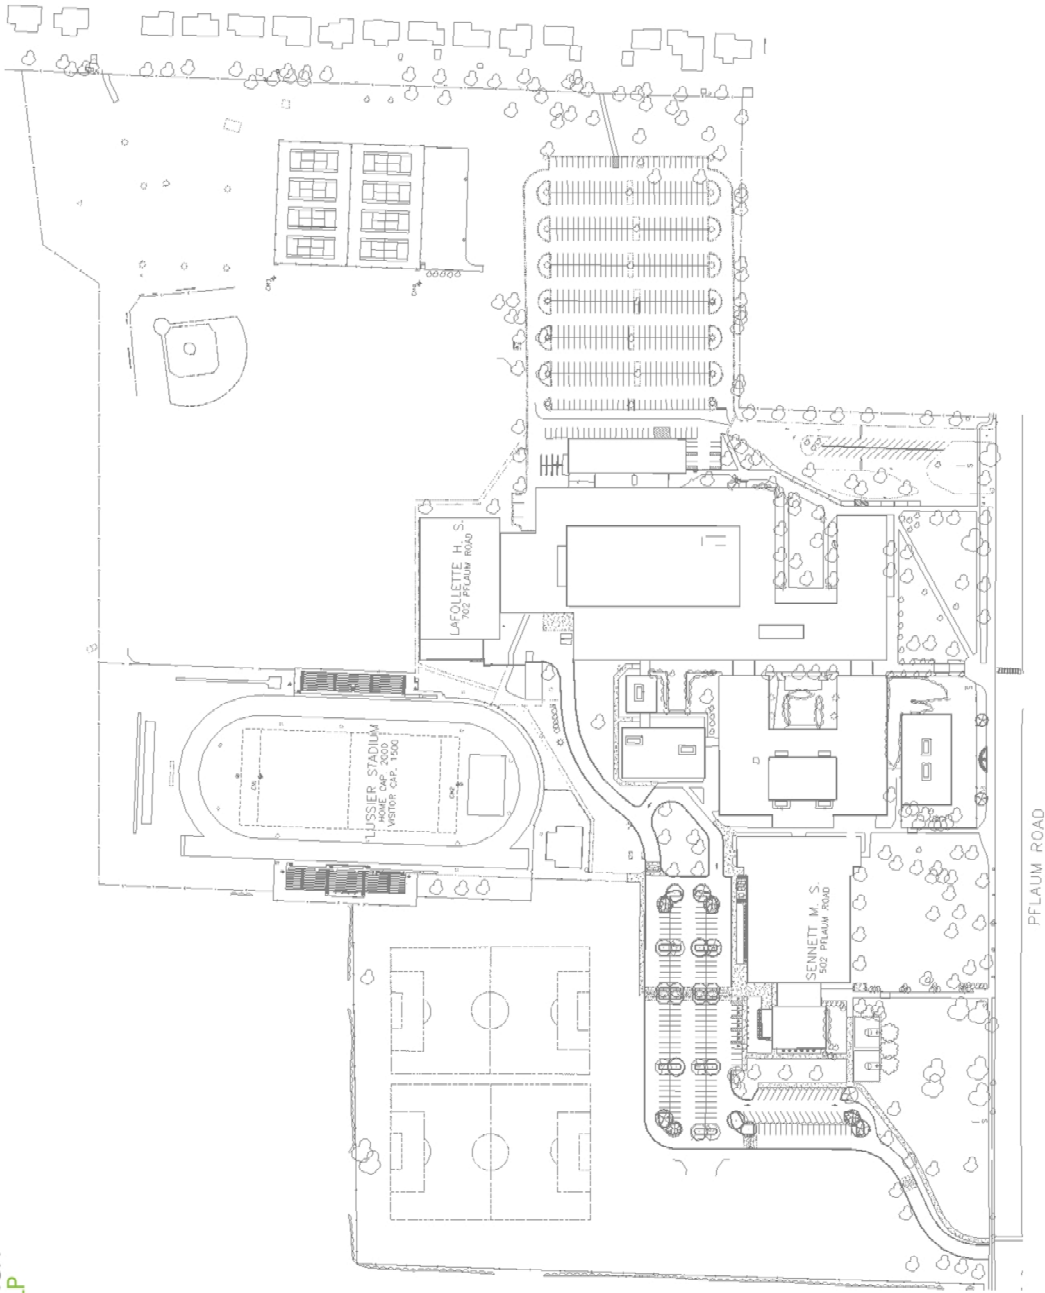
SITE PLAN

To provide an understanding of the property and extents of the site and building. A site plan identifies the attributes about the property and surrounding existing conditions.

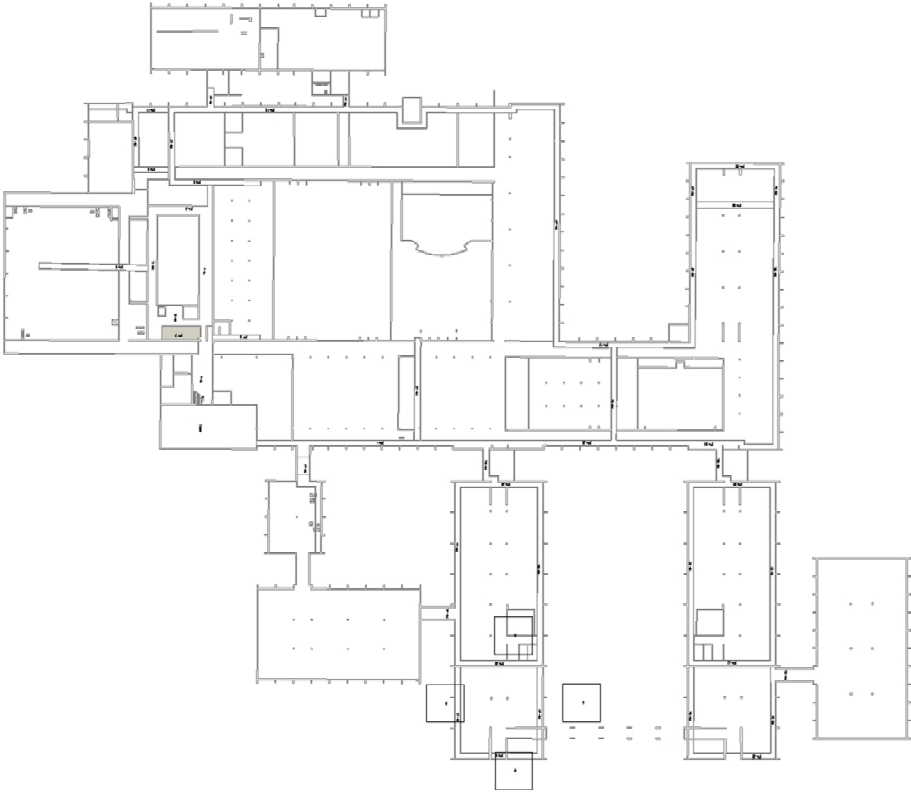
BASEMENT FLOOR PLAN

To evaluate the educational use of the building, a plan that identifies the extent of educational use provides an understanding of how the building provides educational function of space. Understanding where academic and support spaces are located, allows the planning of the building to be used most effectively.

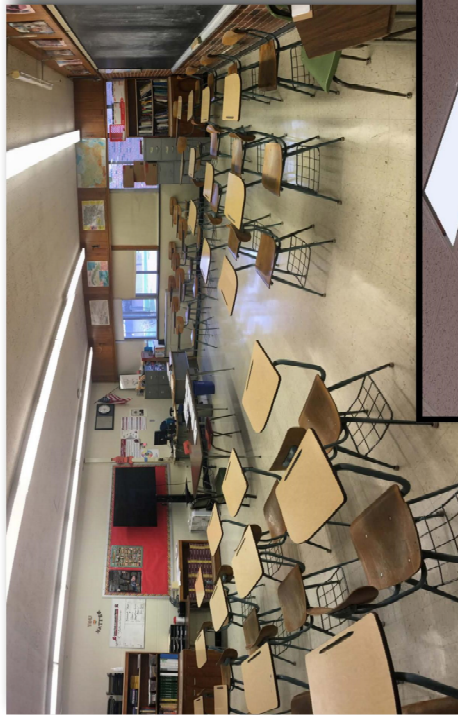
EXISTING CLASSROOM

- Non-flexible, non-ergonomically friendly furniture
- Lack of flexibility as a whole in technology
- Classroom walls are in need of upgrades
- Teaching walls are in need of upgrades
- Dated finishes (flooring, walls, ceilings, etc)
